**Flood Control, Mississippi River and Tributaries  
Yazoo River Basin - Tallahatchie River  
Tallahatchie County, Mississippi**

**Ascalmore Creek - Tippo Bayou  
Item No. 3, Control Structure**

**FOUNDATION  
REPORT**

**January 1992**

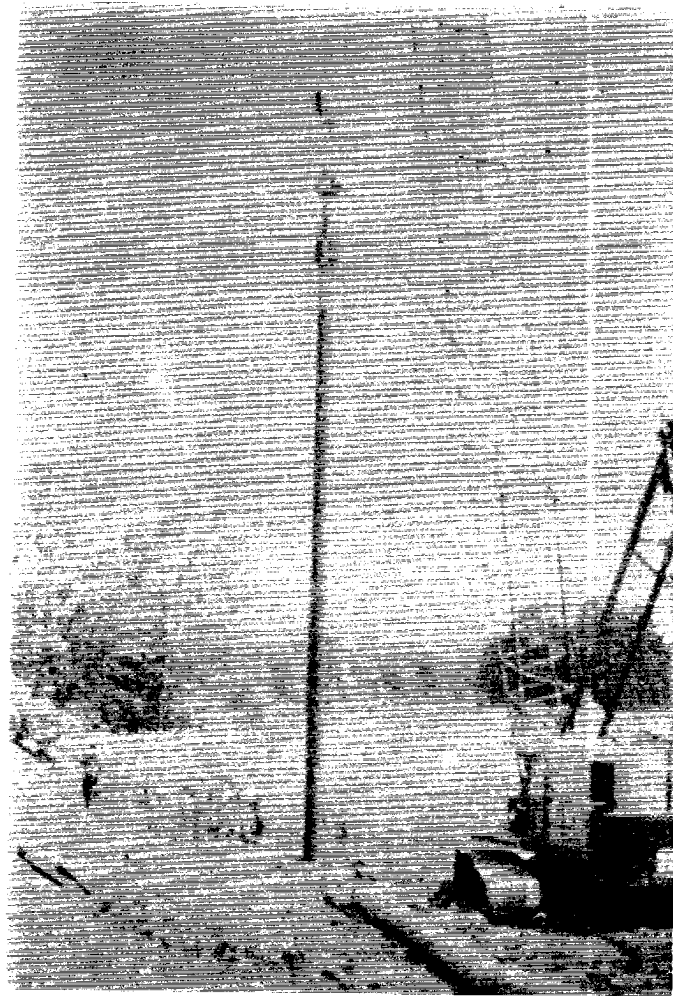
9. INSTALLATION OF DEWATERING WELL WITH JETTING TOOL.

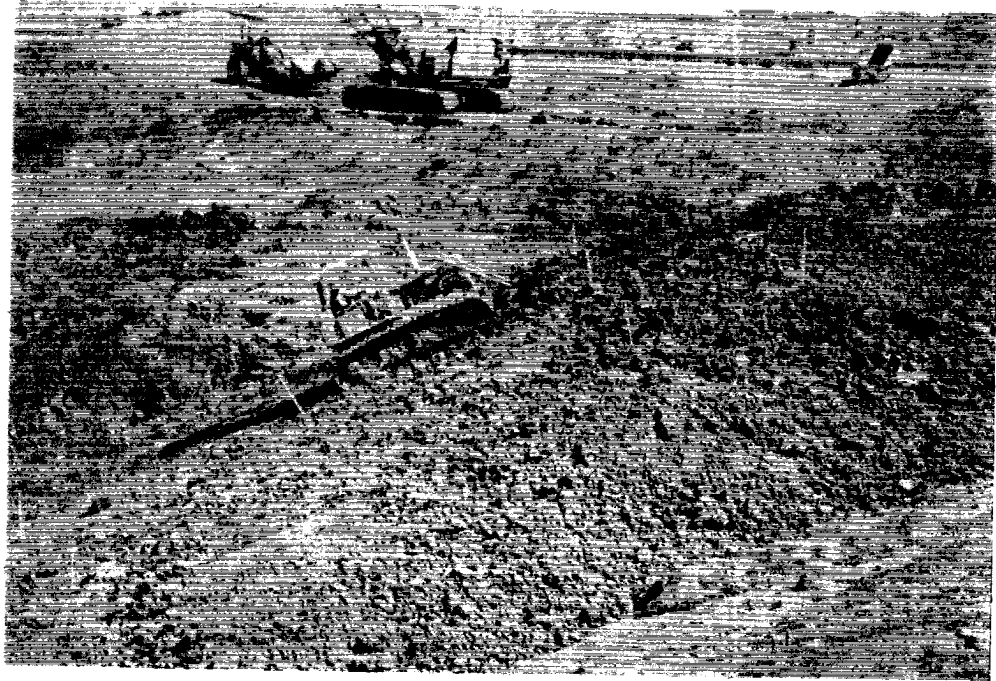
17. COMPACTING IMPERVIOUS BACKFILL NORMAL TO 1 ON 2 SLOPE
