TECHNICAL REPORT M1

SEDIMENTATION STUDY OF THE MISSISSIPPI RIVER SANTE FE CHUTE, DOOLAN CHUTE HYDRAULIC MICRO MODEL INVESTIGATION

September 1996

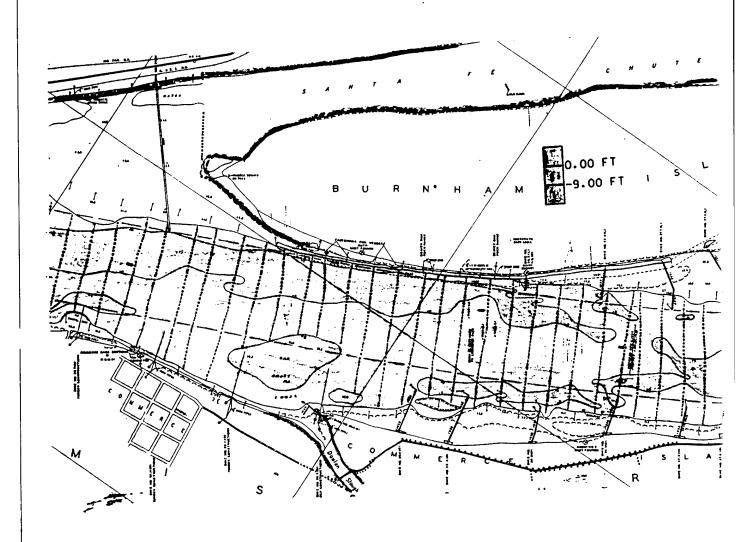
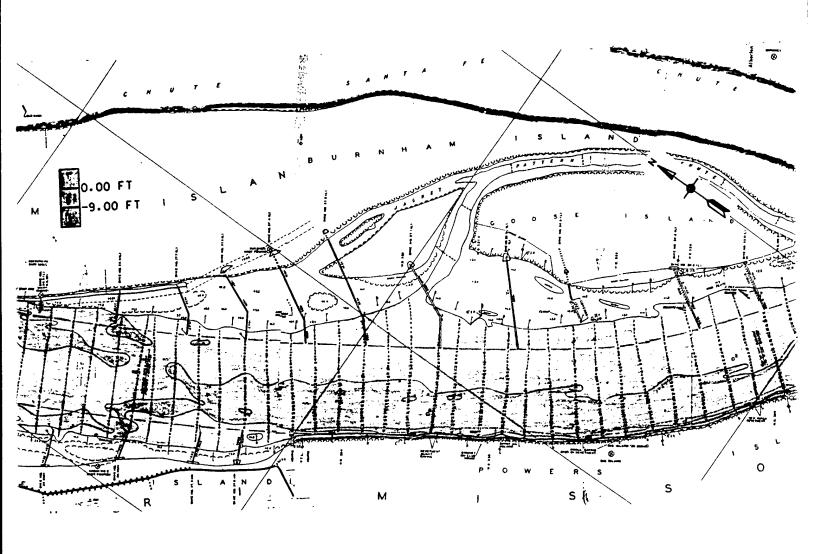
1958 PROTOTYPE SURVEY

Plate 3 depicts the historical condition of the chute in 1958. The entrance of the chute occurred on the right descending bank at mile 38.9. The entrance width was approximately 600 feet. The channel depth in this area was approximately 0 feet relative to the Low Water Reference Plane (LWRP), or approximately +5 at the Cape Girardeau gage. Although vegetation markings in the chute just

The width of the historical chute varied from as little as 200 feet at the lower end to as wide as 300 feet. A conservative estimate on the average width was approximately 250 feet, which is very similar to the present day chute width.

Little is known of the depths of the historical channel, although indications at the entrance and exit conditions from the hydrographic survey indicate that the chute, at least in these areas, was relatively shallow. It is assumed that the elevation of the banks of Doolan Chute was approximately the height of the banks of the main channel, or approximately a +30 LWRP, as indicated from the 1958 survey.
