An Archaeological Curation-Needs Assessment for Headquarters Air Combat Command

Volume 1

7. PERFORMING ORGANIZATION NAME(S) AND ADDRESS(ES) U.S. Army Corps of Engineers, St. Louis District 1222 Spruce Street (CELMS-PD-C) St. Louis, Missouri 63103-2833			8. PERFORMING ORGANIZATION REPORT NUMBER Archaeological Curation-Needs Assessment Technical Report No. 10, Volume 1

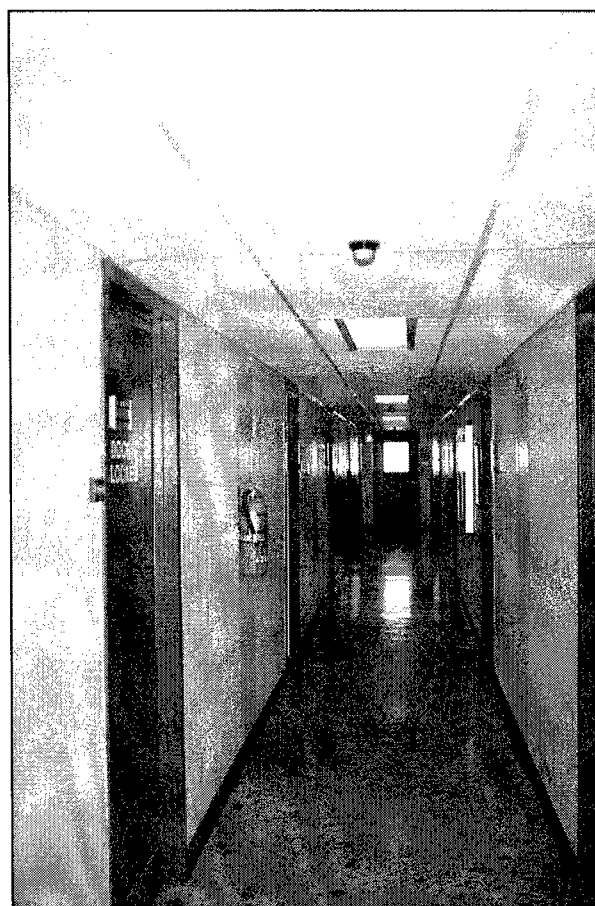
Figure 2. Fire extinguishers, fire doors, and fire walls in the hallway of Building 4300. The motion sensor on the ceiling may be nonfunctional.

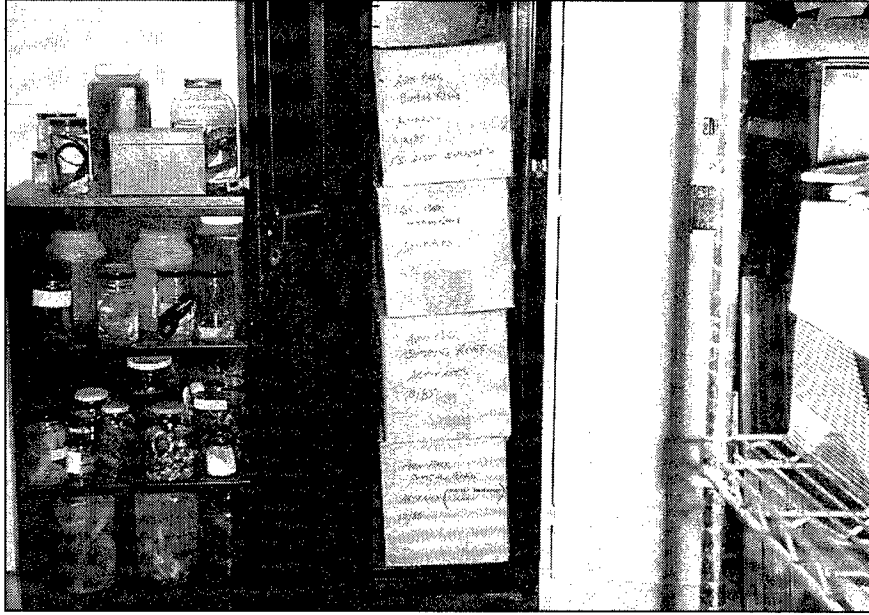
Primary containers consist of four boxes constructed of glued acidic cardboard with folded flap lids. Tape has been used to secure and reinforce the bottoms of the boxes, which measure 12.5 x 12 x 12 inches (l x w x h; approximately 1 ft³ each). Because of the way the boxes are stored, some have begun to show compression

Figure 21. The Avon Park AFR collection is stored in metal cabinets next to biological specimens. Note the damage to primary containers due to stacking.

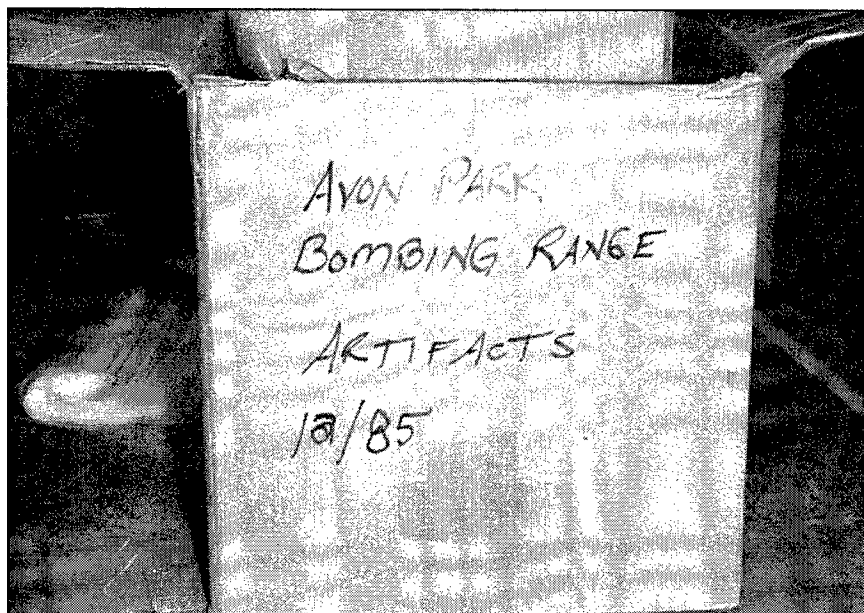
Figure 23. Damaged primary container. Note the direct labeling in marker.

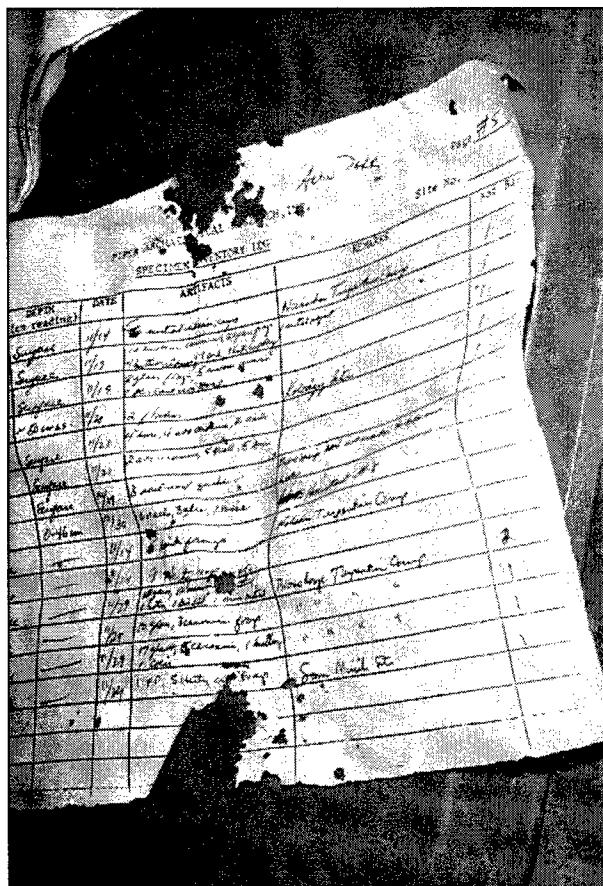
Figure 25. Box-inventory page rendered virtually unintelligible by insect damage.

1. Implement a professional pest-management system for the facility. Address the current spider and silverfish infestations.
2. Install smoke detectors and an overhead sprinkler system in the collections storage area.
11. Make two copies of the artifact inventory on acid-free paper. Store one copy off-site in a separate, fire-safe, secure location. Accession the second copy, place it in an acid-free folder labeled directly in indelible ink, and place in an acid-free primary container.

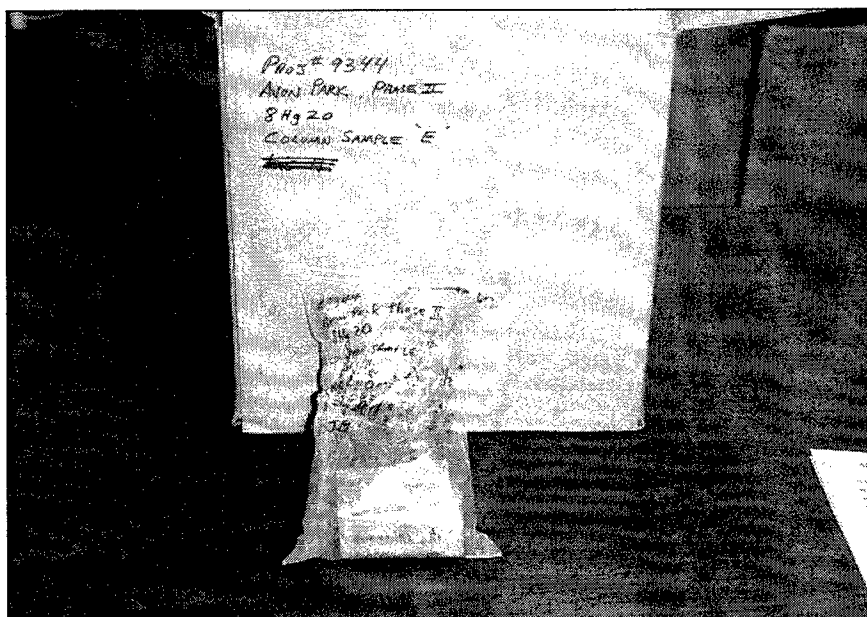
Figure 26. Two boxes are stored in the laboratory at JANUS Research. Primary and secondary containers are labeled directly in marker.

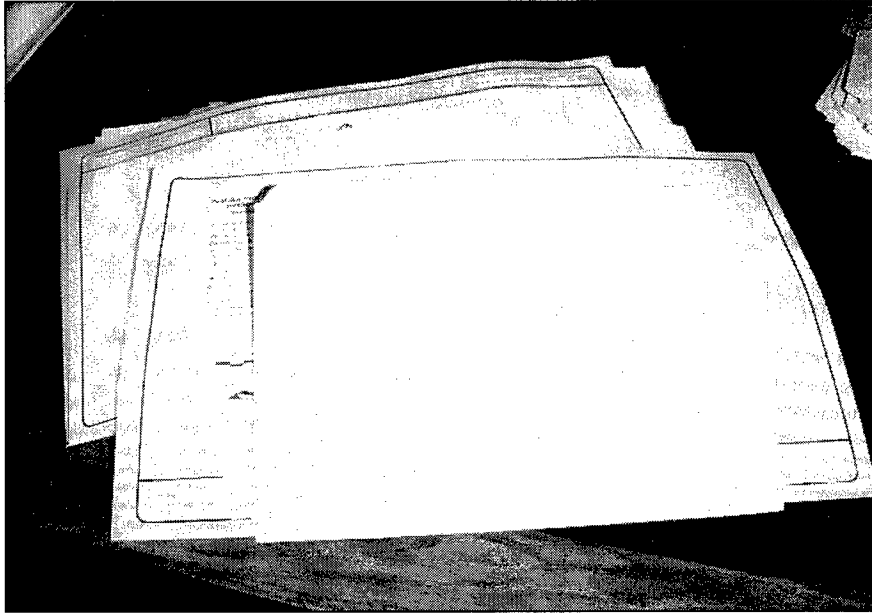
Figure 31. Camera-ready report pages are stored improperly in manila file folders.

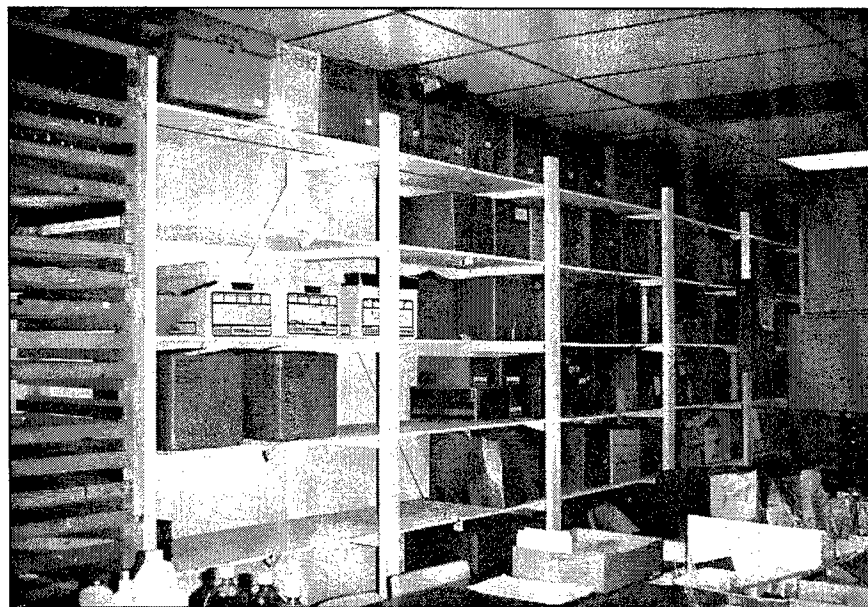
Figure 34. Bulk collections are stored on homemade wooden shelves.

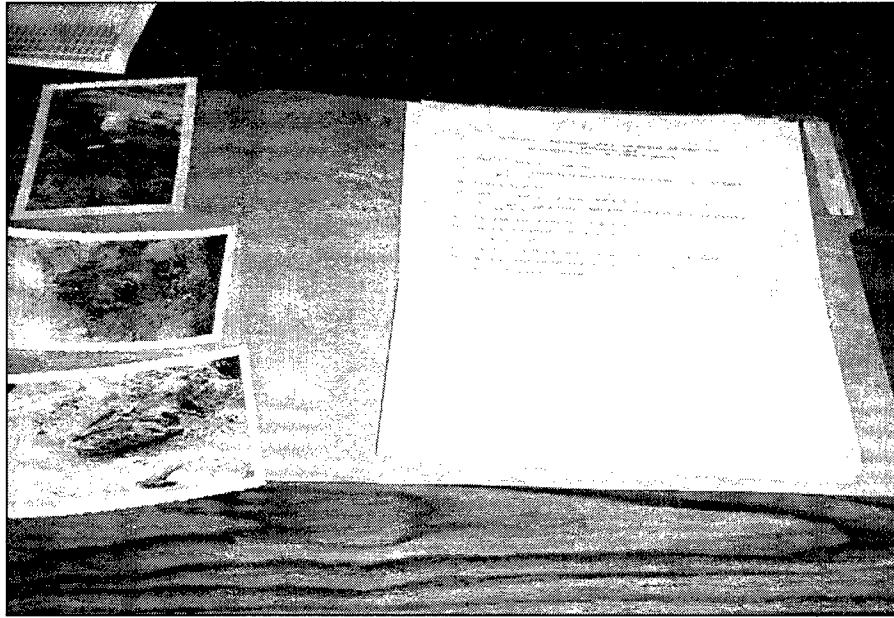
Photographic documentation consists of three black-and-white prints measuring 3 x 4.5 inches. No label information remains for these records. All photographs document the remains in situ. These photographs are filed loose in the file along with the paper documentation (Figure 37).

Figure 37. No special arrangements are made for photographic materials, which are stored improperly.

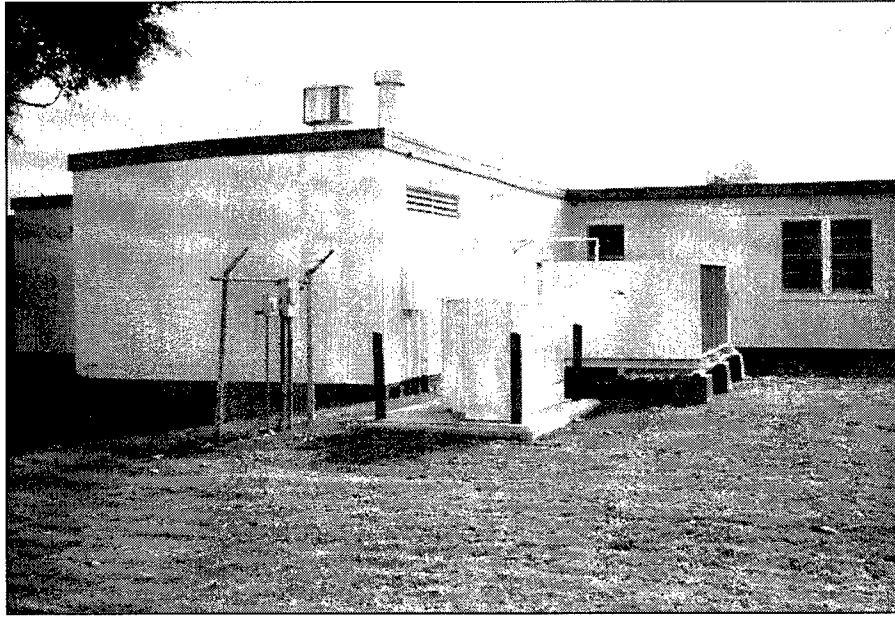
Figure 38. The boiler for Building 5088 is located in a connected, adjacent building.

The boiler, which was replaced in the 1970s, is located in an interconnecting, adjacent building off the south side of the museum (Figure 38). The heating system is original to the building, but some of the electrical work has been updated. A smaller building, used for storage of hazardous materials, is located to the northwest of the museum building. Asbestos is present in the mechanical/tool room and also in some floor tiles. Barksdale AFB has an asbestos-removal unit on base, and the curator plans to have this unit remove the asbestos in the building in June 1995. The assessment team noted no indication of cracks or leaks in the foundation, walls, or around any of the windows. The building is considered structurally sound.

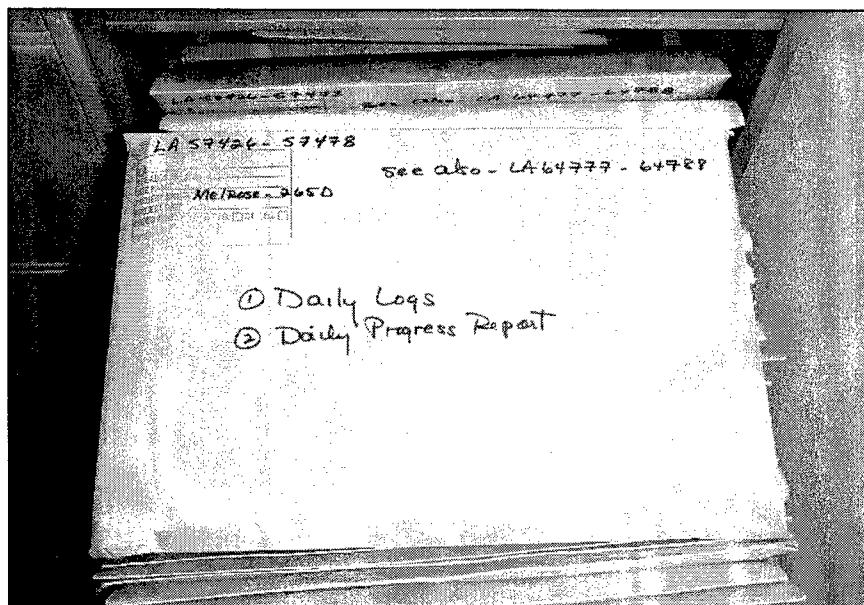
Figure 49. Melrose AFR documentation is housed in acidic manila envelopes that are labeled directly in marker and with a customized stamp.

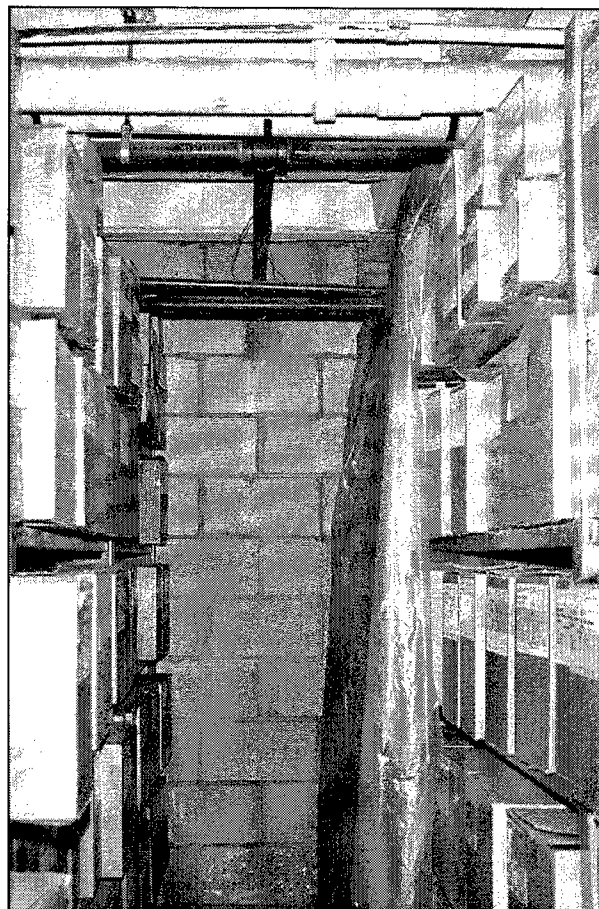
Figure 53. Plastic has been placed over the shelves and primary containers to prevent water damage from leaking overhead pipes.

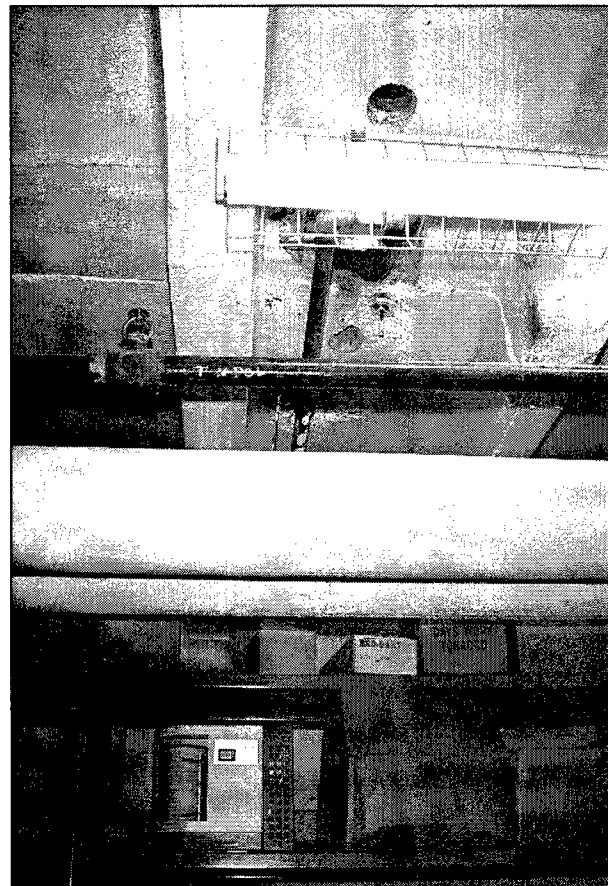
Figure 55. Hygrothermographs are located in each of the collections storage rooms in the LVR building. Also note the sprinkler system, unfiltered fluorescent lights, and holes in the concrete ceiling.

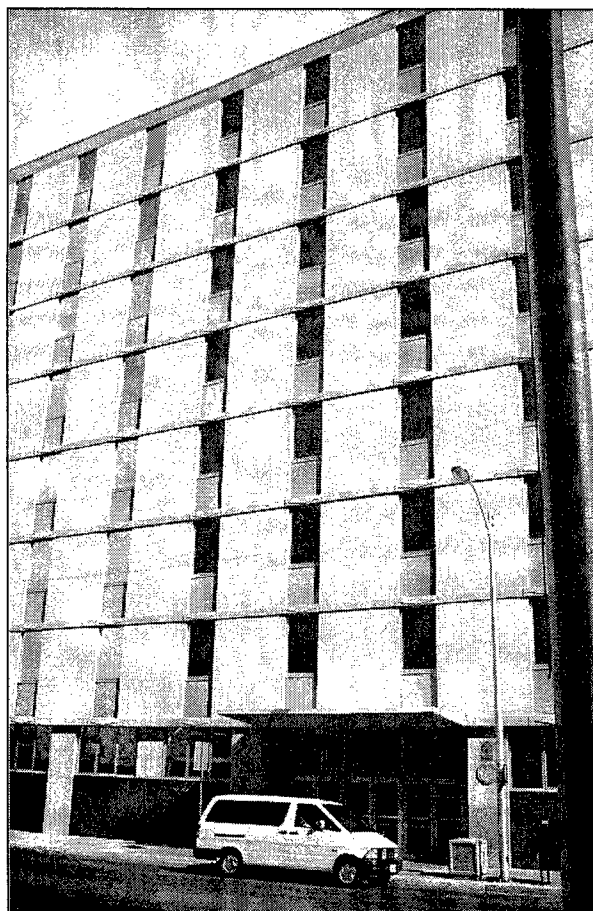
Figure 60. Exterior of the Federal Building in Albuquerque, which is considered structurally unsound.

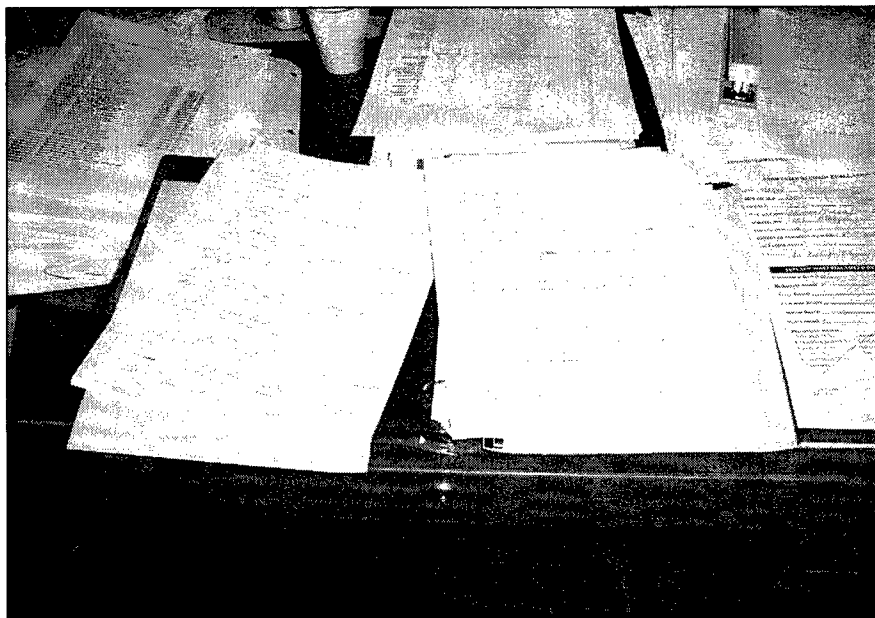
Figure 64. Associated documentation housed in a nonarchival-quality three-ring binder.

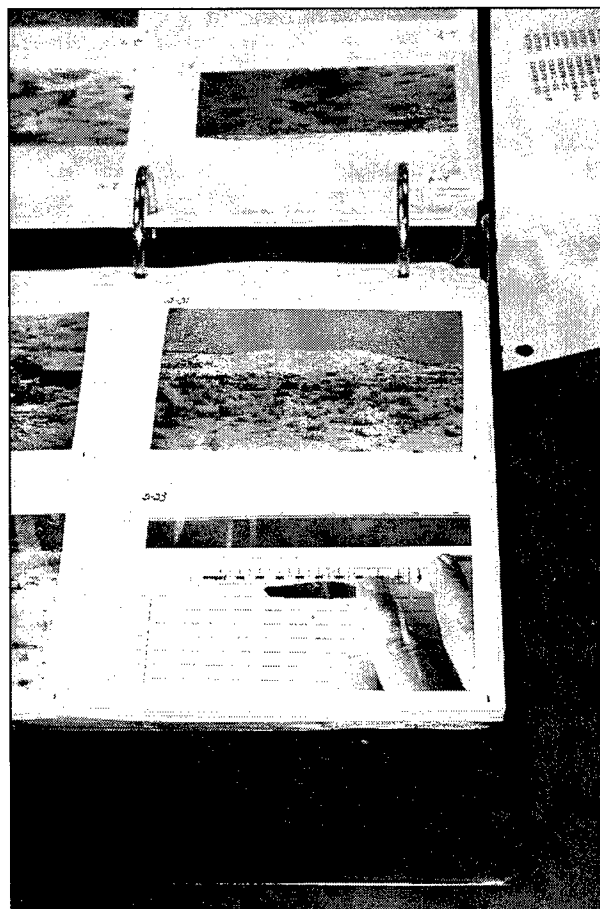
Figure 65. Photographic records are stored in nonarchival-quality sleeves that have begun to adhere to film emulsion.

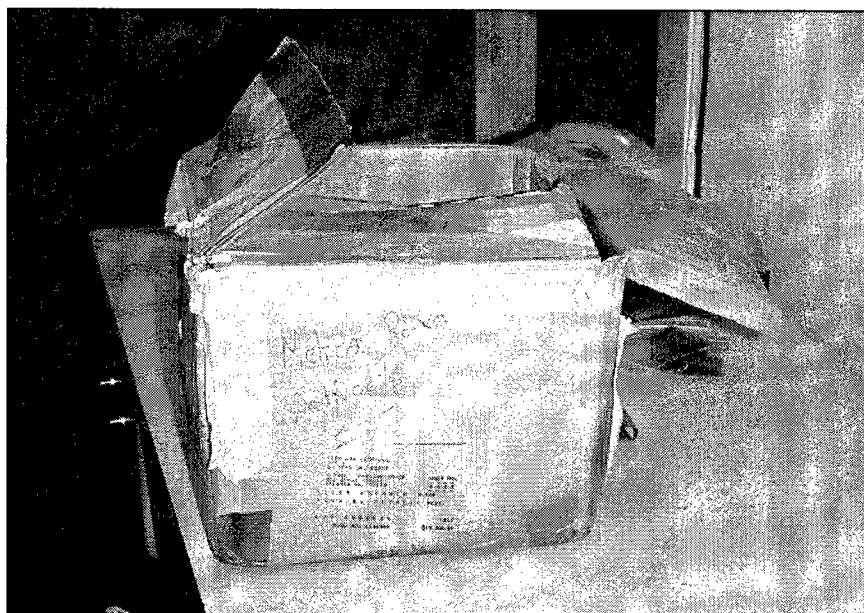
Figure 72. Damaged primary container housing Melrose AFR collection at the time of evaluation.

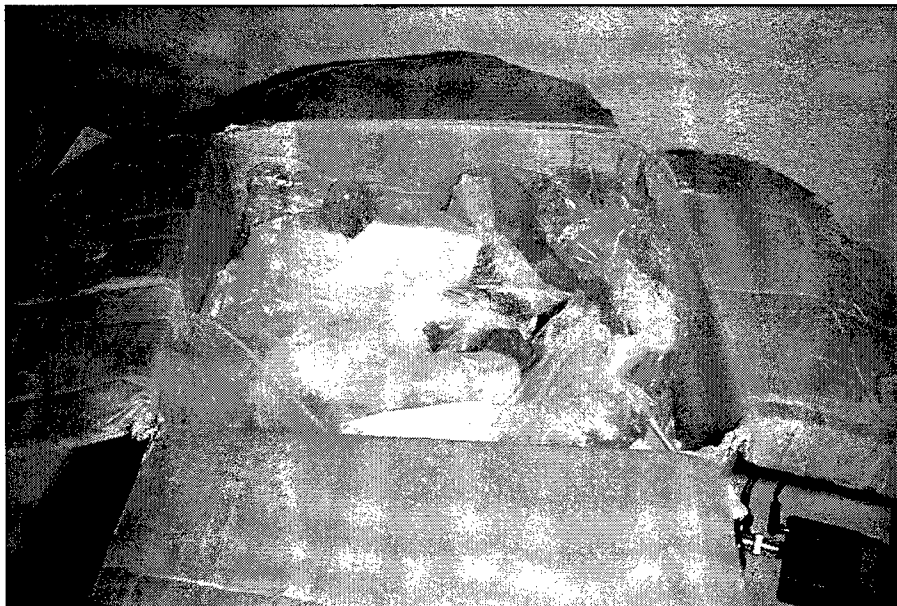
Figure 74. Unlabeled plastic bags were the secondary containers housing the Melrose AFR collection at the time of evaluation.

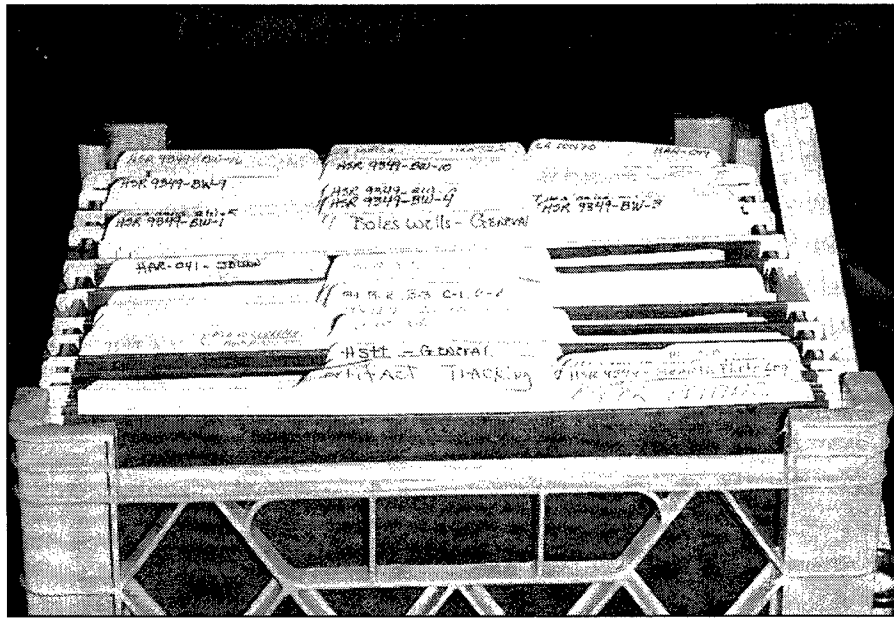
Figure 84. Associated documentation from Holloman AFB temporarily stored in a plastic milk crate.

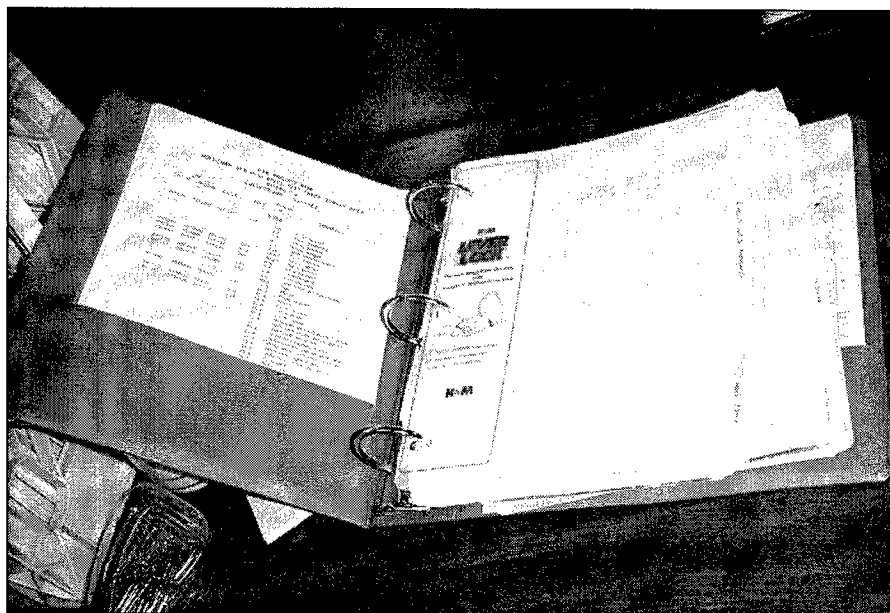
Figure 85. Administrative records for the Holloman AFB collection temporarily stored in nonarchival-quality three-ring binders.

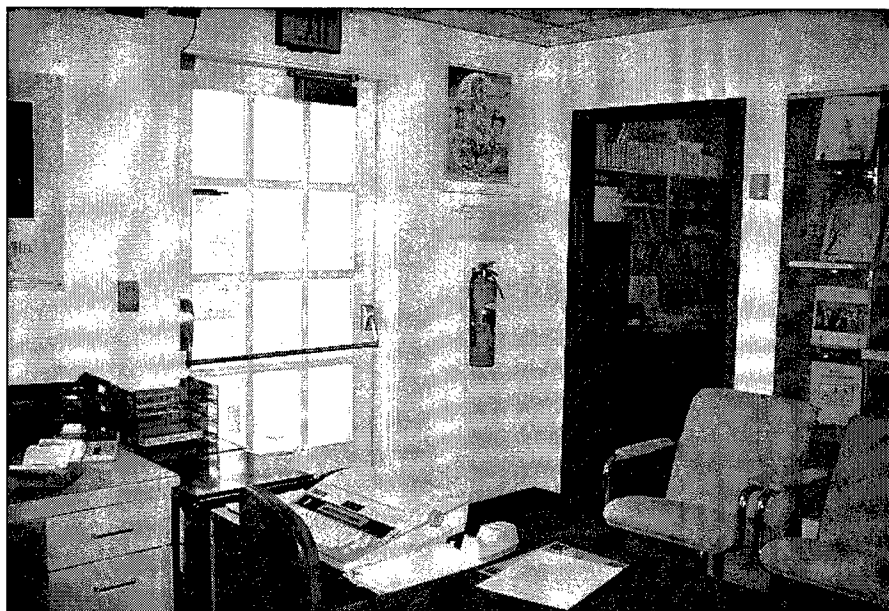
Figure 88. Contact-point intrusion alarms are installed on all doors leading to the exterior. Also note the fire alarm and extinguisher.

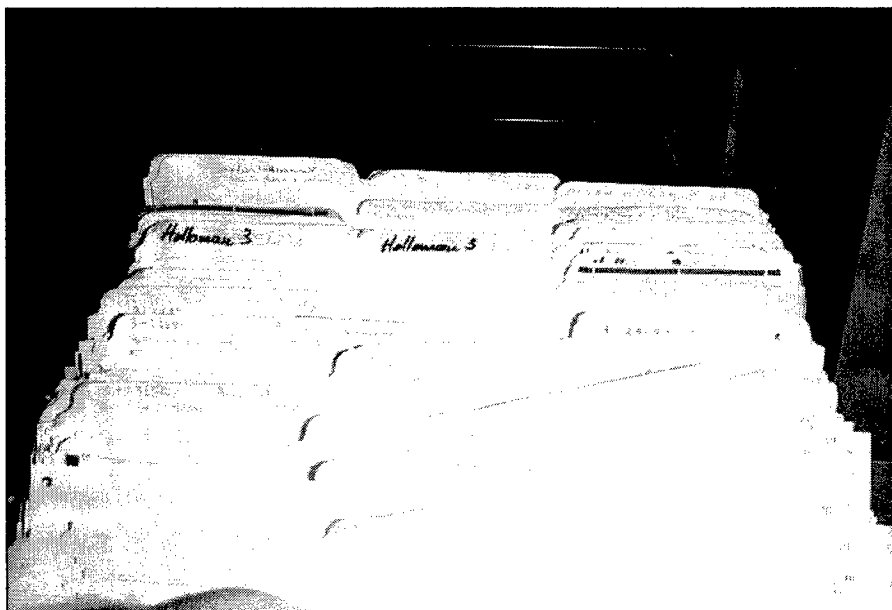
Figure 89. Documentation from investigations conducted on ACC installations is housed in acidic manila folders labeled in a variety of media.
