INVESTIGATION OF FALL PROTECTION FOR
RESIDENTIAL ROOF CONSTRUCTION AND REPAIR IN HAWAII

A THESIS SUBMITTED TO THE GRADUATE DIVISION OF THE UNIVERSITY
OF HAWAII IN PARTIAL FULFILLMENT OF THE
REQUIREMENTS FOR THE DEGREE OF

CIVIL ENGINEERING

AUGUST 1997

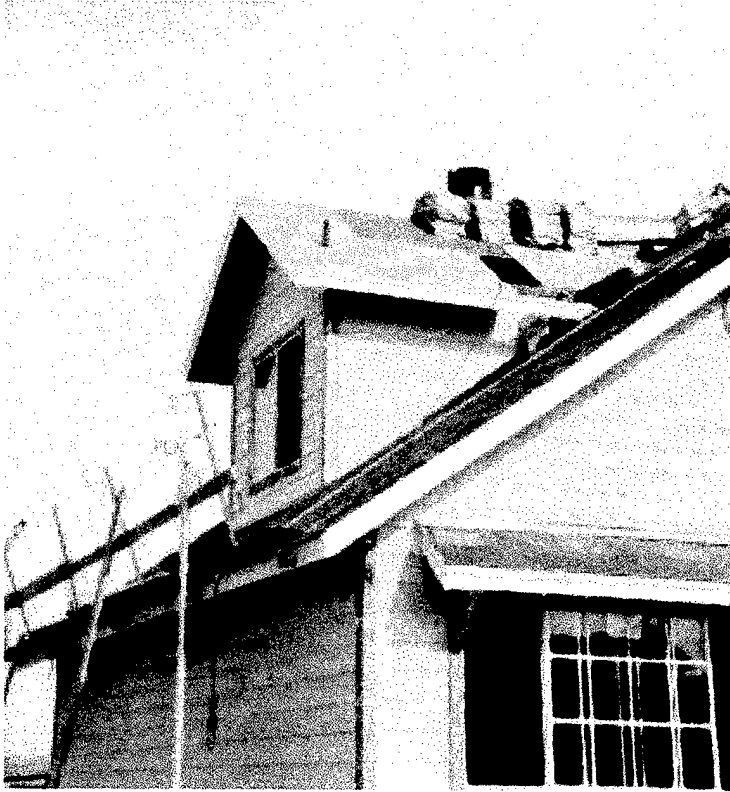
Figure B.5: New construction, Ewa Beach; PR20 Eave Catchguard system and Trus-T PFAS variant, end view

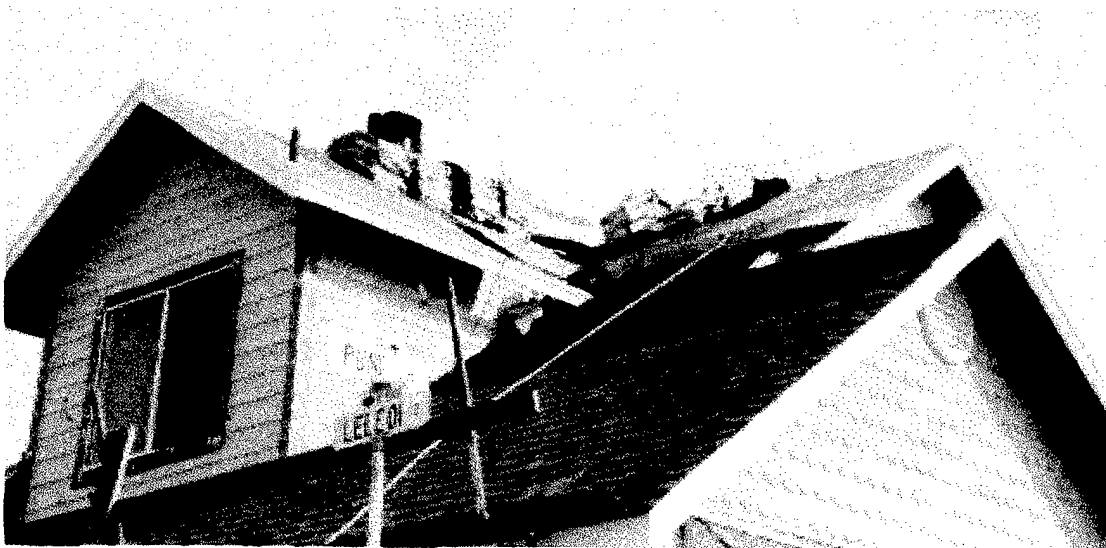
Figure B.6: New construction, Ewa Beach; PR20 Eave Catchguard system and Trus-T PFAS variant, corner view

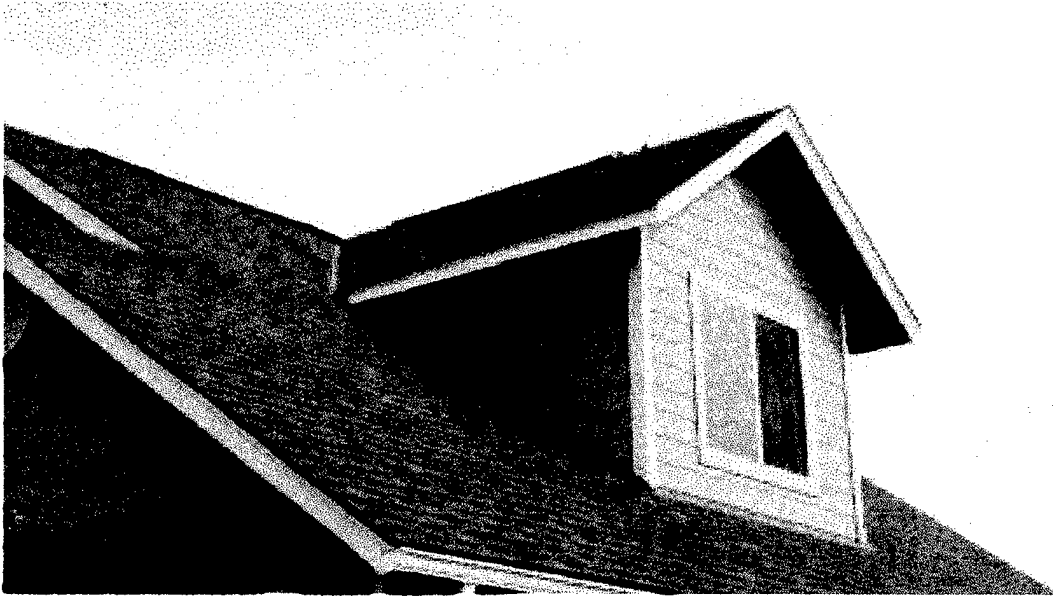
Figure B.7: New construction, Ewa Beach; finished roof with permanent Trus-T anchor system installed on ridge (Note slightly raised portion of ridge cap; Trus-T anchors are spaced evenly along ridge in this raised portion.)

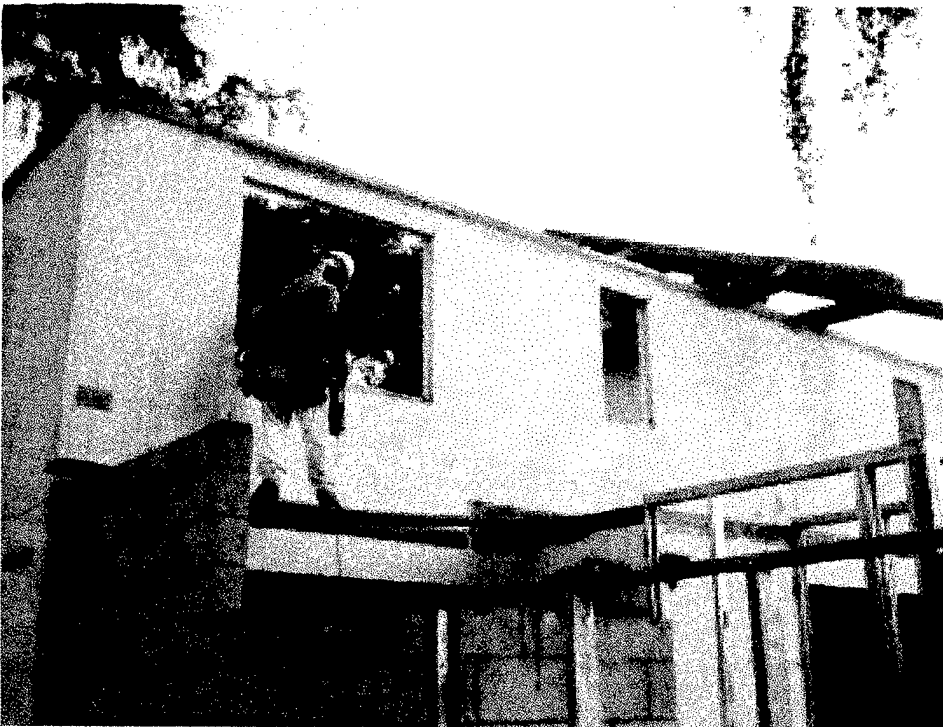
Figure B.8: Renovation project, Hickam Air Force Base; fall protection plan (Note improper work platform and lack of fall protection.)

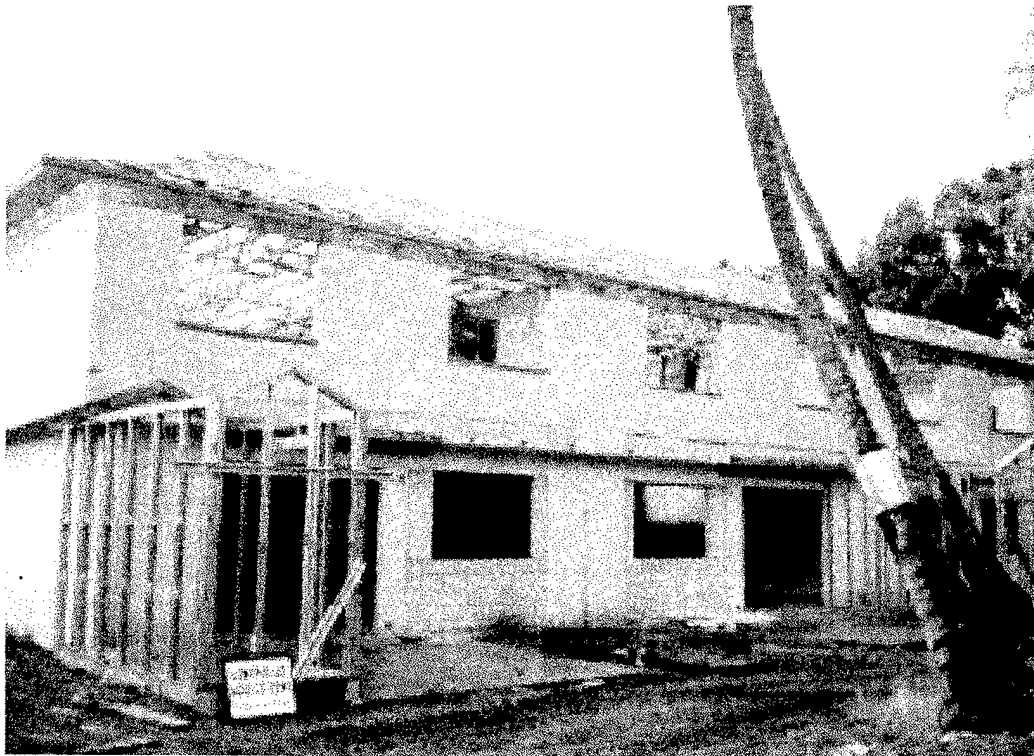
Figure B.9: Renovation project, Hickam Air Force Base; fall protection plan (Note "controlled access zone" sign at left front corner of structure.)

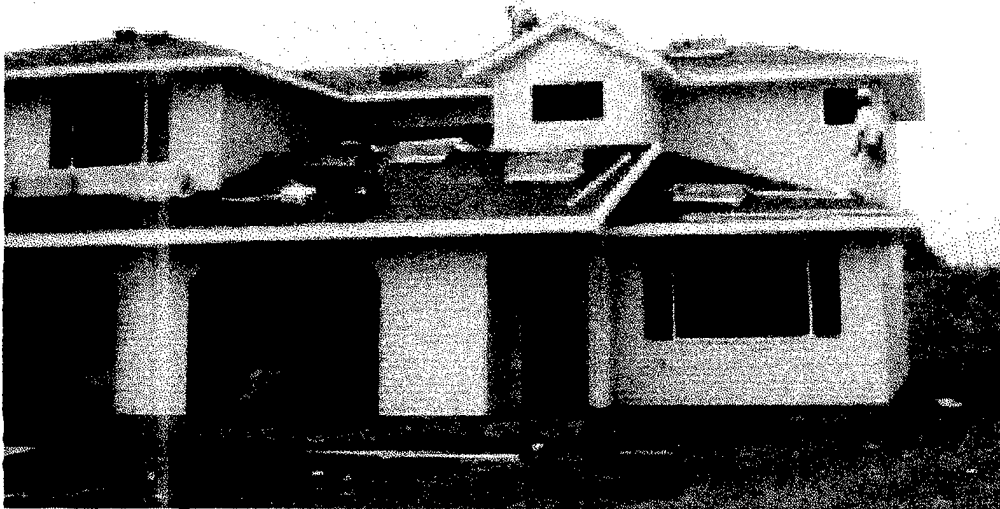
Figure B.11: New construction, Moanalua Navy Family Housing, Pearl Harbor; Safe-T-Strap PFAS variant (Note strap attached to worker's PFAS.)

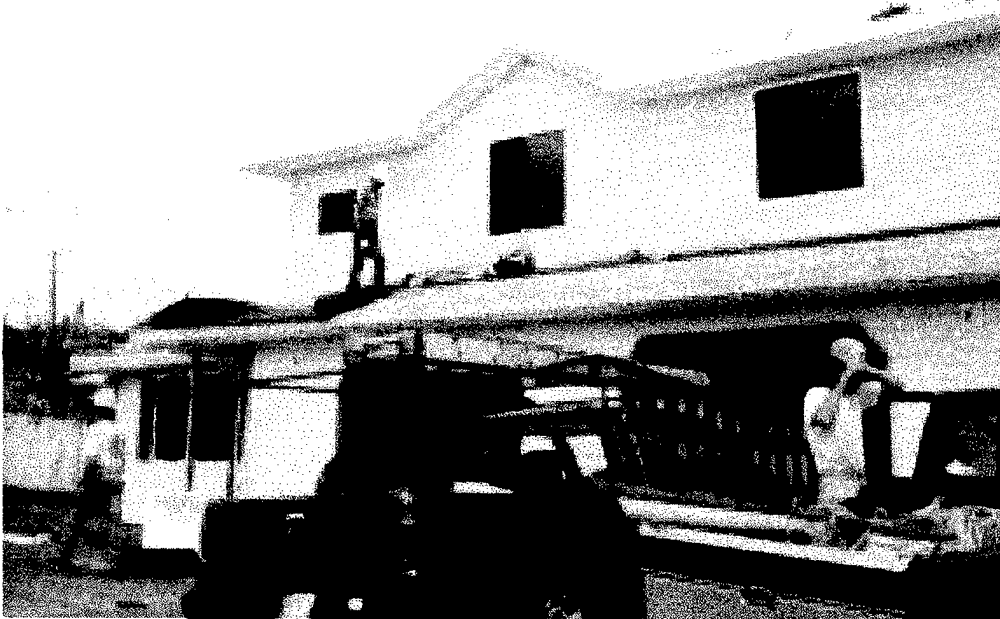
Figure B.12: New construction, Moanalua Navy Family Housing, Pearl Harbor; Safe-T-Strap PFAS variant (Note strap attached to worker's PFAS.)

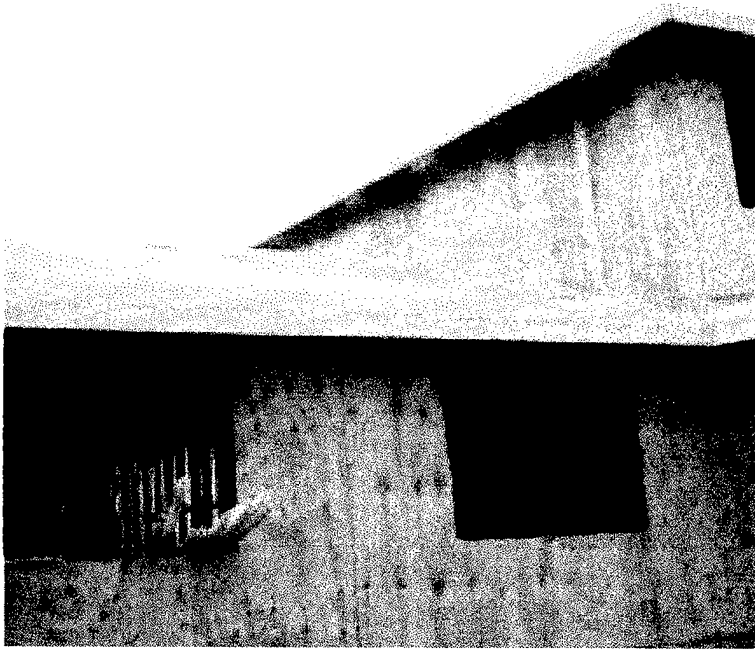
Figure B.13: New construction, Moanalua Navy Family Housing, Pearl Harbor; Safe-T-Strap PFAS variant (Note strap hanging from ridge and proceeding down to right.)

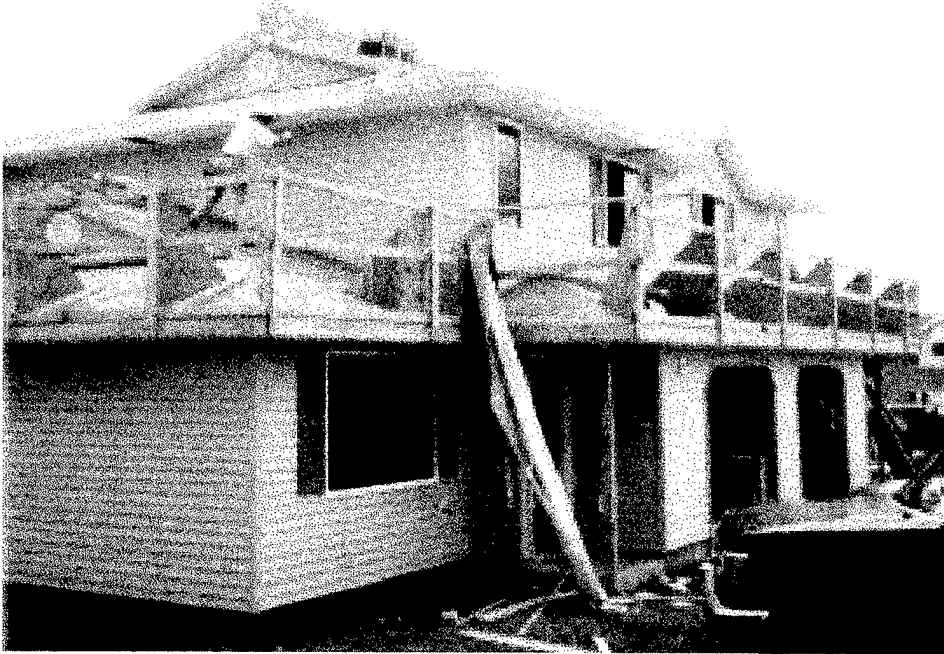
Figure B.15: New construction, Moanalua Navy Family Housing, Pearl Harbor; guardrail system used in siding operations

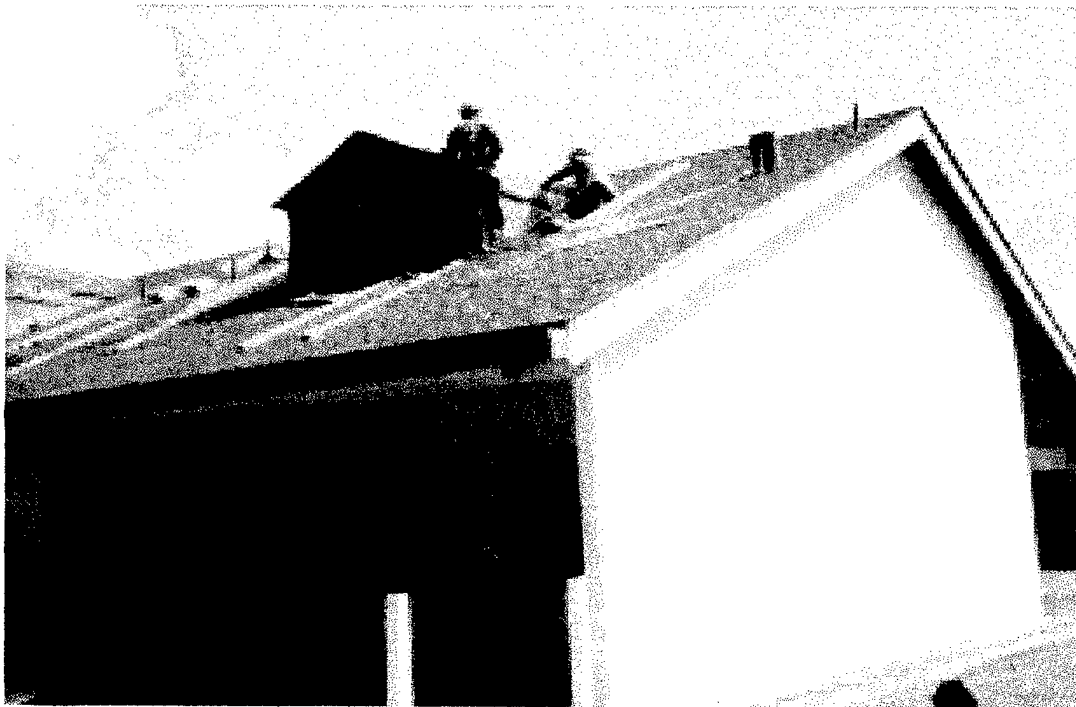
Figure B.17: New construction, Child Development Center, Marine Corps Base Hawaii, Kaneohe; PFAS use (Note the anchorage for the worker's PFAS—a vent pipe!)
