**Effective Condition Monitoring of Aero-Engine Systems Using Automated SEM/EDX and New Diagnostic Routines**

**RAF Tornado Aircraft RB199 Engine Condition Monitoring Project**

**Mr Nicholas W Farrant**

1998

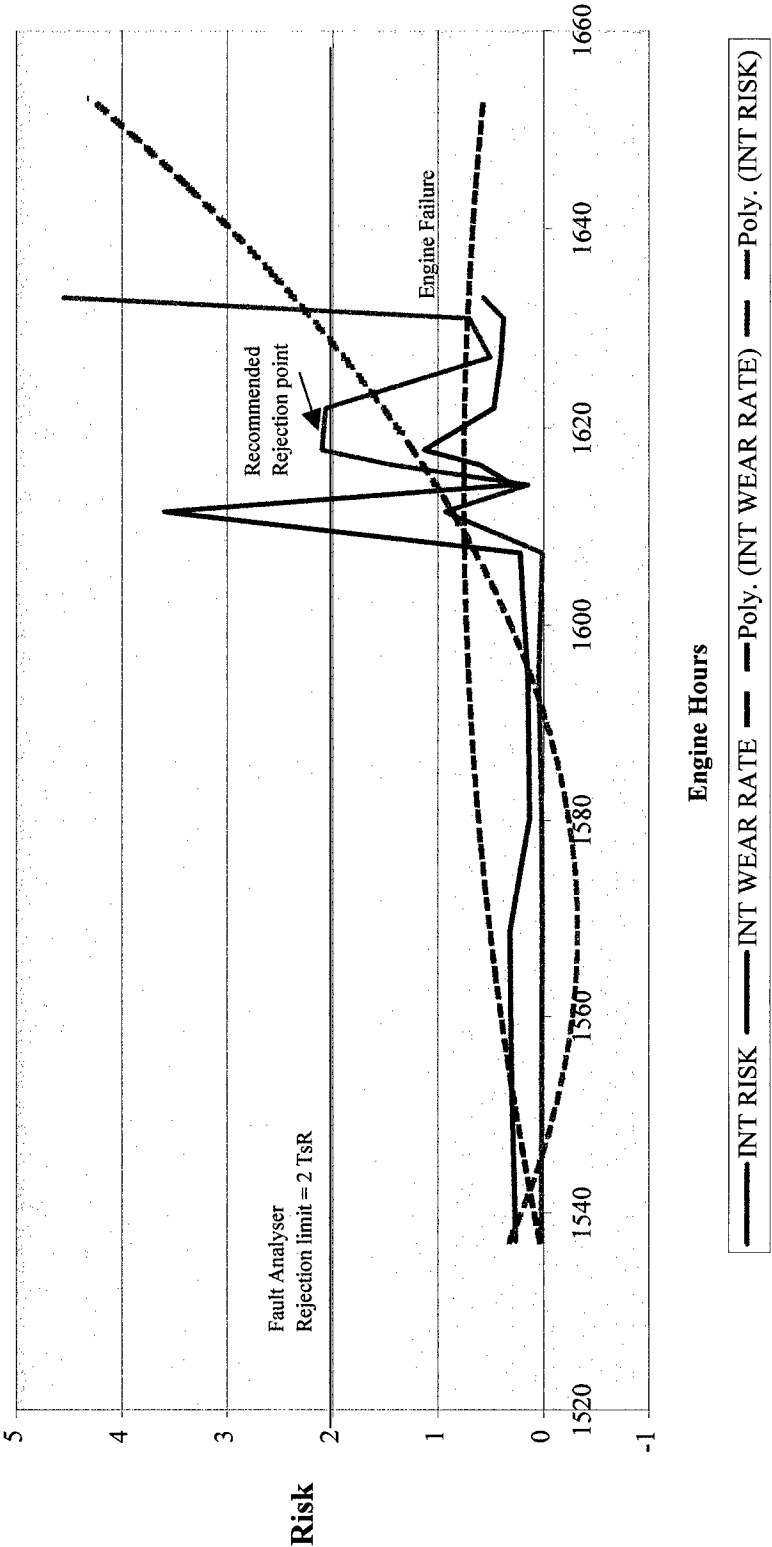
Figure 2 Rolling contact fatigue failure of the No4 Thrust bearing believed to release little or no debris prior to failure. SEM/EDX analysis using version 1 diagnostics still giving 30 hours lead-time and a clear call to reject.

RB199 7259 Retro-analysis of No4 bearing following IFSD

and morphological data gathered from each individually scanned particle, and applies it to engine specific criteria. Known engine failure characteristics established from the Failure Mode Effects Criticality Analysis (FMECA) case studies and the thresholds of general engine behaviour are used to train the software to identify normal, marginal, and abnormal wear trend and absolute conditions. The system is capable, to a high degree of confidence, in detecting wear sources and the incipient failure of oil-wetted components at an early and manageable stage<sup>(16)</sup>, offering a realistic proactive maintenance policy (Figure 2).
