DOT/FAA/AR-97/69

# Automated Inspection of Aircraft

April 1998

Final Report

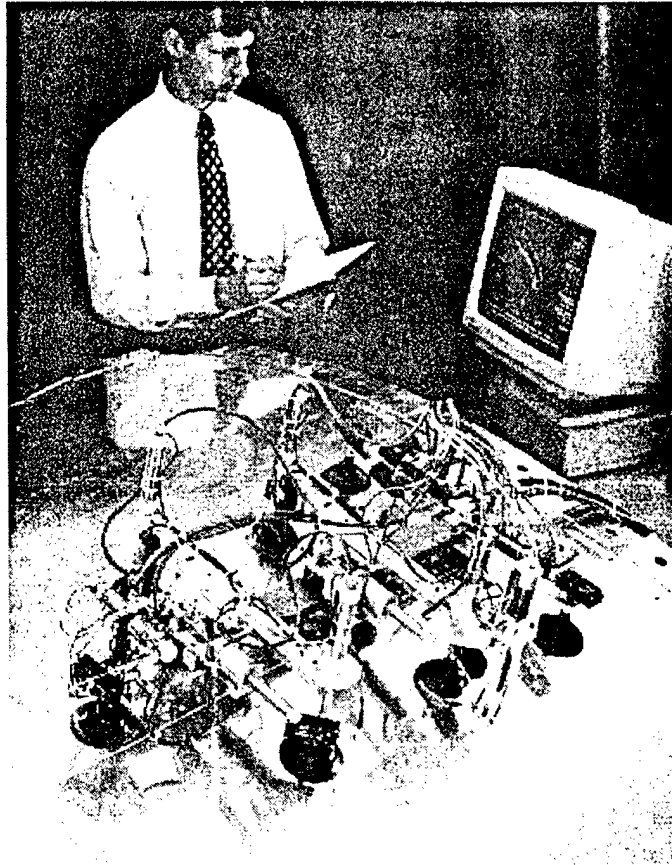
FIGURE 2. FIRST-PHASE ROBOT AND LAB SETUP

A simulated aircraft panel manufactured by Foster-Miller, Inc., was provided to the CMU Automated Inspection of Aircraft Project by the FAA Aging Aircraft Nondestructive Inspection Validation Center (AANC). The panel's curvature and fastener layout are similar to that of a Boeing 737. During the initial phase of development, the simulated aircraft panel was mounted horizontally in the lab; all testing on the panel during this phase was performed with the panel mounted in this position. Because the panel was a curved surface, the robot was also tested on a modest slope during this phase. The lab setup is shown in figure 2.

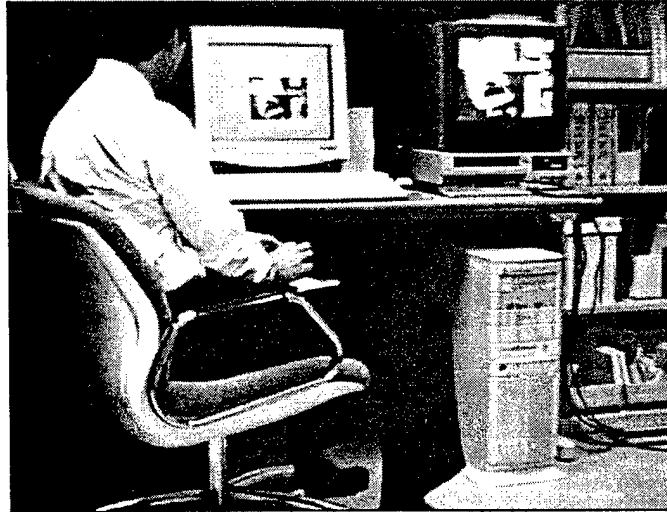
FIGURE 37. OPERATOR WORKSTATION AND VIDEO MONITOR/RECORDER

The operator workstation computer is the main control point for the robotic system. It provides the display and interface resources required by the operator to control and monitor the robot. These interfaces are described in further detail in section 5.3. All high-level robot control and coordination are performed by this machine. Communication channels are provided to the motor controllers, the on-board computer, and the video-processing computers. The eddy-current instrument is contained in and controlled by this machine. A photograph of the operator workstation is presented in figure 37.
