SEDIMENTATION STUDY OF THE MISSISSIPPI RIVER SCHENIMANN CHUTE MISSISSIPPI RIVER MILES 63 TO 57 HYDRAULIC MICRO MODEL INVESTIGATION

U.S. Army Corps of Engineers
St. Louis District
Hydrologic and Hydraulics Branch
Applied River Engineering Center
Foot of Arsenal Street
St. Louis, Missouri 63118

Final Report - May, 2000

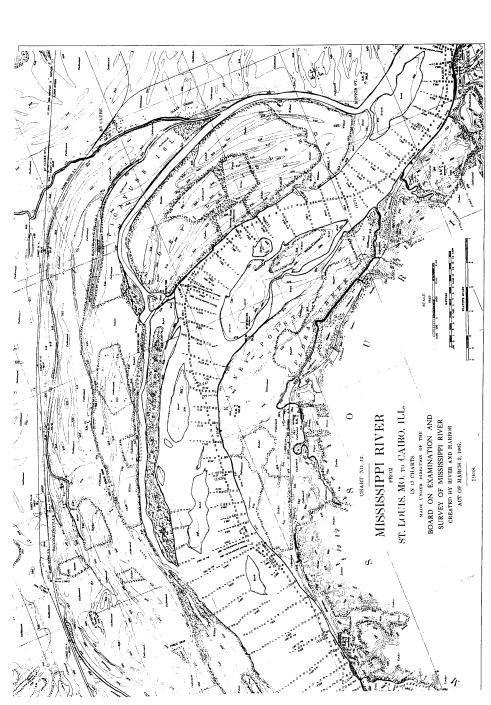
1908 Historic Survey Map of the Mississippi River

SCHENIMANN CHUTE MICRO MODEL STUDY MISSISSIPPI RIVER MILES 63 TO 57 MISSISSIPPI RIVER MILES 63 TO 57 1908 HISTORIC MAP	果器	U.S ARMY ENGINEER DISTRICT, ST. LOUIS CORPS OF ENGINEERS ST. LOUIS, MISSOURI
PLATE NO	PREPURED BY: D. Gordon DOLANN BY: A. Phosels CHECKED BY: R. Dwinney	SCHENIMANN CHUTE MICRO MODEL STUDY MISSISSIPPI RIVER MILES 63 TO 57 1908 HISTORIC MAP
		PLATE NO.

Research of historical hydrographic surveys and aerial photography has revealed that the Schenimann Chute side channel complex is a relatively newly created chute as a result of the construction of river training structures. The upstream half of the Picayune side channel complex was also a result of river training structures. Plates 3 and 4 are survey maps of the Mississippi River from 1880 and 1908. Schenimann Chute and the upstream end of Picayune chute are in the very early stages of development and are nearly nonexistent in these maps. By this period, man's influence on the river was extremely evident. The Mississippi River channel was unnaturally wide and shallow with numerous sandbars.

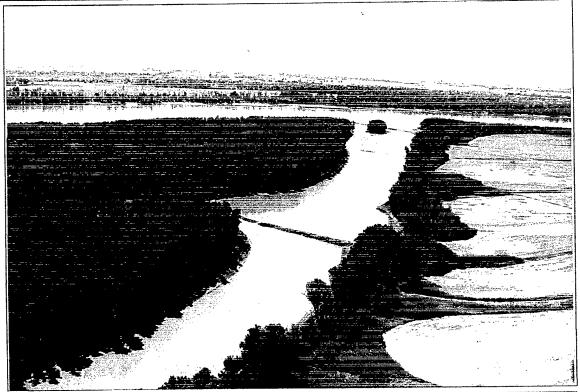
Top Photograph: Rock and Wood-Pile Closure Structures in Downstream End of Schenimann Chute (23 Sept. 1998)

The three main rock closure structures were originally formed by Dikes 59.8R, 58.7R, and 58.2R, which were constructed before the island and side channel formed. Several wooden pile dikes were constructed from the original right descending bankline of the main channel, which is now the right descending bankline of the side channel. Some of the dikes extended nearly 3500 feet into the main channel. The island now covers the middle portion of the dikes. The ends of the dikes have since been rock covered and extend into the main channel. The beginnings of each dike now act as closure structures in the side channel. Each of the large, rock closure structures in the chute forms both a large scour hole and a vertical round-out in the bankline on the downstream side (Plate 8). The structures also inhibit boat access during periods of low water.

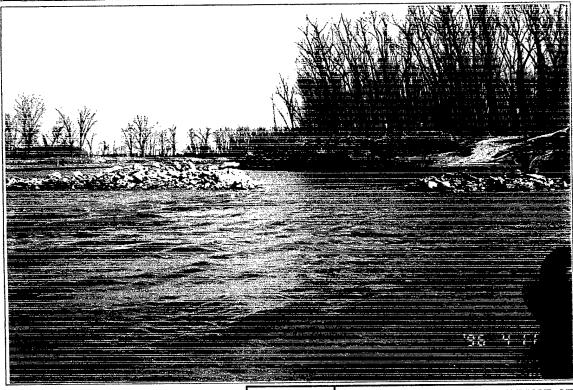
Bottom Photograph: Notched Closure Structure 58.2(R) in Schenimann Chute (11 April 1996)

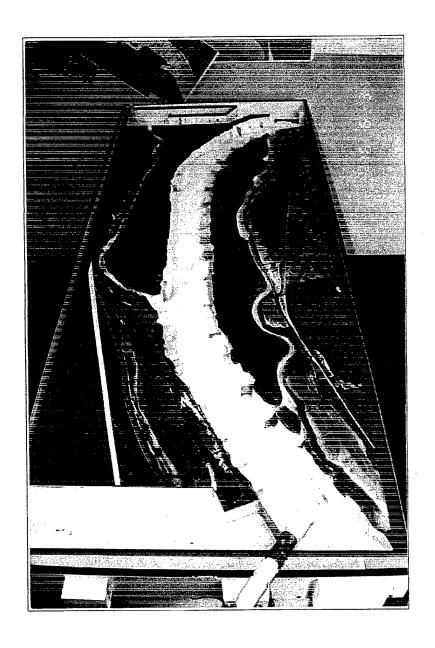
In order to investigate the sediment transport issues described previously, a physical hydraulic micro model was designed and constructed. Plate 9 is a photograph of the hydraulic micro model used in this study.

HYH H	U.S. ARMY ENGINEER DISTRICT, S CORPS OF ENGINEERS ST LOUIS, MISSOURI	T LOUIS	
PREPARED BY: A. Rhoads CHECKED BY: R. Davinroy	SCHENIMANN CHUTE MICRO MODEL STUDY MISSISSIPPI RIVER MILES 63 TO 57 SCHENIMANN CHUTE MICRO MODEL		
		PLATE NO.

The micro model insert was constructed according to 1994 high-resolution aerial photography of the study reach and placed in a standard micro model hydraulic flume. The model employed a horizontal scale of 1 inch = 400 feet, or 1:4800, and a vertical scale of 1 inch = 50 feet, or 1:600, for an 8 to 1 distortion ratio of linear scales. This distortion supplied the necessary forces required for the simulation of sediment transport conditions similar that of the prototype. The bed material was granular plastic urea, Type II, with a specific gravity of 1.23.

Flow in the model was simulated and regulated electronically by a function generator interfaced to a submersible bilge pump. In all model tests, the effective discharge or hydrograph was simulated automatically with the electronic control system. Each hydrograph was a repeatable triangular response representative of a range of low to high flows within the channel. Peak flow in the model represented an elevation near to bankfull flow in the prototype. The recurrence interval of bankfull flow in the prototype is approximately 1.5 years (3). Resultant bed configurations were measured and recorded with a computer interfaced 3-dimensional mechanical digitizer.

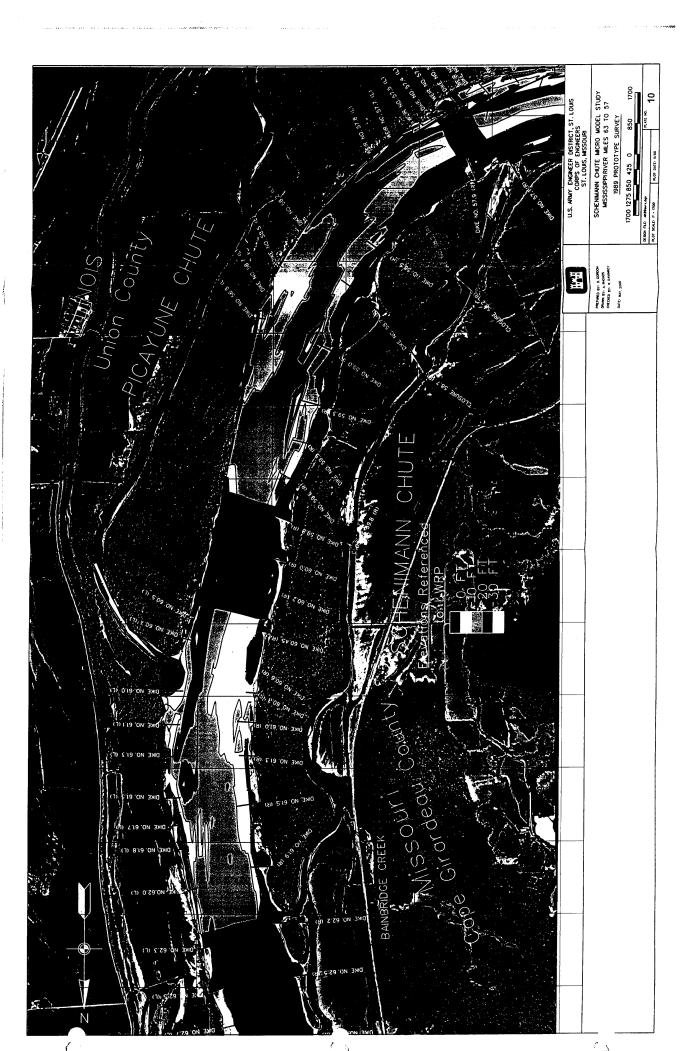
Plate 13 shows the resultant bed configuration of the micro model base test. This survey served as the comparison survey for all future design alternative tests. The base test was developed from the simulation of successive design hydrographs until bed stability was reached and a similar bed response was achieved as compared with the prototype surveys.

- At the upper end of the study reach, near Mile 62.5 and the entrance to Schenimann Chute, the thalweg was positioned along the right descending bankline. A short crossing to the left descending bankline was located near Mile 61.7.
- The thalweg, with depths near –50 feet LWRP, remained along the left descending bankline from Mile 61.5, passed the entrance to Picayune Chute, to Mile 60.5. A crossing to the right descending bankline was located between Miles 60.5 to 60.0.
- The thalweg remained along the right descending bankline for a short distance before another crossing back to the left descending bankline between Miles 59.5 and 59.0.
- The thalweg remained along the left descending bankline throughout the remainder of the study reach. Depths were very shallow between Miles 58.3 and 57.5.

Both Schenimann and Picayune Chutes had depths generally near 0 feet
 LWRP, as shown in the prototype surveys. Some scour was evident near the
 bends and main closure structures within Schenimann Chute.
