**Navigation Study at the Approach
to Lock and Dam 24,
Upper Mississippi River**

**Hydraulic Micro Model
Investigation**

Technical Report M2

Final Report - January 1998

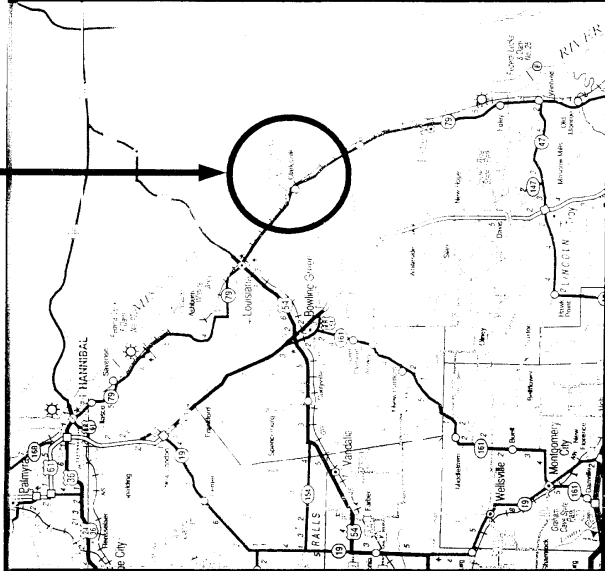
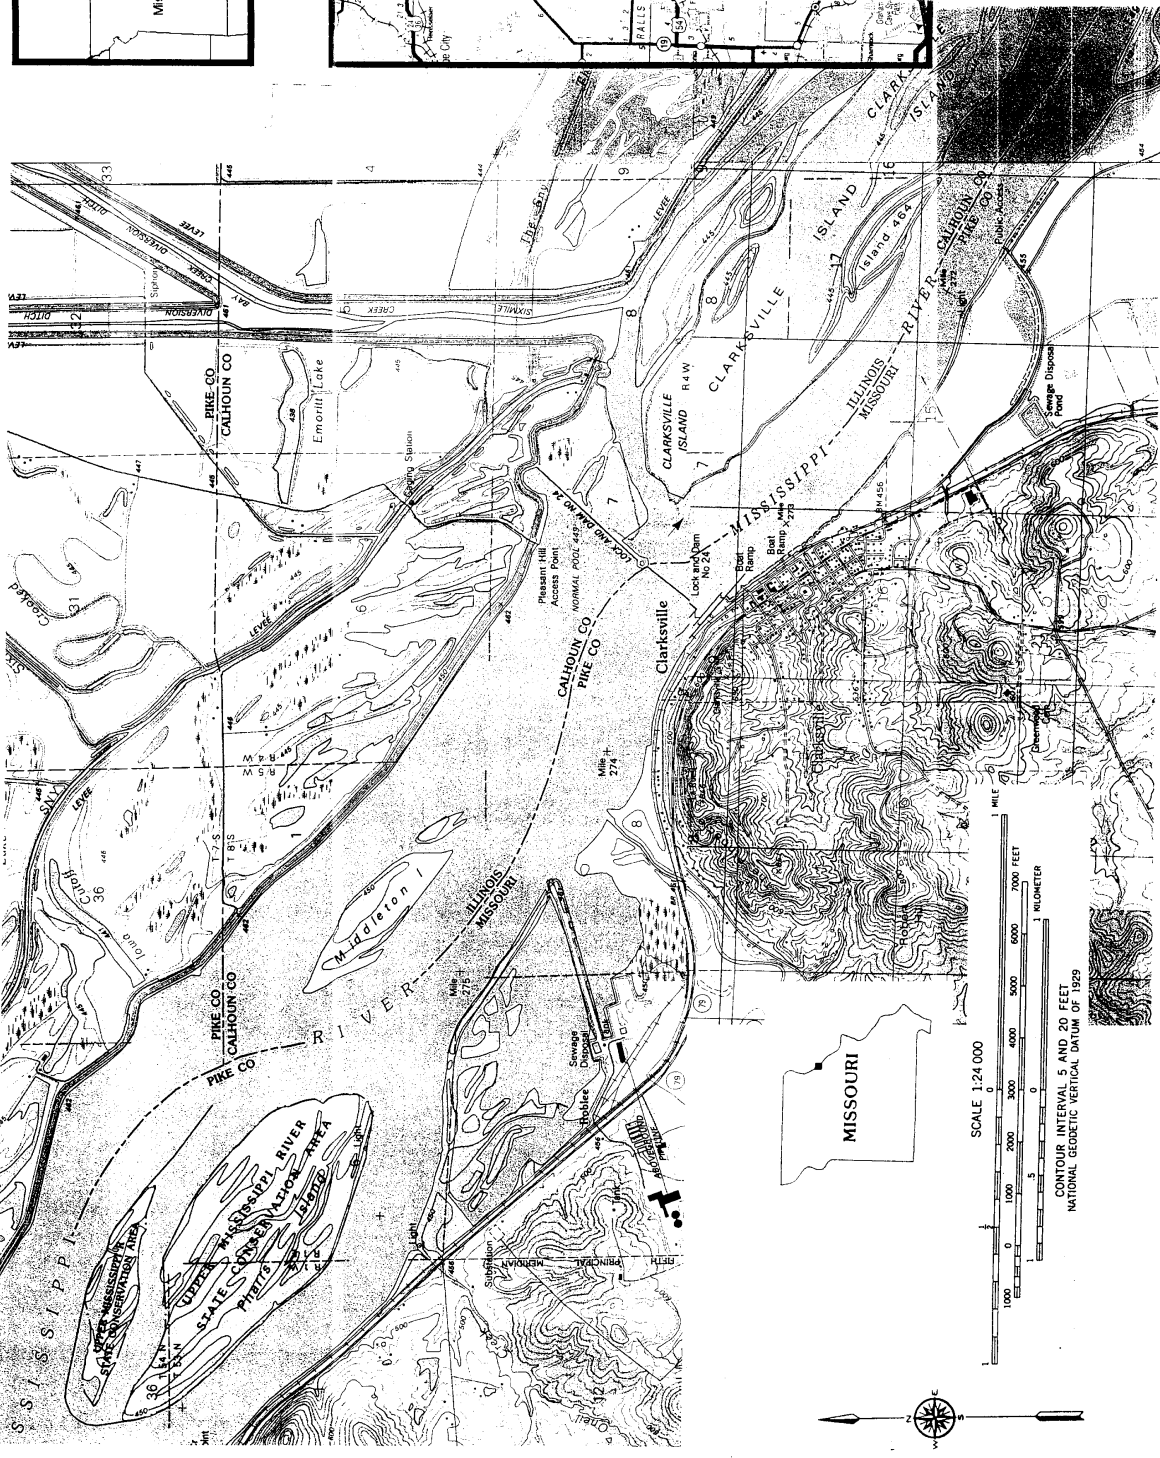
U.S. ARMY ENGINEER DISTRICT, ST. LOUIS CORPS OF ENGINEERS ST. LOUIS, MISSOURI	
	Lock and Dam 24 Micro Model Study Mississippi River Miles 271 - 277 Vicinity Map and USGS Quad Sheet of the Study Area	
PREPARED BY: D. G. Gorman CHECKED BY: R. G. Gorman	DATE: 1

This report details the investigation of a sedimentation and flow study of the Upper Mississippi River using a physical hydraulic micro model. The micro model methodology was used to evaluate detrimental flow conditions experienced at the downbound navigation approach to Lock and Dam 24, Mile 273.5R, at Clarksville, Missouri. Plate 1 displays the vicinity map and USGS quad sheet of the study reach. Plate 2 is a photograph of Lock and Dam 24.

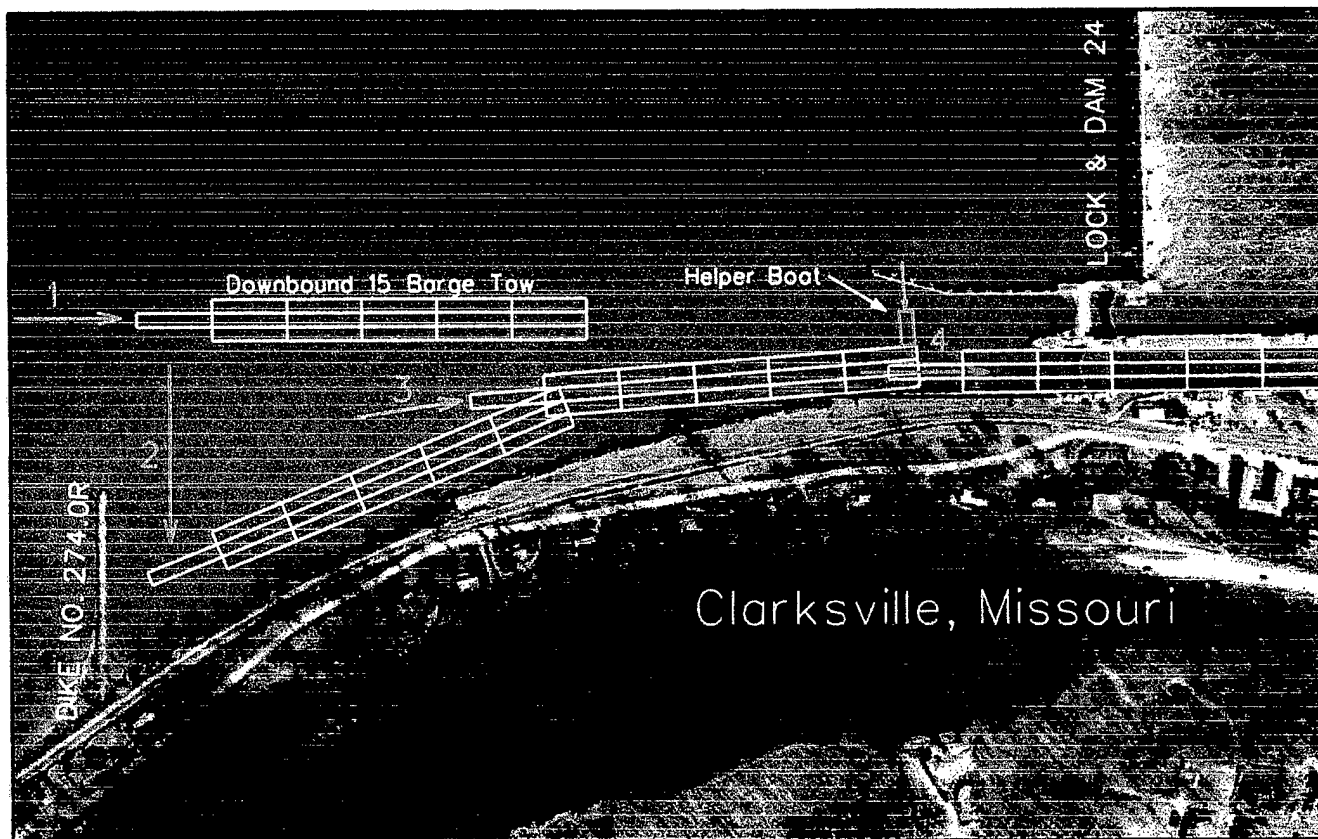
In 1969, a perpendicular stone dike was constructed in the Mississippi River on the right descending bank at river Mile 274.0R (Plate 3). This dike was extended in 1971. The dike was constructed in an attempt to alleviate outdraft conditions and create a waiting or holding area for downbound tows. The downstream eddy or flow shadow of the structure maintains a low velocity region. Most tows approaching the lock will travel downstream of the dike and then back up into the dike before making their final approach into the lock chamber. This allows the pilot to properly align the tow before entering the lock chamber. While within the dike shadow, the next maneuver consists of turning the tow at a skewed angle. The stern is positioned in the slack water near the bankline and the bow is positioned out in the faster current. The pilot then proceeds toward the lock. Plates 3 through 6 show the sequence of events that most pilots use to enter the lock chamber. Model test results discussed later in this report indicate that this dike is crucial in the overall solution to the outdraft problem.

1. Downbound tow prepares to enter Lock 24 below Dike 274.0R.
2. The tow moves against the bankline behind the shadow provided by the dike.
3. A helper boat helps the tow maneuver its bow against the land wall while the stern is held towards the shore line.
4. The tow enters the lock chamber while keeping its stern tightly against the land wall.

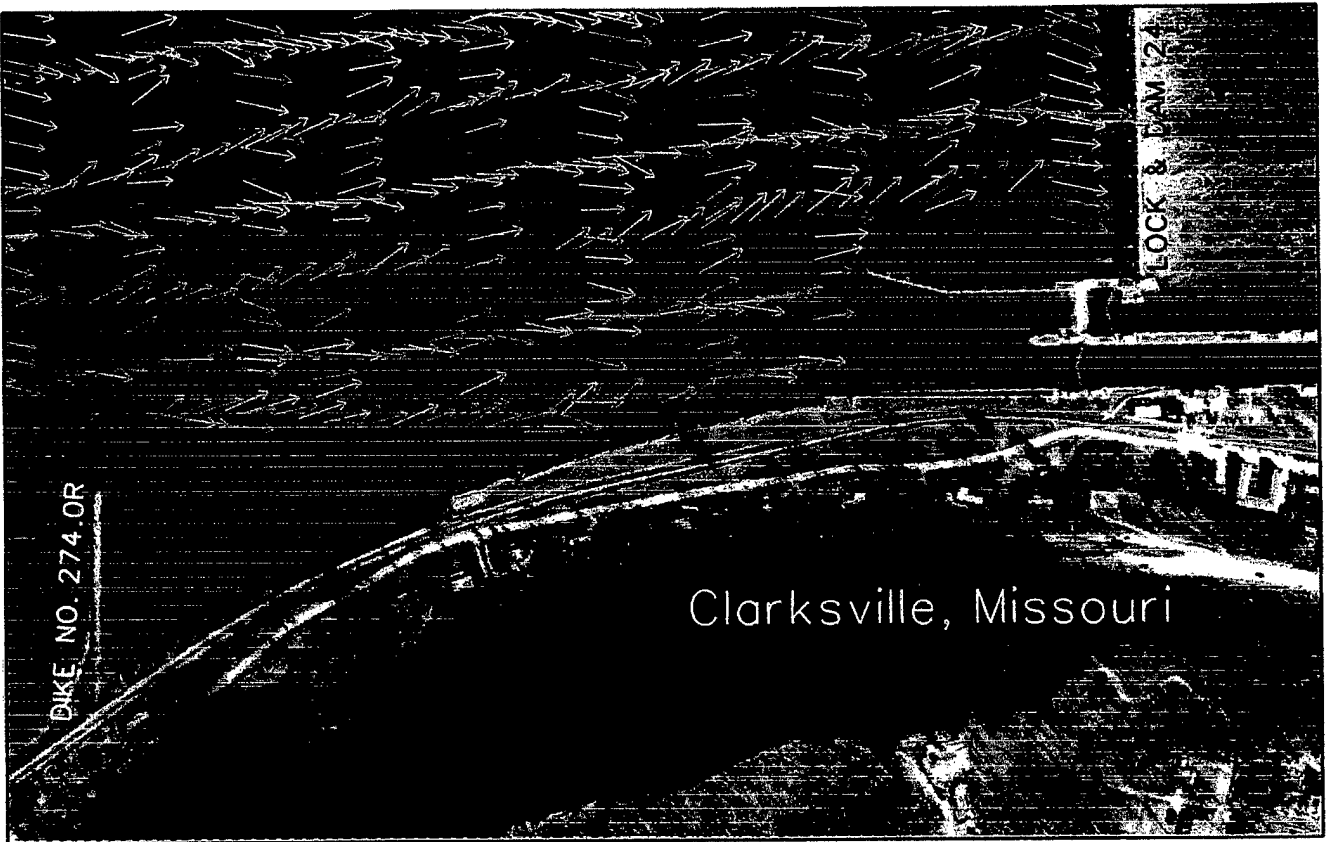
Plates 11 and 12 display velocity vectors and velocity contours at the downbound approach to Lock and Dam 24. This data was collected using ADCP

equipment in March of 1997 during open river conditions. The data was collected to allow engineers to better visualize the outdraft. Since the resolution of the historical data was limited, this data further enhanced the perception of velocity patterns. Results indicated that currents actually deflected off the right descending bankline (near the apex of the rock bluff protrusion) approximately 600 feet upstream of the end of the landwall. This discovery served a vital role in the eventual calibration of the micro model.

Note: The Velocity Vectors Shown were
Surveyed at a Depth of 7.7 Feet Below
WSEL During Open River Conditions.

The remote sensing analysis revealed two important trends. First, it could be seen that currents deflected off the tip of dike 274.0R, as expected. Second, however, it could be visualized that both the deflected currents off the dike tip and the currents within the downstream shadow of the dike were pulled toward and then away from the apex point of the rock bluff protrusion. This visualization of current deflection at the bluff was verified by observations from the ADCP data (Plate 11).

openings. These trends were similar to what was observed from the ADCP and remote sensing prototype data (Plates 11 and 14).

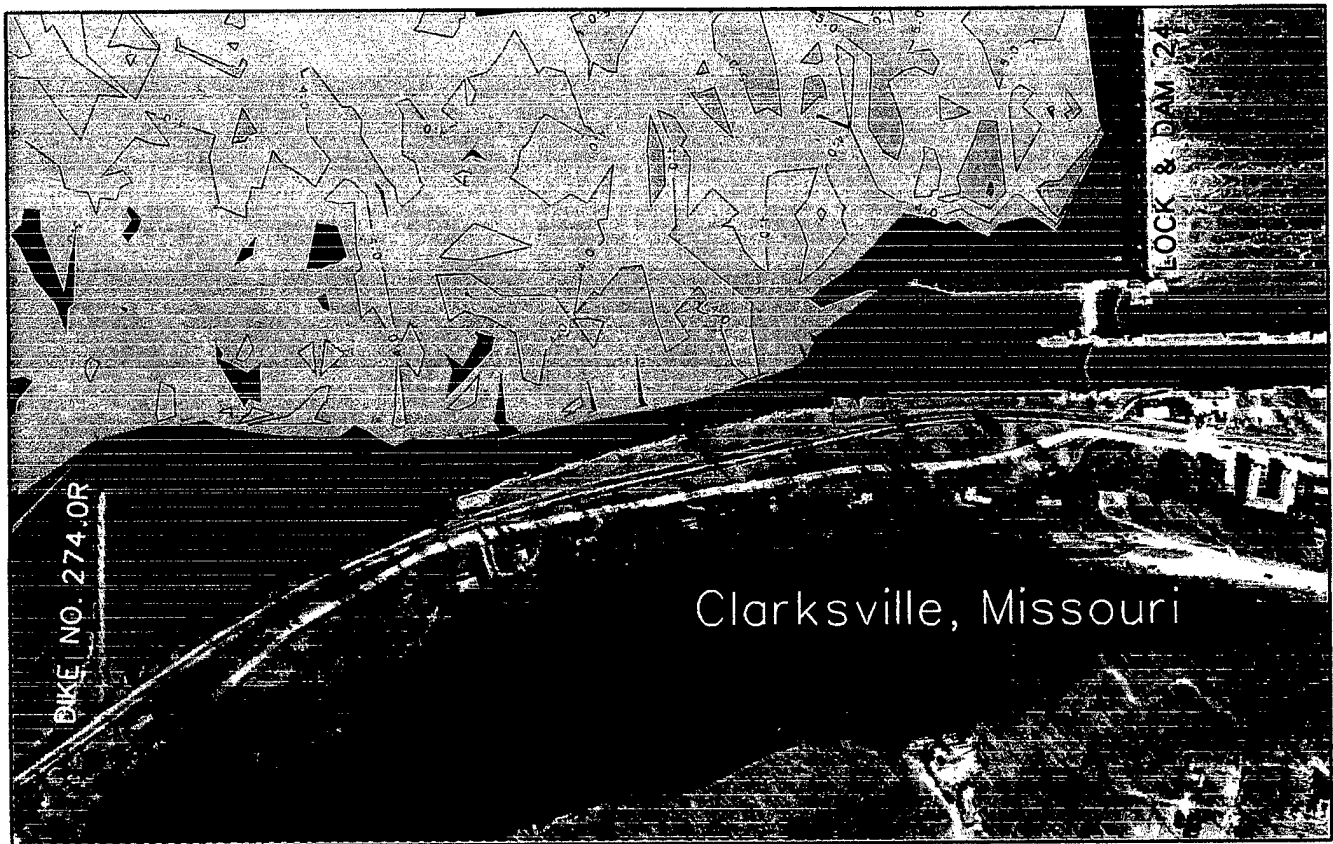
12

Note: The Velocity Contours Shown were
Surveyed at a Depth of 7.7 Feet Below
WSEL During Open River Conditions.

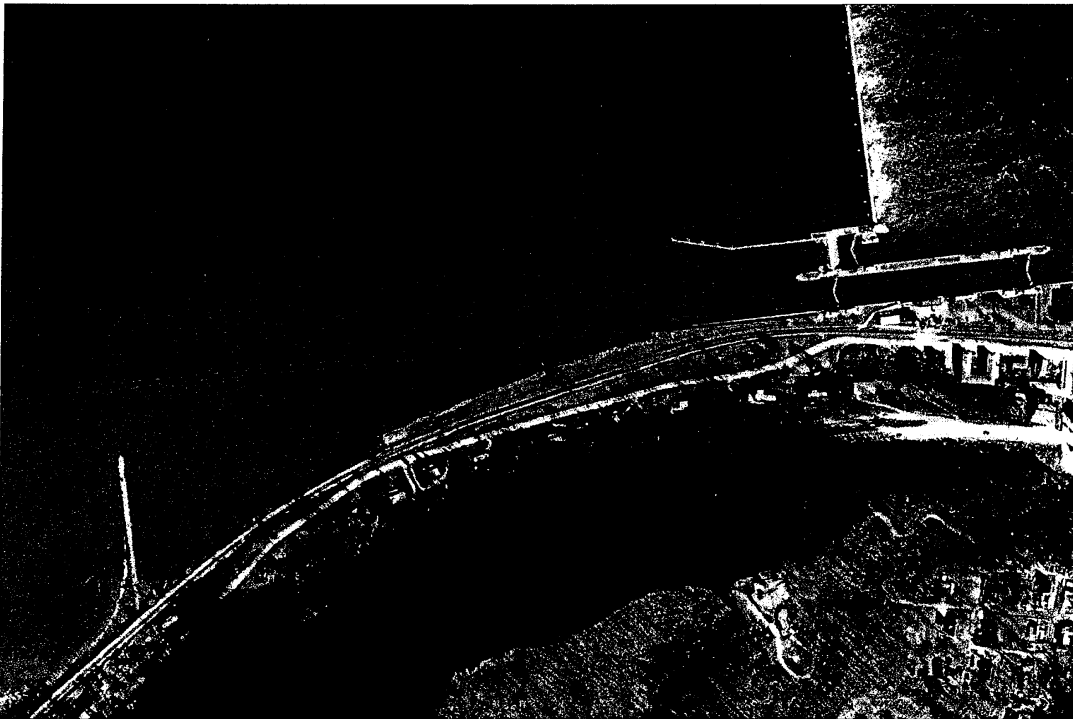
Plate 14 shows the original color aerial and the color-enhanced aerial from a standard image processing software package. Visual comparison between the two images showed a distinct variance in color. This represented the effects of surface roughness and suspended sediment.

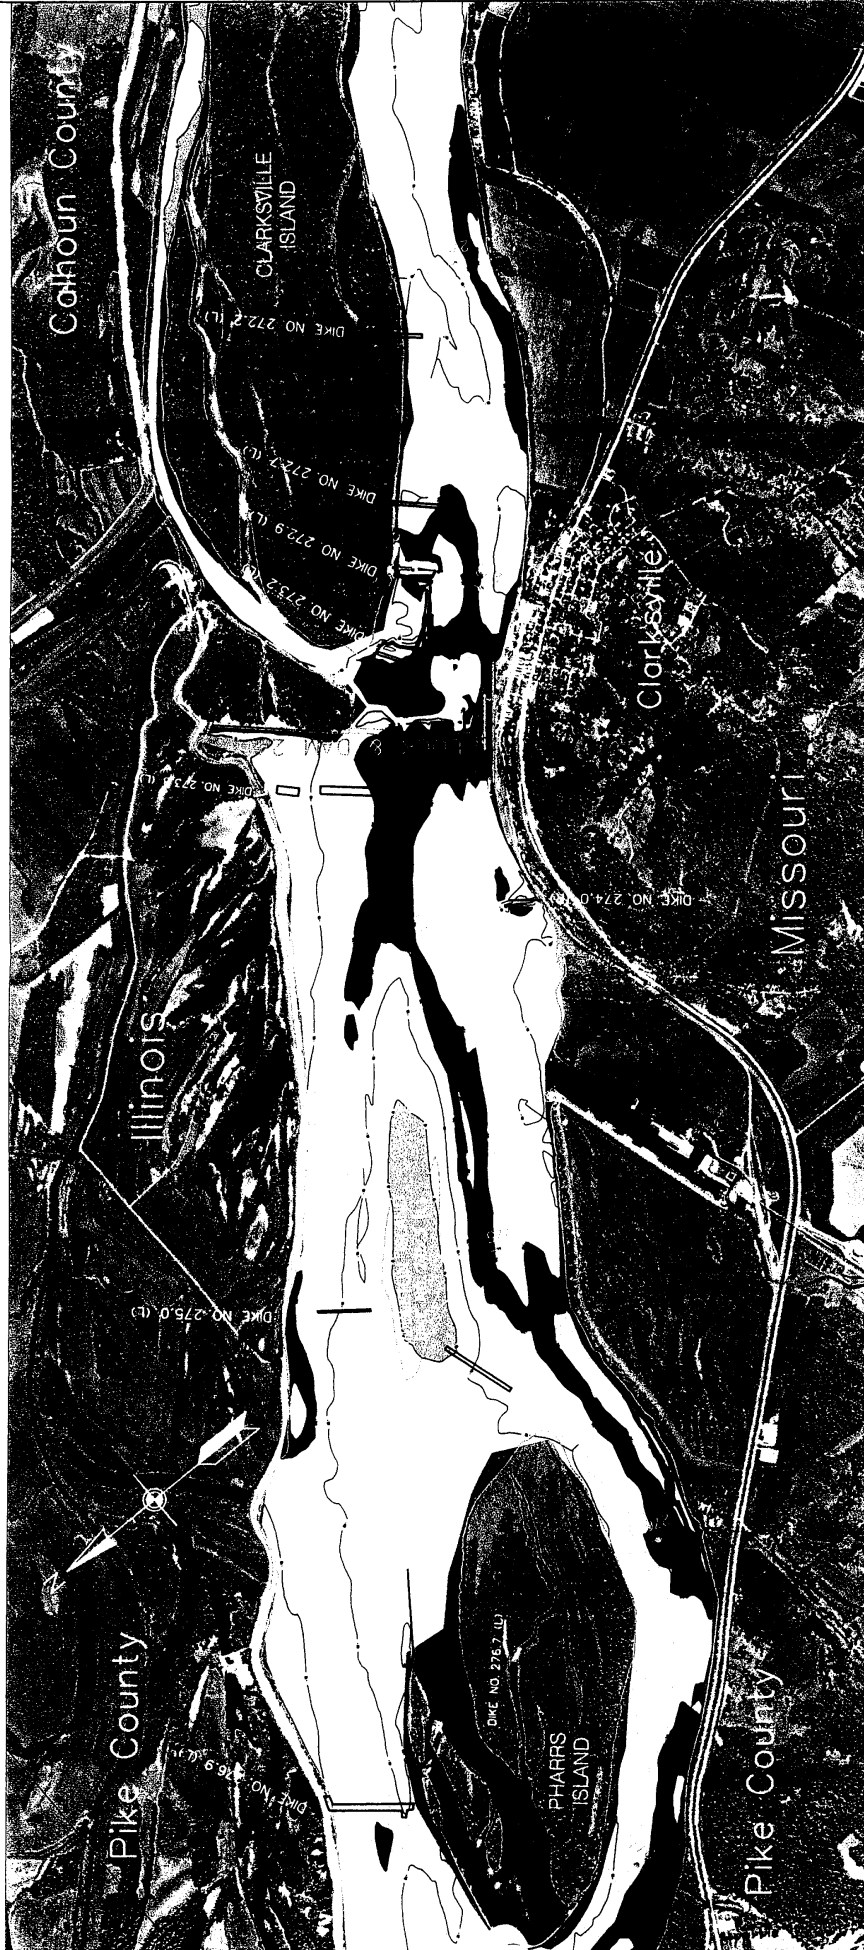
Plate 25 shows the resultant bed configuration of the micro model base test. This survey served as the comparison survey for all future design alternative model tests. The base test was developed by simulating steady flow or open river conditions until bed stability was reached.

Generally, the bathymetric trends established in the micro model were very similar to the trends observed in the historical prototype surveys. The only major noted difference was the location of the scour hole pattern below the dam. The scour had a tendency to occur further downstream in the model as compared to the prototype.
