Implementation Guidance for the Control of Undesirable Vegetation on Dredged Material

PURPOSE: The purpose of this technical note is to provide guidance for implementing selected management practices to control undesirable vegetation on dredged material.

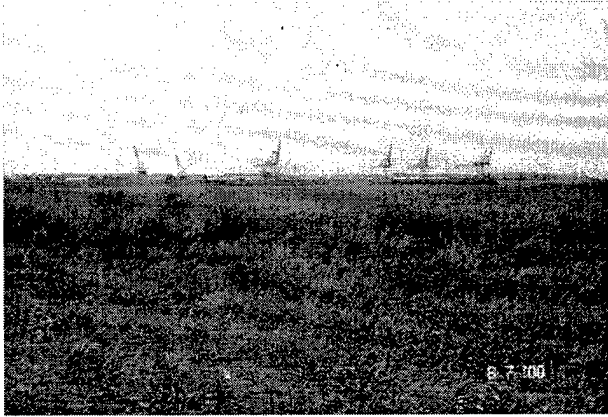
Figure 1. Phragmites (*Phragmites communis*) covering Eagle Island CDF, Wilmington, NC

Wilmington, NC. The Eagle Island CDF was totally covered with 3-m- (10-ft-) tall common reed (Figure 1). The aboveground stems and tops (3 m (10 ft) tall) were cut with a box blade and placed into piles for burning or composting. Because burning can contribute to poor air quality, composting

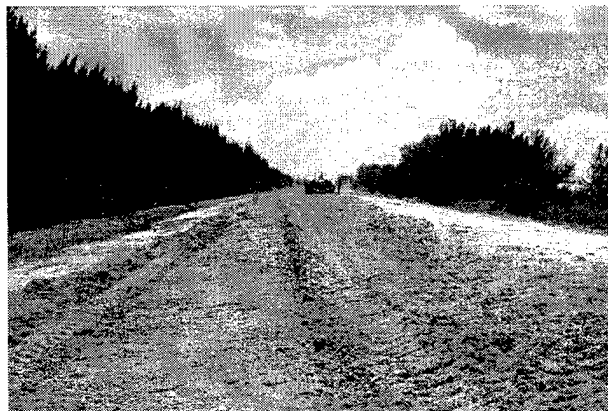
Figure 5. Incorporation of bagasse and N-Viro biosolids into sandy, droughty dredged material on Herbert Hoover Dike (Jun 95)

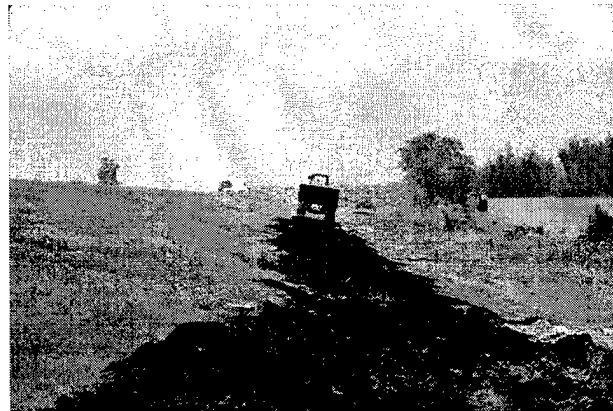
Figure 6. Melaleuca compost applied to the Herbert Hoover dike dredged material and incorporated by disking

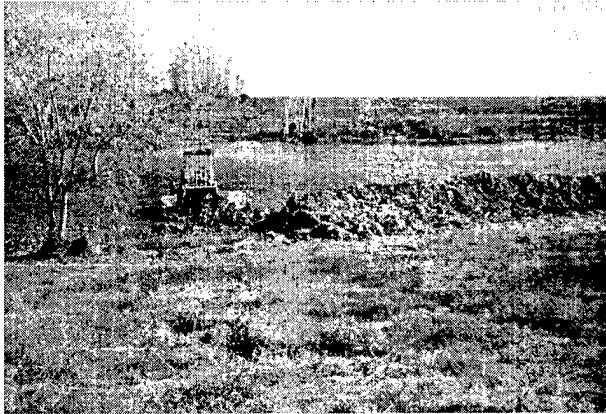
Figure 7. Lake debris harvested from Lake Okeechobee following hurricanes and piled on the shoreline of the Herbert Hoover dike

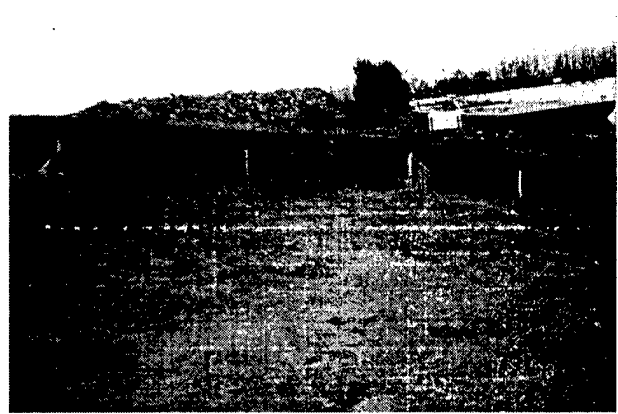
Figure 8. Lake debris in combination with N-Viro biosolids (left side of photo) and Bionsoil biosolids (right side of photo) incorporated by disking

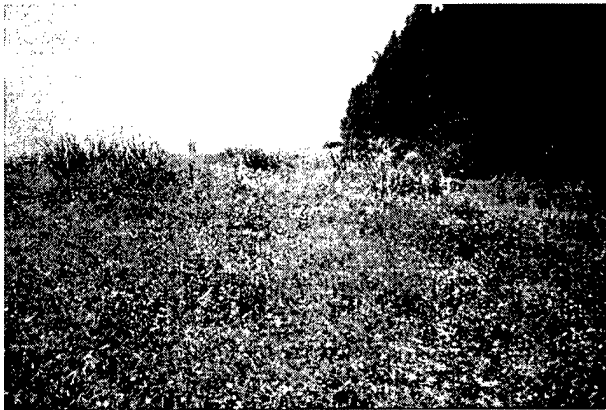
Figure 9. Massive native weed growth on the yardwaste and N-Viro biosolids demonstration plots (Jun 96)

Soil samples were collected for each mile of the Herbert Hoover dike from each side of the dike for the entire dike system. The soil samples were sent to the University of Florida at Gainesville for soil fertility testing. Minimum fertilizer for the maintenance of desired vegetation was recommended based on the soil test results. These fertilizer rates were applied to the dike. In addition to reduction of applied commercial fertilizer being evaluated, other ways to improve soil fertility using available residual materials and management of vegetation were considered. The application of recycled soil manufacturing technology (RSMT) and the use of plant species such as perennial peanut (*Arachis glabrata* Benth. cultivar Florigraze) that required less fertilizer and mowing were also evaluated in the demonstration. Demonstration plots were established using RSMT by incorporating cellulose in the form of yardwaste (Figure 4), bagasse (Figure 5), melaleuca compost (Figure 6) and lake debris (Figures 7 and 8) in combination with biosolids such as N-Viro Soil® (reconditioned sewage sludge) and BionSoil® (reconditioned animal manure). These plots improved the soil fertility substantially but also increased the growth and amount of undesirable weeds whose seed had accumulated in the dike soil over the years (Figure 9). Consequently, weed control was required on

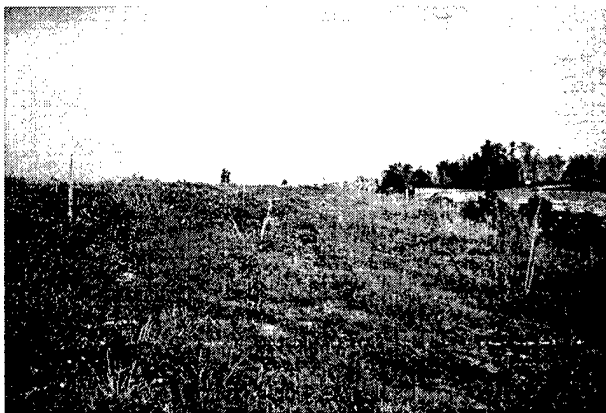
Figure 11. Vegetative cover on yardwaste and N-Viro biosolids demonstration plots (Sep 98)

all demonstration plots. The bagasse and N-Viro biosolids plots showed the least amount of undesirable vegetation and the best growth of planted desirable vegetation (Figure 10). After 2 years of herbicide wiping, Spanish needle continued to reestablish from the massive seed bank collected over the years (Figures 11 and 12). However, perennial peanut became established on the bagasse and N-Viro plots despite the continuous regrowth of Spanish needle (Figure 13).

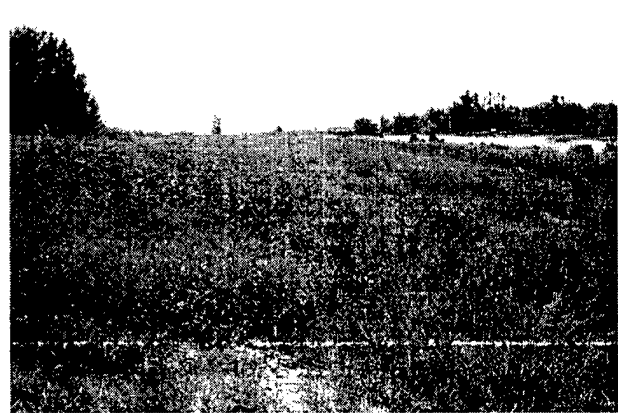
Figure 12. Vegetative cover on bagasse and N-Viro biosolids demonstration plots (Sep 98)

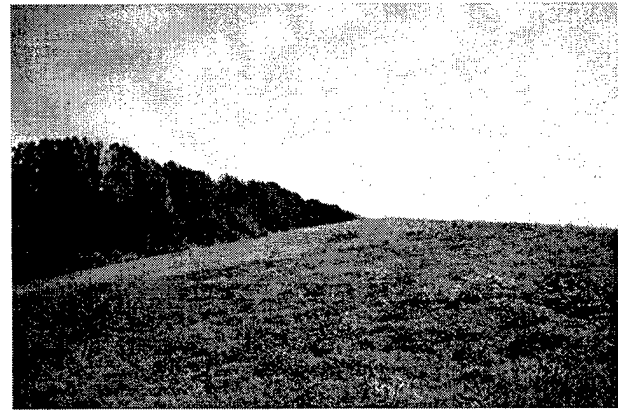
Figure 16. Less napier grass and more Spanish needle 1 month after wiping (May 96)

In areas of predominately napier grass, four wipings (Figures 16 and 17) were required to almost eliminate that plant. However, as soon as the napier grass disappeared, Spanish needle covered the area (Figure 18). Two additional wipings of 2.3×10^2 ml/ha (32 oz/acre) of Round-Up® herbicide were required to control the Spanish needle vegetation. A combination of wiping and mowing over 2 years was required to control napier grass and Spanish needle vegetation and allow the Bermuda grass and Bahia grass to reestablish on the area. The wiper applicator also successfully controlled undesirable weeds on all of the RSMT demonstration plots established on the dike.

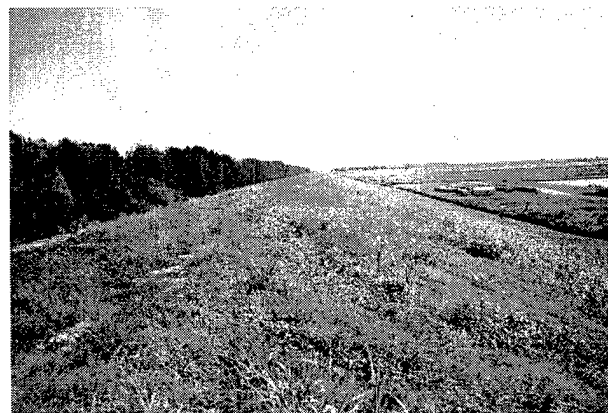
Figure 17. Untreated vegetation on right side of photo (May 96)

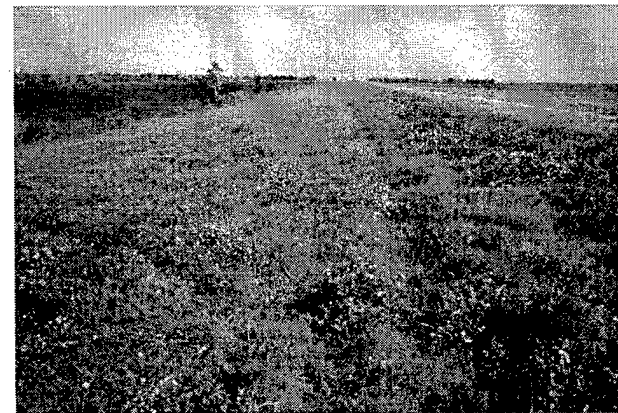
Figure 18. Elimination of napier grass, reduction of Spanish needle, and increased regrowth of Bermuda grass (Dec 99)

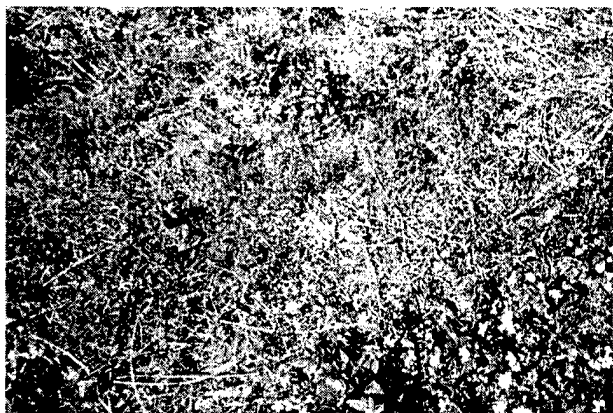
Figure 22. Bermuda grass regrowth among Spanish needle on herbicide-wiped plot (Dec 99)

Additional wiping and mowing were conducted and eventually Bermuda grass recovered (Figure 22) and spread over the area. The untreated control plot was covered with napier grass and Spanish needle (Figure 23). Desirable vegetation is usually present on the dike, but suppressed by the more dominant and aggressive undesirable napier grass. Once the aggressive undesirable vegetation is eliminated, other plant species present get an opportunity to grow. On the Herbert Hoover Dike system, the next plant species to overgrow the areas is Spanish needle. After it is controlled, the more desirable vegetation like Bermuda grass and Bahia grass recover and become dominant. It will take 3 to 4 years of wiper/mowing management to reverse the vegetation progression that has occurred over the past 10 or more years on the Herbert Hoover Dike. A combination of herbicide wiping and reduced fertilizer applications will return the dike system to more desirable vegetation that will be easier to manage. In addition to this weed control program, other technologies such as RSMT are being demonstrated and can improve the long-term fertility of the droughty dike dredged material/soil. The conversion to perennial peanut, which requires only potassium fertilizer and does not require mowing, will substantially reduce fertilizer and mowing costs for vegetative maintenance of this dredged material dike system.

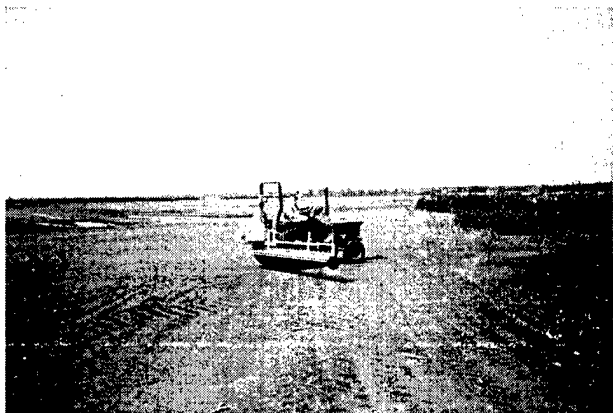
Figure 24. Modified wiper applicator on Eagle Island CDF, Wilmington, NC

The wiper applicator was improved by covering the aluminum panel with an Astroturf™ type carpet material. Plant leaves are chafed by the brace chains ahead of the panels and scraped by the Astroturf™ carpet material. The improved panel works as well as the grit panel and provides for more even distribution of herbicide solution through a series of check valves installed to prevent gravitational flow within the panel while working at acute angles on the side of the levee. Additional improvements were made by applying a 7.01×10^3 ml/ha (96-oz/acre) solution of glyphosate chemical and water. Mixing rates have been 9.46×10^2 ml (32 oz) chemical/18.92 $\times 10^2$ ml (64 oz) of water or 710 ml (24 oz) chemical/2,129 ml (72 oz) of water. The water reduces the viscosity of the herbicide, thus making it easier for the plant to absorb and translocate. The diluted herbicide solution also disperses on the plants better than the pure chemical.

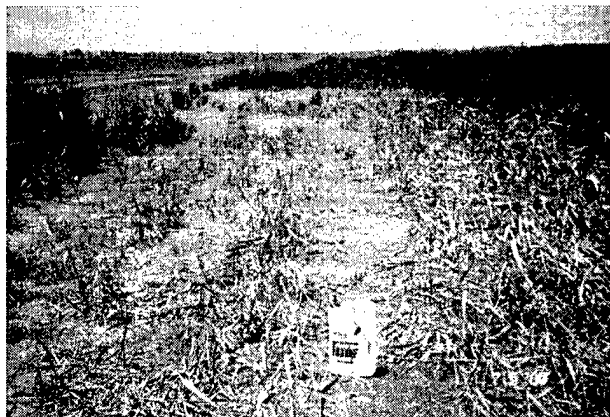
Figure 31. Observation at 43 days of the herbicide-wiped Plot 2 in the foreground with the unwiped control in the background (5 Jul 00)

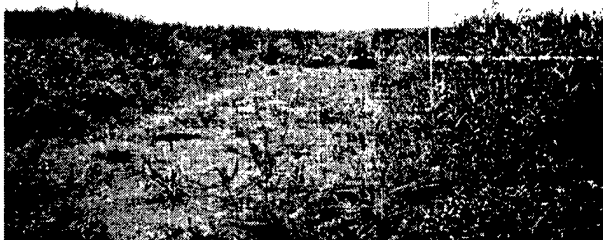
Figure 32. Observation at 60 days of the herbicide-wiped Plot 1 in the foreground with the unwiped control in the background (22 Jul 00)

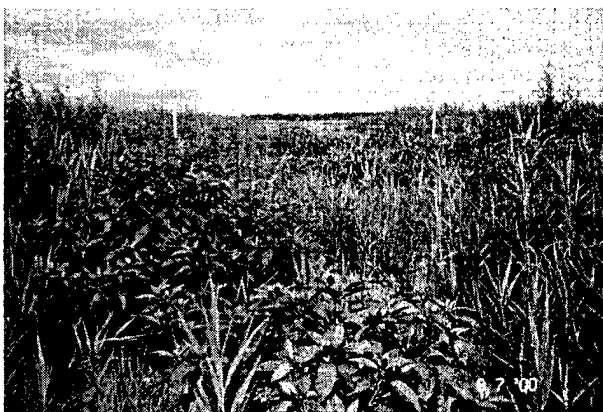
Figure 34. Plot 1 control, unwiped (Jul 00)
