Jackson Hole, Wyoming Environmental Restoration Draft Feasibility Study

Draft Feasibility Study
and
Appendixes A - B

April 2000

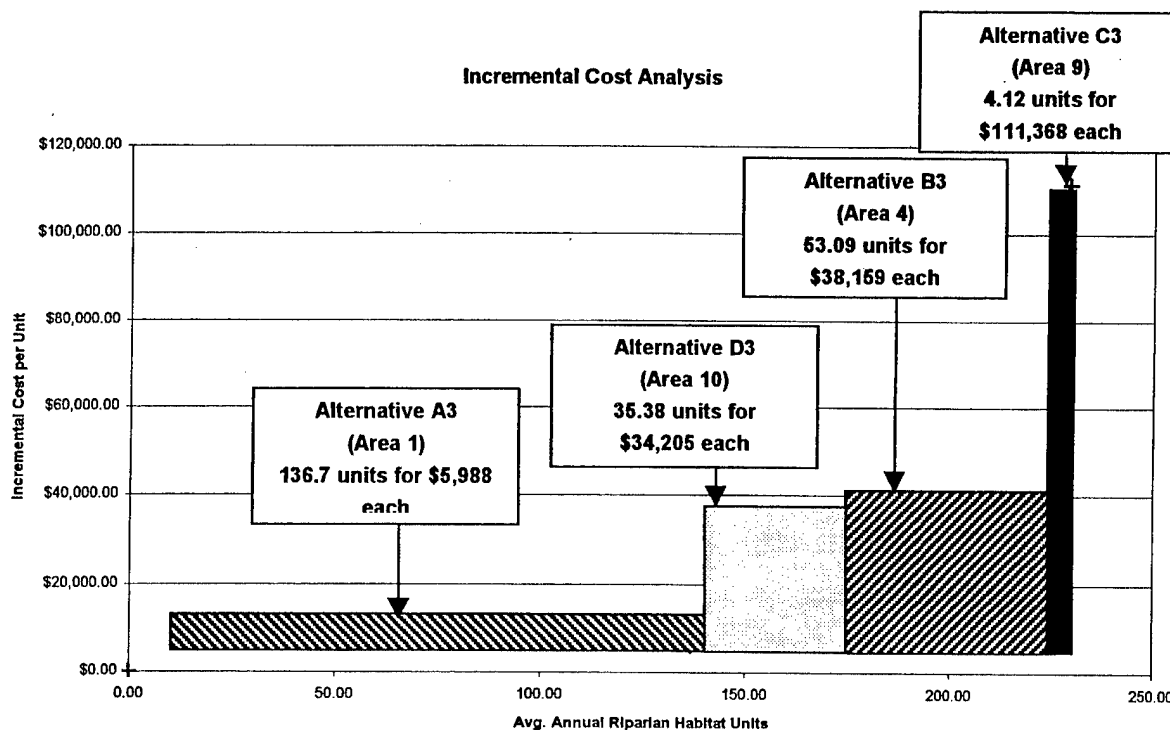
The figure on the following page provides a graphical representation of the data in Table 4.22. Incremental cost per unit is plotted on the vertical axis and output along the horizontal axis. The graph shows a large return for investment with A3 (Area 1), then a jump in incremental cost per unit to get to the next alternatives (B3 and D3), which each provide significant output for similar incremental cost per unit. A significant increase in incremental cost per unit comes as Alternative C3 is implemented. This is largely due to the relatively small change in riparian output with the alternative. While C3 ranks last in riparian habitat production efficiency, this is in large part due to the riparian habitat demonstration project that has already been completed at Area 9 and factored into the without-project analysis. Further examination should be conducted to determine if implementing the aquatic habitat restoration features at Area 9 would provide for sustainability of benefits to be provided by the Area 9 demonstration project.

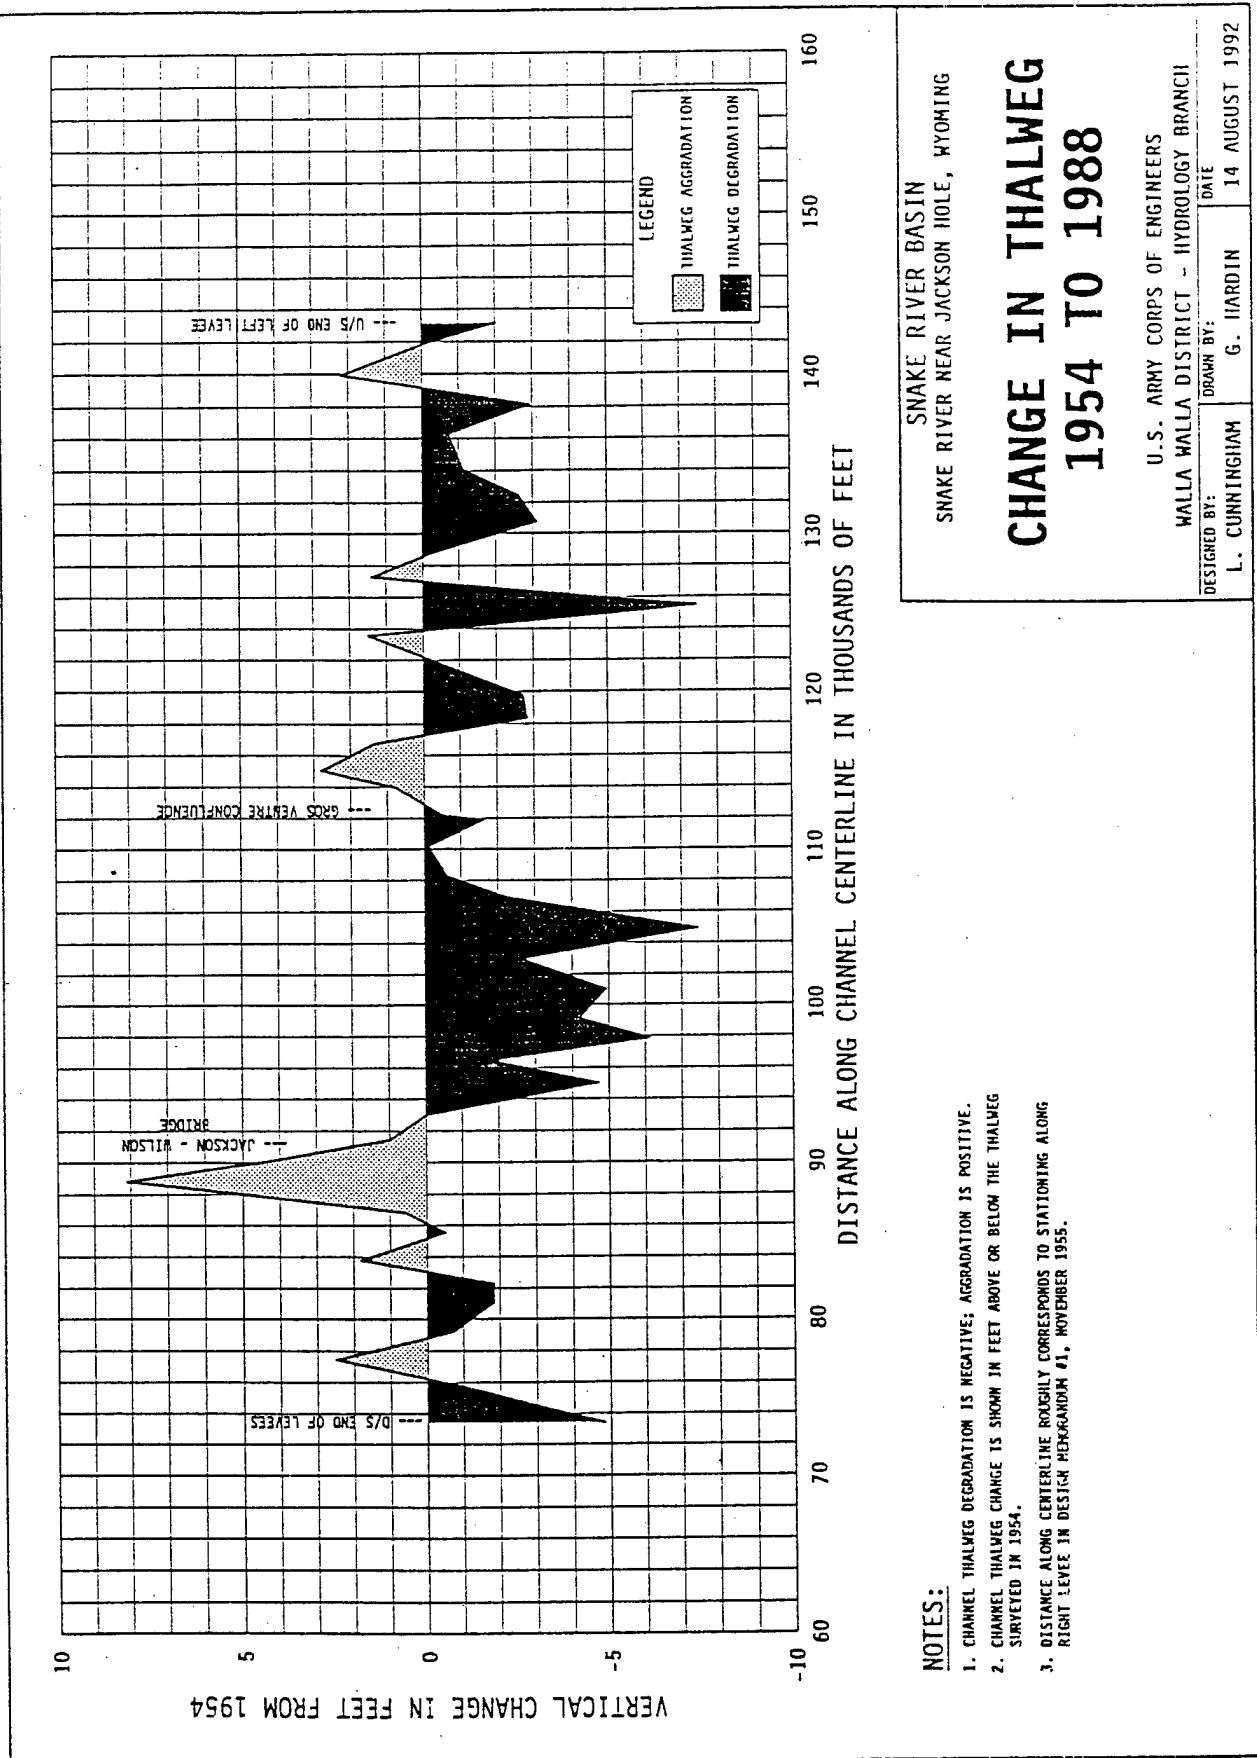
CHANGE IN THALWEG 1954 TO 1988

1. CHANNEL THALWEG DEGRADATION IS NEGATIVE; AGGRADATION IS POSITIVE.
2. CHANNEL THALWEG CHANGE IS SHOWN IN FEET ABOVE OR BELOW THE THALWEG SURVEYED IN 1954.
3. DISTANCE ALONG CENTERLINE ROUGHLY CORRESPONDS TO STATIONING ALONG RIGHT LEVEE IN DESIGN MEMORANDUM #1, NOVEMBER 1955.
