ERDC/CRREL TR-03-21

Use of Military Demolition Explosives in a Remediation Project

October 2003

Prepared for U.S. ARMY ENVIRONMENTAL CENTER
and
U.S. ARMY ALASKA

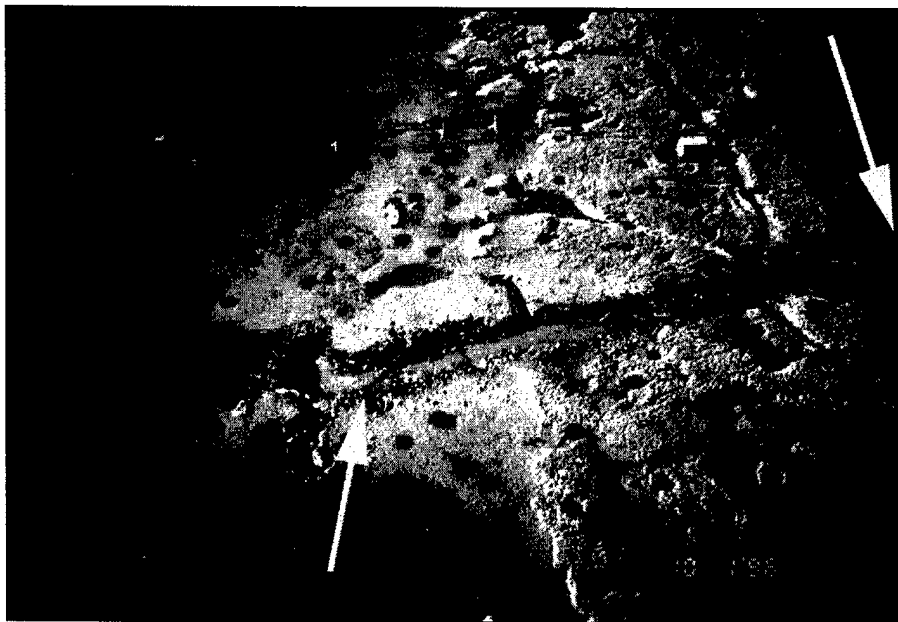
Figure 5. Bread Truck ditch, October 1996. Arrows point to the ends of the blasted ditch. Headwall erosion is evident to the left of the left arrow.

The explosion of the cratering charges produced a series of craters forming a nearly continuous ditch 90 m long. Craters were up to 2 m deep and varied from 3.3 to over 6 m in diameter. The mean crater diameter was 4.92 m. The smallest-diameter craters were within the slightly higher vegetated mudflat area near the northern end of the ditch and in the pond sediments at the southern end. The ground at the northern end was more deeply frozen, and the explosive charges

may not have been as efficient in removing material. It is unclear why the craters at the southern end were smaller than predicted. Differences in crater diameter were likely due to differences in the effectiveness of tamping. Between one and three sand bags were placed in each borehole above the cratering charge, and almost all holes were filled with meltwater. The smaller-than-expected size of several of the craters caused some craters not to overlap. This created several blockages that prevented any initial flow through the ditch. Following the spring thawing of the pond ice and the surrounding seasonally frozen ground, a series of flooding high tides in late May eroded the blockages and initiated draining of the pond on 19 May 1996. Accelerated headwall erosion was evident by October of that year (Fig. 5).
