**An Assessment of the Emergency Egress Characteristics
of the U.S. Army Airborne Command and
Control System (A2C2S)**

ARL-MR-0635

January 2006

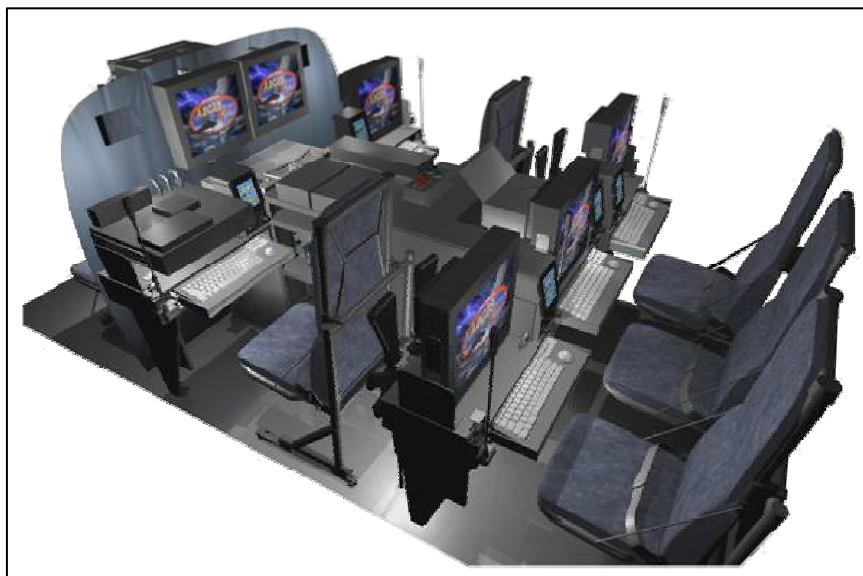
The Army Airborne Command and Control System (A2C2S) (see figure 1) is a command and control (C2) system consisting of an A-kit and a B-kit and will be hosted by the utility helicopter (UH)-60L (and newer) Blackhawk. The A-kit is permanently affixed to the airframe and consists of antennas, wiring, and aircraft interfaces (e.g., power, structural, etc.) that enable the B-kit to be installed in the airframe.

Figure 1. A2C2S.

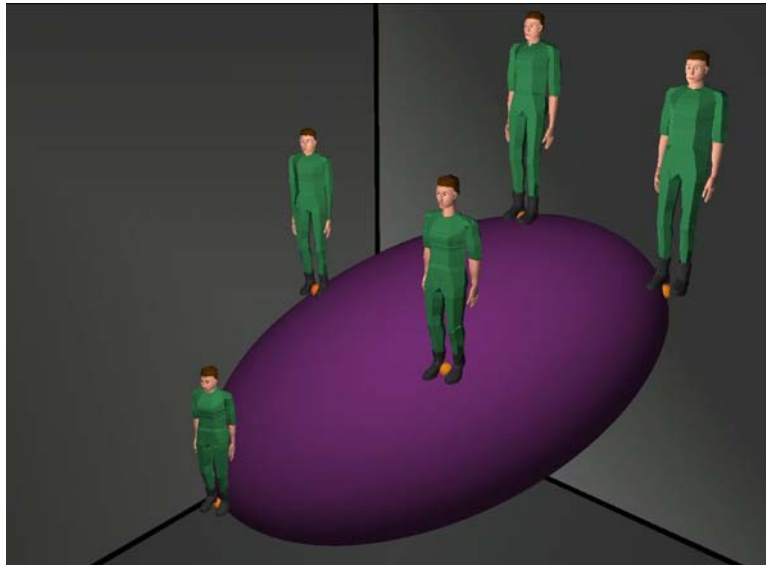
The U.S. Army Natick Soldier Center, Natick, Massachusetts, supplied the data set used to generate the boundary forms that were then used to construct the human figure models for this analysis by the principal components analysis (PCA) method. Some human figure boundary models are shown in figure 2.

Figure 2. Boundary models representing an accommodation envelope.

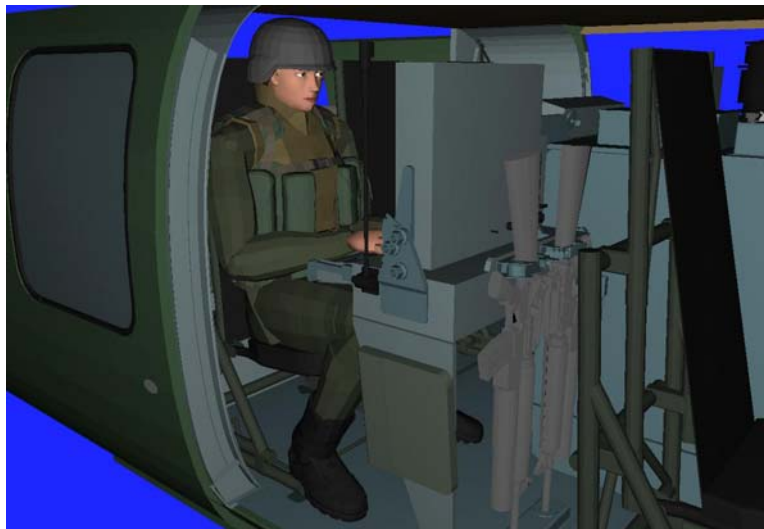
The first egress task examined simulated the operator seated at the right rear workstation position (figure 5) and exiting through the left side cargo door. This scenario assumes an inoperable right side cargo door or a blocked right side cargo door opening.

Figure 5. Human figure model seated at the right rear workstation.

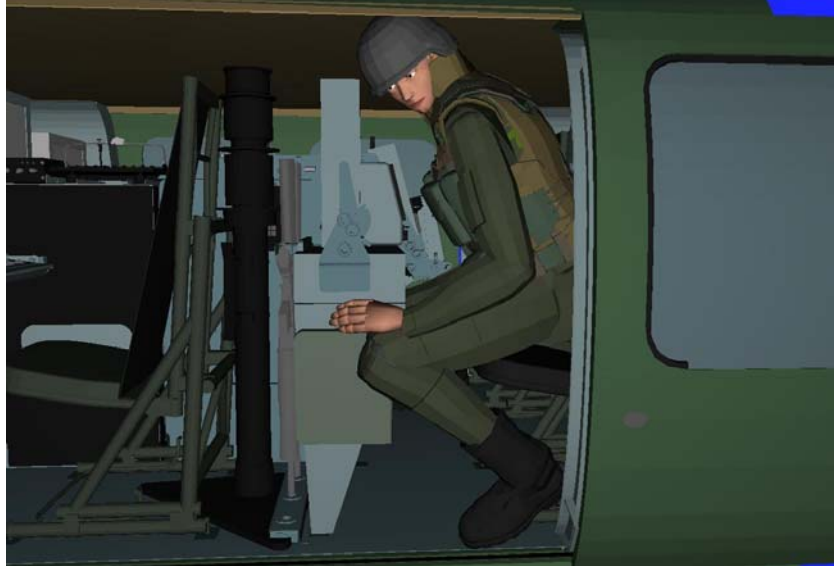
Figure 7 also shows that the operator has retracted the right and left keyboards and folded the center workstation keyboard into a stowed position in order to maximize the available space during this type of egress. With these keyboards moved out of the way, sufficient space does exist for the operator to perform the egress in this manner. One possible problem area noted when this type of egress is performed is shown in figure 8. Large males could have a problem with their heads striking the upper left-hand corner of the flat screen monitor just before they exit the aircraft through the left cargo door opening.

Figure 8. Human figure model sliding across rear seats.

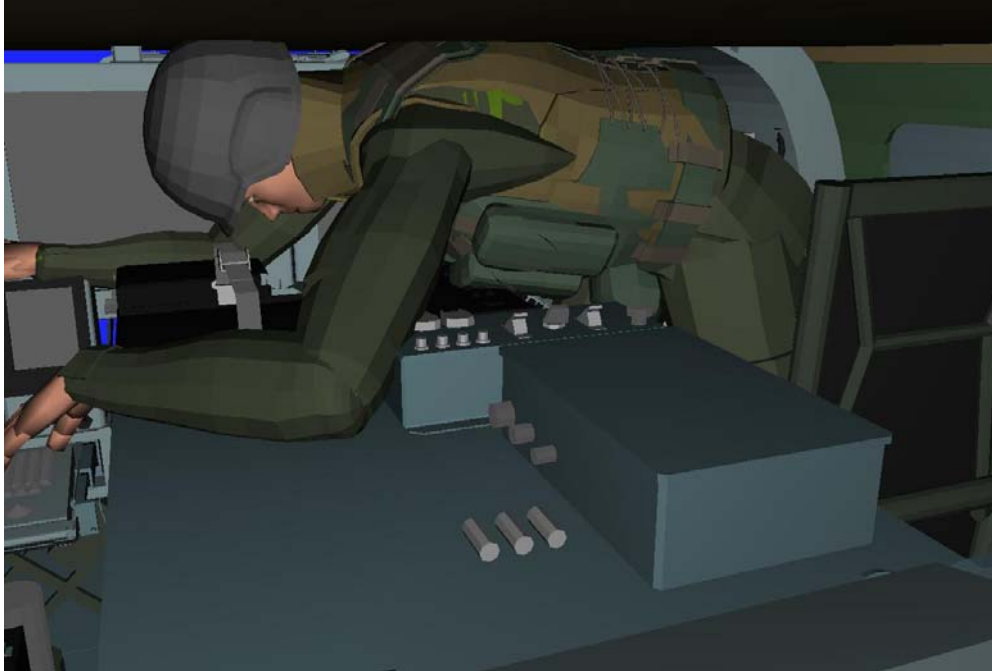
The dimensions taken from the CAD model show that the clearance between the top of the center console and the interior aircraft ceiling narrows to as little as 10.75 inches. Therefore, the two most critical body dimensions that must be examined are the chest depth and buttock depth. The large male figure used in this analysis has a chest depth dimension of 11.26 inches and a buttock depth of 11.40 inches. However, these are standing dimensions and when a person assumes a crawling position, one could expect significant soft tissue compression along with a compression of the chest cavity so that even a large male Soldier should be able to squeeze through the limited space available over the center console if the standard BDU clothing worn did not include any additional equipment. On the other hand, an LBV such as the one worn by the large male human figure in this analysis, can add 4 to 5 inches to the chest depth measurement and would make egress over the center console very difficult, if not impossible, for the larger end of the male Soldier population (see figure 11).

Figure 11. Large male figure attempting egress over the center console.

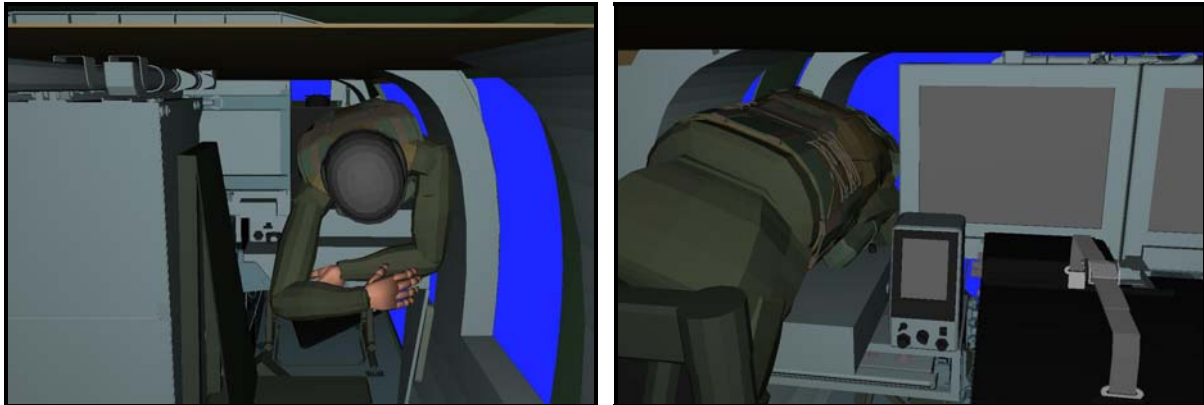
Once the shoulders have cleared, sufficient room exists, even for the large male wearing the added clothing and equipment items, to clear the rest of the body through the opening (see figure 15).

Figure 15. Aft and forward facing views of large male figure clearing shoulders through workstation.

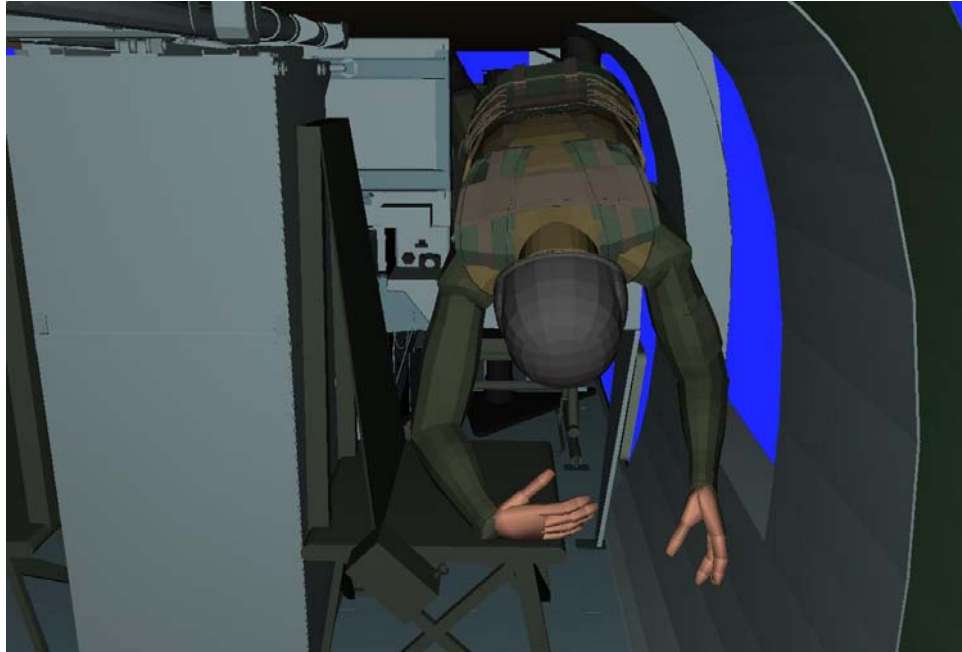
One other point to note about this egress route is that once the operator is able to clear the torso through the opening, the seat on the other side of the workstation can be used for support, in addition to providing a structure that can be used to pull the rest of the body through the opening (see figure 16).

Figure 16. Large male figure using the crew chief for support.

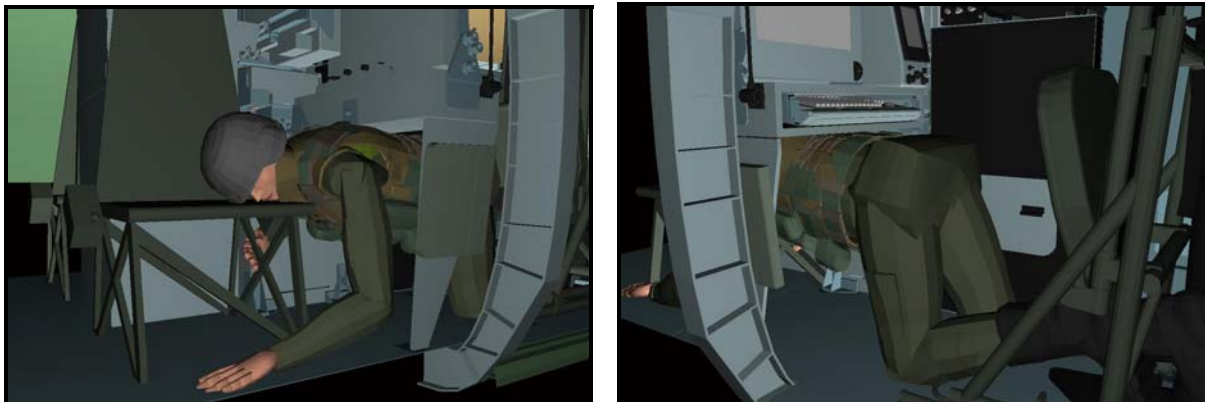
The analysis performed for this egress route assumed that the operator's initial steps would be to fully retract the keyboard into the workstation platform, lift the seat pan into the vertical stowed position, and then proceed to crawl under the workstation platform on hands and knees. The key body dimensions that one would want to consider for this egress route are bideltoid breadth as well as the buttock-knee length and the chest depth. As noted earlier, the bideltoid breadth dimension of the large male figure was 21.25 inches and so the width of the crawl space is adequate to accommodate large male Soldiers even with additional clothing and equipment. However, the buttock-knee dimension of the large male figure was 26.4 inches and the height of the crawl space is only 25.25 inches. This means that although the larger male Soldiers would not be able to crawl under the workstation platform with the arms fully extended and legs upright, enough space does exist so that, with a slightly lower profile crawling posture, these Soldiers could get through (see figure 18).

As seen on the left side of figure 18, upon emerging from under the workstation platform, the Soldier will have to negotiate around the seat directly in front of the platform. Whereas this seat assists the Soldier when he is performing the egress maneuver over the top of the workstation platform, it is clearly an obstacle in the path when the Soldier is attempting to egress underneath. The analysis showed that although this seat would not prevent the larger Soldiers from completing the egress, it could make this route a much more time-consuming option versus going over the top of the workstation.

Figure 18. Aft and forward facing views of large male figure crawling under the workstation.

A third recommendation applies to an egress from the front left or right workstation positions where the path would involve crawling under the workstation platform. As shown previously in figure 18, sufficient space does exist under the platform even for larger Soldiers to crawl under the workstation platform. However, the seat directly in front of the workstation positions could significantly slow egress. A quick release that would allow the seat to be moved or rotated away from the workstation would provide much needed additional space and would allow this egress maneuver to be performed more easily.

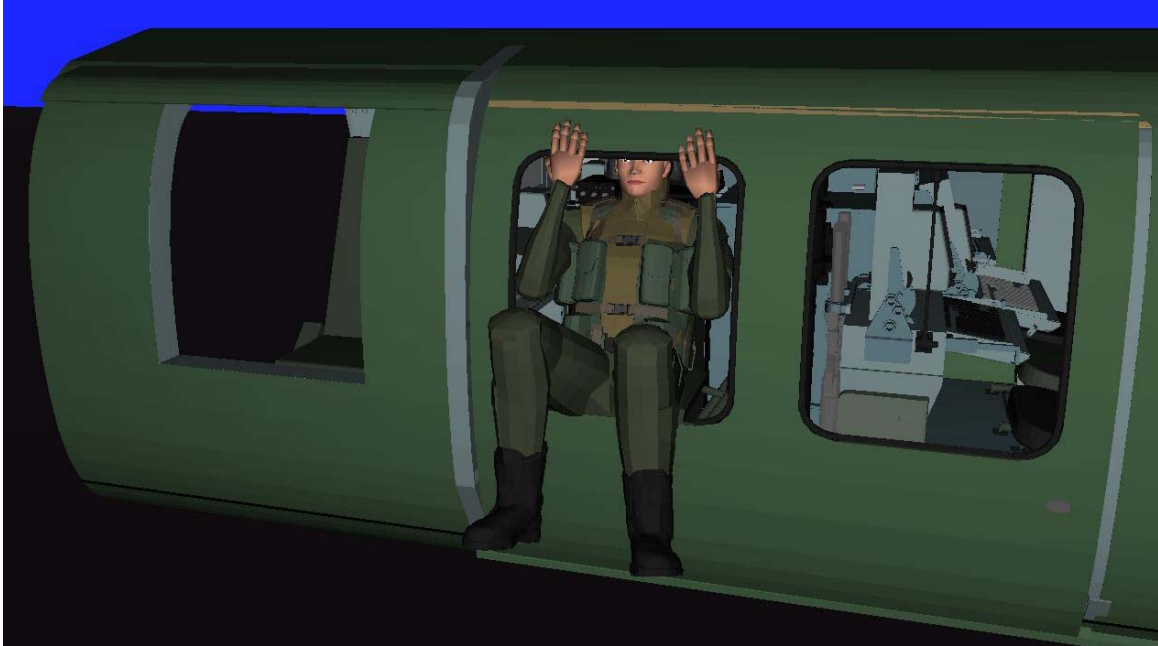
Figure 21. Exterior view of the large male figure leaving through left front cargo door window.

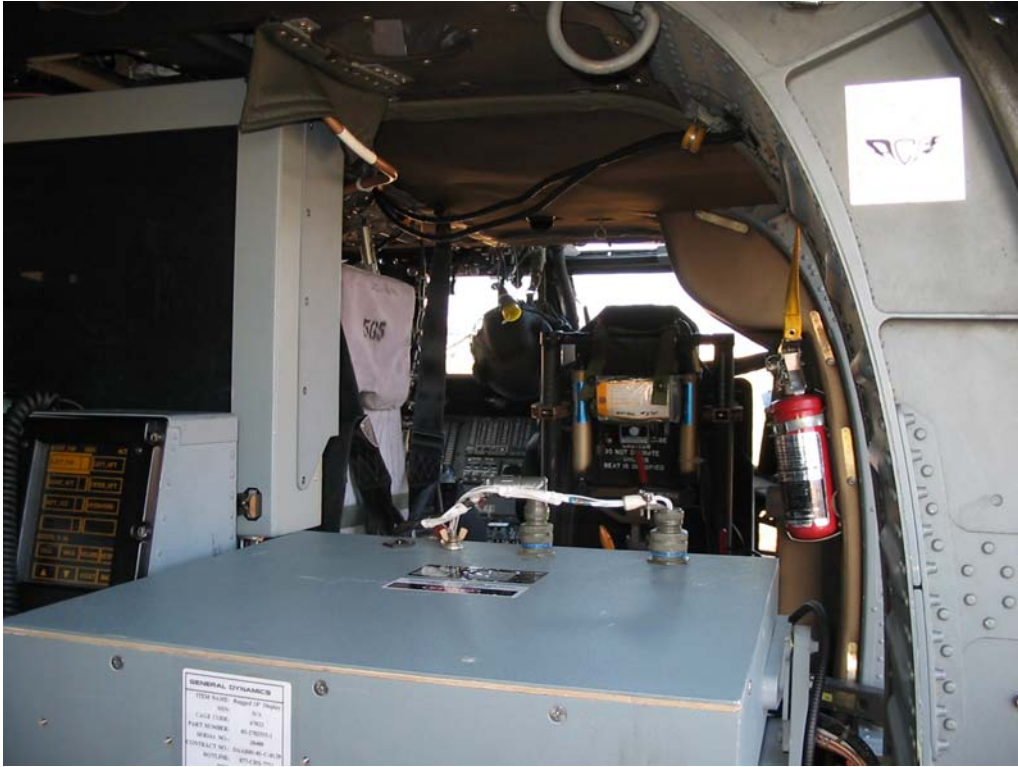
The second phase of egress trials included blocking the exits on the left side of the aircraft to simulate an aircraft on its side or otherwise blocked exits. During these trials, the three rear operators maneuvered across the back row of workstations and exited through the right cargo door. The front right operator also exited through the right cargo door. The operator seated at the left front workstation was the large male participant. This operator exited the aircraft by lowering the workstation monitor, crawling over the workstation into the crew chief station, and exiting through the right gunner's window. Figure 22 shows the opening over the workstation provided when the monitor is folded down. The operator was unable to egress over the center console because of the restricted space between the center rack and the cabin roof. Figure 23 shows the space restriction caused by the height of the center rack. The recorded times for these three trials ranged from 17 to 23 seconds, and the average egress time was 19.3 seconds.

Figure 22. Egress route over workstation.

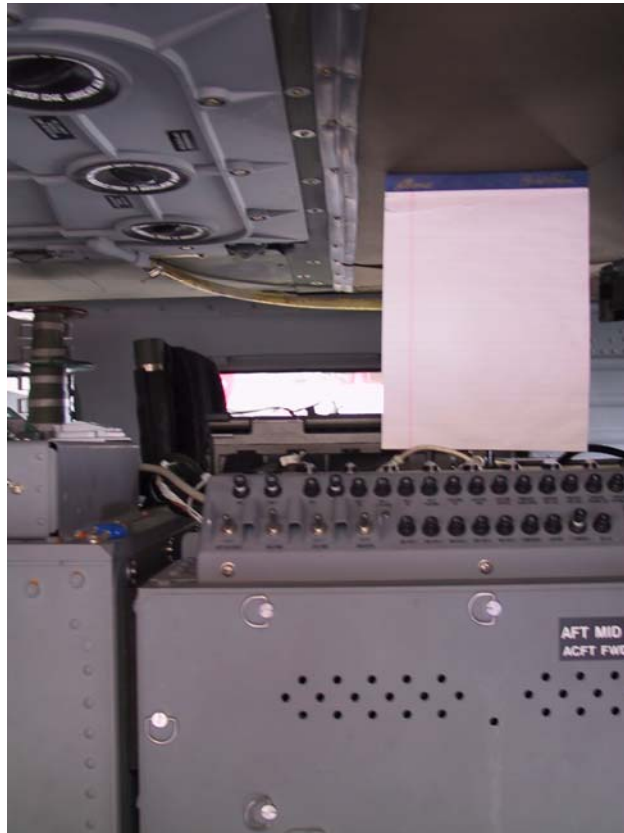
Several issues were identified during Phase 3 of the egress test. The participants and observers noted that the rear center keyboard would not remain in the stowed position because of interference with the ICS hookup. Another issue identified during the egress testing was the location of “quick connect” cables on the back of the workstation monitors. These connections caused snag hazards when the front operators were forced to egress over the top of the workstation. During the second trial of Phase 3, the large male participant was attempting to egress under the front workstation. In the process, the Soldier’s butt pack became snagged on

Figure 23. Restricted space above center rack.

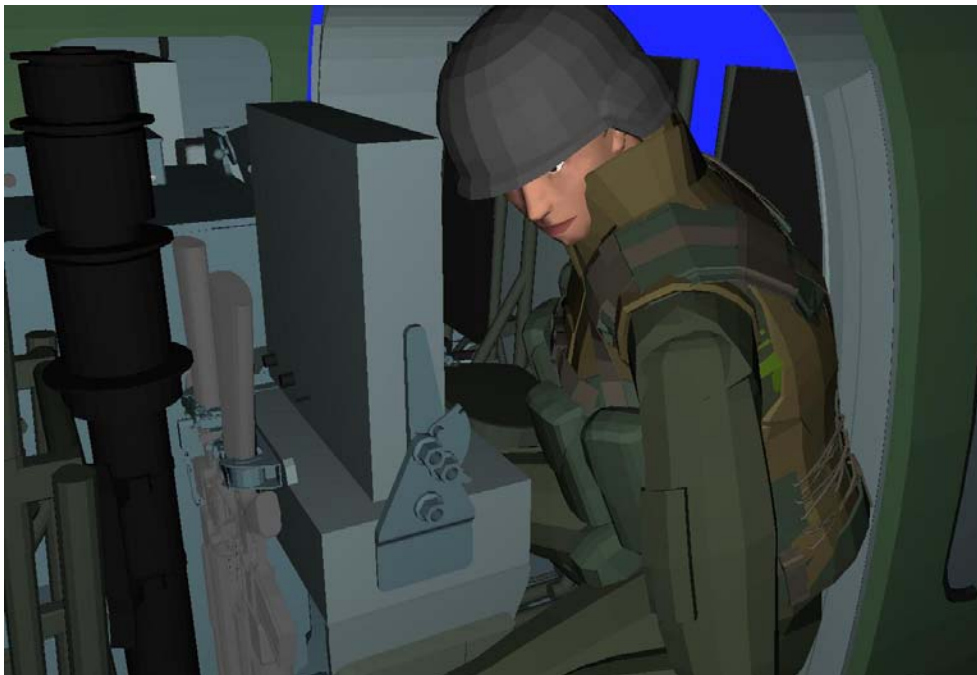
The first recommendation pertains to egress from the rear workstation positions or, more specifically, the first type of egress analysis addressed in the results section. As noted in the results section, larger Soldiers could have problems with head contact to the upper outboard section of the flat screen monitor at the right or left rear workstation positions. A solution that would provide extra headroom would be to allow the flat screen monitors to rotate back beyond the full upright position. The current rotation back seems to be limited to about 20 degrees because of weapon stowage in back of the right and left rear workstation positions. However, even this limited rotation of the monitors could provide the additional space to make egress from the rear workstation positions easier for the larger Soldiers (see figures 24 and 25).

Figure 24. Restricted head space with monitor positioned upright.

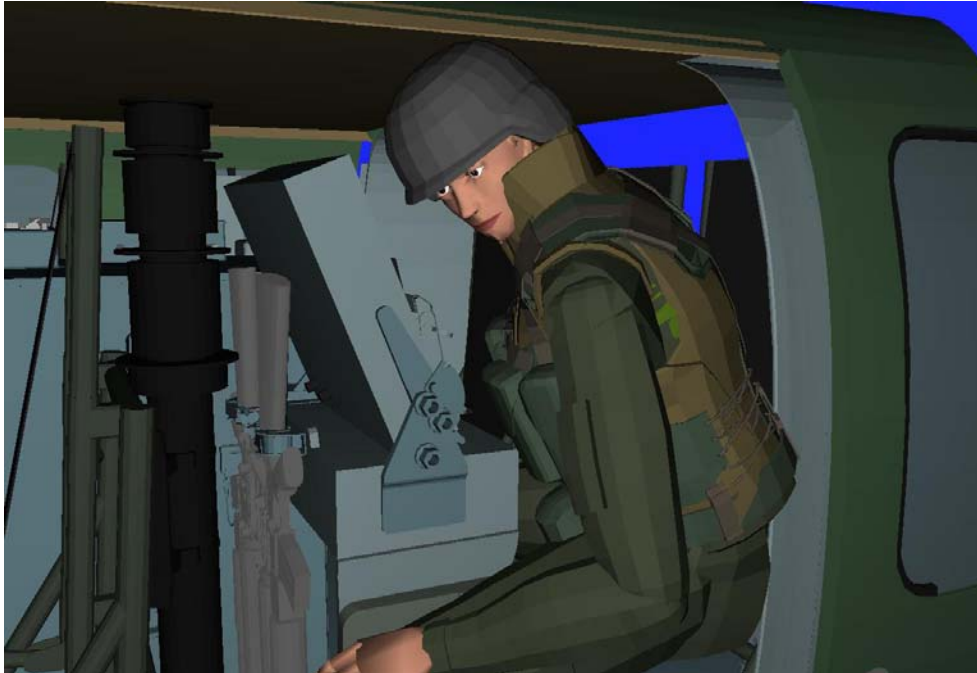
Figure 25. Additional head space provided by rotating monitor backward 20 degrees.

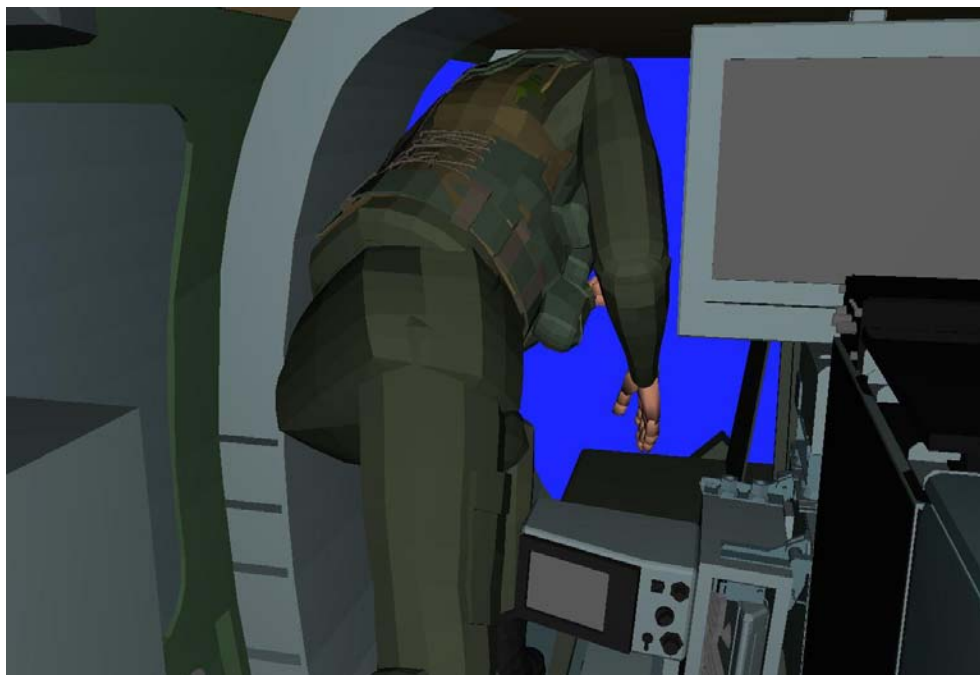
Figure 27 shows the clear benefit provided by the additional space created when the workstation platform collapses. This potential design alternative would provide ample space for even large male Soldiers to use for an egress path and would be much more preferable than their having to climb over or crawl underneath the workstation.

Figure 27. Large male figure leaving through space provided when workstation is folded down.
