NASA TECHNICAL NOTE

NASA TN D-3198

DYNAMIC INSTABILITY OF UNDAMPED BELLOWS FACE SEALS IN CRYOGENIC LIQUID

by John C. Hudelson

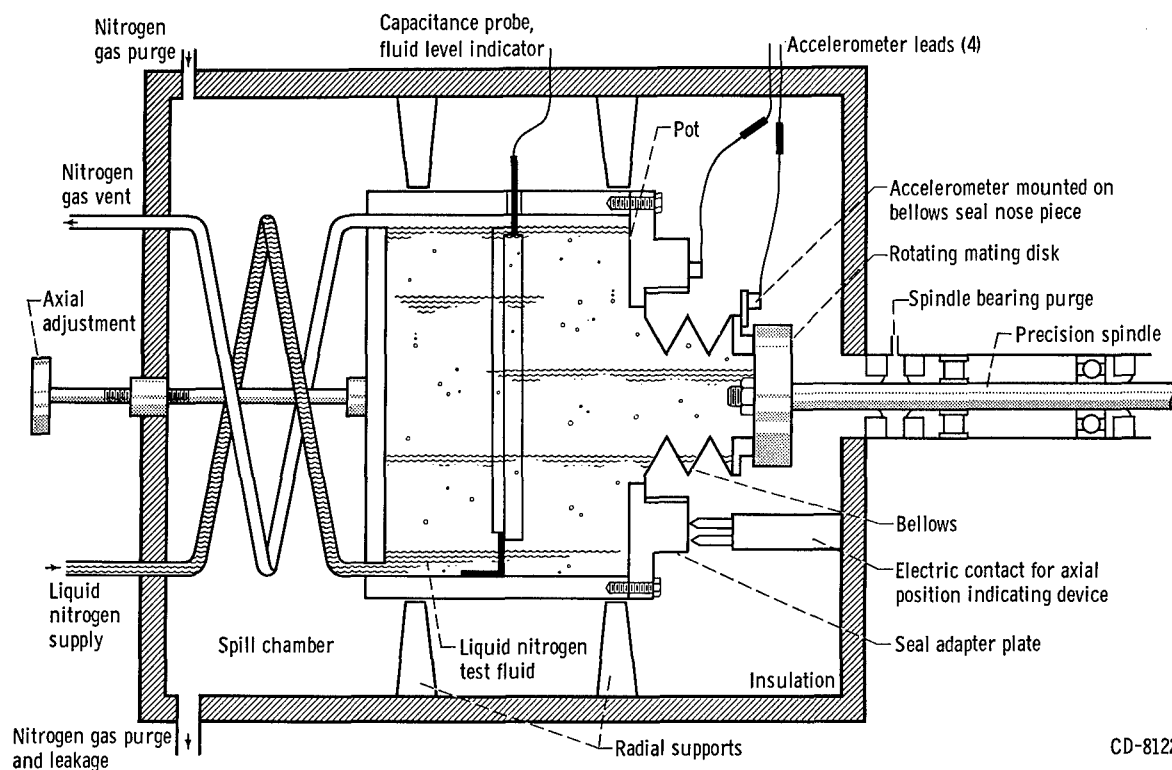
CD-8122

Figure 1. - Schematic of cryogenic seal test facility and seal test head.

The cryogenic-oxidant seal test facility at the NASA Lewis Research Center was used for this investigation. The test facility can accommodate radial face seals to nominal 3-inch diameters. The test bellows face seals were nominally $1\frac{3}{4}$ inch in size having a 2-inch mean sealing diameter and did not use any damping devices such as lugs, lips, or springs. A schematic diagram of the test head (fig. 1) shows the major elements of the apparatus. The pot contains the test fluid, in this case, liquid nitrogen. One end of the pot was the adapter plate, which contained the test bellows seal. With this configuration, the seal was pressurized on the inside diameter and the leakage direction was from the inside to the outside diameter of the seal nosepiece.

During operation a continuous flow of liquid nitrogen was maintained through the pot. The liquid nitrogen was supplied to the pot near the bottom, and the gaseous nitrogen boiloff and excess liquid nitrogen were vented from the top of the pot. The fluid level was indicated on a capacitance recording device by means of a capacitance pickup in the pot.

The pot was constrained radially and torsionally but was free to move axially over a 0.200-inch range. A screw for axially adjusting the pot had micrometer-type markings in 0.001-inch increments. The axial position of the pot was indicated by two preset electrical contacts. These contacts were so located as to minimize the effect of contraction of the pot as it was chilled down for a test.

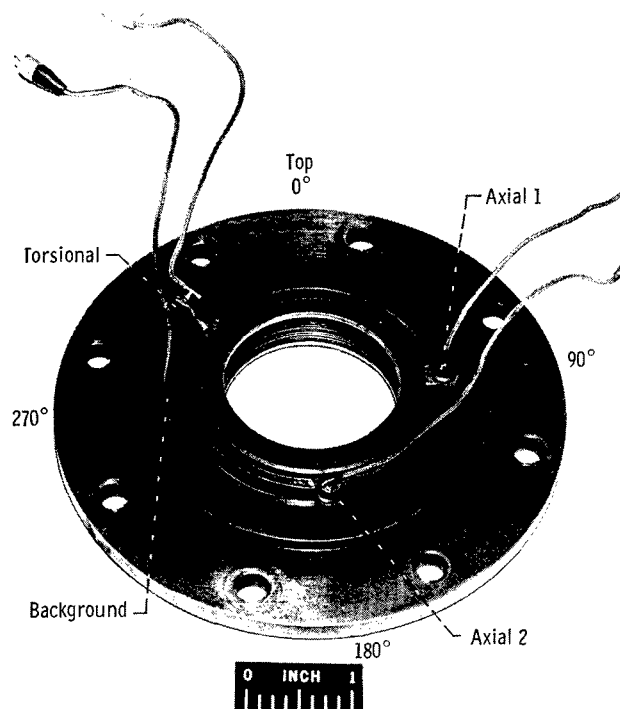
C-65-3357

Figure 2. - Bellows face seal mounted in adapter plate with accelerometer mounting locations indicated.

The accelerometer placement is illustrated in figure 2. Three of the accelerometers were attached to the seal nosepiece and the fourth was attached to the adapter plate adjacent to the seal housing. The accelerometers were sensitive along one axis only, thus the orientation was important. The accelerometers mounted at the 90° and 180° positions measured accelerations parallel to the axis of the seal. The accelerometer mounted at the 315° position measured the torsional acceleration of the seal nosepiece. The fourth accelerometer, mounted on the adapter plate, measured the background accelerations and also acted as a control to monitor electrical interference. For this reason, the background accelerometer was operated at five times the sensitivity of the other accelerometers. In the trace photographs some low frequency wave shape can be seen in the background trace. This was 60-cycle hum in the playback system and does not represent background vibration.

The different motions of the seal nosepiece can be illustrated by examining the trace photographs and referring to their position on figure 2.

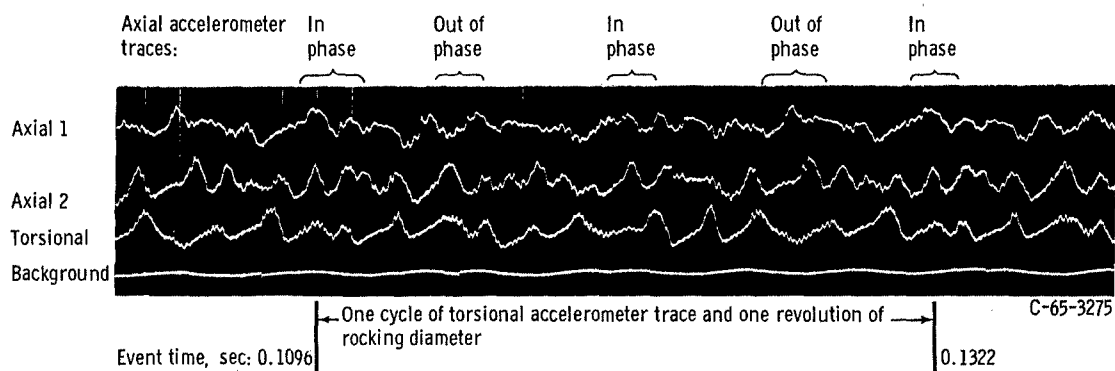
Figure 3. - Composite trace showing phase relations of diametral rocking about revolving diameter.

The phase relation of the axial and torsional accelerometer traces is shown in figure 3. The trace photograph represents the sixth cycle of a longer trace photograph covering seven complete cycles.

In the case of severe diametral rocking (fig. 3) the torsional trace is a combination of torsional oscillations and a component of the rocking motion acting in the same direction as the torsional component. For this reason the phase relation of the two axial and one torsional accelerometer is an indication of the seal nosepiece motions.

The two axial accelerometer traces shown in figure 3 are alternately in phase, then out of phase. The in-phase relation corresponds to rocking about the 45° to 225° diameter. The out-of-phase relation corresponds to rocking about the 135° to 315° diameter. Each revolution of the rocking diameter would be represented by two in-phase, out-of-phase cycles of the axial accelerometer traces. This means that an event time from 0.1096 to 0.1322 second is equivalent to one revolution of the rocking diameter.

The torsional trace in figure 3 does complete one cycle in 0.1096 to 0.1322 second. Thus, both the axial and torsional accelerometer traces are in

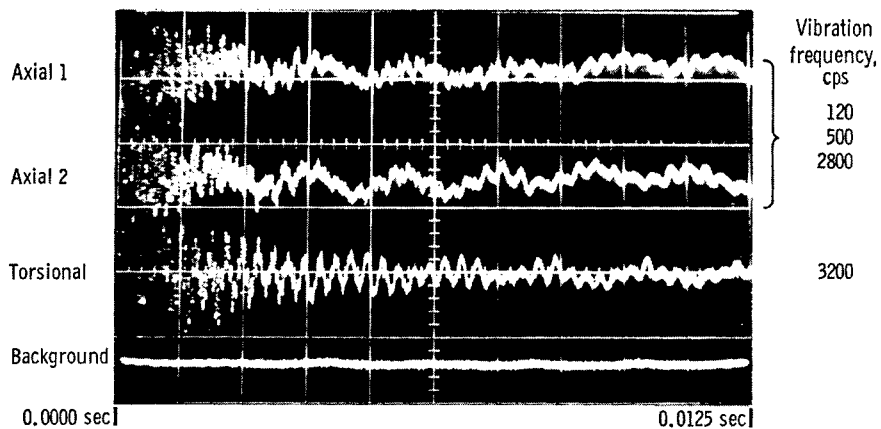
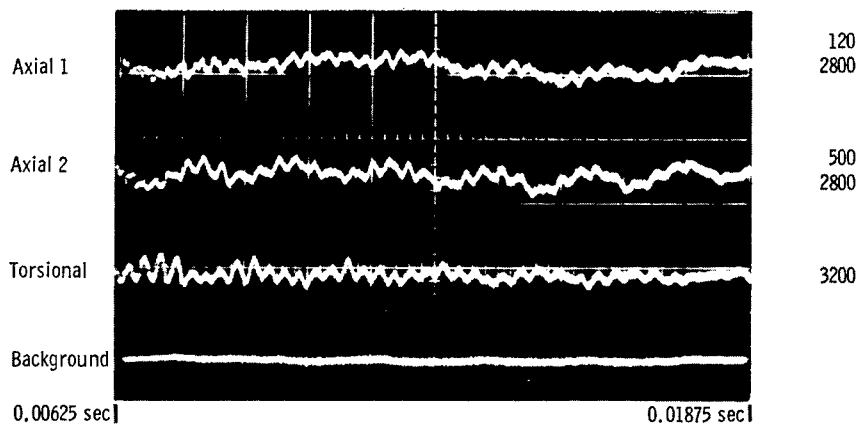
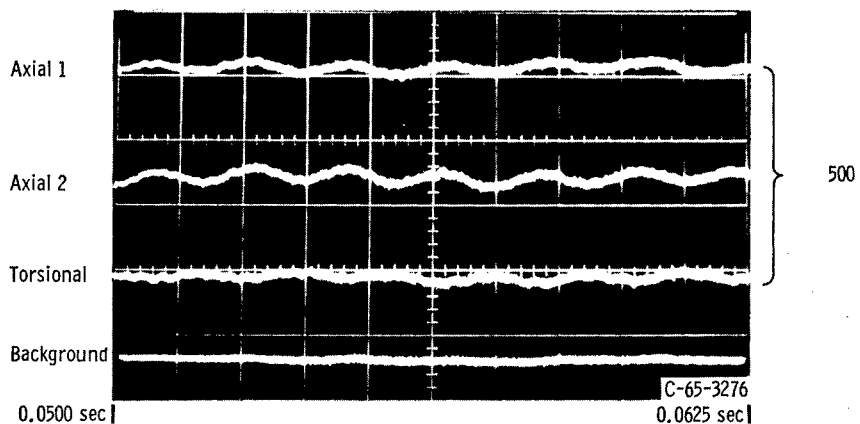
(a) Event time, 0.0000 to 0.0125 second.

(b) Event time, 0.0625 to 0.01875 second after excitation.

(c) Event time, 0.0500 to 0.0625 seconds after excitation.

Figure 4. - Natural resonant frequencies during free vibration.

The natural vibration characteristics of the bellows face seals were measured by plucking the seal nosepiece and allowing it to vibrate out of contact with the mating surface. At the onset of free vibration, high-frequency oscillations were visible in both axial and torsional directions. These high-frequency vibrations of about 20 kcps were damped out in about 4 milliseconds. Figure 4(a) shows the high-frequency vibrations decreasing in amplitude and the emergence of medium- and low-frequency vibrations. The axial vibration frequencies were 120, 500, and 2800 cps. The torsional vibrational frequency was 3200 cps. The top trace, axial 1 accelerometer, of figure 4(b) shows the 120- and 2800-cps frequencies combined. The second trace, axial 2 accelerometer, shows the 500- and 2800-cps combined frequencies. The third trace represents the torsional accelerometer and shows the 3200-cps vibration. In all the trace photographs the abscissa scale is the same, and each large division is 0.00125 second.

Figure 4(c) shows the same excitation at a mean time from 0.0500 to 0.0625 second after initiation. The two top traces, which represent the axial accelerometers, show only the 500-cps vibration. A weak 500-cps signal in the third or torsional trace can also be seen. This has been excited by the axial vibration that predominates.

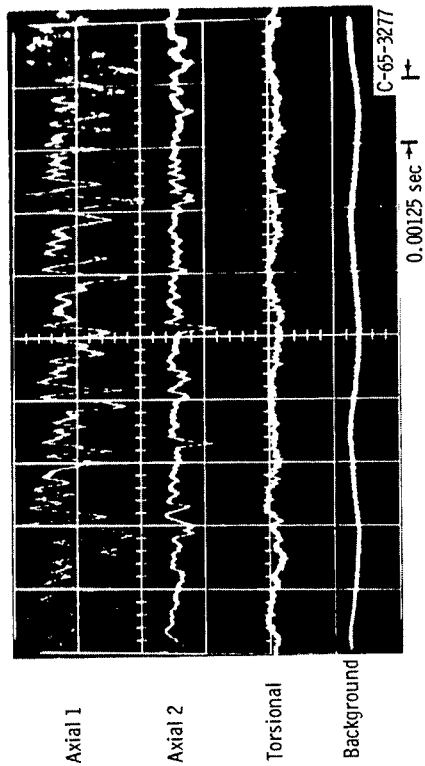
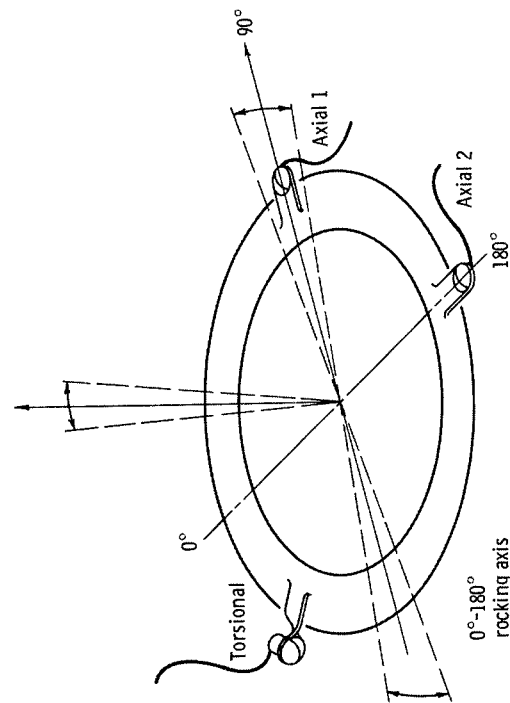
Figure 5. - Maximum amplitude on axial 1 accelerometer. Shaft speed, 9000 rpm; pressure difference, 20 pounds per square inch. Axial 1 accelerometer conditions: vibration frequency, 740 cps; displacement, 10 000 micro-inches; acceleration, 300 g.

The trace photograph in figure 5 shows maximum amplitude on the accelerometer located at the 90° position, which represents a 740-cps motion of 10 000-microinch amplitude. This is caused by a rocking about the 0° to 180° diameter.

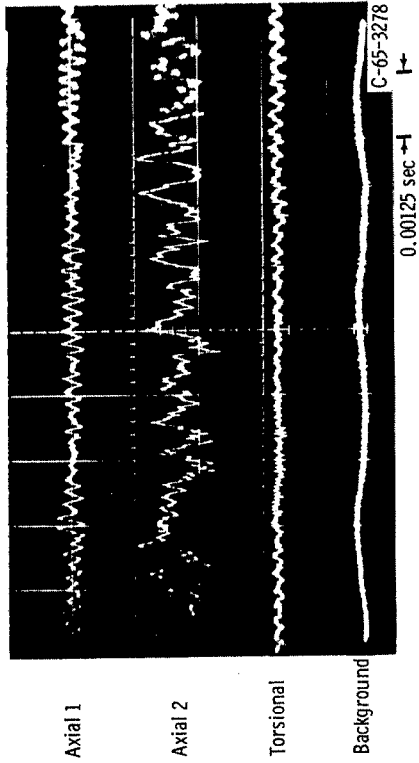
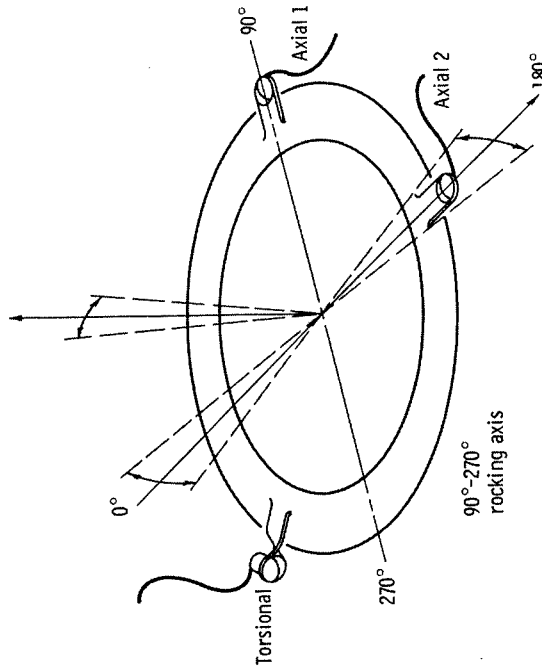
Figure 6. - Maximum amplitude on axial 2 accelerometer. Shaft speed, 6000 rpm; pressure difference, 20 pounds per square inch. Axial 2 accelerometer conditions: vibration frequency, 1455 cps; displacement, 1600 micro-inches; acceleration, 190 g.

The trace photograph in figure 6 shows that the accelerometer located in the 180° position has the maximum amplitude. This trace represents a 1455-cps motion of 1600-microinch amplitude. This motion is also rocking about a diameter, in this case the 90° to 270° diameter.

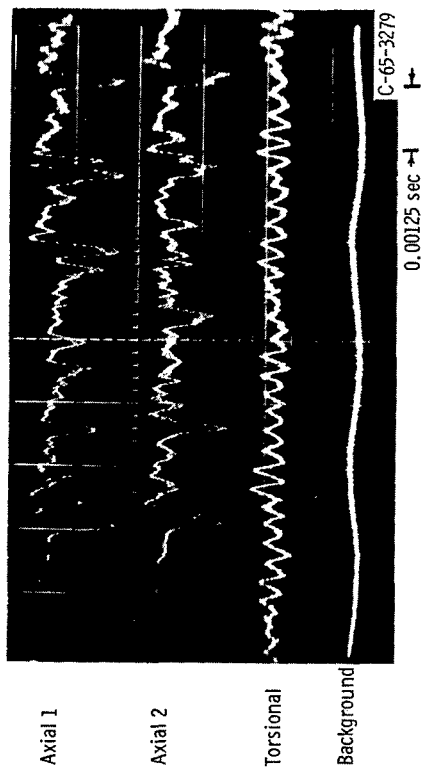
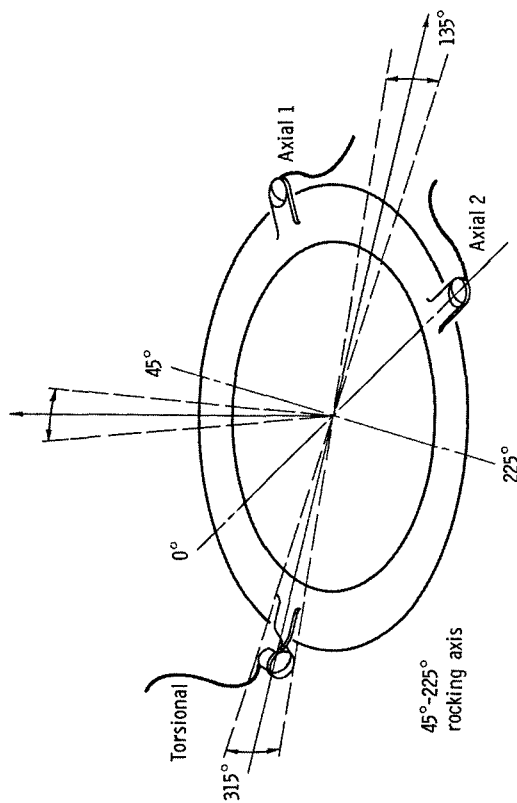
Figure 7. - In-phase axial accelerometer traces. Shaft speed, 7000 rpm; pressure difference, 20 pound per square inch.

In-phase axial accelerometer traces are shown in figure 7, representing diametral rocking about the 45° to 225° diameter.

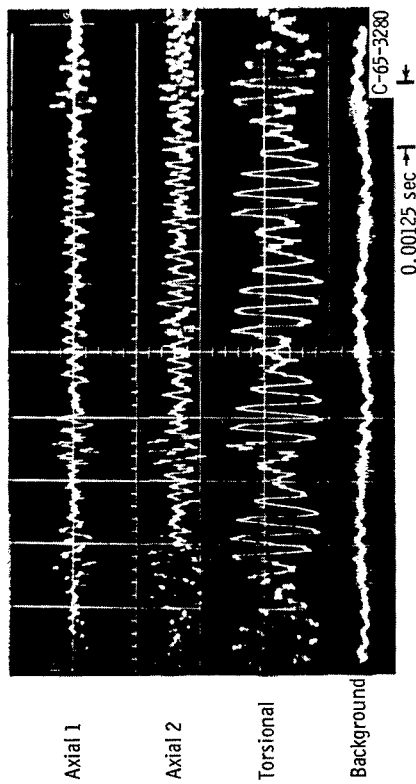
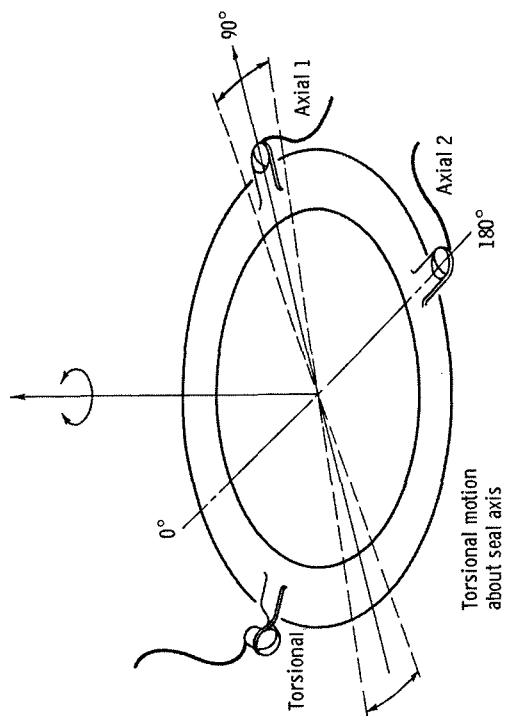
Figure 8. - Maximum amplitude on torsional accelerometer. Shaft speed, 6000 rpm; pressure difference, 20 pounds per square inch. Torsional accelerometer conditions: vibration frequency, 2800 cps; displacement, 600 microinches; acceleration, 250 g.

The torsional motion is shown on the trace photograph in figure 8, which shows that the torsional accelerometer has the maximum amplitude. The torsional vibration frequency was 2800 cps at a 600-microinch displacement. This motion was not sensed by the axial accelerometers.

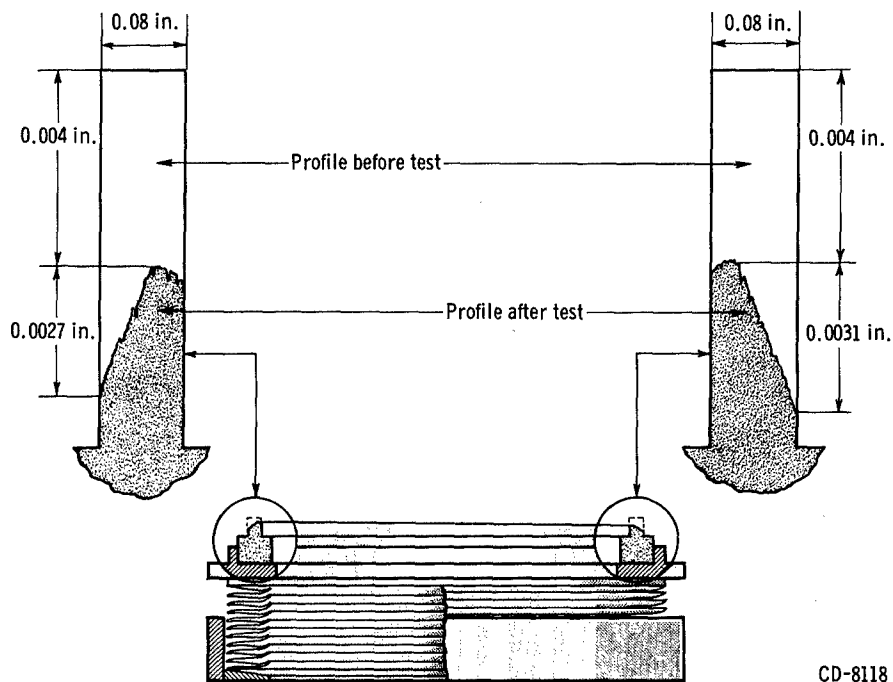
CD-8118

Figure 9. - Graphic profile of bellows face seal wear during 38-minute test in which diametral rocking was encountered.

The wear on the carbon nosepiece is on the outside diameter, and cases of severe instability cause rapid wear. This excessive wear causes the nosepiece to assume a cone or convex shape. Figure 9 shows a graphic profile of a carbon nosepiece after a 38-minute test during which diametral rocking instability was encountered. A minimum of 0.004 inch of the original nose height was worn off during the test.

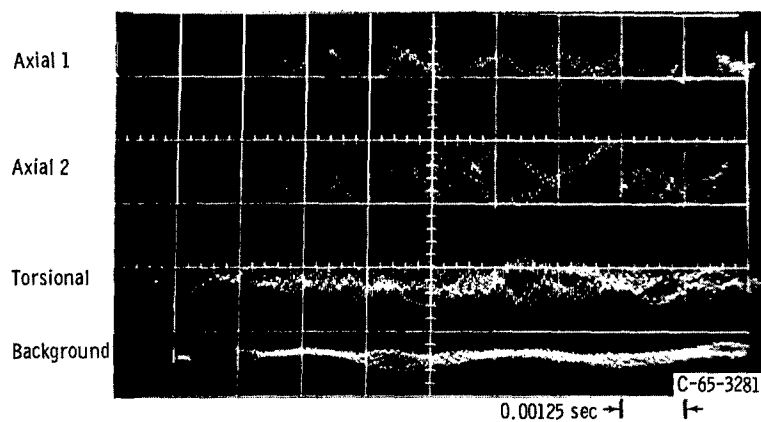
Figure 10. - Amplitude-modulated signal on all traces. Vibration frequency, 20 kcps; shaft speed, 2500 rpm; pressure difference, 20 pounds per square inch.

High-frequency (above 10 kcps) vibrations were recorded quite frequently during dynamic testing. These high-frequency vibrations averaged about 20 kcps, and had displacements of 1 to 10 microinches. Figure 10 shows vibrations of 20 kcps in the two axial and one torsional accelerometer traces. The high-frequency vibrations were being amplitude modulated to form the envelope patterns. Figure 11(a) shows a characteristic trace without vibrations of 20 kcps, while figure 11(b) taken 5 seconds later in real time shows a very similar trace with the superimposed 20 kcps frequency vibrations.

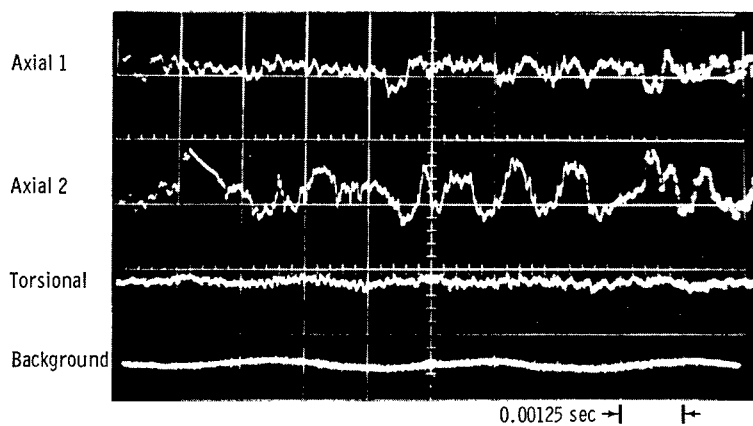
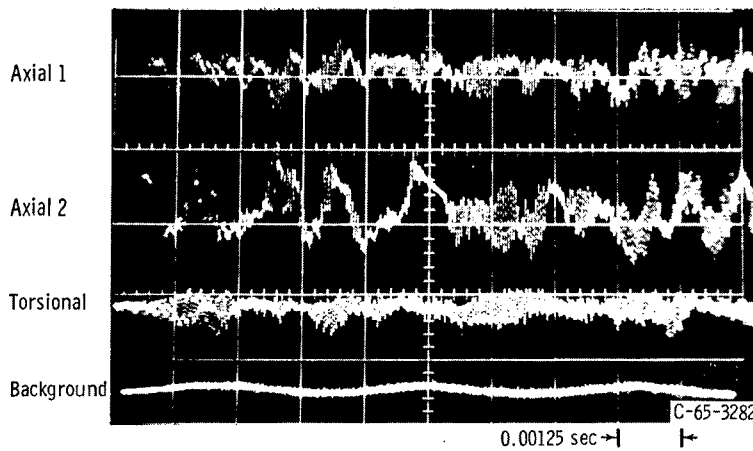
(a) Low-amplitude vibrations without high frequencies. Event time, 14 minutes 5 seconds.

(b) Low-amplitude vibrations with high frequencies (20 kcps). Event time, 14 minutes 10 seconds.

Figure 11. - Superimposed high-frequency vibrations. Shaft speed, 5000 rpm; pressure difference, 20 pounds per square inch.

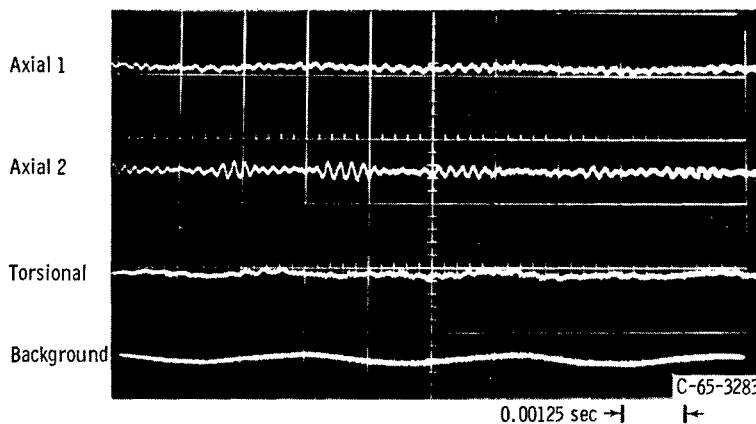
Figure 12. - Stable operation. Shaft speed, 9000 rpm; pressure difference, 20 pounds per square inch; vibration frequency, 4420 cps; displacement, 46 microinches; acceleration, 50 g.

When the seal was operating under stable conditions, the trace photograph is characteristic of that shown in figure 12. This trace picture shows relative calm on all three accelerometers with a very low-amplitude, medium-frequency vibration on the axial 2 accelerometer.

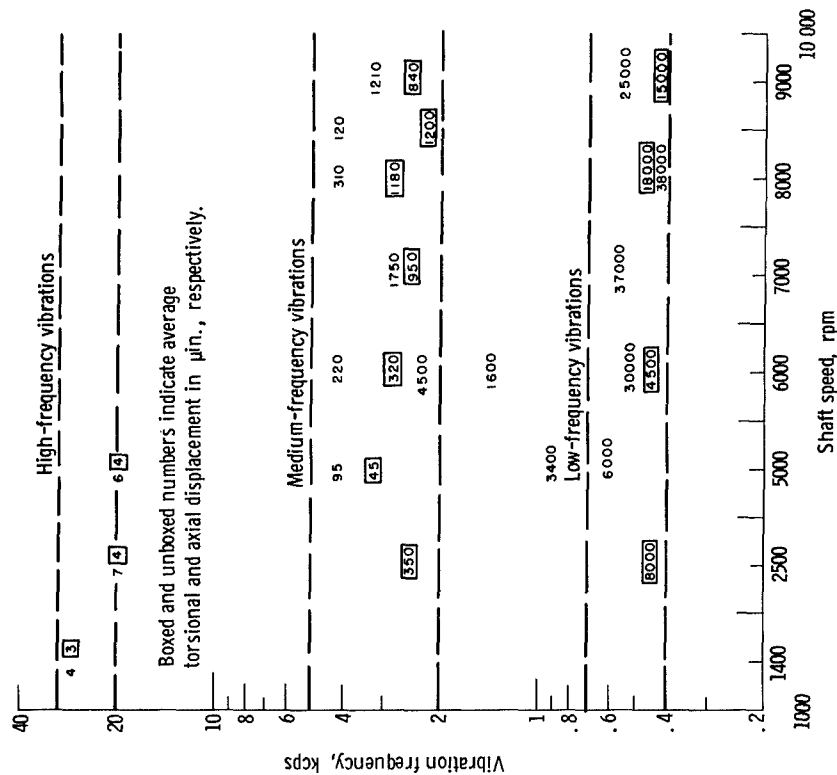
Figure 13. - Axial and torsional displacement as function of vibrational frequency and shaft speed.

The results of a test run with the undamped bellows face seal are shown in figure 13. Fifty-seven trace photographs were analyzed, and 132 data points were tabulated. Figure 13 represents the data with most of the plotted points

being an average of several tabulated values. The bands of low-, medium-, and high-frequency vibrations are indicated and contain 92 percent of all the tabulated data points.

Figure 13 indicates the relation between the vibrational characteristics during periods of instability and the shaft speed. As the shaft speed increases, the high-frequency vibrations become less noticeable; that is, the increase in the displacement of the medium- and low-frequency vibrations tends to wash out the high-frequency vibrations in the trace photographs. Both the medium- and low-frequency vibrations increase in displacement as the shaft speed increases. The frequency bands are not a function of the shaft speed.

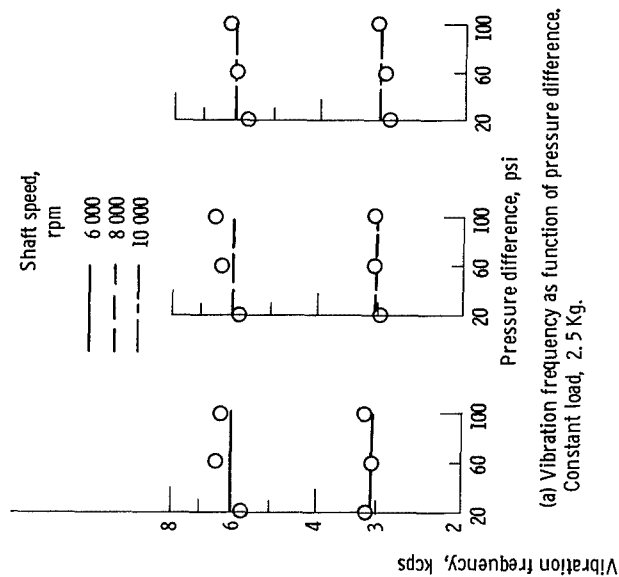
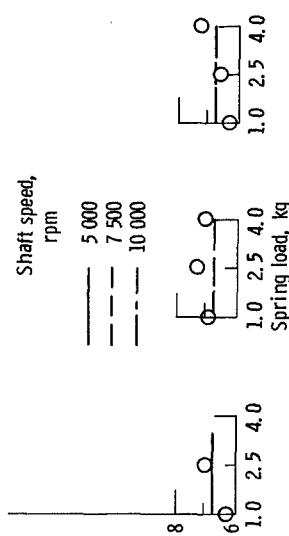
(a) Vibration frequency as function of pressure difference. Constant load, 2.5 Kg.

(b) Vibration frequency as function of spring load. Constant pressure difference, 10 pounds per square inch.

Figure 14. - Medium-frequency vibrations for balanced seal at various shaft speeds.

The effect of different pressure differentials across the seal on the vibrational characteristics of the seal were examined. The test used a seal pressure balanced in such a manner that very little change in the contact pressure occurred when the pressure difference across the seal was changed. Figure 14(a) shows the medium-frequency vibrations from 1 to 10 kcps of the balanced seal at pressure differences of 20, 60, and 100 pounds per square inch and shaft speeds of 6000, 8000, and 10 000 rpm.

Figure 14(b) also shows the results of a test on a seal in which the operating length of the seal was changed at constant pressure difference and shaft speed. By changing the operating length the contact load was changed by deflecting or compressing the bellows. The load increments were 1.0, 2.5, and 4.0 kilograms. These results are plotted for shaft speeds of 5000, 7500, and 10 000 rpm.

From the results of changing pressure difference (fig. 14(a)) and changing axial load (fig. 14(b)) against vibrational frequency and shaft speed, some conclusions can be made. The most significant fact is that the vibrational characteristics of the bellows seal are not changed by either variable. Thus, the practice of pressure unbalancing a seal so that the interface load is increased in the hope of stabilizing the seal only results in wear, heat buildup, distortion, and excessive power loss in the seal.

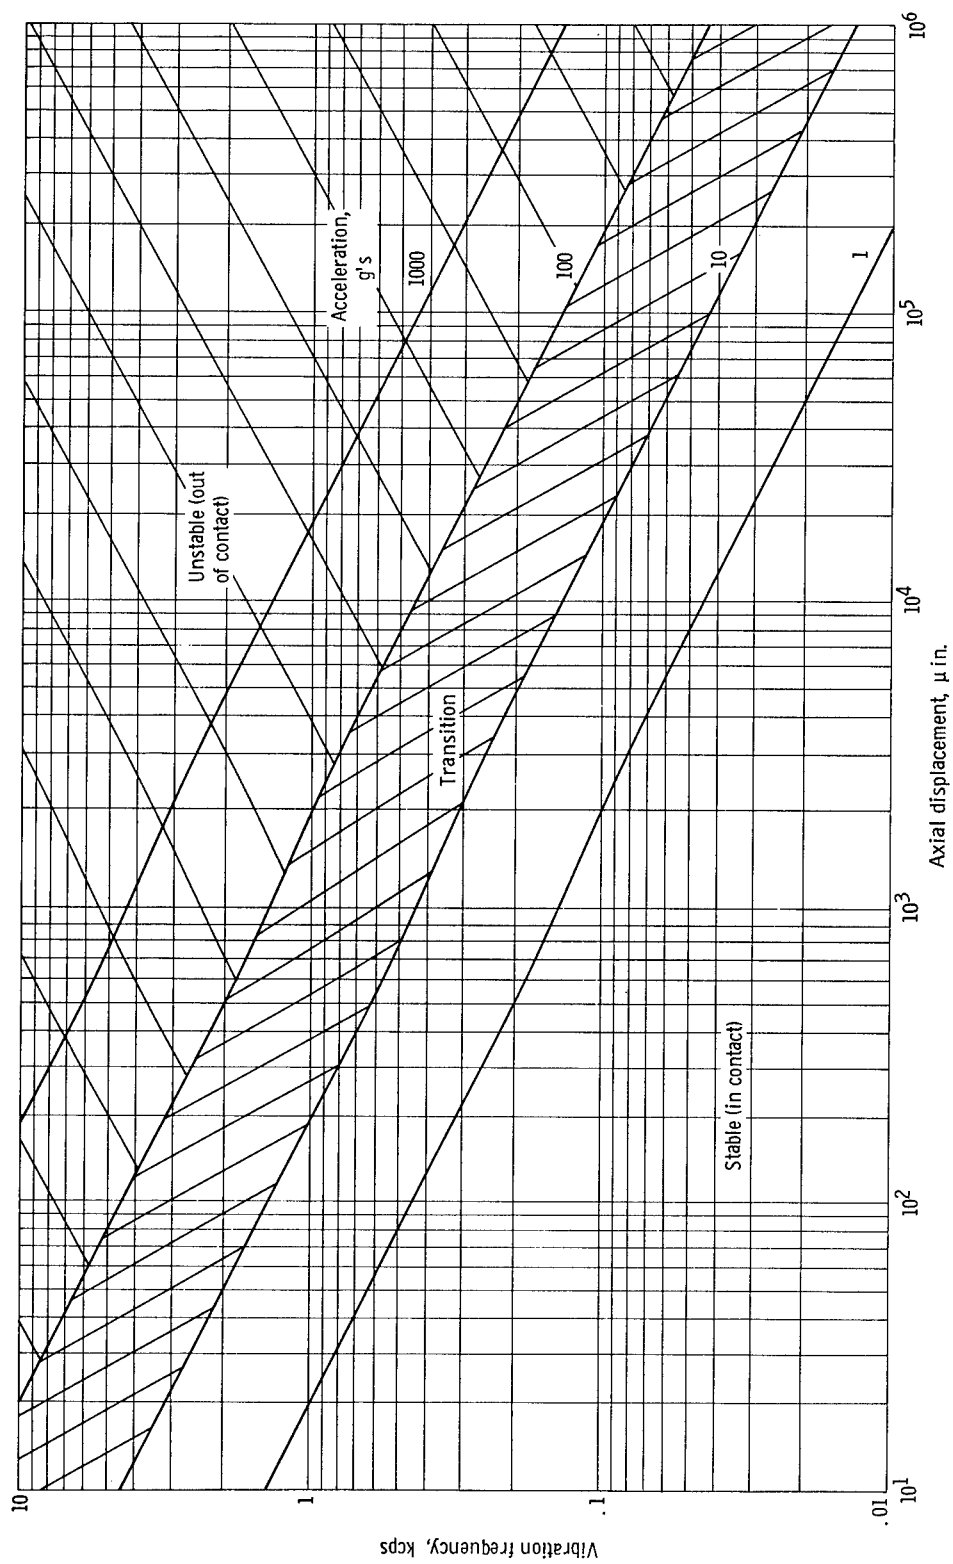
Figure 15. - Vibrational frequency against displacement showing constant acceleration lines and areas of stable and unstable operation.

The relation between axial displacement, acceleration, and vibrational frequency is shown in figure 15. Stable operation can be characterized by accelerations less than 10 g. Unstable operation can be characterized by accelerations greater than 100 g with a transition zone between. There were few data points within the transition zone.
