**NSWCCD-50-TR-2007/030** June 2007

Hydromechanics Department Report

**Experiment to Characterize Sea Fighter FSF-1 Wave  
Slamming**

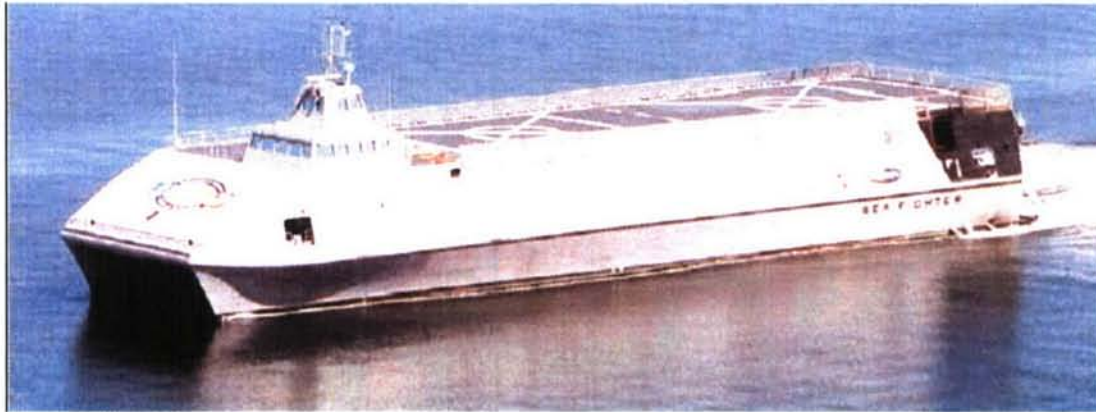
Figure 1. Photograph of *Sea Fighter*.

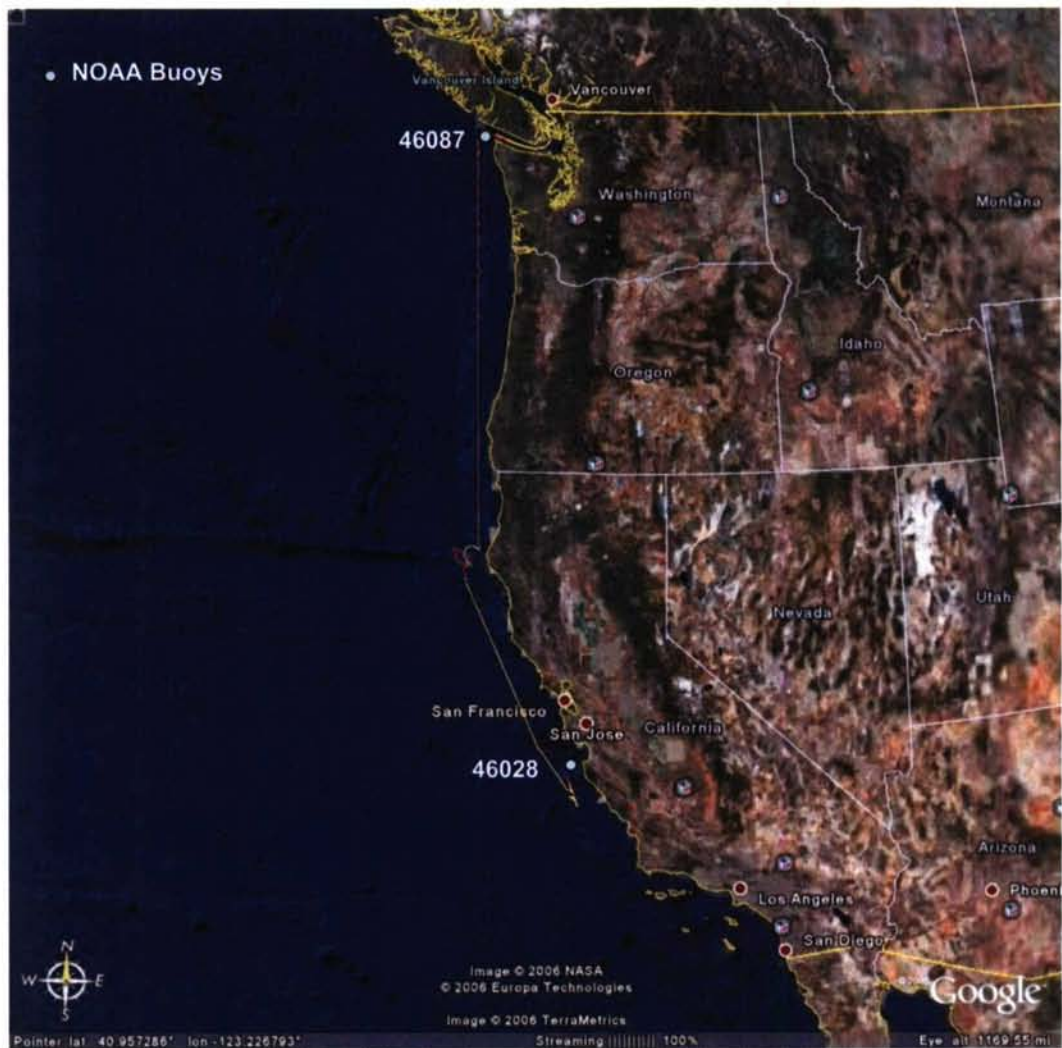
Figure 3. *SeaFighter* course during trial.

\*\* NOAA buoy located at 35.75N, 121.89W - 30 to 40 nm NE maneuvering hexagon (see Figure 3)

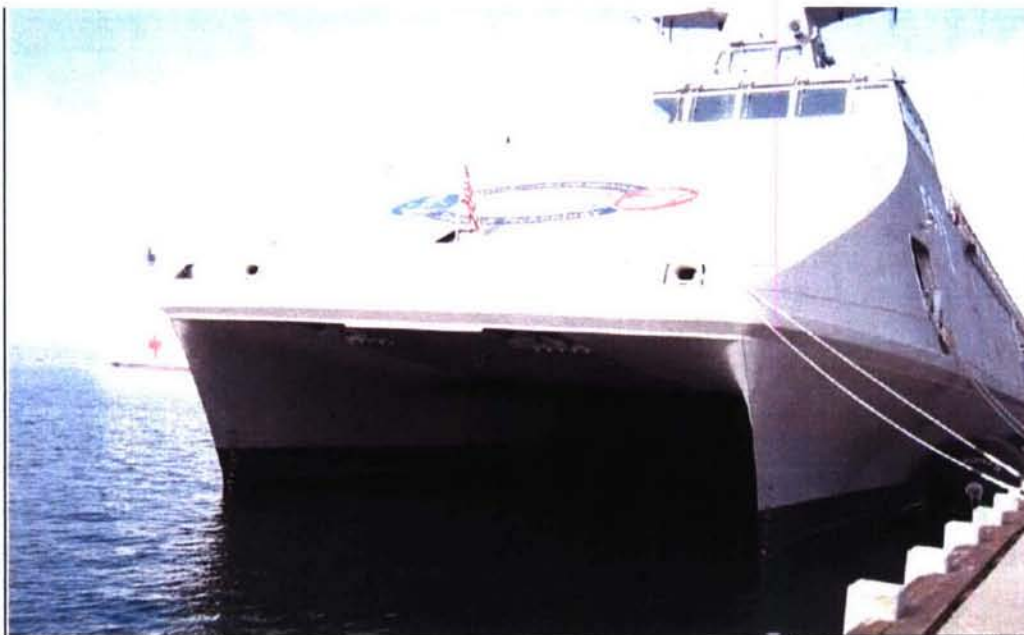
Figure 5. View of the *Sea Fighter* hatch opening at the bow.  
The forward LIDAR tower was mounted to the anchor deck beneath the hatch, and extended out its opening.

The forward LIDAR tower was 20 ft in length and was comprised of standardized 55G steel radio mast sections. It was located as far forward as possible onboard on the *Sea Fighter* to provide the necessary look angles for operation of the fixed and scanning LIDAR units. It stood approximately 35 ft above the water surface. The tower was mounted to the anchor deck directly underneath the forward hatch opening (near the flagpole). This location was required to allow the measurement of the free-surface as close as possible to the ship's bow (Figure 5 and Figure 6). The hatch is very near the centerline of the vessel. The tower also had guy wires to existing tie down points located on the *Sea Fighter*. A 2 ft x 2 ft 6061 AL baseplate was welded to the anchor deck directly beneath the hatch opening to provide a secure mount for the tower. The LMS-Q140 LIDAR was mounted on top of a pan/tilt unit at the top of the tower. The pan/tilt unit controlled the orientation of the LIDAR and could be operated remotely. The LIDAR was oriented to scan a swath parallel to the ship's bow (Figure 7); it was tilted 30 degrees downward such that it could see the free-surface, approximately 15 ft forward of the bow. The swath width was approximately 69 ft; the spatial resolution was 1 in. The second LIDAR, LMS-Q240, was mounted below the LMS-Q140, and fixed such that its swath was perpendicular to the bow and tilted approximately 45 degrees downward (Figure 8), and the swath width was 111 ft. The spatial resolution was 0.2 in. The tower also contained the third LIDAR unit, LD90-3800EHS-FLP, which provided a single point measurement. It was tilted approximately 13 degrees downward from vertical and had a spatial resolution of 2 in. The system was operated to provide single point time series of water surface elevation forward of the vessel, at the centerline. Figure 9 shows a photograph of the LIDAR tower on the *Sea Fighter*. Figure 10 illustrates the locations of the LIDAR and WaMoS towers. The data collected by the LIDAR system were not collected by NSWCCD and therefore will not be discussed in this report.

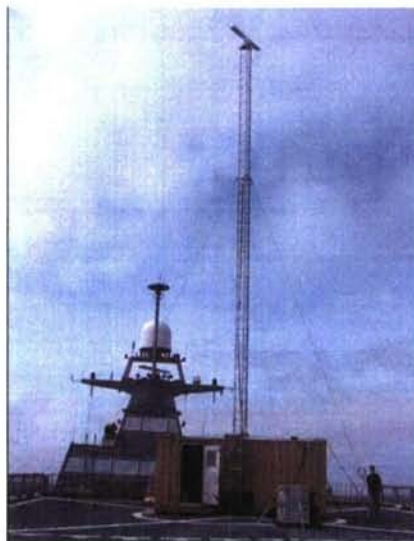
Figure 11. Photograph of x-band radar tower during testing.

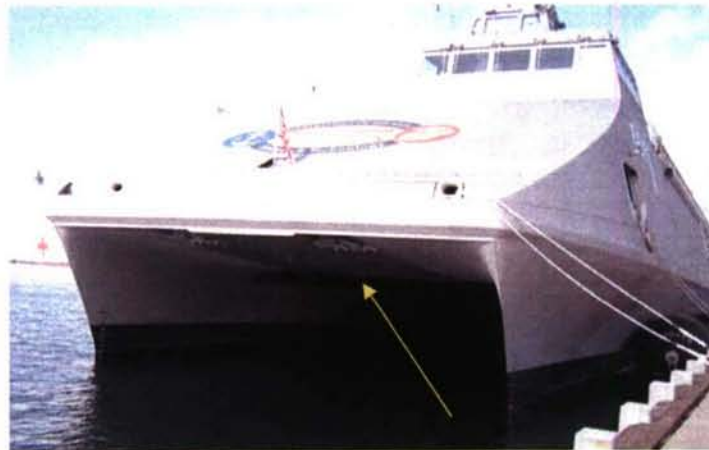
Figure 19. Schematic showing the bottom of the hull that required impact to define a slam event.

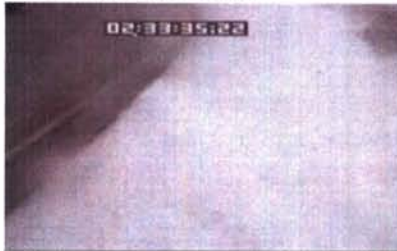
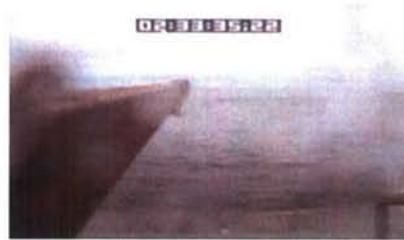
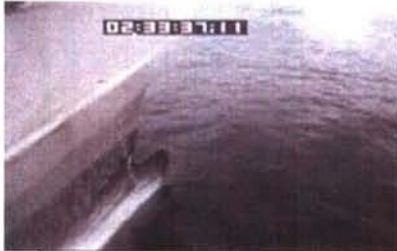
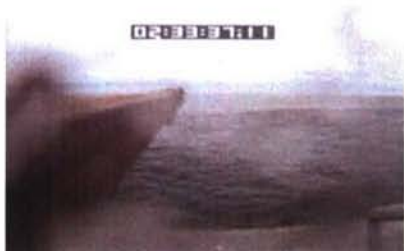
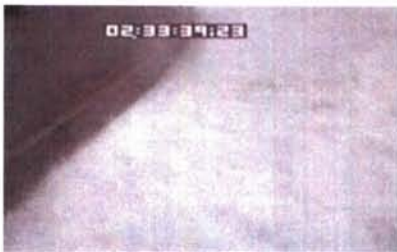
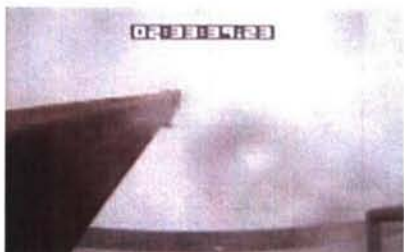
1<sup>st</sup> crest: Small slam

1<sup>st</sup> trough: Bow lifts out of water

2<sup>nd</sup> crest: Slam

Figure 30. Slam Event 1: Snapshots of on-board cameras. The first row shows the small slam due to the first crest and the third row shows the second, more violent slam.

Figure 30 shows this sequence of events using the on-board bow center and starboard cameras respectively. The first row of snapshots show the first crest which causes a small slam, but it is not large enough for white water to be seen by the center

camera. The second row of photos shows the first trough that lifts the bow out of the water just before the second slam. The third row shows the second crest slamming into the bow, which is the most violent slam of the three crests. The intensity of the slam can be seen by the large amount of whitewater in the bow camera view in both the third and fourth row photos. The fourth row shows the following trough and the remnants of the previous slam can still be seen by the white water and spray that is still present in the bow center camera. The last row shows the last crest which is the largest crest in the wave height plot, but it does not produce a slam.

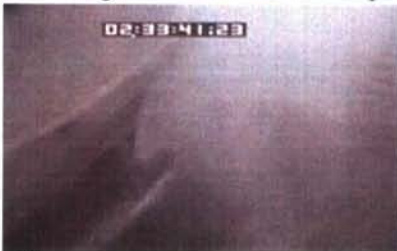
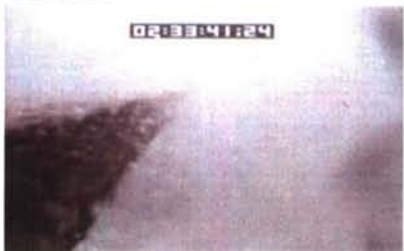
2<sup>nd</sup> trough: White water from previous slam

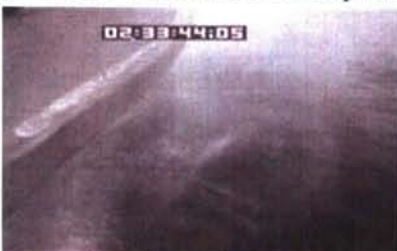
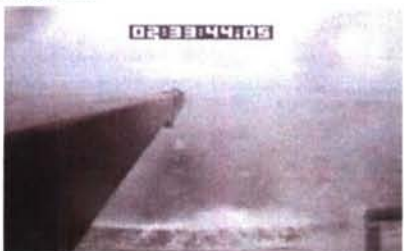
3<sup>rd</sup> crest: White water from previous slam

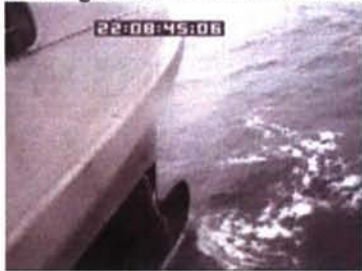
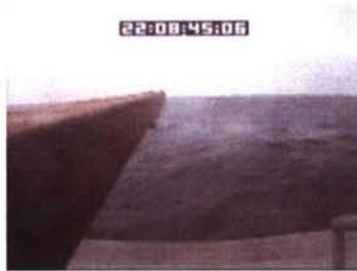
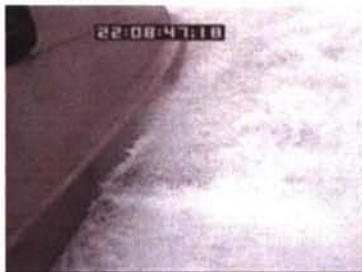
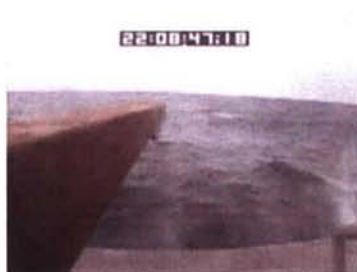
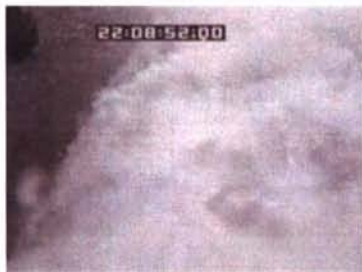
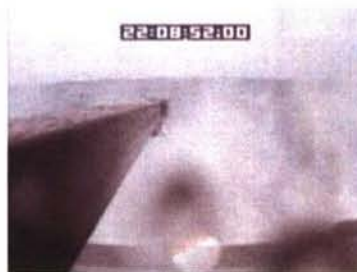
1<sup>st</sup> trough: Bow lifts out of the water

1<sup>st</sup> crest: Slam

2<sup>nd</sup> crest: 2<sup>nd</sup> and more violent slam

Figure 39. Slam Event 4: Snapshots from on-board cameras.

Figure 39 shows snapshots from the starboard, bow center, and starboard bowline cameras respectively during the slam event. With the first trough the bow lifts out of the water and with the following crest there is a slam impact. The bow then rises out of the water again with the second trough and the second crest also slams into the bow, this time more violently than the first as seen by the large amount of whitewater the cameras see and the sharp peak in vertical acceleration seen in Figure 38. With each trough the bow of the ship pitches upward, above the 3 degree boundary of the envelope and downward below zero degrees with each crest. The second crest, which causes the more violent slam, causes the greatest bow down pitch of -2 degrees that is seen which corresponds with the largest spike in vertical acceleration seen in Figure 38. Figure 40 shows a 30-second section of the plots shown in Figure 38 and illustrates how the ship's greatest bow down pitch corresponds with its maximum vertical acceleration.

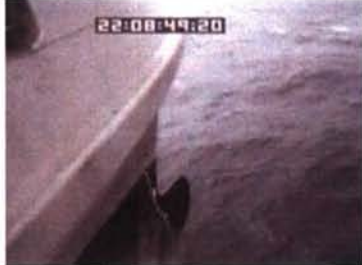
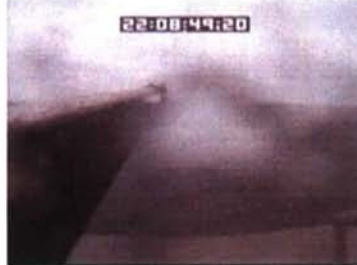
2<sup>nd</sup> trough: Bow lifts out of the water

The event begins with a 5 ft wave trough which is followed by a 20 ft crest, a trough of 2 ft and another large crest over 15 ft. Both troughs cause the bow of the vessel to completely lift out of the water and both crests cause a slam impact with the bow. Figure 32 provides snapshots from three of the on-board cameras (starboard, center, starboard bowline respectively) showing the sequence of events of the slam as described. The first row of snapshots shows the ship encountering the first trough when the bow lifts completely out of the water. Row 2 shows the impact of the first crest and the small slam it causes. The third row shows the second trough and the bow again lifting out of the water. Finally, the fourth row of snapshots shows the larger slam caused by the impact of the second crest.

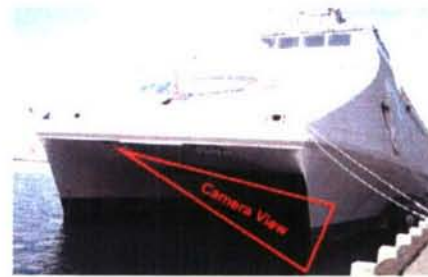
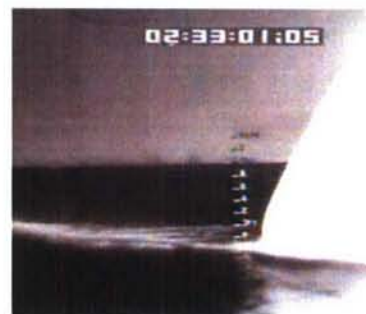
Figure B5. Diagram of view from starboard anchor well camera.
