**Characterization of Two 120-mm Primers –
the M129 and M125**

by Stephen L. Howard and Anthony W. Williams

ARL-TR-4346

December 2007

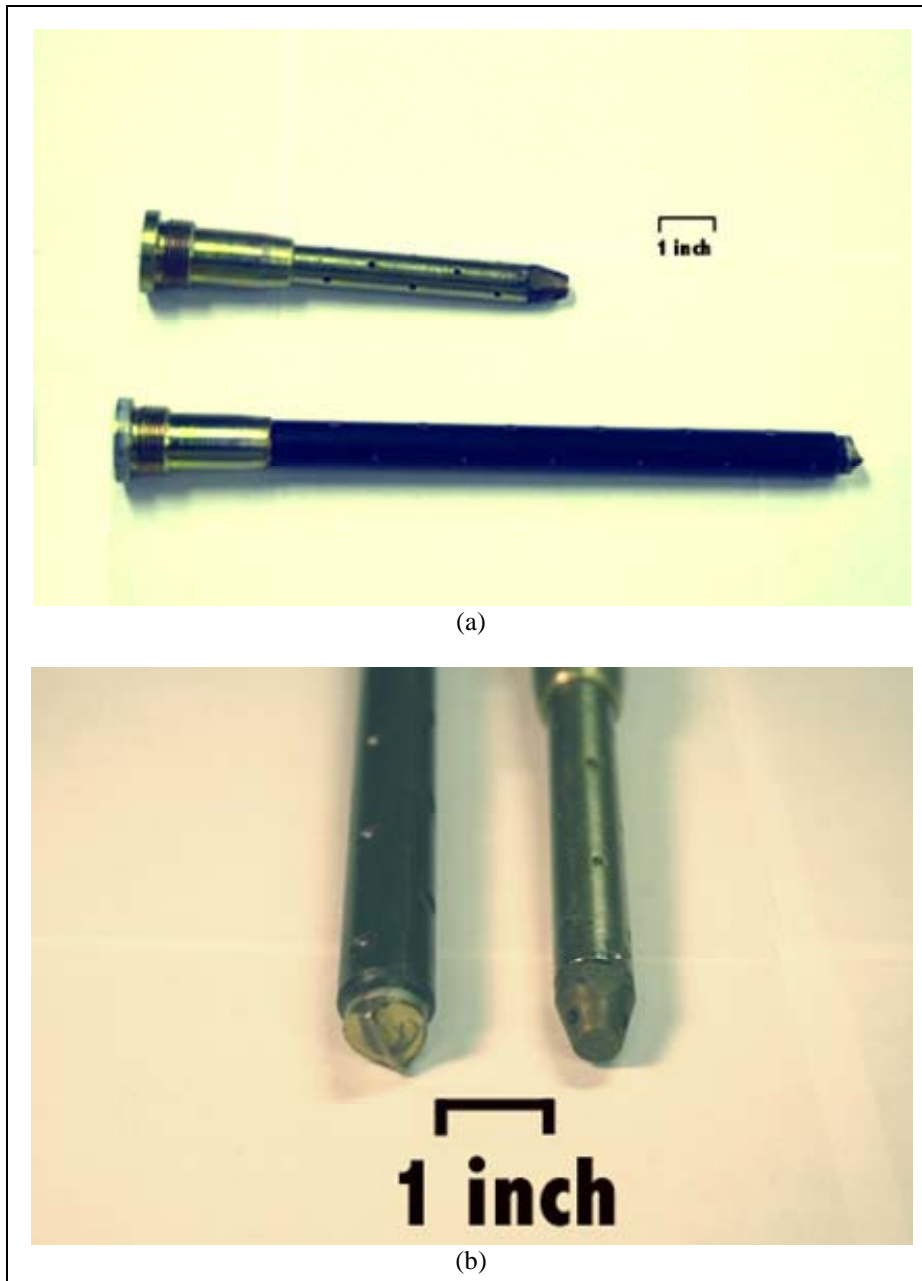
Figure 1. Photographs of (a) M129 (taper tip) and (b) M125 (black rubber coated) primers.

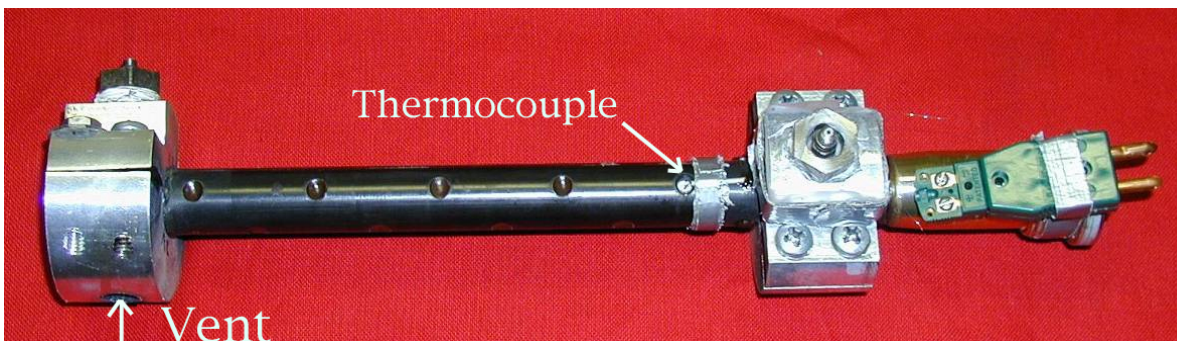
Figure 2. Photograph of M125 primer with pressure clamps (note vent hole on bottom of left clamp) and thermocouple in place.

Since the measurement of an object can change its properties, pains were taken to reduce the impact of the act of measuring the temperatures and pressures of the gases that these primers produced. For example, the clamps for holding the pressure transducers in place were designed to only cover and seal one vent hole (see figures 2 and 3). The other venting holes in the clamp were designed so as to minimize pressure perturbations in the venting jet. With pressure measurement desired at the base of the primer and at the tip, this measurement necessitated two vent holes to be covered (for the M125 primer, this number was 2 out of 24, and for the M129, 2 out of 18). Other studies may have had designs for the clamps that possibly covered other vent holes (or impaired the venting) at the same axial position (8–10). It should be remembered that properties of a gas or a particle-laden gas through a vent can be strongly influenced by the backing pressure into which it is vented. Such properties include velocity, expansion radius, residual pressure, and temperature. Therefore, the vent in the clamp must take such variables into account in its design.

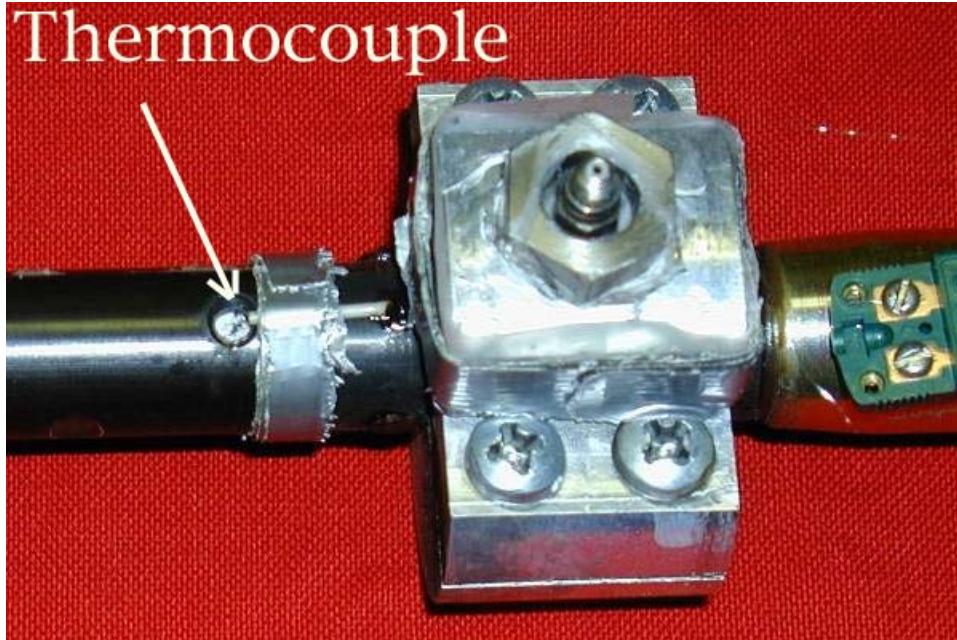
Figure 5. Photograph of a 2-mil thermocouple in a ceramic tube support taped next to a vent hole on an M125 primer.

A couple of placement methods for the thermocouple were tried (see figures 4 and 5). Previous work with planar ignition waves in solid propellant beds used a holder (figure 4) that contained the thermocouple for protection and to maintain laminar flow past the thermocouple (11). This holder was placed next to the primer tube over the top of an opened vent hole (with paper liner punctured to allow early gases to be detected) at a distance of ~6 or 14 mm from the primer. The larger distance was chosen in an attempt to protect the thermocouple (early tests at 6 mm resulted in severed thermocouple wires), but it worked about as well as the 6-mm distance in this holder. It was later found upon examining the high-speed video that large chunks of material were ejected from the vent hole and so a fine-wire thermocouple stretched across the vent hole would

In the second method, the two wires of the thermocouple were threaded through a small section of a two-holed ceramic tube leaving the thermocouple junction a small distance from the tube end. The tube was taped securely to the primer tube with the thermocouple junction (which was slightly separated from the end of the ceramic tube) slightly protruding into the region of the vent hole where the venting jet would be located (figure 5). The ceramic tube was held in place by several laps of a fiber-reinforced tape with sufficient strength to hold the ceramic tube securely in position during the entire venting process.

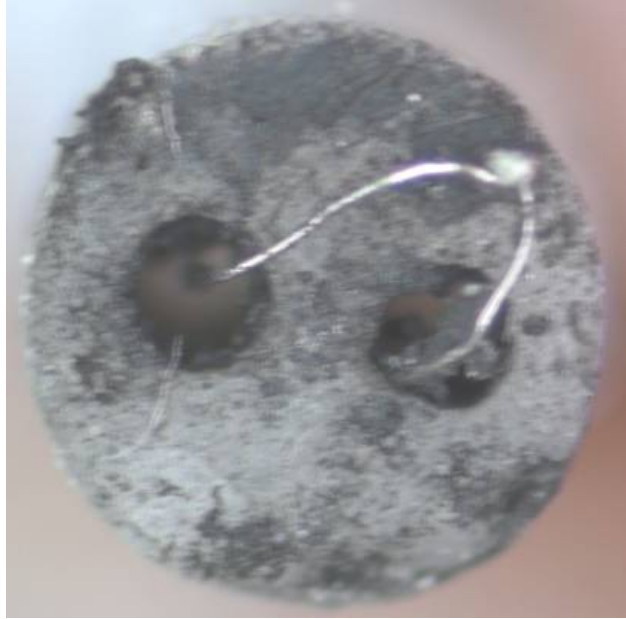
Figure 6. Photograph of 1-mil thermocouple junction mounted with ceramic tube after venting event.

As can be seen in figures 6 and 7, it is possible that the junction of even the 1-mil and the 2-mil thermocouple wires can survive the venting event when mounted with the two-holed ceramic tube. The voltages from the thermocouple were processed through a miniature ice point and recorded on the digital oscilloscope. Correction was made for radiation cooling (11–13) and results for the M129 primers are plotted in figure 8. The similar temperature results for the M125 primer are plotted in figure 9.

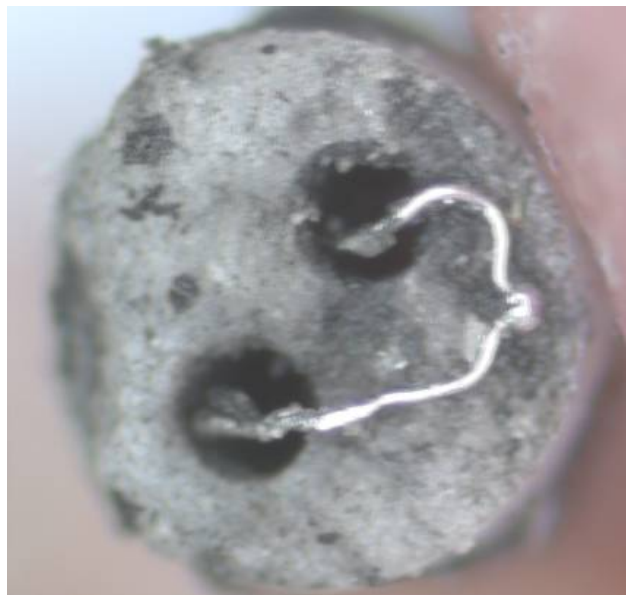
Figure 7. Photograph of 2-mil thermocouple junction mounted with ceramic tube after venting event.

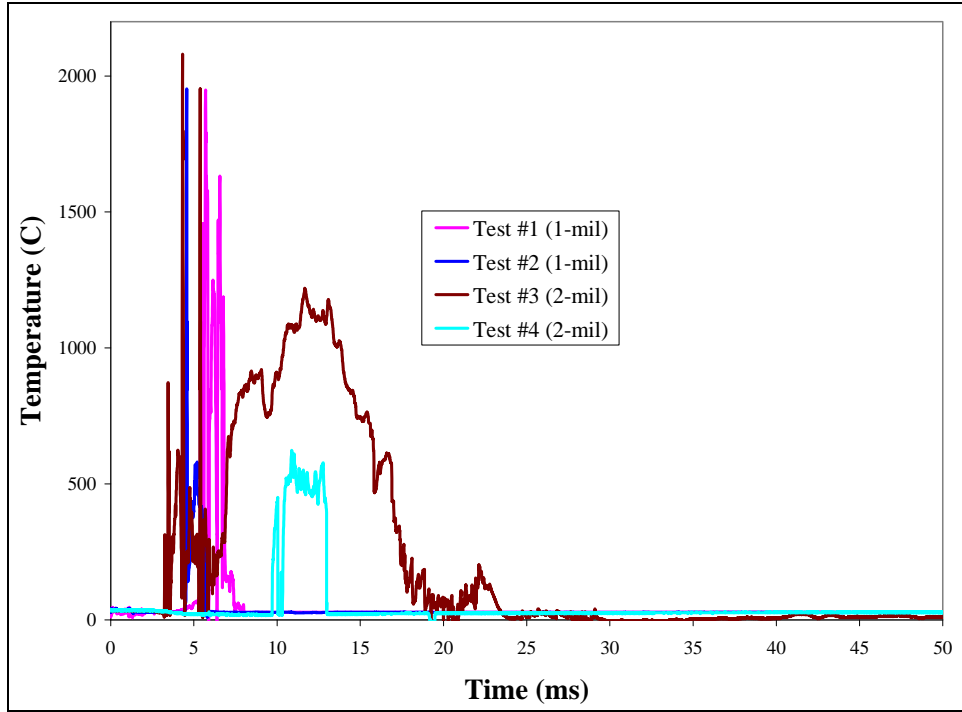
Figure 8. Temperature-time histories recorded for M129 primer.

As shown in figure 8, the similarity from shot-to-shot with regards to temperature was not too good (it will be shown later in the high-speed video that the opening and venting of the pattern of vent holes was not as uniform as desired). However, there were some similarities from shot to shot. The temperatures increased after the pressure began building in the primer and the temperatures decreased at lower pressures. The rapid fluctuations at the beginning of the temperature increase appeared to be real and to correlate somewhat with the timing of shock structures (regions of intense light emissions) in the expanding jet that was evidenced in the high-speed video.

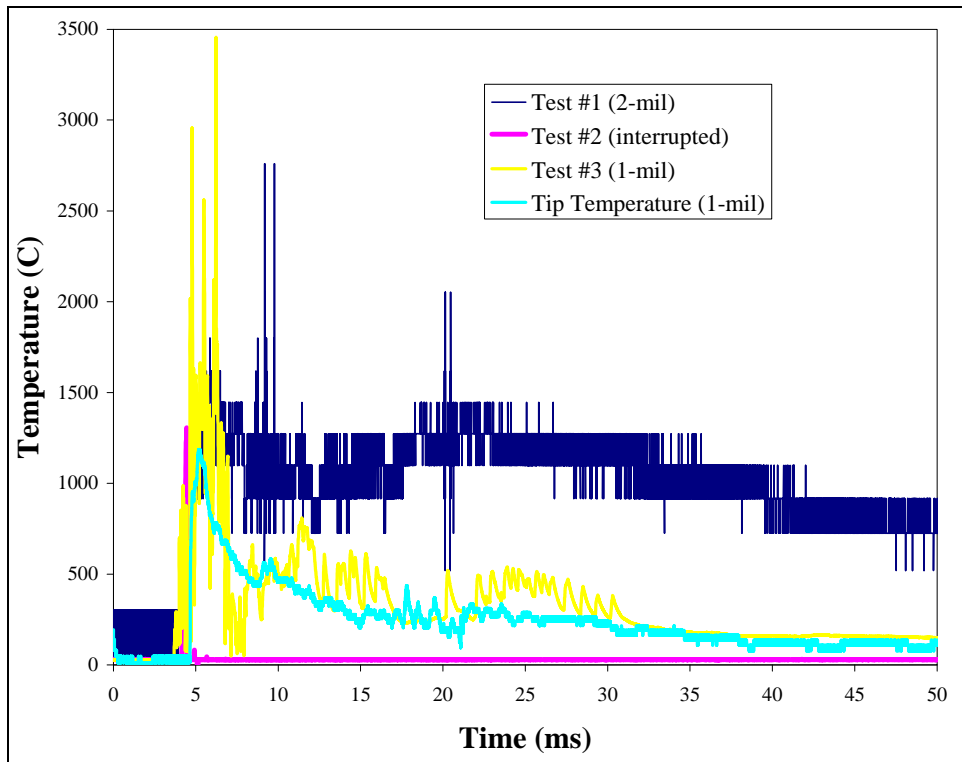
Figure 9. Temperature-time histories recorded for M125 primer.

These same fluctuations also were noted for the M125 primer (see figure 9). However, the hole size in the M125 (nominal 4 mm in diameter) was bigger than the hole size in the M129 (nominal 3 mm in diameter). Therefore, the supersonic flow from the M125 vent hole would exhibit a lower Mach number and a potentially shorter and weaker shock structure than for the M129 (this trend was evidenced in the high-speed video).

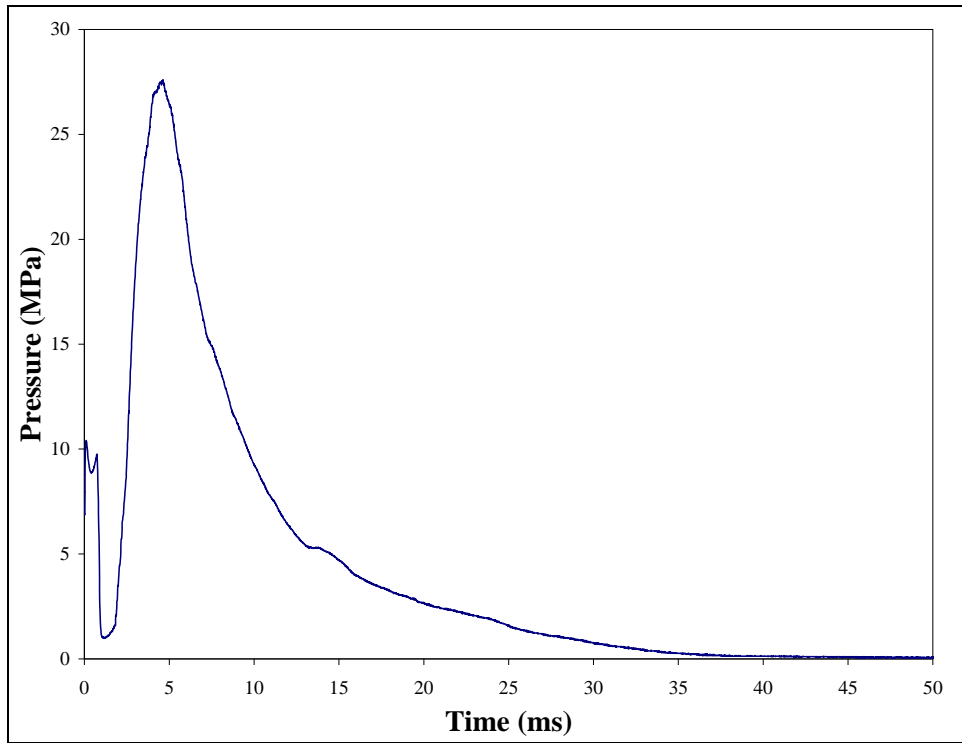
Figure 10. Early pressure-time history obtained for the M129 primer.

Early pressure measurements of the M129 primer with only a rubber gasket around the sealed vent hole resembled the typical pressure-time history as shown in figure 10. The early pressure peak was assumed to be from the headstock initiating since it occurred at the appropriate time and the strength of the headstock initiation was previously unknown. However, in later measurements (in this study) the dynamic electrical parameters of the bridgewire in the headstock also were measured (figure 11). Upon comparison of the firing current and the early pressure peak, the two traces were very similar in shape and timing. It was therefore assumed that a voltage leakage or ground loop problem existed between the bridgewire (firing supply) power supply and the pressure gauge (with associated electronics). The fiber-type gasket material was then placed completely around the entire circumference of the M129 primer tube (with proper placement for the two remaining vent holes at that particular axial position). Once the fiber was in place, electrical contact between the primer tube and the clamp holding the pressure gauge was broken. At this point, the alleged pressure peak disappeared.

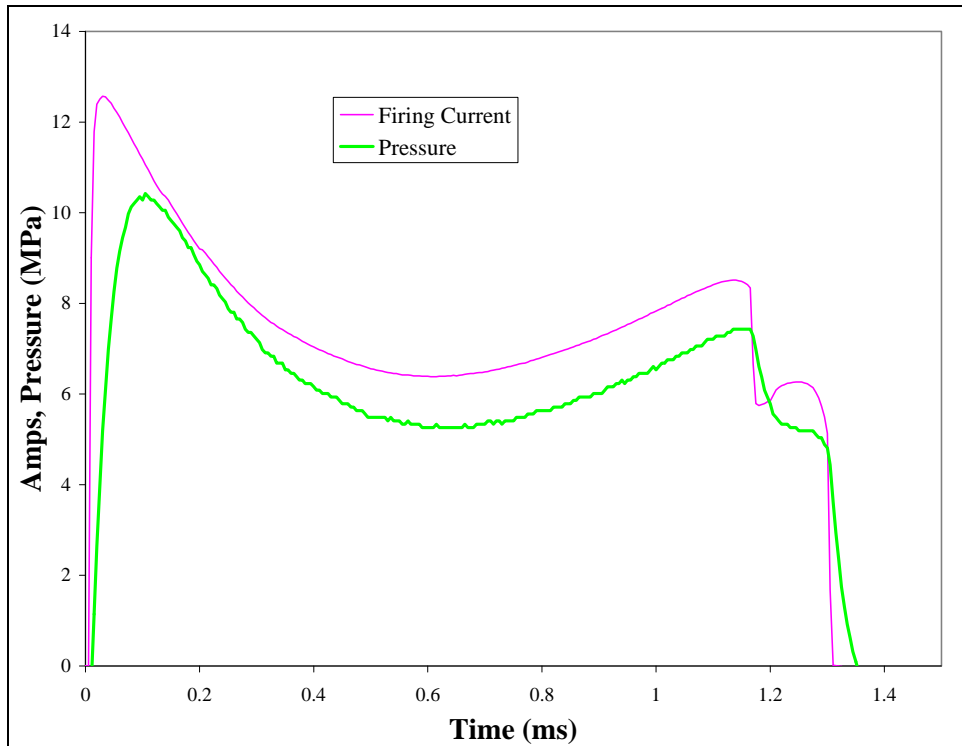
Figure 11. Comparison of firing current trace and early peak in pressure-time history of an M129 primer from figure 10.

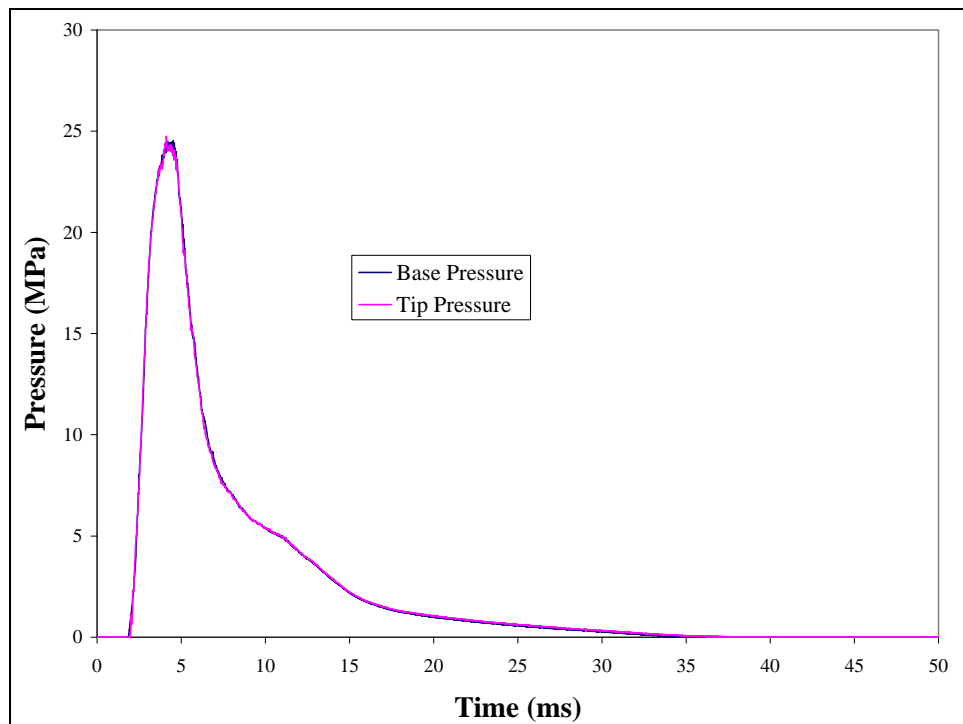
Figure 12. Average pressure-time history produced in the M129 primer (three tests).

Figures 12 and 13 show the average pressure-time histories (averaged over three primer tests) for each primer (the M129 and M125, respectively). The first difference noted was the lack of pressure oscillations in the histories for the M129 and their presence for the M125. The M125 is considerably longer than the M129 and pressure differences (active pressure waves) between the base and the tip could be more easily created (1).

The maximum pressure of the M129 primer occurred slightly earlier than that of the M125 (4.35 vs. 4.5 ms) and the base and tip pressures more closely tracked one another. The maximum pressure produced in the M129 was 24.3 MPa and was 25.2 MPa in the M125. It was originally assumed that since the M129 had fewer holes than the M125, and that since the holes had a smaller diameter, that the pressure would be higher. It would appear that the complicated arrangement of a higher loading density in the M129 as related to that of the M125 (1.6 vs. 1.3 g/cm) and increased number of holes per unit length (1.5 vs. 0.9 holes per cm) allowed the pressures to vent as they did. The high-pressure venting of the M129 was slower than that of the M125. The high-pressure full-width-half-maximum of the of the pressure-time histories was 3.4 vs. 2.5 ms. It has been noted in plasma-ignited gun simulators (14) that a longer venting time for the primer gases could lead to increased ignitability (propellant bed dependant). This effect could be useful for harder-to-ignite ammunition.

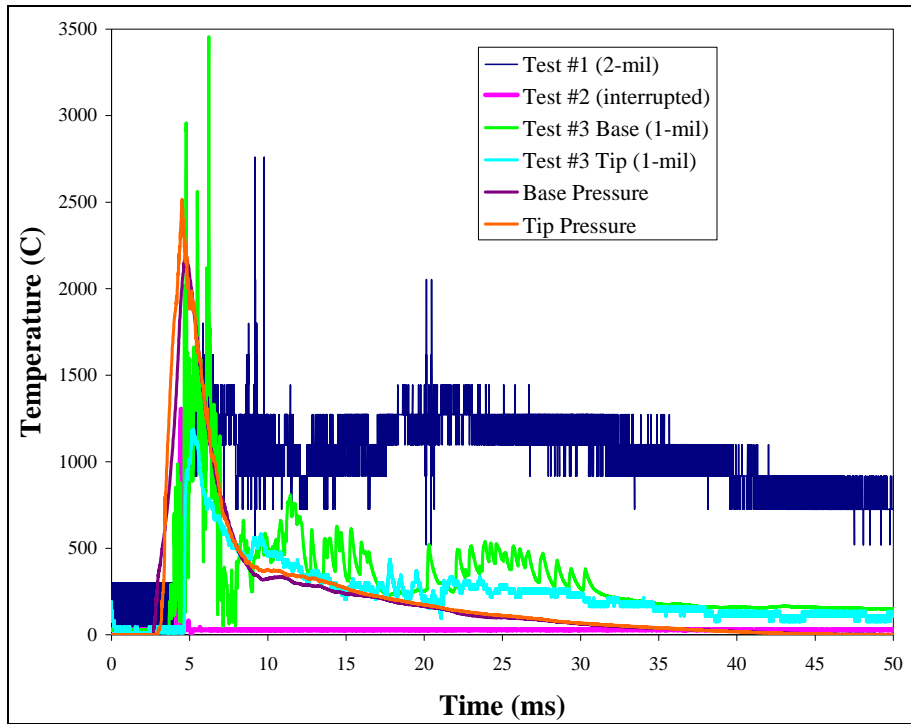
Figure 14. Pressure-time histories produced by the M125 primer in figure 13 compared to temperature-time histories in figure 9.

The use of the ceramic support allowed the use of 1- and 2-mil thermocouples that would usually survive the entire venting. As shown in figures 14 and 15, the smaller thermocouples follow the pressurization/depressurization more closely than the larger thermocouple and show that the fluctuations in the early venting were very narrow in time and approach the temperatures that could be expected in the supersonic expansion shock structure (15). Equilibrium (longer duration) measurements were somewhat lower than the theoretical benite flame temperature (2518 C, obtained from an adiabatic flame temperature calculation). These lowered temperatures were also reflective of various heat loss mechanisms as the gases vented (such as heat loss to the metal primer tube, radiative heat losses, and temperature drop due to high-pressure/high-velocity expansion of venting gases). Initial delay in the temperature rise from the onset of pressurization should also have included the delay that escaping ambient temperature gases from the primer tube in advance of the flame-heated gases would have created.

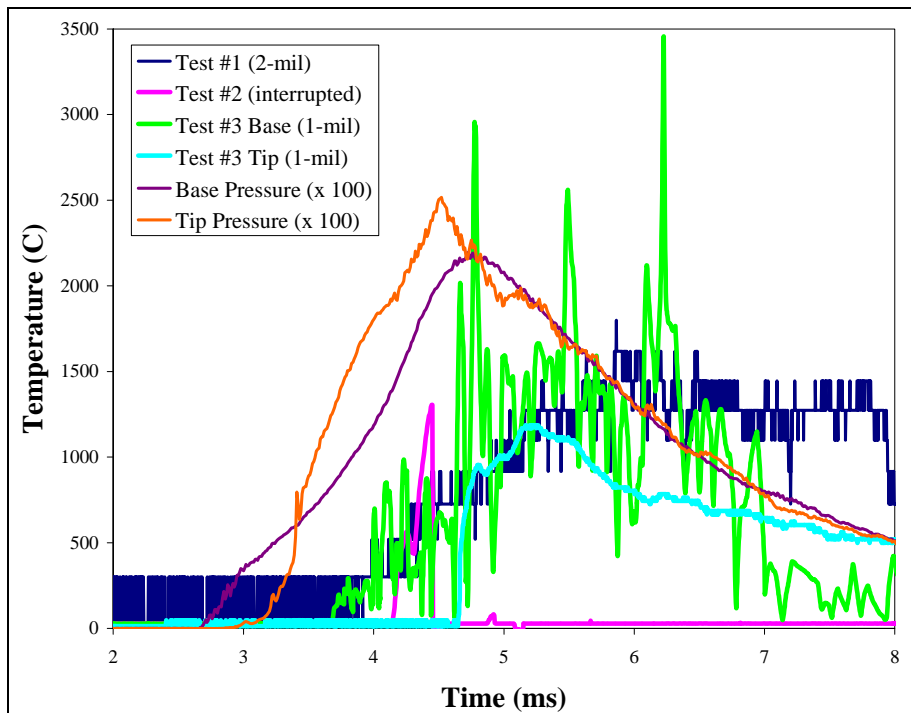
Figure 15. Close-up of pressure-time history and temperature-time history produced by the M125 primer in figure 14 showing delays in temperature rise relative to onset of pressurization.

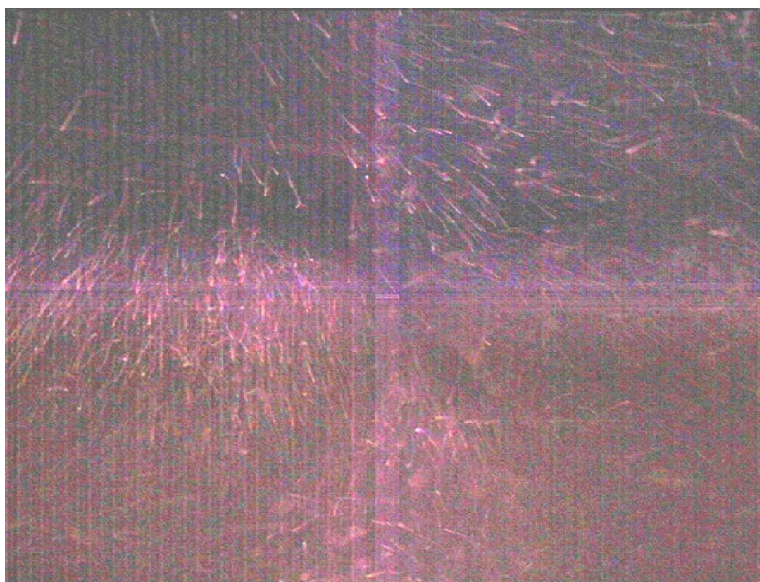
Figure 16. Photograph of end view of M125 firing during low-pressure venting showing glowing particles.

It was noted that a much longer low-pressure venting occurred after the high-pressure venting in both primers. It was assumed that this effect was, in part, due to firing the primer in open air and not within a ballistic simulator where the venting gases would be trapped and the pressure surrounding the primer would increase, especially when the propellant bed ignited. It was noted in the high-speed video that during this low-pressure venting that the light emissions from the venting gases diminished. The diminished light emissions generally correlated with decreased temperature of the venting gases as reported by the thermocouple. Another important item noticeable during this time was, due to the diminished light emissions, the view of many glowing (possibly burning) particles (for example, the M125 primer in figure 16). Most likely, these particles were present during much of the venting period but visual reporting of their glow was not possible due to the large visible emissions from the hot gases that would mask their presence.

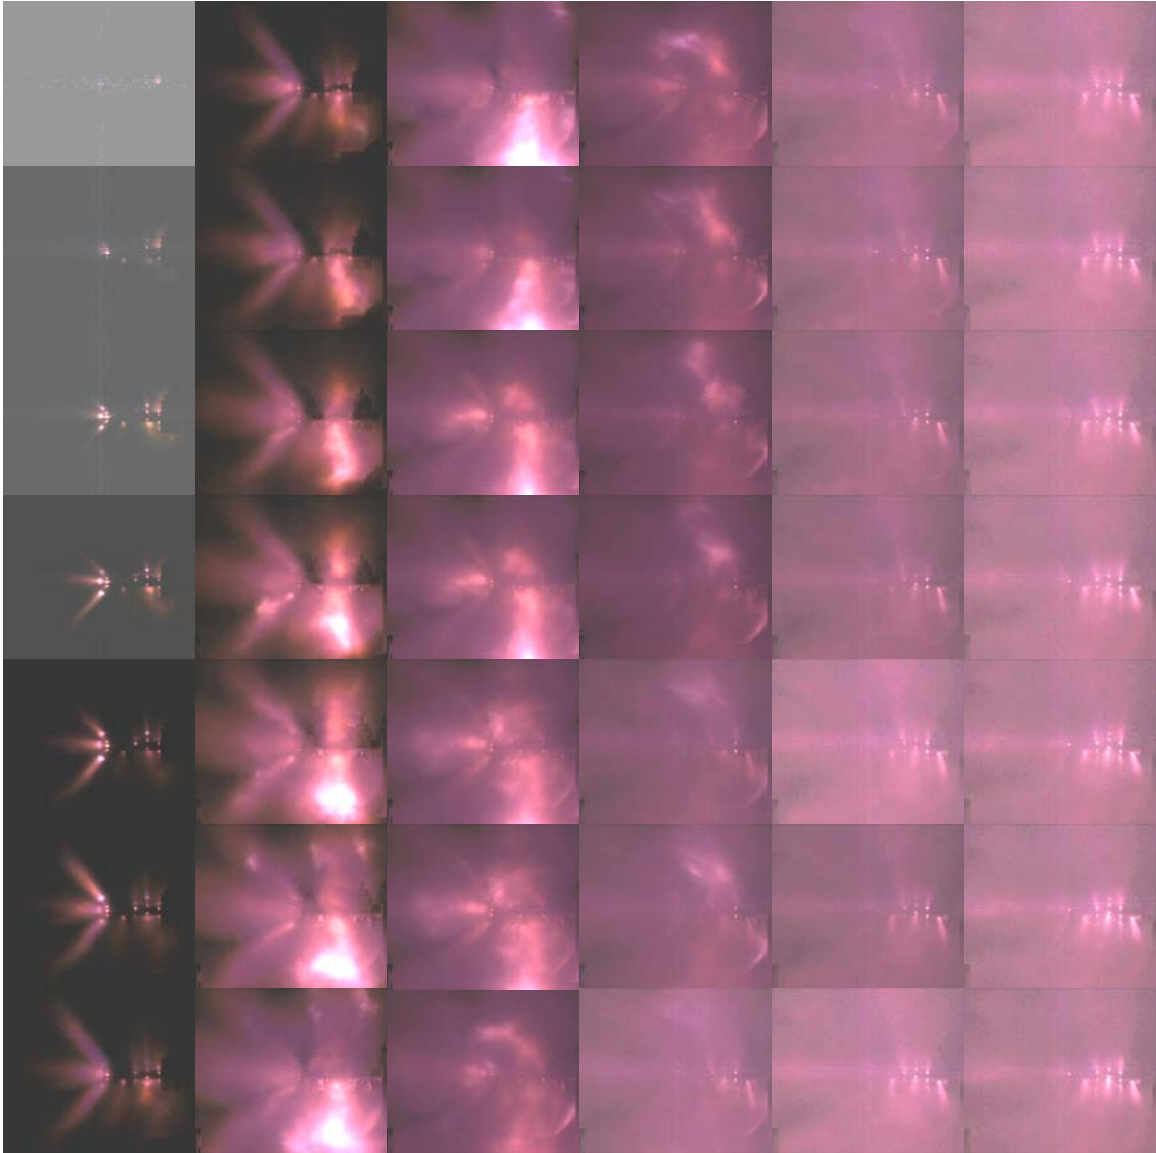
Figure 19. High-speed frames (from top to bottom) of axial view of M129 primer; frame time was 263 μ s.

hole-to-hole venting pattern once again became mostly even. The end view (figure 20) also showed the shock structure from the tip vents (until the jets from the other vent holes had expanded past the radius of the pressure clamp as shown in figure 17, they were not visible). The end view showed that the venting pattern was erratic during the entire venting process with the most active vents changing from frame to frame. Even at low pressure, the erratic hole-to-hole venting (not so obvious in the final frames of the axial view in figure 19) continued.

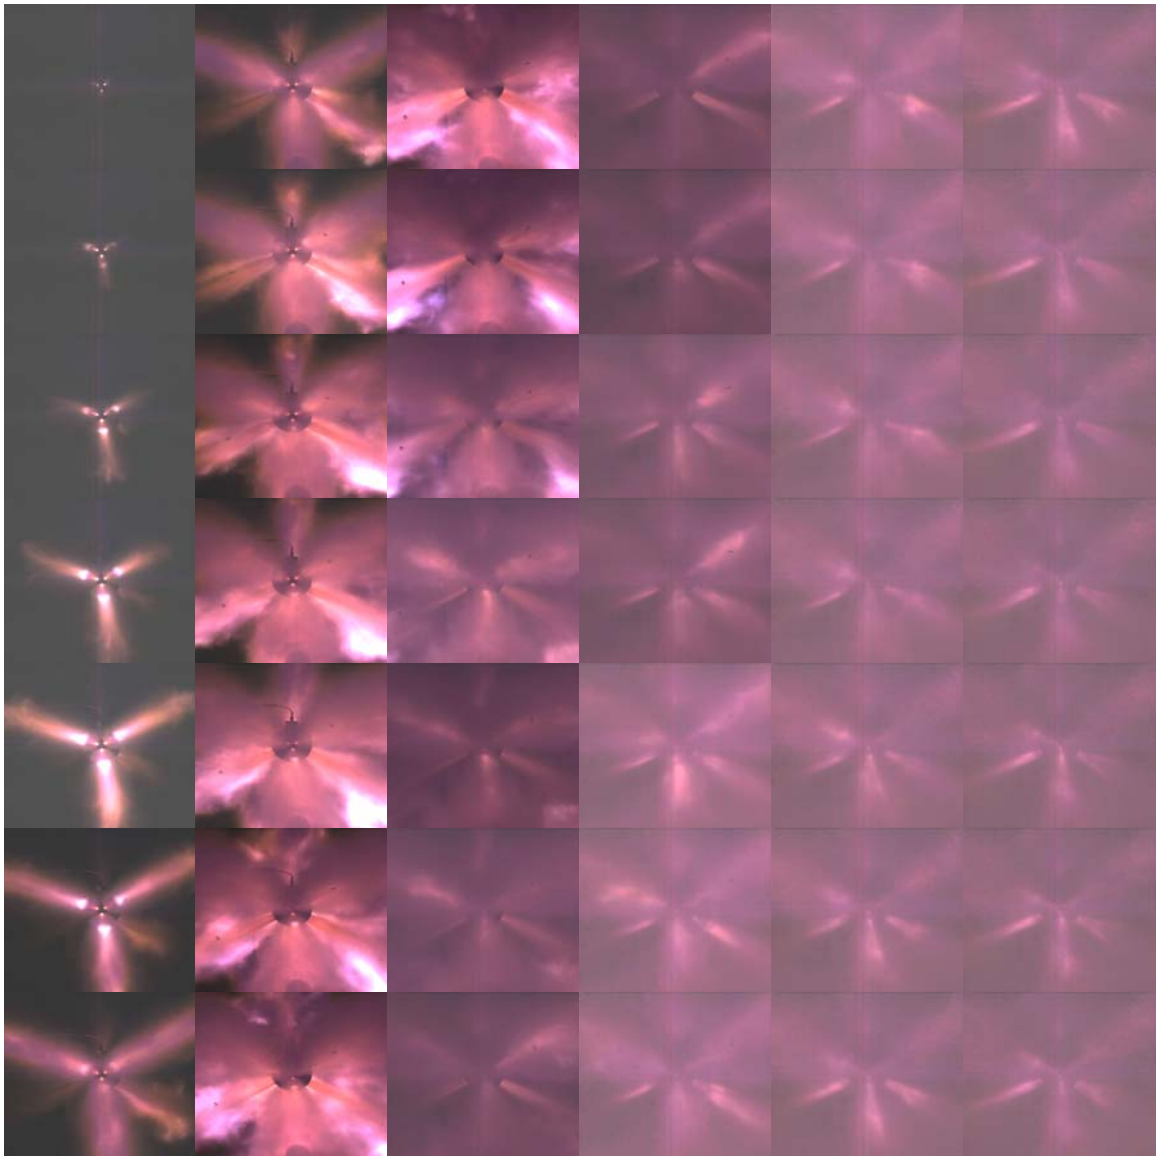
Figure 20. High-speed frames (from top to bottom) of end view of M129 primer; frame time was 263 μ s.

The view of the tip vents of the M129 primer in figure 20 and the axial view of the M125 primer in figure 21 clearly showed that the benite was not totally consumed within the confines of the primer body. Dark chunks that looked like pieces of benite were seen in the jet flows during the approximate interval of 1–5 ms. If they continued to escape the primer body after this interval, the background illumination from the expanding jets was not sufficient to allow detection. After firing, small pieces of benite were found on the table under the primer as well as across the room (see figure 22). It is unknown from which primer each piece of benite originated since the pieces were not found until experimental series had finished. However, the long piece in the photograph was ~2 cm in length. It was assumed that the only manner by which it could have escaped the primer tube was through the vents on the tip of the M129 primer since the tip vents were aligned axially as was the original benite rods.

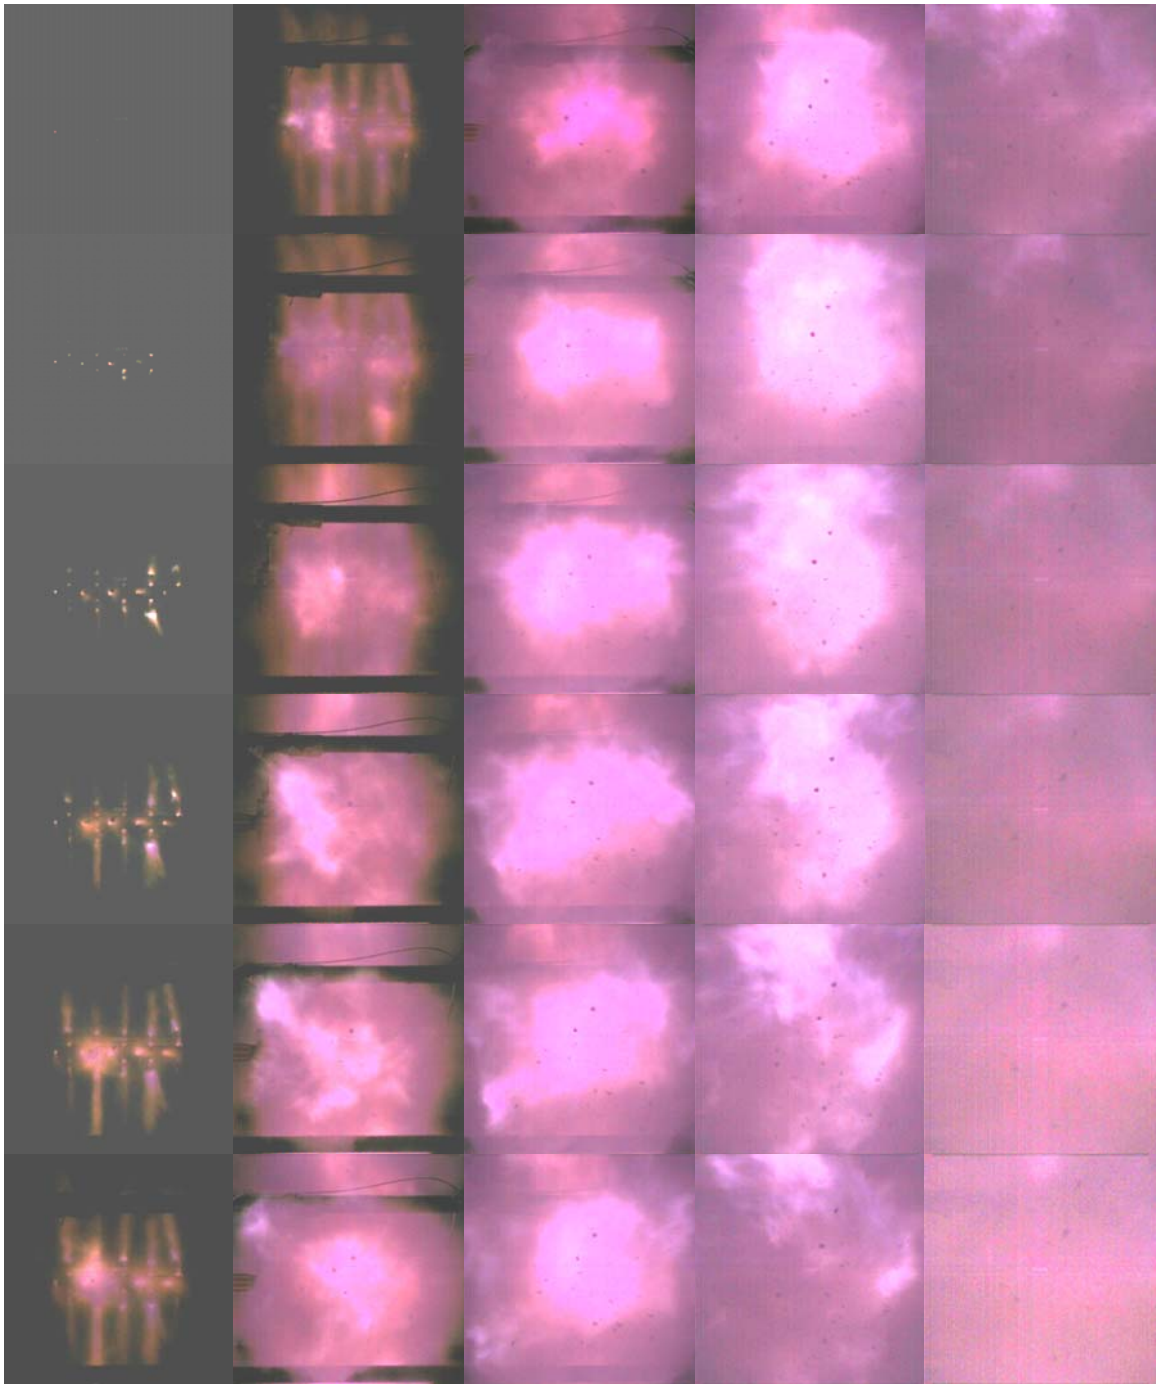
Figure 21. High-speed frames (from top to bottom) of axial view of M125 primer; frame time was 263 μ s.

The findings on the high-speed video for the M125 are shown in figures 21 and 23. Both the unevenness in hole-to-hole venting and the relatively large solid objects in the venting jets show quite readily. For particular integrated ammunitions, these attributes must be taken into account in order to design the optimal performance or remove safety concerns.

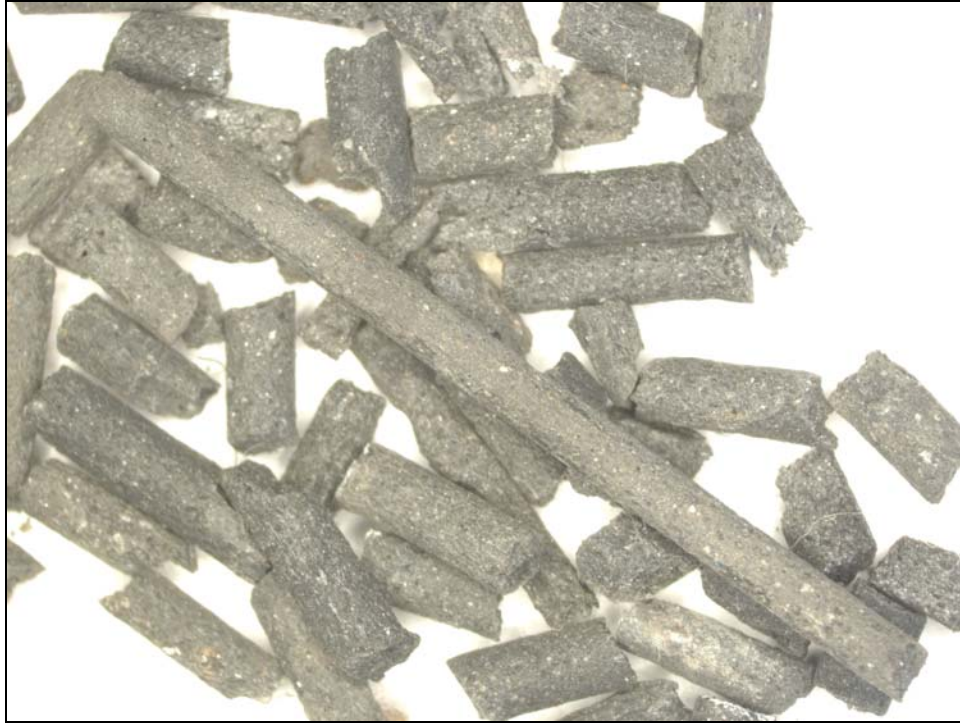
Figure 22. Photograph of pieces of benite found on floor after experiments (origin from M129 or M125 unknown, long piece probably from M129 due to length).

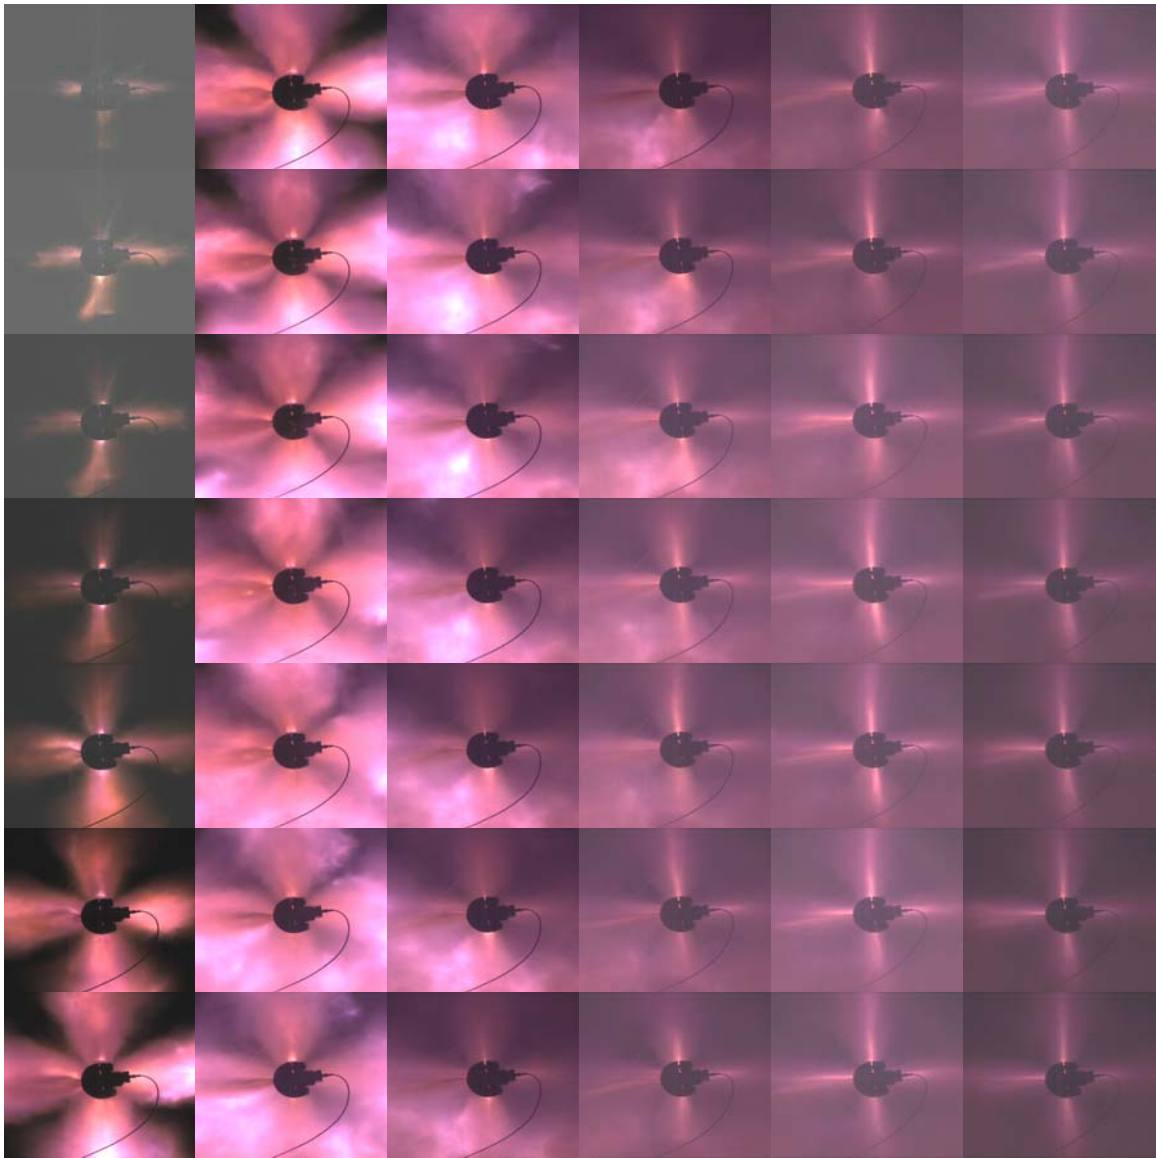
Figure 23. High-speed frames (from top to bottom) of end view of M125 primer; frame time was 263 μ s.
