1. REPORT DATE <b>14 MAR 2005</b>		2. REPORT TYPE <b>Technical, Success Stories</b>		3. DATES COVERED <b>19-10-2004 to 14-03-2005</b>	
4. TITLE AND SUBTITLE <b>Humvee Mobile Antenna Mount</b>				5a. CONTRACT NUMBER	
				5b. GRANT NUMBER	
				5c. PROGRAM ELEMENT NUMBER

## PROBLEM / OBJECTIVE

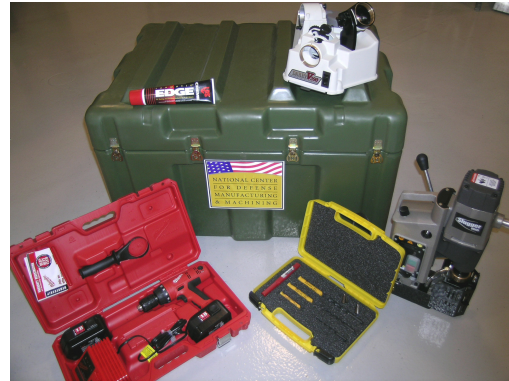
Comtech Mobile Datacom armor kit for field retrofits

The mobile tooling kit includes:

- (2) Sets of drill bits in all the required diameters in both HSS and in carbide

- (1) High torque hand help drill with two batteries and one rapid recovery battery charger
- (2) Specially designed drill for the armor plate
- (1) Drill sharpener for HSS drill
- (1) Mobile magnetic base drill
