Acquisition Directorate

Report No. CG-D-10-09

Inland Rivers Floating Aids Final Technical Report

October 2009

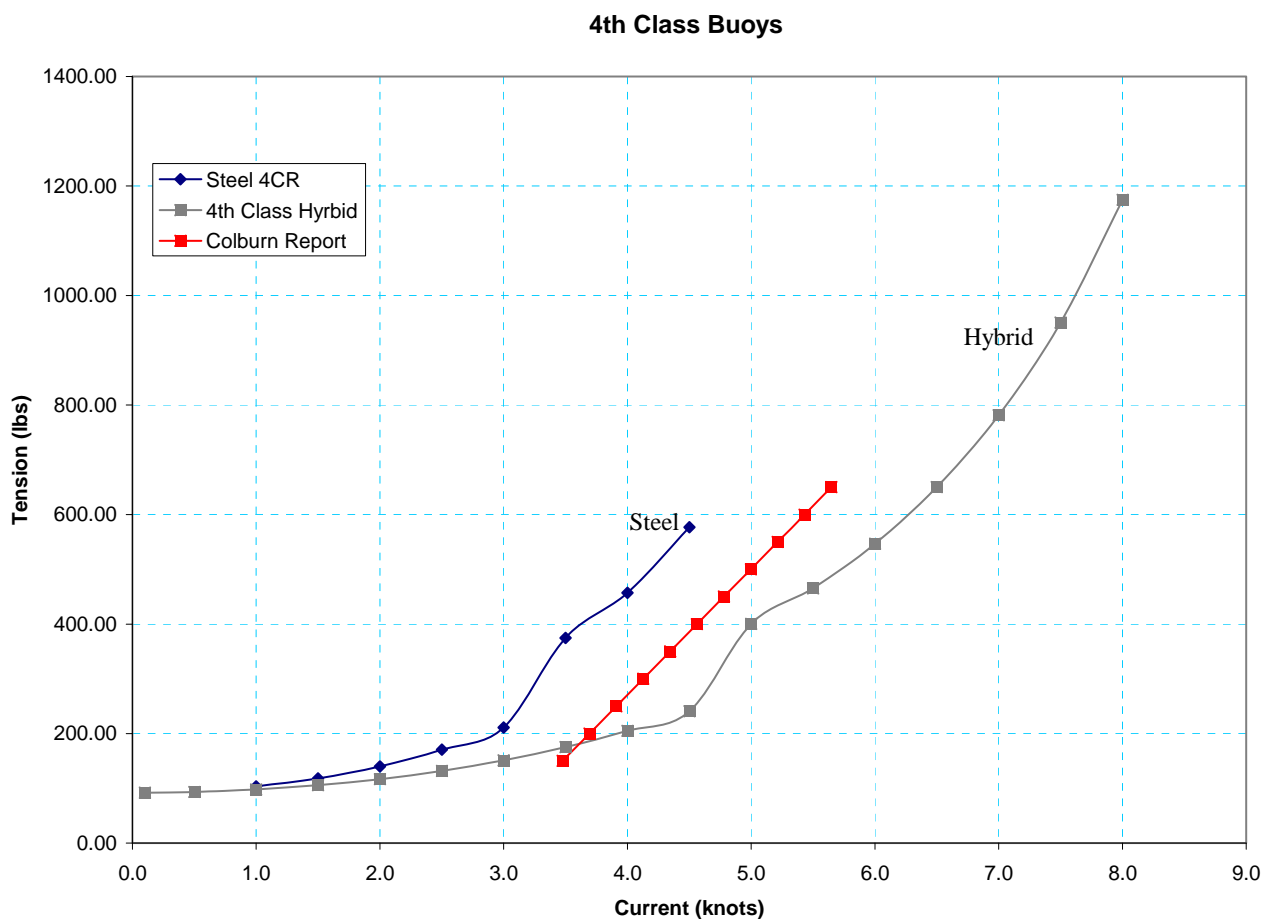
Figure 13. 4th Class buoy comparison: current vs. mooring tension.

Using the formulas shown in Section 5.1.2, the mooring line tension of the candidate buoys versus the current velocity has been graphically displayed in Figure 13 and Figure 14. Data from Reference 3 has been entered as comparison under data line “Colburn Report” for both 4th Class and 6th Class buoys. Reference 3 data was taken from actual field evaluation, which explains the discrepancy in data points. Buoy inclination and oscillation allow the buoy to prevent submergence compared to an assumption of upright orientation at all currents, constantly increasing the frontal area of the buoy drag.

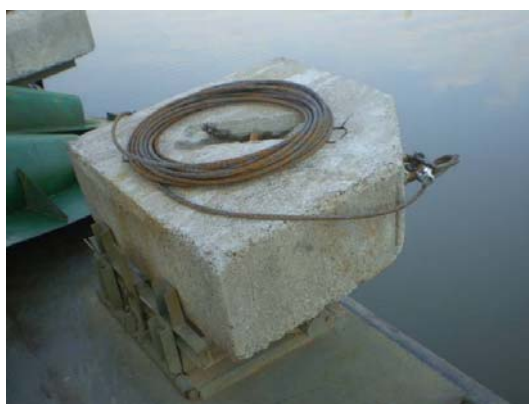
Figure B-2. Sinker and mooring on kickboard.

For the stretch of the Mississippi River that is the KANKAKEE's AOR, it deploys and retrieves 4th Class buoys exclusively, using 90 ft of ½-in. wire rope attached to a 1,500 lb concrete sinker. At the start of the visit, the crew demonstrated the setting and recovery of a buoy while the cutter was still at the dock. To deploy a buoy, the sinker is set on a kickboard launching mechanism at the barge side by the barge crane; see Figure B-2. The buoy is placed at the barge side, with the coiled wire rope connecting the buoy and the sinker. When the kickboard is released, the sinker tips into the river and the wire pays out. The buoy is then pushed over the side by two crew members.

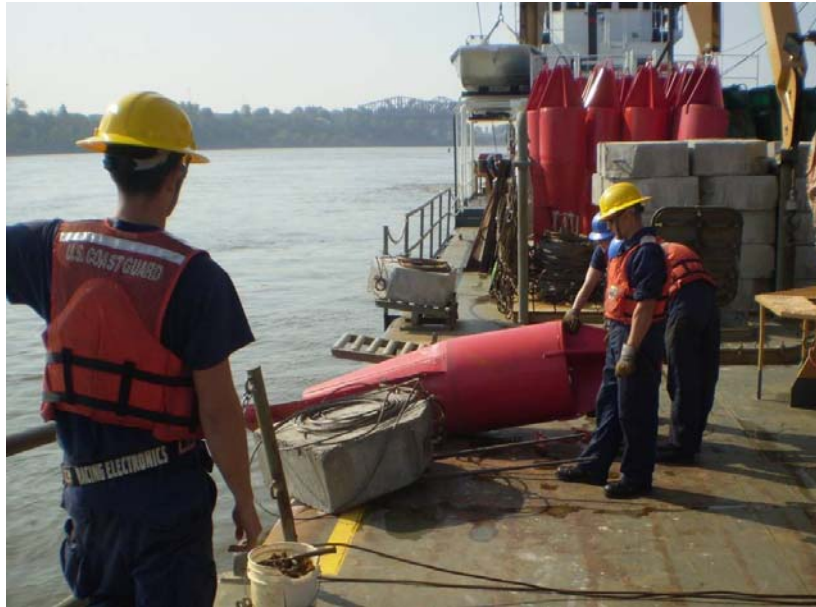
Figure B-3. Crew ready to set buoy using pinch bars to launch sinker.

To recover a buoy, the crew lassoes the buoy using a wire rope lariat with a running noose. The buoy is held against the barge by the lasso and a hook at the end of a wire rope is attached to a lifting eye at the top of the buoy. The buoy is then pulled aboard using the barge's centerline capstan. When the buoy is pulled up on the deck, the mooring line is detached from the buoy and pulled up using the capstan until the sinker is brought up on deck. The buoy is then removed to the storage pen (corral) and a new buoy is placed ready for launching. The wire rope and sinker may be reused, depending on condition. If the sinker is to be reused, it will be launched directly from the deck by a crew member using two pinch bars rather than lifting it onto the kickboard. See Figure B-3.

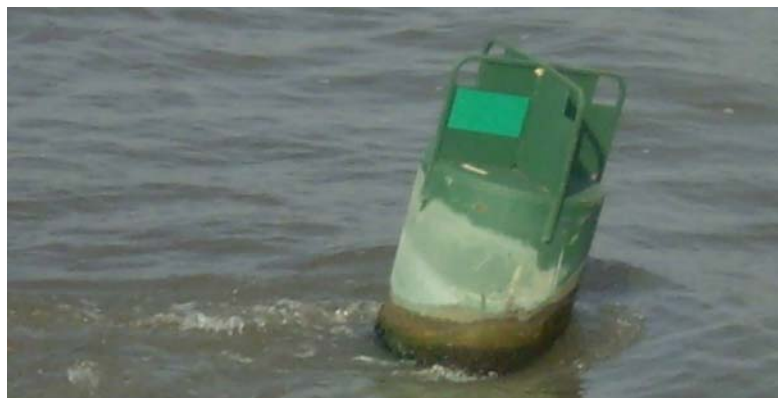
Figure B-4. Buoy leaning into current.

The fast waters tend to cause the buoys to become inclined, which reduces visibility and radar reflectivity. The inclination can be controlled by the location of the mooring connection on the buoy, as multiple holes are available. Attachment above the center of resistance will cause the buoy to lean into the current, while attachment at a lower point will cause the buoy to lean away from the current. The attachment point can be varied seasonally by the WLR crew as the buoys are reset, allowing the buoy to remain upright, despite the current. See Figure B-4. (Note: The series of attachment points is visible in Figure 7 and Figure 14.)

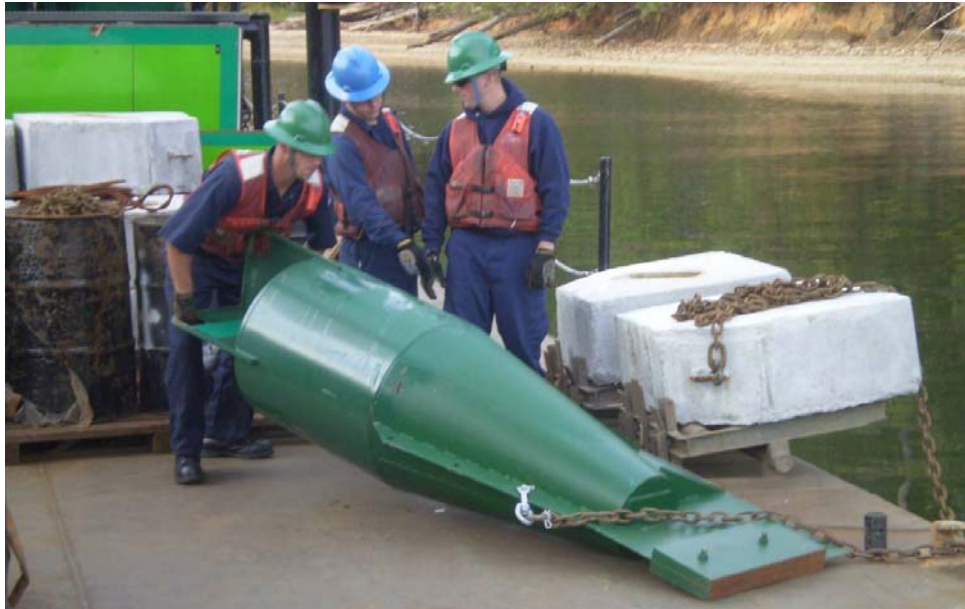
Figure B-6. 4th Class buoy, chain, and sinker ready to be set.

The OUACHITA sets and retrieves 4th Class buoys, using 45 ft (half shot) of ½-in. chain attached to a 1,500 lb concrete sinker. At the start of the visit, the crew demonstrated the deployment and recovery of a buoy while the cutter was at the dock, which was similar to the procedure on the KANKAKEE except that chain is used for the mooring instead of wire. See Figure B-6.

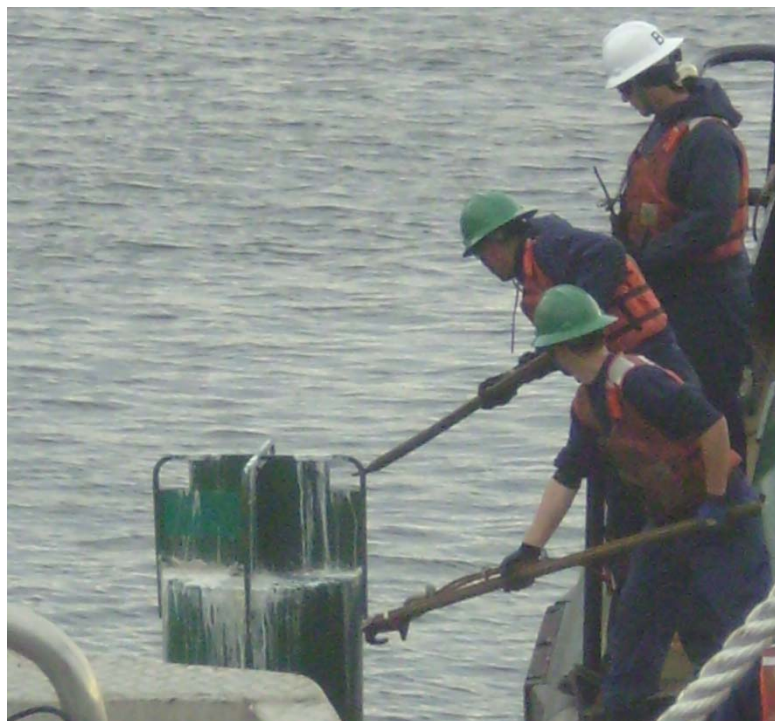
Figure B-7. Buoy recovery using boat hook and wire rope on pole.

To recover a buoy, the crew uses a boat hook to grab the buoy from one of the lifting eyes at the top of the buoy. A second pole with a snap hook attached is used to secure a wire rope to a lifting eye. The wire rope is used to pull the buoy aboard using the barge's centerline capstan. When the buoy is pulled up on the deck, the mooring chain is detached from the buoy and may be pulled up using the capstan if the buoy is to be reset. The buoy is then removed to the storage corral and a new buoy is placed ready for launching. The chain and sinker will typically be reused if the buoy is not reset. See Figure B-7.

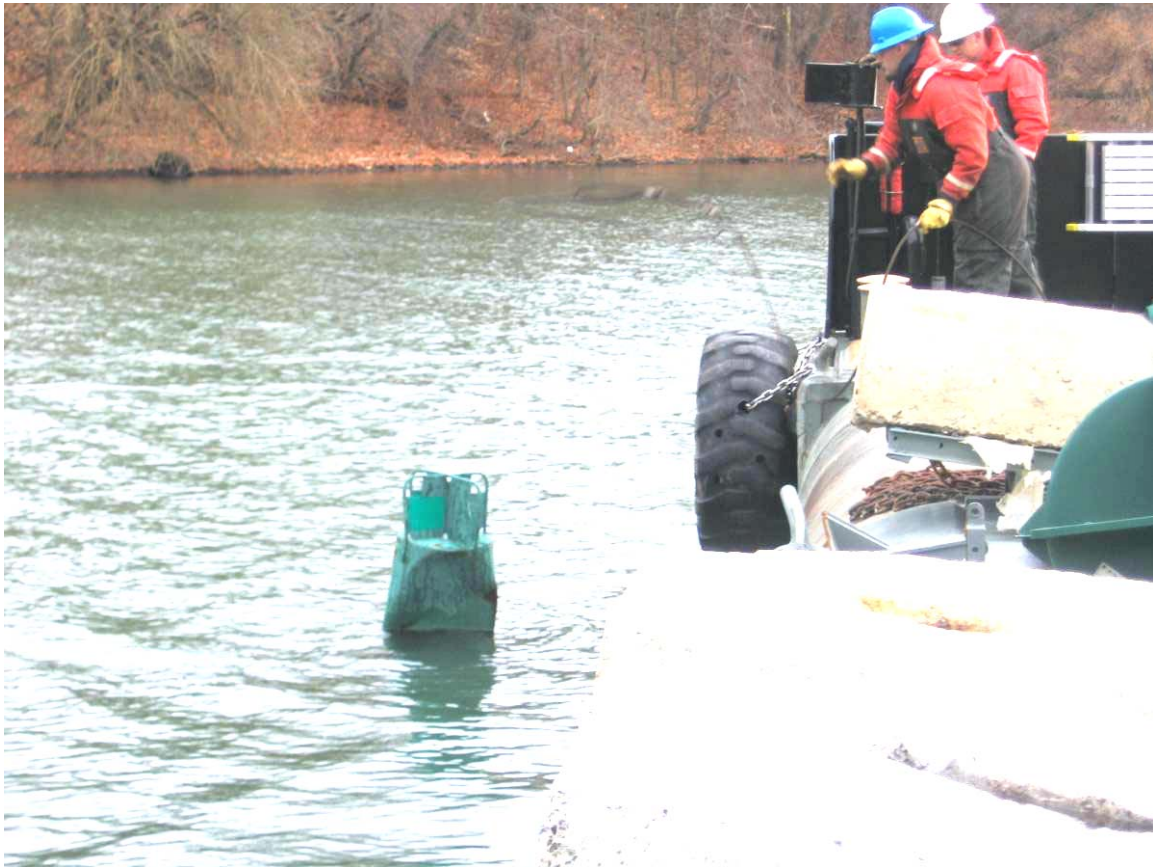
Figure B-9. Buoy recovery using lasso.

The OSAGE sets and retrieves 4th Class and 6th Class buoys, using 90 ft (one shot) of ½-in. chain attached to a 1,500 lb concrete sinker. To recover a buoy, the crew lassoes the buoy using procedure similar to that used on the KANKAKEE. Once the buoy is brought alongside, a wire rope is attached to a lifting eye which is used to pull the buoy aboard using the barge's centerline capstan. When the buoy is pulled up on the deck, the mooring chain is detached from the buoy and may be pulled up using the capstan if the buoy is to be reset. The buoy is then removed to the storage pen (corral) and a new buoy is placed ready for launching. The chain and sinker will typically be reused and not inspected if the buoy is not moved. See Figure B-9.
