## **Ft. Hood iScout to Persistent Ground Surveillance System (PGSS) Cueing Demonstration**

**ARL-MR-0783**

**June 2011**

**Thomas W. Walker**  
**Sensors and Electron Devices Directorate, ARL**

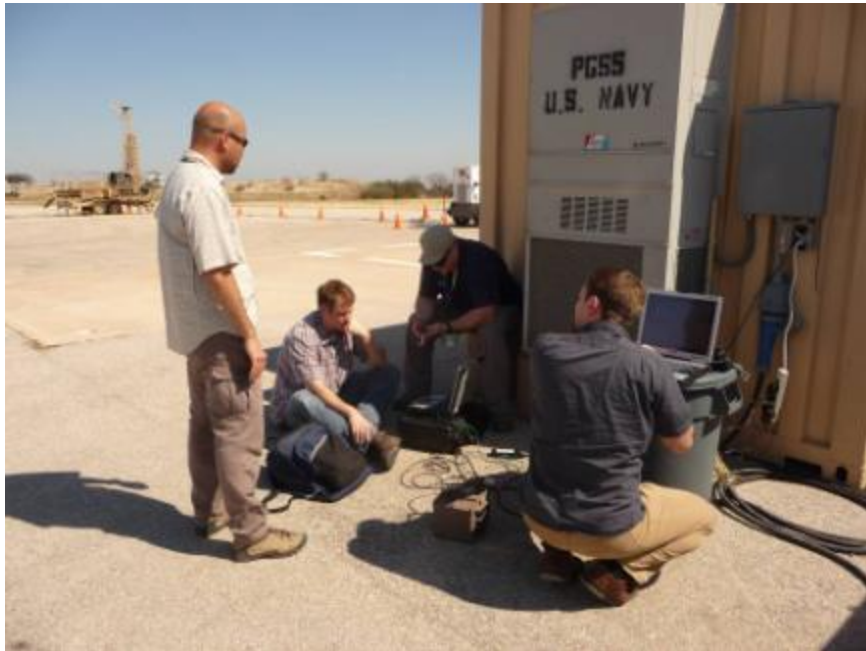
Figure 2. Setup and testing of the equipment at the PGSS aerostat site.

On Thursday, March 3, the team met with Don Nibblett at the TOC, which was located on the north end of Ft. Hood near Gatesville, TX. The day's activities were discussed, the equipment needed to run the demo was picked up, and then we went to the aerostat site. The aerostat was already flying, so Nibblett arranged to have it lowered so we could install the base station repeater and antenna that would communicate with the emplaced iScouts. The equipment was set up on the ground and checked out before installation on the aerostat (figure 2). The winds picked up significantly as the team waited for the aerostat crew to finish their day's testing. By the time the aerostat was moored on the trailer, it was moving about vigorously enough that it was deemed unsafe to attempt to install the equipment or raise it back up to begin testing, so the PGSS crew was dismissed for the day.

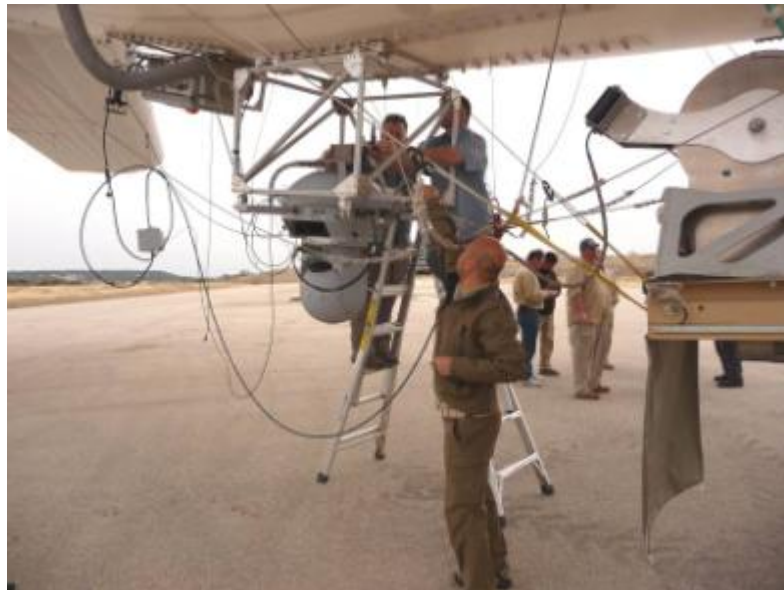
Figure 3. Installation of the equipment on the PGSS aerostat gondola.

On Friday morning, the winds were still above the recommended level for launching the aerostat (more than 15 mph at ground level), but we were able to attach the base station repeater and antenna to the aerostat gondola (figure 3). A full checkout of the system on the ground was performed including the following:

- We triggered an iScout located in the aerostat parking area.
- We logged receipt of the iScout cue by the base station repeater.
- We confirmed the relay of the iScout cue to the UTAMS controller.

- The UTAMS controller processed the message and forwarded it to the PGSS Gatekeeper, which issued a camera position command.
- The PGSS camera slewed to the location of the iScout in the parking area.

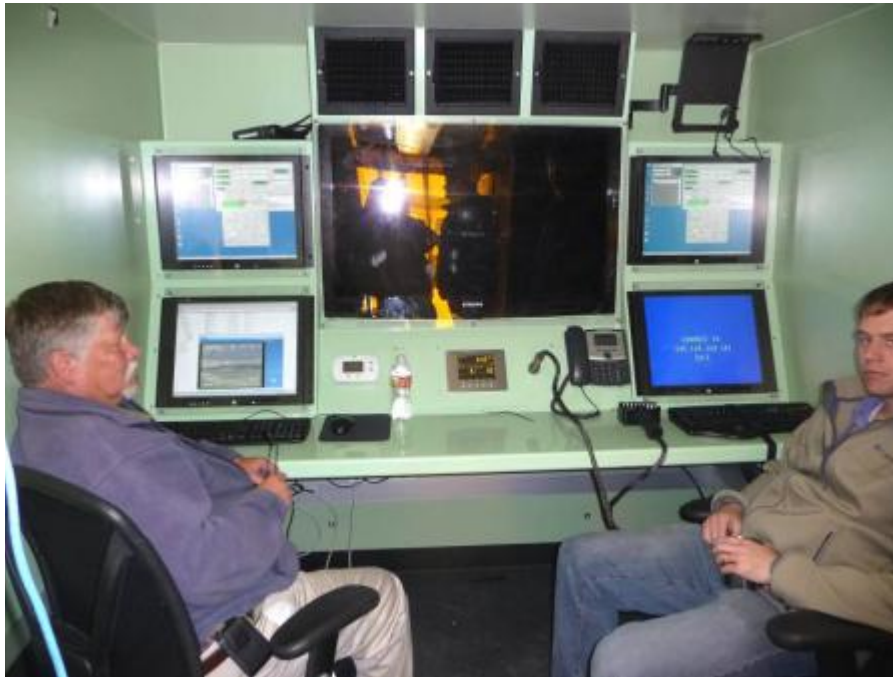
Figure 6. Reviewing the aerostat camera video clips at the PGSS ground station.

The TacSAD system began receiving video from the TOC AGIG network, albeit a blank screen as the aerostat camera was stowed. After more testing at the TOC to make sure the system was working, we shut down and went to the aerostat site to view the stored video clips that the PGSS camera took of the training area near Highway 36 (called Jalalabad). These stored clips illustrated where the best location was to emplace the iScouts in order to ensure that line of sight

to the aerostat would be maintained (figure 6). After looking over several movie clips, we drove back to the TOC to discuss emplacement strategy with Nibblett, who already had a good idea from scouting the Jalalabad site earlier with his team of where to put the sensors. Nibblett disclosed that his team would emplace two iScouts in Jalalabad later that evening. These sensors were configured for seismic mode and set to high sensitivity for detecting personnel and low sensitivity for detecting vehicles. One iScout was buried near Highway 36 and the other near the hilltop water tower (figure 7).

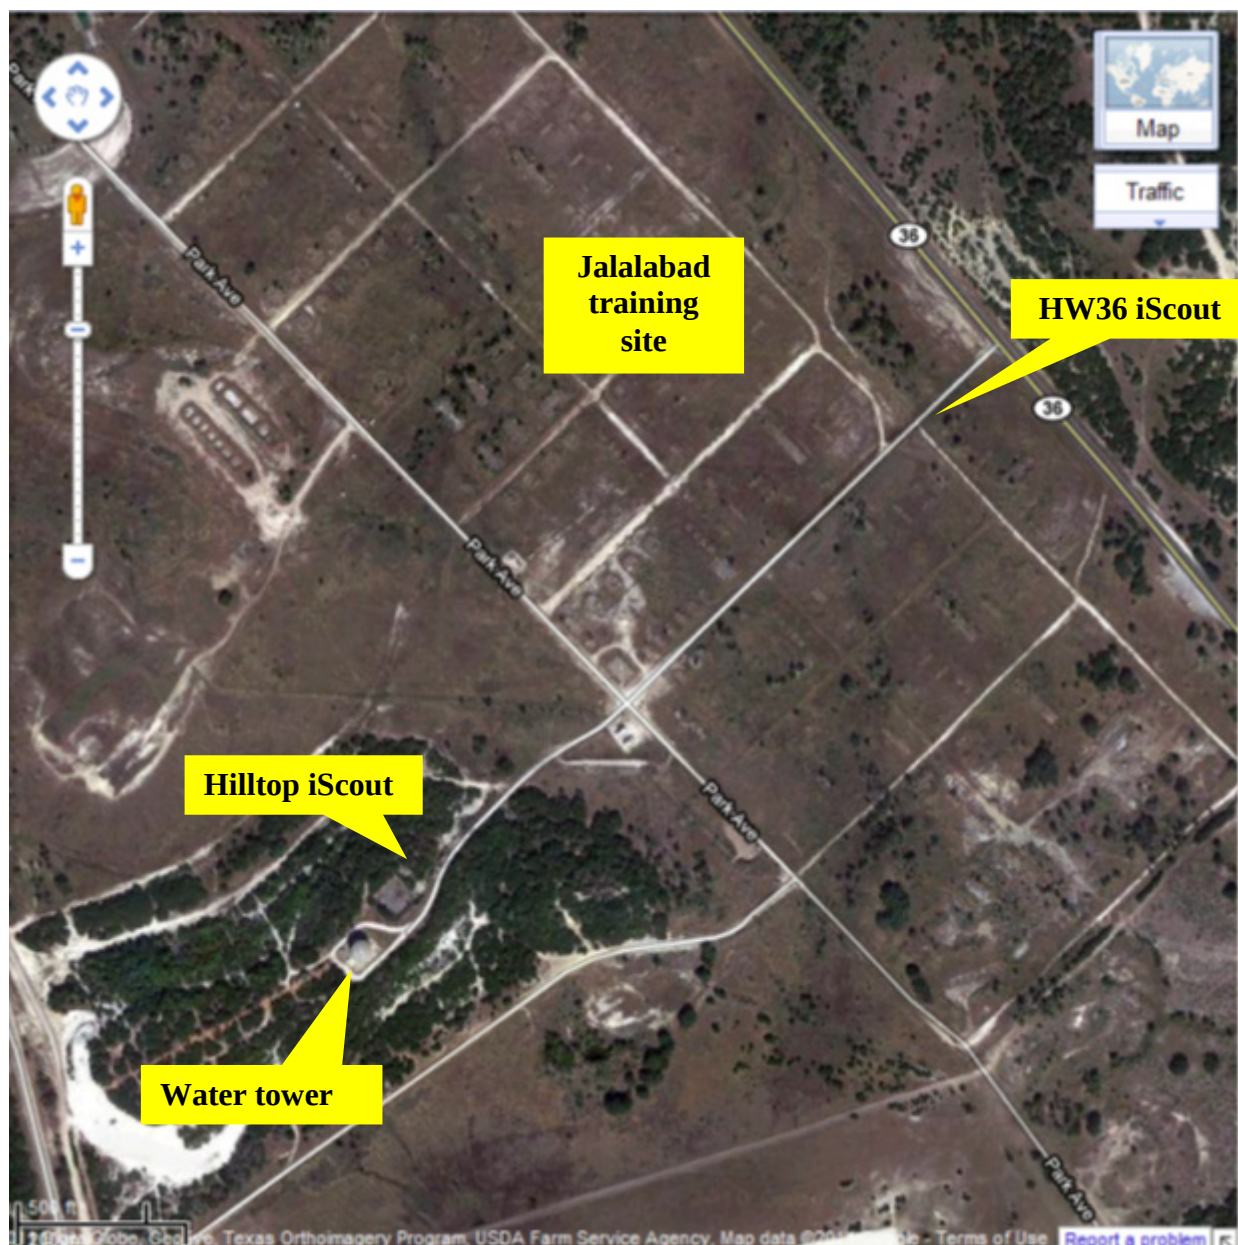
Figure 7. Map showing the placement of iScout sensors at the Jalalabad training site.

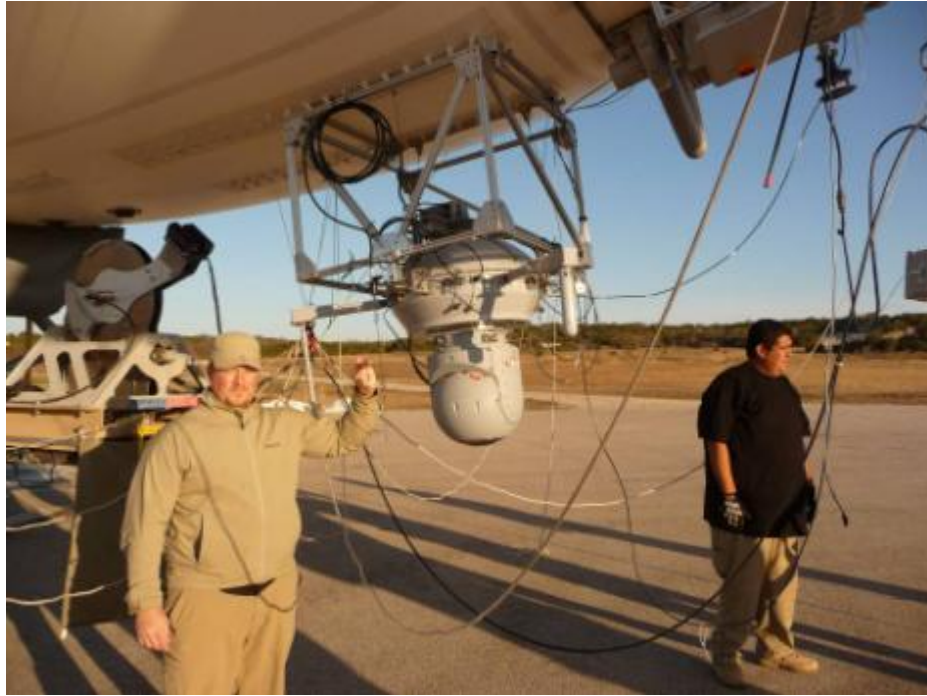
Figure 8. High-gain repeater antenna mounted on the PGSS camera gondola.

On Sunday, March 6, we arrived at the PGSS aerostat site and mounted a higher-gain antenna for the base station repeater on the camera gondola (figure 8). We then connected the antenna cable to the base station repeater, booted up the UTAMS controller, connected the TacSAD to the network to view the sensor detections, and turned on an iScout and triggered it. The system properly received and processed the iScout trigger message and the aerostat camera slewed to the iScout location in the parking lot. All systems operated properly so the crew began raising the aerostat to 2000 ft (figure 9).

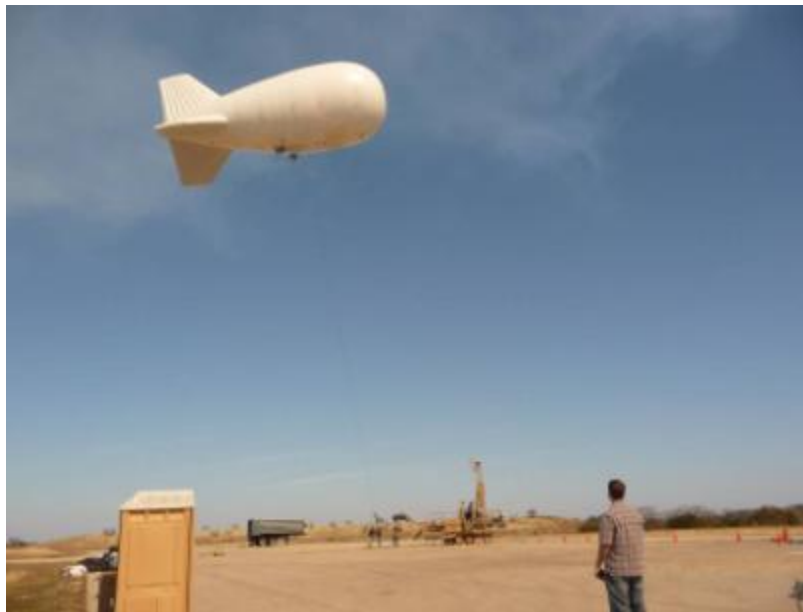
Figure 9. PGSS aerostat.

As the aerostat reached an elevation of about 1500 ft, it began receiving detections from the iScout that was emplaced that morning at the TOC just outside the training tent. The iScout was set to passive infrared (PIR) mode and was placed on top of the ground looking out at the road. However, only a single detection was received from the sensors at Jalalabad while the aerostat

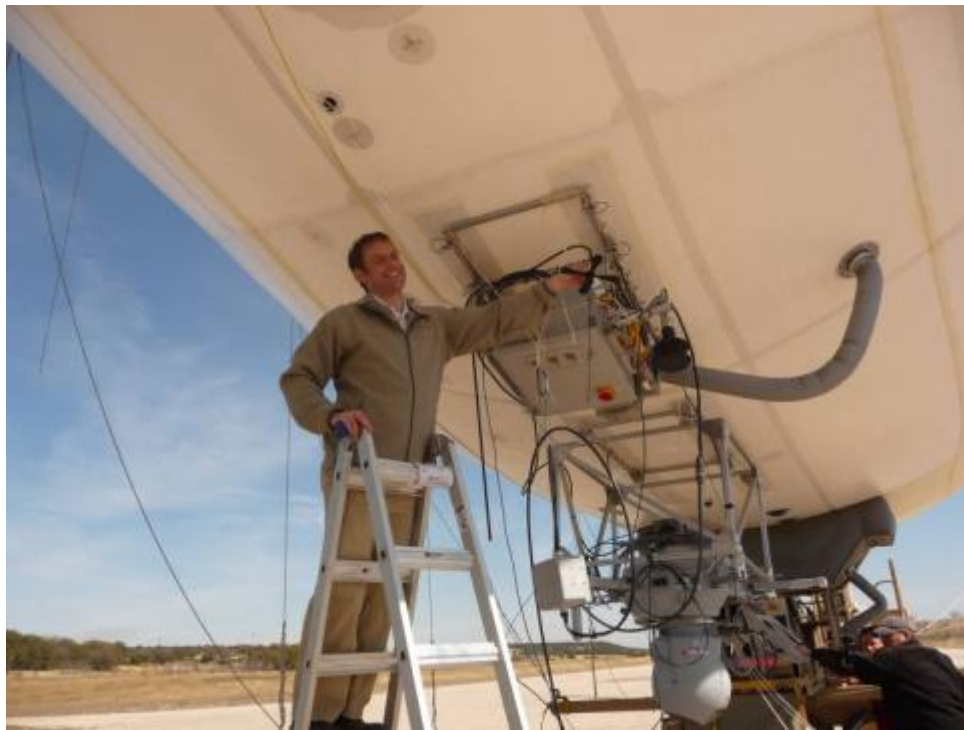
Figure 10. Mounting site for the repeater antenna on the PGSS controller frame.

was on the way up and none were received after the aerostat reached 2000 ft. Detections continued to arrive from the iScout at the TOC. Unsure as to why we were not receiving detections from the Jalalabad sensors, we sent Mike Brunda and Shane Nguyen to investigate. They replaced the batteries in the HW36 iScout and triggered it several times and monitored the detections using a Wireless Mobile Relay (WMR) and Handheld Programming Module (HHPM). Unfortunately, the detections were still not received by the aerostat repeater. In addition, the PGSS aerostat camera quit working; the crew attempted to reboot it several times to no avail. The aerostat was lowered so the crew could inspect the equipment and we took the opportunity to try another mounting location for the repeater antenna. We moved it from the camera gondola to the controller frame in hopes that this new location would allow reception of signals from the Jalalabad sensors (figure 10).

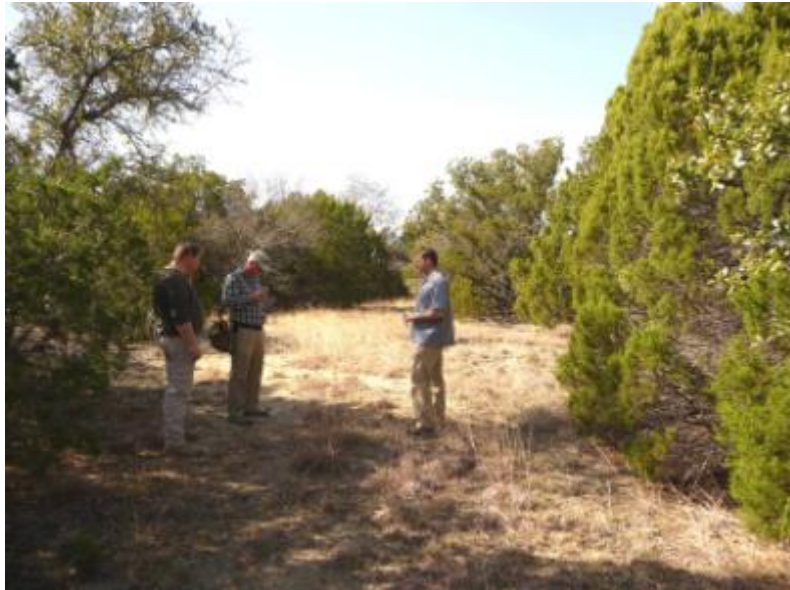
Figure 12. Scouting the hilltop area of Jalalabad for a suitable relay site.

We decided to scout the Jalalabad hilltop area for a suitable repeater site. We checked the hilltop iScout, replaced the two AA batteries and exchanged the stub antenna with a whip antenna on a 6-ft cable and strung it up in a juniper bush. We also scouted the hilltop area for a good repeater location that had line of sight to the aerostat as well as to the HW36 and hilltop iScouts. We located a suitable spot near the front of the hill and were able to receive detections from both iScouts using the WMR and HHPM (figure 12). After the day's activities were over, we stopped at the local Home Depot to pickup hardware for mounting the high-gain whip antenna to the 10-ft repeater mast.

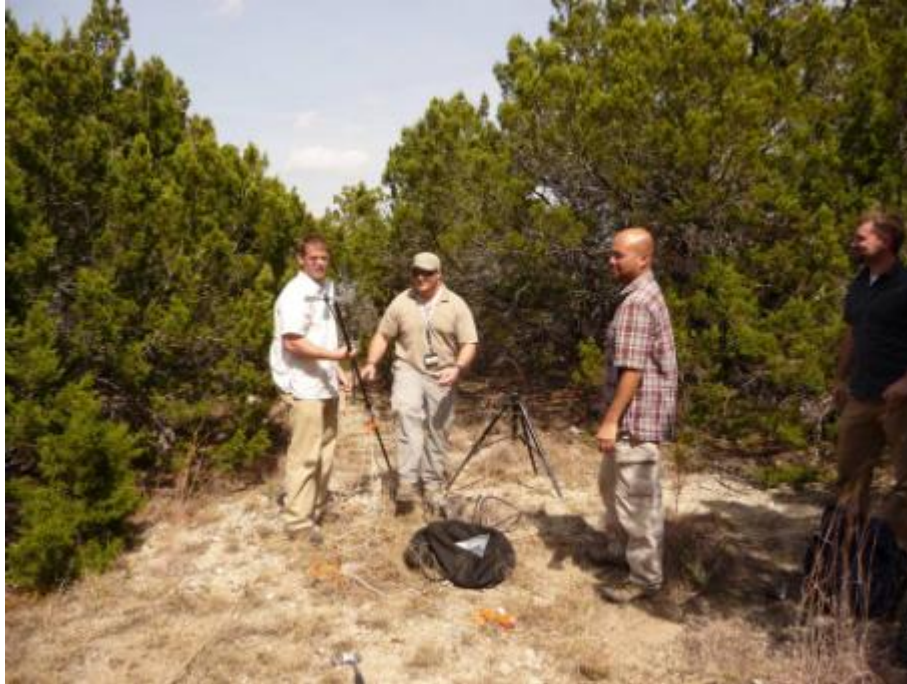
Figure 13. Installing the Jalalabad hilltop repeater.

Tuesday, March 8, the winds were still too strong to fly the aerostat. We retrieved the equipment shipped overnight from McQ and traveled to Jalalabad to emplace the hilltop repeater. We mounted the high-gain whip antenna on the 10-ft mast at the desired location and connected the antenna cable to the repeater and battery box (figure 13). We used a laptop connected to the serial port on the repeater to monitor messages from the iScouts and were able to receive detections from both sensors.

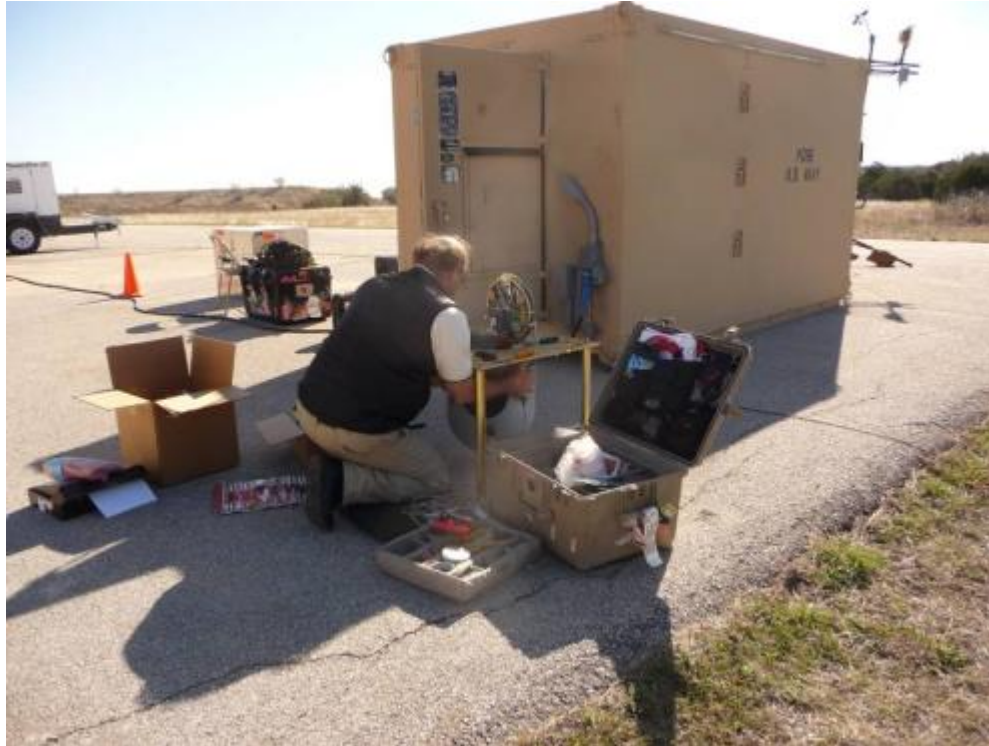
Figure 14. Technician troubleshooting the PGSS aerostat camera.

Wednesday, March 9, it was again too windy to fly. We watched the PGSS crew install the new camera on the aerostat gondola and run system checks before energizing the entire system. The new camera failed to initialize properly and shut down just like the previous one. The gondola was removed and the technician went to work diagnosing the problem with the new camera. The 504<sup>th</sup> practice exercise at Jalalabad was scheduled for today and the live run tomorrow; the last day of the CERTEX. Nguyen took over running the iScout training classes from Anderson who needed to return home (figure 15); Colin McCabe planned to leave the following day since the UTAMS system was operating as expected.

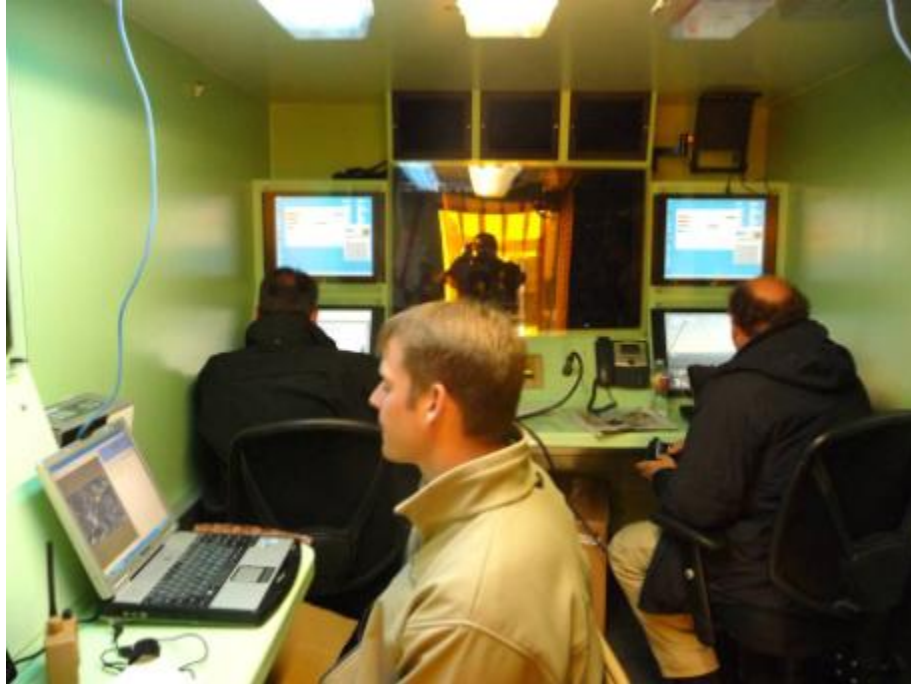
Figure 18. Monitoring iScout detection reports with TacSAD at the PGSS ground station.

We performed a complete system check with the aerostat on the ground and the camera successfully slewed towards the iScout placed near the vehicles. The crew raised the aerostat and the camera worked properly. However, even when the aerostat reached 2000 ft, we could not receive signals from the hilltop repeater. We replaced the iScout batteries and triggered both sensors, but still no detection reports were received from the hilltop repeater (figure 18).
