# **Demonstration/Validation for Federal Specification MMM-A-121 Hazardous Air Pollutant-Free Adhesive Replacement**

**ARL-TR-5502**

**April 2011**

# **Army Research Laboratory**

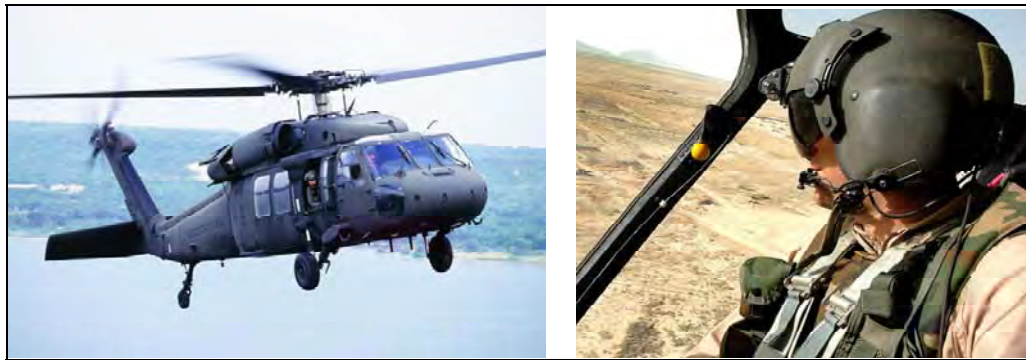
Figure 1. UH-60 Blackhawk helicopter (left) and HGU-56/P aviation helmet (right).

demonstrating and validating 3M-847 adhesive on an HGU-56/P aviation helmet and a UH-60 Blackhawk helicopter (figure 1), conducted at Lowe Army Heliport Fort Rucker, AL. Specifically, this HAP-free product was demonstrated/validated on aviation helmet model no. HGU-56/P “edge beading” preventative maintenance/repair (figure 2), a UH-60 Blackhawk helicopter “nose door seal” (NDS) (figure 3), and for general Army use. Furthermore, this report details the identification and solution of several previously undocumented issues associated with substrate materials currently used by the Army, resulting in modified adhesive application procedures and updated laboratory tests related to the MMM-A-121 specification.

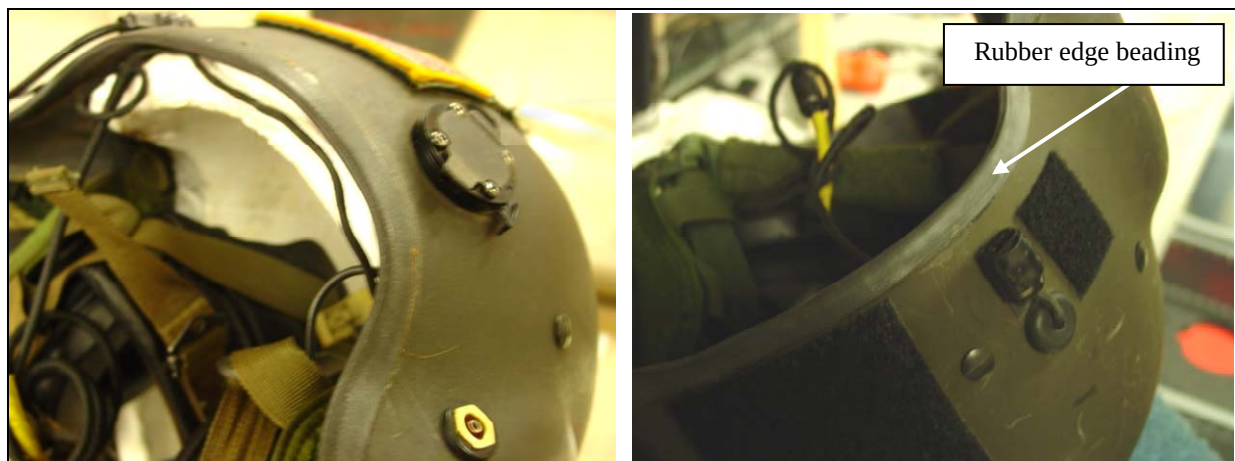
Figure 2. HGU-56/P aviation helmet without beading (left) and with beading (right).

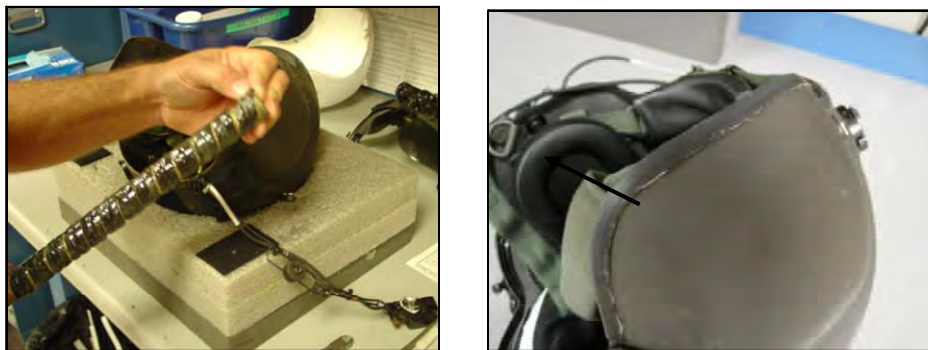
Figure 4. Adhesive application for aviation helmet.

A demonstration/validation plan was written for the replacement of edge beading on aviation helmet model no. HGU/56/P to compare the baseline adhesive 3M-1357 and the HAP-free 3M-847 (appendix A). The helmet repair demonstration/validation was performed on 31 March 2009 at the U.S. Army Aviation Center Logistics Command (ACLC) Repair Shop, Lowe Army Heliport, Fort Rucker, AL. Two aviation helmets were selected for concurrent demonstration /validation. Helmet ID no. G3660 used the baseline adhesive 3M-1357, and helmet ID no. B0985 used the HAP-free adhesive 3M-847. The old adhesive and edge beading (11) were removed from the helmets. The helmet surface was wiped clean, removing any old adhesive. One coat of new adhesive was applied by brush to both the edge beading and the perimeter of the helmet shell. Figure 4 shows a photograph of the new helmet edge beading (11) wrapped around a wooden stick with one coat of freshly applied adhesive. Once aggressively tacky, the adhesive coated edge beading was then unrolled onto the perimeter of the helmet shell.

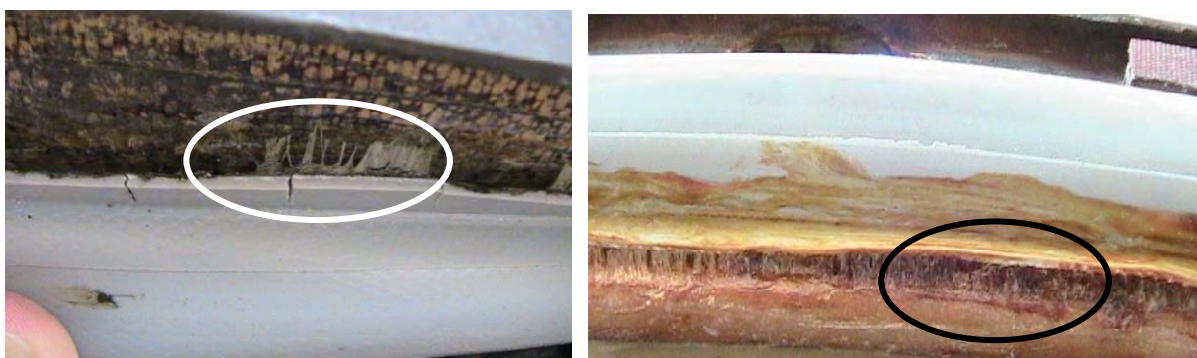
Figure 7. Edge lifting 3M-1357 (left) and 3M-847 (right).

The NDS HAP-free adhesive performance was required to be equal to or better than the baseline. The UH-60 NDS was evaluated at the adhesive interface by the inspector for blistering, edge lifting, deterioration of adhesive, or failure of the adhesive bond (12). The evaluations were conducted at the time of application—24 h, 7 days, 30 days, and 90 days after initial application (appendix A). Technicians evaluated the ease of adhesive application and performance of the HAP-free (3M-847) initial bonding relative to the baseline (3M-1357) at the time of the initial application. The technician commented that the initial application of the 3M-847 adhesive was slightly harder to work with compared to the baseline 3M-1357 because of the higher viscosity and faster solvent evaporation. The 24-h inspection showed no significant differences between the two adhesives. However, on 7 April 2009, both the baseline (3M-1357) and HAP-free adhesive (3M-847) exhibited significant failure on the UH-60 helicopter NDS (figure 7). In addition to edge lifting seen in the figure 7 photographs, both adhesives also exhibited legging. (Legging is the drawing of filaments or strings when adhesive bonded substrates are separated [12]). Due to the failure captured in figure 7, Lowe Army Heliport technicians removed the NDS from both Blackhawk helicopters and thus ended the demonstration/validation at that time.

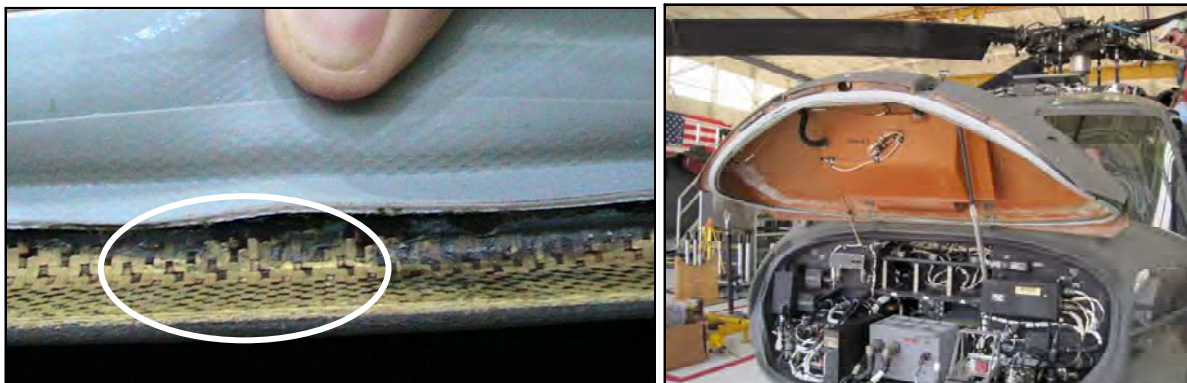
Figure 8. UH-60 composite nose door.

During the field trial, we discovered a number of issues with the demonstration/validation plan. First, the UH-60 helicopter NDS was made of silicone rubber (ZZ-R-765, Class 3B, and Grade 50). Class 3B was tear and flex resistant, and Grade 50 corresponded to the nominal shore-A-durometer hardness value (15). MMM-A-121 specified only three kinds of rubber substrates, consisting of neoprene, SBR, or nitrile (16). Second, the UH-60 helicopter nose door was constructed of a lightweight composite material which was highly porous, whereas MMM-A-121 specified a low-porosity metal substrate such as unpolished steel (figure 8). Furthermore, only a single layer of adhesive was applied per substrate. Higher substrate porosity could negatively affect adhesion performance if the adhesive is not applied sufficiently.

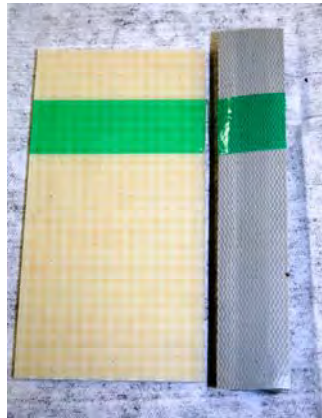
Figure 9. Composite panel and UH-60 NDS.

composite panel and a 1- × 6-in strip of UH-60 NDS (ZZ-R-765, Class 3B, and Grade 50). The contact surface of the NDS was hand-sanded with a course abrasive paper to roughen the bonding area and cleaned with acetone (appendix A). The rough side of the composite panel was used for bonding to simulate the rough texture of the interior of the UH-60 nose door. Release tape was placed on both substrates to create a clean edge to start the peel ~2 in from the top of the panel (figure 9). The adhesives included in this test series were 3M-1357, Clifton E-1293, and 3M-847 (table 1). Peel assemblies were prepared both with one coat of adhesive per substrate and with two coats of adhesive per substrate. Peel assemblies with two coats of adhesive per substrate were allowed to dry between coats. Adhesive was applied with a brush to achieve a thin uniform coat. Once the adhesive had dried to a tacky consistency, the two substrates were bonded together. A roller 2 inches in diameter was used to remove any trapped air between the substrates and assist with the bonding process.

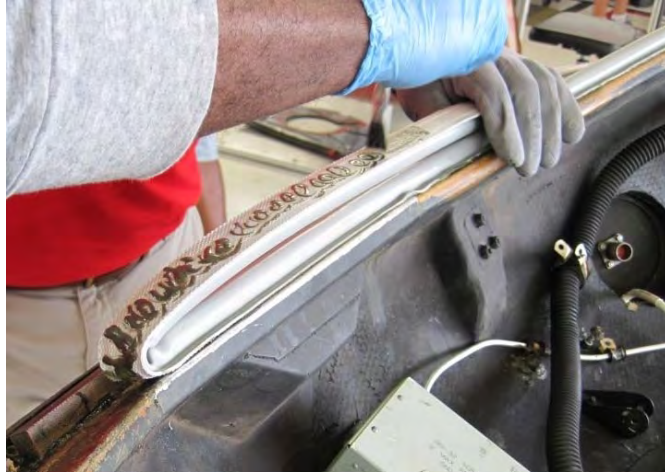
Figure 14. Baseline (3M-1357) adhesive application to UH-60 NDS.

On 29 July 2009, in conjunction with the U.S. Army Research Laboratory (ARL) and AMCOM G-4 team, the ACLC Environmental Group executed the ARL “Demonstration/Validation Plan II For MMM-A-121 Federal Specification Adhesive, Bonding Vulcanized Synthetic Rubber to Steel, HAP Free Replacement” (appendix B) at Lowe Army Heliport (appendix C). The purpose of this demonstration/validation was to determine if the HAP-free rubber and gasket adhesive alternative (3M Scotch-Weld 847) could be substituted for the baseline material (3M Scotch-Weld 1357 and Clifton adhesive E-1293) for MMM-A-121 adhesive on an Army UH-60 Blackhawk helicopter nose door seal, HGU-56/P aviation helmet preventative maintenance/repair, and for general Army use. Simultaneous tests were conducted on a UH-60 helicopter nose door seal and HGU-56/P aviation helmet edge beading. A baseline was used in each test so that the HAP-free alternate (3M-847) could be assessed in real time with the adhesive used currently. The baseline for the UH-60 nose door seal was 3M-1357, and the baseline for the helmet edge beading was Clifton E-1293. Teams were used to apply the baseline and alternative on two UH-60 nose door seals, one for the baseline (tail no. 4633) and one for the alternate (tail no. 4441) (appendix B). Both teams closely followed the demonstration/validation plan (appendix B) that outlined the proper way to apply each adhesive, ensuring that two coats of adhesive per substrate were applied for each product, as the photos in figures 14 and 15 illustrate. This application directive was vital for the success of the field trial. Comments from the alternative adhesive team spoke of the tackiness of the new adhesive and the shorter drying time

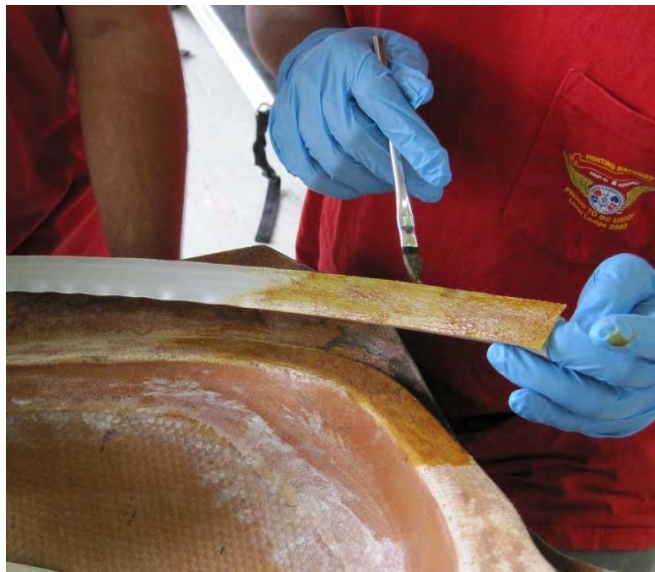
Figure 15. Alternative (3M-847) adhesive application to UH-60 NDS.

both of which contributed to the difficulty in spreading the material evenly. Overall, the team stated the alternative adhesive (3M-847) appeared to perform well but was slightly more difficult to apply than the baseline (3M-1357).

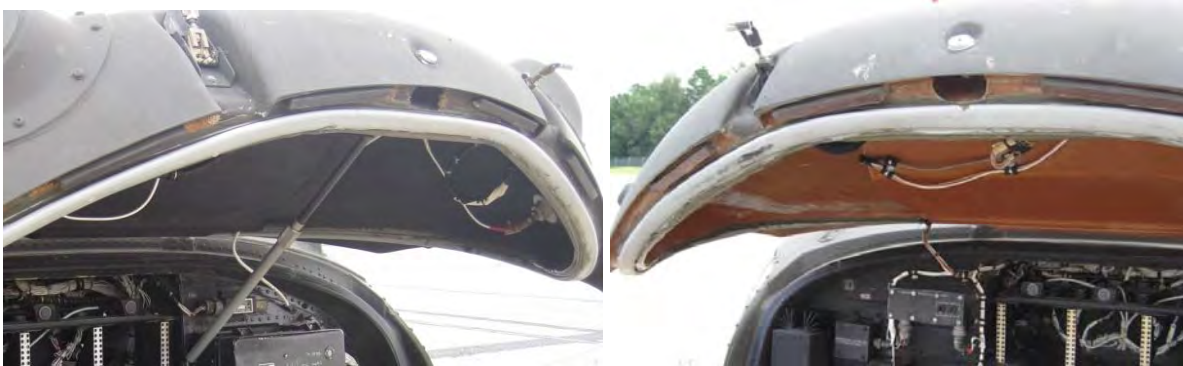
Figure 16. UH-60 NDS after 90 days in the field, baseline (left) and alternate (right).

After the adhesive application, the nose doors were reinstalled on the aircraft (figure 16) and released into the field for normal operation. Inspections were conducted at 24 h, 7 days, 30 days, and 90 days after application to determine how the adhesives performed over time (appendix B). In each inspection, the alternative adhesive did not show any signs of slippage, delamination,

blistering, deterioration, or failure compared to the baseline (appendix B). The photos in figure 16 show the two UH-60 helicopters after 90 days in the field. The helicopters were photographed intentionally with the nose door open to view the condition of the NDS. At the end of the 90 day field trial, both NDS's were still properly adhered to the respective UH-60 nose door. Overall, the inspector concluded that the alternative adhesive (3M-847) performed as well as the baseline (3M-1357).

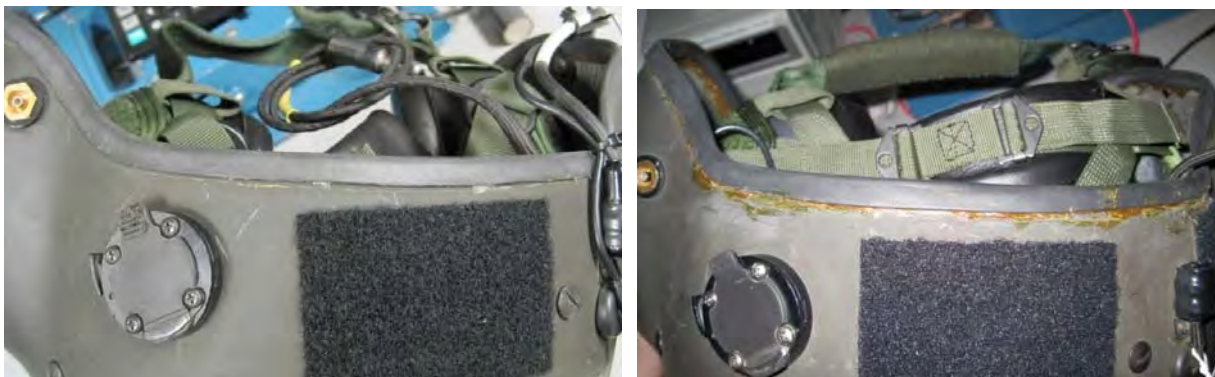
Figure 17. Aviation helmet after adhesive application, baseline (left) and alternate (right).

One technician applied the baseline Clifton E-1293 (helmet ID no. R20048) and the alternative 3M-847 (helmet ID no. L284) to two HGU-56/P aviation helmets to secure the edge beading (appendix B). The technician closely followed the demonstration/validation plan that outlined the proper procedure for the application of the adhesives (appendix B). Applying two coats of adhesive per substrate was a key change from the first demonstration/validation (March 2009) and the second demonstration/validation (July 2009). Comments from the technician indicated that the alternative 3M-847 dried faster than the baseline, causing the edge beading to look sloppy and pucker in the curved areas (figure 17). Overall, the technician preferred the baseline adhesive (E-1293) to the alternative (3M-847) because of the ease of application. Once the adhesive application was completed, the helmets were released to the field for normal operation.

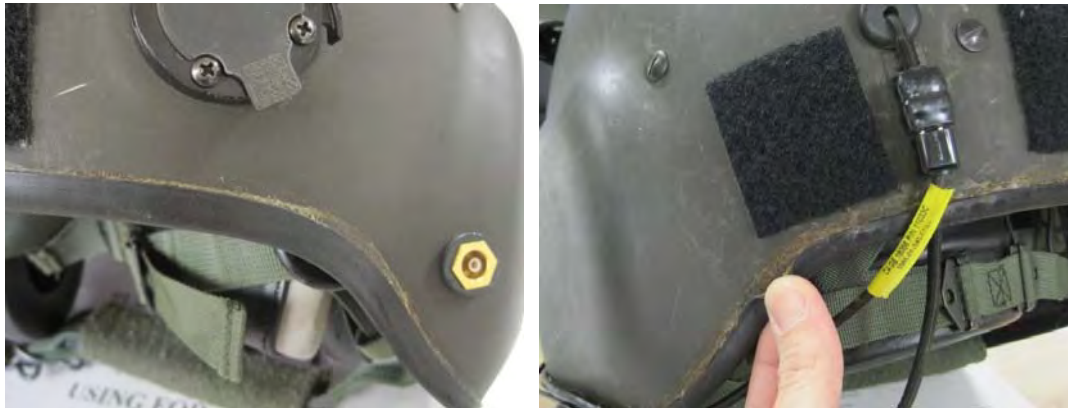
Figure 18. Aviation helmet after 180 days in the field, baseline (left) and alternate (right).

Inspections were conducted at 24 h, 90 days, and 180 days after adhesive application to determine how the products performed over time (appendix B). In each inspection, the alternative adhesive did not show any signs of slippage, delamination, blistering, deterioration, or failure, except for a slight lifting in the curved areas (appendix B). This lifting appeared to be caused by the fast drying time during application rather than failure of the adhesive over time (figure 18). Overall, the inspector concluded that the alternative adhesive (3M-847) worked as well as the baseline (E-1293) if the quick drying time was considered in the application process.
