# FINAL REPORT

Low Temperature Cure Powder Coatings

ESTCP Project WP-200614

October 2010

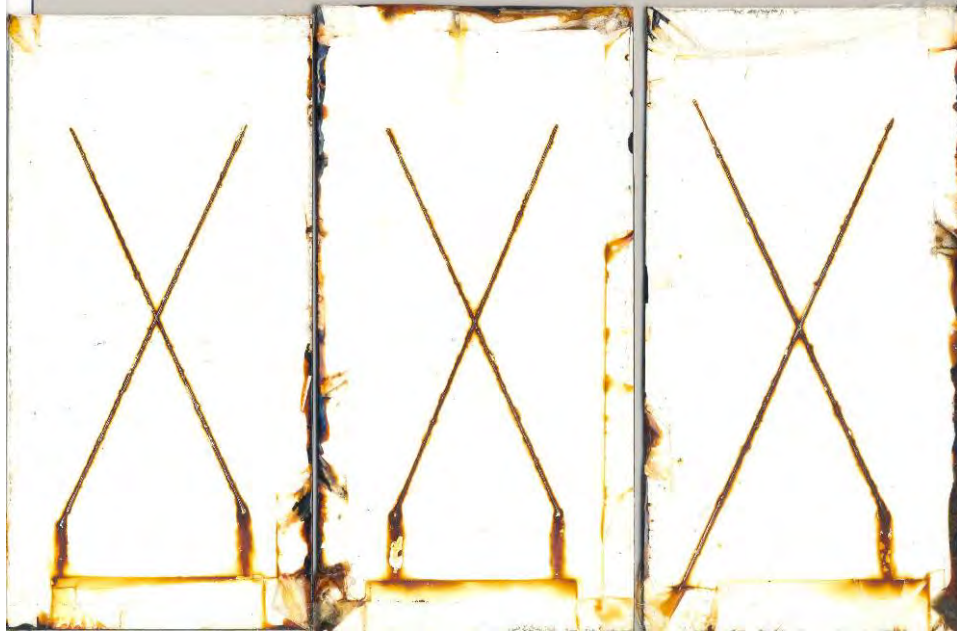
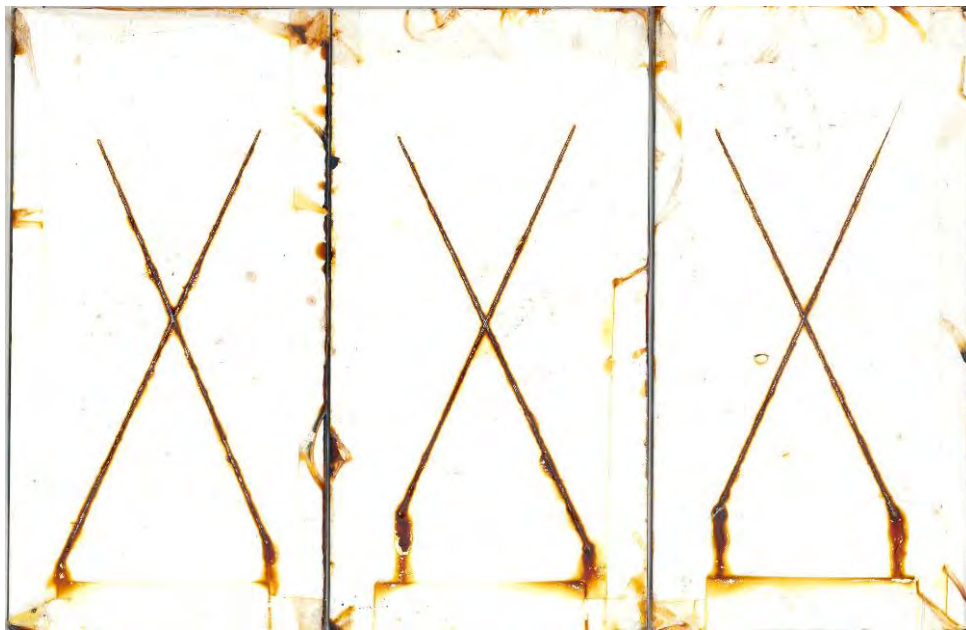
Figures 17 through 22 are of the test coupons following the SO<sub>2</sub> corrosion resistance testing.

SO<sub>2</sub> corrosion resistance test results confirmed that LTCPC performs in a similar fashion as the baseline coating stack-ups when prepared and tested in a production-like environment. Evaluation of the selected aluminum coupons resulted in acceptable SO<sub>2</sub> corrosion resistance (as defined by the JTP) for only the Alodined 2024-T3 LTCPC and control-coated coupons. All remaining aluminum specimens suffered major blistering near the scribed regions. Stakeholder discussion produced a consensus that poor surface pretreatment was likely to blame for the test failures of low copper content aluminum alloys while the 2024-T3 specimens passed. From a

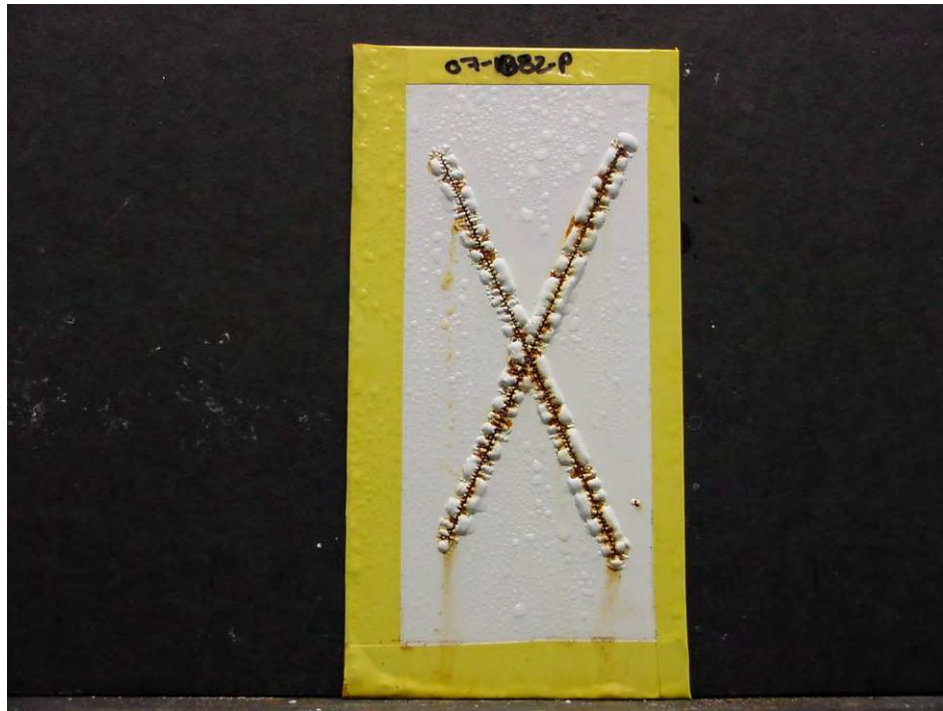
Figures 23 through 26 are of the test coupons following the cyclic corrosion resistance testing.

Overall cyclic corrosion resistance test results confirmed that LTCPC performs in a similar fashion as the baseline coating stack-ups when prepared and tested in a production-like environment. The Alodined 2024-T3 Alclad coupons outperformed the baseline MIL-PRF-

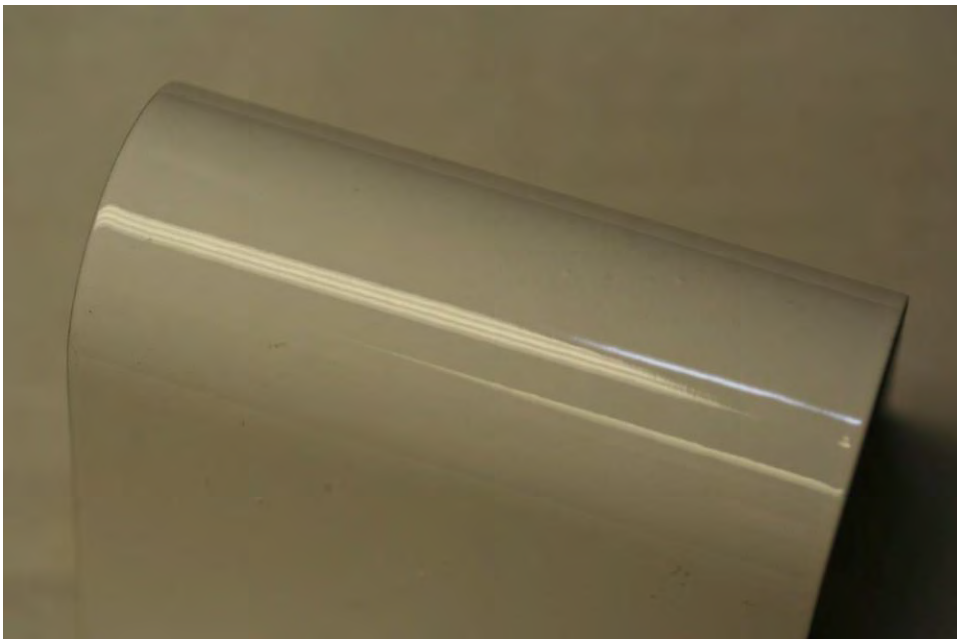
**Figure 38. Acceptable LTCPC Low Temperature Flexibility Outcome**

**Figure 39. Unacceptable LTCPC Low Temperature Flexibility Outcome**

**Figure 40. Control Coating Low Temperature Flexibility Outcome**

Laboratory test results confirm that LTCPC exhibits acceptable low temperature flexibility as measured by the requirements of MIL-PRF-85285. Each control coupon and all but one of the LTCPC specimens passed low temperature flexibility at -60°F. Stakeholder analysis of the failed test coupon identified adhesion failure due to inconsistent coverage of the chromate pretreatment as the most likely source of cracking within the coating.

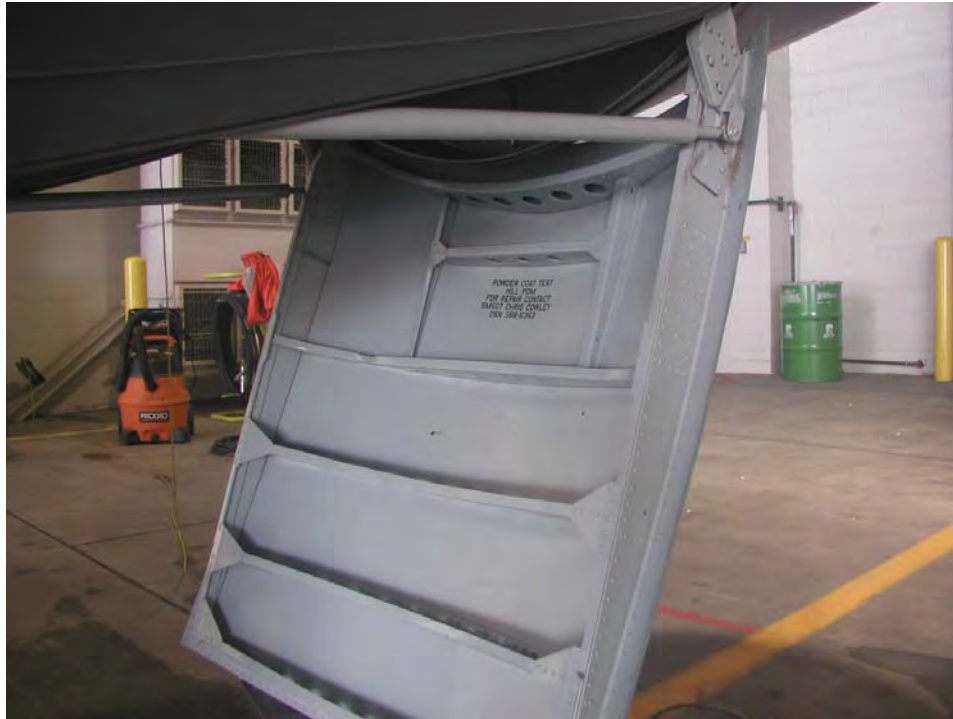
**Figure 50. C-130 Nose Landing Gear Forward Door (AC: 92-1534) After 12 Months of Exposure**

**Figure 51. C-130 Nose Landing Gear Aft Door (AC: 92-1534) After 12 Months of Exposure**

**Figure 52. C-130 Nose Landing Gear Aft Door (AC: 92-1534) After 12 Months of Exposure**

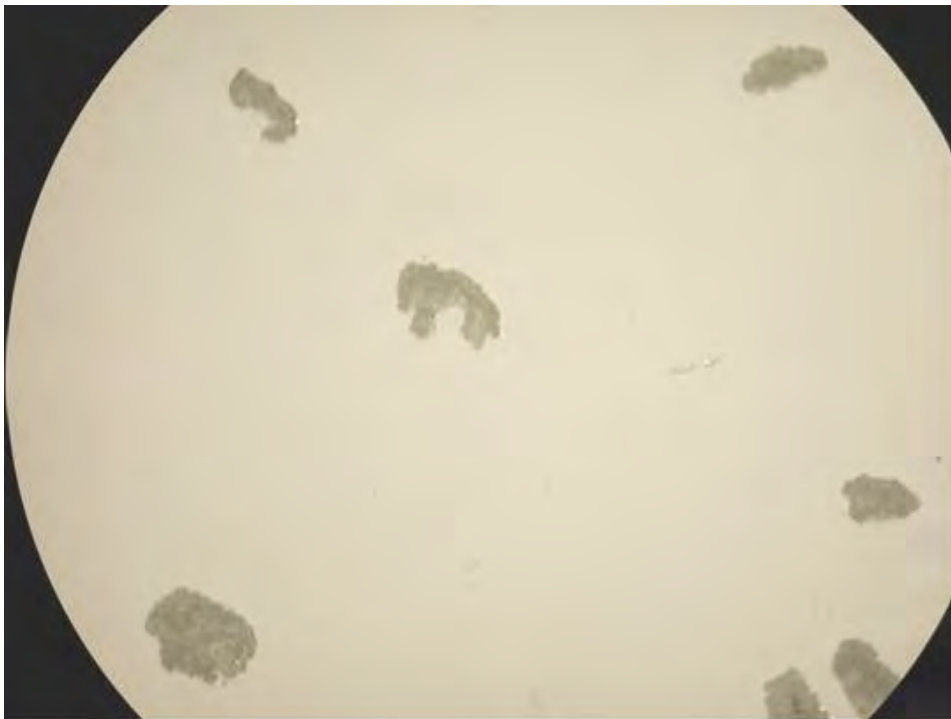
The use of a gravelometer to determine chipping resistance produced specimen coating damage comparable to the two coupons shown in Figures 56 and 57 under 10X magnification.

Chipping resistance tests confirm that LTCPC performance equals or exceeds the results observed for the selected baseline stack-up. The 2024-T3 LTCPC specimens exhibited lower
