FINAL REPORT

Daylight Redirecting Window Films

ESTCP Project EW-201014

Raghu Padiyath
3M Company

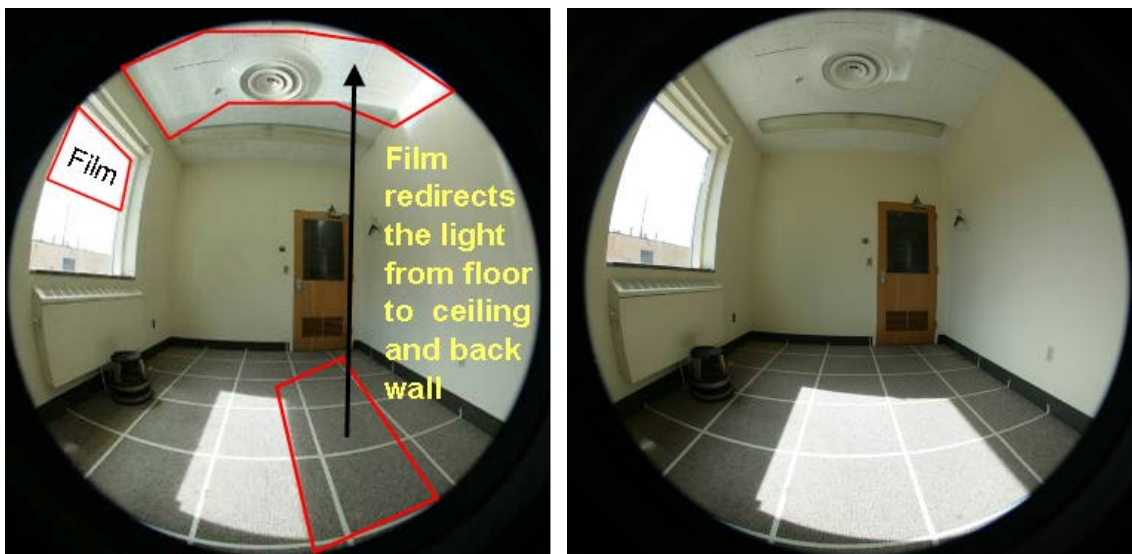
Figure 1. Photographs taken with a fisheye lens demonstrates the effectiveness of the daylight redirecting film.

In Figure 1, the photograph on the left is taken with the daylight redirecting film on the window and one on the right without. The increase in brightness even in the corners of the room is remarkable. As evident from Figures 1 and 2, the light incident on the upper portion of the window is redirected towards the ceiling and the back of the room. It is also clear that the direction and intensity of the redirected light will be a strong function of the factors listed in Figure 2.

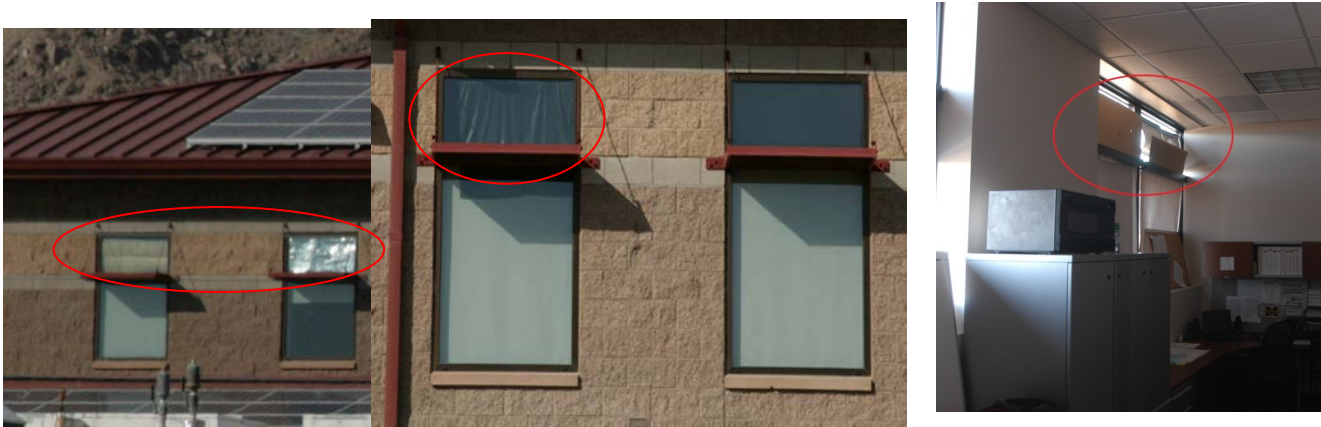
Figure 7. Upper windows blocked with cardboard, paper, dark plastic sheet, foil, etc.

Each window was fitted with a roller blind mounted below the mullion with the metal awning, but no operable shading devices were provided above the metal awning. Thus, direct sunlight entered the spaces from the upper windows. This was clearly a problem for many occupants, as many of them had already taken some action to block this direct sunlight, placing cardboard or aluminum foil in the upper windows (Figure 7).

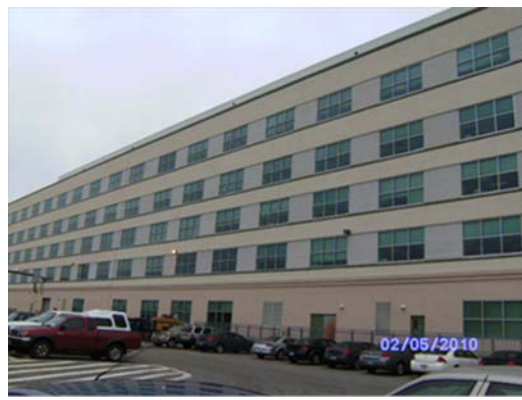
Figure 7. Building Z-133 from the south east (study area 4th floor)

Building Z-133 is a five story facility used primarily as administrative office space for base personnel. The building is more than forty years old, and was recently retrofitted with new windows. The building's front entrance is orientated due North (Figure 20), with the study spaces on the south facing façade (Figure 7). The final study spaces used were open offices; the six (6) west-most bays of south-facing facade were treated with the DRF product and the nine (9) east-most bays were used as the control spaces. No exterior obstructions block direct sunlight from reaching any of the study area windows. Perforated horizontal mini-blinds were installed on all windows for sun control, and observed to be generally deployed over the upper 1/2 or 2/3 of the windows (Figure 8). A 24” deep white counter runs continuously at the bottom of the windows, and along with 6” deep window recesses, which acts as a reflector of some sunlight into the space (see Figure 9 and Figure 10).

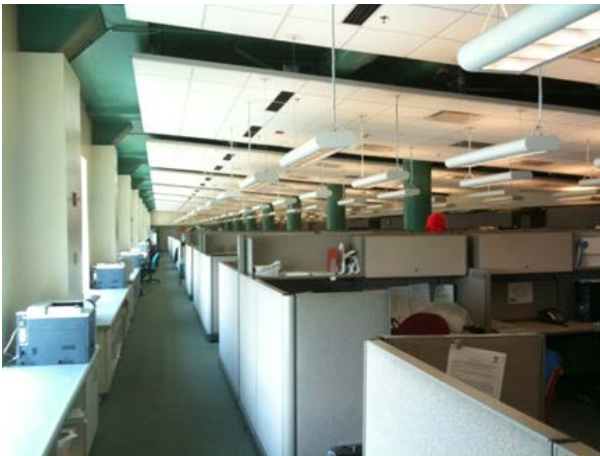
Figure 9. Open office plan - Norfolk

The open office area (Figure 9) is 48' deep with a sloped ceiling designed to disperse light down into the cubicle workstations. The sloped ceiling starts at 12' above finished floor (AFF) near the windows slopes down to 8' AFF at the rear of the cubicle area. The study space windows (Figure 10) consisted of groups of 3 double pane fixed windows per bay, for a total of 18 bays in the open office area. The DRF was applied in the upper panes, from 6' AFF to 9' AFF. The retracted blinds blocked the top 6" of this area. In Figure 10, two upper panels on left are treated with DRF while the panel on right of upper window is untreated.

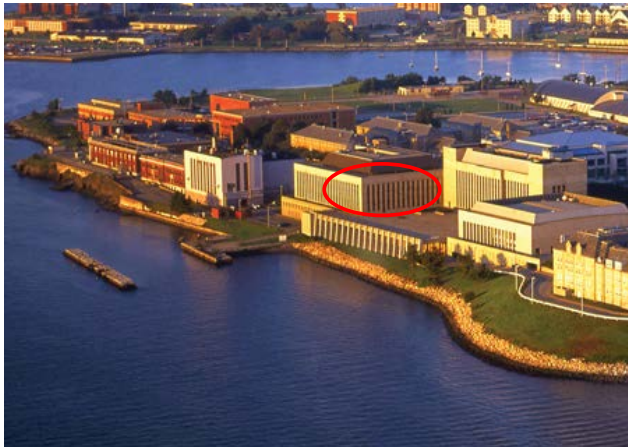
Figure 11. Hewitt Hall, study area circled in red.

Hewitt Hall (Figure 11) is a four story building that houses the colleges’ library and professors’ offices and was used for both the pilot and main study. The building’s entrance (Figure 12) is oriented approximately due east, and the study spaces were located on the west and south facades of the building. The building is over fifty years old.

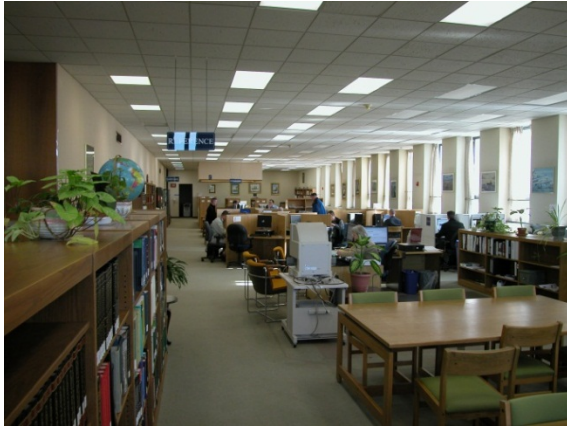
Figure 13. Library, South facing windows

There were two types of study spaces: a section of the second floor library (Figure 13) oriented primarily to the South, with a corner that also included western exposure; and private offices (Figure 14) located on either the second or third floors also oriented South, plus one pair of offices oriented to the West. Windows (Figure 15) in the study spaces were 8' high x 4' wide, mounted 3' above the floor, and flush with the 11' high ceiling (Figure 15). The top 6' consisted of inwardly opening casement windows, and the bottom 2' x 4' section non-operable, both with clear, double pane glass.

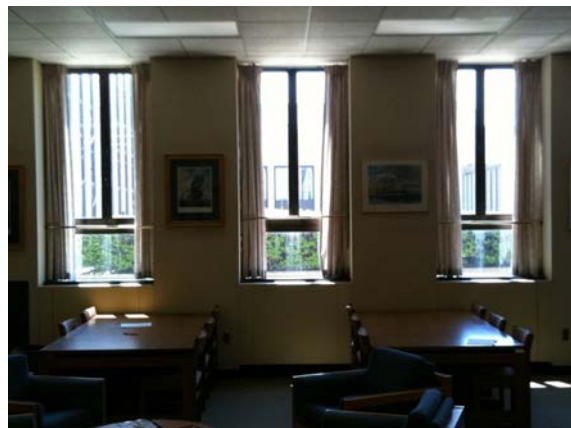
Figure 15. Library, Window geometry

4'-5' tall book stacks. Furniture (Figure 15) is located on the perimeter of the space near the windows and in the center of the study space with a walkway on each side. The south and west facing walls are white, and the back wall is cream in color. The electrical lighting system consisted of recessed 2x4 lensed troffers. The two rows of fixtures nearest the windows were operated on photocontrols. Other lights were left on whenever the space was open.

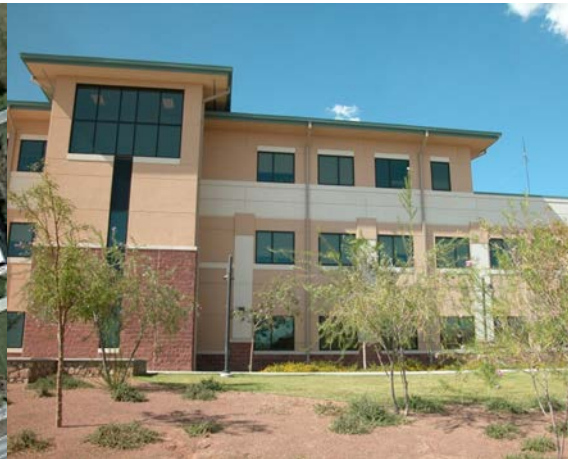
Figure 17. Building 20400, study windows (2nd floor)

Building 20400 is a three-story office building with the front entrance orientated south-east (approximately 170 degrees from due North) (Figure 16). Study spaces are located on the second floor and consisted of private and open office plans on the south-east façade (Figure 17). Façade faces 20 degrees east of south. The building is less than five years old.

While the climate conditions make this site an ideal location for a daylighting retrofit, the specifics of the building do add to some complications in evaluating the full potential of the DRF technology. The roof overhang (see Figure 17) creates shading of the study windows in the summer time, and the central tower created morning shading for the control area to the west, and afternoon shading to the study area to the east.

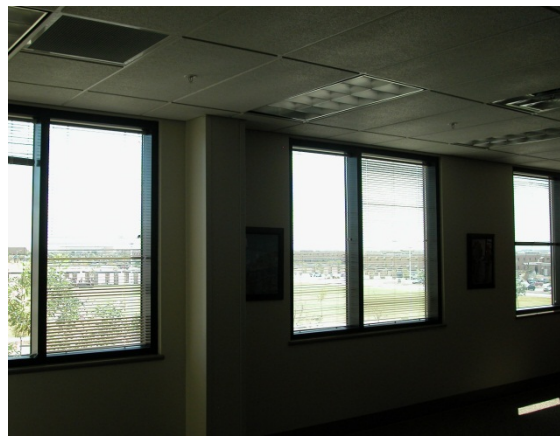
Figure 19. Interior window geometry

For the open office spaces (Figure 18), the six bays of windows in the eastern wing of the building were treated with the product while the western wing was used as the control space. For the private office area, alternating perimeter offices in the east and west wings were treated with film in six of the twelve offices. Windows (Figure 19) are dual-glazed low-E with approximately 40% visible light transmittance. Windows are non-operable and approximately 2' wide and 4' high. Ceilings in the open and private office spaces are approximately 8' high with white t-bar dropped ceilings.

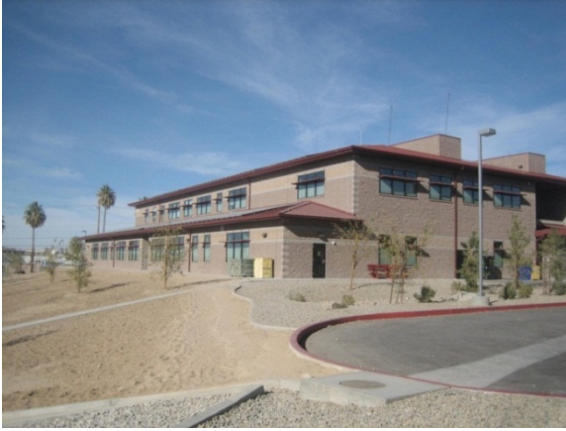
Figure 20 Building 1416, south corner

Building 1416 (Figure 20) is a two story facility containing administrative offices and medical offices in the form of a battalion aid station (BAS) which are part of this training facility used by the Marine Corps. This site participated in both the pilot phase and the final phase of the study as outlined in Section 5.

window and a 2' high daylighting section above, separated by a grated metal awning to shade the exterior of the lower window (see Figure 23). Some rooms had only one such window, others had groups in two or three, on one or more facades (see Figure 20). The windows on the second floor also received some shading in the summer from the roof overhang.

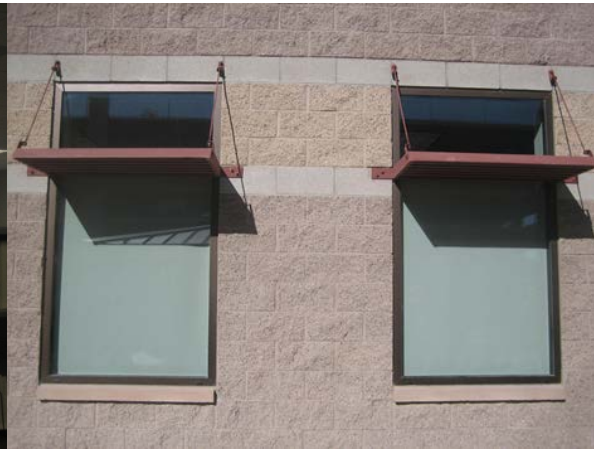
Figure 23. Exterior window geometry

The study spaces are occupied by two Marine Corp battalions undergoing training which are rotated at least annually; consequently, there is little continuity in staff or occupancy. The windows in each space are sets of 4' x 7', non-operable double pane, high visible transmittance (VT), aluminum framed windows. Each window has a 5' high view

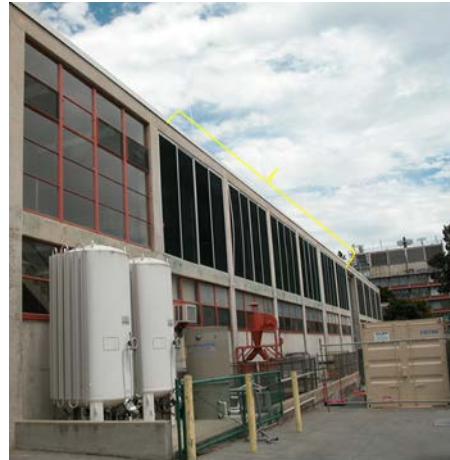
Figure 26. Halligan Hall, southwest-facing

Halligan Hall (Figure 25) is a two-story building built in the 1950s with the front entrance oriented to the northeast (approximately 80 degrees from due north). The study spaces are located on the southwest-facing façade (see Figure 26) and have black shade screens installed on the exterior of the windows. The building has two nearby buildings providing some late afternoon shading.

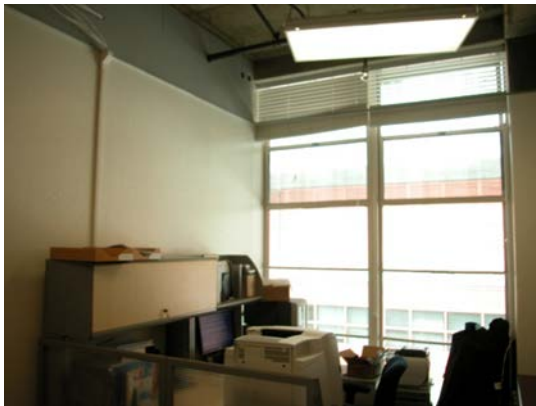
Figure 27. Window geometry

Eight private offices (Figure 27) were selected for the study; each containing two to three people and measuring 10' wide by 20' deep with southwest-facing windows. All offices have 10' high ceilings with an HVAC unit hanging from the ceiling near the door and

Office windows were made up of five single-pane floor to ceiling windows (Figure 27). One of the window panes, the second from the top, is an inward operating hopper window. With no central air conditioning in the building, these hopper windows are frequently opened. Black shade screens had been retrofitted some years ago on the exterior of all windows to reduce afternoon heat gain and glare (see Figure 28). Some of these were removed during the study.

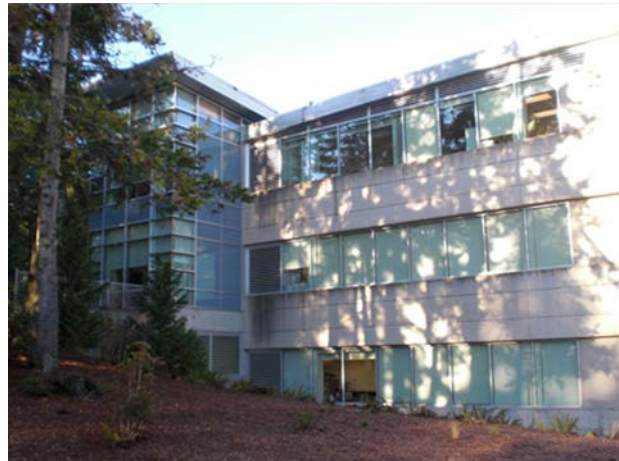
Figure 30. Study areas located on top two floors

The Naval hospital is a three story building with the front entrance orientated to the southeast (approximately 20 degrees from due East) (Figure 29), with the study spaces located in the south-east wing (Figure 30) on the second and third floors. The study spaces experience some shading from nearby vegetation (see Figure 30), and afternoon shading from the western wing of the building. The building is less than ten years old.

occupied, reducing the clarity of the view and the presence of daylight (see Figure 30). In the treated study rooms, 1” cream colored blinds were installed below the DRF. Occupants were instructed not to operate the blinds and leave down for patient privacy.

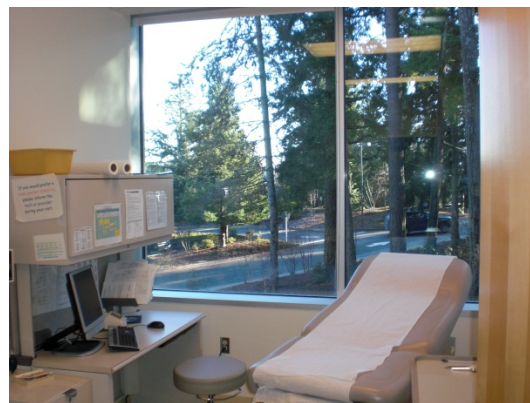
Figure 31. Office layout and window geometry

The study spaces (Figure 31) consist of six private medical offices with intermittent occupancy, by various, rotating medical staff. All rooms are approximately 10' deep by 10' wide, with 9' high dropped ceiling. Offices contained non-operable, dual-glazed bronze anodized windows. Windows are 5' by 7'6" on average with a sill height of 30". Since the windows are continuous along the façade and the office layout does not always match the window sizes, the amount of window area per room varies.

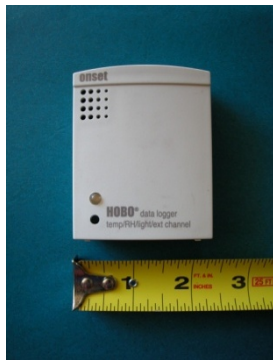
Figure 35. HOBO U12-12 for interior illuminance monitoring¹

The research team utilized off-the-shelf monitoring equipment. Interior illuminance was monitored with HOBO U12-12 loggers (Figure 35); outside illuminance was monitored with HOBO UA-002-64 loggers (Figure 36). In addition, a hand-held illuminance meter, a Minolta T-10, was utilized during site visits to obtain real-time illuminance readings. Time of illuminance readings were recorded so that they could be compared to data from the HOBO loggers to assess accuracy. Lighting circuits and blinds were monitored with DENT Lighting Loggers or Pacific Scientific Technology Lighting Loggers.

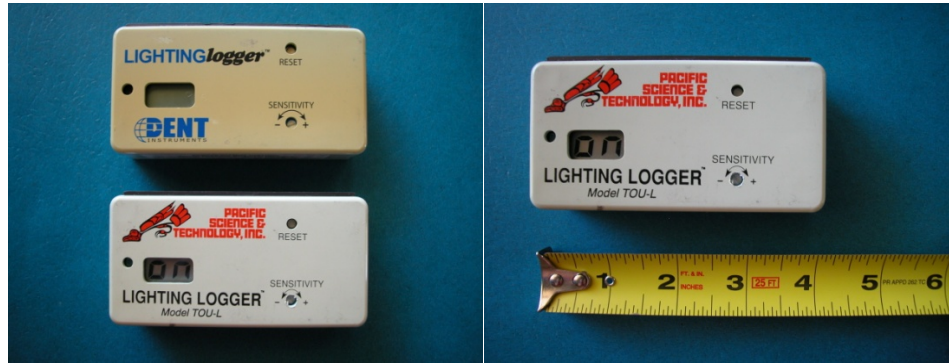
Figure 37. Lighting Loggers for lighting and roller shade monitoring.

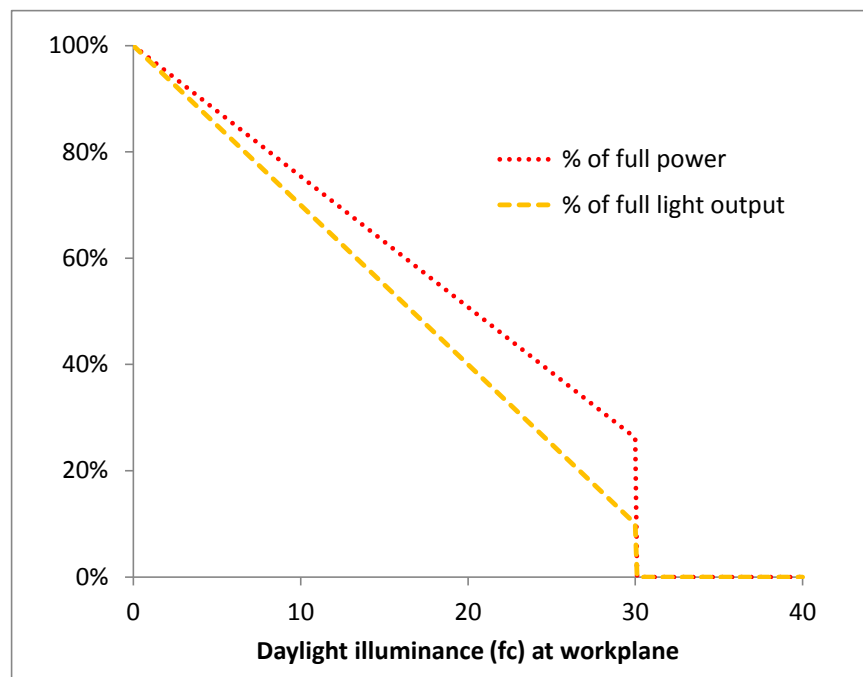
Figure 42. Simulated dimming system energy consumption and light output.

Dimming photocontrols were modeled for this assessment. The dimming strategy modeled in this report is pictured in Figure 42. This system turns off once the target illuminance is reached to maximize energy savings. This type of system generally provides optimal daylight energy savings. Note the difference between light output and power consumption: fixture efficiency declines at lower light output levels due to loads within the ballast.

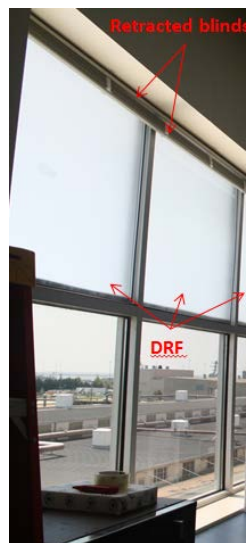
Figure 73. DRF installed on top three panes, Blinds retracted to top of treated window

Secondly, due to existing window geometry, with a center dividing mullion, the film was mounted above the center mullion, starting at 6’ above the floor (Figure 73). This mounting height is lower than recommended, as it is more likely to bring redirected sunlight within eye level to the back or sides of the space, creating more potential for glare problems.

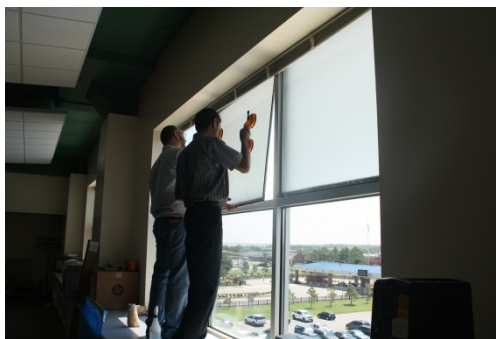
Figure 74. Magnetic frame attachment for DRF application

As discussed earlier, the facility manager at Norfolk was particularly concerned about mounting anything to the frame of the existing windows. As a result, the blinds were not relocated, and the film was installed using a magnetic frame attachment (Figure 74). This type of concern for not wanting any un-reversible changes to a space is a likely barrier to retrofitting spaces with the DRF, and should be addressed in future product attachment options.

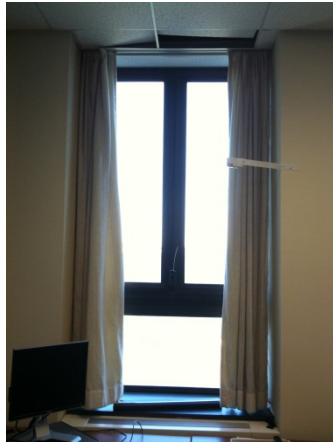
Figure 88. Private office, curtains fully open

hung from the top of the windows. The curtains were never relocated, or removed, in the eight study offices. In the offices, the windows were capable of being opened throughout the study, but it is believed that they were only operated during the summer and early fall months. In addition, even when fully open the curtains still blocked approximately 25% of the glazing as seen in Figure 88.

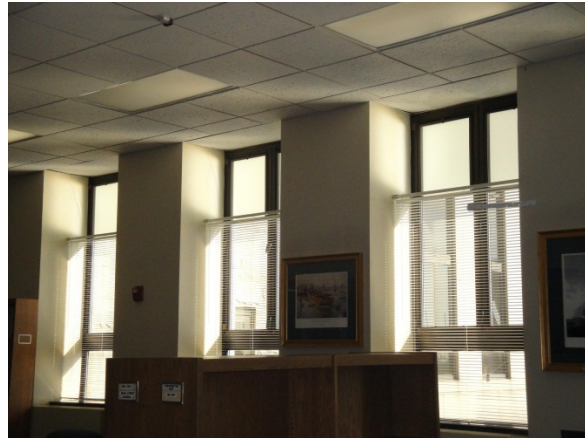
Figure 89. Library, blinds installed below DRF

In the library, the curtains were removed in anticipation of installing horizontal mini-blinds below the DRF film application as seen in Figure 89. However, there was a period of over two months before the new blinds were installed. Thus, the library data is broken into three periods: 1.) ‘Pre’, before the DRF was installed, with curtains; 2.) ‘Post-w/o blinds’, after the DRF was installed, but with no window coverings; and 3.) ‘Post-blinds’, after the DRF was installed, and with horizontal blinds below the film. Unfortunately, these three periods spanned different seasons (summer, fall, winter); therefore, the angles of the sun and the performance of the DRF is very different. Once the horizontal blinds were installed, the casement windows could no longer be opened more than a crack. However, the project team was told that the windows in the library were never operated.

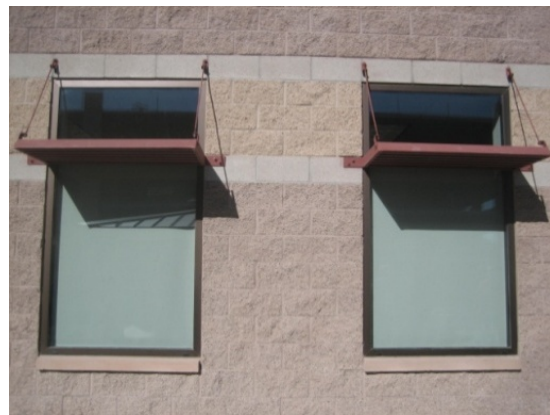
Figure 103. Window exterior, showing shading

Figure 102 illustrates how the roller blinds were mounted below the upper mullion and exterior shading device (Figure 103), leaving the upper portion of the window unshaded. Direct sunlight could come into all the windows, often at a very low sun angle. Some occupants had tried to block these upper windows with cardboard or aluminum foil. This problem created by the unshaded upper windows on the southeast and southwest facades, with their high VT glass, also created a perfect opportunity for application of the DRF.

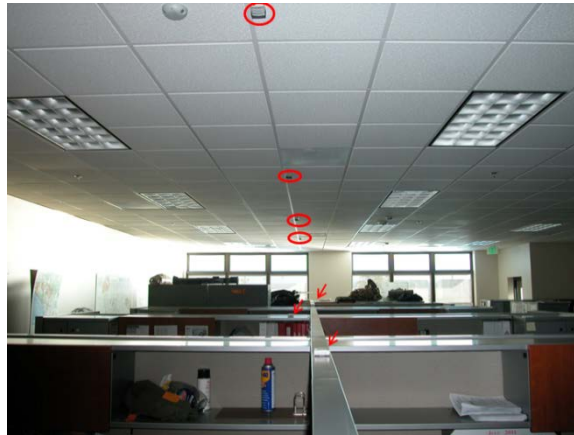
Figure 104. Open office, Ceiling (circled) and Partition (arrows) locations

Monitoring at Twentynine Palms, CA took place from July 2011 to June 2012. The first six months, July 2011-December 2011, were part of the pilot period. The monitoring period captured a full year’s worth of sun angles. However, the data analysis from the monitored data revealed a problem: the location of the ‘workplane’ loggers (see Figure 104) on top of the high partitions resulted in very spotty and unreliable data. Many sensors were covered, moved, disabled, or lost. Furthermore, a number of ceiling sensors fell off and/or stopped recording for extended periods for unknown reasons. Thus, there was not sufficient data to establish clear patterns of performance, or support rigorous analysis.
