RM No. A7A15

FLIGHT-TEST MEASUREMENTS OF AILERON  
CONTROL SURFACE BEHAVIOUR AT  
SUPERCRITICAL MACH NUMBERS

Ames Aeronautical Laboratory  
Moffett Field, Calif.

April 23, 1947

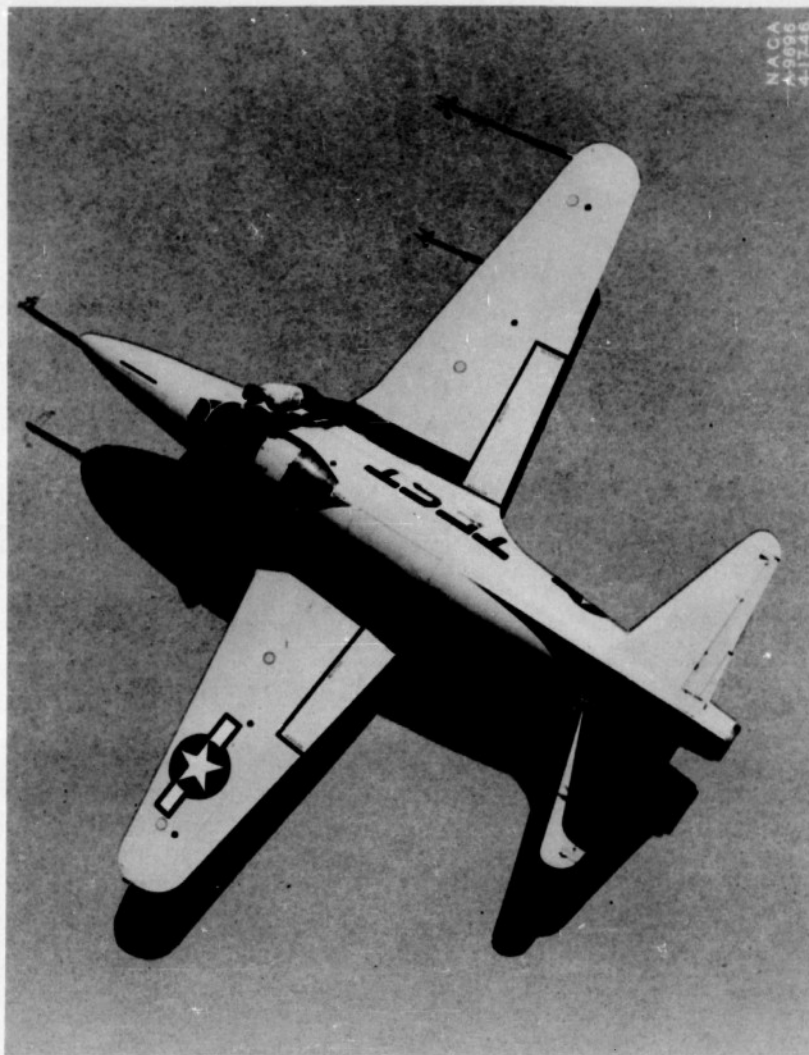
Figure 3.- Plan view of the test airplane as instrumented for flight tests.

The tests were conducted on the turbojet-propelled fighter airplane shown in the three-view drawing. (See fig. 1.) Figures 2 and 3 are side-view and plan-form photographs, respectively, of the airplane as instrumented for flight tests.
