NATIONAL ADVISORY COMMITTEE FOR AERONAUTICS

THE RUPTURE TEST CHARACTERISTICS OF SIX PRECISION-CAST  
AND THREE WROUGHT ALLOYS AT 1700° AND 1800° F

By J. W. Freeman, E. E. Reynolds, and A. E. White  
University of Michigan

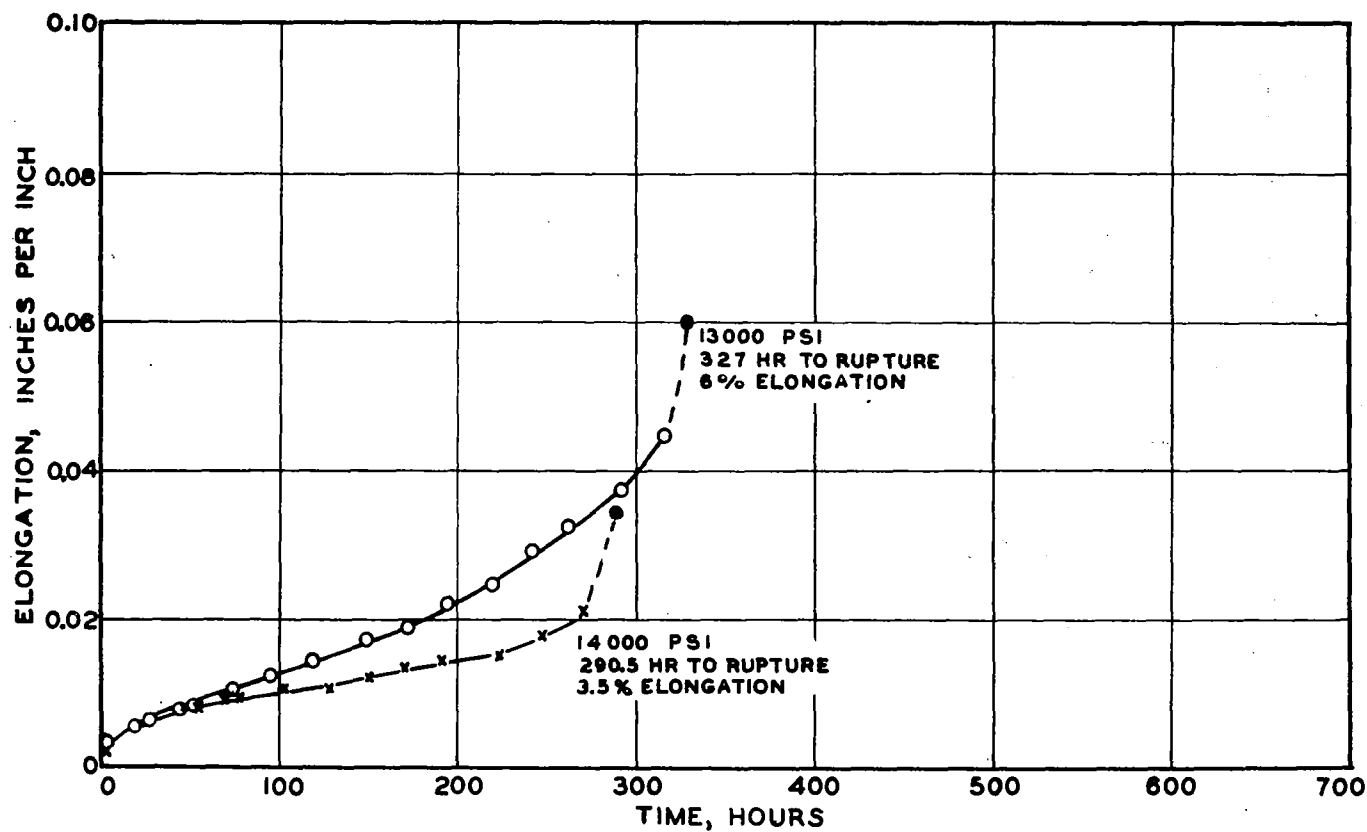
FIGURE 31.- TIME-ELONGATION CURVES FOR RUPTURE TESTS AT 1700° F ON PRECISION-CAST S816 ALLOY.

The time-elongation curves (figs. 14 through 36) offer additional information regarding the deformation characteristics of the alloys. In some cases high total elongation was associated with high rupture strength even though the deformation rate was faster than in other alloys with lower total elongation to fracture. Alloy X-40 (fig. 33), in comparison with X-50, 422-19, and cast S816 at 1700° F (figs. 35, 25, 31) are examples. In general, the deformation rate of the cast specimens decreased or remained constant during most of their life. The wrought specimens underwent increasing deformation rates from the beginning of the tests. As is usual, the specimens with low total elongation generally had low rates of deformation and short periods of so-called first-stage creep.

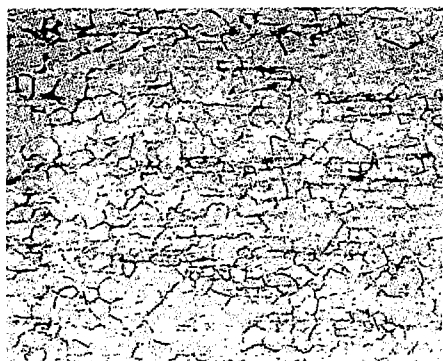
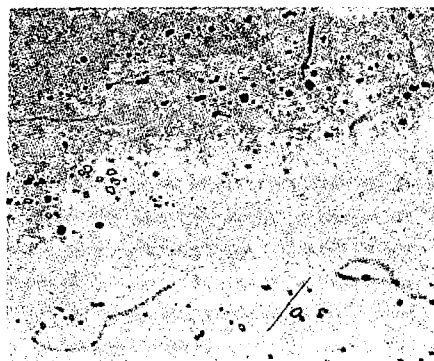
- (a) Original Microstructure.  
Aqua Regia in Glycerine etch - Vickers hardness 201.

- (b) 516 hours for rupture at 1700° F under 5500 psi.  
Electrolytic Chromic acid etch - Vickers hardness 199.

- (c) 415 hours for rupture at 1800° F under 3500 psi.  
Electrolytic Chromic acid etch - Vickers hardness 201.

The higher rupture strength of solution-treated Low-Carbon N155 alloy was associated with a larger grain size, fewer precipitated particles in the grain boundaries, and a more uniform distribution of excess constituents than in the weaker hot-rolled samples. (See figures 37 and 38.) Reprecipitation during testing probably resulted in a distribution of particles more favorable to rupture strength than existed in the hot-rolled condition. After rupture-testing, the hot-rolled specimens showed evidence of considerable oxygen penetration by the presence of easily etched areas near the fracture and along the surface of the specimens. The oxidation resistance apparently was increased by the solution treatment with a consequent improvement in properties.

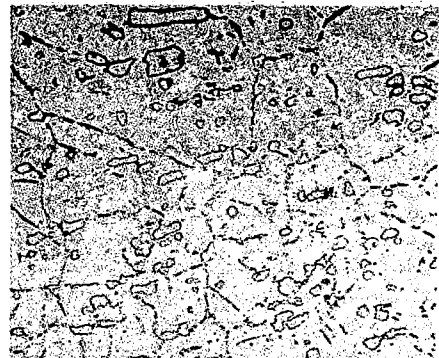
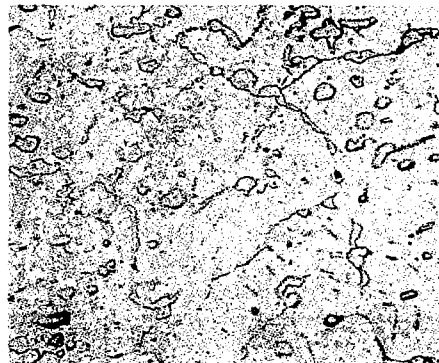
(a) Original microstructure.  
Electrolytic Chromic acid etch - Vickers hardness 231.

(b) 374 hours for rupture at 1800° F under 4200 psi.  
Electrolytic Chromic acid etch - Vickers hardness 216.

FIGURE 40.- MICROSTRUCTURES OF WROUGHT S590 ALLOY WATER QUENCHED  
FROM 2270° F AND AGED 16 HOURS AT 1800° F.

There seemed to be little relationship between structure and rupture strength in the case of wrought S590 and wrought S816 alloys. (See figures 39 through 42). The S590 material had lower short-time rupture strengths and higher long-time rupture strengths than S816 alloy. Aging S590 at 1700° F produced heavy general precipitation; while aging at 1800° F agglomerated the precipitates to a considerable extent. Relatively little general precipitation occurred in S816 after aging at 1700° F and a large amount after 1800° F. On the other hand, the rupture specimens of S590 alloy did not show so much agglomeration as did those of S816 alloy. The precipitated constituents in S590 may have contributed to the long time strength of the alloy through greater stability.
