SINGLE-CYLINDER ENGINE TESTS OF POROUS CHROME-PLATED  
CYLINDER BARRELS WITH SPECIAL BORE COATINGS  
FOR RADIAL AIR-COOLED ENGINES

NACA ARR No. E5L18a

ADVANCE RESTRICTED REPORT

By Robert L. Johnson and Roy I. Anderson

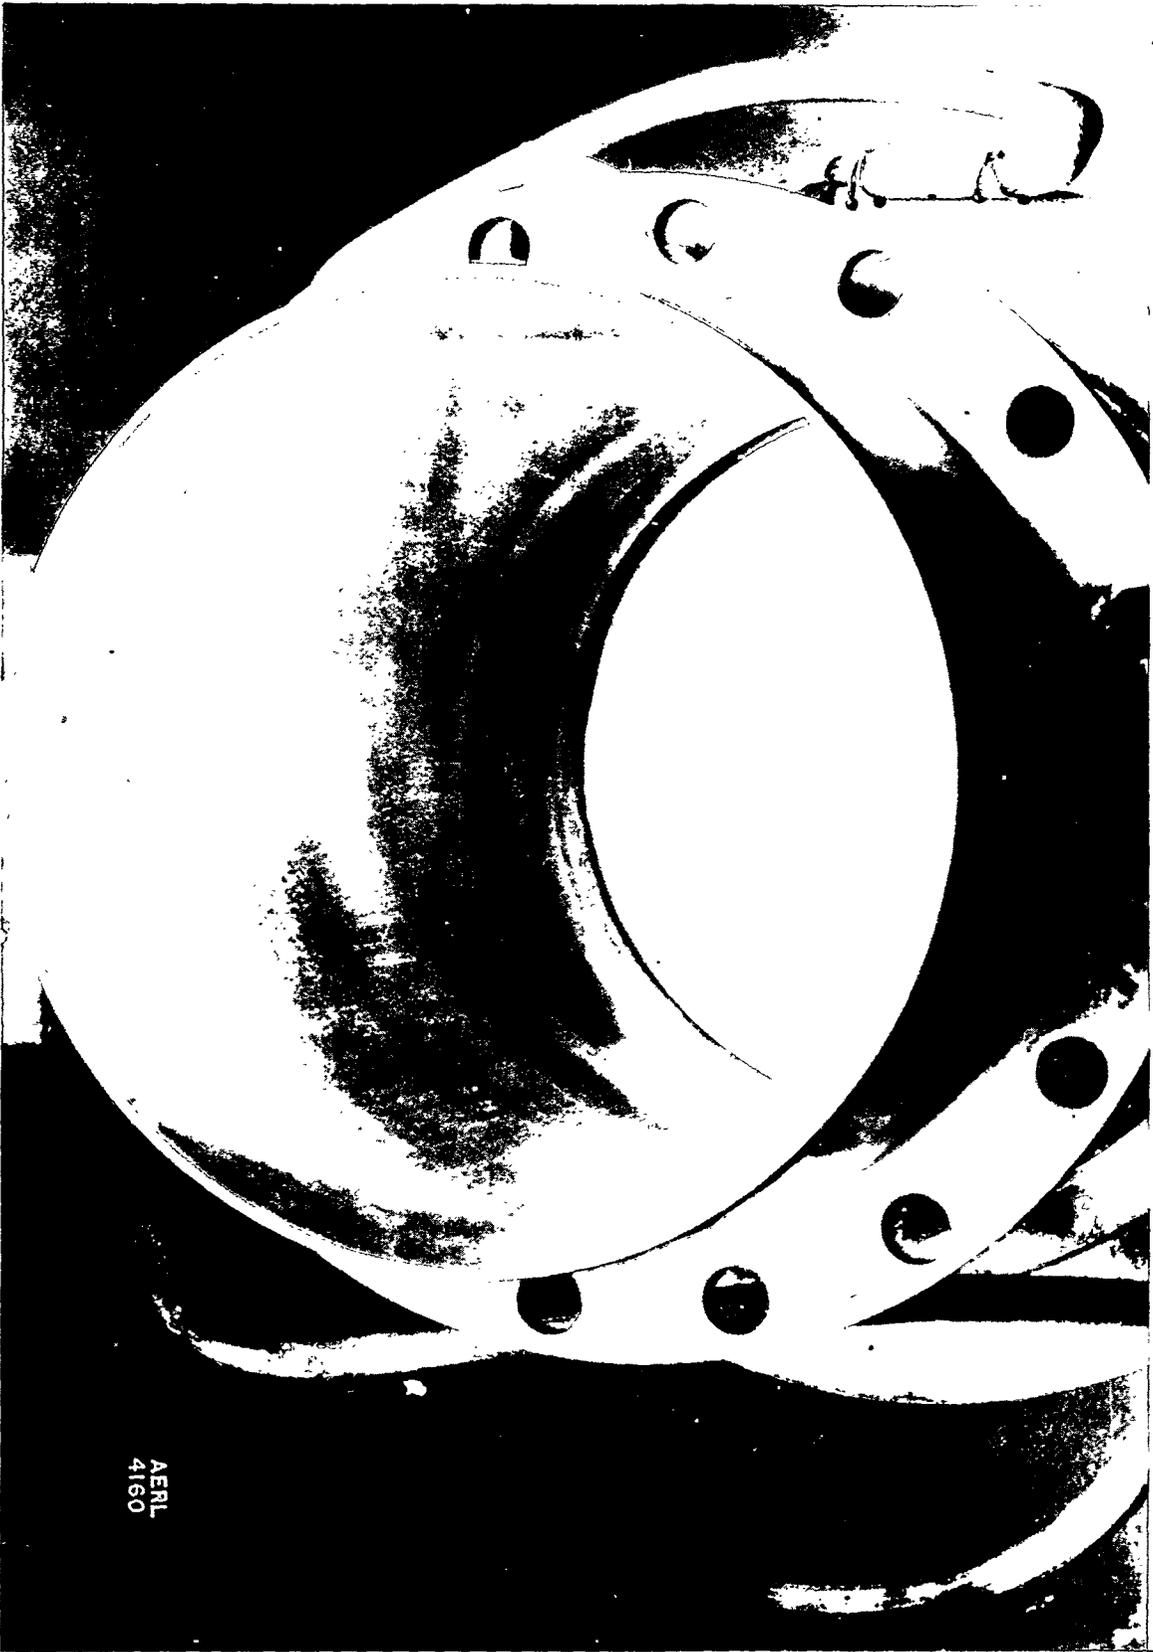
Figure 9. - Downstream face of choke-bore porous chrome-plated cylinder barrel with a silver overplate. Condition after test 8.

areas in which the silver did not completely adhere. The irregularity of the appearance of the bore shown in figure 9 does not indicate harmful operating characteristics. This observation is substantiated by figure 10, which shows the piston assembly run in test 8; the assembly is considered to be in very good condition.
