DEVELOPMENT OF THERMAL ICE-PREVENTION EQUIPMENT
FOR THE B-17F AIRPLANE

By Alun R. Jones and Lewis A. Rodert

Ames Aeronautical Laboratory
Moffett Field, California

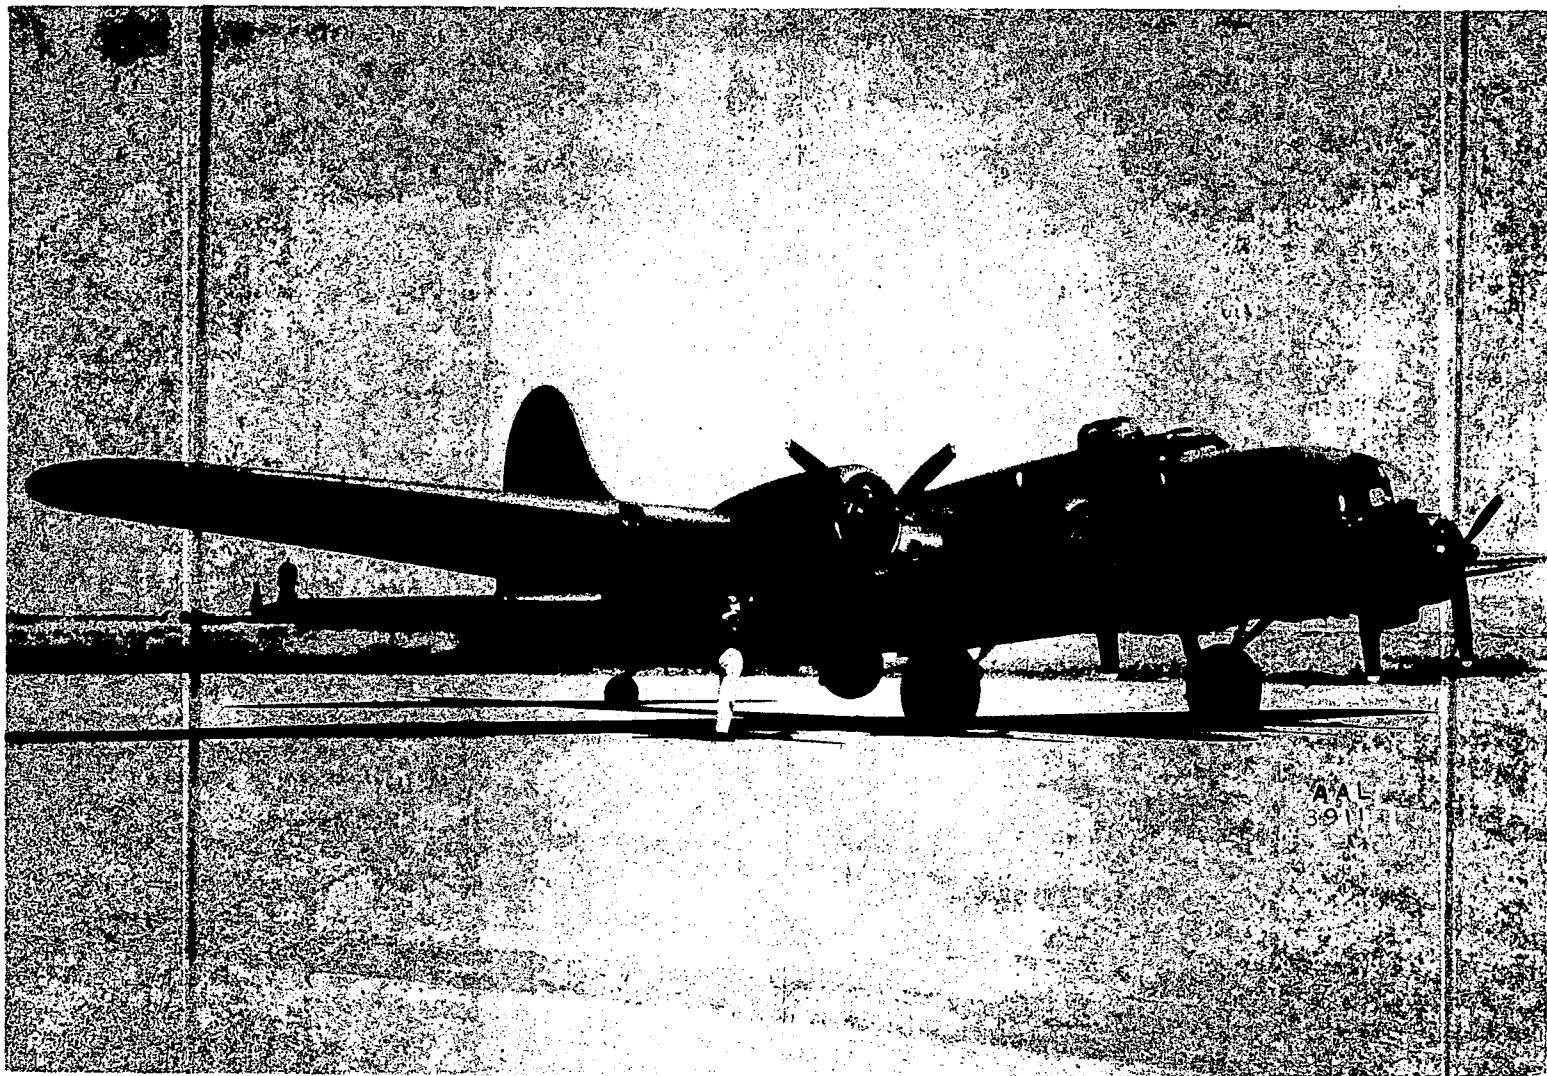
Figure 1.- The B-17F airplane in which thermal ice-prevention equipment was installed and tested.

The B-17F airplane is shown in figure 1. The airplane is a midwing monoplane of the heavy bombardment type, powered by four Wright model R-1820-97 engines, having a sea-level rating of 1000 horsepower. Each engine is equipped with an exhaust-driven type B-2 turbosupercharger.

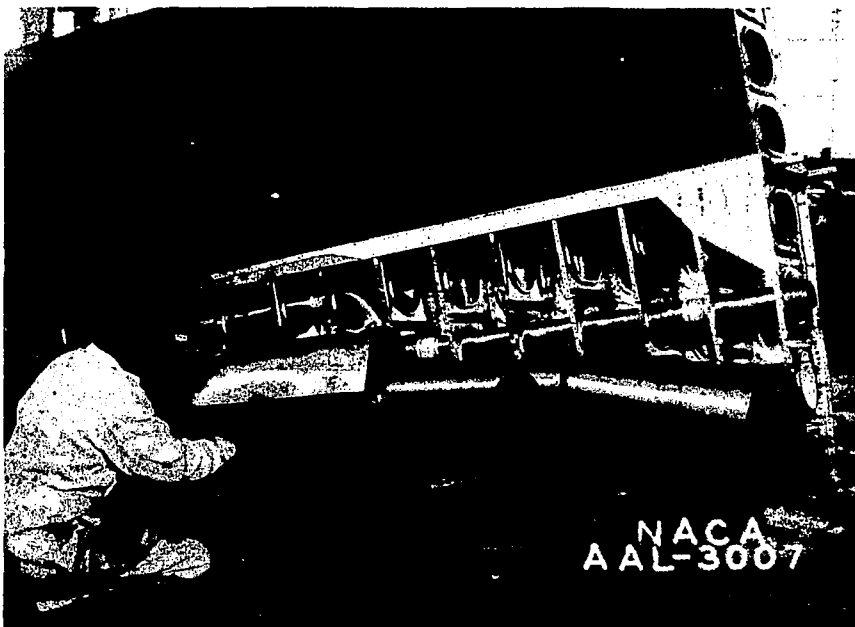
Figure 15.- Heated-air supply duct in inboard portion of horizontal stabilizer, B-17F airplane.

spanwise bulkhead aft of the slotted tubes. Details of the stabilizer ice-prevention installation are shown in figures 15 and 16. For the entire empennage design, the outer skin of the leading edge covers approximately the same surface area as that originally occupied by the rubber de-icers.
