FINAL TECHNICAL REPORT <sup>L</sup>

EVALUATION OF PRINCIPAL FACTORS  
FOR OBTAINING DUCTILE HOT-HARD  
MICROSTRUCTURE ELECTROPLATE FOR CANNON

September 1, 1948

BATTELLE  
MEMORIAL INSTITUTE  
505 King Avenue  
COLUMBUS 1, OHIO

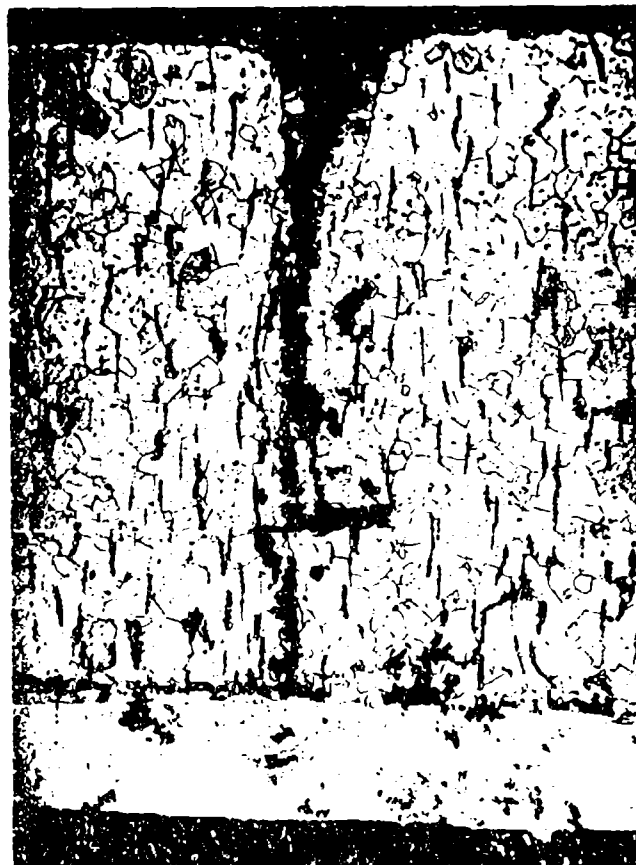
Figure 8. Hard chromium annealed at  $1100^\circ\text{C}$ . for 12 hours. Grains have now become nearly equi-axed. Inclusions are clearly shown to be in original positions with no evidence of migration into grain boundaries. Note the nitride penetration along the large vertical crack in the plate.

This section of the report presents Figures 6, 7, and 8, which show additional data on recrystallization of conventional hard chromium plate at elevated temperatures.
