**AFRL-RH-WP-TR-2015-0041**

**Biodynamic Assessment of Pilot Knee-Board Configurations  
During Simulated T-38 Catapult Acceleration**

**April 2015  
Interim Report**

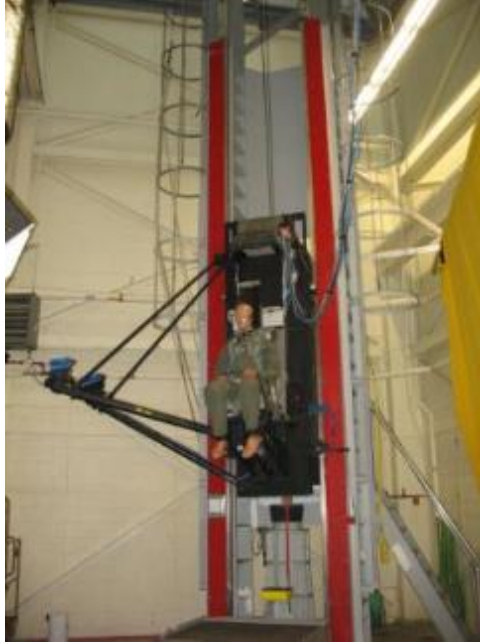
**Figure 1. 711<sup>th</sup> HPW VDT Tower Facility used for Kneeboard Dynamic Testing**

The 711<sup>th</sup> HPW VDT located in Bldg. 824, WPAFB OH was used for all the impact tests conducted for this test effort. The VDT facility is composed of a 50 ft. vertical tower composed of two vertical steel rails and a drop carriage (Figure 1). The carriage is allowed to enter a free-fall state (guided by the rails) from a pre-determined drop height. A plunger mounted on the rear of the carriage is guided into a cylinder filled with water located at the base and between the vertical rails. A +Gz acceleration pulse is produced when water is displaced from the cylinder by the carriage-mounted plunger. The pulse shape is controlled by varying the drop height, which determines the peak G-level, and by varying the shape of the plunger, which determines the rise time of the pulse. A Mk series ejection seat was mounted in a +z-axis impact orientation on the front vertical surface of the VDT drop carriage (Figure 2).

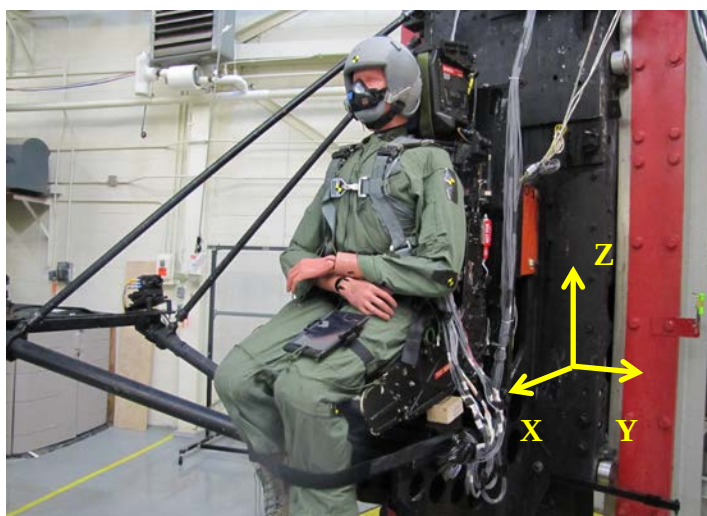
**Figure 3. VDT Facility with Seat and Manikin Showing Impact Coordinate System**

The positive axis of the coordinate system for the test configuration for this program is defined with respect to the orientation of the manikin positioned in the seat mounted to the VDT carriage. The coordinate system is shown for this test configuration in the Figure 3 below.

The accelerometer and load transducer coordinate system for the VDT seat fixture in the three orthogonal orientations were shown in Figure 3. The coordinate system is right-hand rule with the z-axis parallel to the spine of the manikin or the seat back, and with positive being up towards the head of the manikin. The x-axis is perpendicular to the z-axis and points outward away from the chest of the manikin or the face of the seat fixture. The y-axis is perpendicular to the x- and z-axes according to the right-hand rule. The manikin coordinate system used was an inverted SAE J211 system (The moments were reverse from the SAE J211 system). Flexion (head rotation forward) was measured as positive, and extension (head rotation rearward) was measured as negative. Compression on the neck load cell and the lumbar load cell was positive, and tension was negative. Flexion of the femur down (relative to the seat pan) was measured negative, and flexion of the femur up away from the seat pan was measured positive.

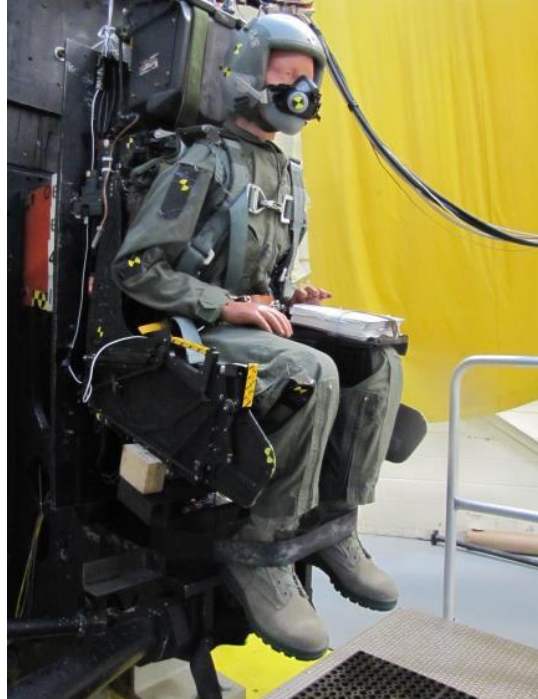
**Figure 4. Position of Kneeboard on LOIS Manikin's Left Leg Prior to Impact**

The 12 FTW at JBSA-Randolph, TX supplied both sets of kneeboard configurations used for this comparative risk assessment. These configurations consisted of the currently authorized kneeboard with paper in-flight guide and checklist weighing approximately 3.0 lbs, and the proposed EFB composed of the iPad Mini and a cover case weighing approximately 1.5 lbs. These weights also included the Velcro straps systems used to restrain each configuration on the leg. The current kneeboard and the proposed EFB configurations are shown in Figure 4 and 5.

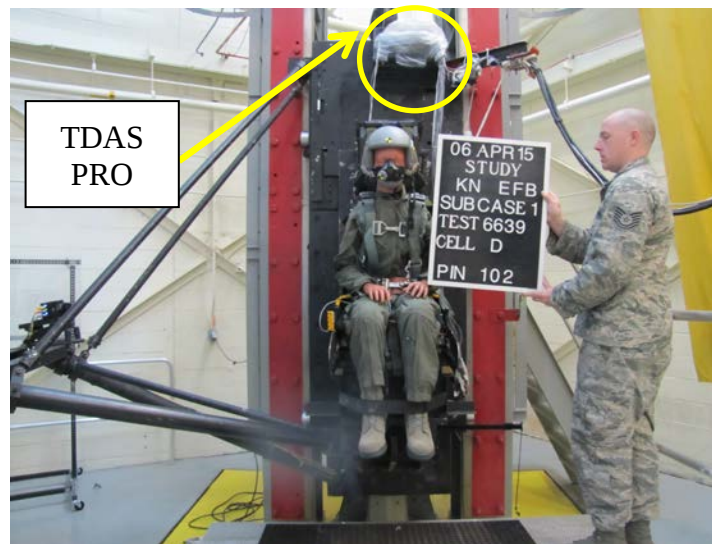
**Figure 7. Location of TDAS PRO DAS System When Mounted on VDT Carriage**

This research program used the TDAS Pro manufactured by Diversified Technical Systems (DTS), Inc., to collect all the fixture and manikin data for each test as defined by the test matrix. The 64 channel TDAS Pro was mounted on-board the VDT at the top of the impact carriage (Figure 7). The TDAS PRO is a ruggedized, DC powered, fully programmable signal conditioning and recording systems for transducers and events. The TDAS PRO was designed to withstand a 100 G shock. The TDAS unit is covered by plastic on the VDT to protect from water splash due to the water break system employed by the VDT facility.

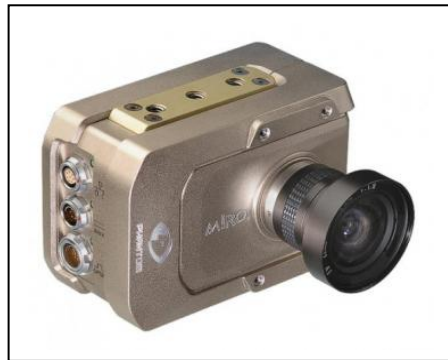
**Figure 8. Phantom Miro-3 High-Speed Digital Camera**

Two Phantom Miro-3 High-Speed digital cameras (Figure 8) were used to collect video of each test. The cameras were mounted on-board the VDT carriage at perpendicular and oblique angles relative to the manikin as shown in Figure 9.

The Phantom Micro line is a compact, light-weight, rugged family of cameras targeted at industrial applications ranging from biometric research to automotive crash testing. Rated to survive 100g acceleration this rugged camera can take 512x512 images at up to 2200 frames-per-second (fps). Reduce the resolution to 32 x 32 and achieve frame rates greater than 95,000 fps. With an ISO rating of 4800 (monochrome, saturation-based ISO 12232), the camera has the light sensitivity for the most demanding applications. With shutter speeds as low as 2 microseconds, the user can freeze objects in motion, eliminate blur, and bring out the image detail needed for successful motion analysis. The camera accepts any standard 1" C-mount lens. The Phantom Miro-3 member of the family is optimized for applications such as Hydraulically Controlled, Gas Energized (HYGE) crash simulations used in the automotive industry. Selectable 8-, 10- or 12-bit pixel depth allows the user to choose the dynamic range that best meets the demands of the

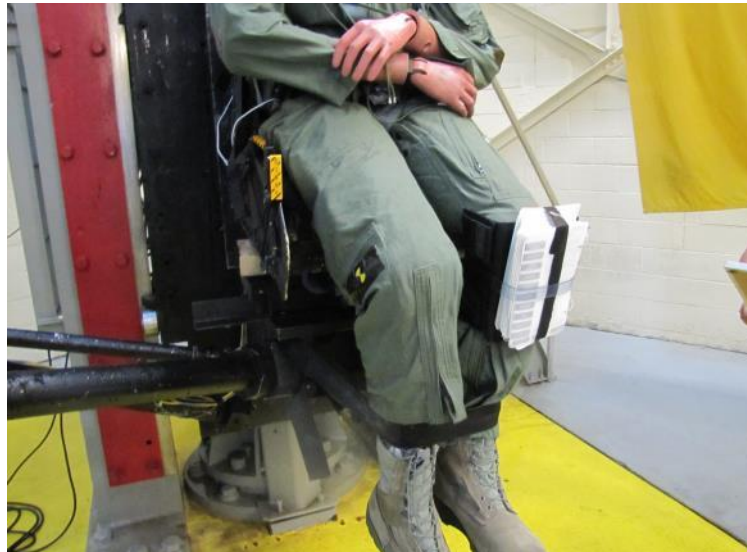
**Figure 10. Post-Test Position of Paper Kneeboard Configuration for Test 6650**

Evaluation of the test set-up after each impact provided some important information relative to the method used to restrain the kneeboard configurations to the leg. The tests with the large manikin showed that the Velcro strap and the Buckle Clip Strap had a difficult time keeping the kneeboard configurations on the upper leg during the impact. This was true for both the paper

kneeboard configuration and the proposed EFB configuration. The Velcro strap used for the paper kneeboard allowed the kneeboard to slip off the upper leg over the knee and down to the lower leg for the first two tests in this configuration (Figure 10). The Velcro did not fail and the paper guide and checklist never separated from the leg. An additional test was run with additional tape used to secure the kneeboard to the leg and prevent the configuration from slipping to see if this had an effect on the measured load. The kneeboard stayed on the upper leg, and the measured torque with this additional restraint was still within the range of the first two tests.

Recommendations are to investigate a Velcro or Buckle Clip strap configuration that possibly interfaces through loops in the flight suit garment, and to investigate a better side clamp system for the EFB. The laboratory tests indicated that the side clamps may not sufficiently hold the EFB during the catapult.

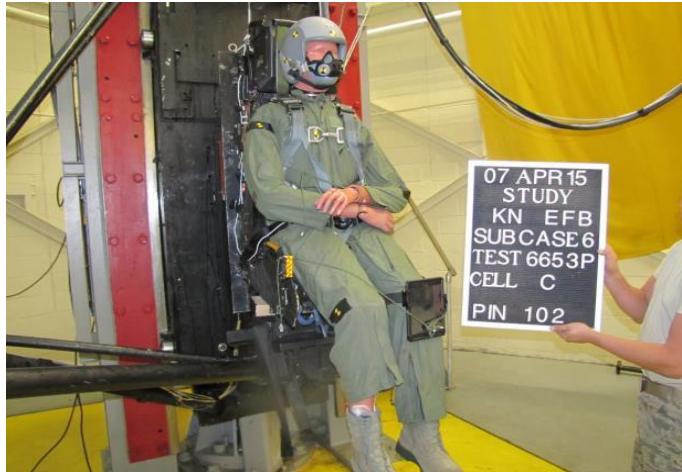
**Figure 11. Post-Test Position of EFB Configuration for Test 6653 with Case 6 Manikin**

The tests with the large manikin and the EFB configuration had similar issues with the Buckle Clip Strap, however, the EFB unit slip over the knee on one test, and the EFB unit separated from the side clamps on the second test and was restrained by secondary parachute cord (Figures 11 and 12). An additional test was run with additional tape, used to secure the EFB to the leg and prevent the unit from slipping off the leg and out of the side clamps, to see if this had an effect on the measured load. The EFB stayed on the upper leg, and the measured torque with this additional restraint was still within the range of the first two tests.
