TITLE: Proceedings of the Antenna Applications Symposium Held in Urbana,  
Illinois on 17-19 September 1986. Volume 1.

## EHF/SHF SATCOM ANTENNA AND RADOME TEST RESULTS

Allen L. Johnson  
Wayne O. Fischbach  
Avionics Laboratory  
Wright-Patterson AFB, Ohio 45433

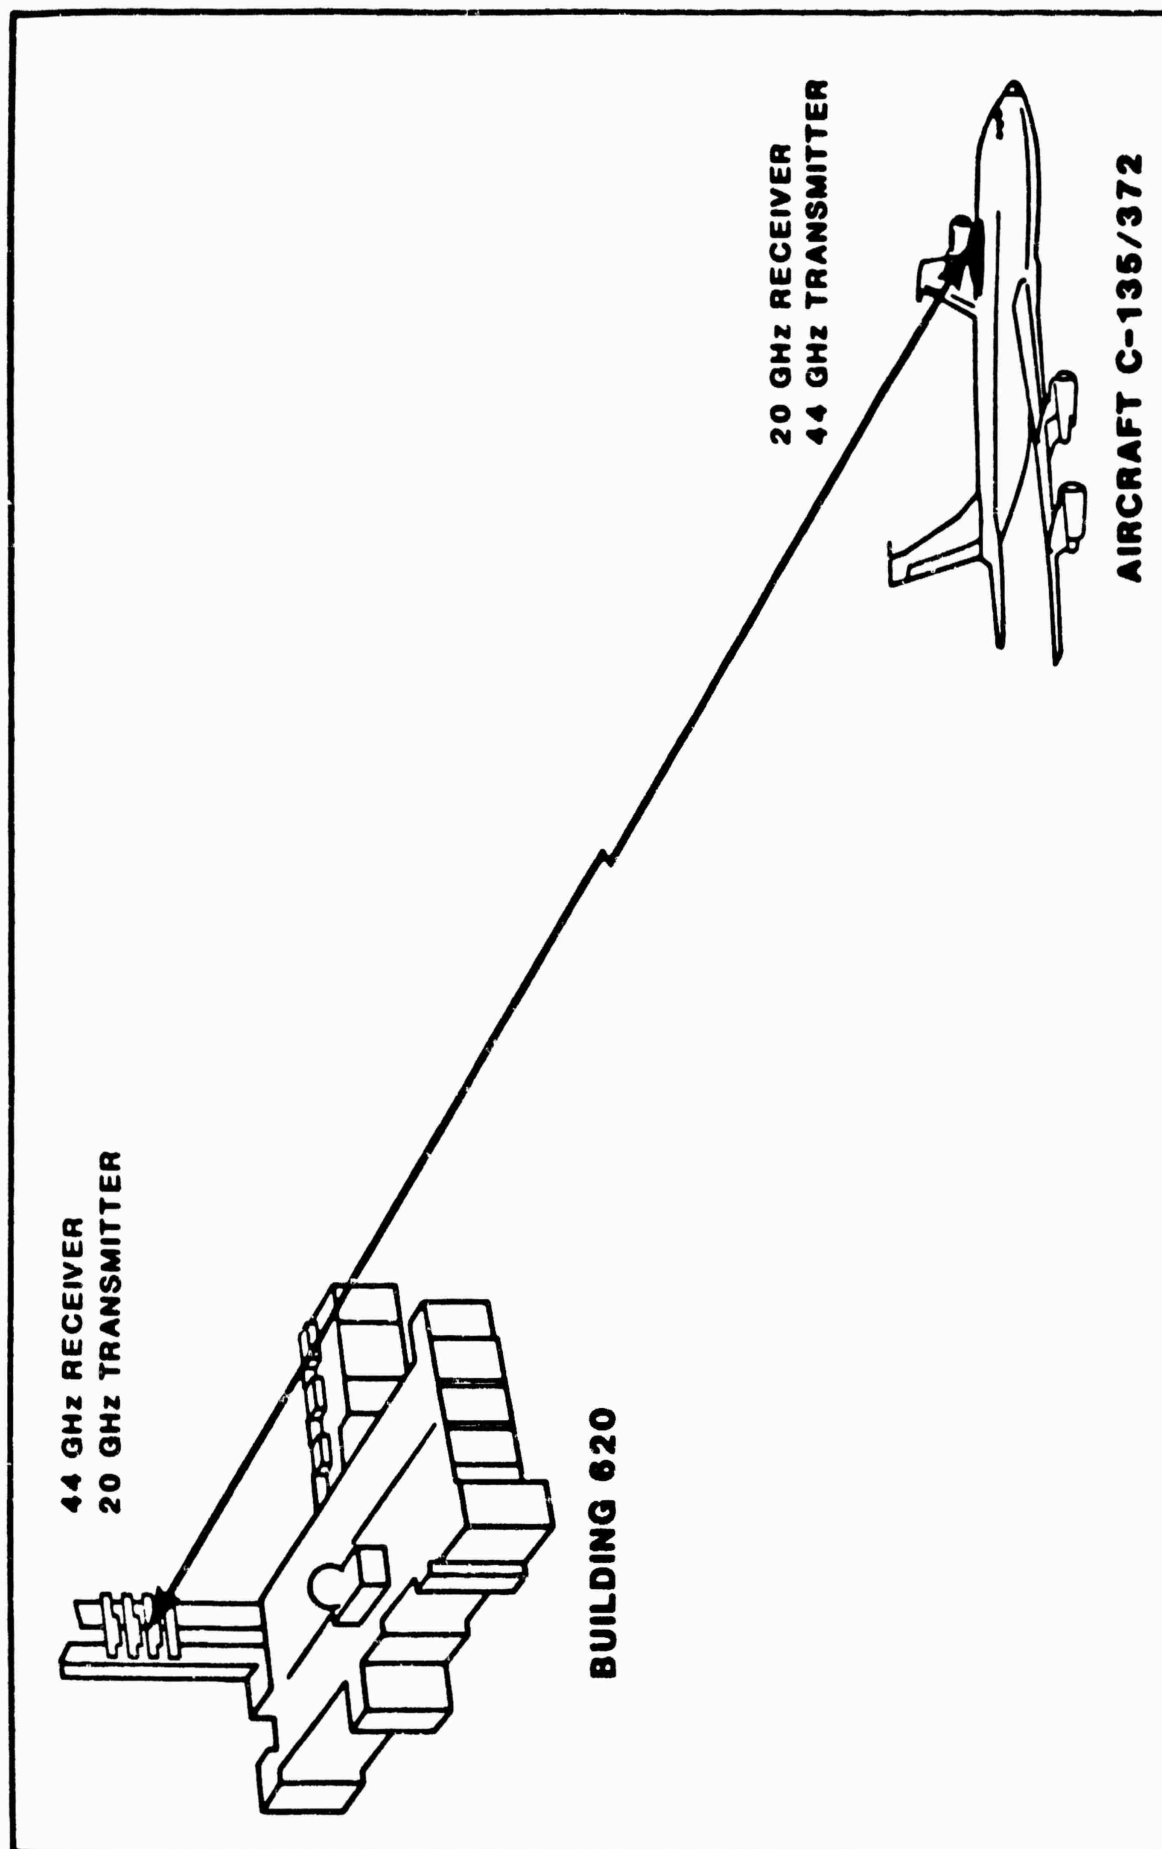
**Figure 1 TRI-BAND RADOME BEAM SQUINT TEST CONFIGURATION**

Measurements of the RF beam squint were accomplished by comparing the optimum antenna pointing angles with the radome in place and removed. One practical problem in measuring the beam squint of the AN/ASC-30 tri-band radome was the lack of a 20/44 GHz satellite on-orbit to use as a signal source. In place of the satellite, a simulator was used, consisting of a 20 GHz transmitter and a 44 GHz receiver on the tower of building 620 at WPAFB, OH, Figure 1. The AN/ASC-30 with its 44 GHz transmitter and 20 GHz receiver was installed in aircraft C-135/372, which was located on the ground at Patterson Field.

For the beam squint test the 20 GHz tower transmitter and 44 GHz aircraft transmitter were turned on and their antennas pointed toward the respective receivers. The aircraft antenna was moved in  $0.1^\circ$  azimuth steps for  $\pm 2.5^\circ$ , and  $0.1^\circ$  elevation steps for  $\pm 1.0^\circ$  of

the calculated pointing angle from the aircraft to the tower. In the tower and aircraft, the azimuth antenna beam patterns were received, recorded, and correlated with the transmitter pointing angles. The radome was then removed and the azimuth/elevation steps repeated. Any difference in the pointing angle for the peak of the beam was attributed to radome-induced beam squint. Due to the complex curvature of the radome, various portions were measured from the nose, to broadside, to the tail, Figure 2.

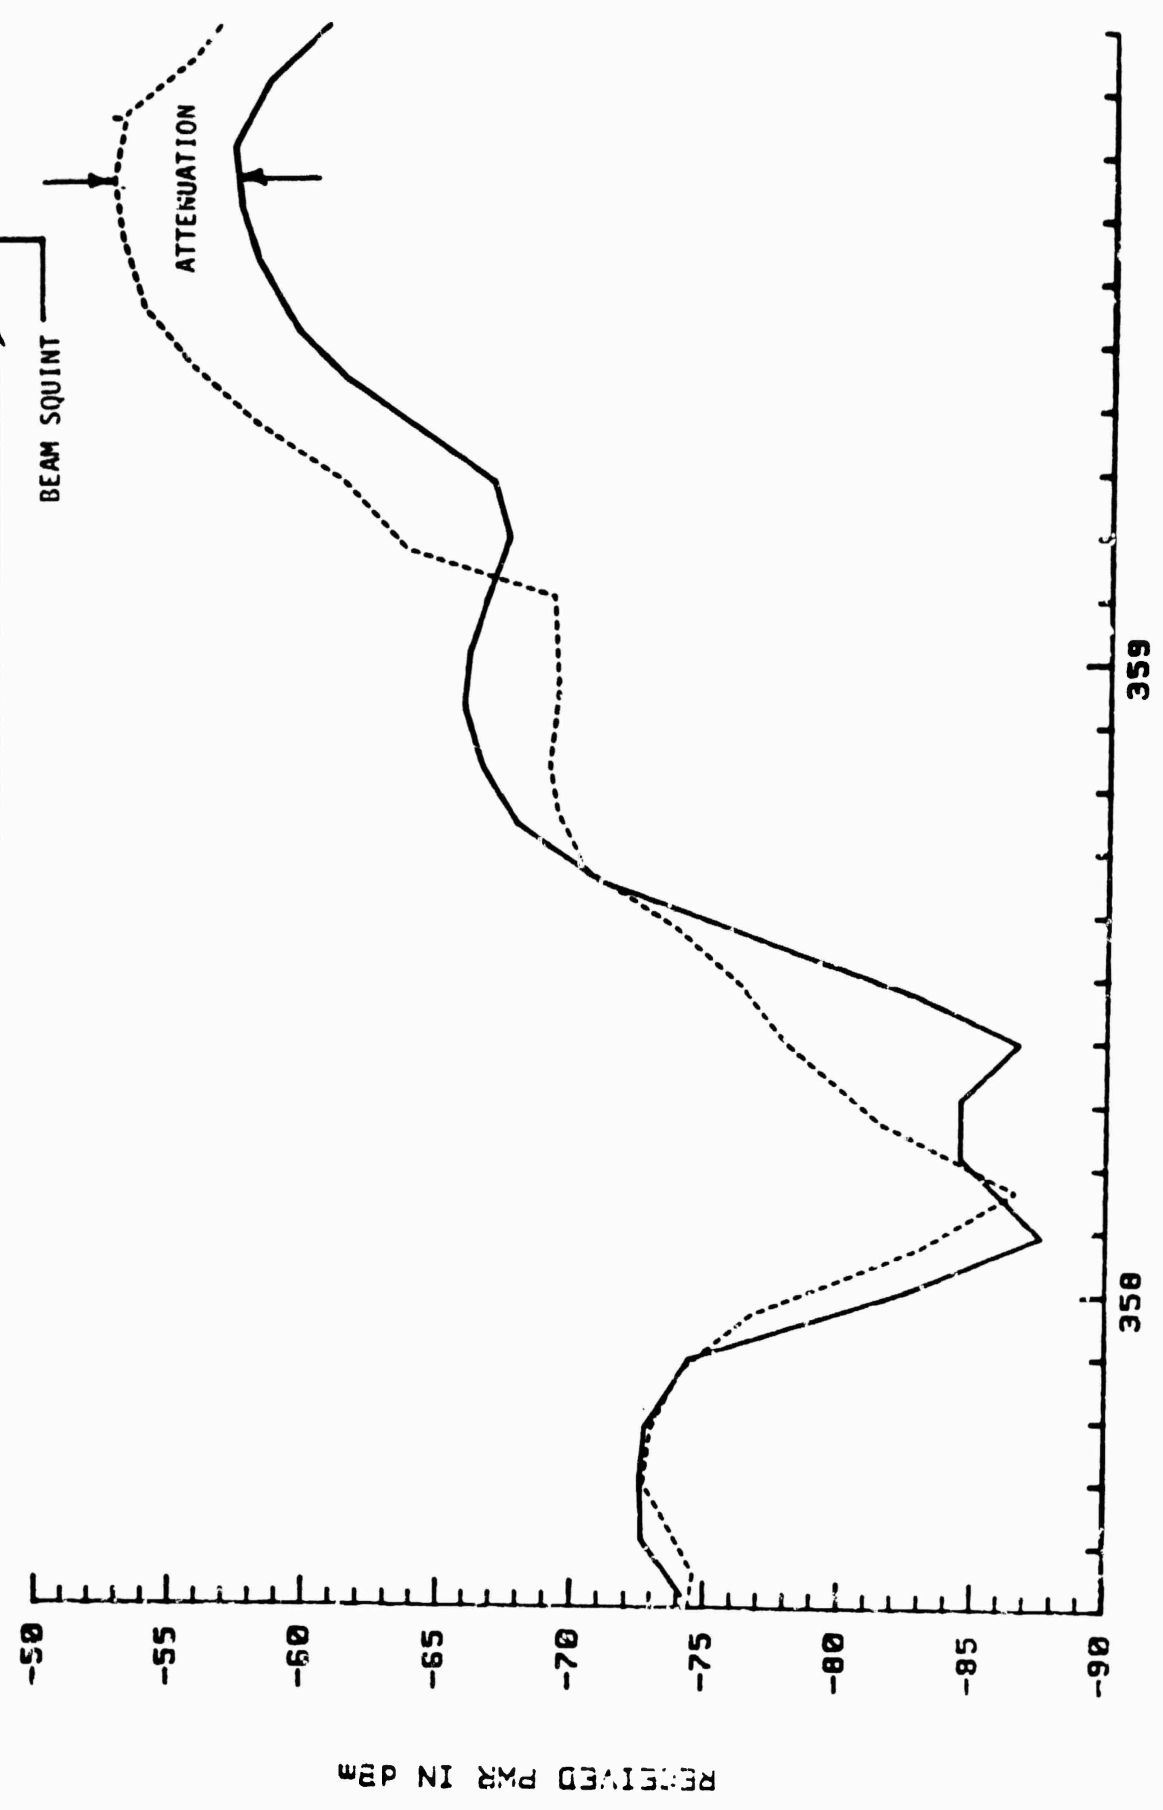
SQUINT TEST      1 Mar 1986  
 FREQ 44 GHz    NORMALIZED TO TX PWR OF 12 dBm  
 ON: MAX PWR -57.2 dBm    AZ 359.9 DEG    EL 2.1 DEG  
 OFF: MAX PWR -52.9 dBm    AZ 359.0 DEG    EL 1.7 DEG

FIGURE 10 AN/ASC-30 RADOME PERFORMANCE DURING AZIMUTH SWEEP  
 AZIMUTH IN DEGREES

the beam squint. A summary of the beam squint for various portions of the radome (azimuth angles) is shown in Figure 9. One azimuth sweep showing the worst beam squint is presented in Figure 10. The beam squint appears to be approximately  $0.4^\circ$  over the nose and tail and on the order of  $0.1^\circ$  broadside.

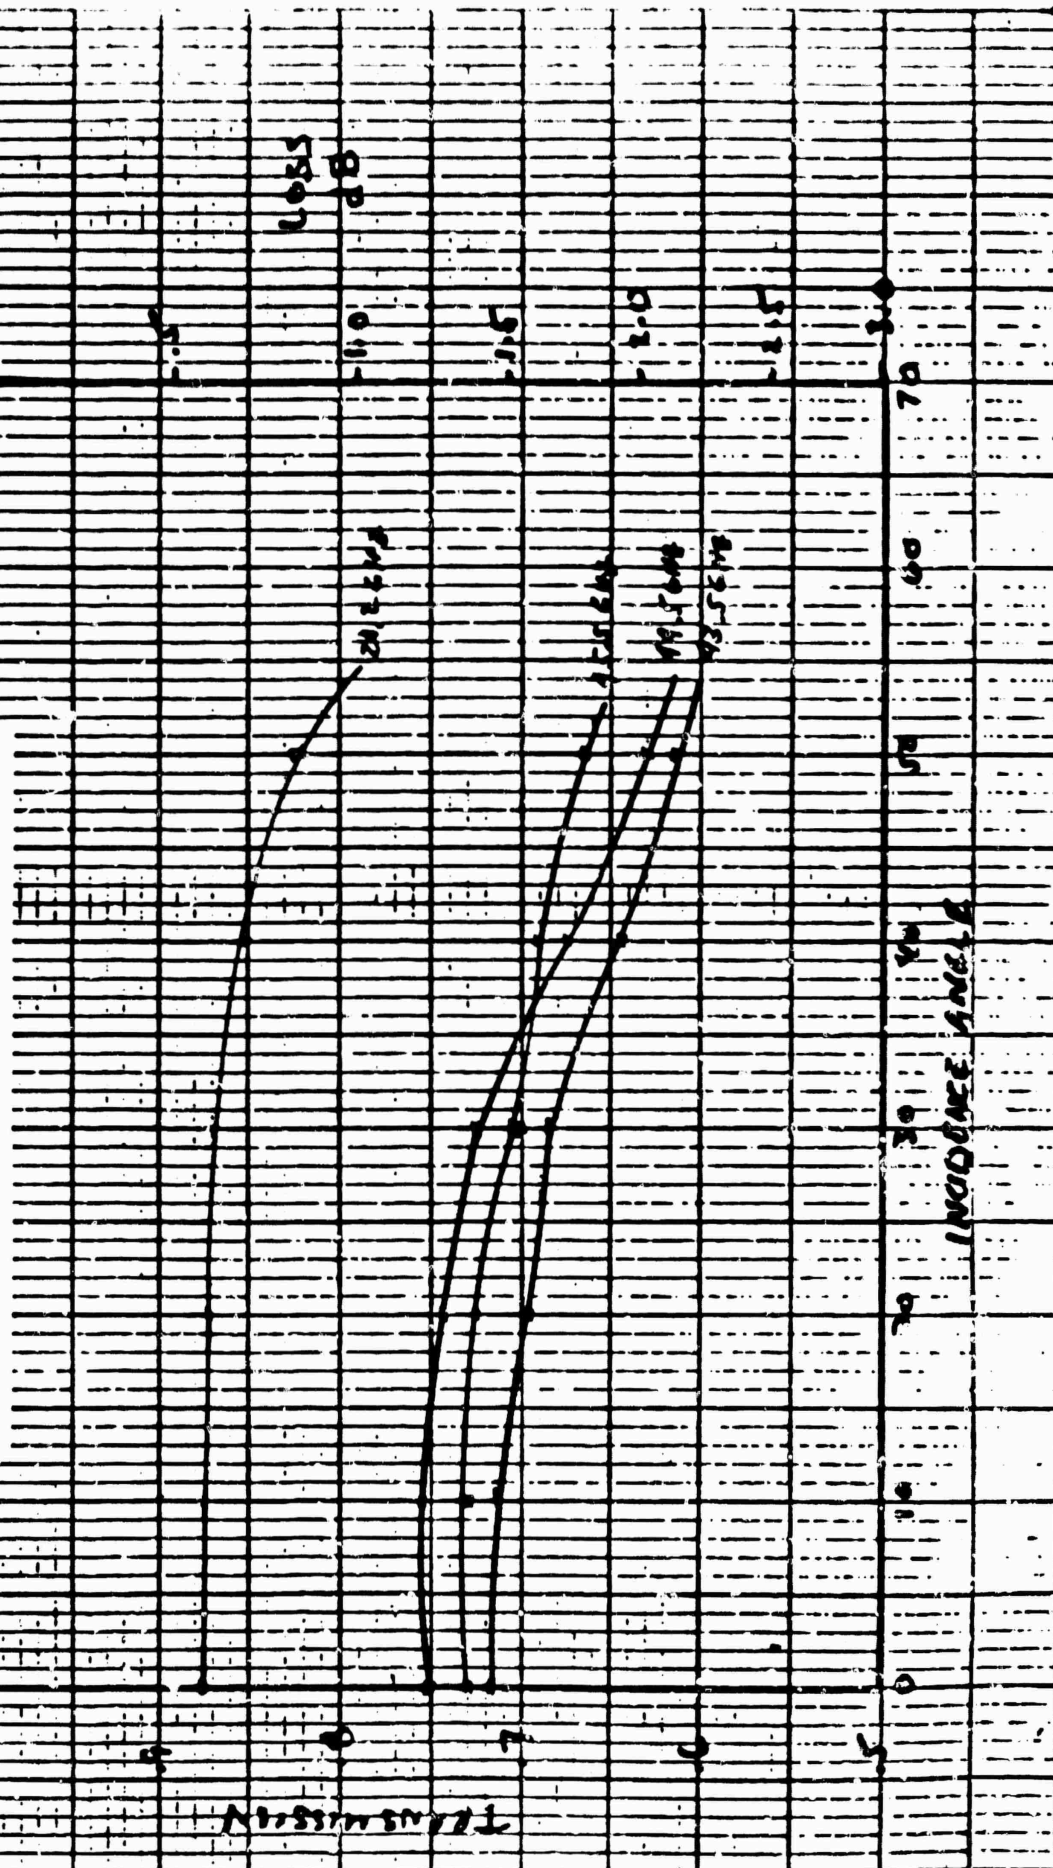
AN/ASC-30 TRI-BAND RADOME  
 FLAT PANEL TESTS - CP DATA  
 0.130" KEVLAR PANEL WITH  
 WHITE ANTISTATIC COATING

FIGURE 11 20/44 GHz FLAT PANEL MEASUREMENTS WITH COATING

In an effort to evaluate the effect of radome thickness and incidence angles on the radome attenuation, a 36-inch square flat panel was constructed of the same material and thickness as the tri-band radome. Attenuation tests were conducted on the flat panel. The results of the 20 GHz and 44 GHz measurements are shown in Figure 11.
