U. S. NAVAL PROVING GROUND
DAHLGREN, VIRGINIA

REPORT NO 973

2"75 AUTOMATIC ROCKET LAUNCHER T-110-E2B

1st Partial
Report

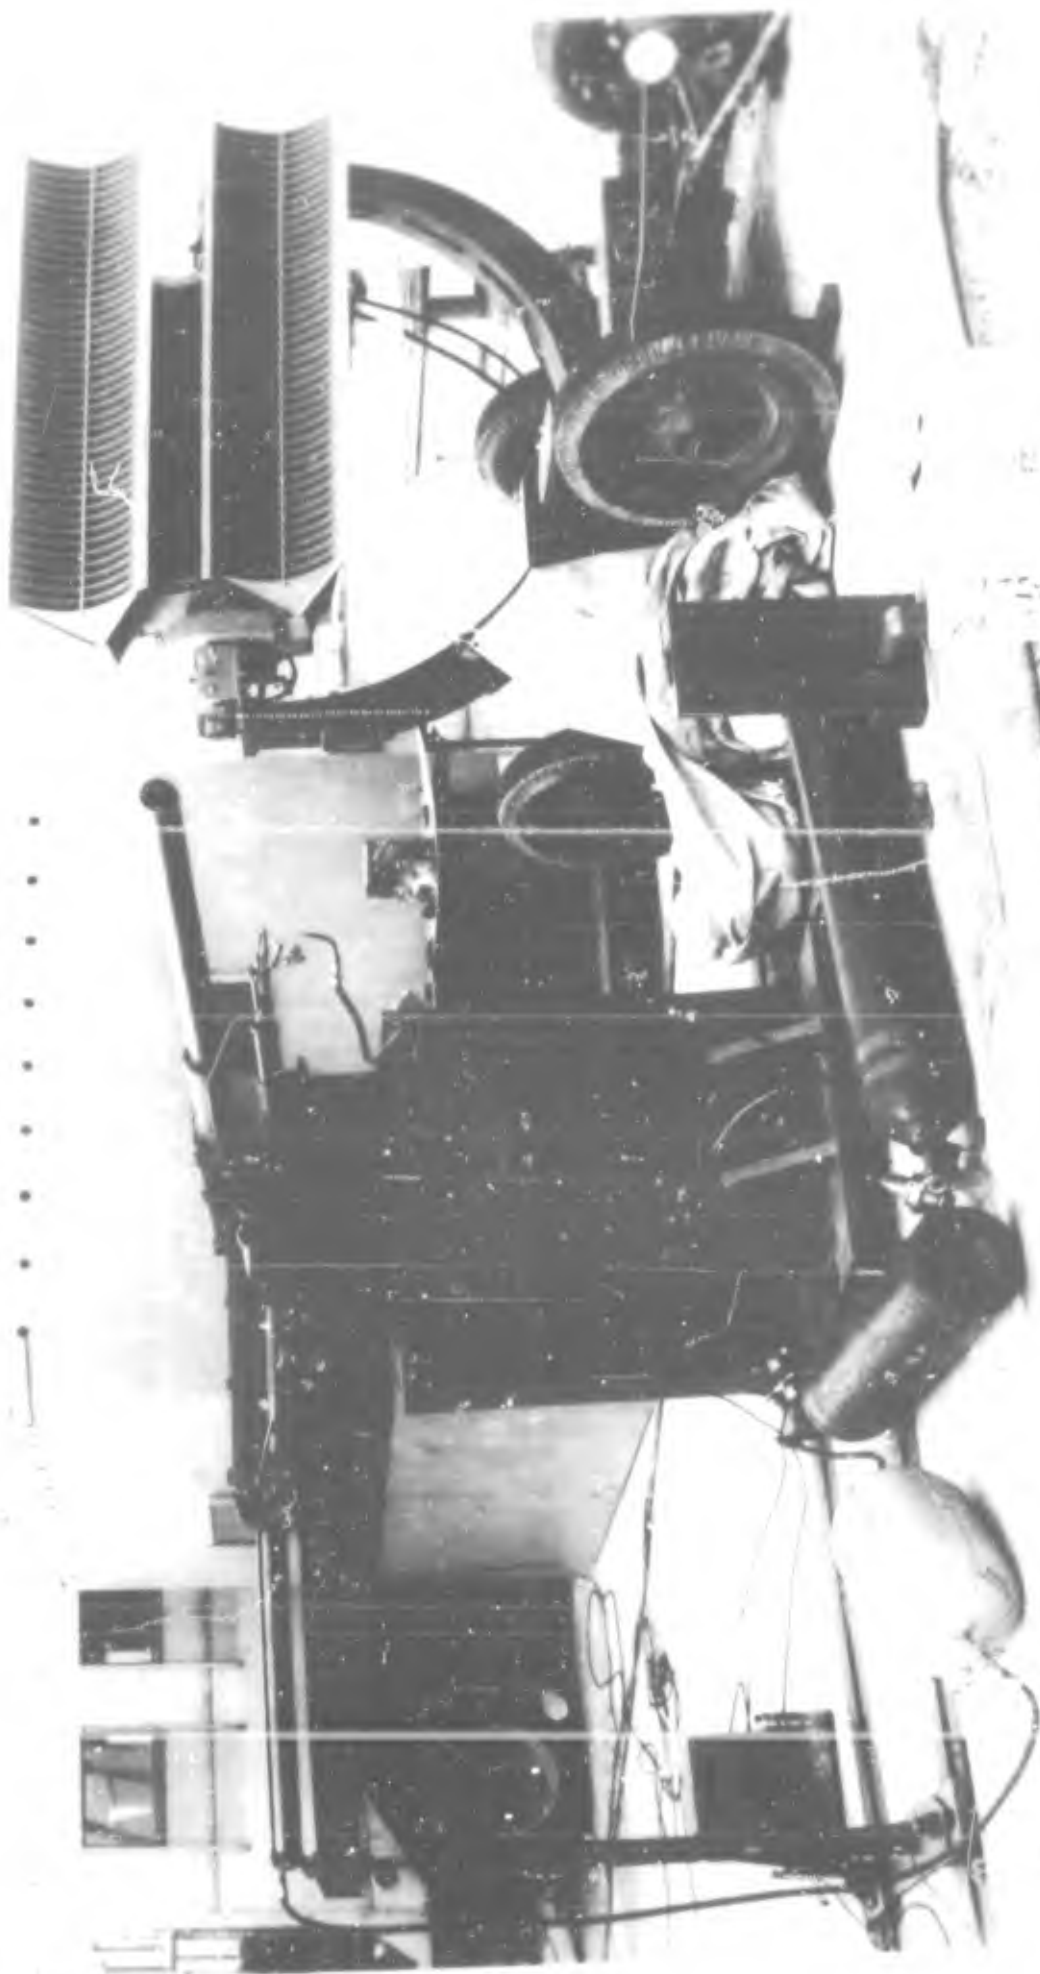
Coppler.
Figure 2

APP 48467
Front view showing T11C Rocket Launcher on 1,000,000 pounds/inch mount with Sperry Radar

The gun was thoroughly cleaned and assembled, and was mounted on a gun mount having a rigidity of approximately 1,000,000 #/inch, and laid at an elevation of 2° (Figures 2 and 3). Air bottles were connected to the pneumatic charger and the feeder, and an attempt made to cycle the gun using empty cases. According to verbal instructions given by Re8b, Bureau of Ordnance, the Belleville Washers at the rear of the feed sprocket were precompressed to 2-9/16". However, it was found that the driving springs would not return the slide to battery when the washers were compressed this much. It was determined

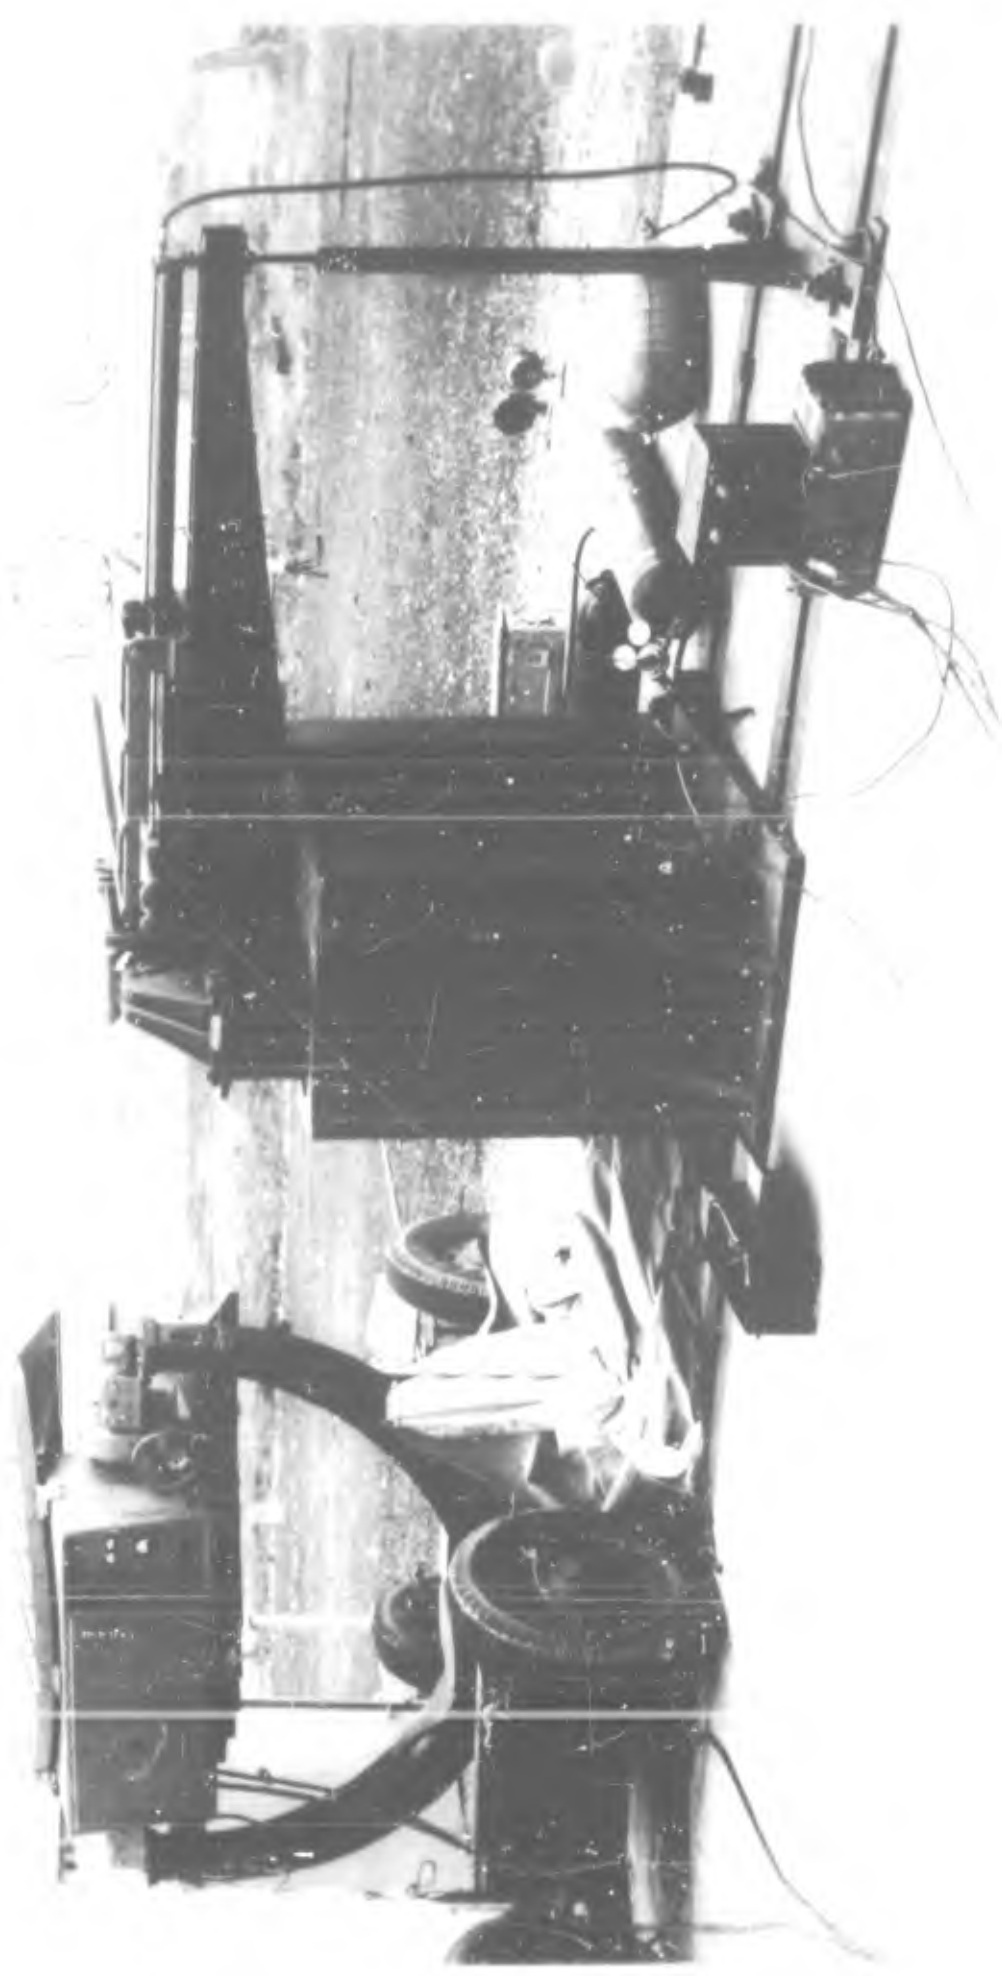
NP9 48468
Rear view of T110 Rocket Launcher mounted on gun mount have a rigidity of approximately 1,000,000 pounds/inch, with Sperry Radar Doppler.
Figure 3

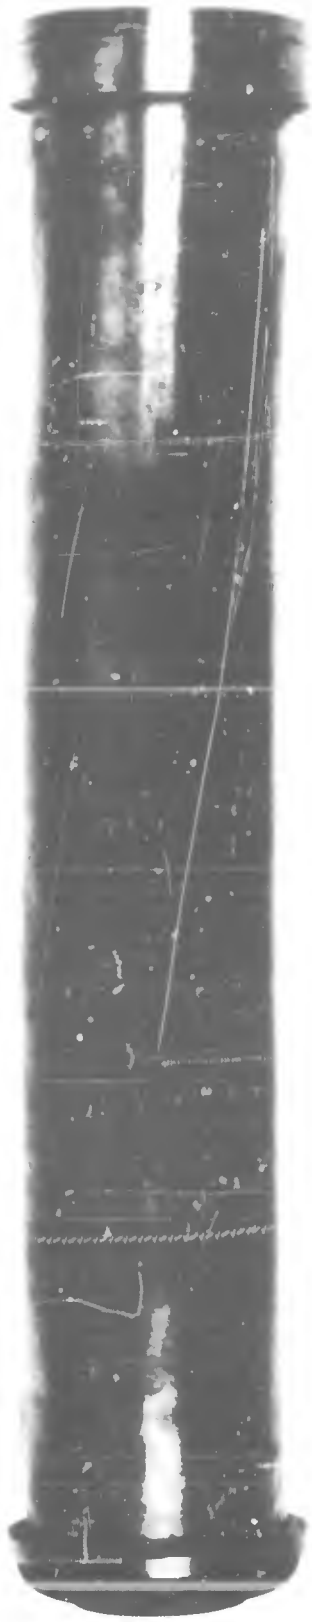
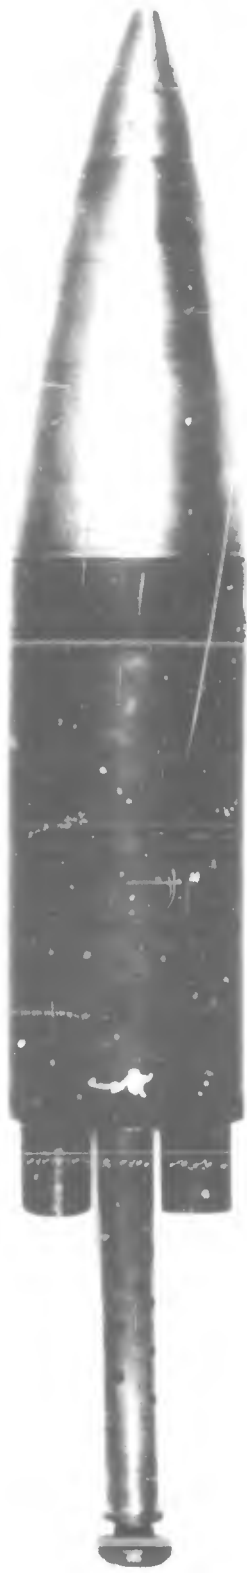
NP9 48470
View of T132 practice rocket showing (a) Cartridge Case, (b) Gas Sealing Ring, (c) Retaining Nut, (d) Ignitor Tube, (e) Shot Start Device, (f) Nozzle Plate, (g) Rocket Motor, (h) Rotating Band, (i) Head, (j) Fuze.

The T131 HE Rocket consists of a cartridge case, an electric primer, an igniter tube, a propellant or launcher charge, a shot start device, a rocket motor, a head containing a bursting charge, a fuze, and an obturating ring. The T132 Practice Rocket is similar, except that the head is inert loaded and a dummy fuze is used. Figures 4 and 5 show this round. The T217 proof (or slug) rounds omit the entire rocket and head, and substitutes an iron slug of approximately the same weight (Figures 6 and 7).

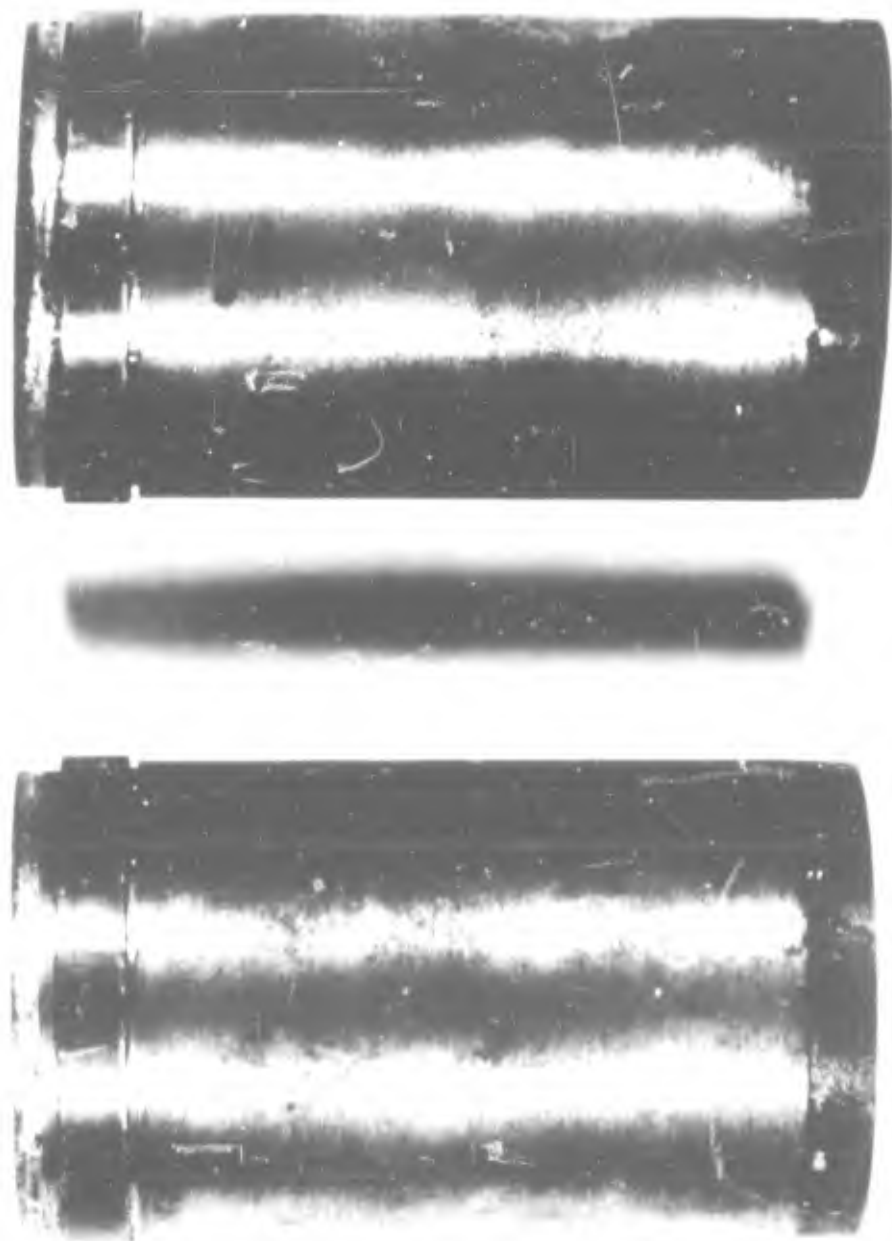
View of forward end of two T217 proof (or slug) rounds showing rap in rotative band.
Figure 7

Further difficulty was encountered in assembling the rounds, when it was found that the rotating bands on slugs would not enter the cartridge case. A check of the drawings for these parts showed the diameter of the rotating bands should be 2.815 + .000-.001 while the I.D. of the case should be 2.816 + .001-.000. Actually, the diameter of the slugs was found to be as much as 2.818, and at least 30% of them measured 2.816 at some point. It was necessary to turn all slugs to the proper dimensions, after which another attempt was made to load the rounds. It was then found that there was a shoulder in each of the cases, 7-1/2" from the mouth, beyond which they were not ground, as the rotating band on the T131 or T132 Rockets does not pass beyond this point when the rockets are properly positioned in the cartridge cases.

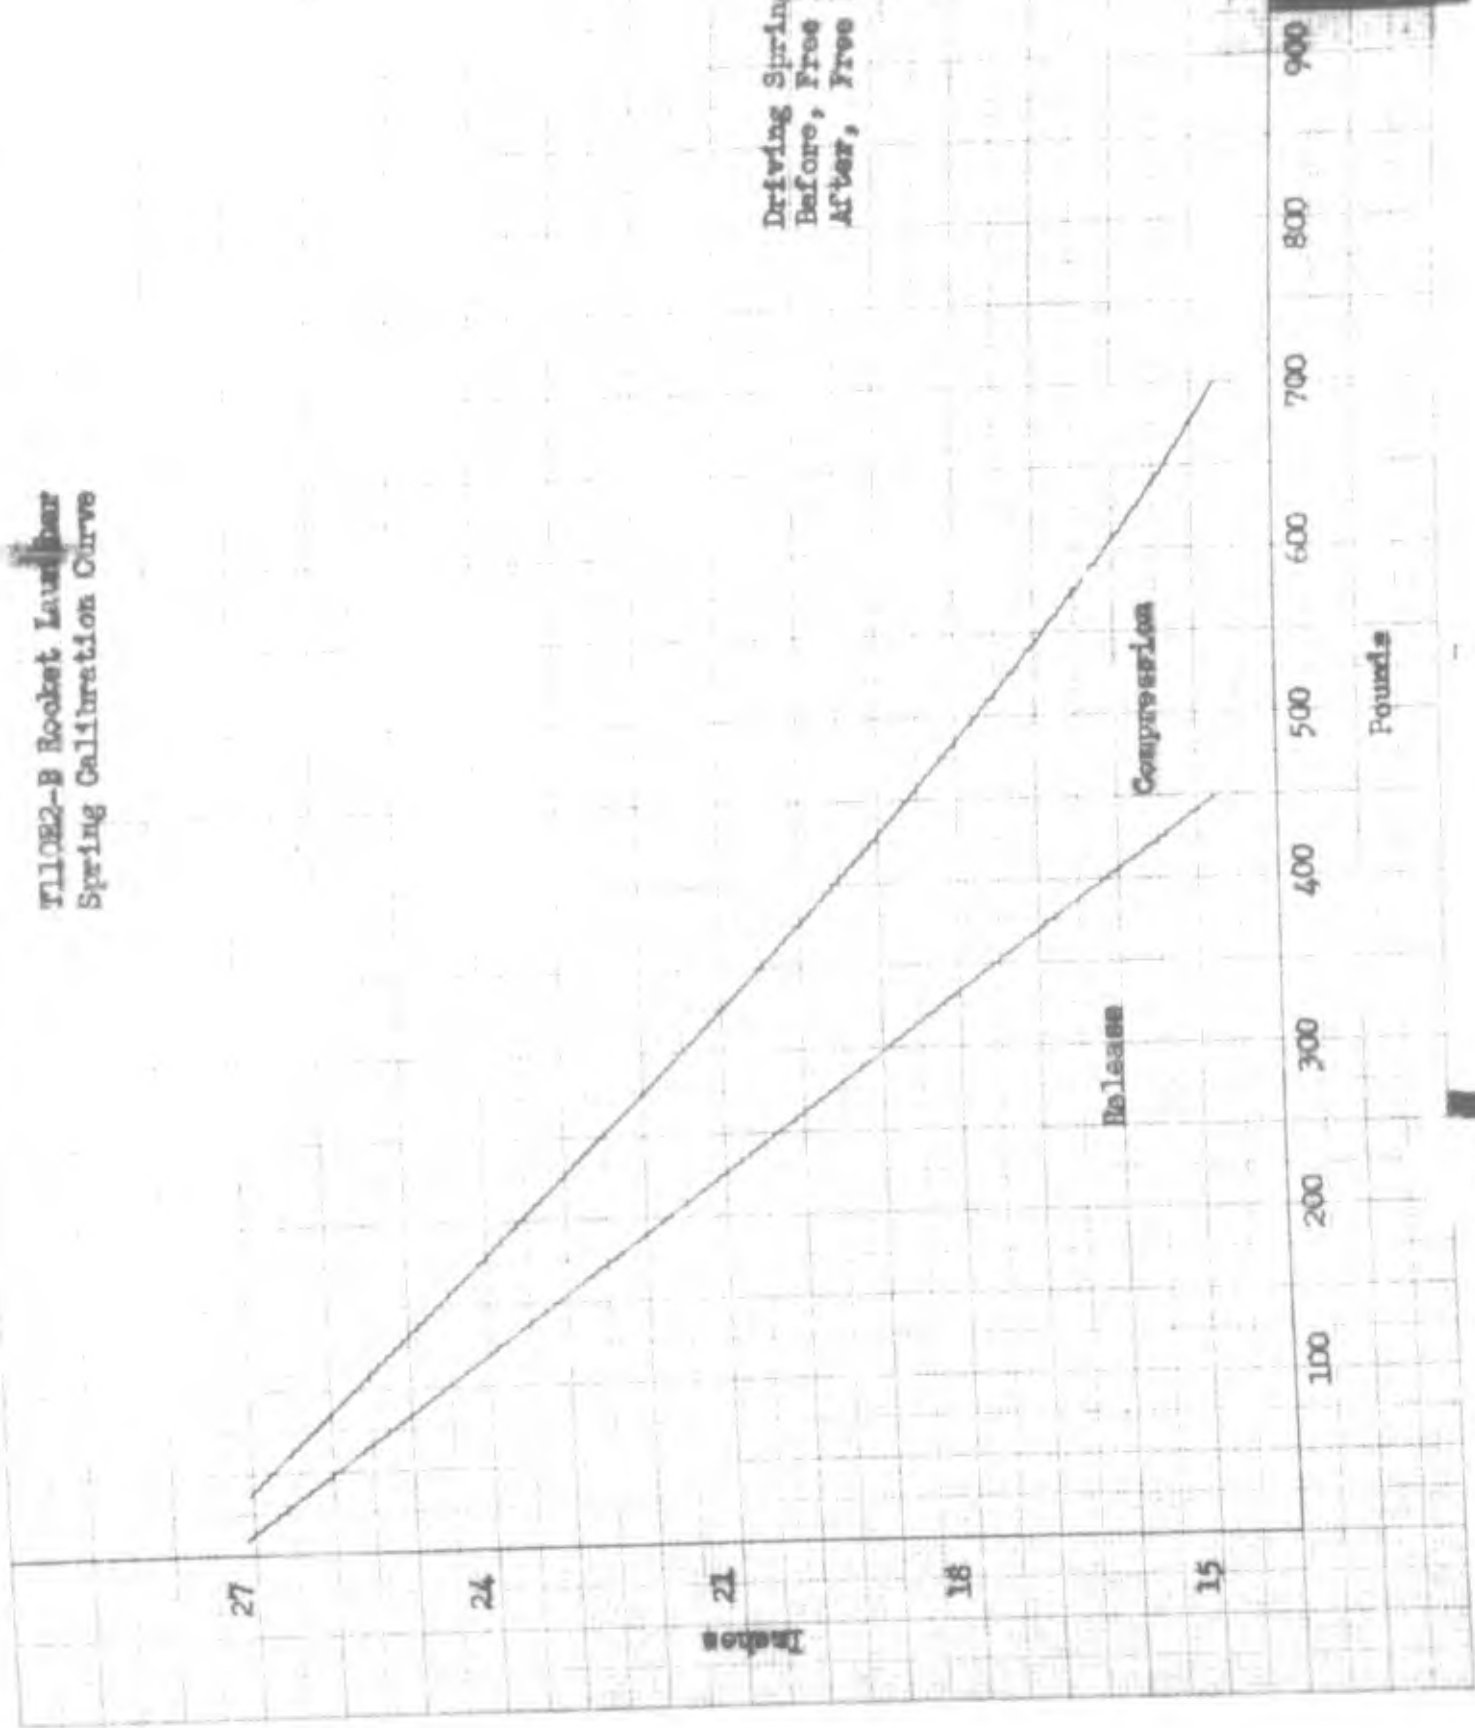
FIGURE 8

T110E2-B Rocket Launcher
Spring Calibration Curve

Driving Spring, Right Hand
Before, Free Length 27.95
After, Free Length 27.85

that 2-11/16" was the tightest that the Bellevilles could be compressed to permit the gun to be cycled by air, using the twisted wire driving springs as received with the gun. A calibration of these springs is given as Figures 8 and 9. 100 psi pressure was used on the feeder and 250 psi on the charger during these cycling operations. Several of the empty cases were damaged during these operations by the cam following roller on the center sprocket. It was found that the air pressure on the feeder was not sufficient to keep the third round in position against the force of the two spring loaded detents, and this round was hitting the cam following roller as it rotated. Increasing the feeder pressure to 250 psi corrected this difficulty.

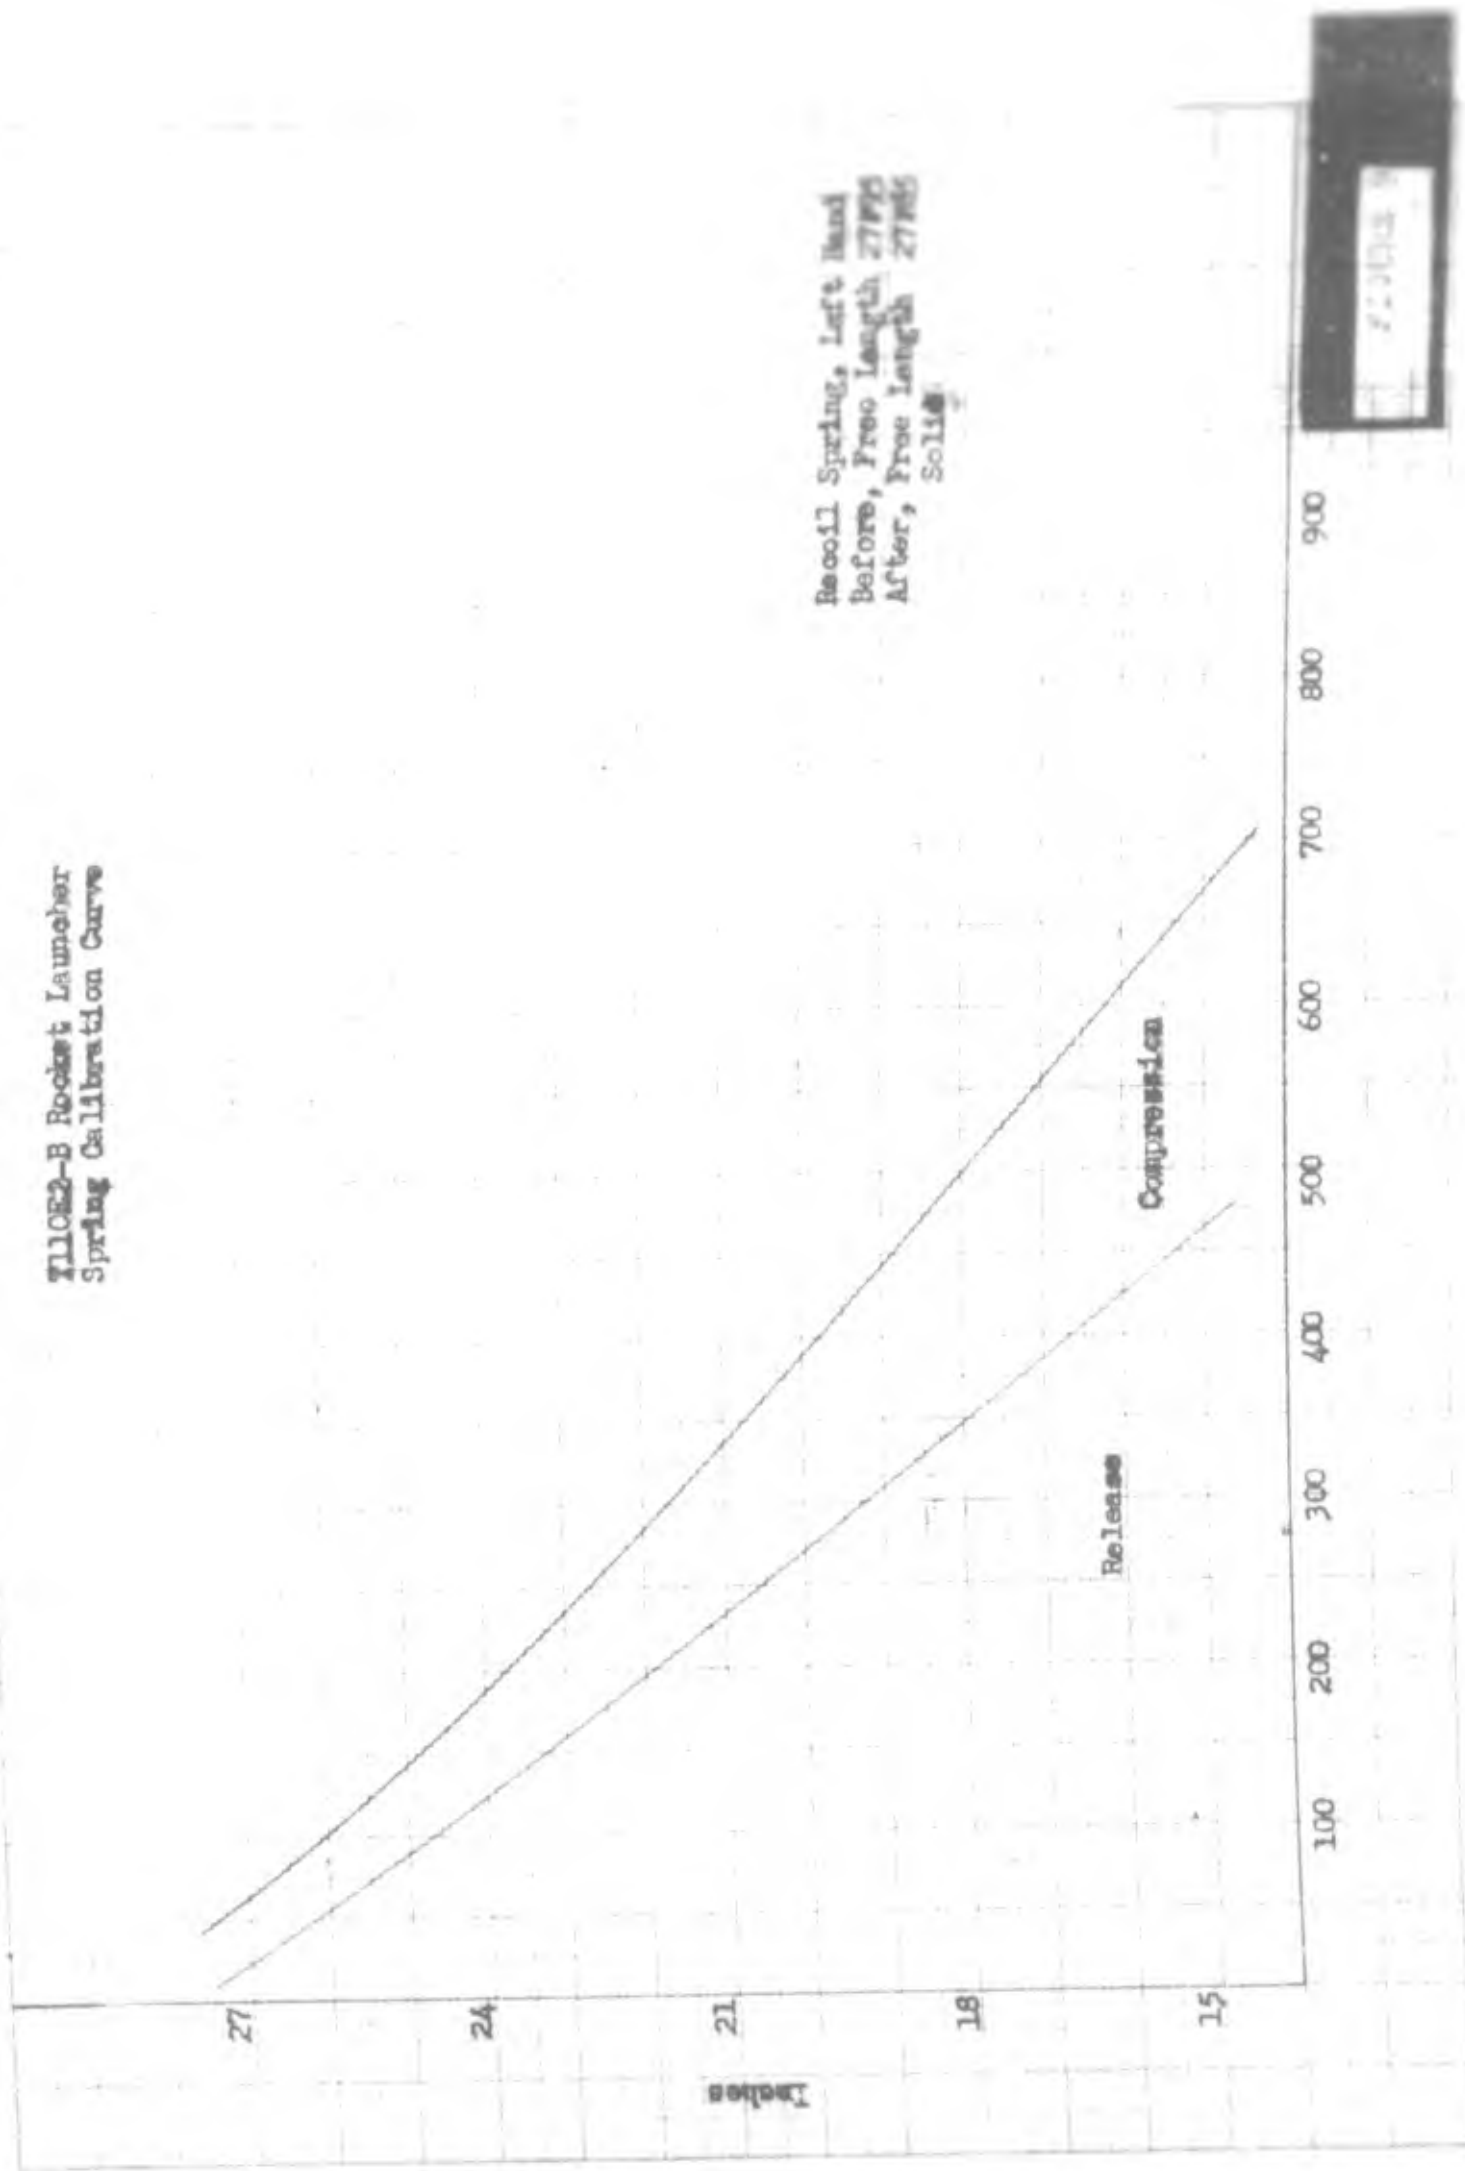
**T110E2-B Rocket Launcher
Spring Calibration Curve**

Recoil Spring, Left Hand
Before, Free Length 27.750
After, Free Length 27.865
Solid

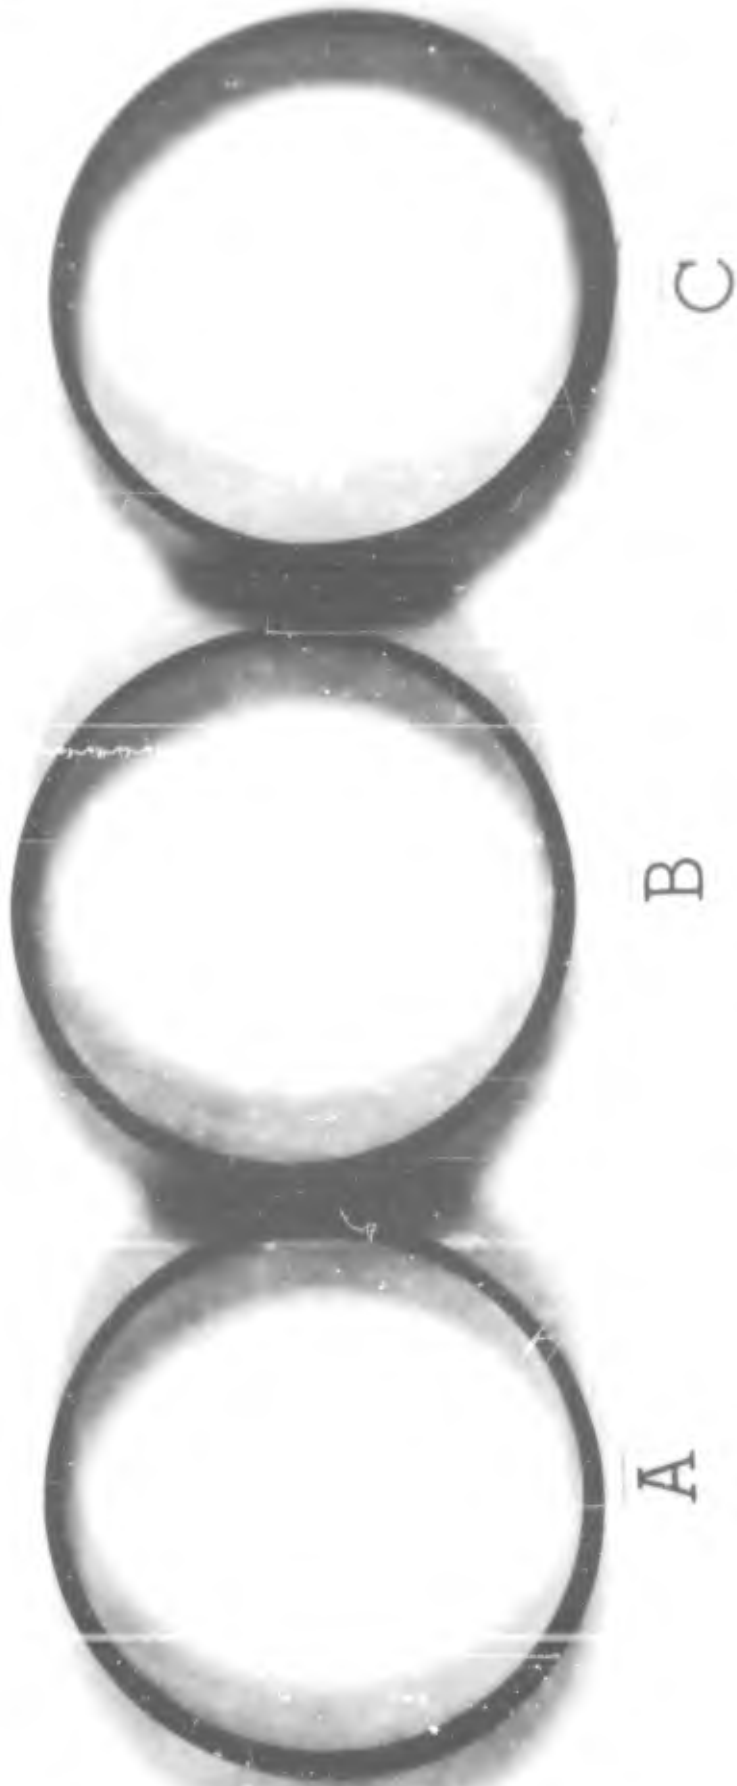
View showing cross sections of gas sealing rings: (a) New ring, (b) Ring after firing which had been held in with scotch tape, (c) Ring after firing which had been cemented in place.

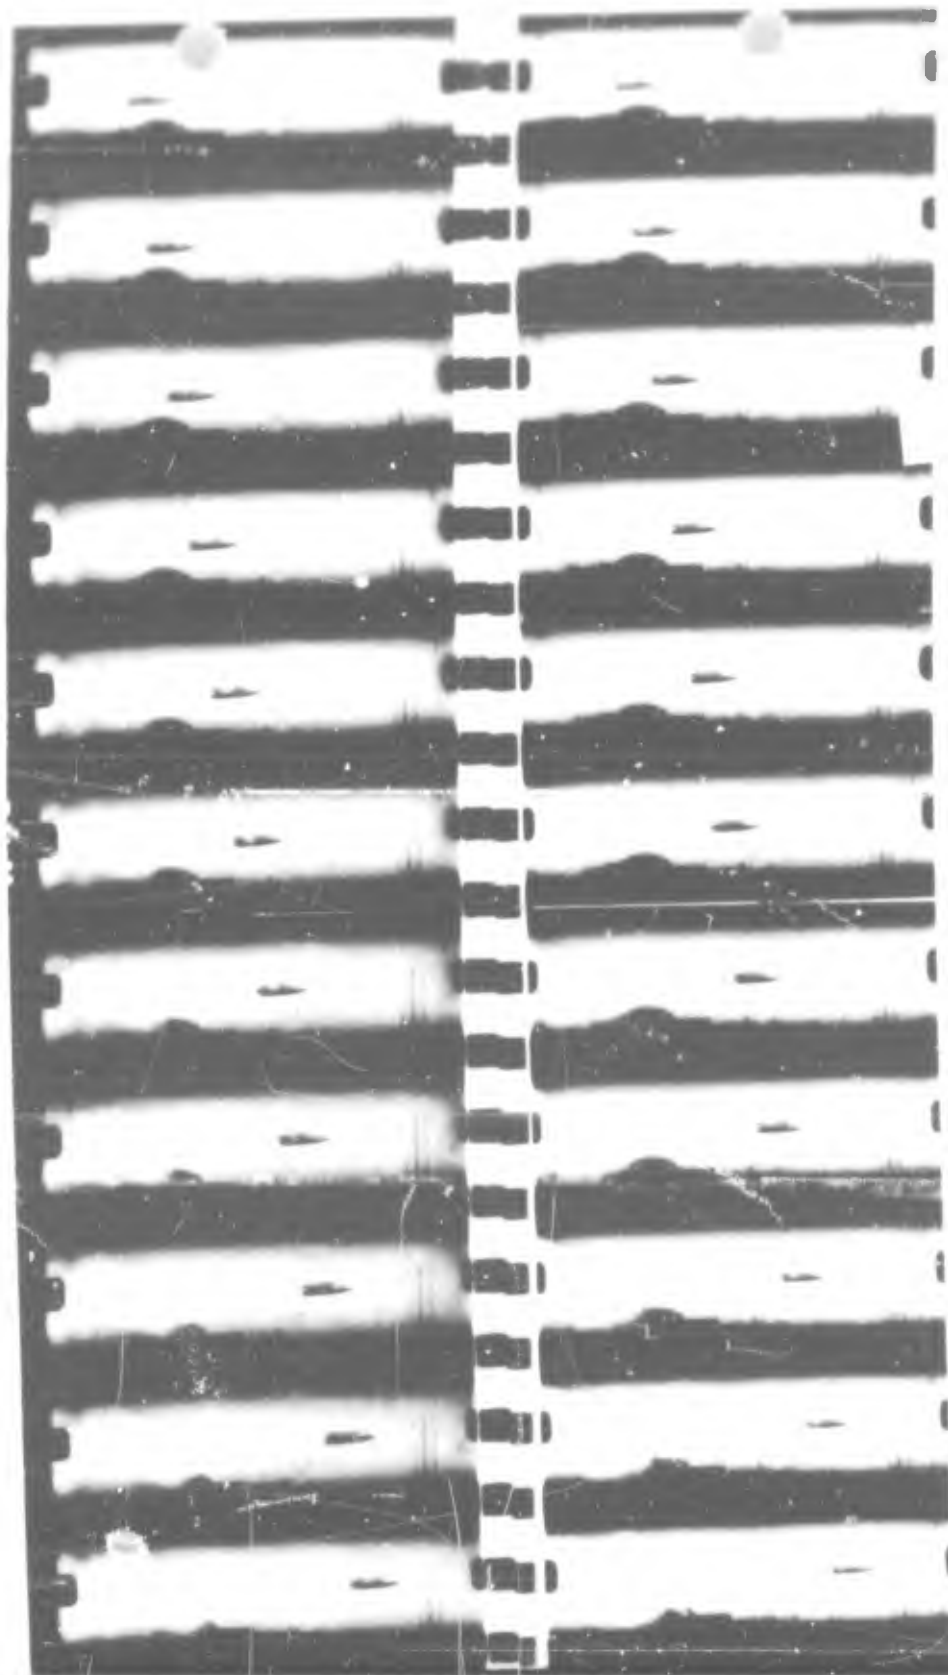
High speed photographs of T132 rockets in flight at 20' from muzzle, taken with Fastax Camera at 3200 frames/seconds.

To observe rocket stability and burning, high speed photographs of rockets in flight were obtained by two methods, High Speed Fastax Cameras with a frame rate of 3200 pictures per second, and a Ballistic-Synchro Camera. These photographs are given as Figures 17 and 18.

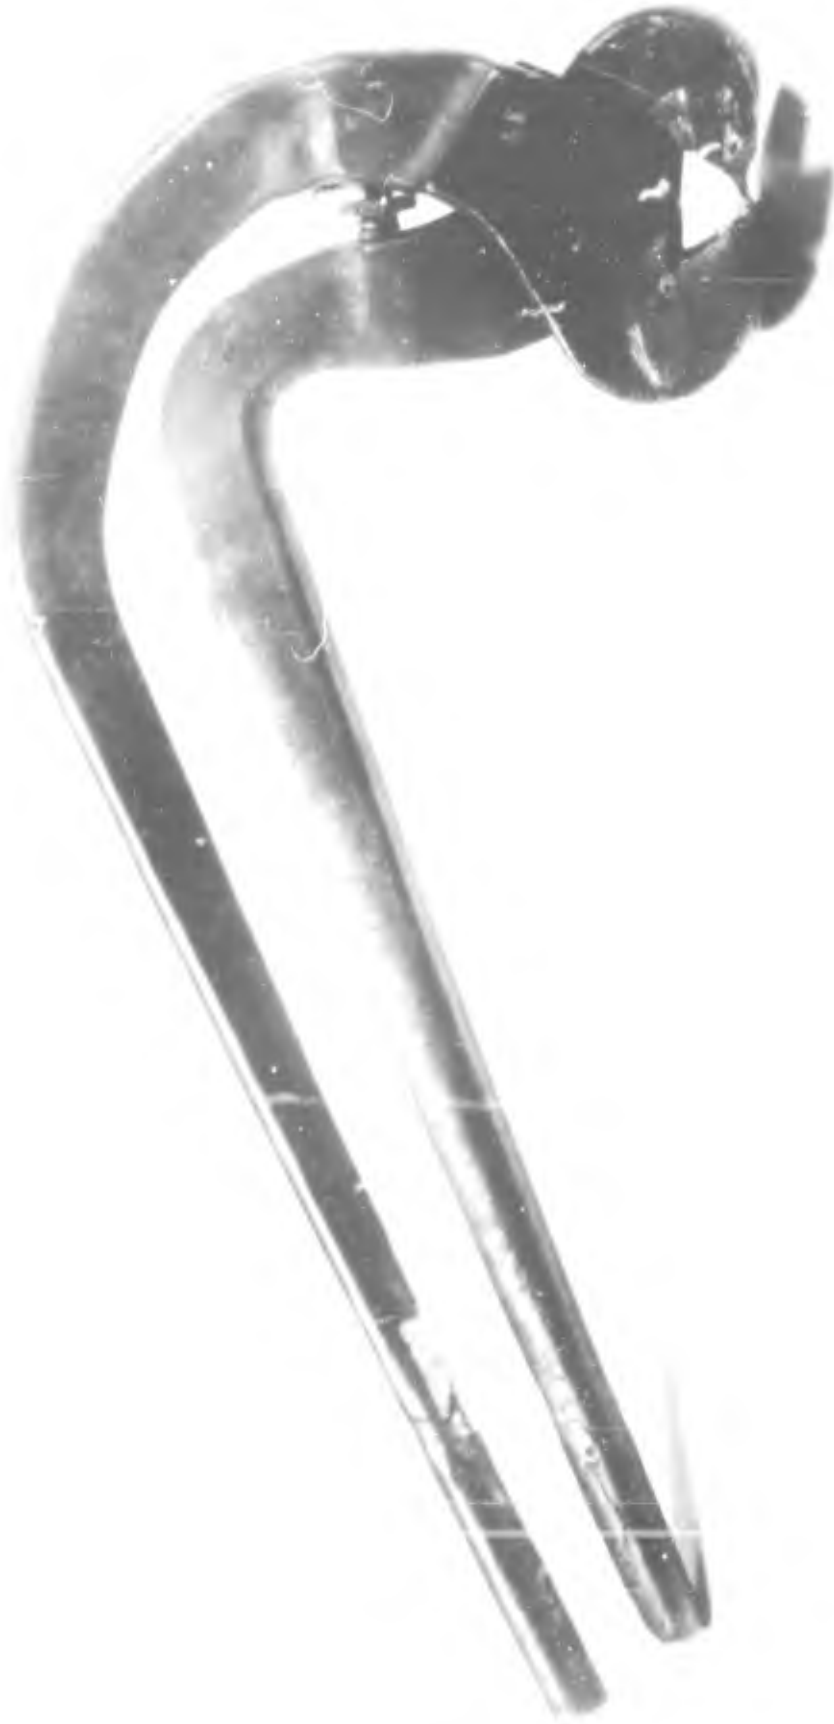
NP9 48482
View of gas sealing ring, part of which was carried away on firing.
Figure 21

It was found that by inverting the ring, i.e., placing it in the mouth of the case with the thin section forward, and by either staking the thick section lightly or using Scotch Tape, excellent sealing and operation was obtained. Photographs of the device used to stake the rings are shown in Figures 19 and 20. If staking was too deep, it was found that the ring was weakened, and, in one instance, a part of it was completely carried away, (Figure 21).

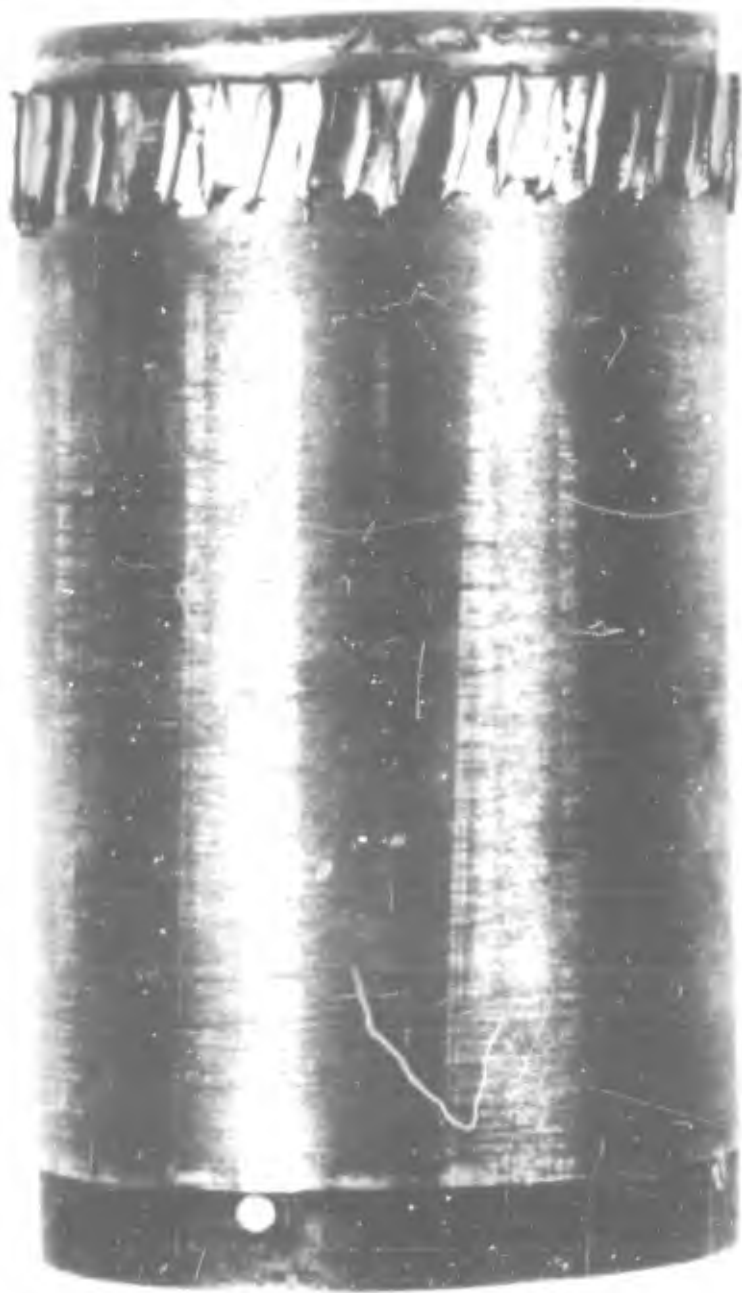
View showing "X" engraving on rotating band of a T217 round which had been forced through the barrel.

c. In firing a two round series at each temperature in a cold ammunition test, it was noted that the first round fired had a velocity considerably greater than the second round. There were no changes in the gun or ammunition, except that the barrel had been cleaned and oiled prior to firing the first round, but not the second. To determine whether or not the lubricated barrel affected velocities, six (6) additional rounds were fired at 0°F without lubricating the barrel, and none reached the velocity of the first round, when the barrel was oiled. Apparently the increasing twist rifling in the tube, with its resulting "X" engraving (Figure 23) of the rotating band will give greater velocities when lubricated.

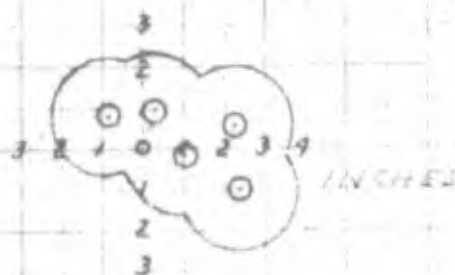
FIGURE 27

Date: 27 September 1951
2 Single Rounds
3 Round Burst
Target 1000 Inches From Muzzle
Target, .25 Inch Beaver Board
Boresight is at Intersection
of X and Y Axis
Type of Ammo. T-132

IA = 3.00 Mils
YA = 2.05 Mils

f. The accuracy of the T217 proof round at 1000" is much better than that of the T132 Rocket Round. (Figures 24 through 30). Apparently the ballistite does not burn uniformly and a different amount of gas is forced from each orifice, although this cannot be detected in the high speed photographs (Figures 17 and 18). Figures 28, 29 and 30 are a series of patterns obtained at 1000", 2000" and 3000" from one firing sequence, and from them it may be seen that the rockets are not traveling in a straight line. Variations in peak velocity and burning time as shown in Figure 15 may be due to uneven burning. It is possible that, due to the loose fit of the launcher propellant bag in the cartridge case, the position of the rocket orifices on firing may affect the ignition and burning of the ballistite. If they were in a vertical plane, the lower orifice would be directly against the launcher propellant, while the upper one would not, probably causing uneven ignition.

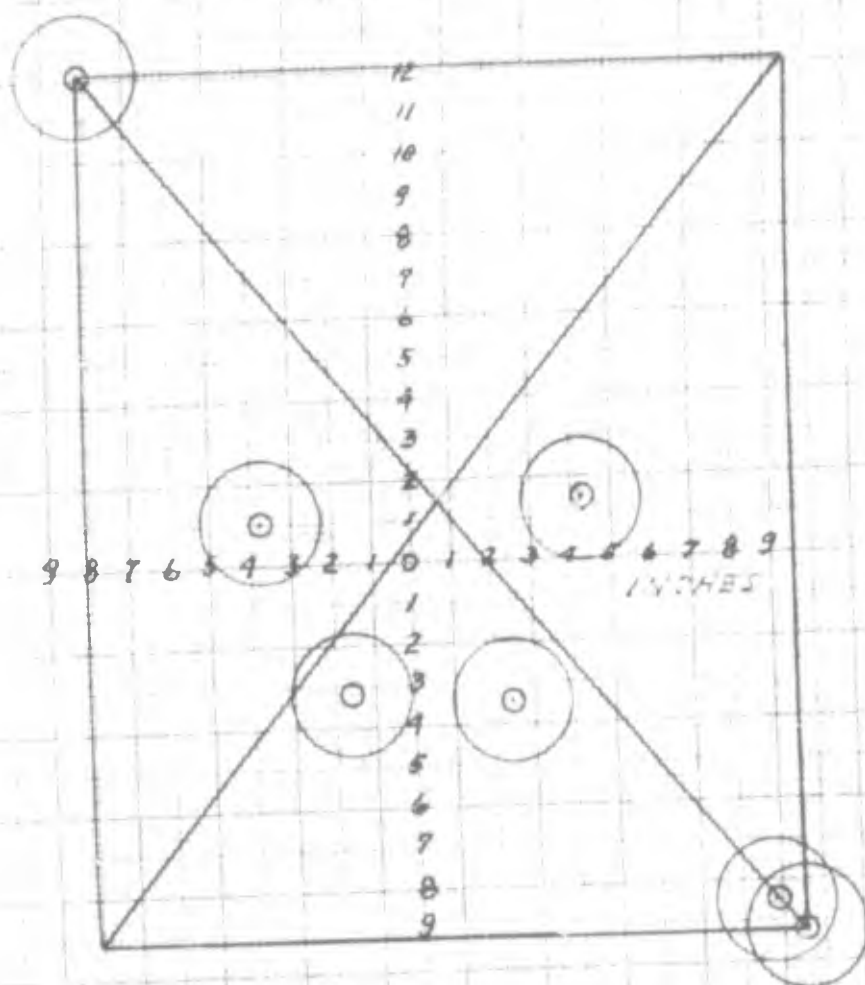
FIGURE 29

Date: 12 October 1951
 2 Single Rounds
 5 Round Burst
 Target 2000 Inches From Muzzle
 Target, .25 Inch Beaver Board
 Bore-sight is at Intersection
 of X and Y Axis
 Type of Ammo. T-132

KA = 9.32 Mils
 YA = 10.69 Mils
 XB = .05 Mils
 YB = .7 Mils

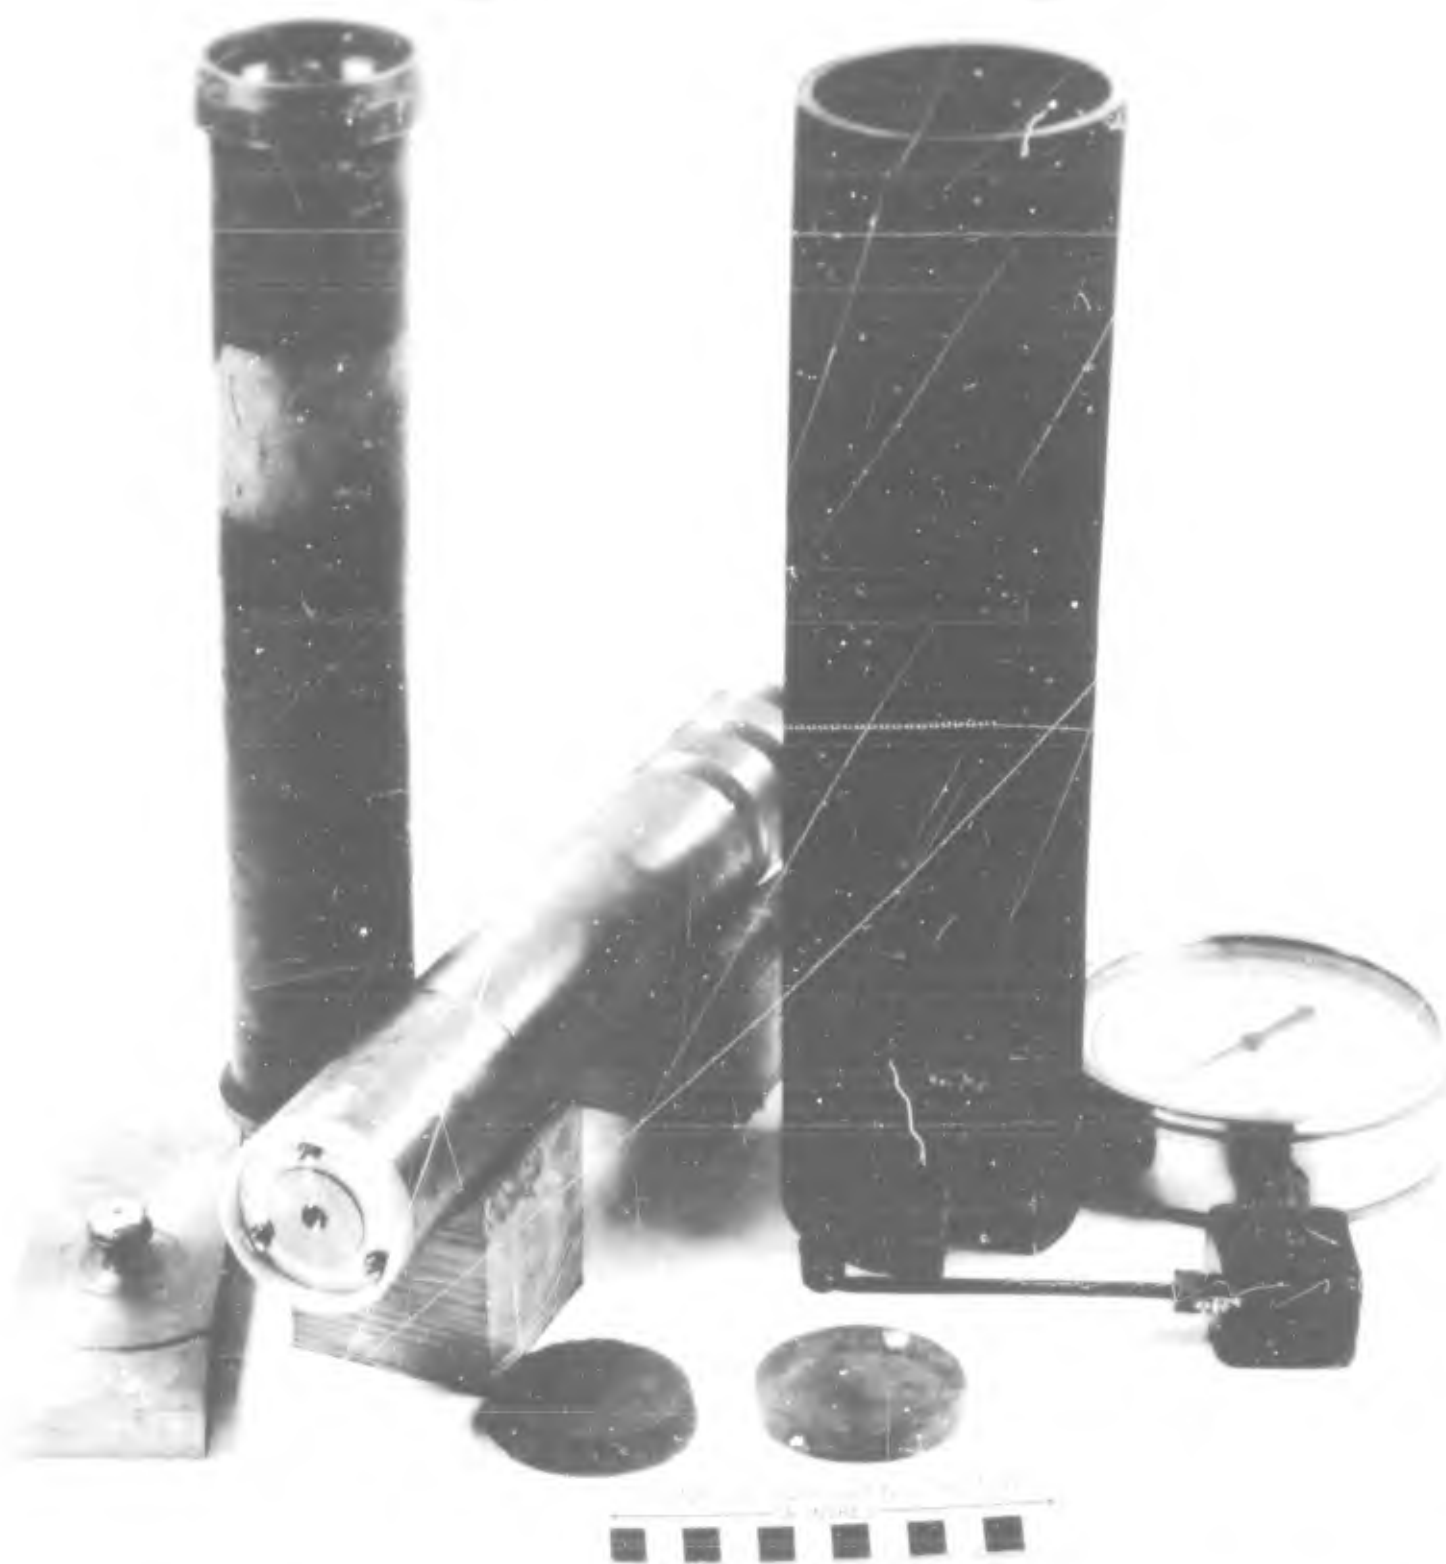
View of piston, washers and gauge fabricated by the Naval Proving Ground to test used cartridge cases hydrostatically at 7500 p.s.i.

g. In order to reuse the cartridge cases, the Naval Proving Ground was advised by the Bureau of Ordnance to test them hydrostatically at 7500 psi before reloading. To accomplish this, a piston was made with a nylon cup type washer, Figures 31 and 32, that fitted snugly inside the case. This was put under a hydraulic press, and forced downward into a case filled with oil, until the desired pressure was obtained. It was noted that oil was flowing past the nylon washer and it was impossible to maintain pressure. To overcome this, several discs, 2.75 diameter, were cut from 1/2" gasket rubber. It was found that if one was placed on top of the oil in the case, and one placed inside the nylon cup, pressure could be maintained for an indefinite period. The Naval Gun Factory later manufactured an enclosed type of tester, shown in Figure 33 which was superior to the piston type, as a case could be tested in 5 minutes using it, compared to 15 minutes using the piston. During the testing of approximately 50 cases, some of which were fired as many as six times, only one showed a leak. This particular defective case had been fired only once, and the leak was between the base and the cylinder.
