U. S. NAVAL PROVING GROUND
DAHLGREN, VIRGINIA

REPORT NO 973

2"75 AUTOMATIC ROCKET LAUNCHER T-110-E2B

1st Partial
Report

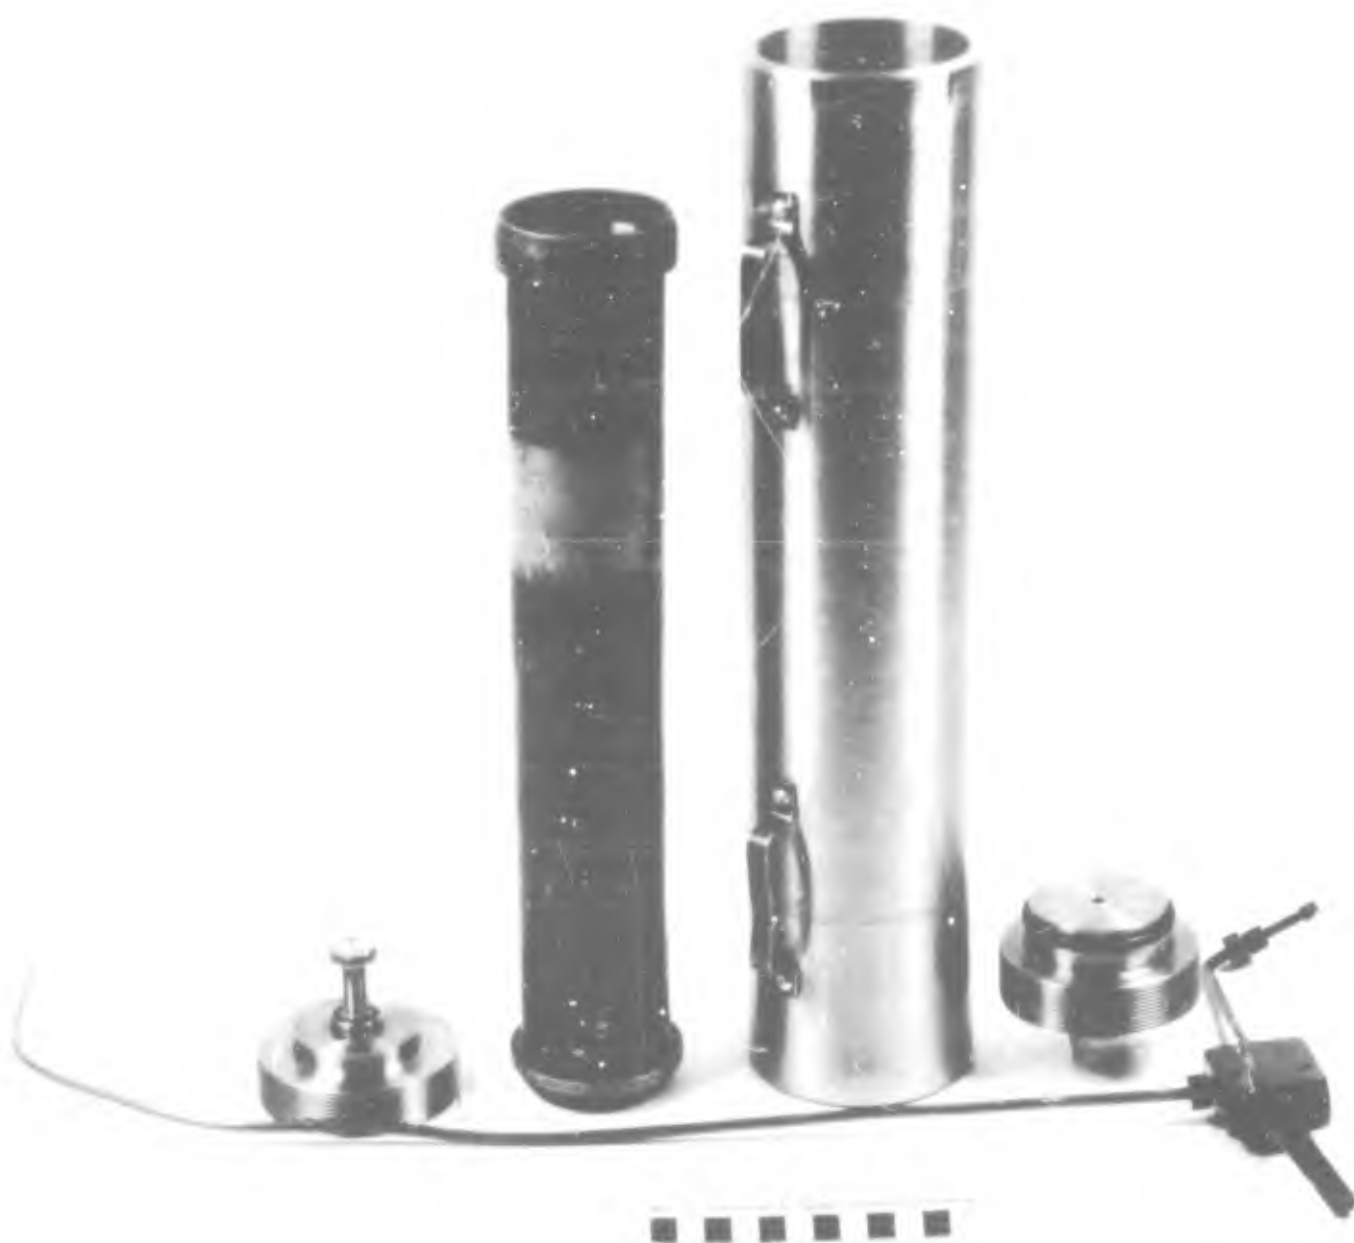
View of enclosed type cartridge case tester manufactured by the Naval
Gun Factory.

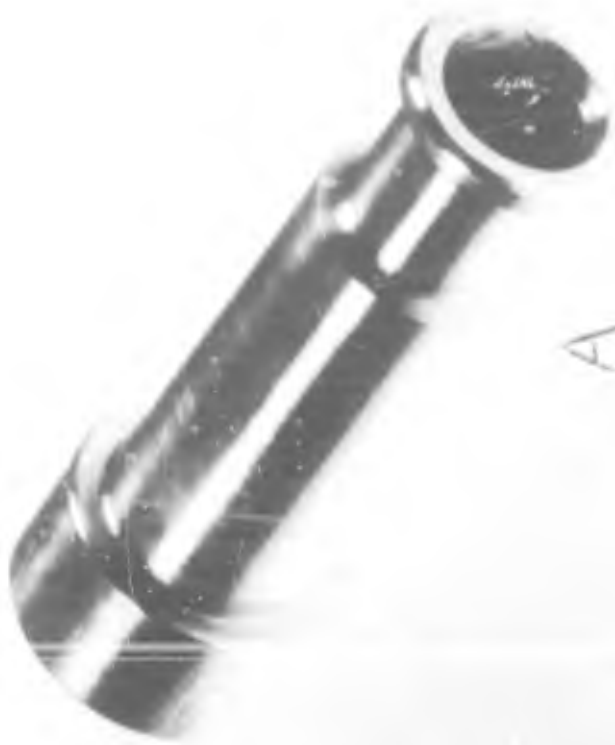
View of Naval Proving Ground designed and manufactured replacement parts (a) One piece cam
following roller and shaft, (b) Teflon firing pin insulator.
Figure 35

Several misfires were encountered during the early part of the firing, due to the breakdown of the Firing Pin Insulation Cone (Drawing Number 22D2-206) which was made of #005 Fishpaper. To overcome this shorting and arcing, three experimental Firing Pin Seats were made, one each of Nylon, Teflon and Synthane (Figure 35). Of the three, the seat made of Synthane was found to be the best, as both of the others tended to seize the firing pin and hold it in.
