GAO

OPERATION DESERT STORM

Early Performance Assessment of Bradley and Abrams

B-247224

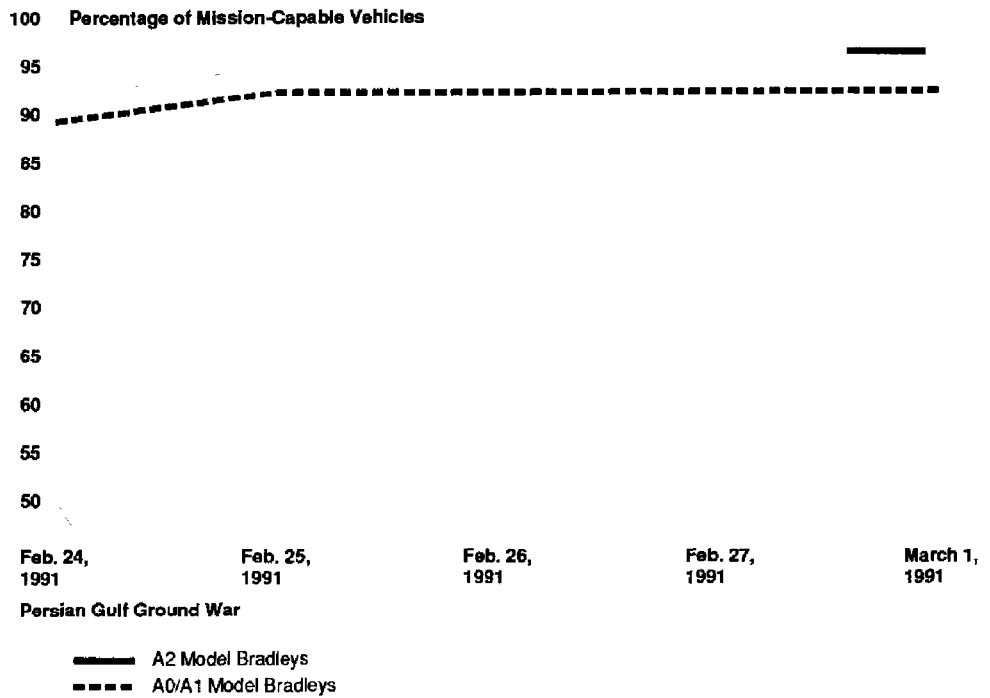
Figure I.2: Percentage of Bradley Fighting Vehicles That Were Combat Ready From February 24 Through March 1, 1991

Note. Data for February 28, 1991, was not available.

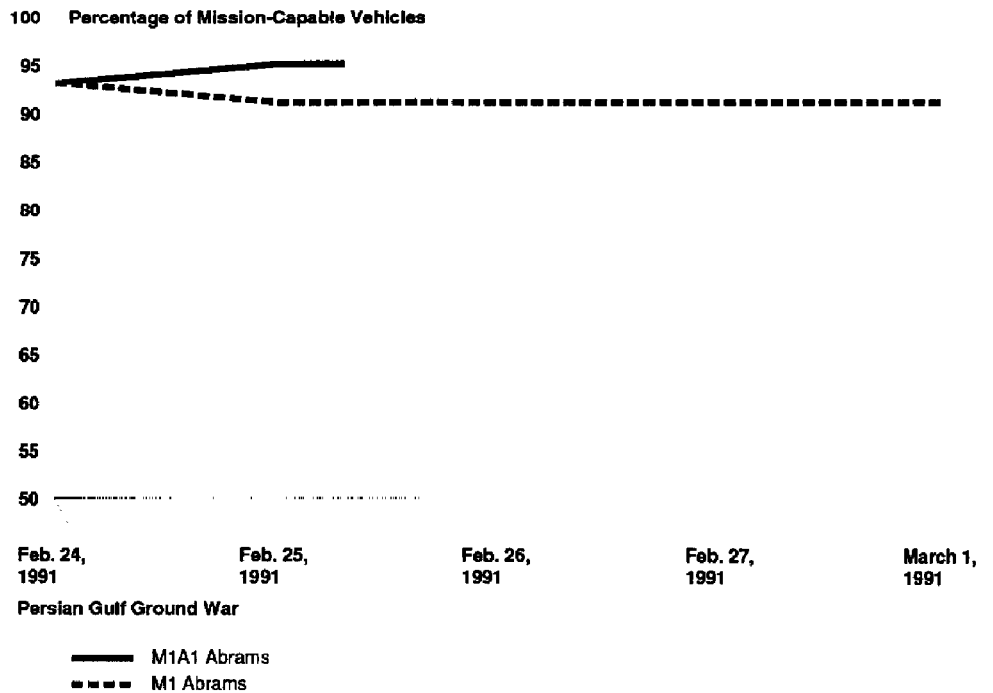
Figure II.2: Percentage of Abrams Tanks That Were Combat Ready From February 24 Through March 1, 1991

As shown in figure II.2, the percentage of Abrams tanks that were reported as combat ready, based on whether the vehicle could move, shoot, and communicate, exceeded 90 percent during the ground war.

Note: Data for February 28, 1991, was not available.

The high reliability indicated by the readiness rates shown in figure II.2 was supported by the observations of tank commanders, crews, and maintenance personnel at each unit we visited. According to those we interviewed, the Abrams' reliability throughout the ground campaign was very good, provided the necessary spare and repair parts were available. Some crews reported that the Abrams tanks were the "best combat vehicles on the battlefield." Others stated that they traveled unprecedented distances with few reliability problems.
