BUREAU OF SHIPS GROUP

TECHNICAL INSPECTION REPORT

FAILURES OF MASTS, YARDARMS, BOOMS, AND RIGGING

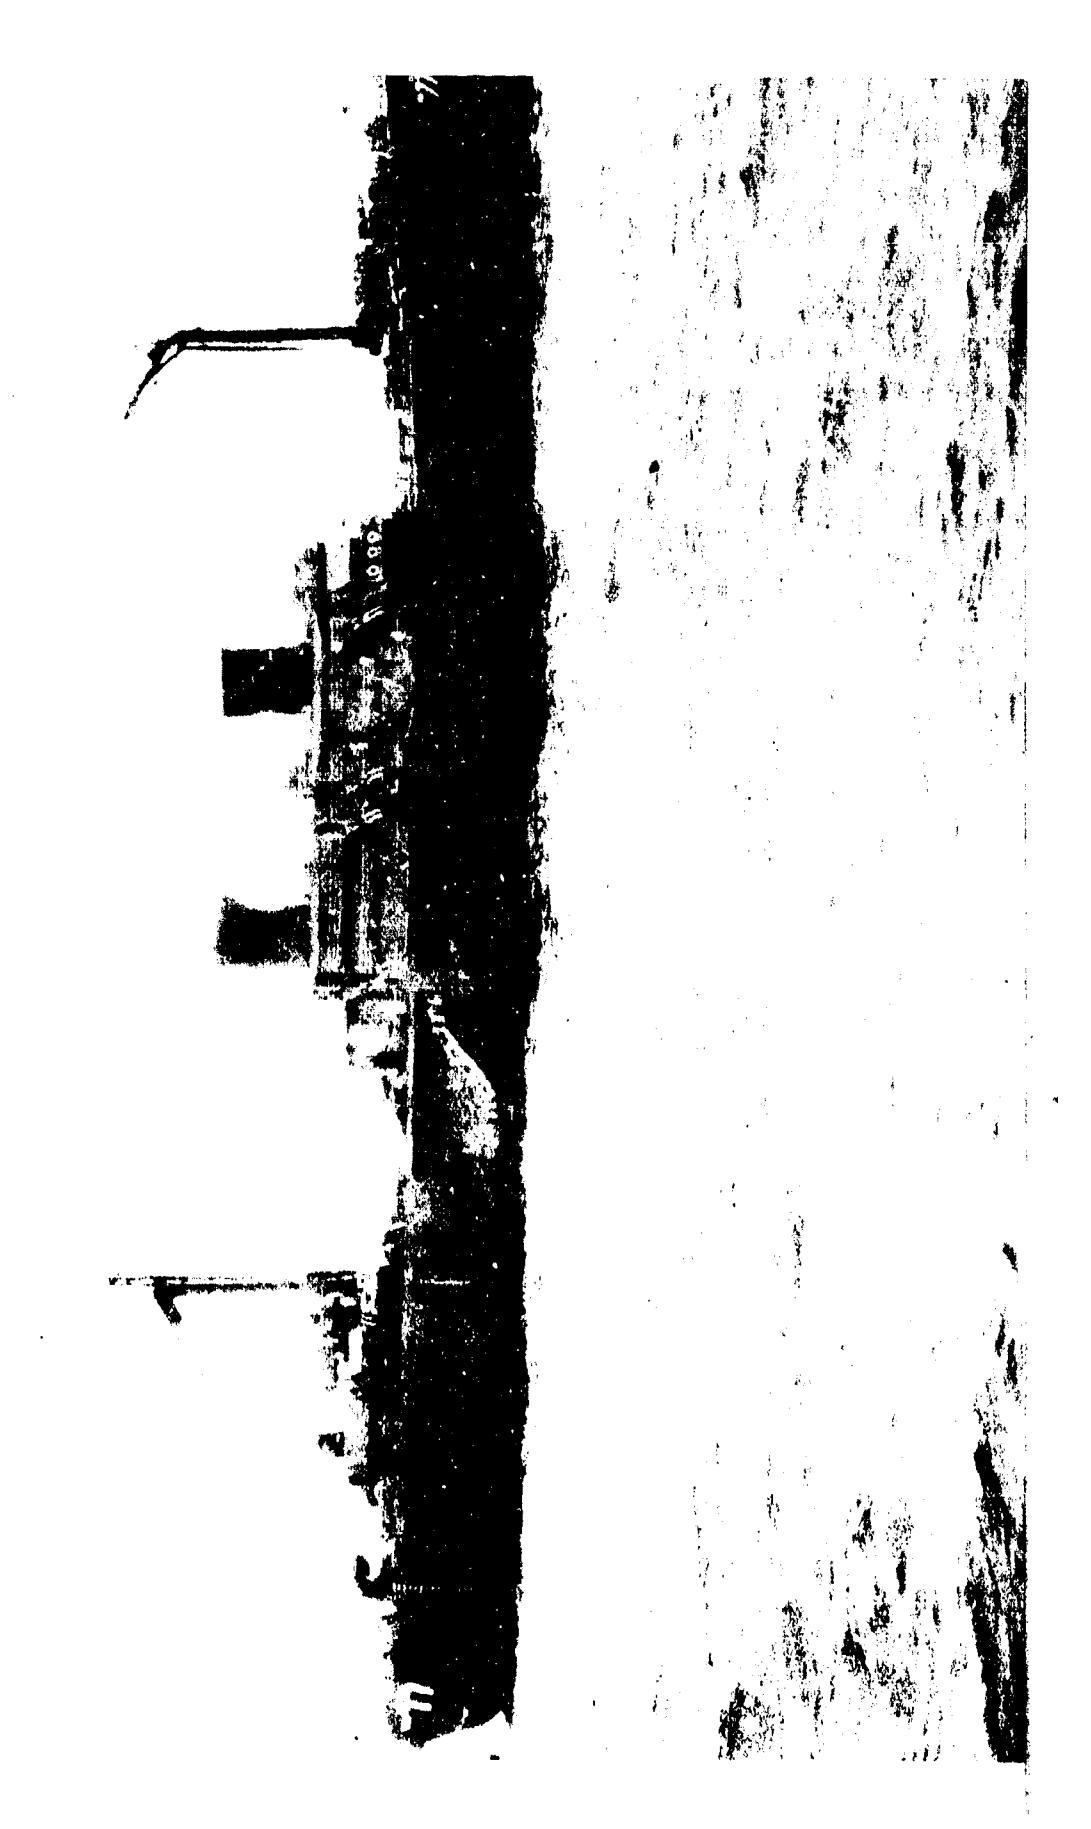
3. The maintopmast is bent about 110 degrees out of its normal vertical position and in the direction of the blast travel. See photos 227-49-116, 1906-9, 1906-12 and 1921-12; pages 26, 37, 38, and 39. The bend occurs just above the crosstree level and, as in the case of the foremast, the mast is fractured at the bend. The mainmast cargo booms, which were stowed in clamps along the mast, are useless due to their severe deformation. Photos 1922-2 and 1905-11; pages 40 and 41 show severe kinking of the starboard boom about 10 feet above the hinge pin. The port boom is bent in an easy curve.

AB-CR-227-49-116. USS CRITTENDEN (APA77). View looking at starboard beam after Test A.

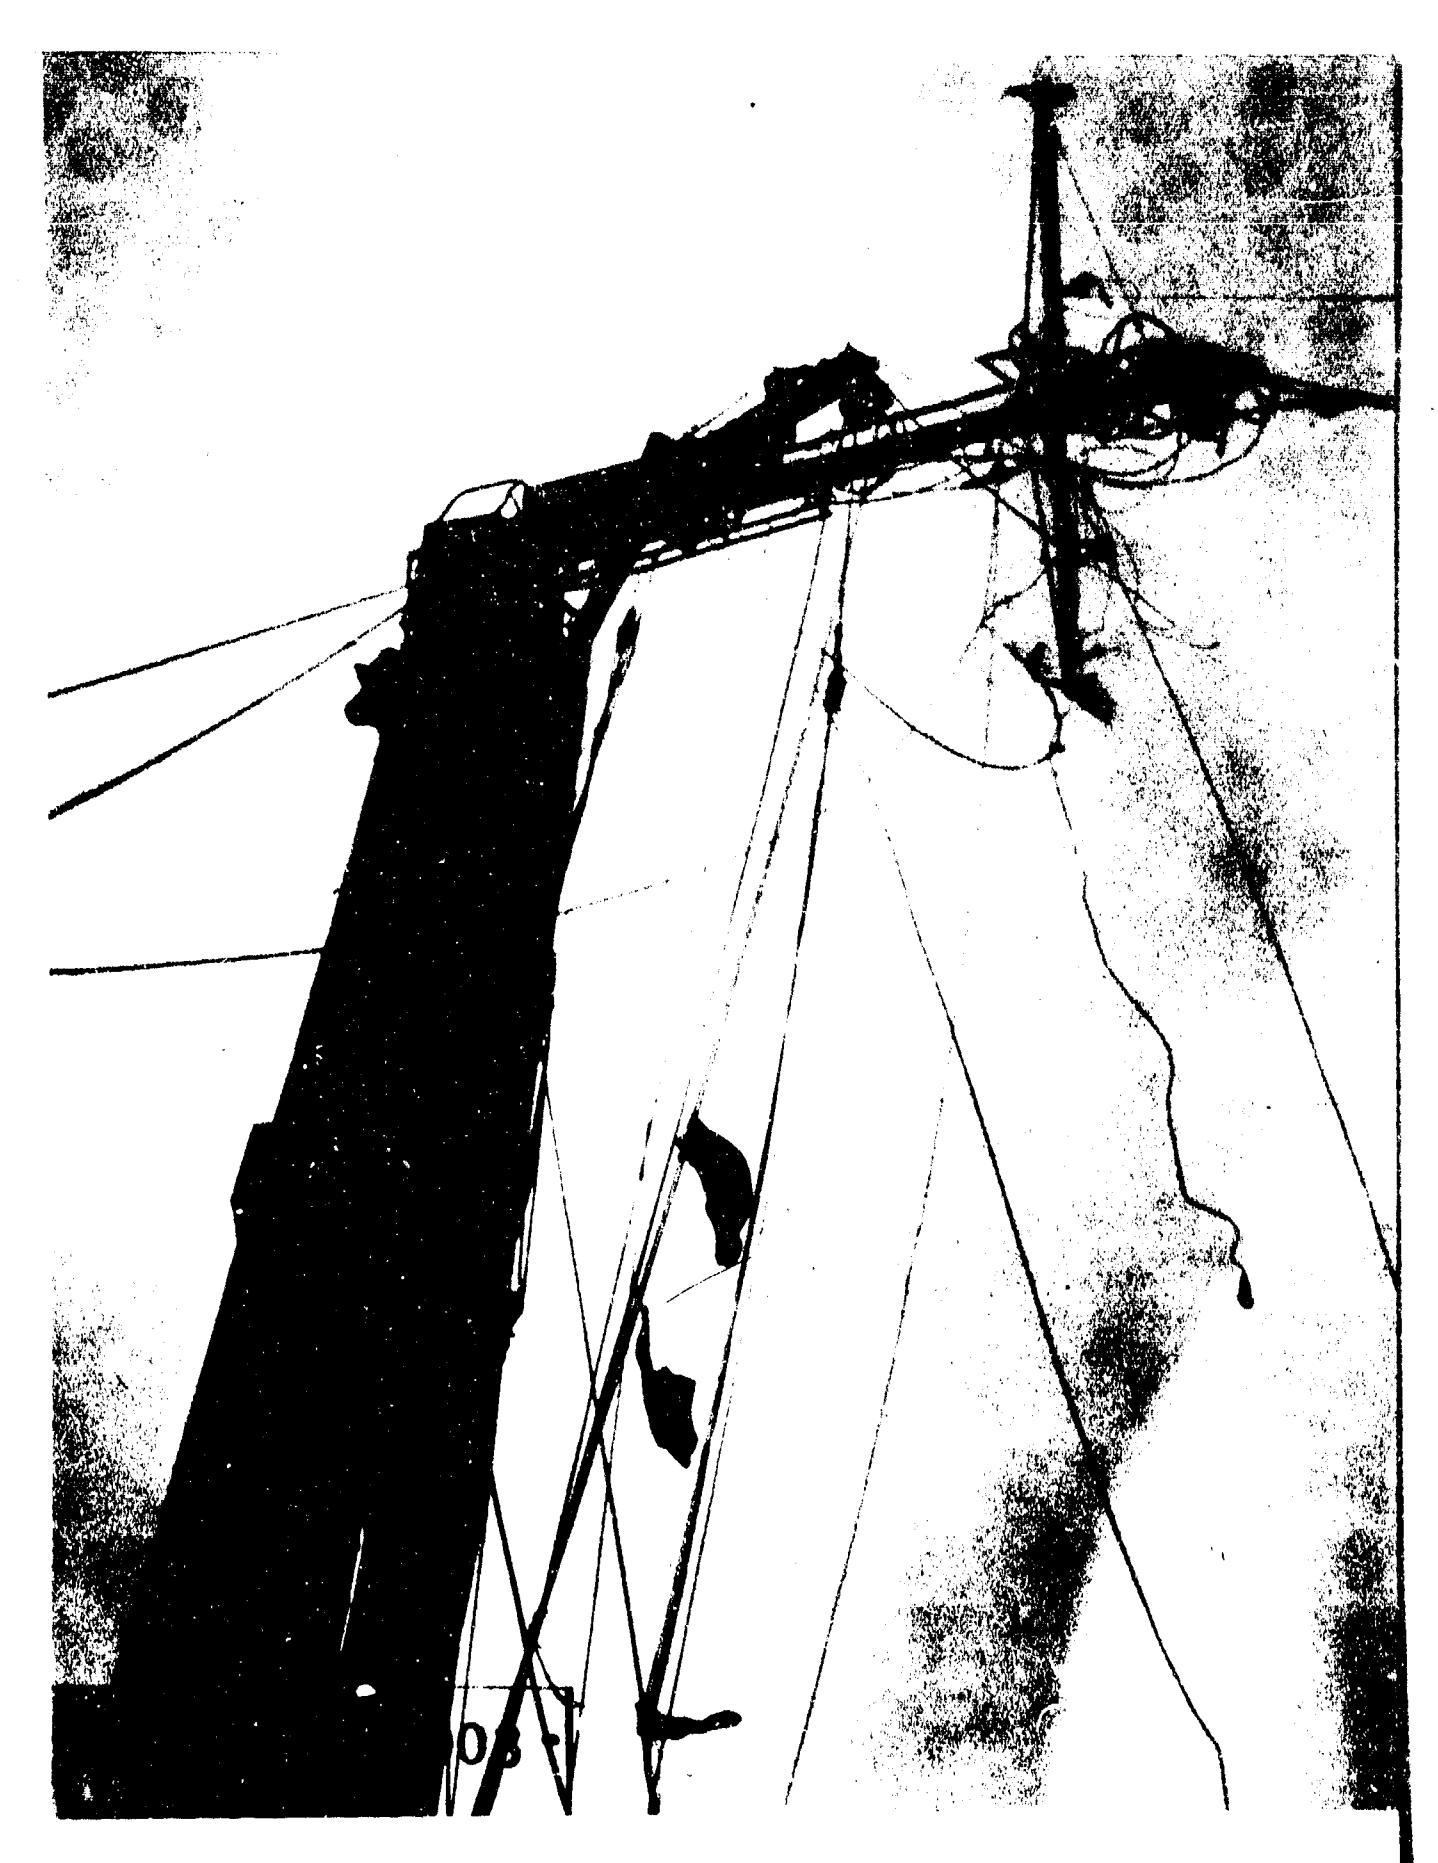
AA-CR-80-1903-7. USS CRITTENDEN (APA77). Foremast, looking to starboard. Note sharp bend in port and starboard cargo booms.

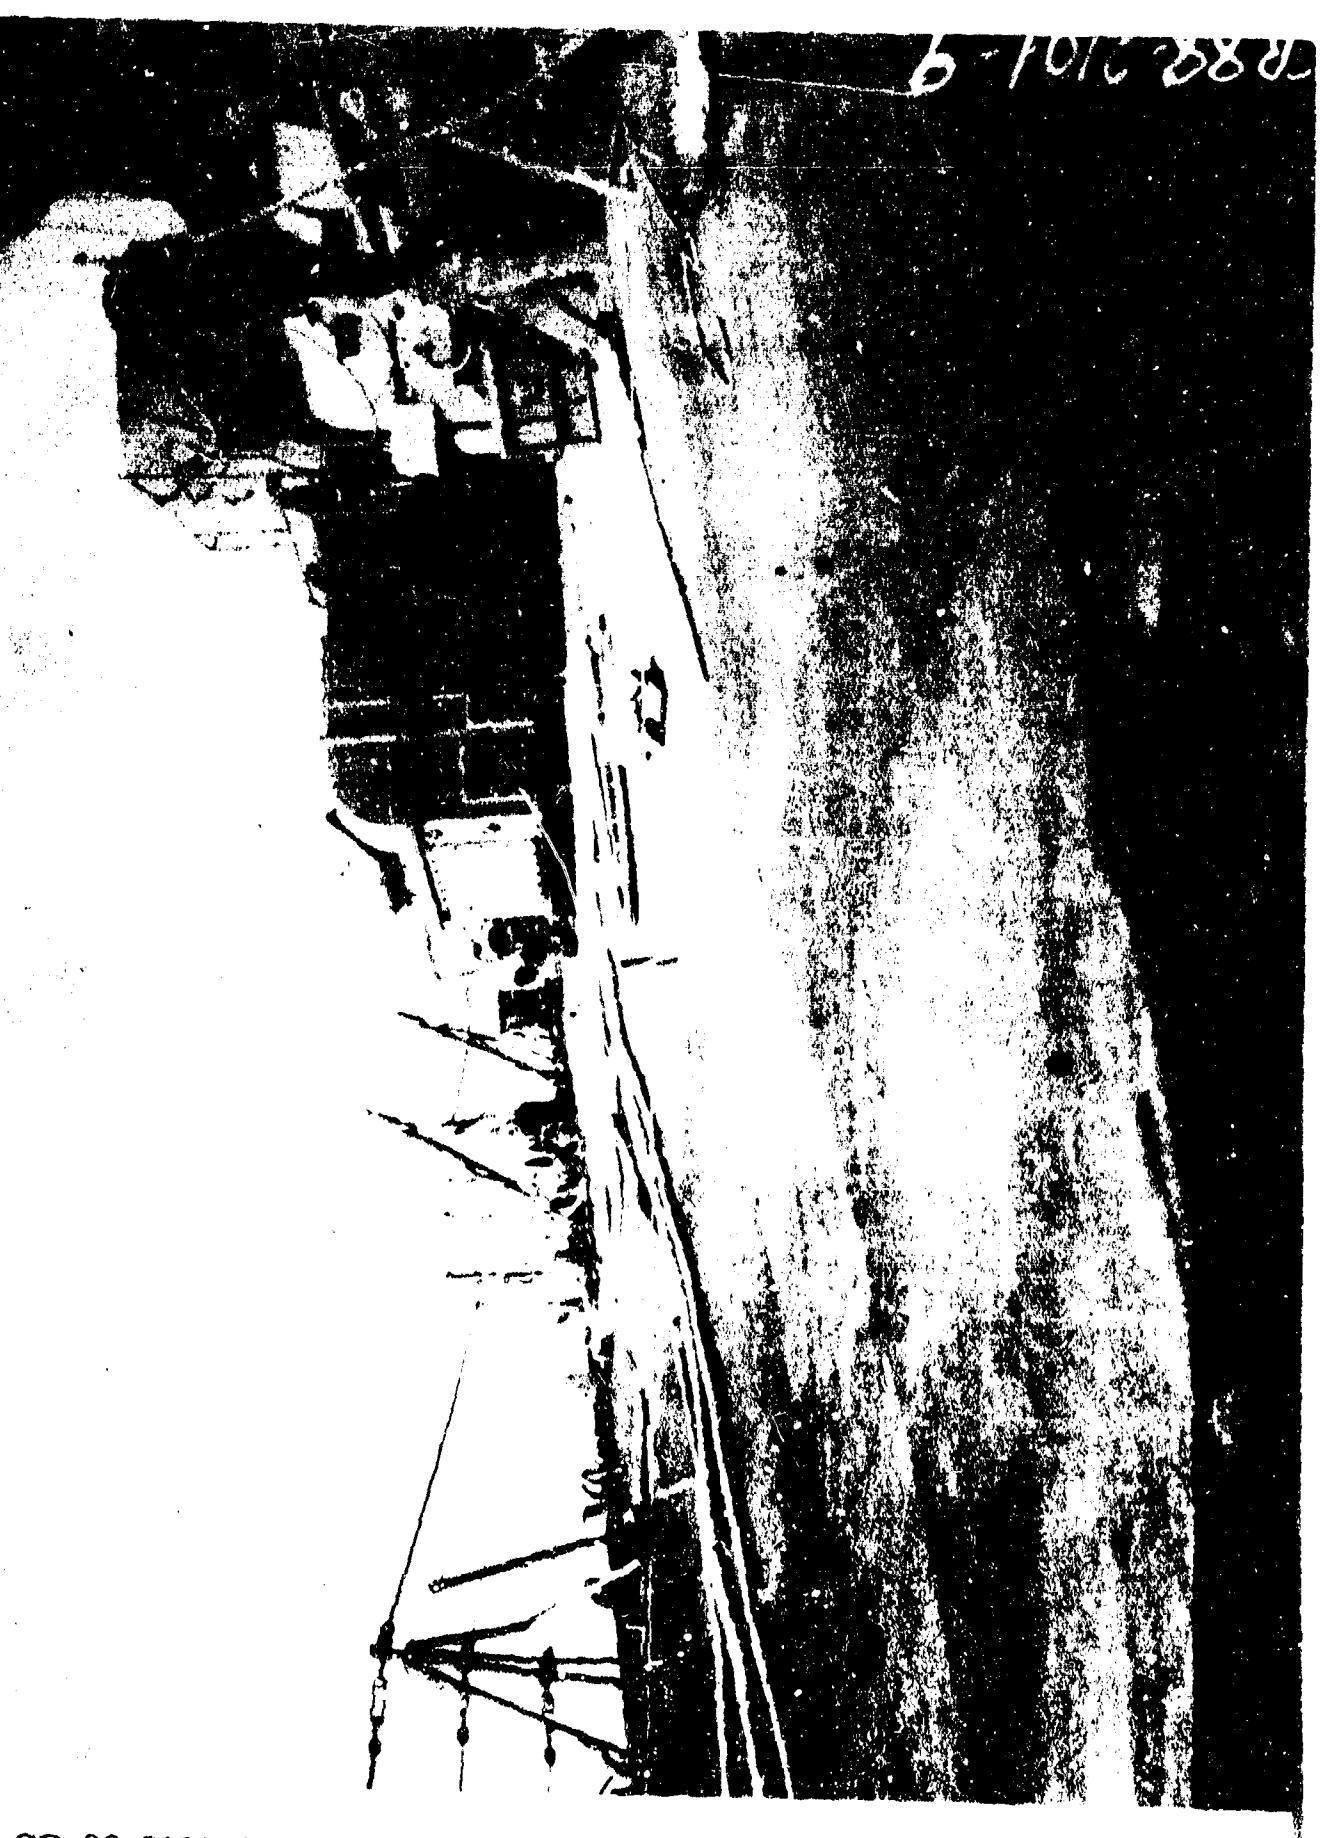
AA-CR-88-2101-9. USS CRITTENDEN (APA77). Upper deck, port side, showing foremast stay turn-buckles.

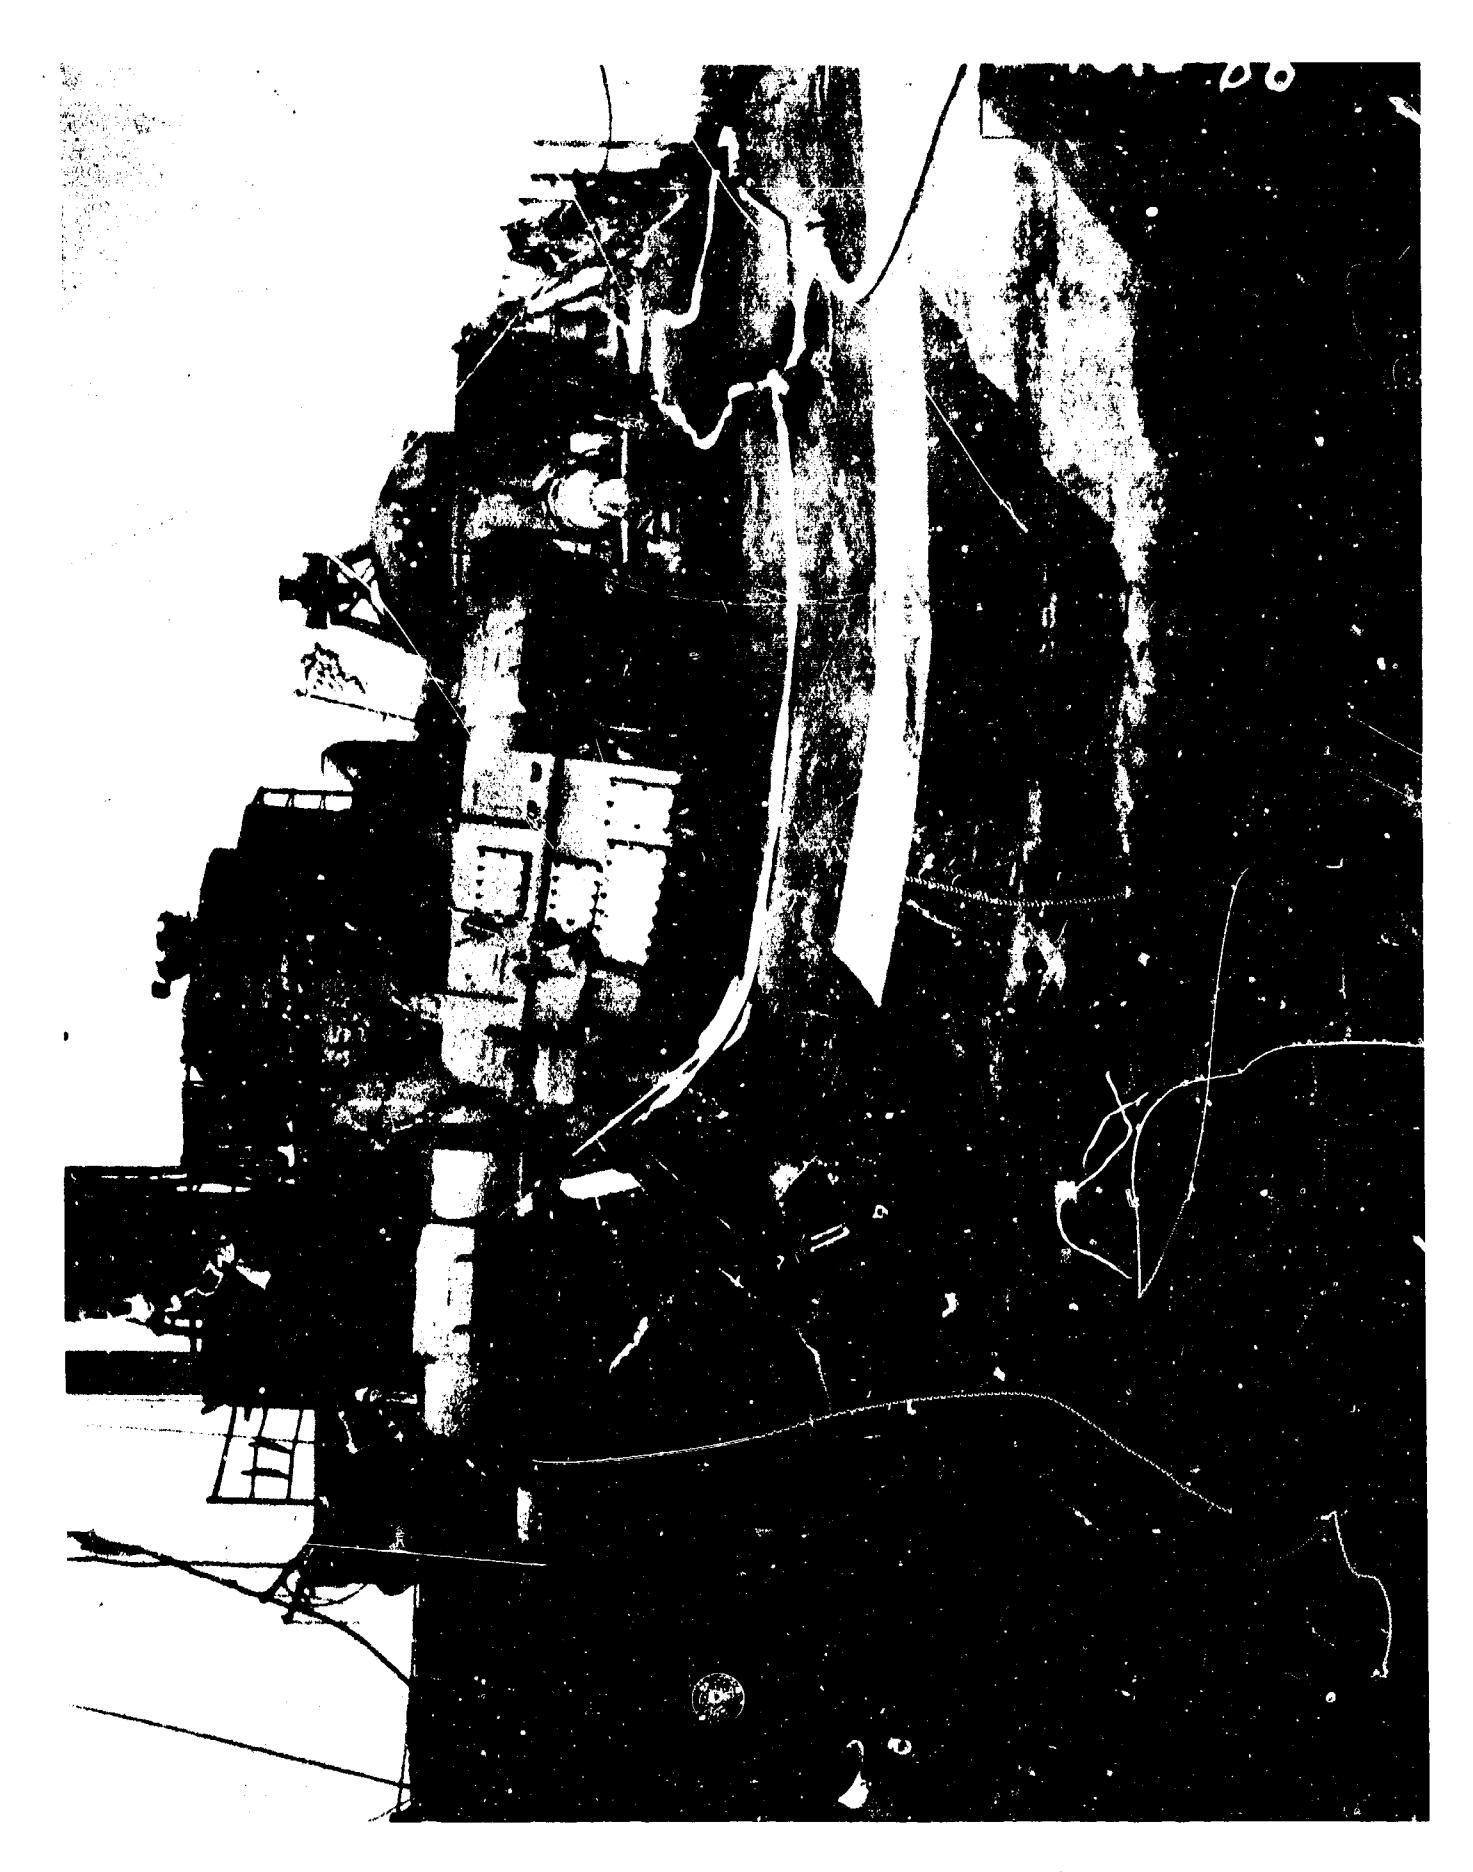
AA-CR-88-2101-12. USS CRITTENDEN (APA77). Upper deck, starboard side, showing foremast stay turn-buckles.

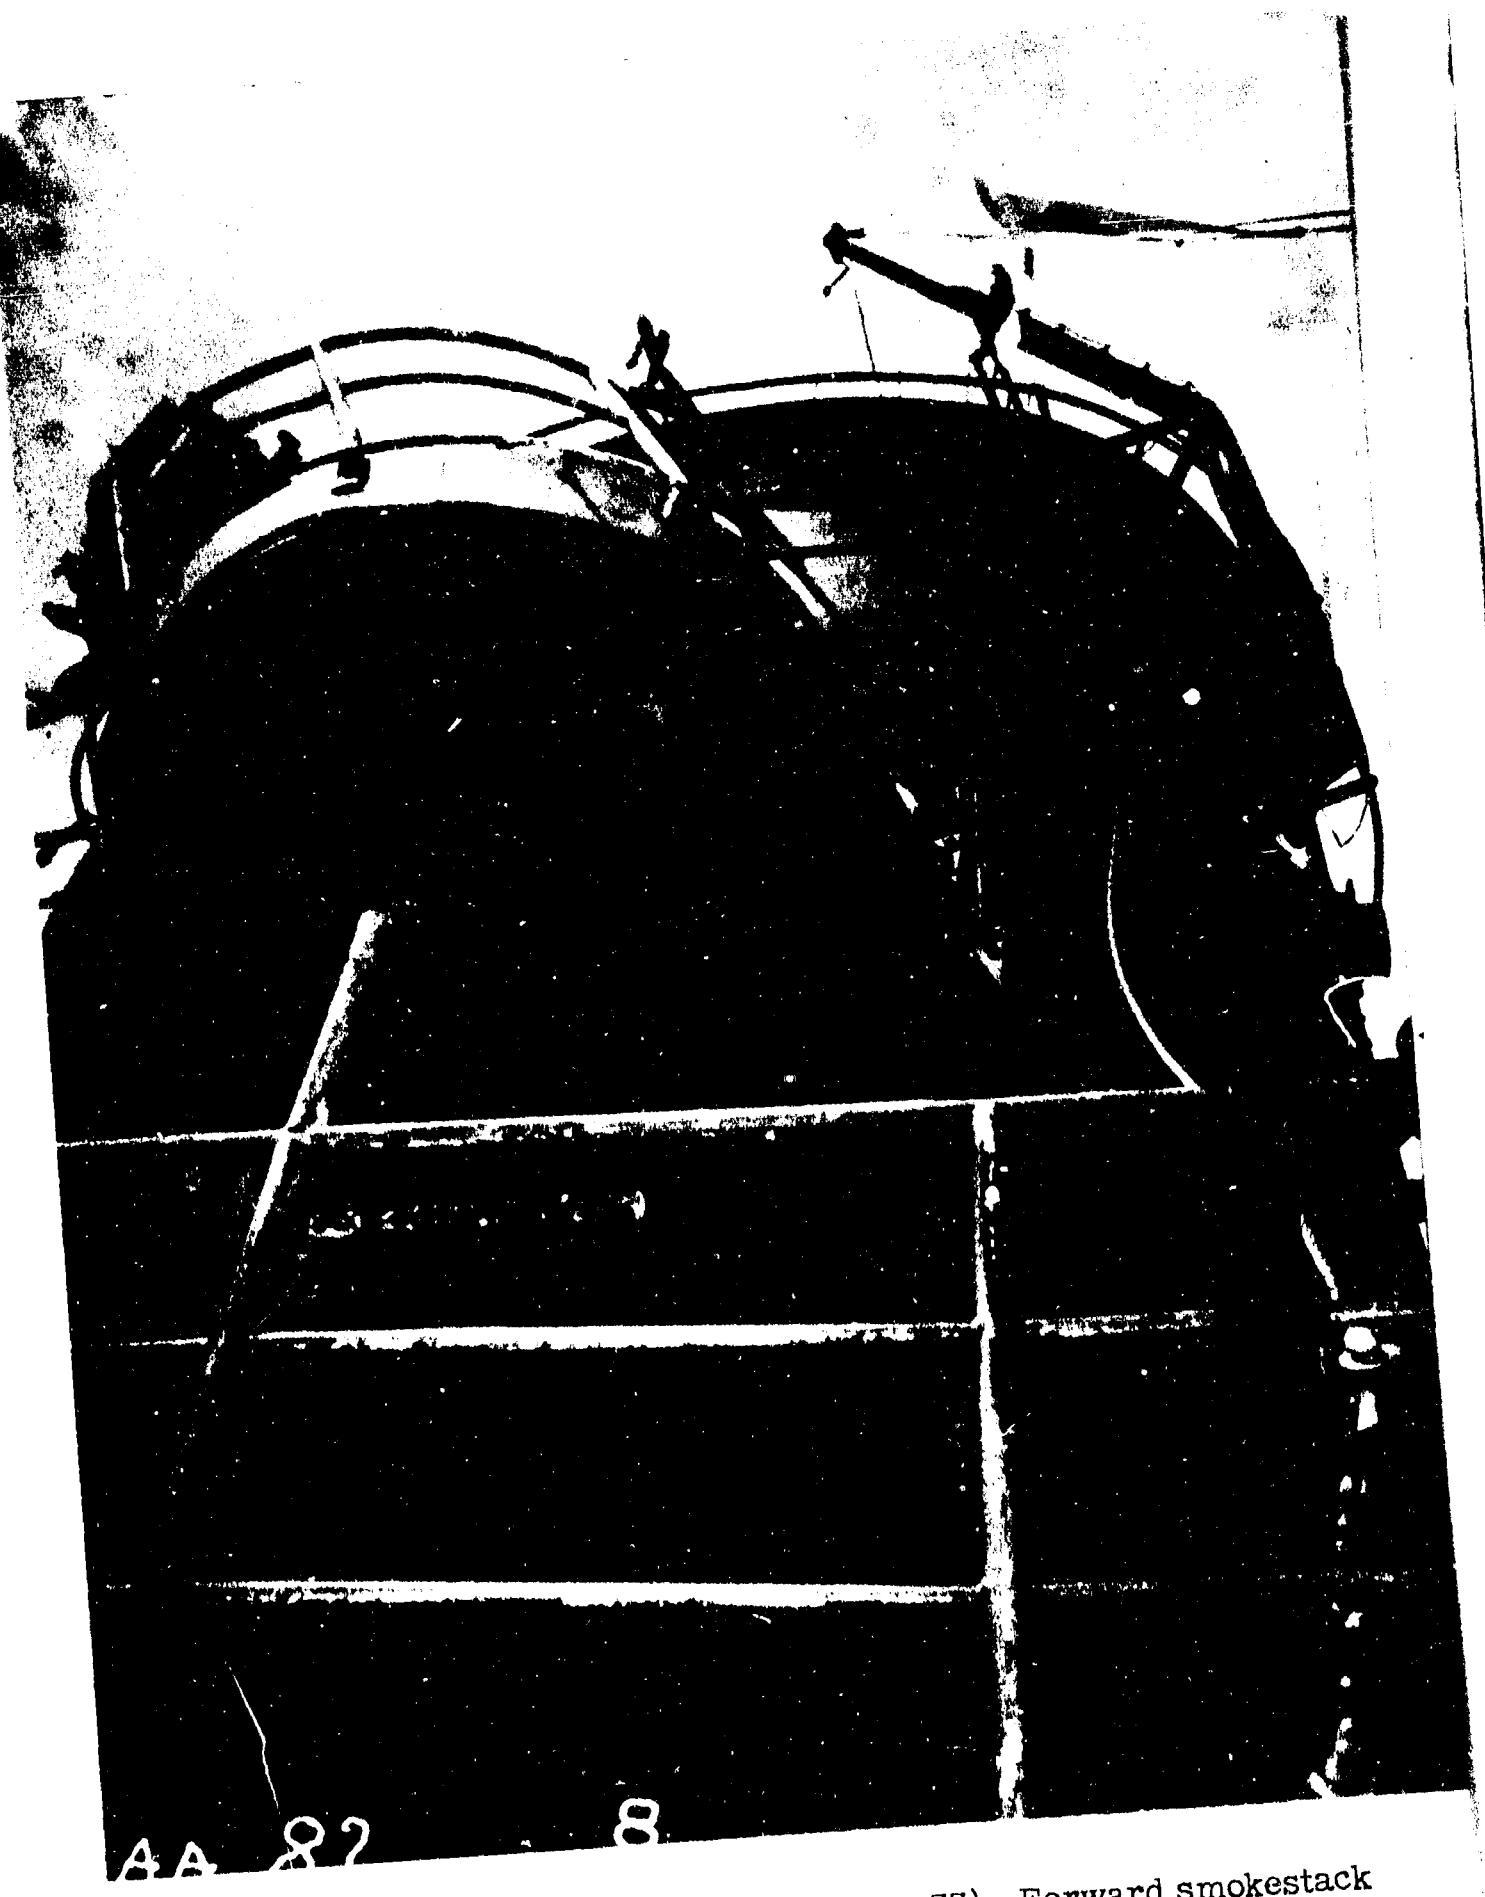
photos 1904-7, 2058-9, and 1922-8; pages 34, 35, and 36. Just above the braces, at mid-height, the mast bends sharply aft and slightly to starboard. The braces are sharply bowed. The port yardarm bends sharply at the mast and extends somewhat to starboard. The starboard yardarm is broken off about six inches from the mast.

AA-CR-82-1922-8. U.S.S. CRITTENDEN (APA-77). Forward smokestack and signal mast. Page 36 of 211 Pages

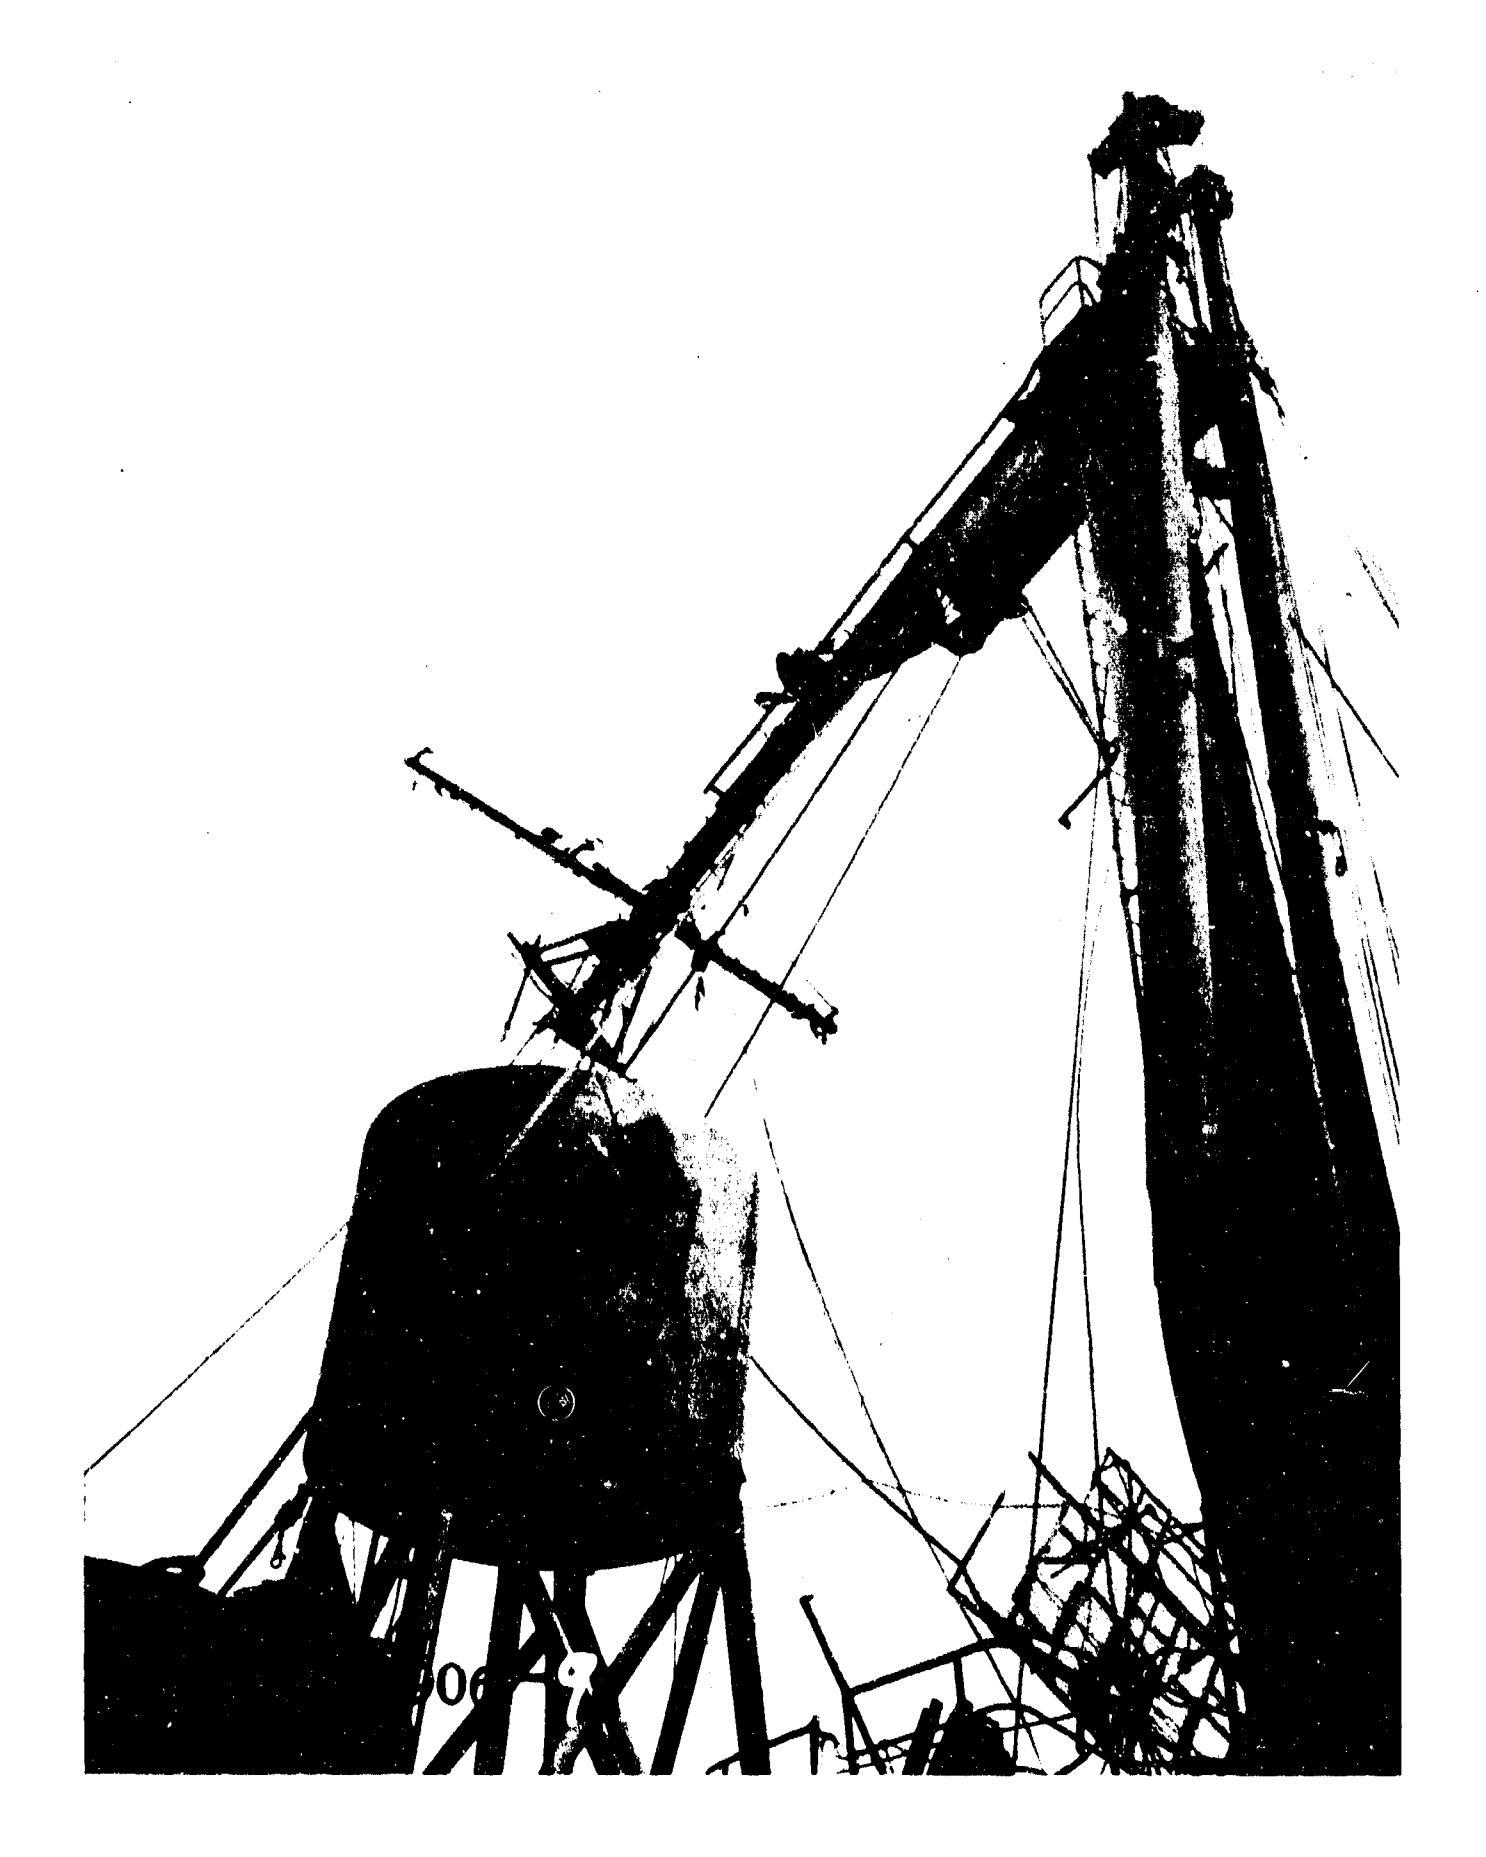
AA-CR-80-1906-9. U.S.S. CRITTENDEN (APA-77). Mainmast. Note relatively sharp bend of starboard cargo boom, and long easy curve of port cargo boom.

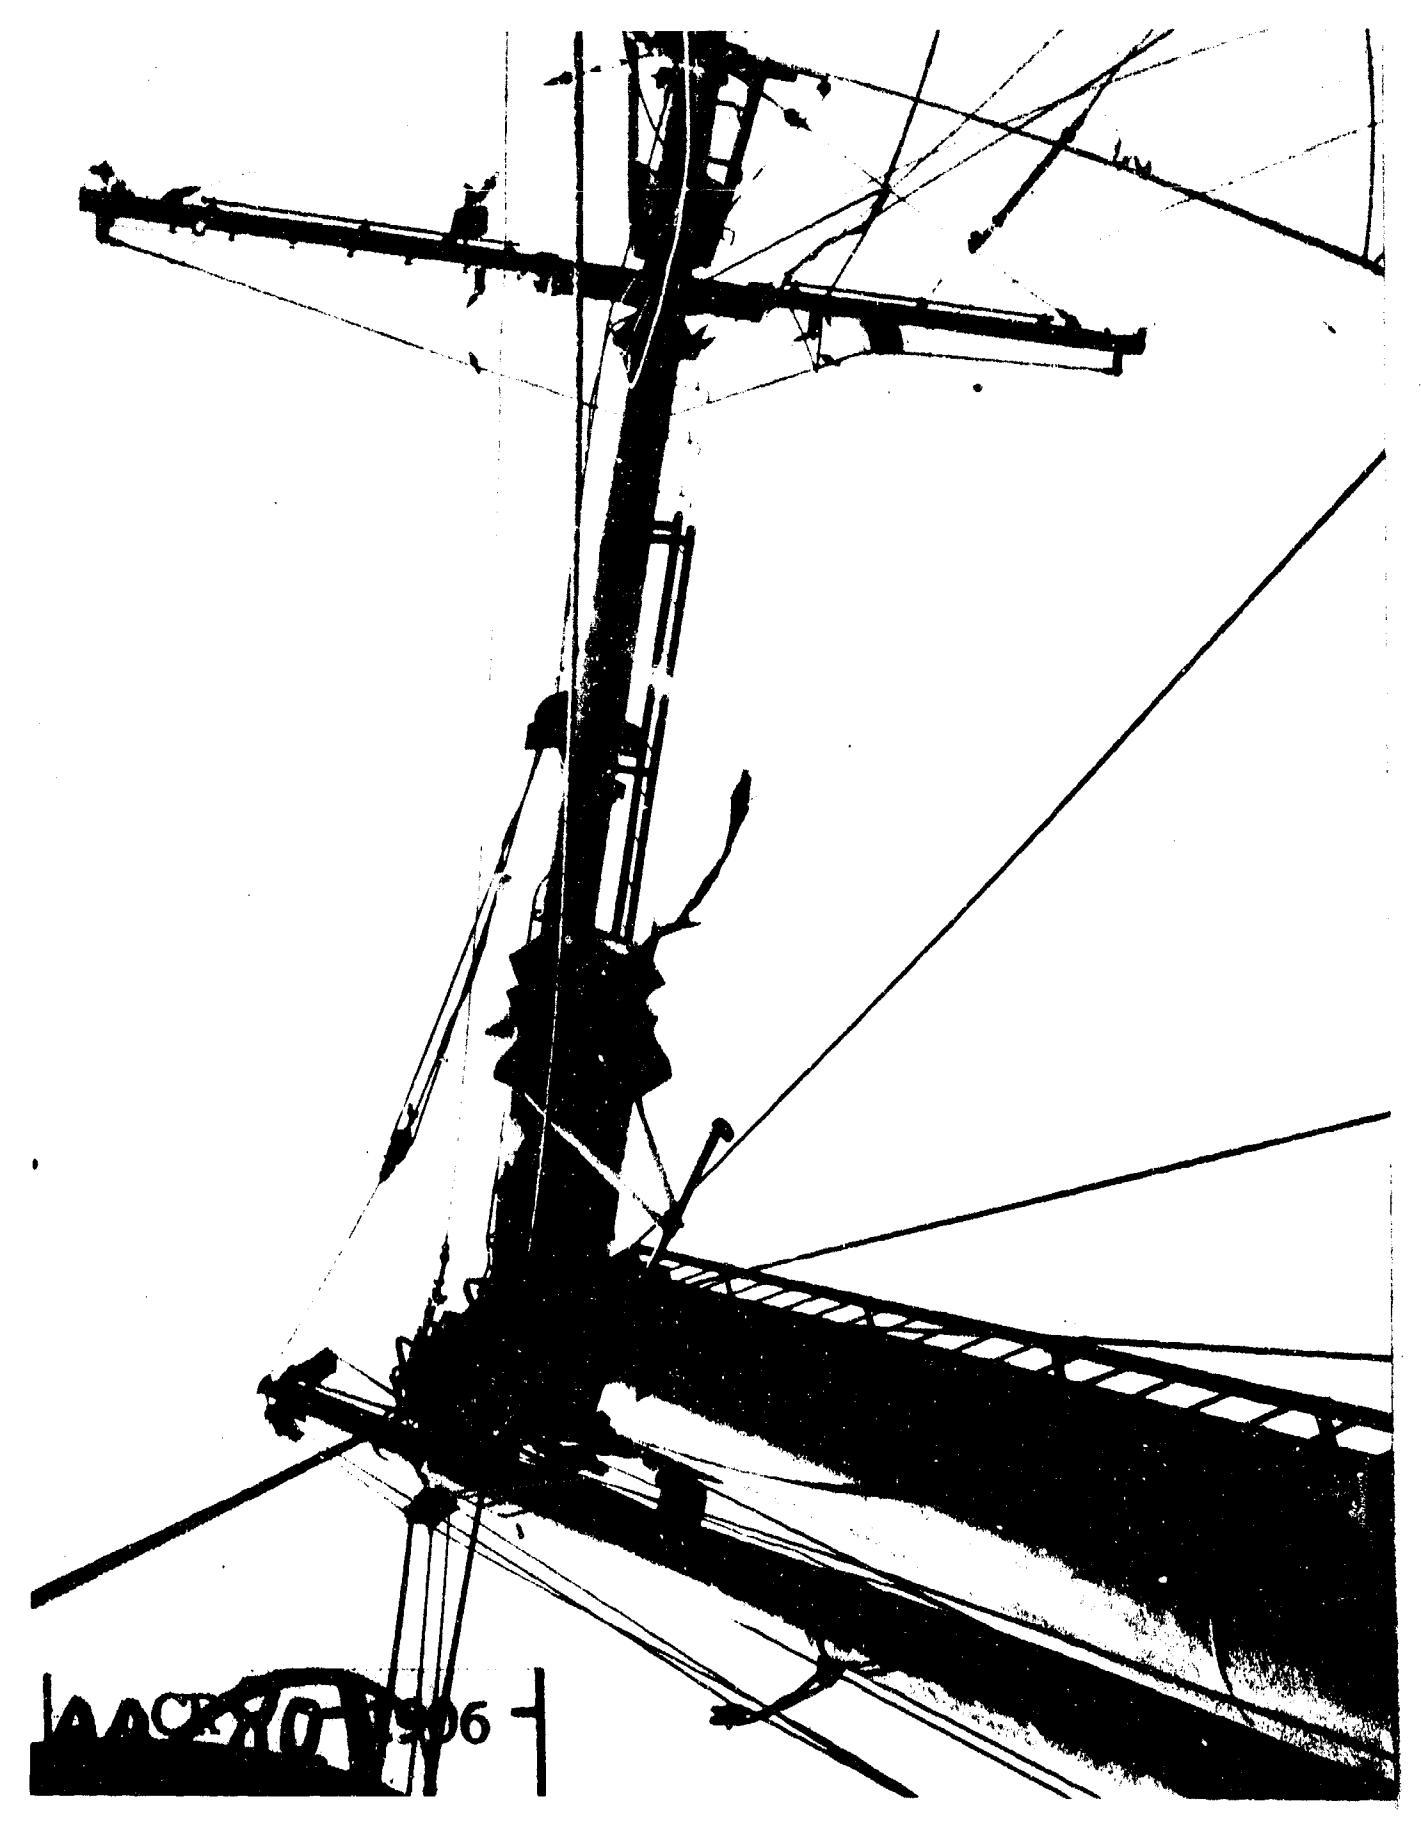
AA-CR-80-1906-12. U.S.S. CRITTENDEN (APA77). Maintopmast. Looking up from top of after deckhouse.

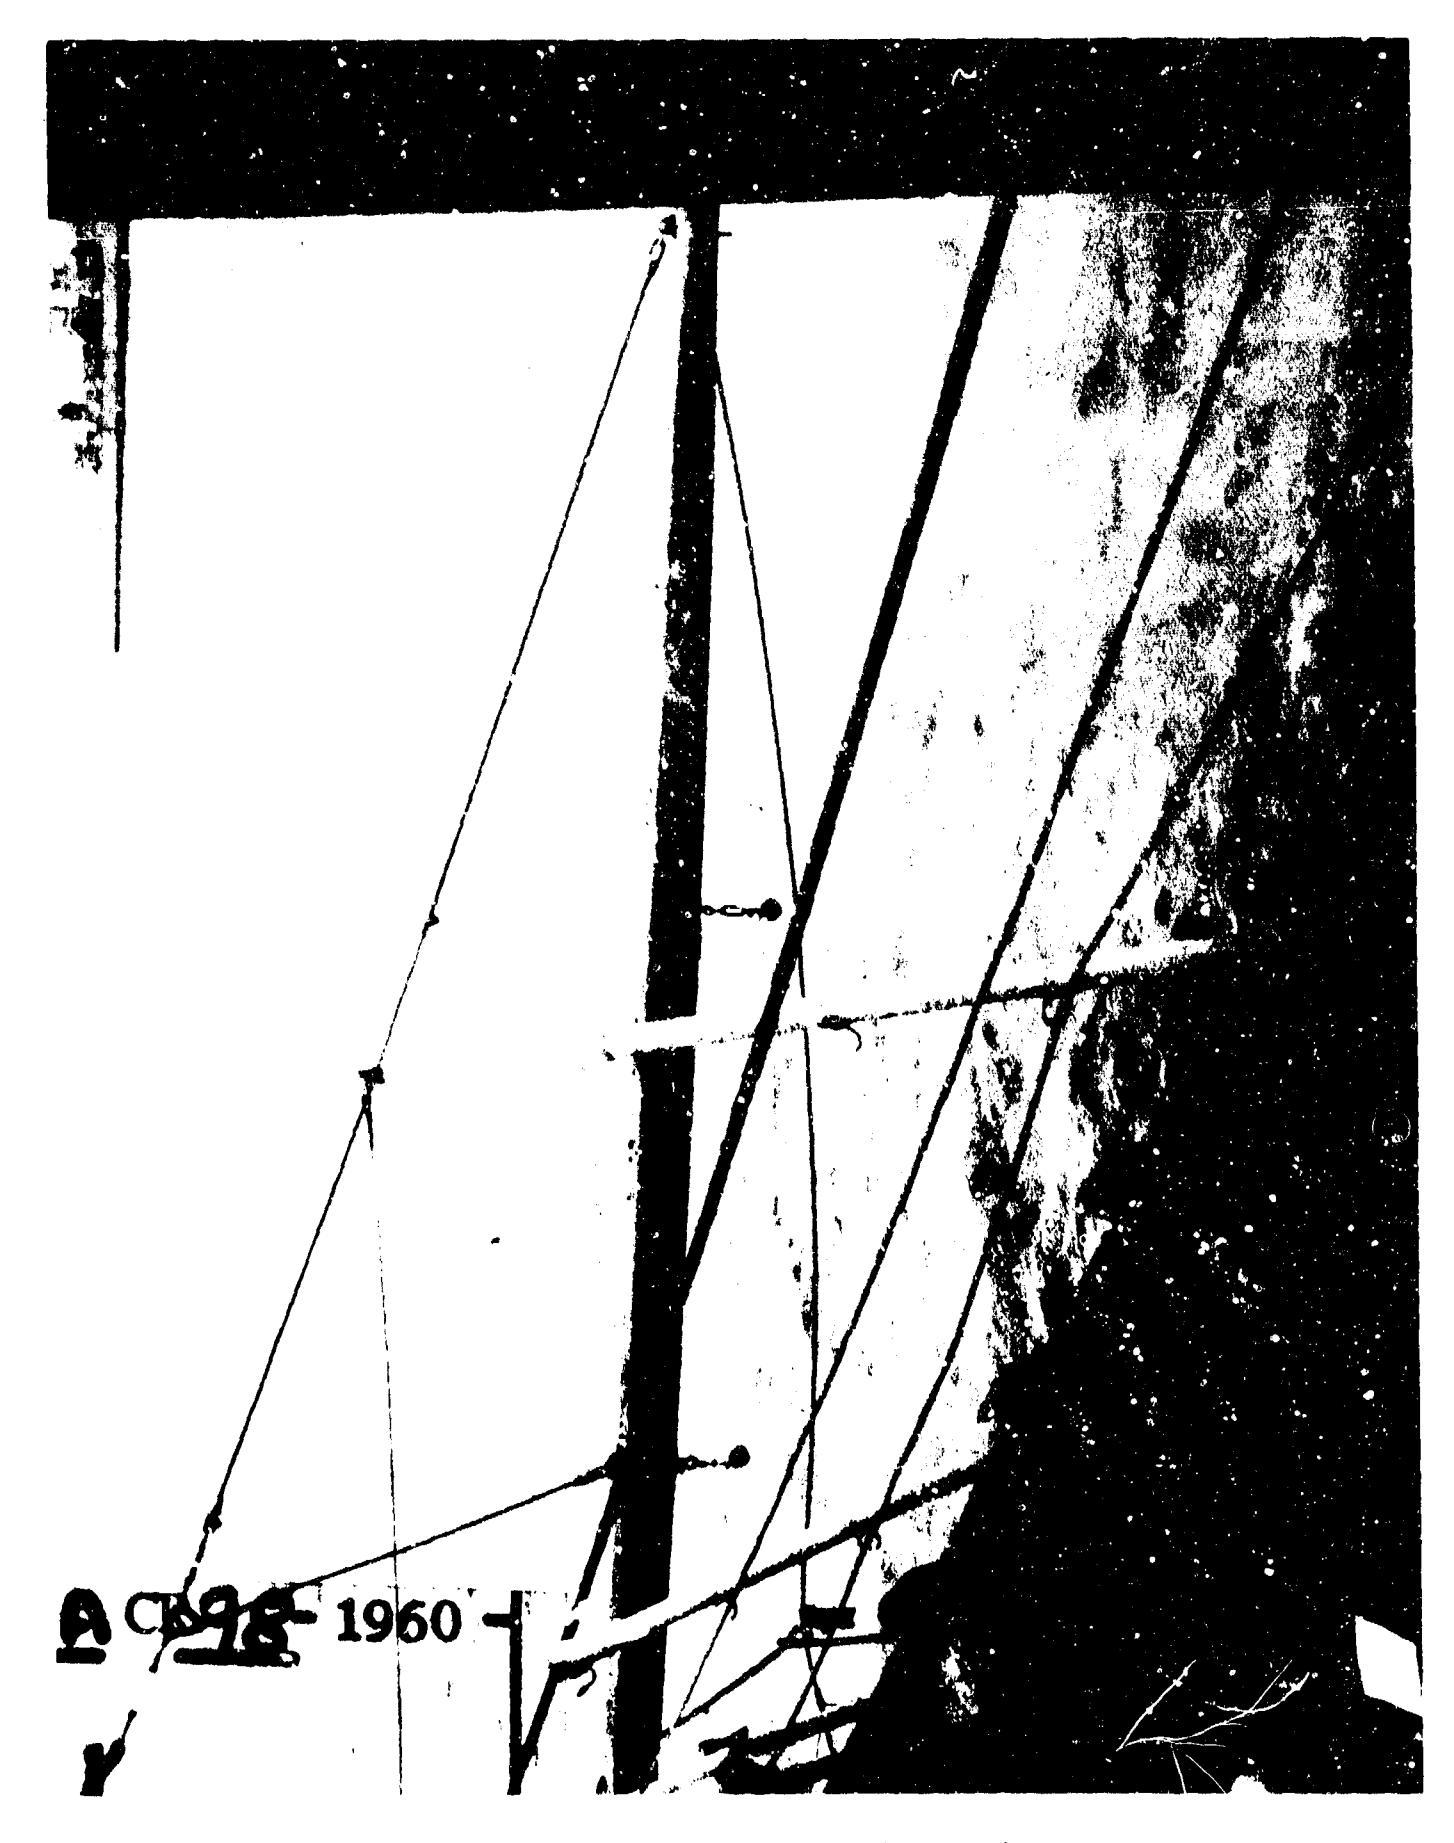
5. Photo 1960-12, page 43 shows the port boat boom, frame 59, swinging free. This boat was clamped in place before the test. The starboard boat booms remained in place. The pipe life rails on the port side are generally damaged, and on the upper deck forward, port side, there are large gaps in the rail. The rails on the upper deck suffered more severely than did those on other levels.

AA-CR-98-1960-12. USS CRITTENDEN (APA77). Port boat boom knocked out of clamp.
