BUREAU OF SHIPS GROUP

TECHNICAL INSPECTION REPORT

FAILURES OF MASTS, YARDARMS, BOOMS, AND RIGGING

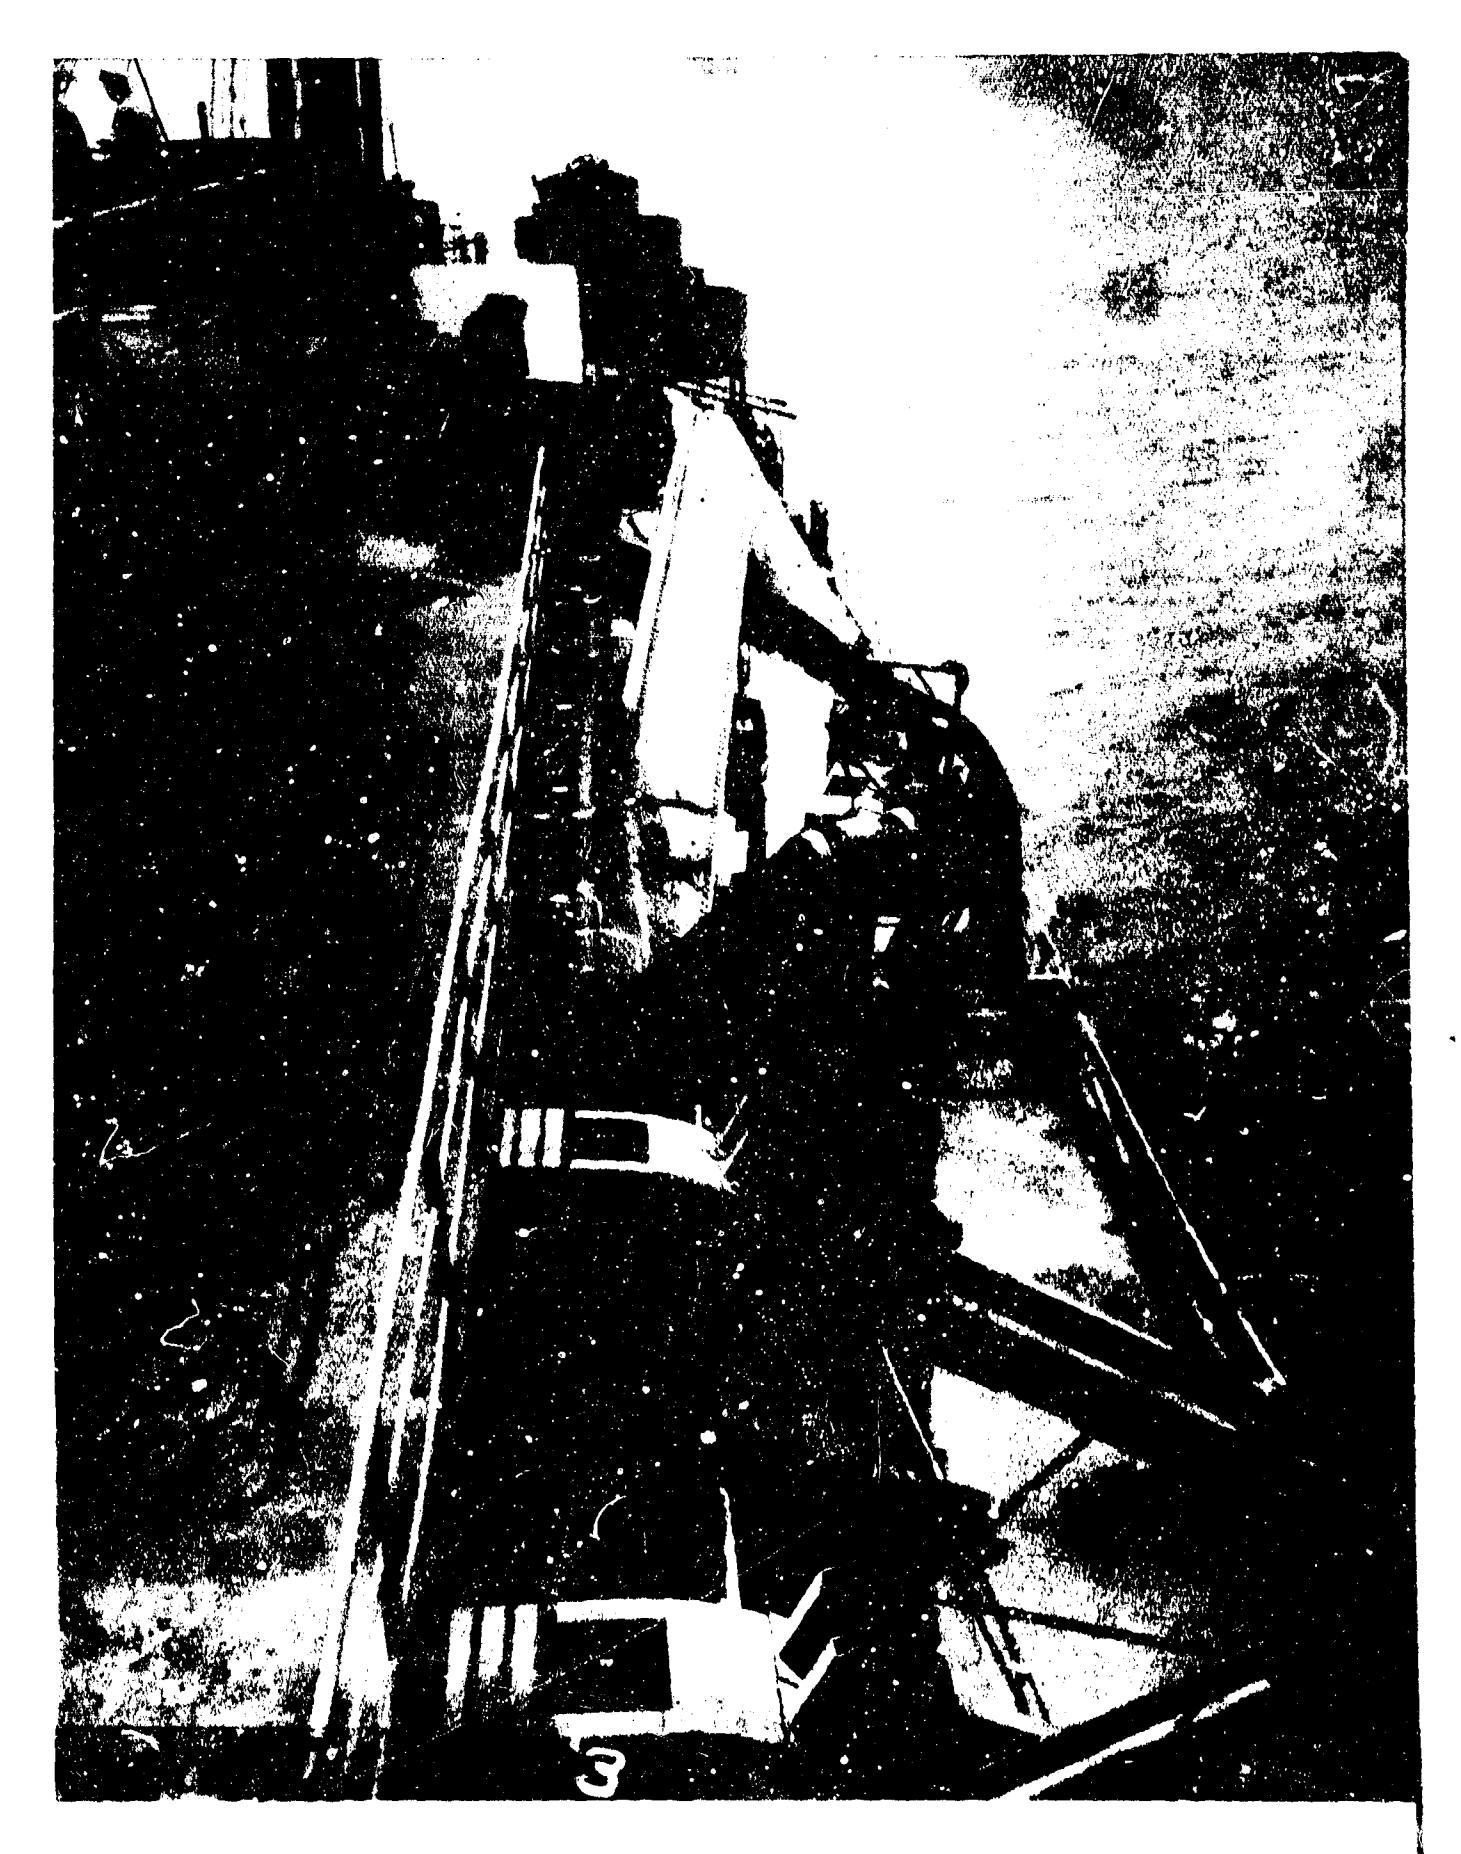
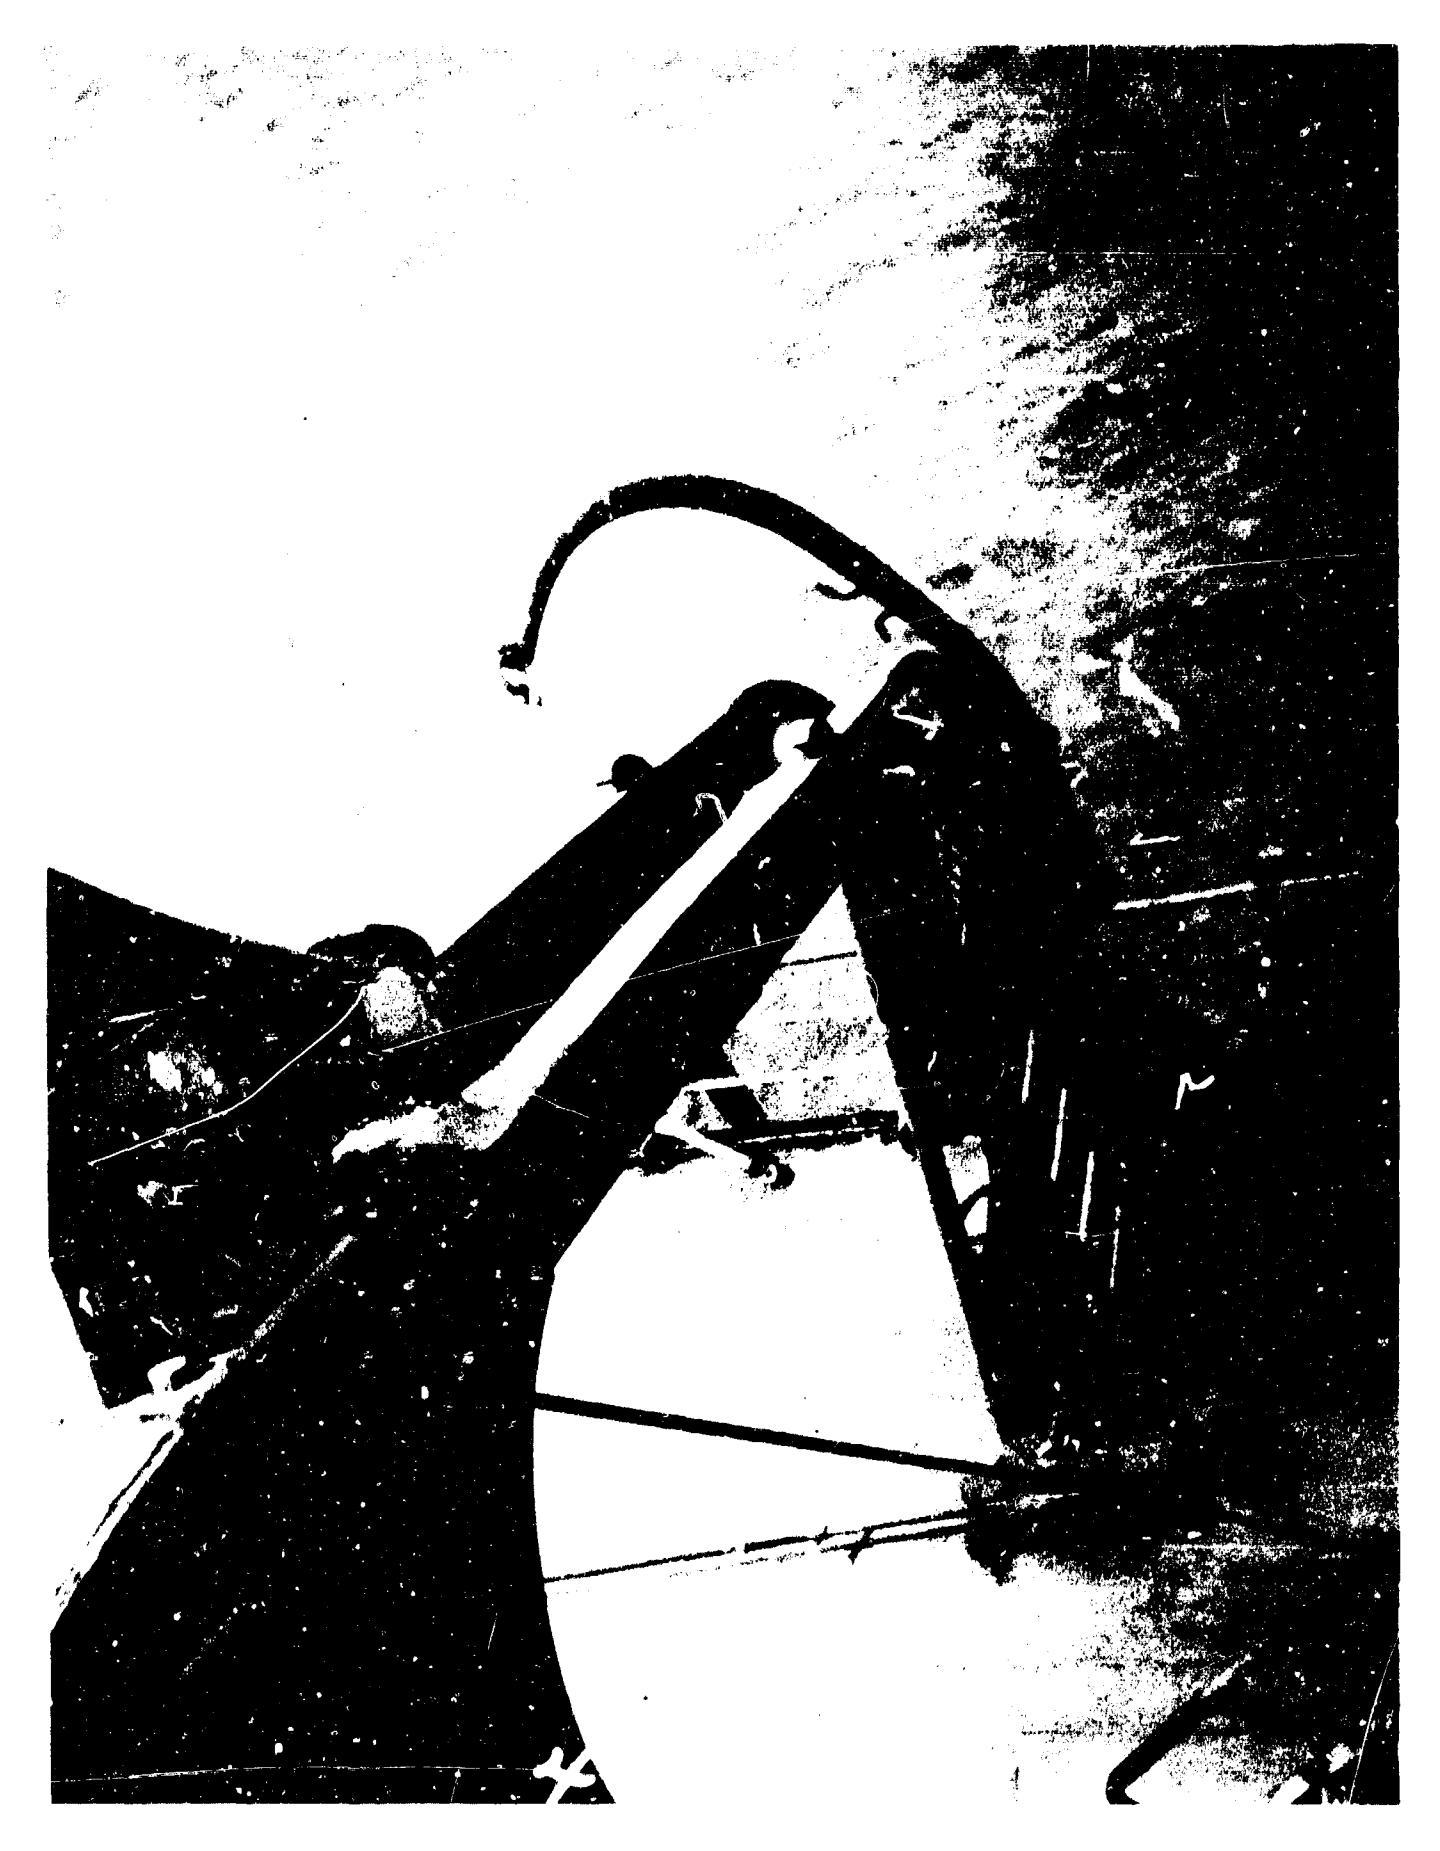
6. All boat davits, except the starboard forward unit, are inoperable. Photos 1922-3, 4, 6 and 7; pages 44, 45, 46, and 47. are views of the port after davit, which is the most severely damaged. The davit arms are the most vulnerable part of the davit as the large area of the arm, when under attack by high pressures, tends to pull the roller out of the track as is shown in the photographs. The roller is completely out of the forward arm of the after pair, and the after arm and davit are distorted.

AA-CR-82-1922-3. USS CRITTENDEN (APA77). General view of No. 4 - port after boat davit.

AA-CR-82-1922-4. USS CRITTENDEN (APA77). Forward area of No. 4 boat davit. Note twisted flange and bend in auxiliary davit.

AA-CR-82-1922-6. USS CRITTENDEN (APA77). No. 4 davit - looking up and outboard from below.

AA-CR-82-1922-7. USS CRITTENDEN (APA77). No. 4 davit - head of forward arm and forward end of strong back.

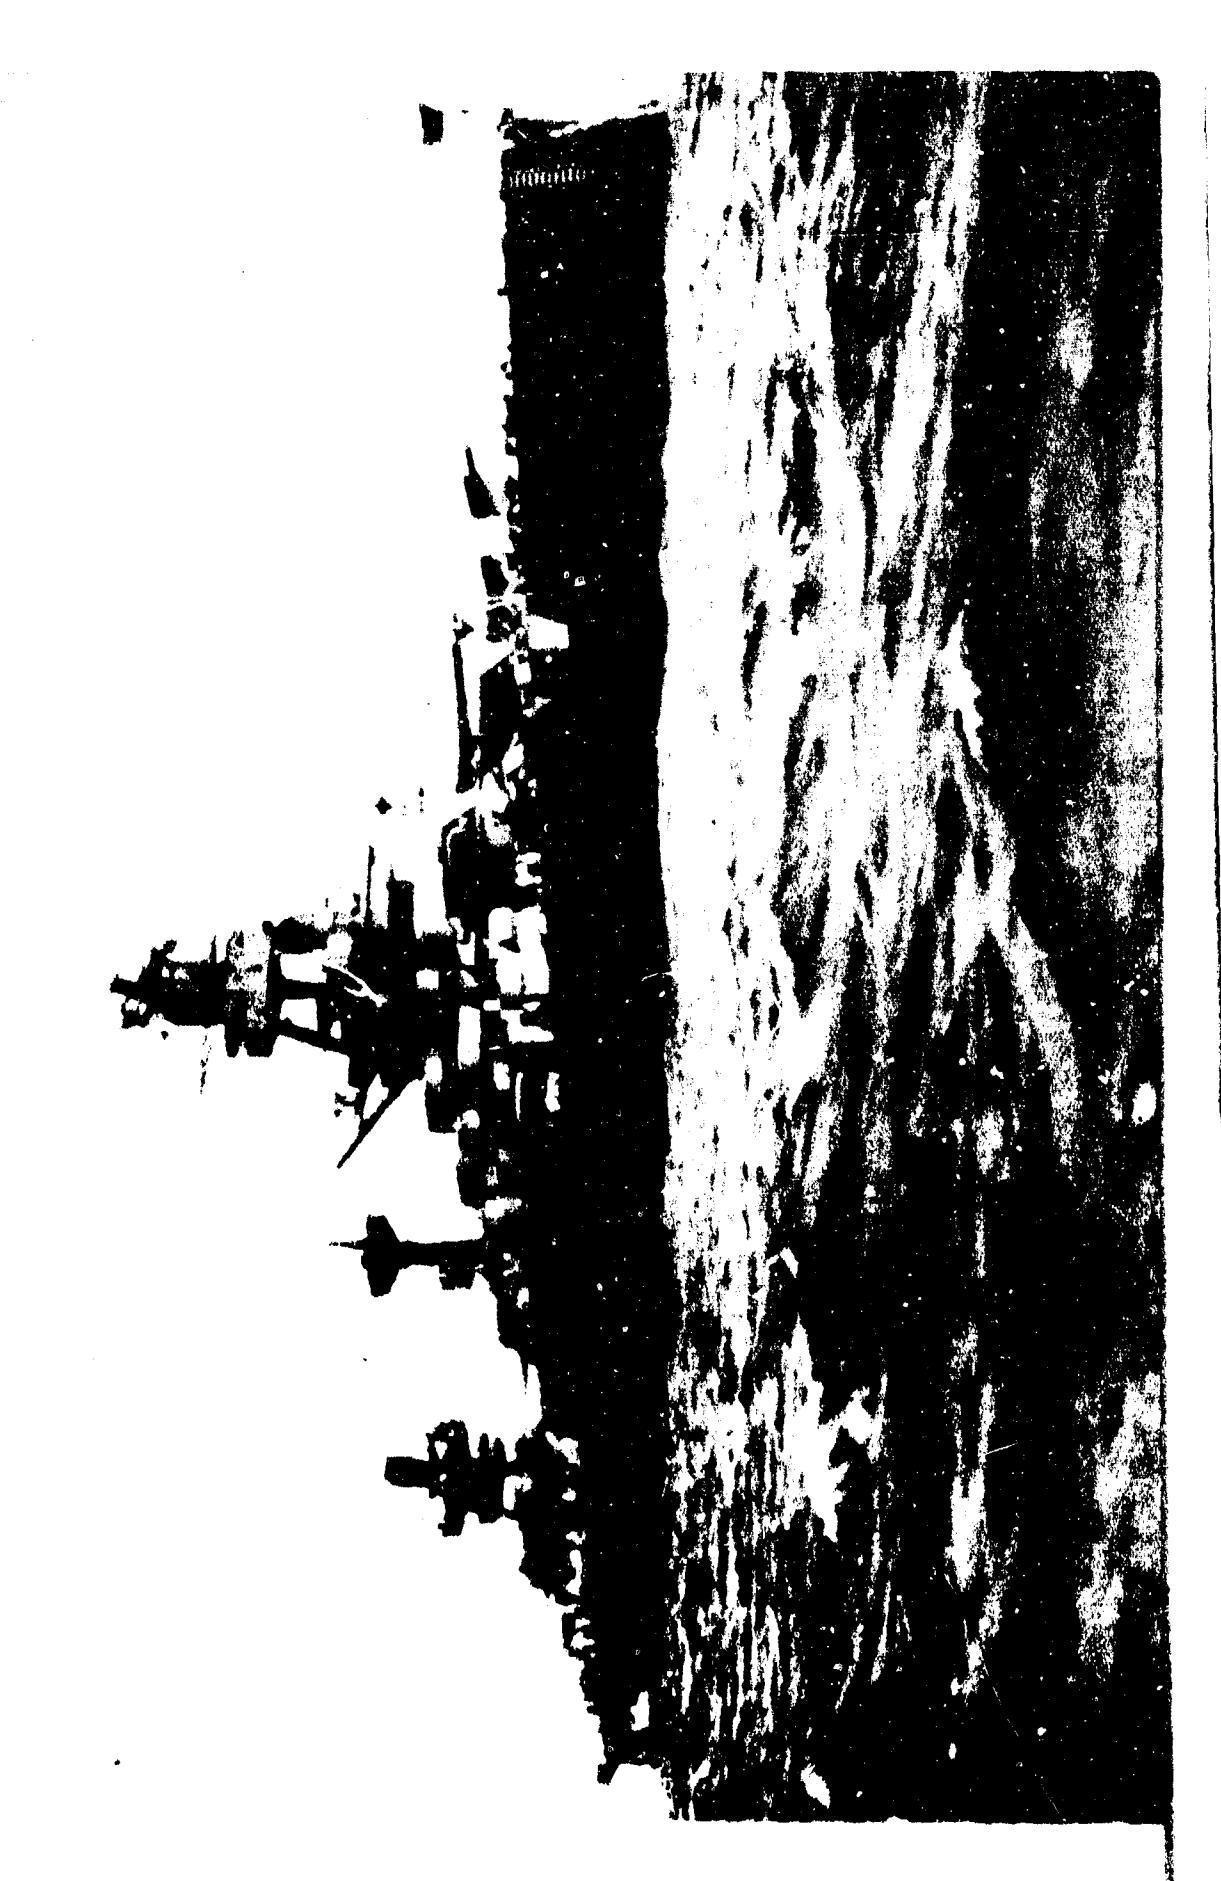
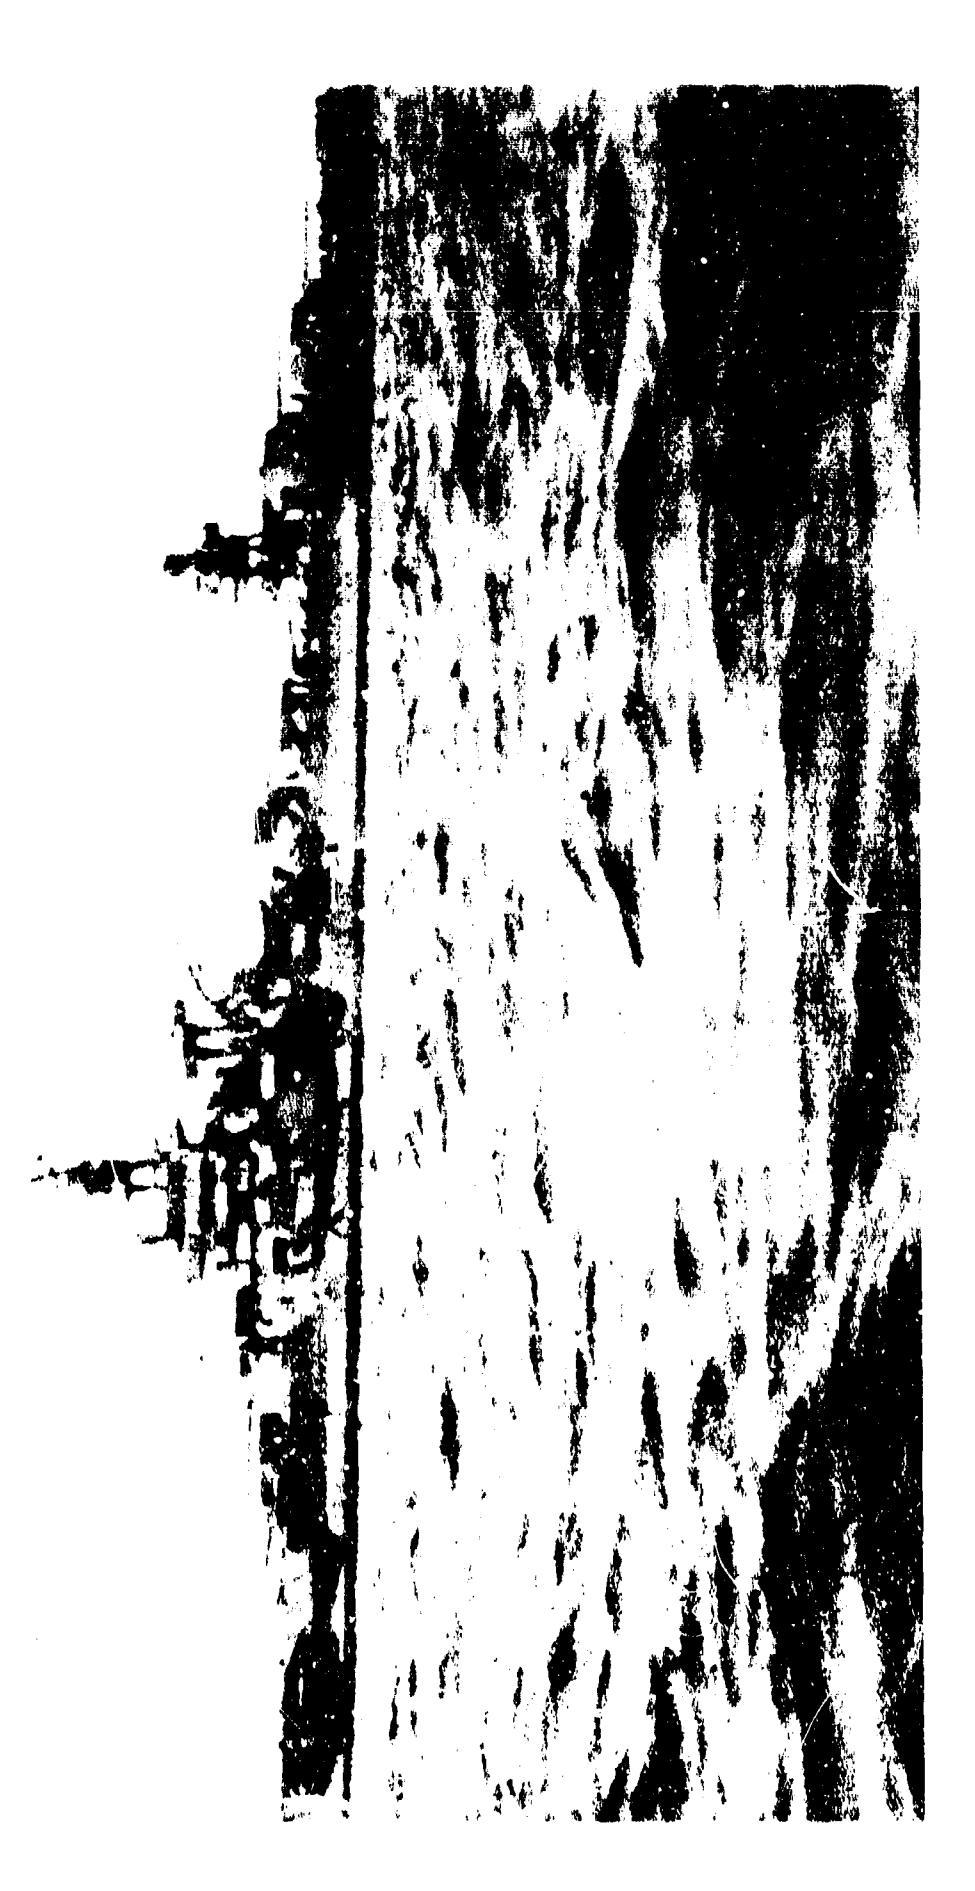
1. Photos 196-166-30, 33, 34, and 227-91-40, 42 and 45; pages 48, 49, 50, 51, 52, and 53 inclusive; are for comparative purposes. All life lines, which were not protected by structure, were blown away. Life line stanchions are distorted and about half are missing. The jack staff, beginning about 6 feet above the deck, is bent about 30 degrees out of the vertical and in the direction of the blast wave, which was about 135 degrees relative. The 8 inch diameter SG radar pole mast collapsed about 4 feet above the main radar platform, and is bent forward and about 45 degrees to port. The change in vertical position is about 100 degrees, so that the pole rests on the port side of the 5 inch diameter pipe yard arm at the SK radar platform level. There is no discernible fracture in the pole. The port yardarm is bent and distorted as a result of the pole mast having hit it, and the yardarm clamps loosened allowing the arm to slide about 6 inches to port. The marked bend of the pole is due to the inability of the collapsed pipe section to support the offset weight which resulted from the initial bending caused by the blast. The starboard wing of the SK radar plot frame is bent up about 40 degrees from normal. The overhead of the director station at the 07 level is supported by pilasters, all of which were bent in the direction of the blast. The 15 inch pole mast, which supports this director station, is bent smoothly in a direction of about 300 degrees relative and about 20 degrees out of the vertical. Photos 2091-3, 2094-1, and 3; pages 54, 55, and 56 are views of the conditions in this area. The photographs show the rigging is still connected. Below the 06 level, there are two areas of damage to the foremast tripod, both of which are just below the rangefinder platform, one port and one starboard. Here, as shown in photos 2094-7, 8, 9, 10; 1783-1, 2 and 2135-3; and 63, the blast wave pages 57, 58, 59, 60, 61, 62, acted on the overhang of the platform with sufficient force to pull these brackets out of the tripod legs. There is no perceptible deformation of the tripod legs. No damage to the deck connections at the foot of the legs or to any of the tripod supports is observable.

AA-CR-227-91-42. USS ARKANSAS (BB33). View after Test Able looking at the starboard bow.

AA-CR-227-91-45. USS ARKANSAS (BE33). View after Test Able looking at the port side.

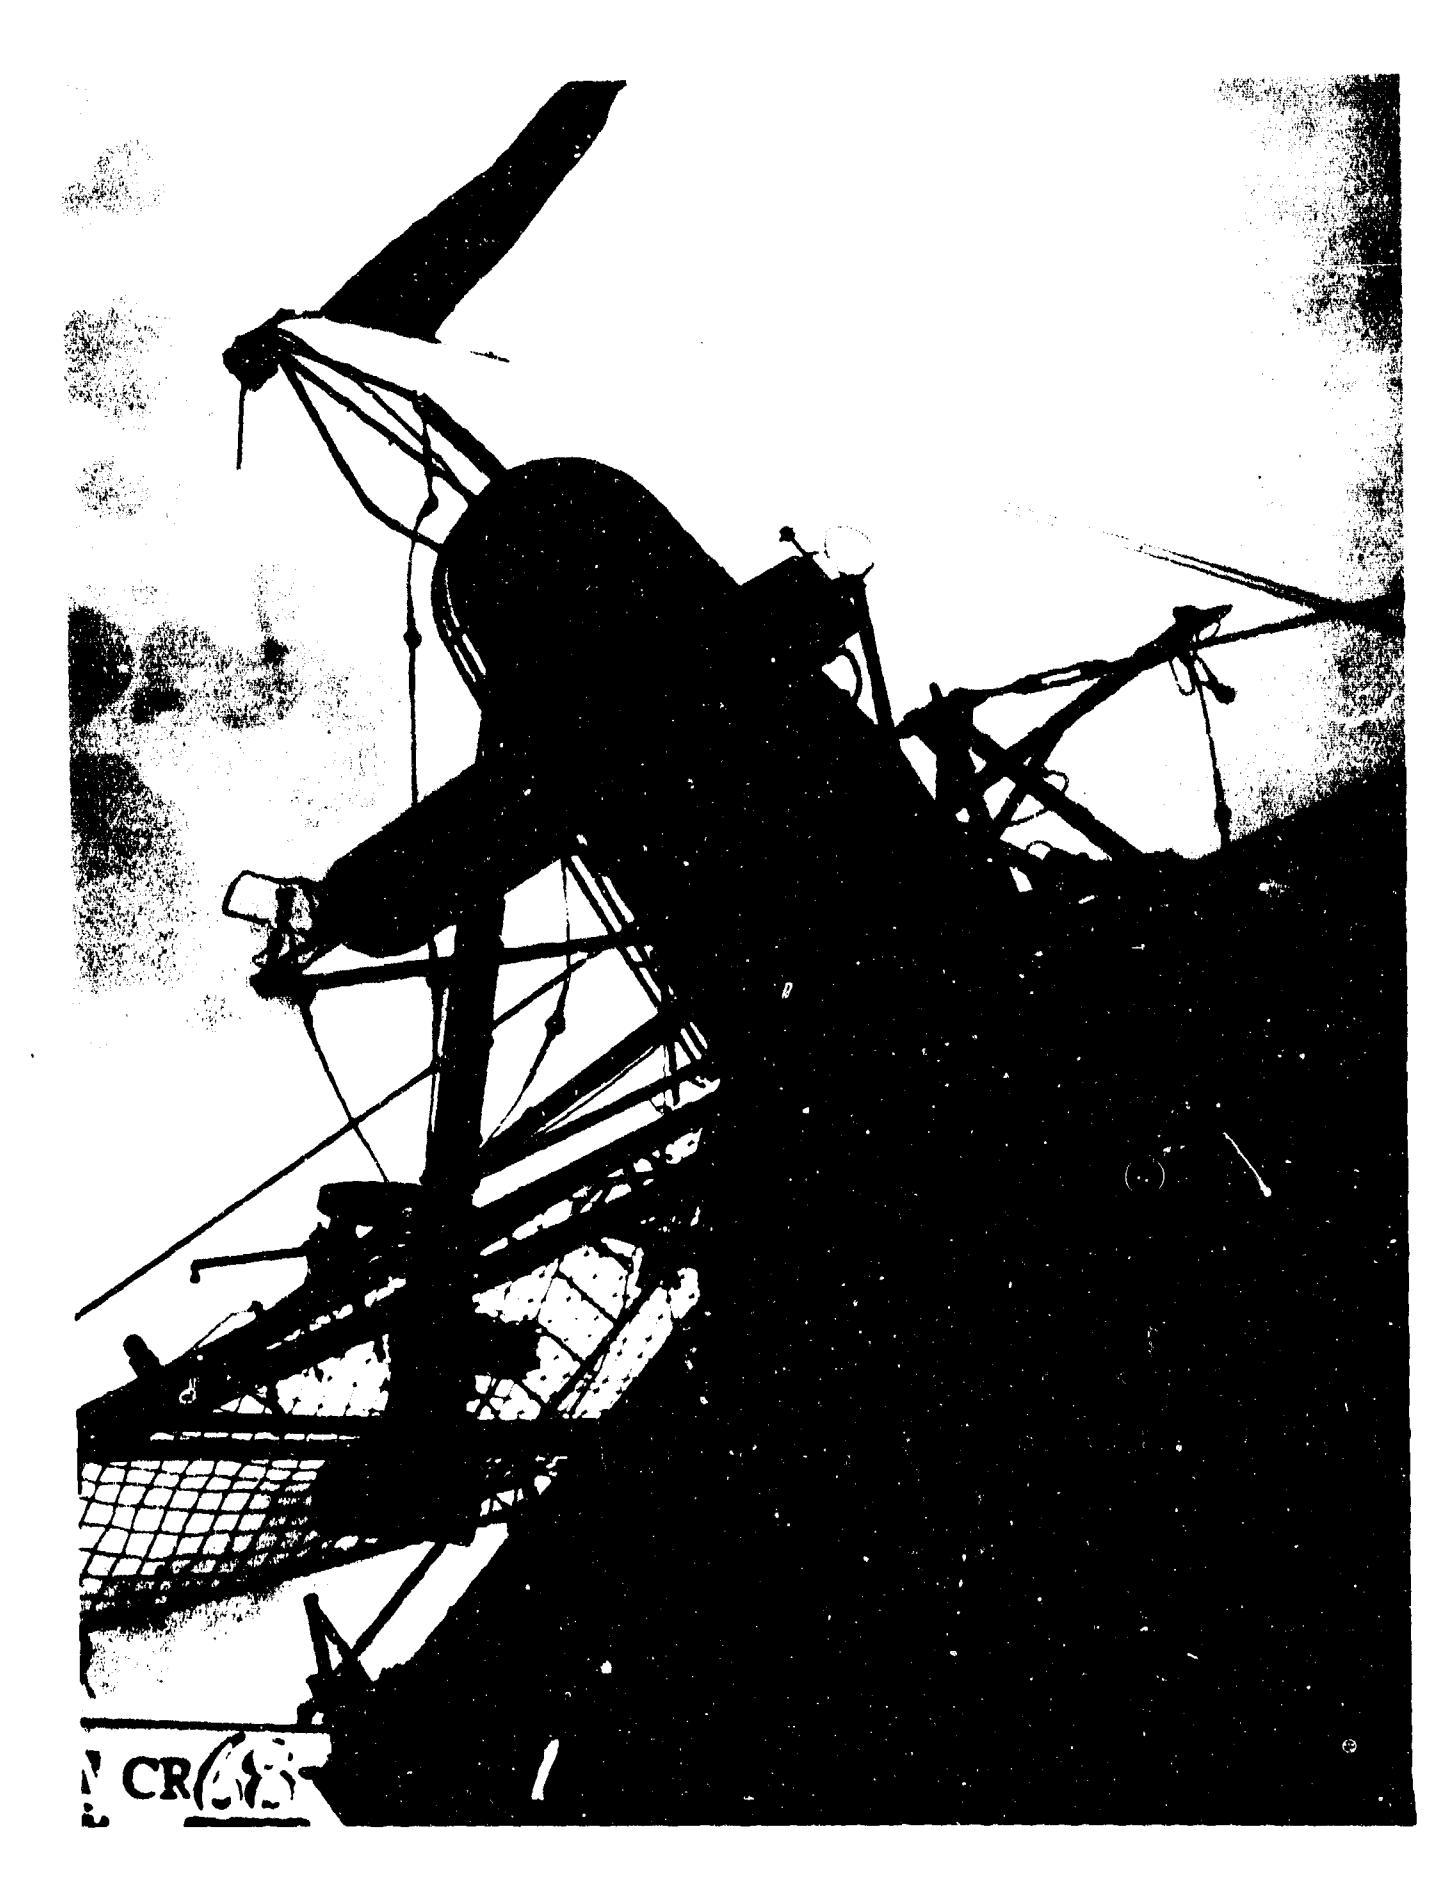
AA-CR-68-2094-1. USS ARKANSAS (BB33). Forward yardarms, SK radar pole and platform.

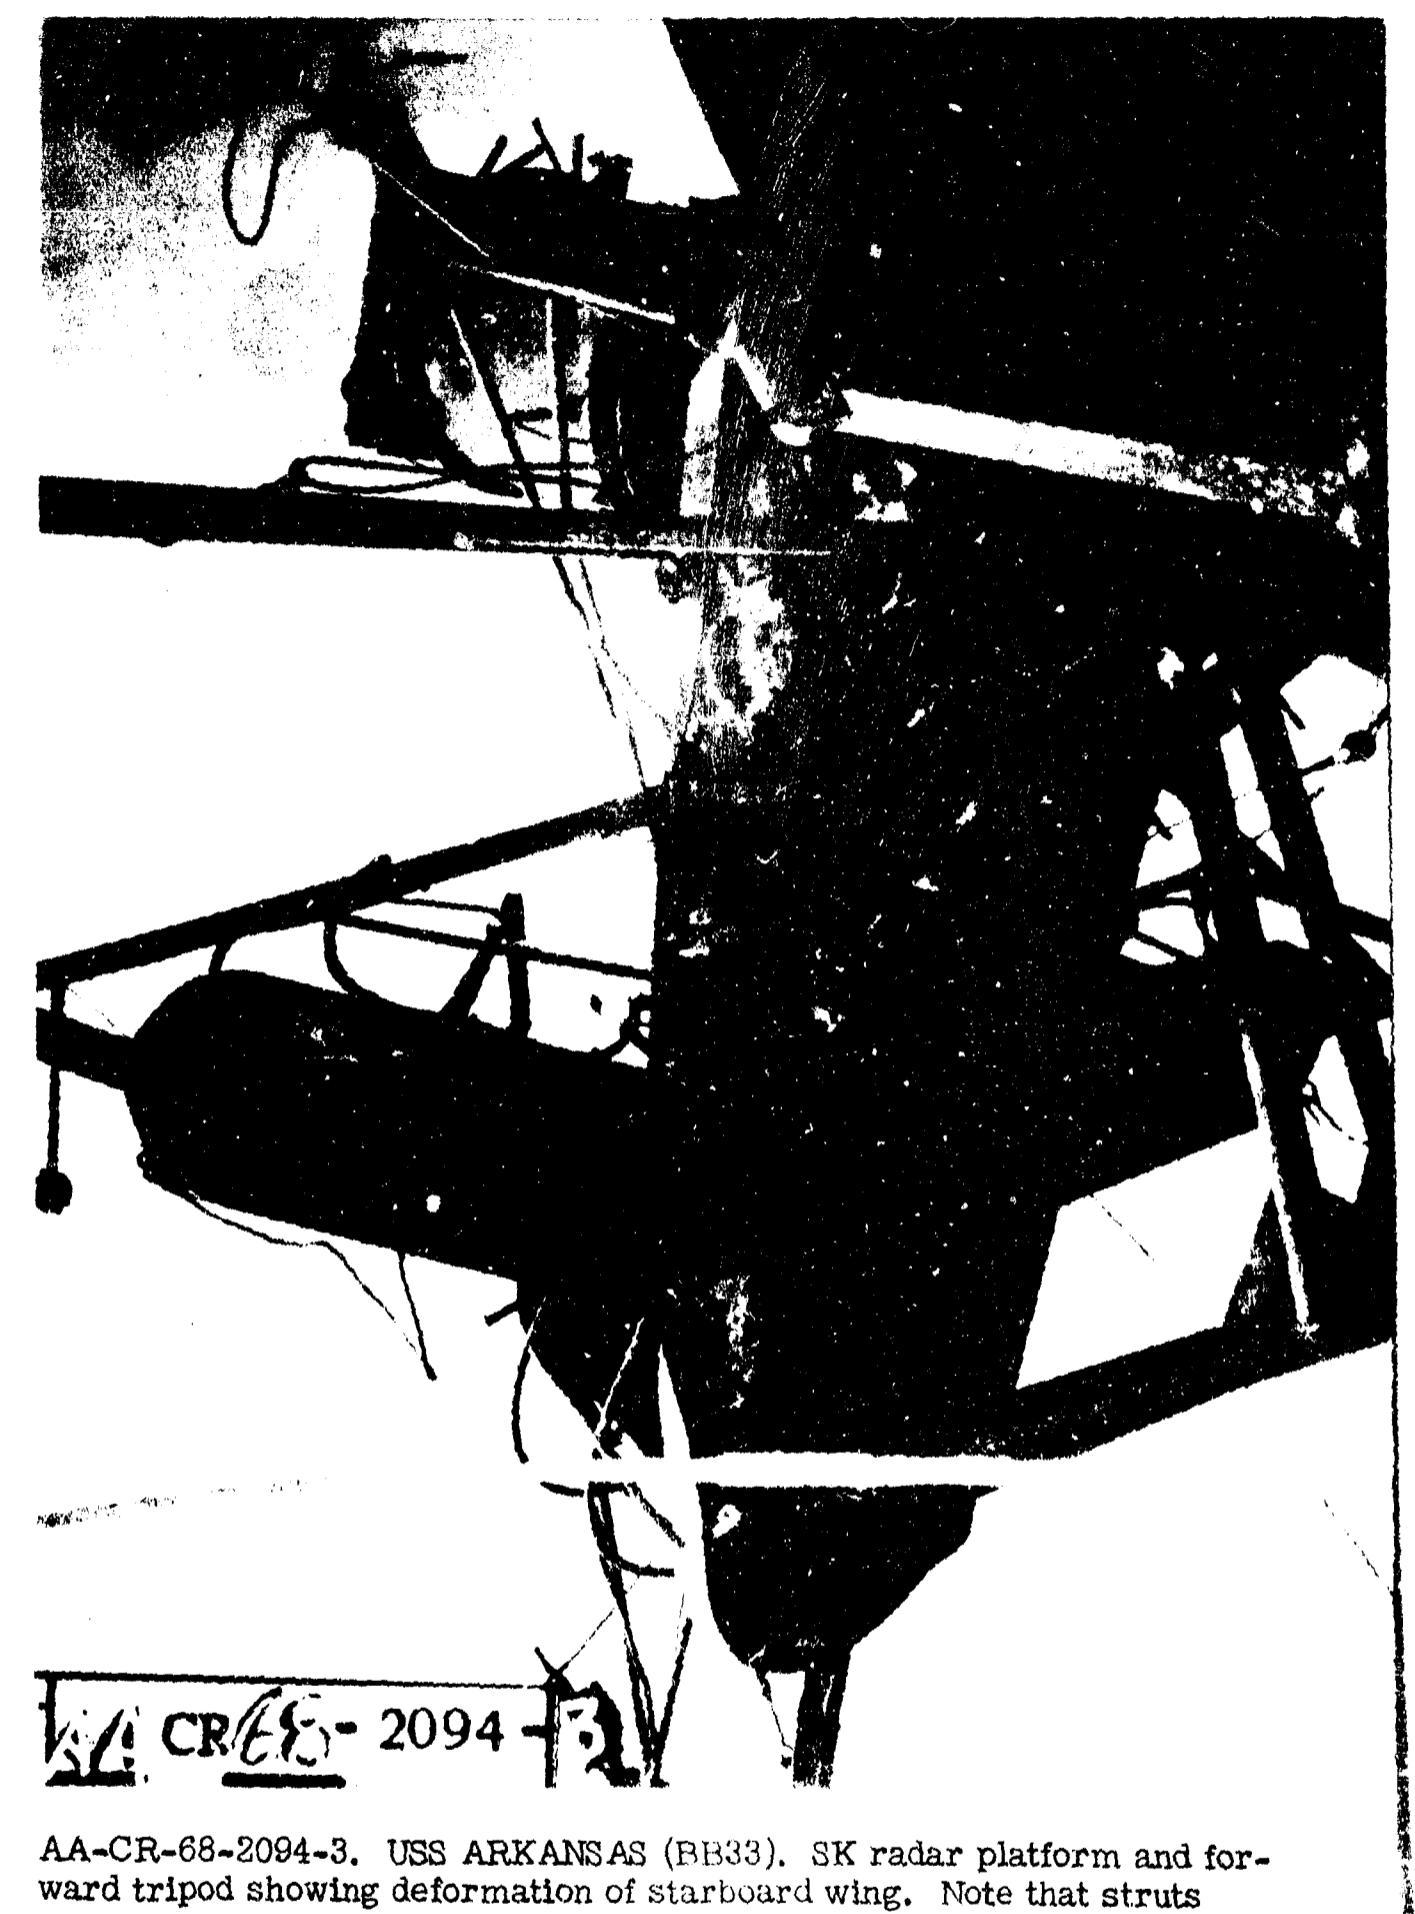
AA-CR-68-2094-3. USS ARKANSAS (BB33). SK radar platform and for-ward tripod showing deformation of starboard wing. Note that struts appear unaffected.

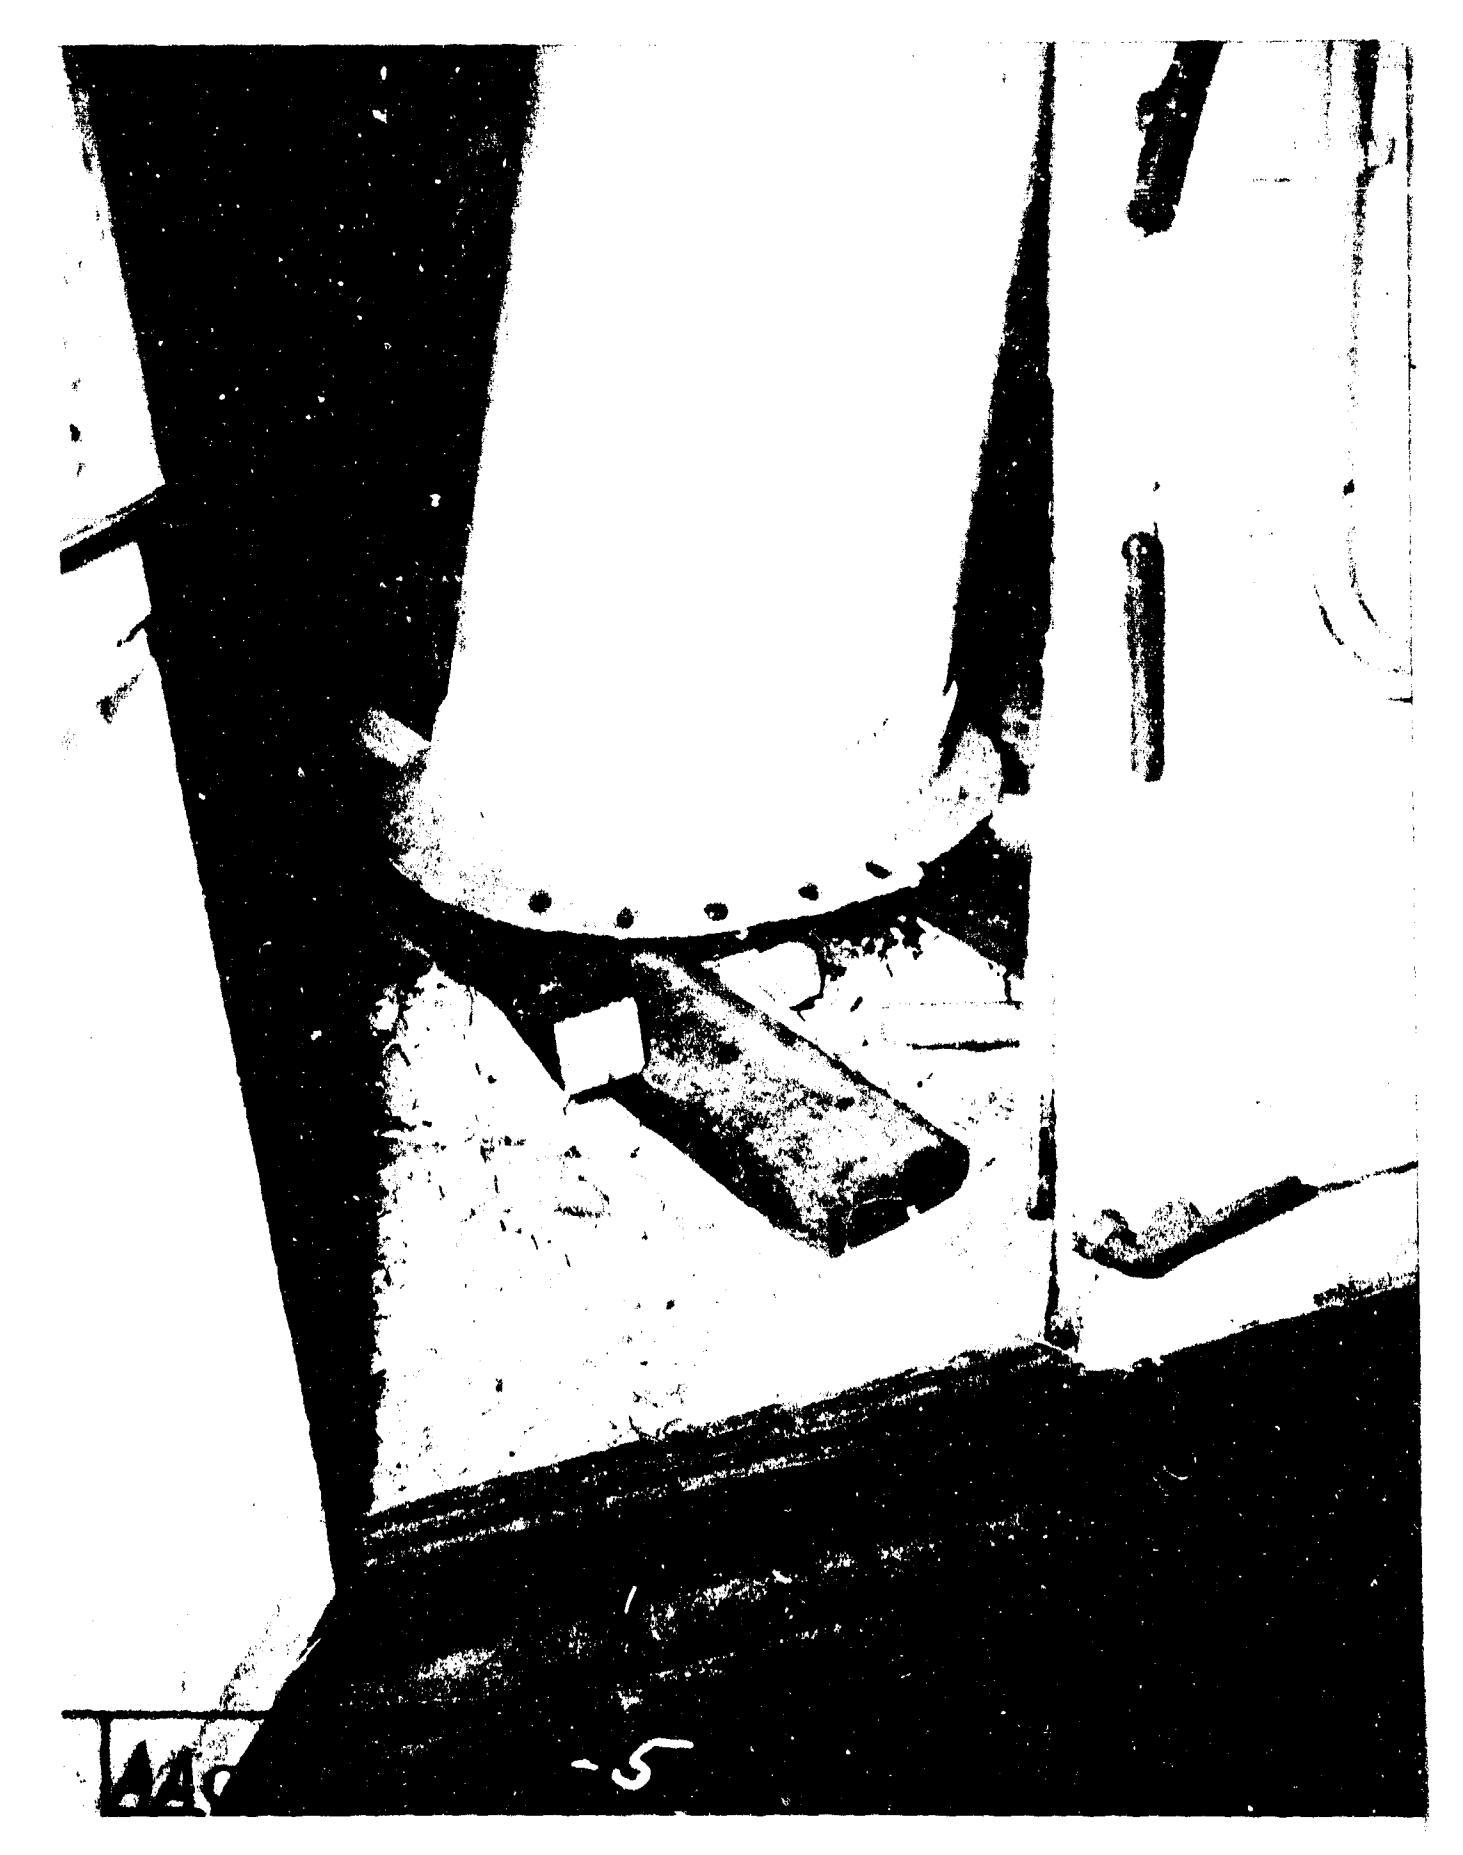
AA-CR-2146-5. USS ARKANSAS (BB33). 2nd deck, base of starboard aft leg, frame 103.
