BUREAU OF SHIPS GROUP

TECHNICAL INSPECTION REPORT

FAILURES OF MASTS, YARDARMS, BOOMS, AND RIGGING

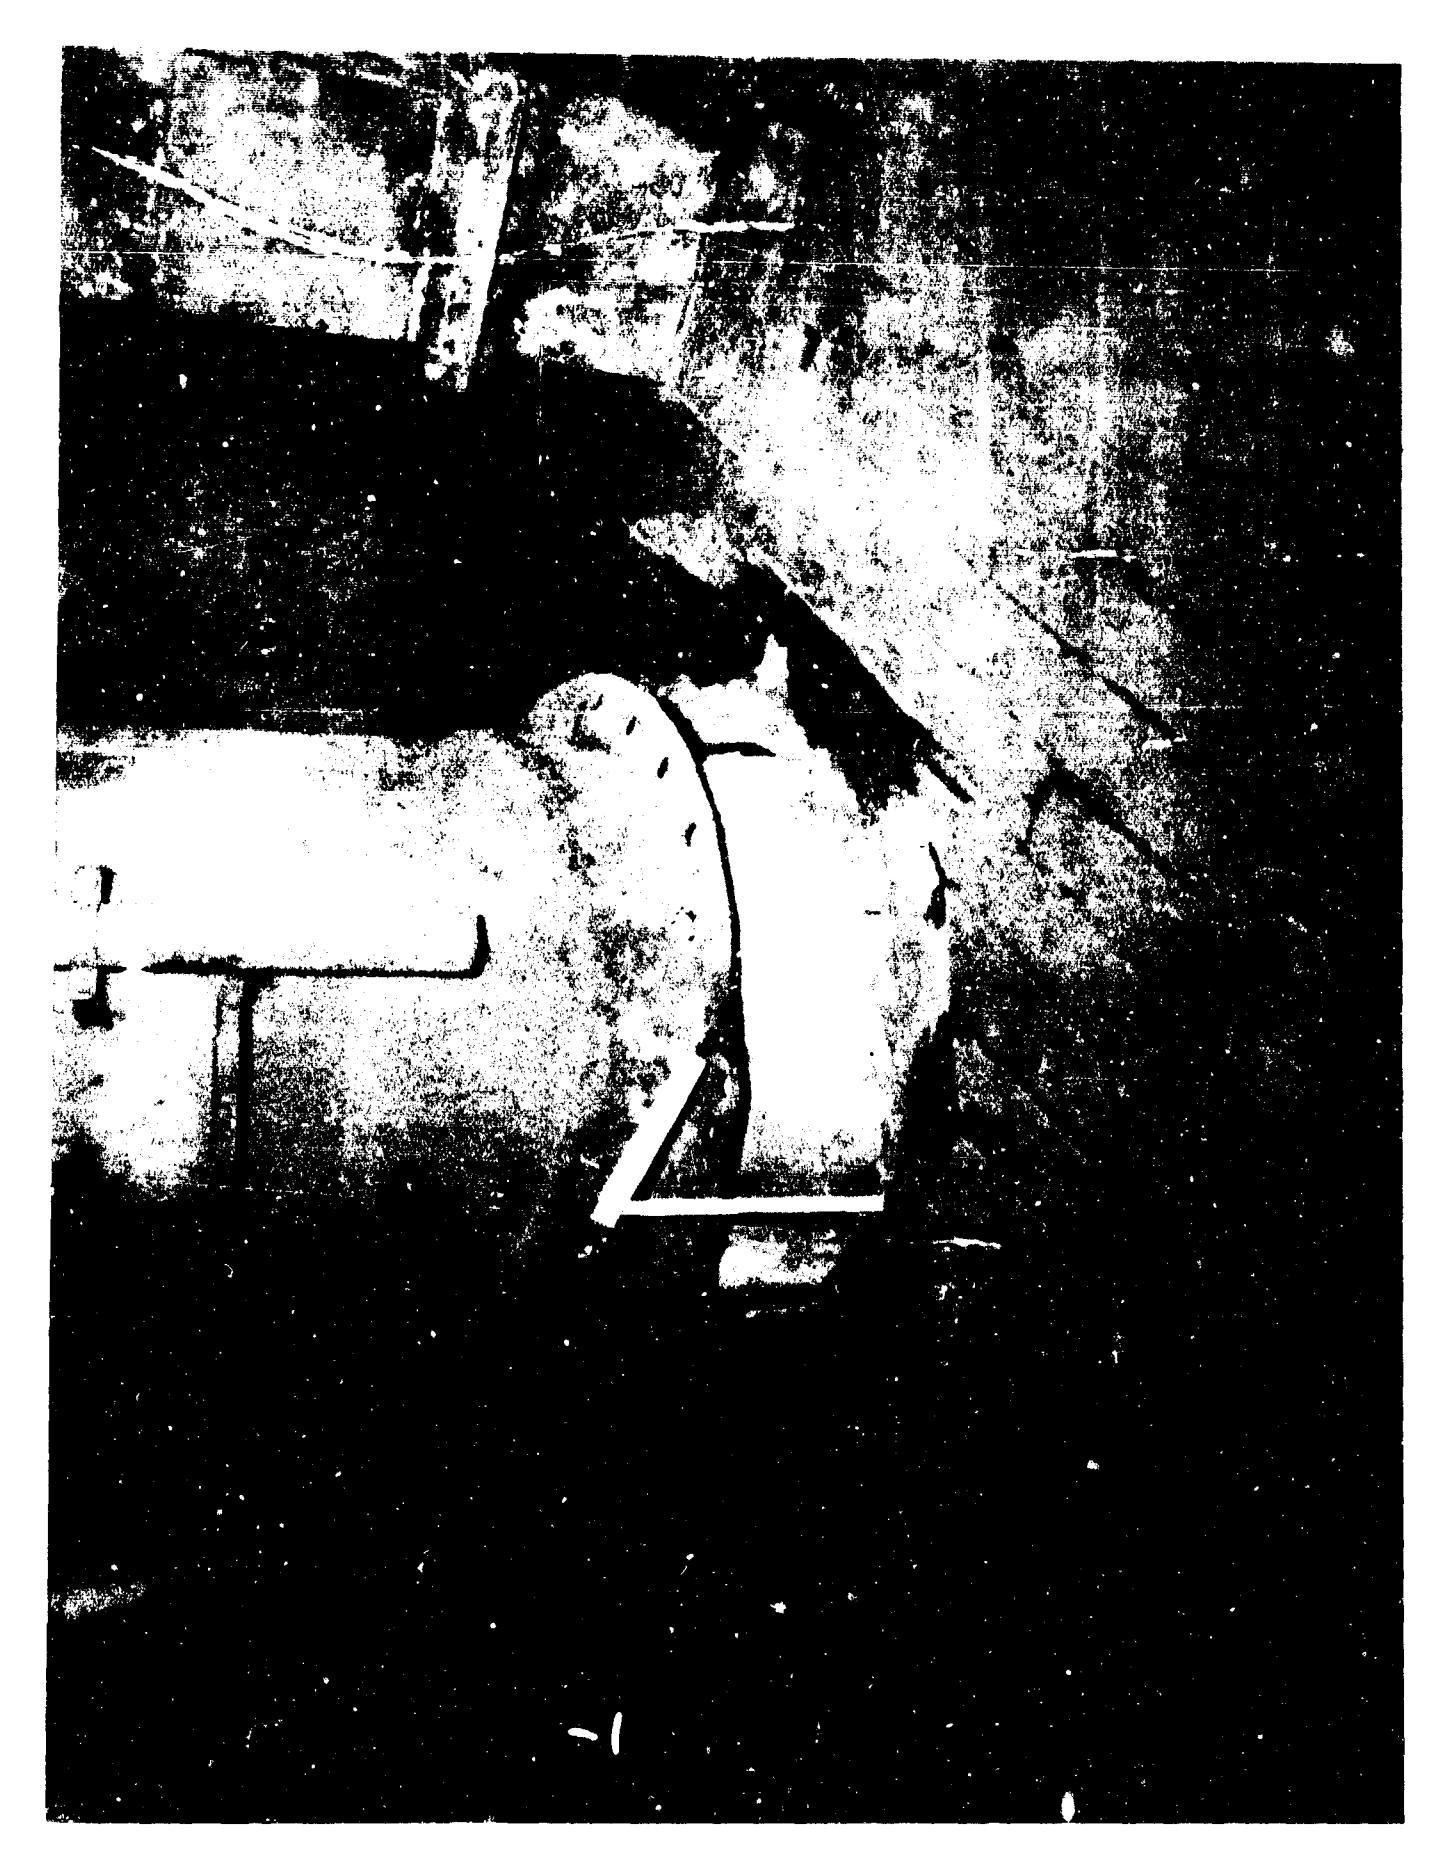
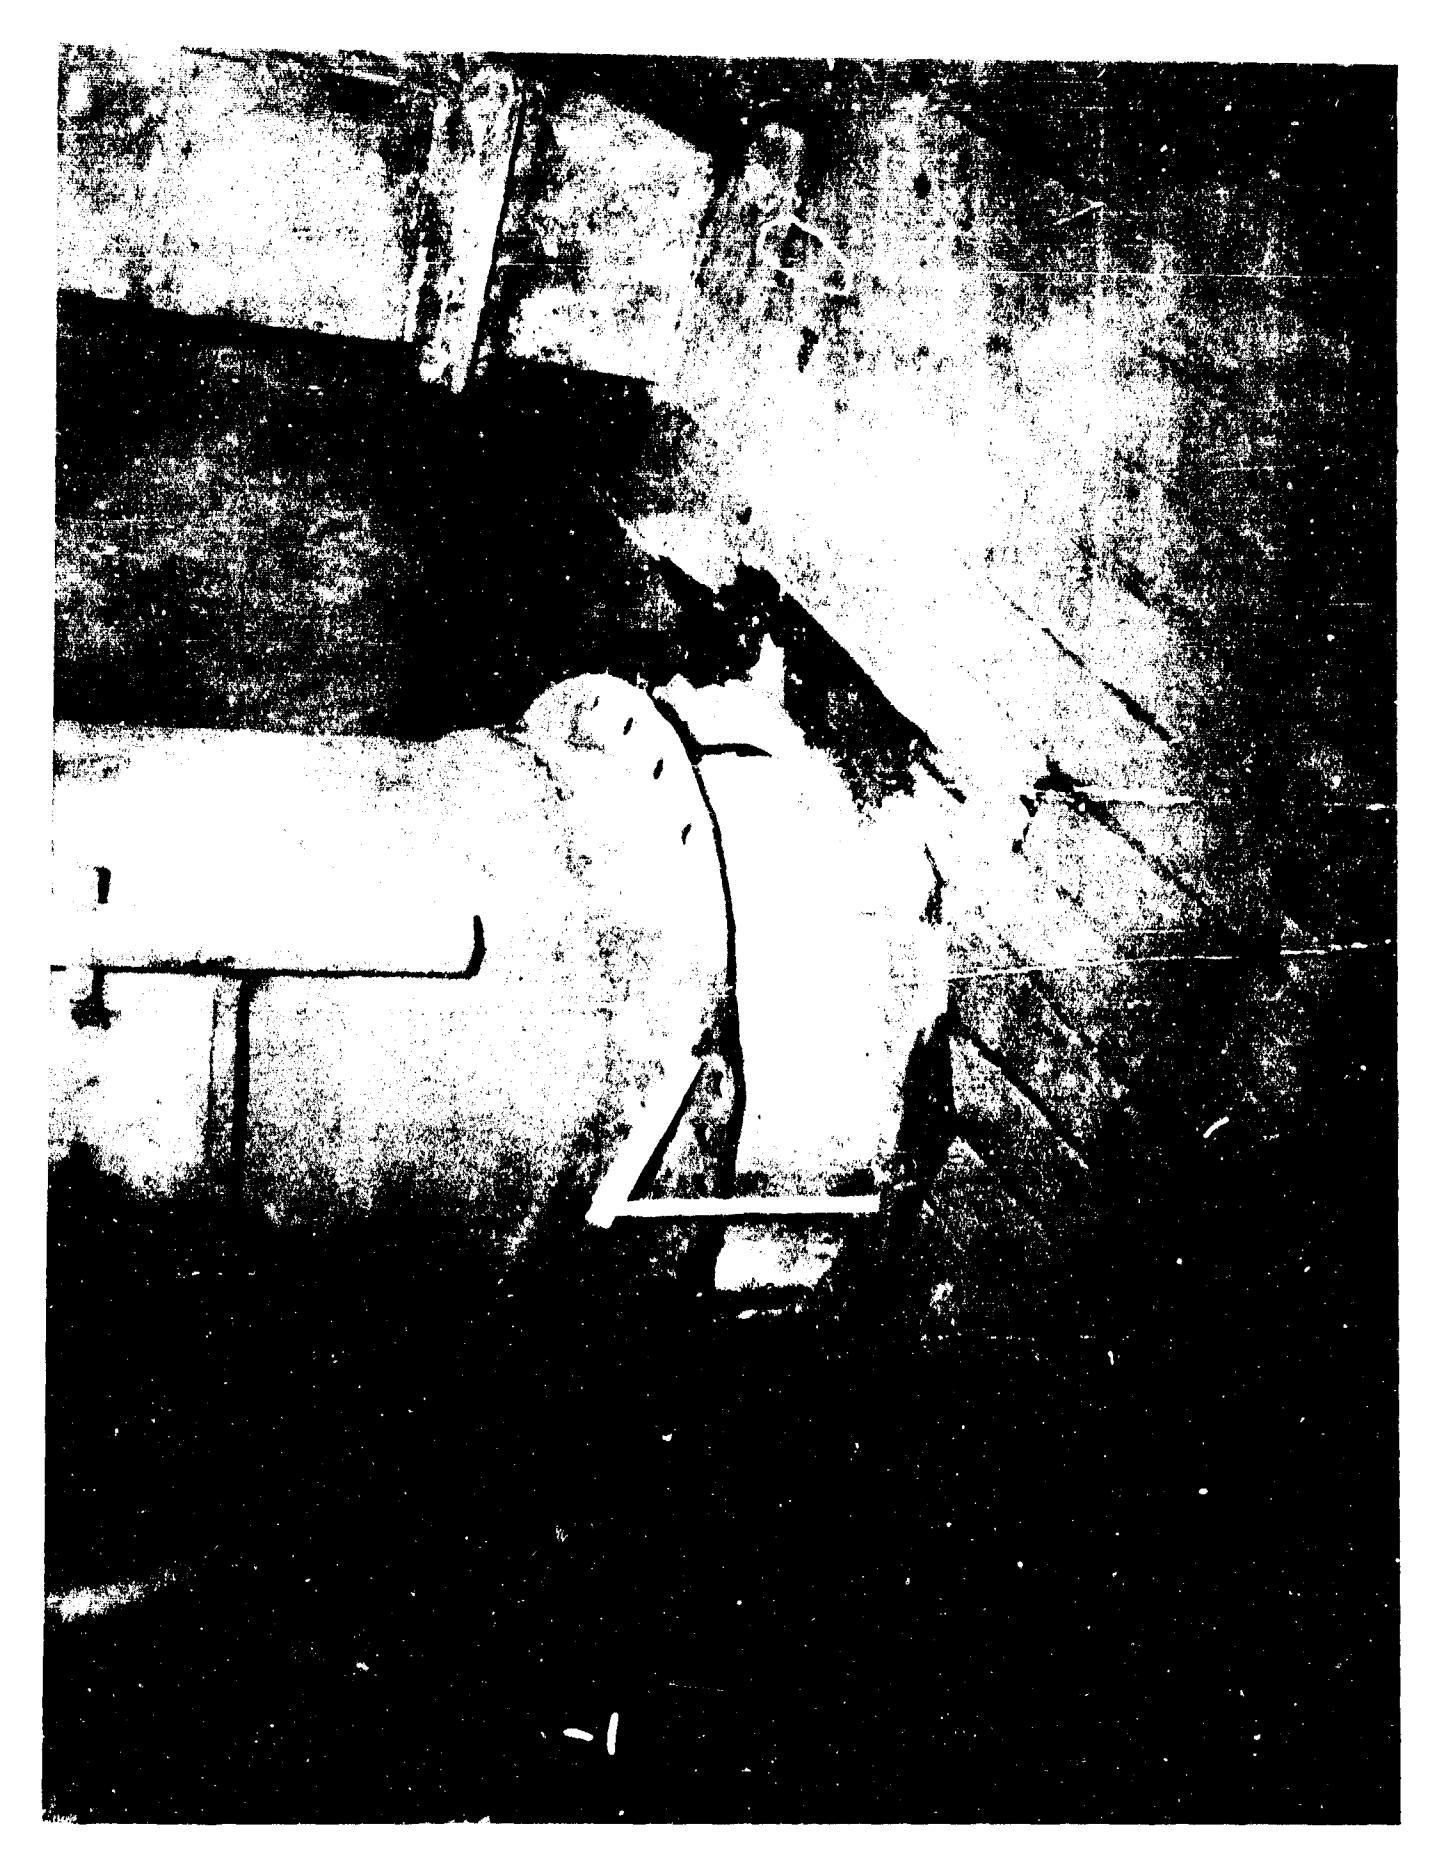
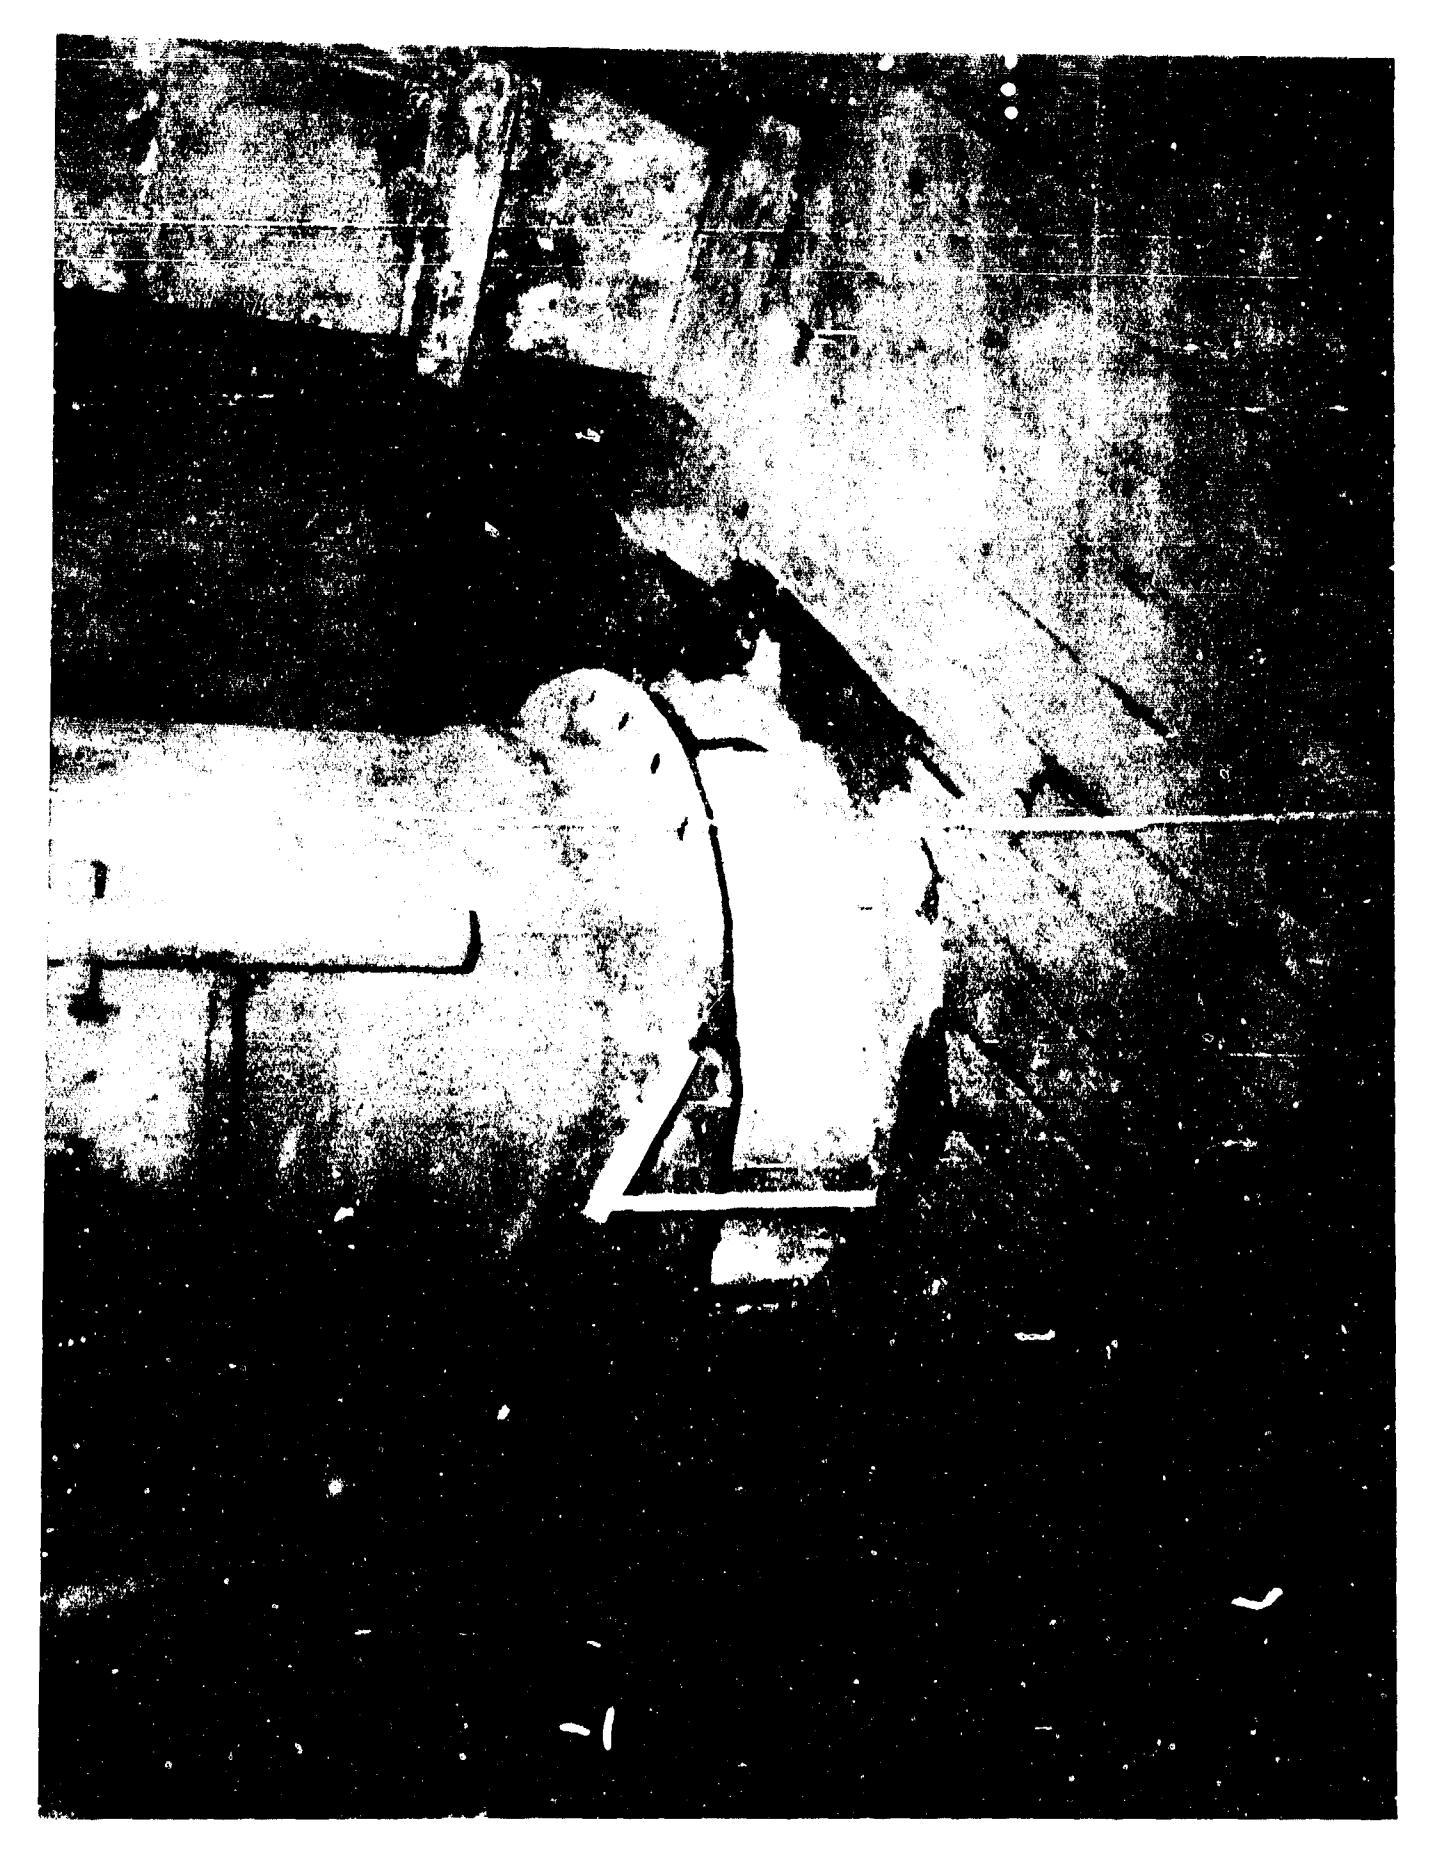
AA-CR-68-2146-1. USS ARKANSAS (BB33). Mainmast, starboard aft leg, showing lift from deck, main deck.

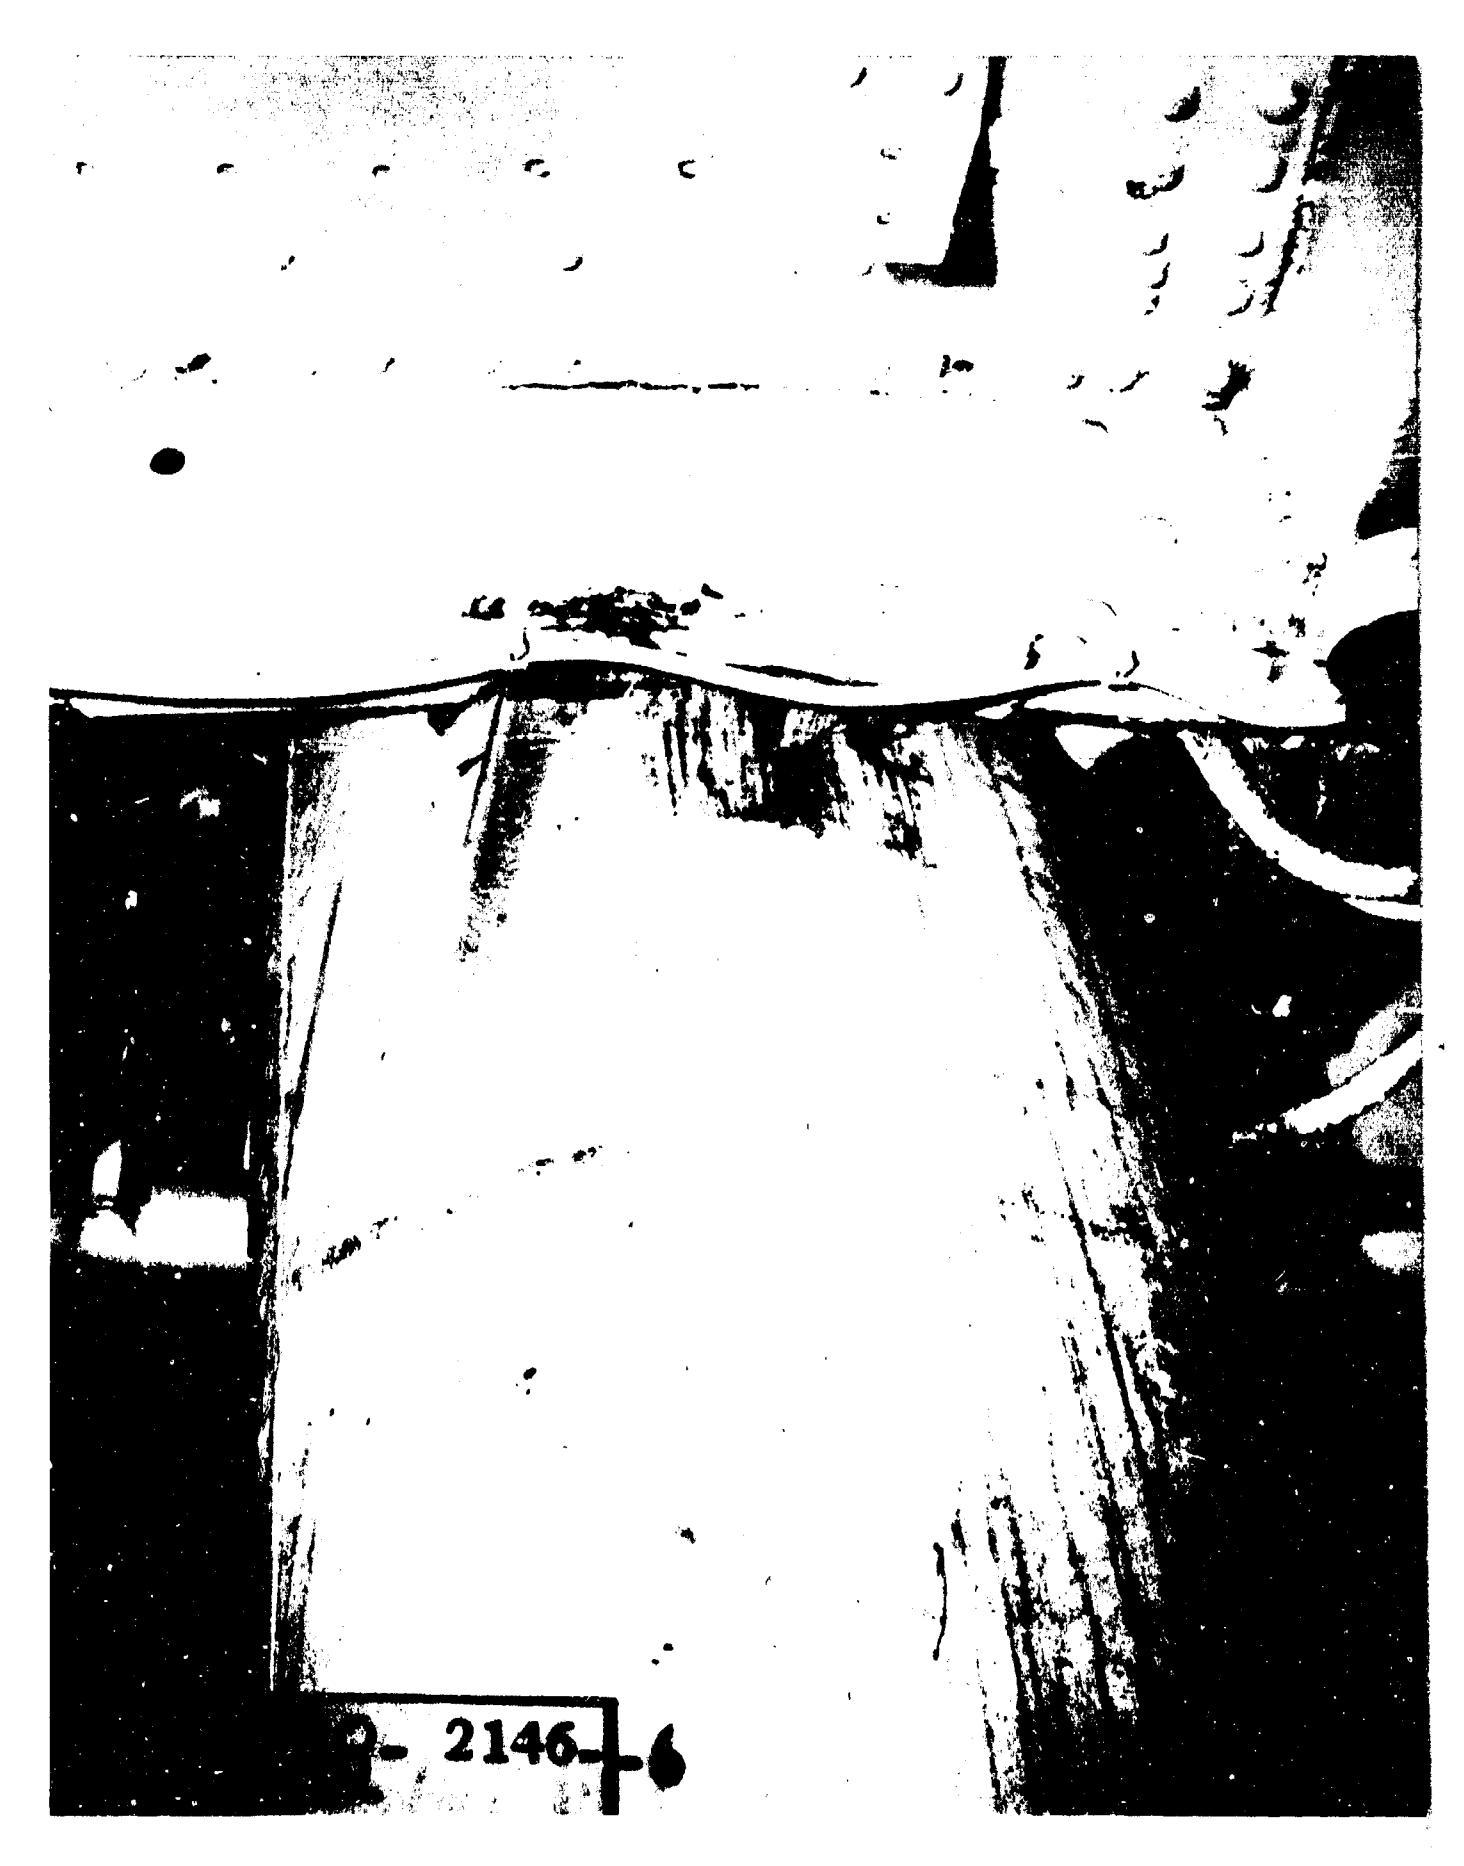
AA-CR-68-2146-6. USS ARKANSAS (BB33). Starboard aft leg, frame 103, underside main deck.

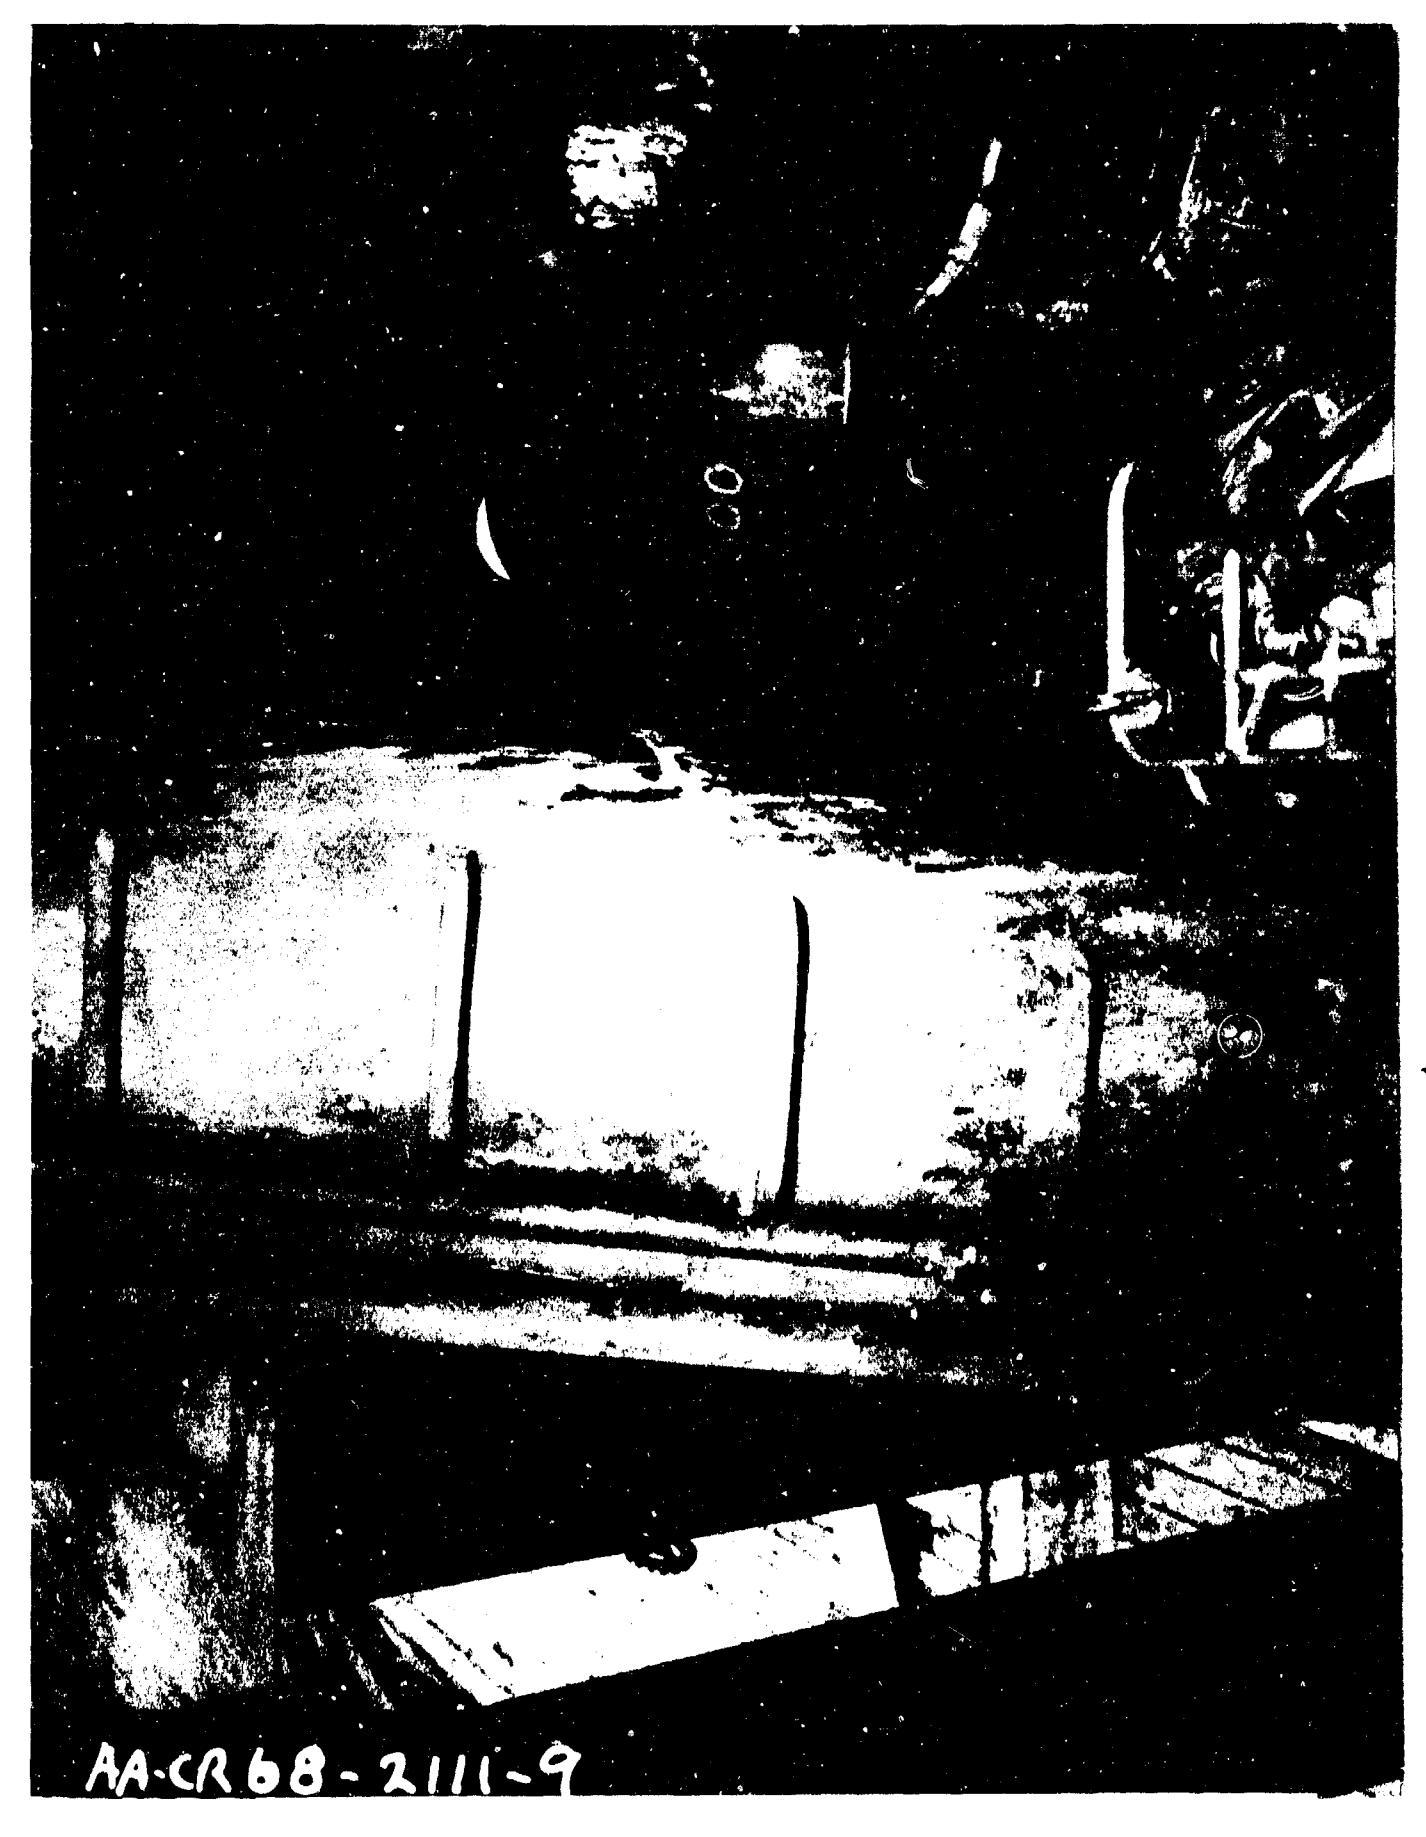
3. There is some tipping of the structure about the 01 level as can be seen in upper left photo 2111-9, page 70. Note buckle in plating of 01 level. Photos 1783-3 and 1783-4, pages 79 and 79 are further evidence of this tipping. Note tear in plating in photo 1783-4, page 79 and separated weld in photo 1783-3, page 78 See also photo 2111-11, page 80. The entire structure has been cracked as evidenced by photo 2146-3, page 81 showing a buckle

AA-CR-68-2111-9. USS ARKANSAS (BB33). Port aft leg-mainmast showing wrinkle between leg and wrapper plate.

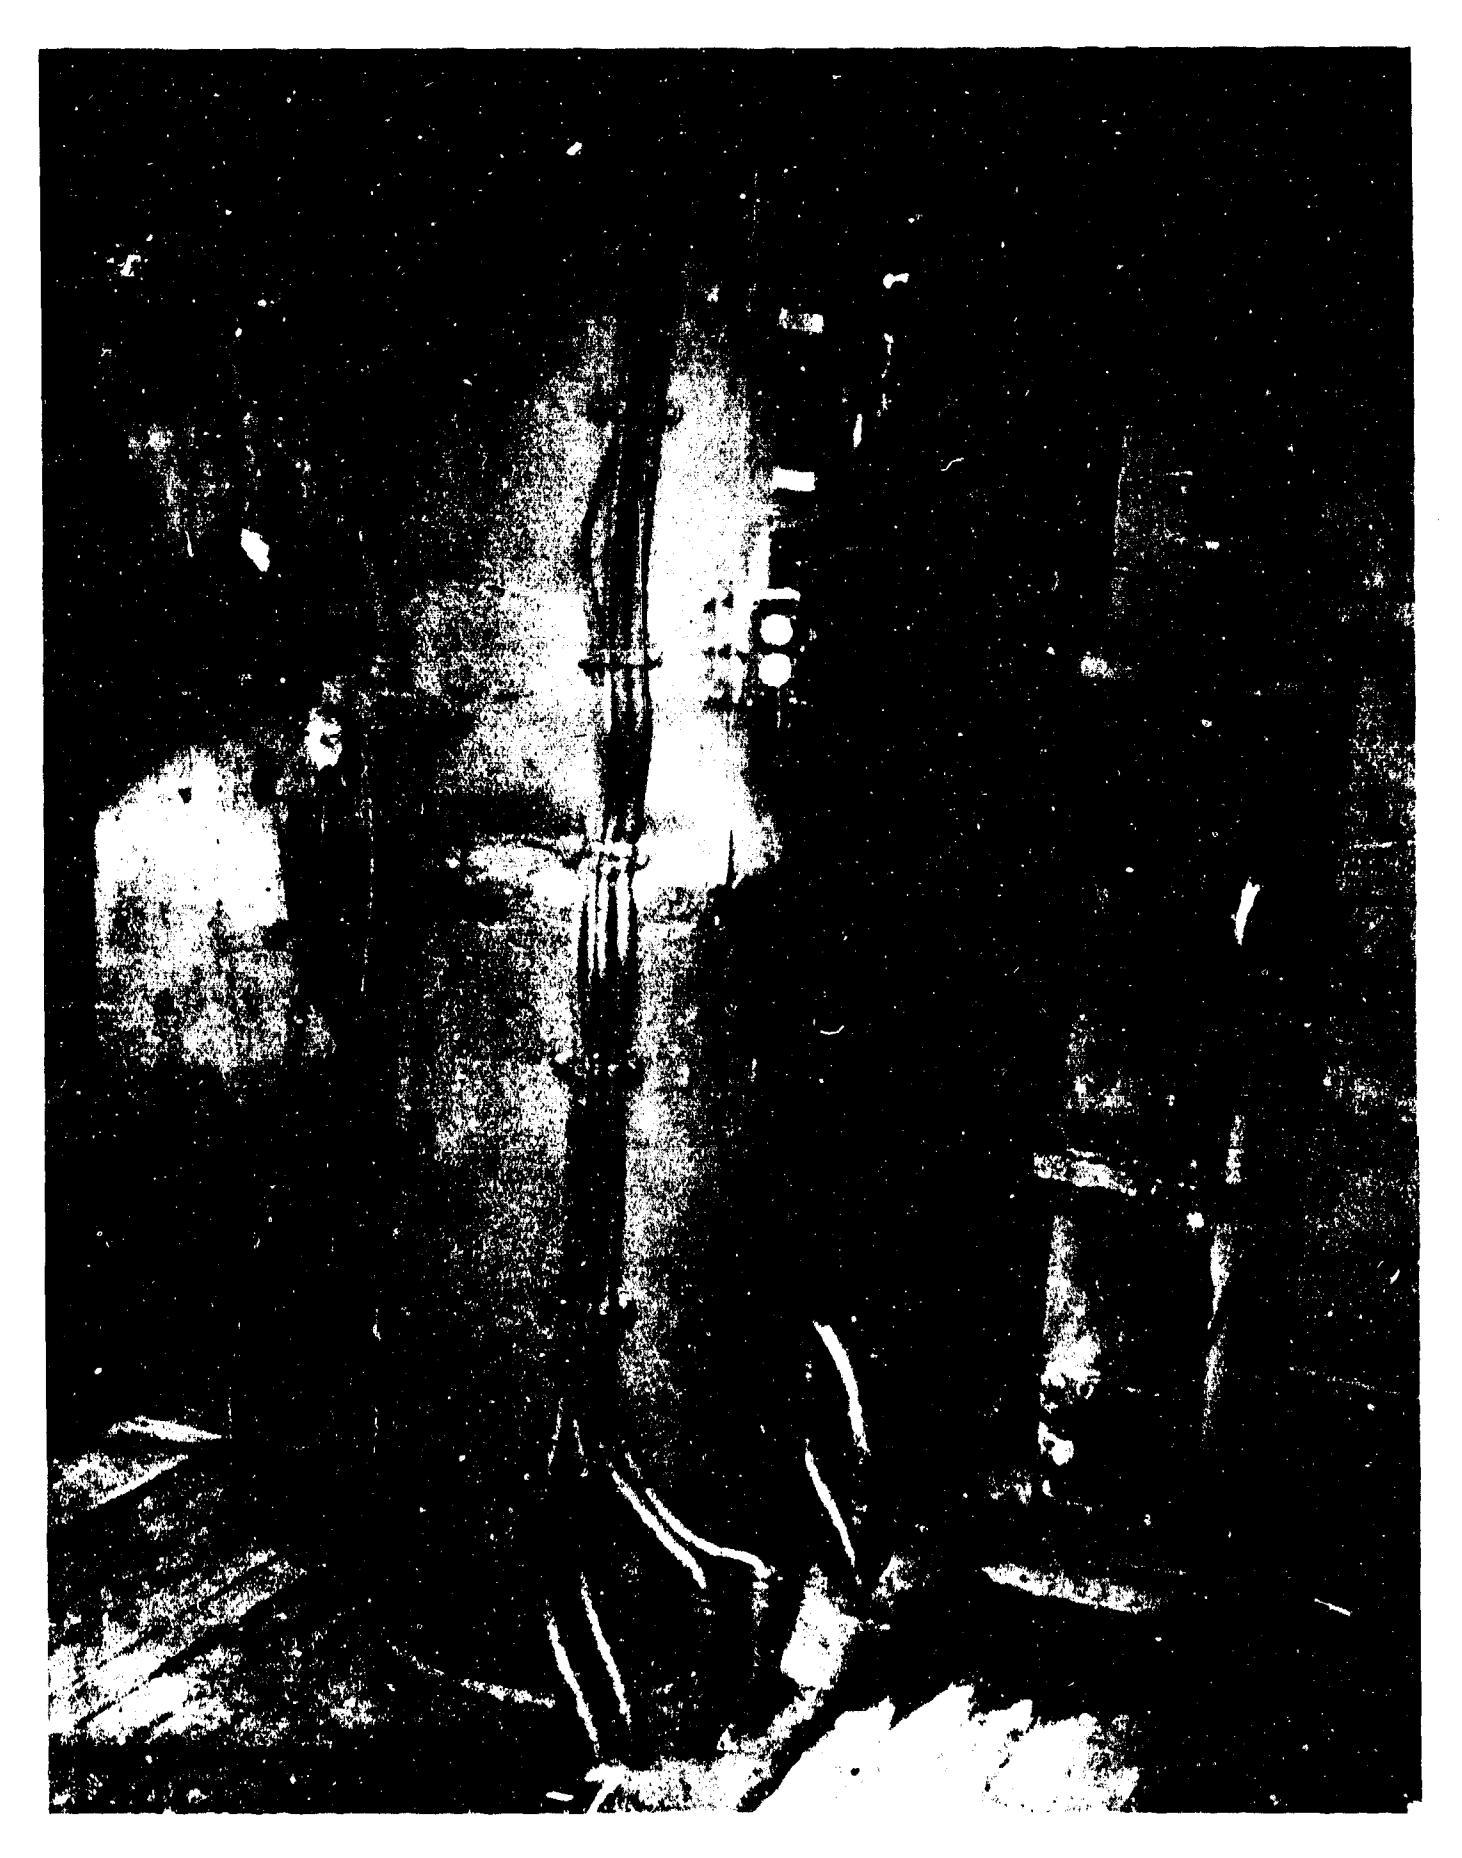
AA-CR-68-2111-7. USS ARKANSAS (BB33). Foreleg-mainmast tripod - looking at port side, wrinkle in leg.

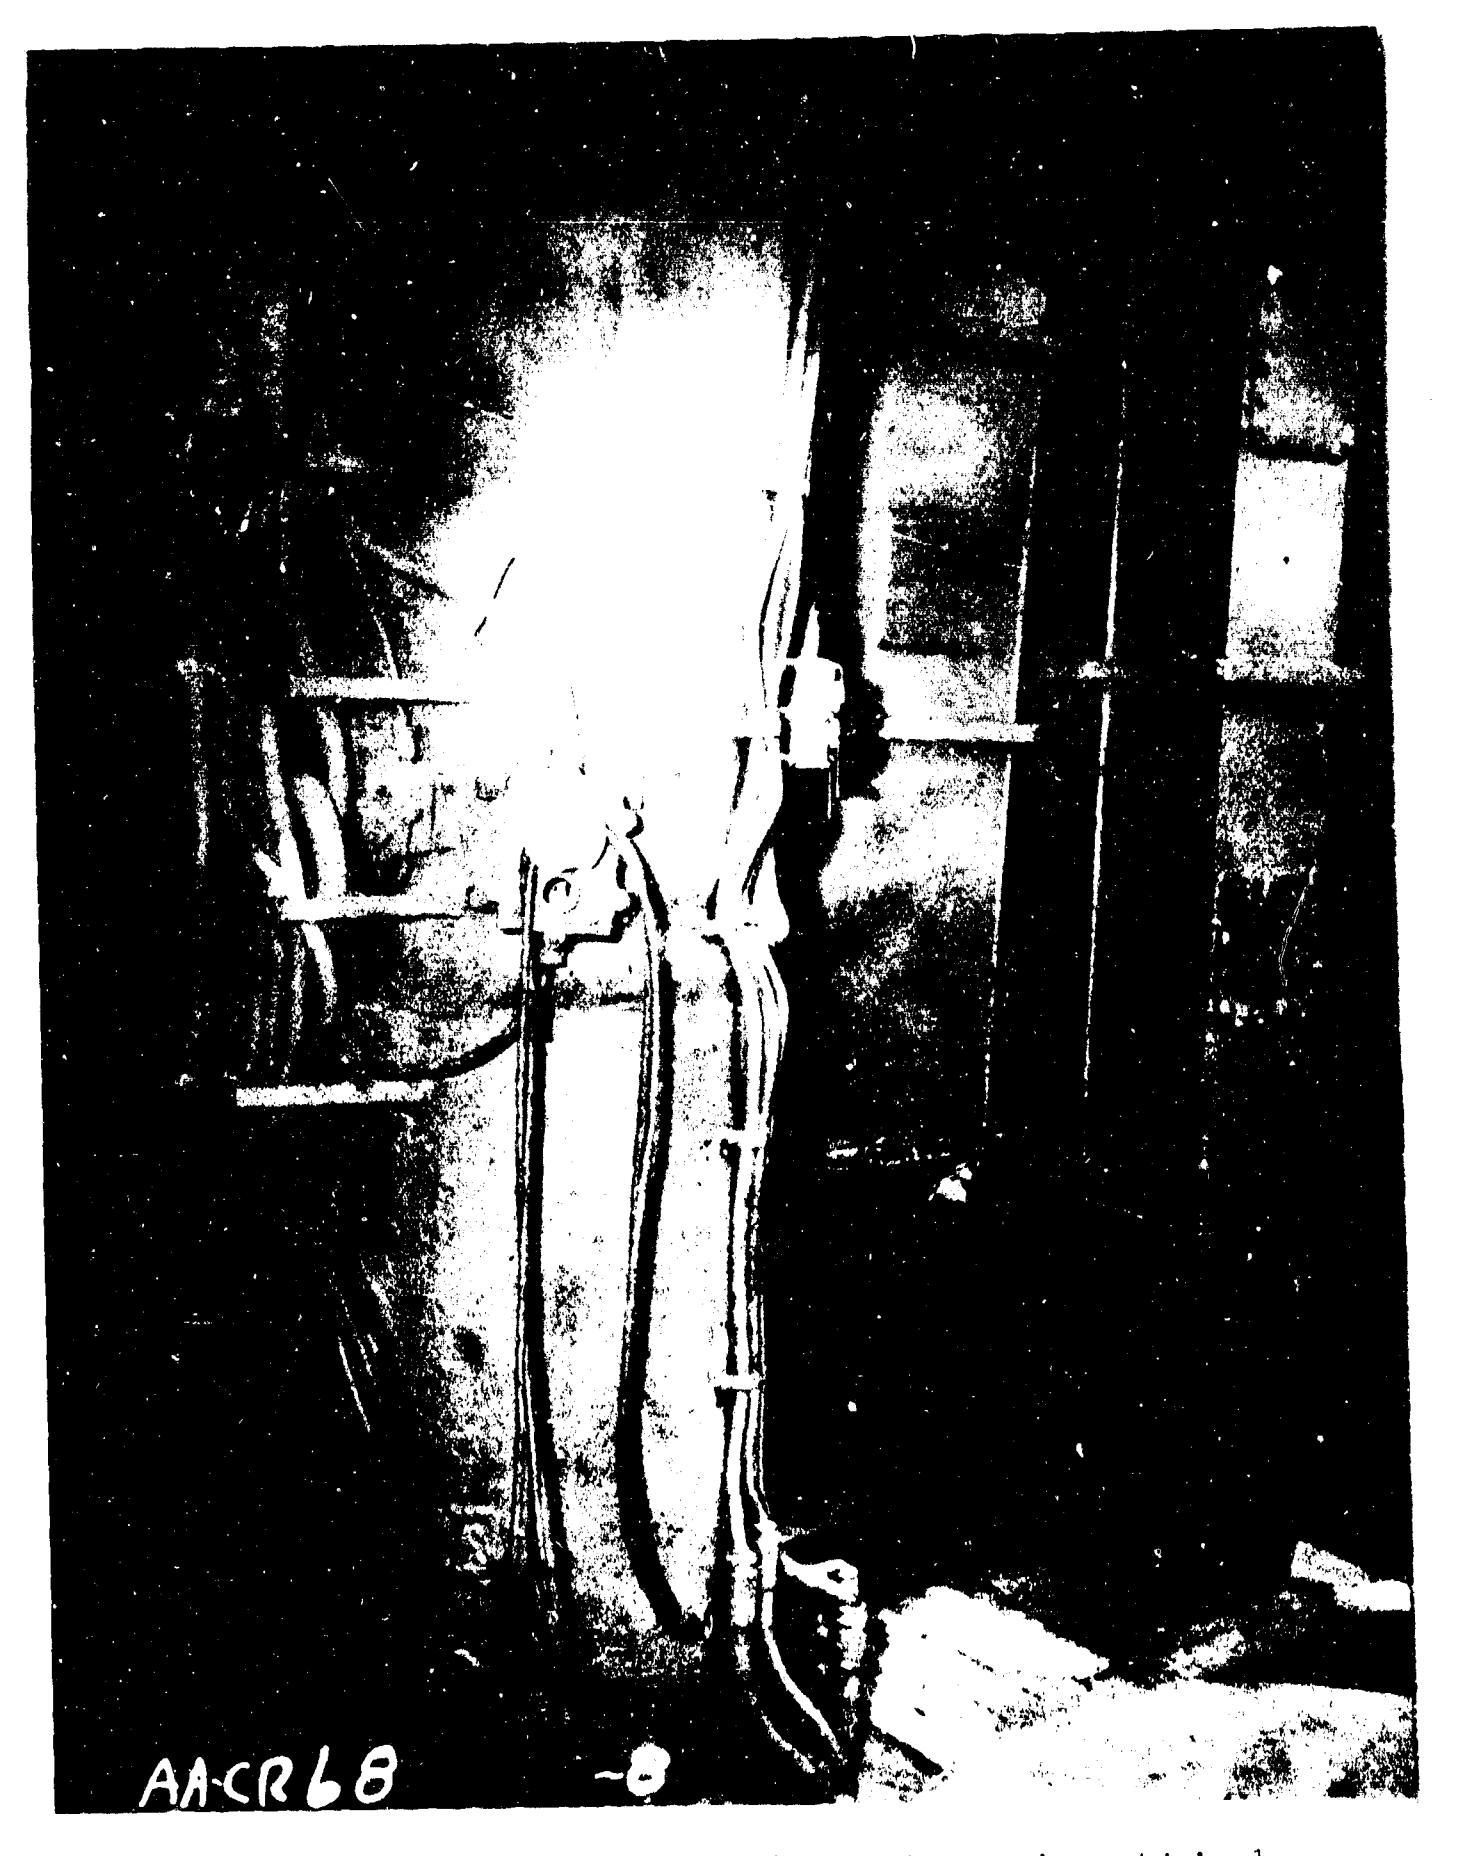
AA-CR-68-2111-8. USS ARKANSAS (BB33). Foreleg- mainmast tripod looking at wrinkle from starboard side.

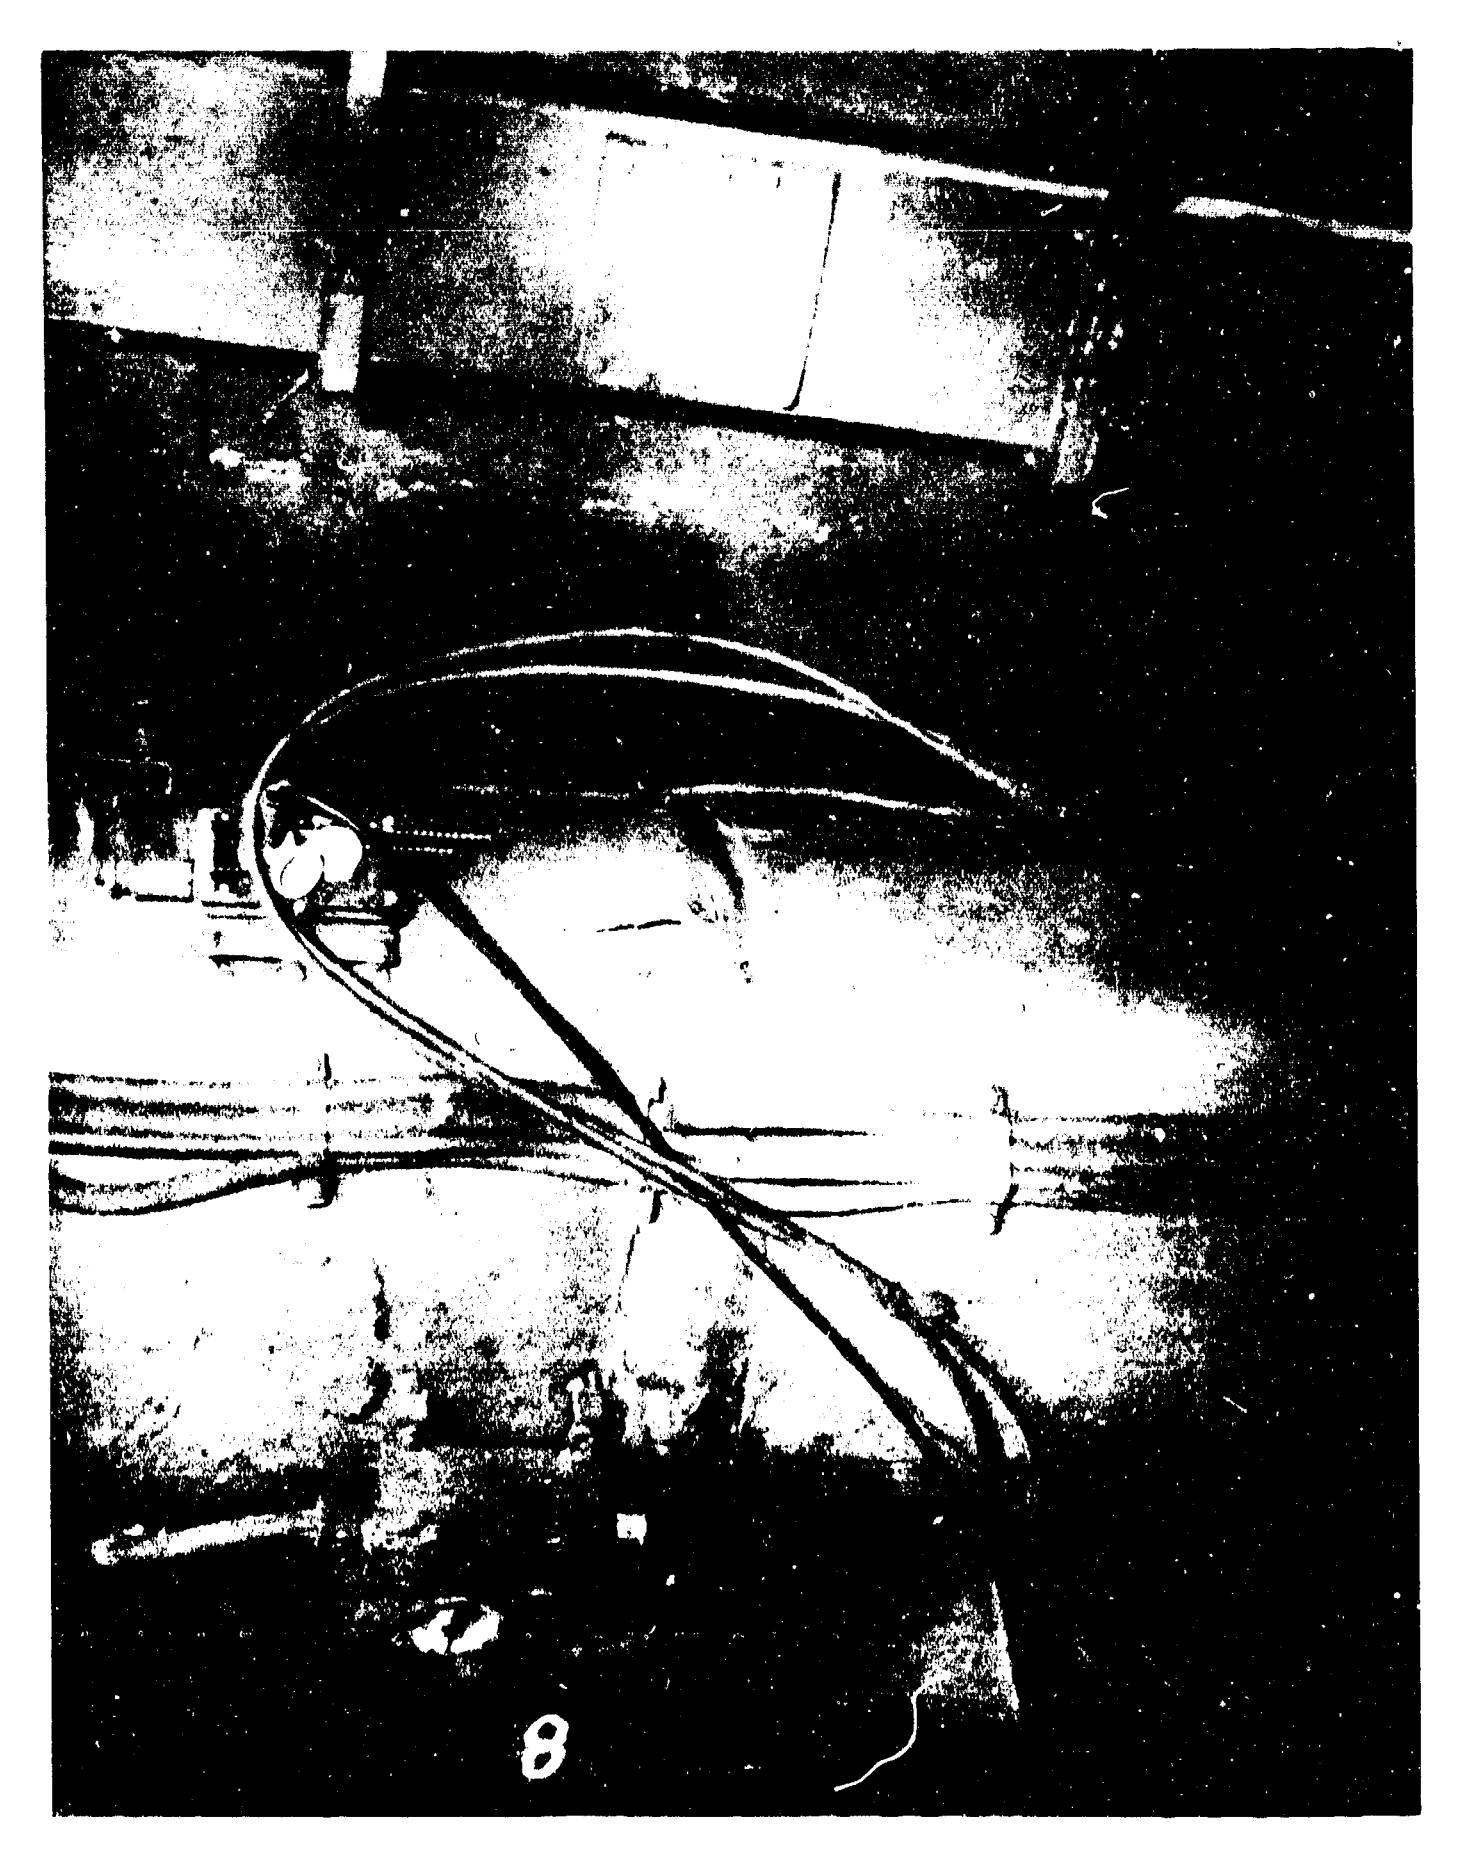
AA-CR-175-2134-8. USS ARKANSAS (BB33). Forward leg of after tripod showing wrinkling at top of wrapper plate, and opening of beam on port side.
