BUREAU OF SHIPS GROUP

TECHNICAL INSPECTION REPORT

FAILURES OF MASTS, YARDARMS, BOOMS, AND RIGGING

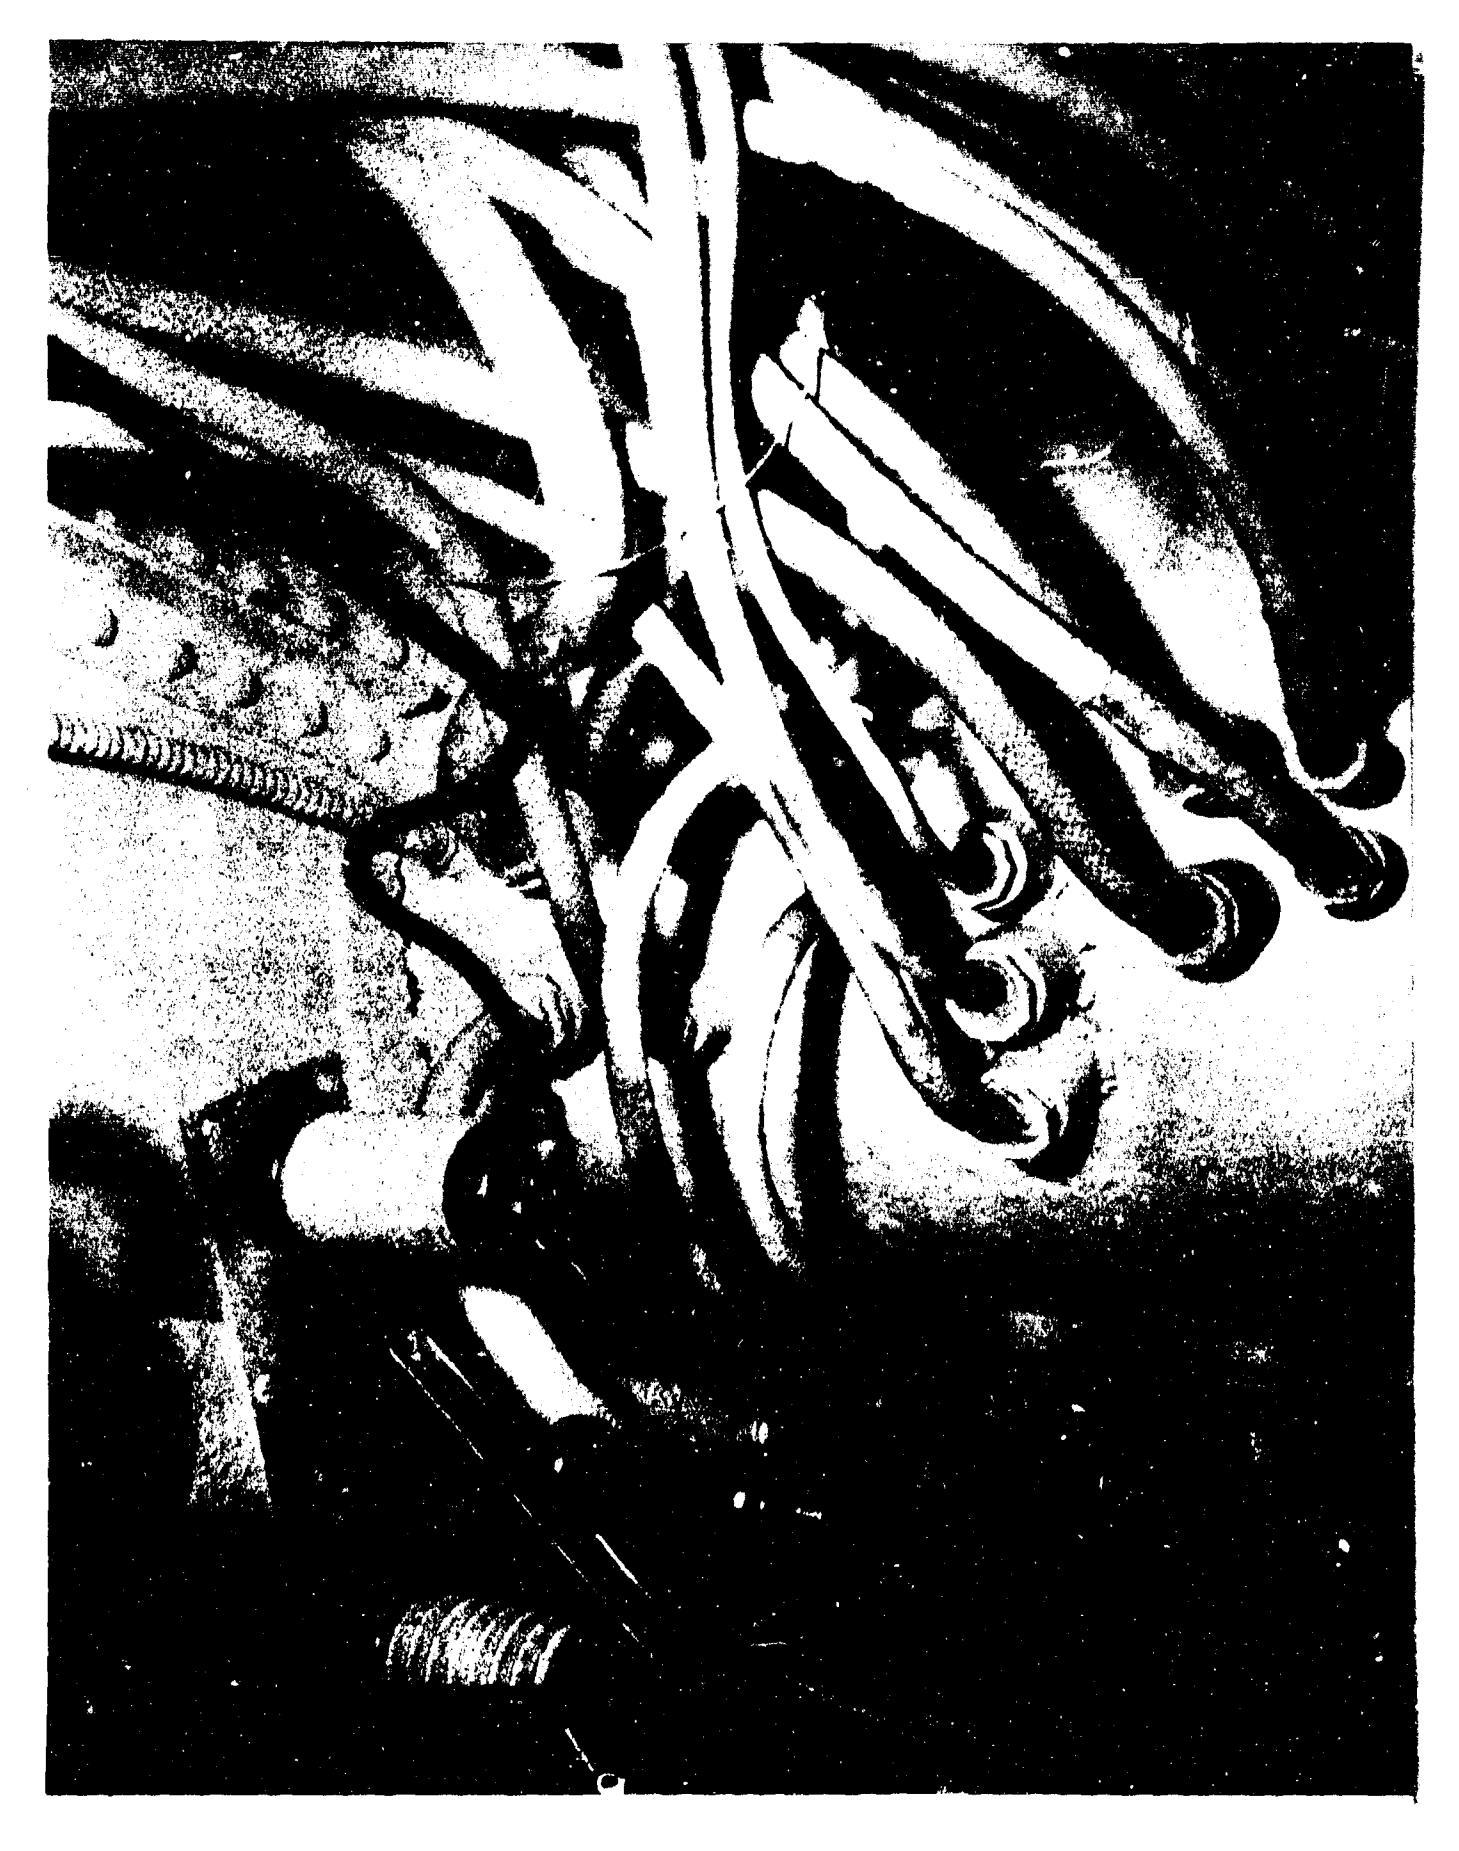
AA-CR-68-2146-9. USS ARKANSAS (BB33). Center leg, after tripod, frame 99, looking aft under second deck.

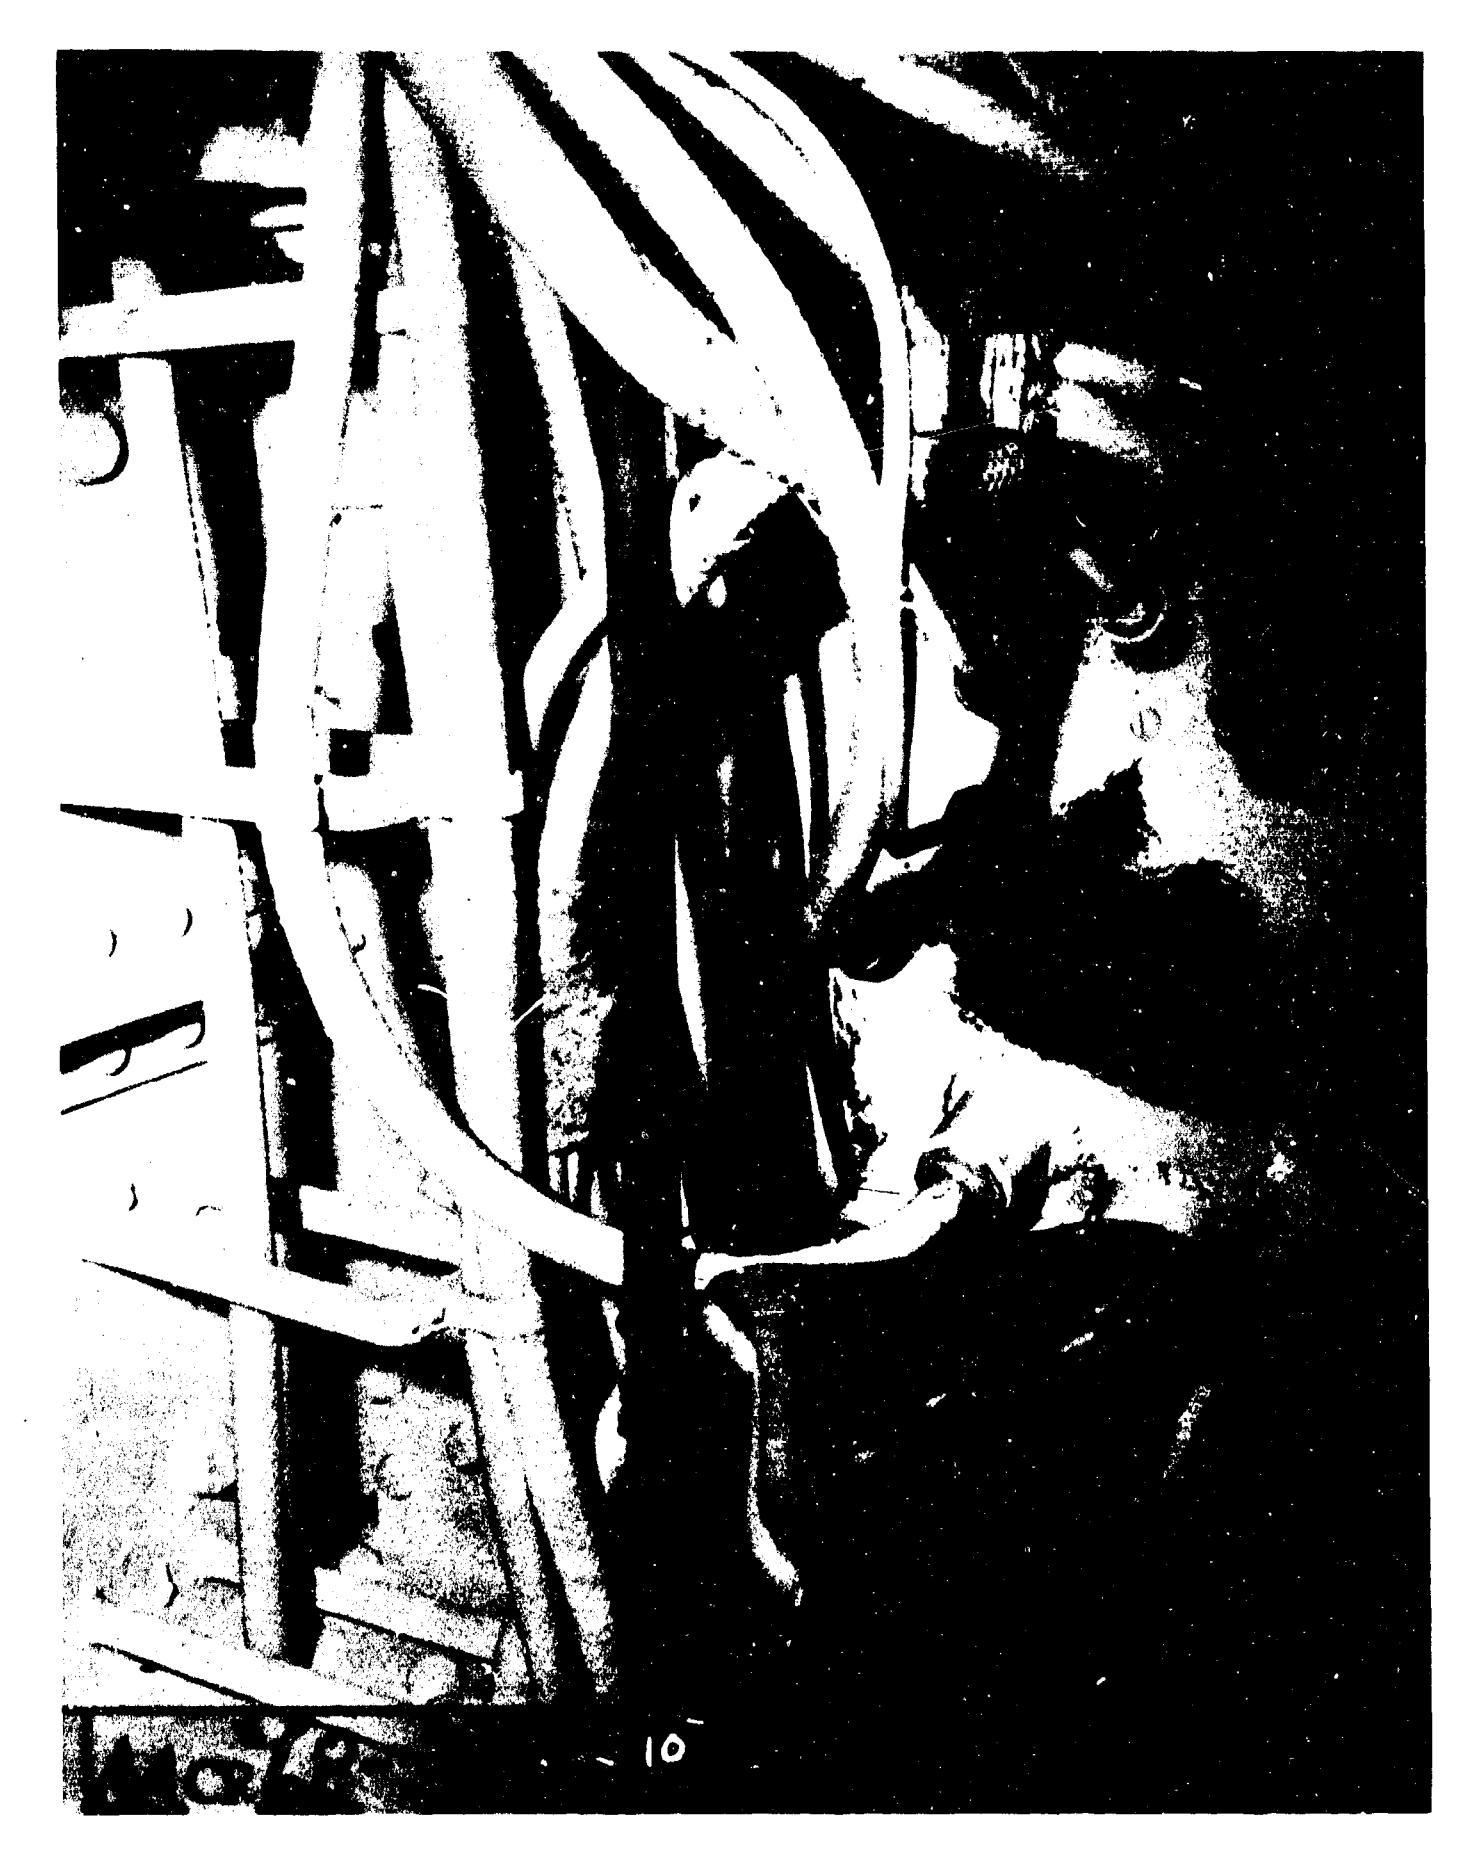
AA-CR-68-2146-10. USS ARKANSAS (BB33). Center leg, after tripod, frame 99, looking aft, under second deck.

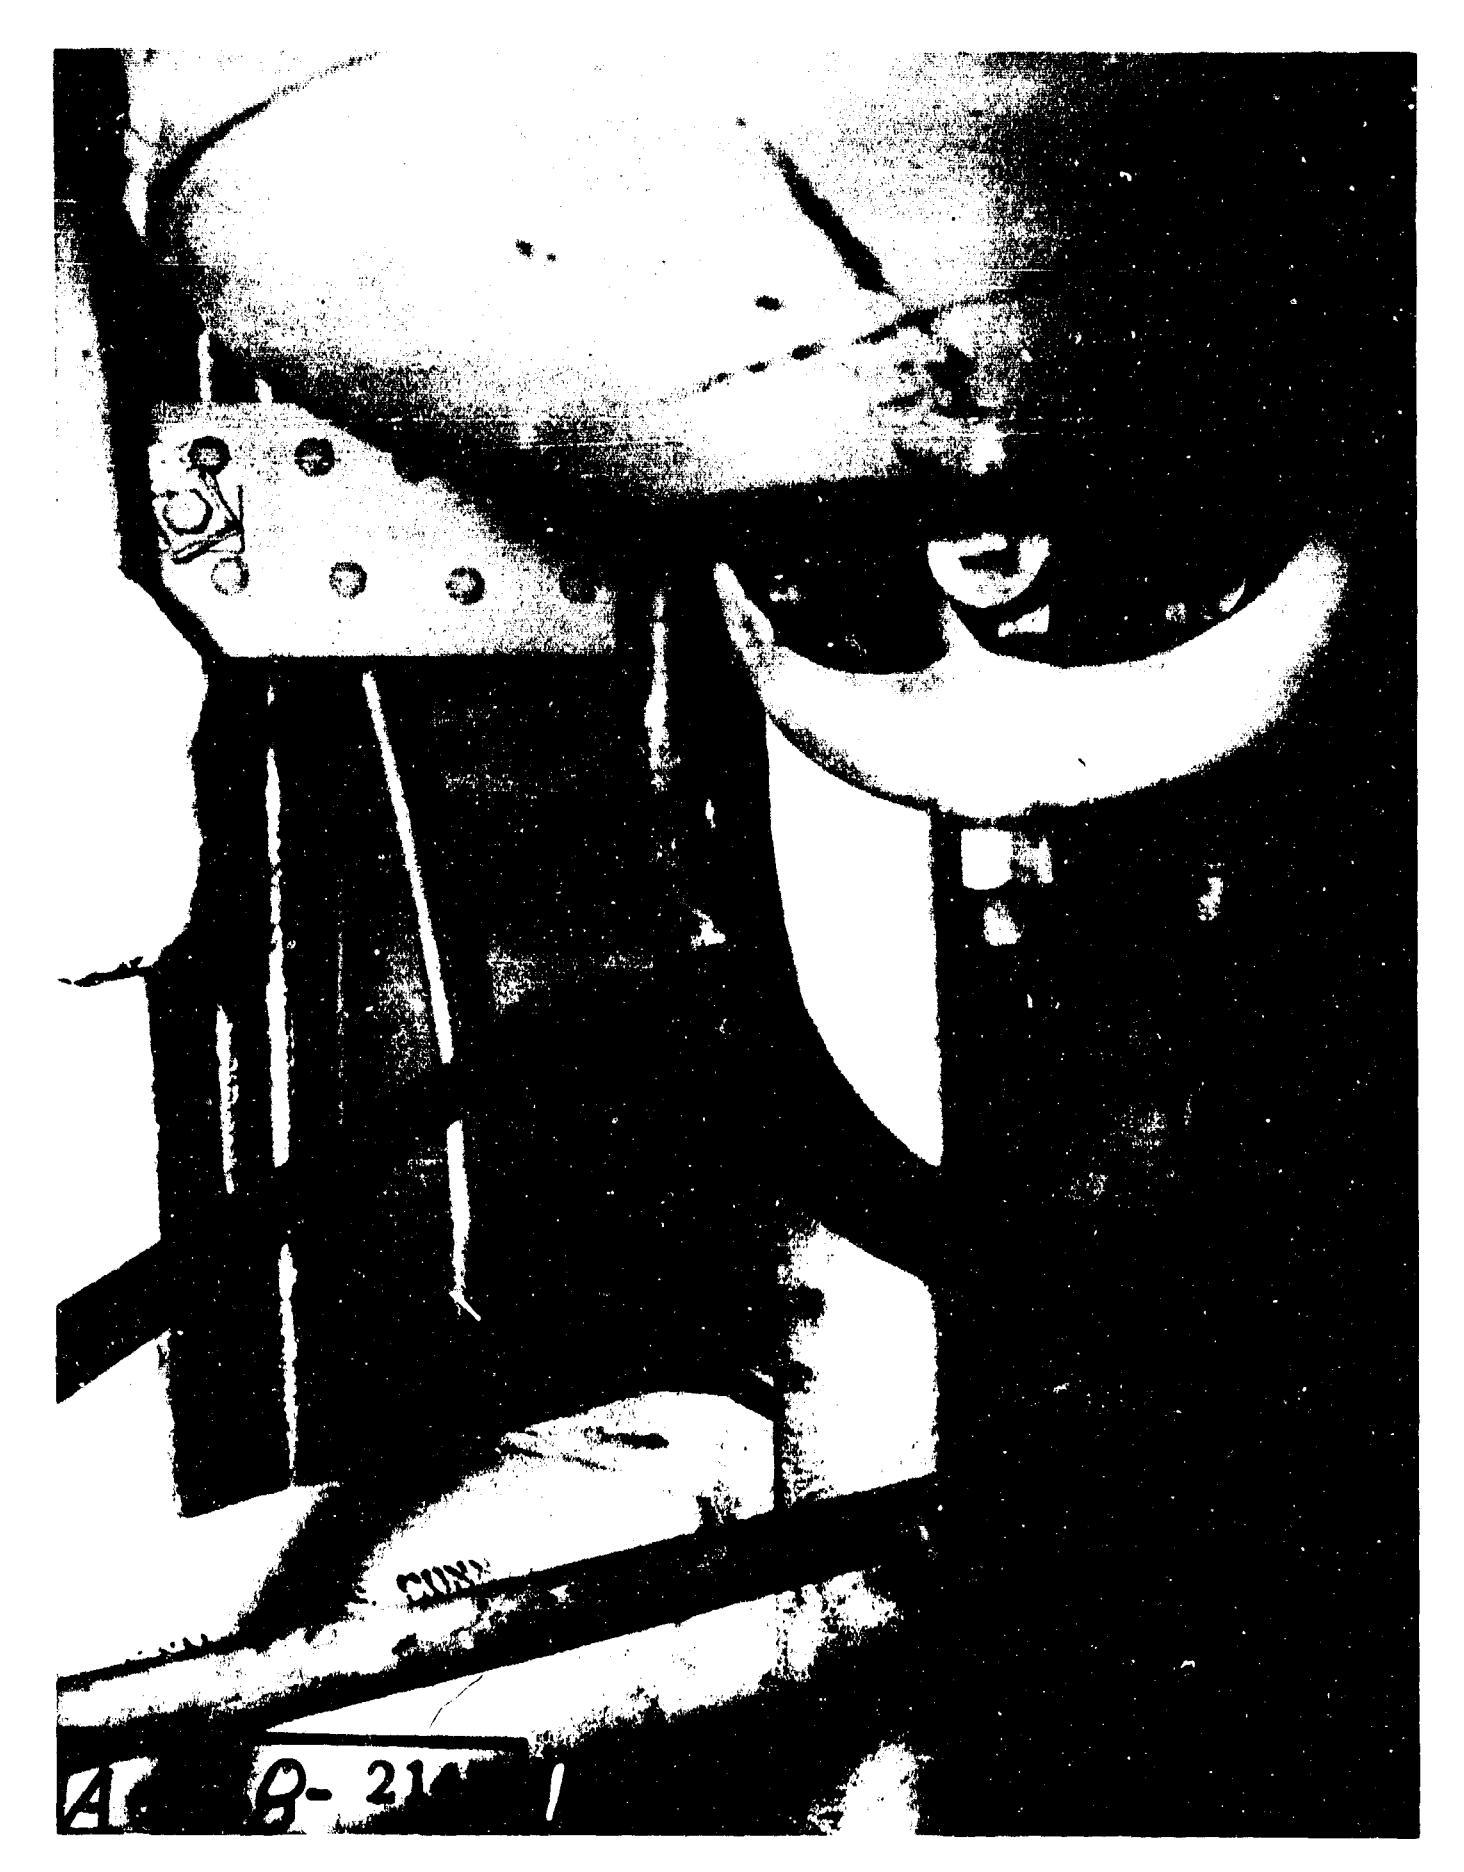
AA-CR-68-2147-1. USS ARKANSAS (BB33). Bulge in longitudinal bulkhead under 3rd deck - frames 98-99. Looking to starboard.

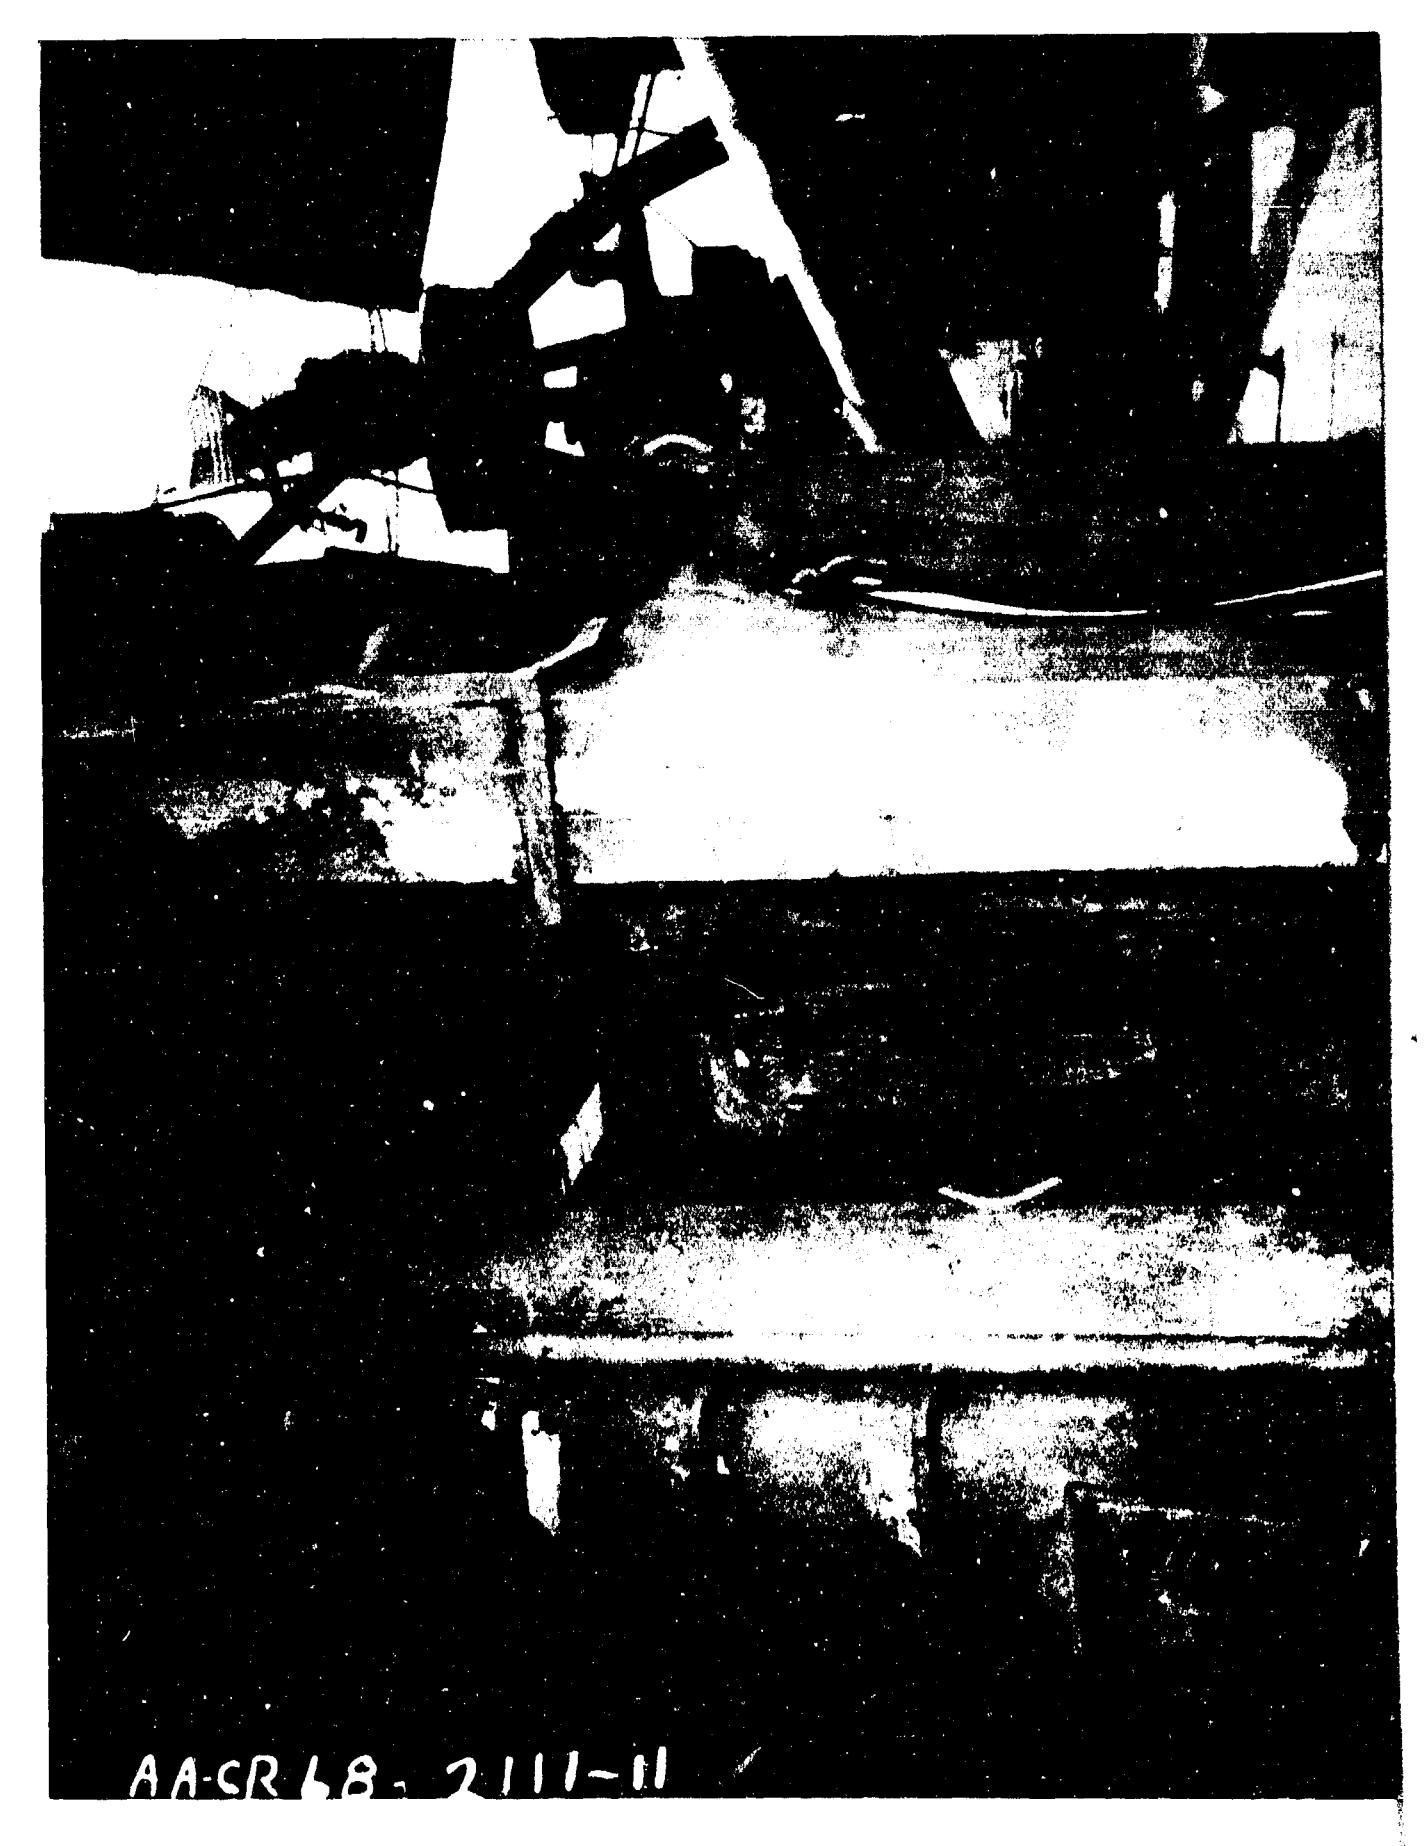
AA-CR-68-2111-11. USS ARKANSAS (BB33). Mainmast structure - starboard side - gap at 01 level.

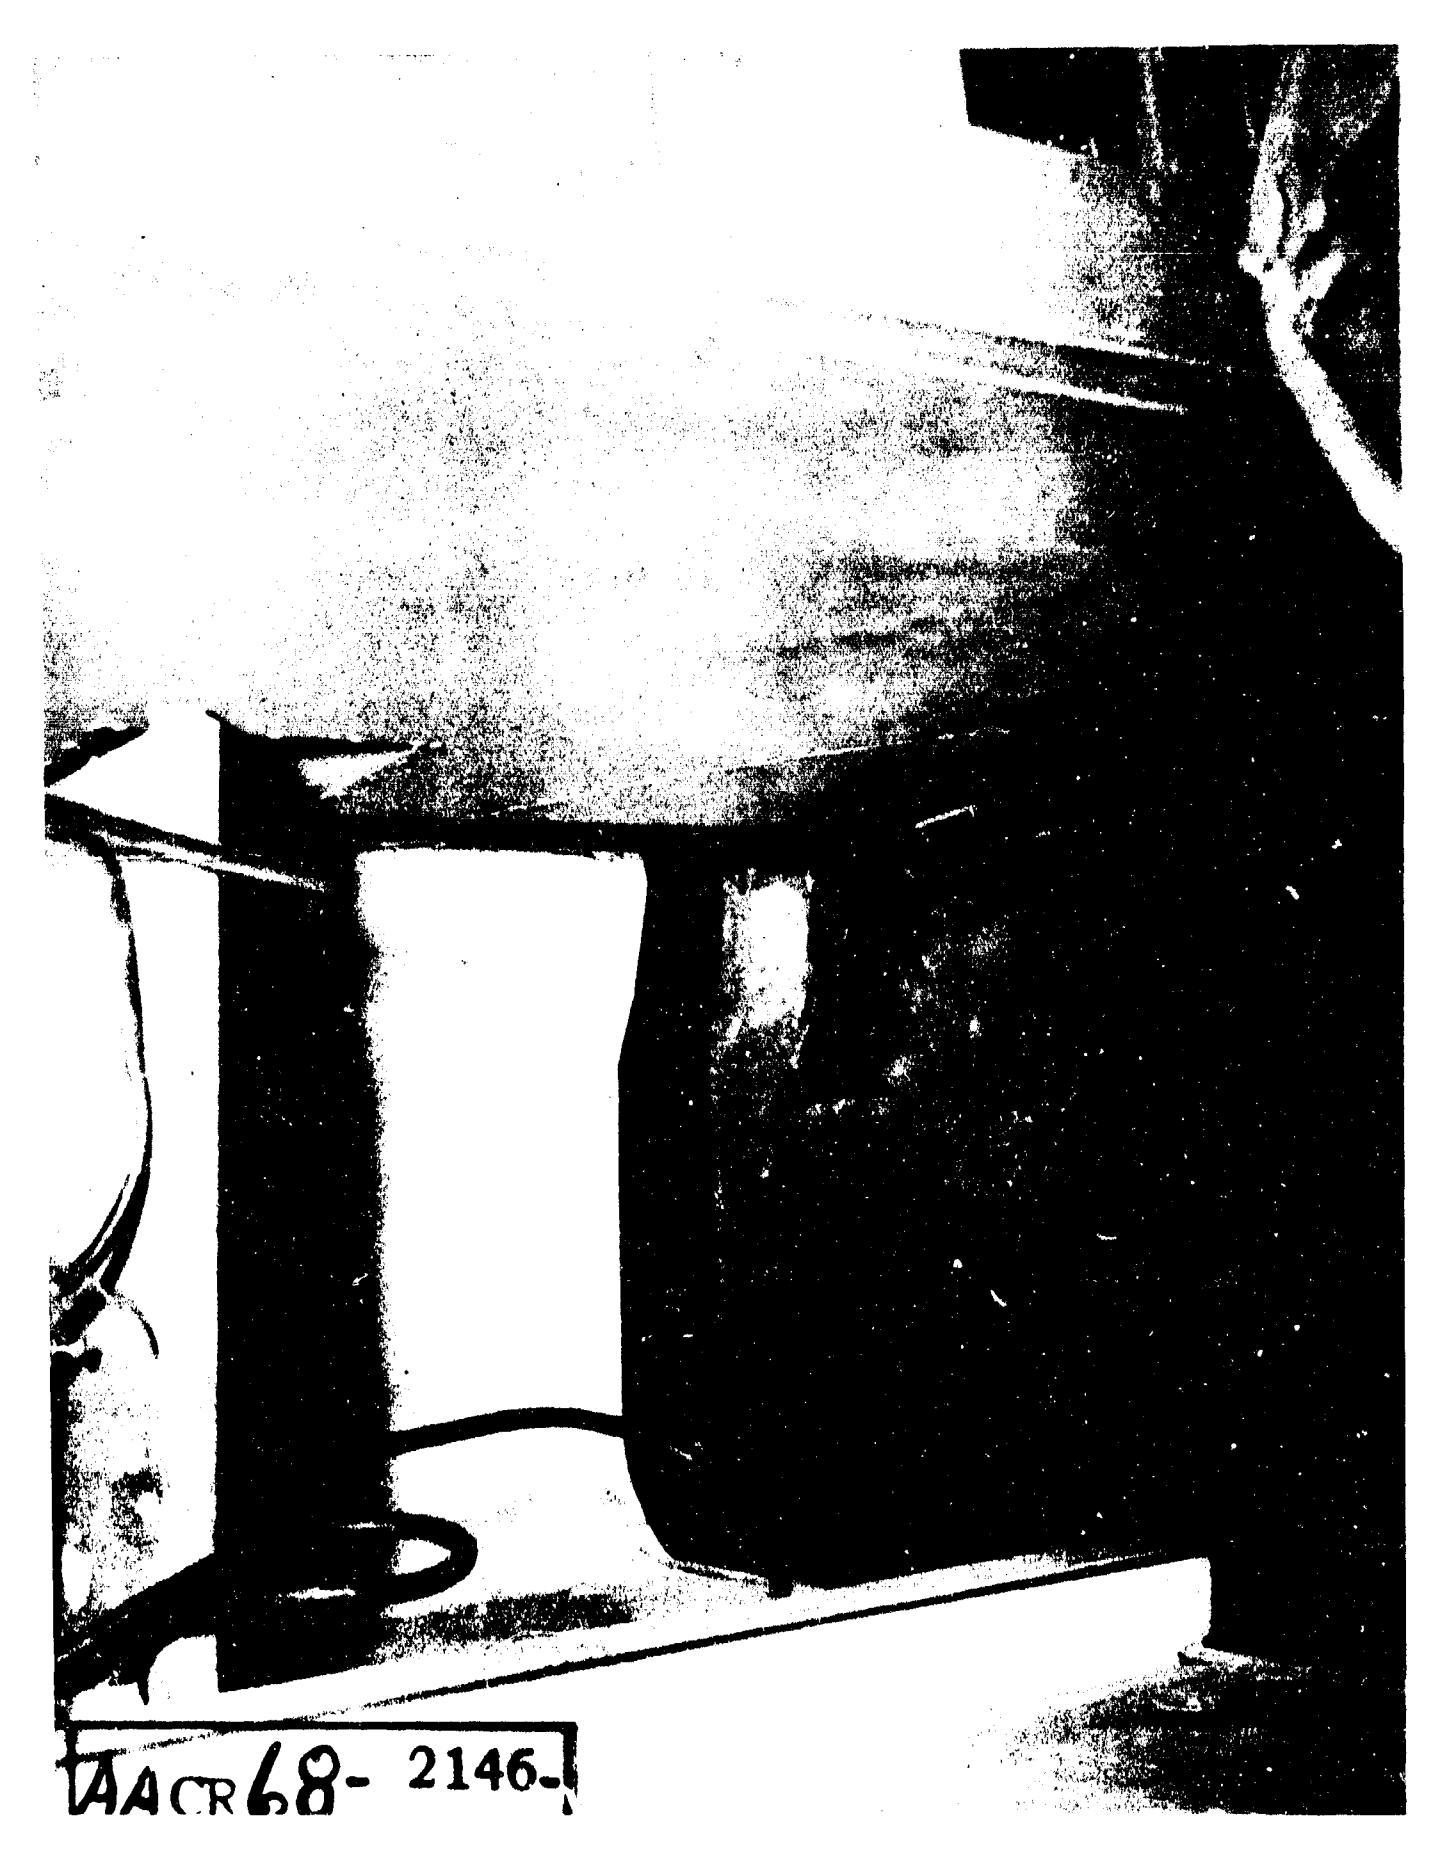
AA-CR-68-2146-3. USS ARKANSAS (BB33). Aft starboard leg, wrinkle at 01 level.

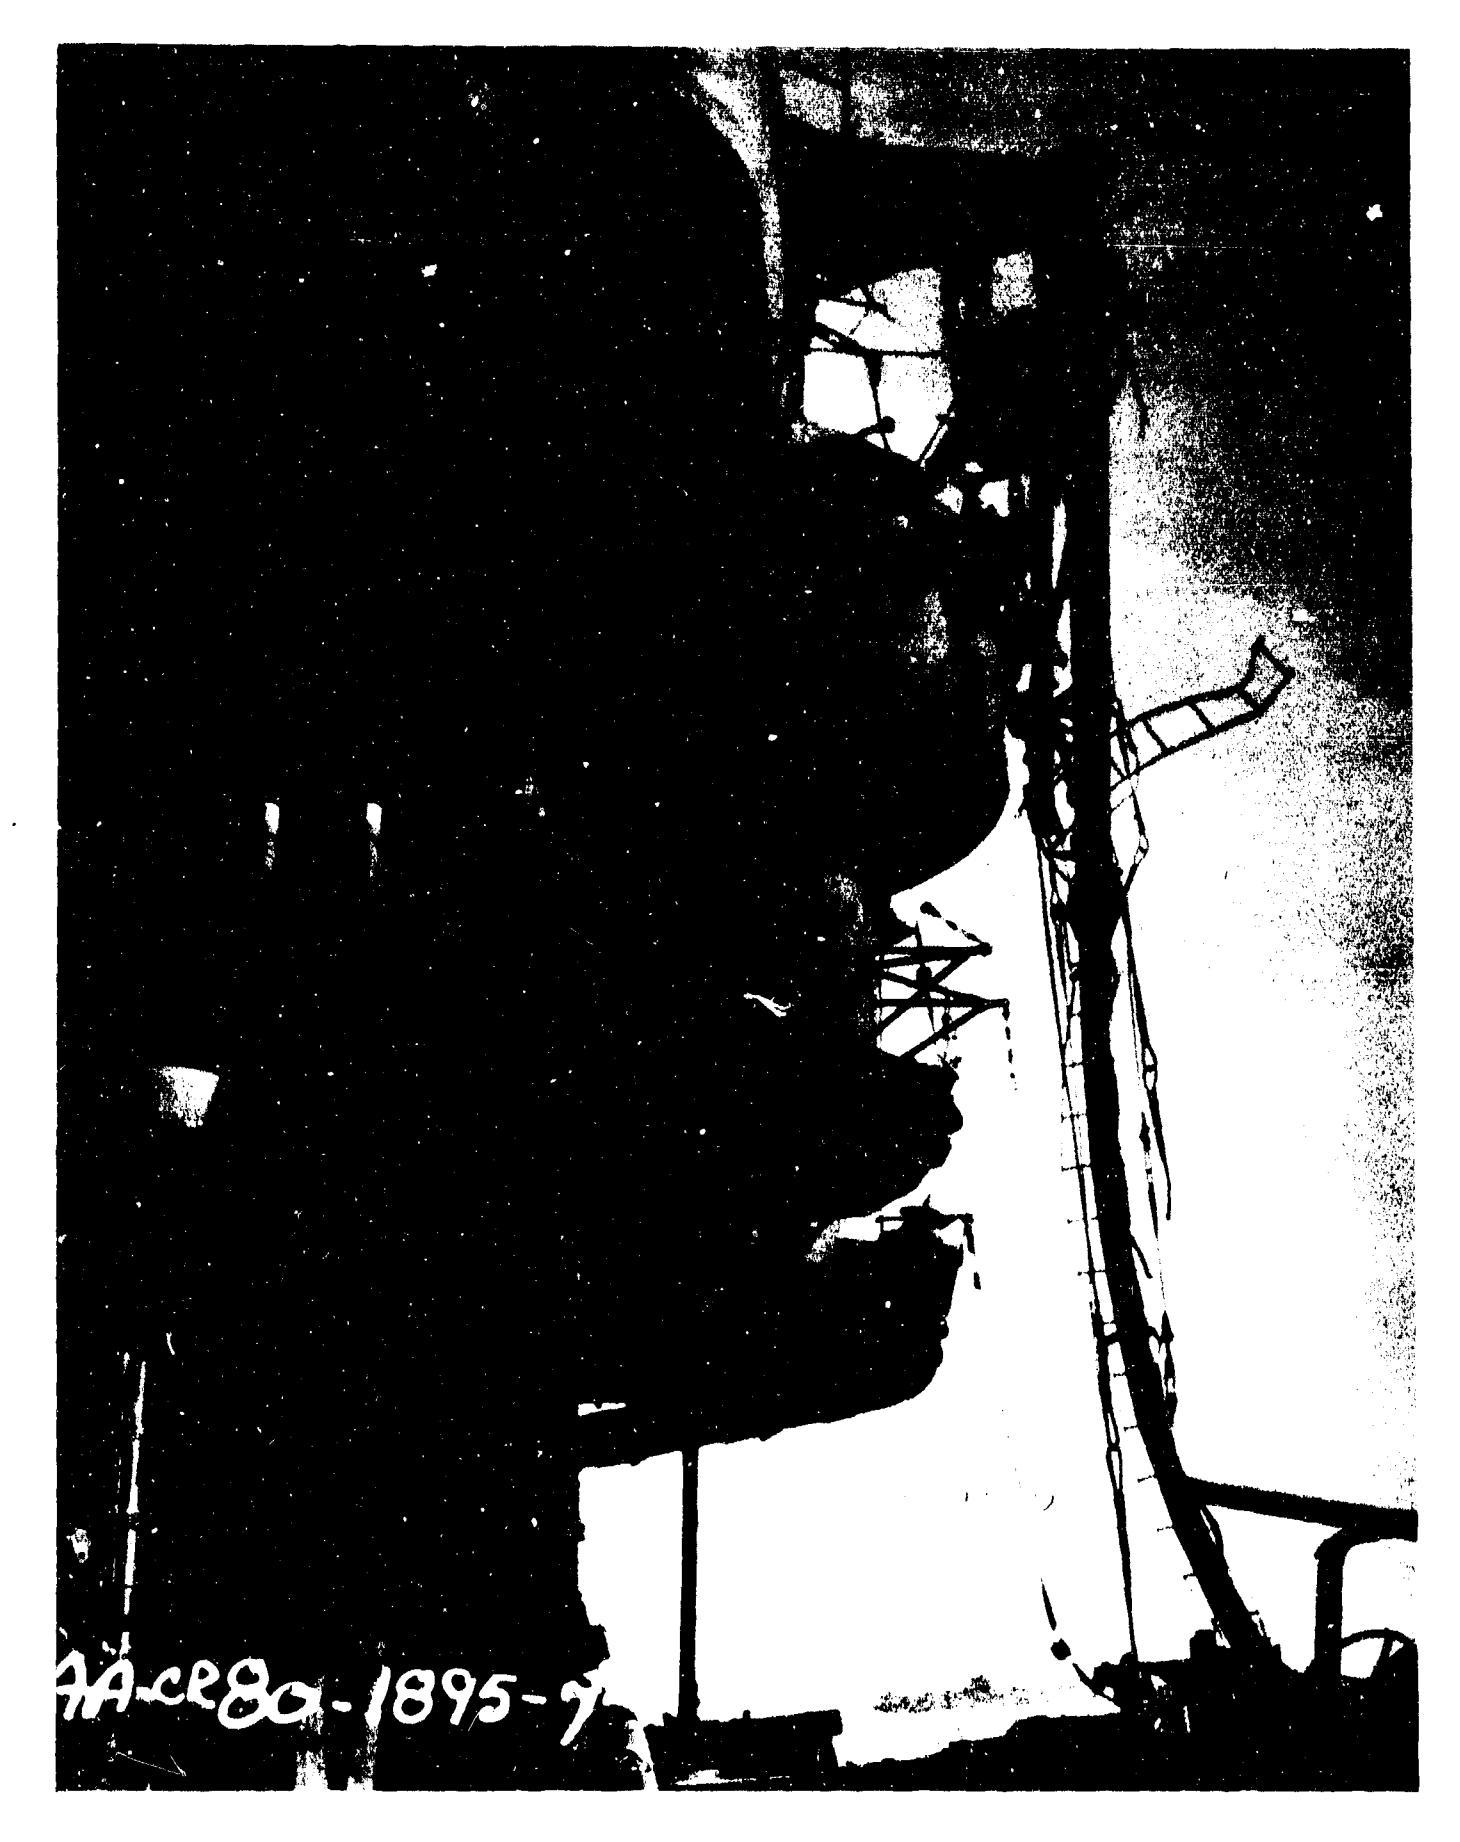
AA-CR-80-1895-7. USS ARKANSAS (BB33). Forward area of after tripod, looking to port, showing main mast hanging top down.

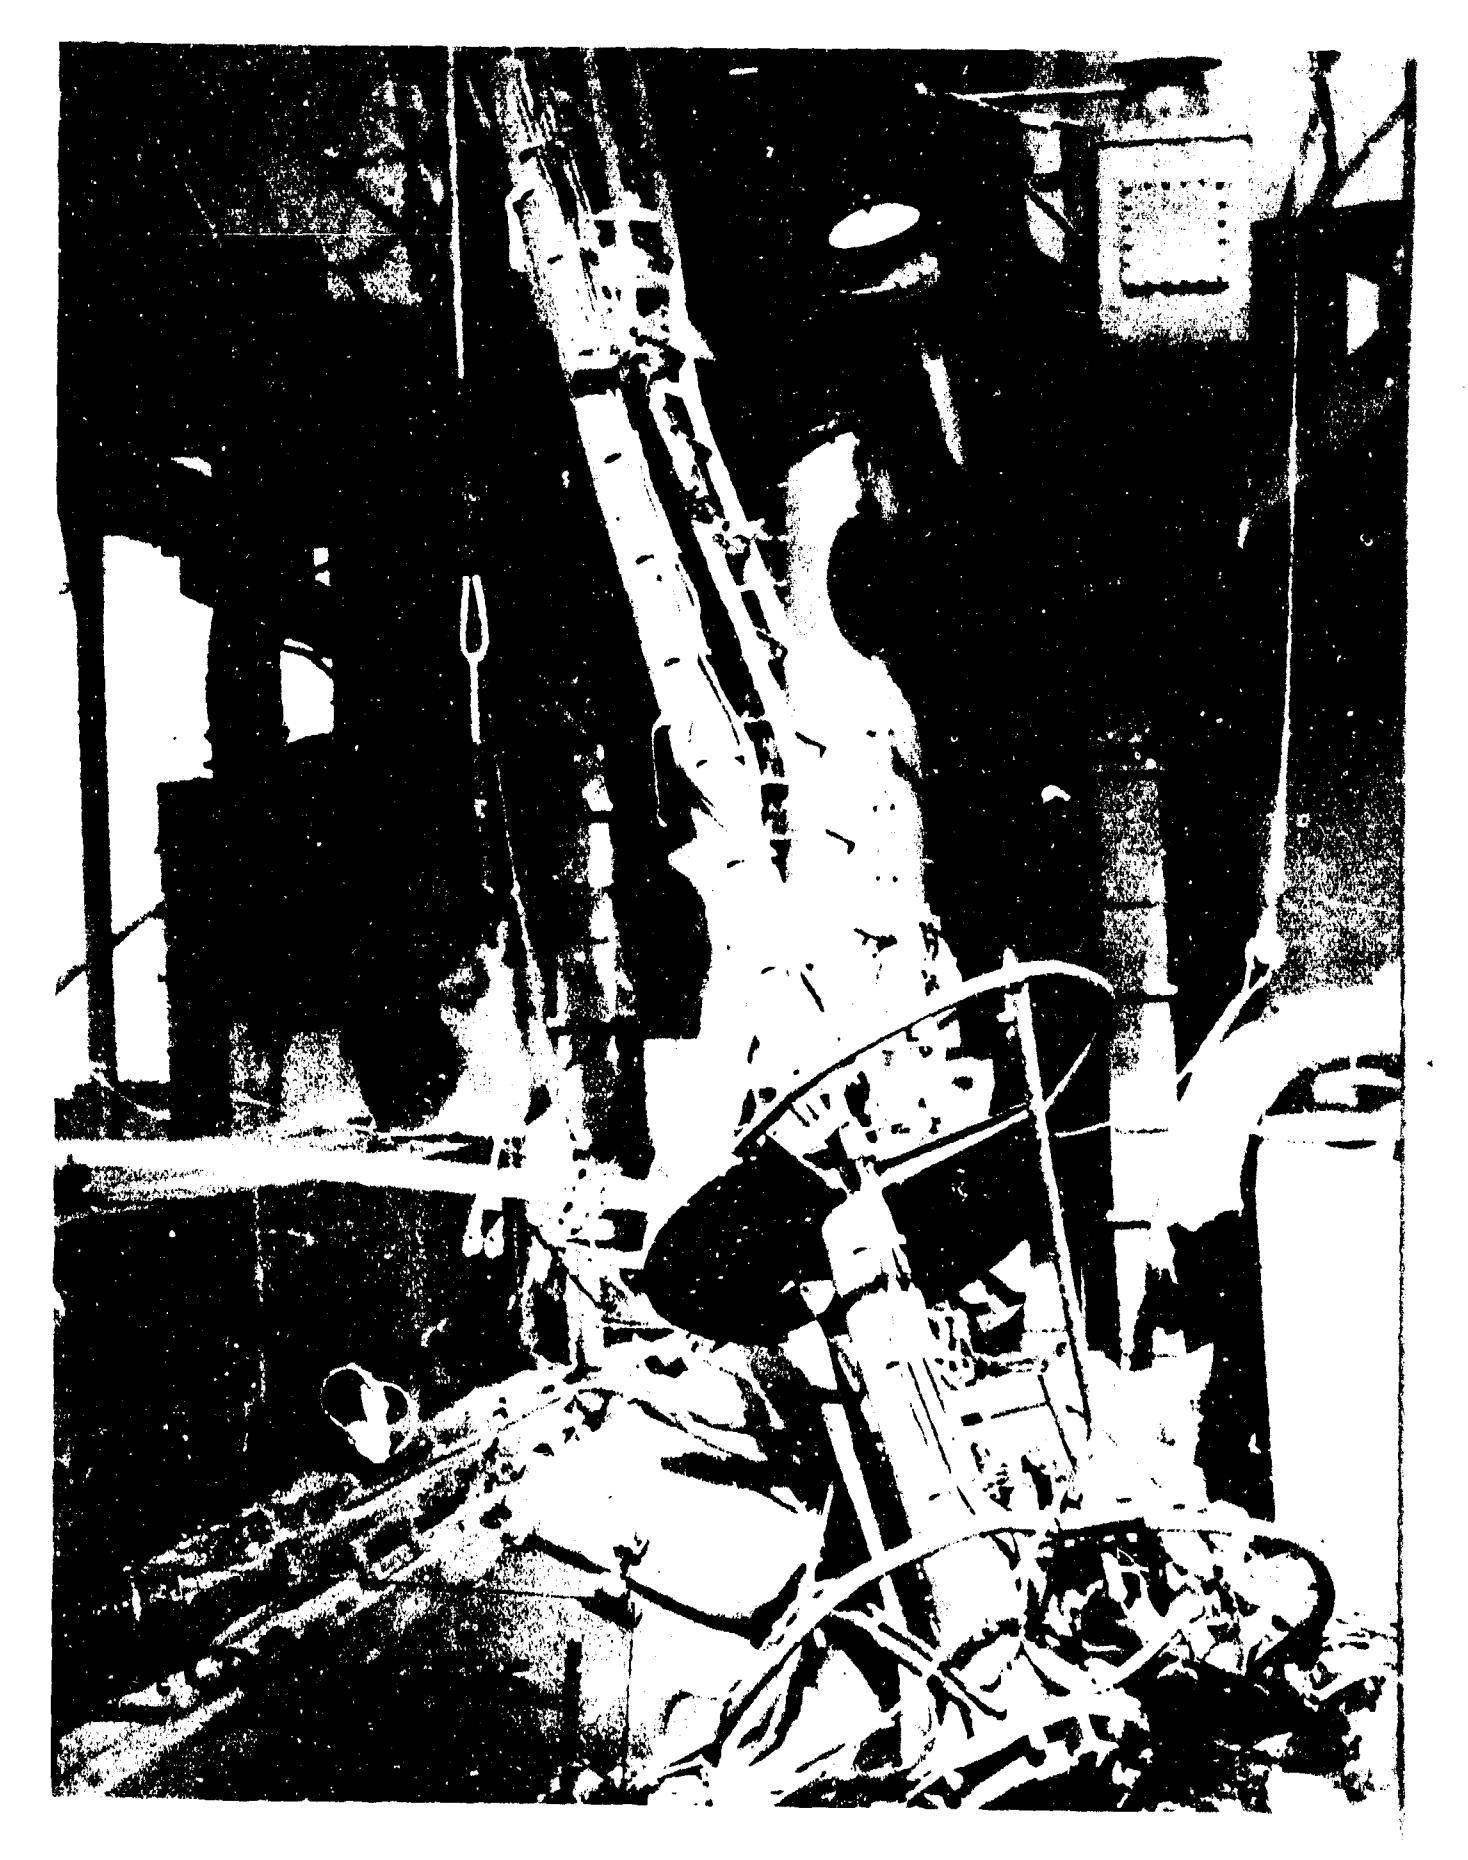
AA-CR-80-1895-9. USS ARKANSAS (BB33). Detail of top of mainmast.

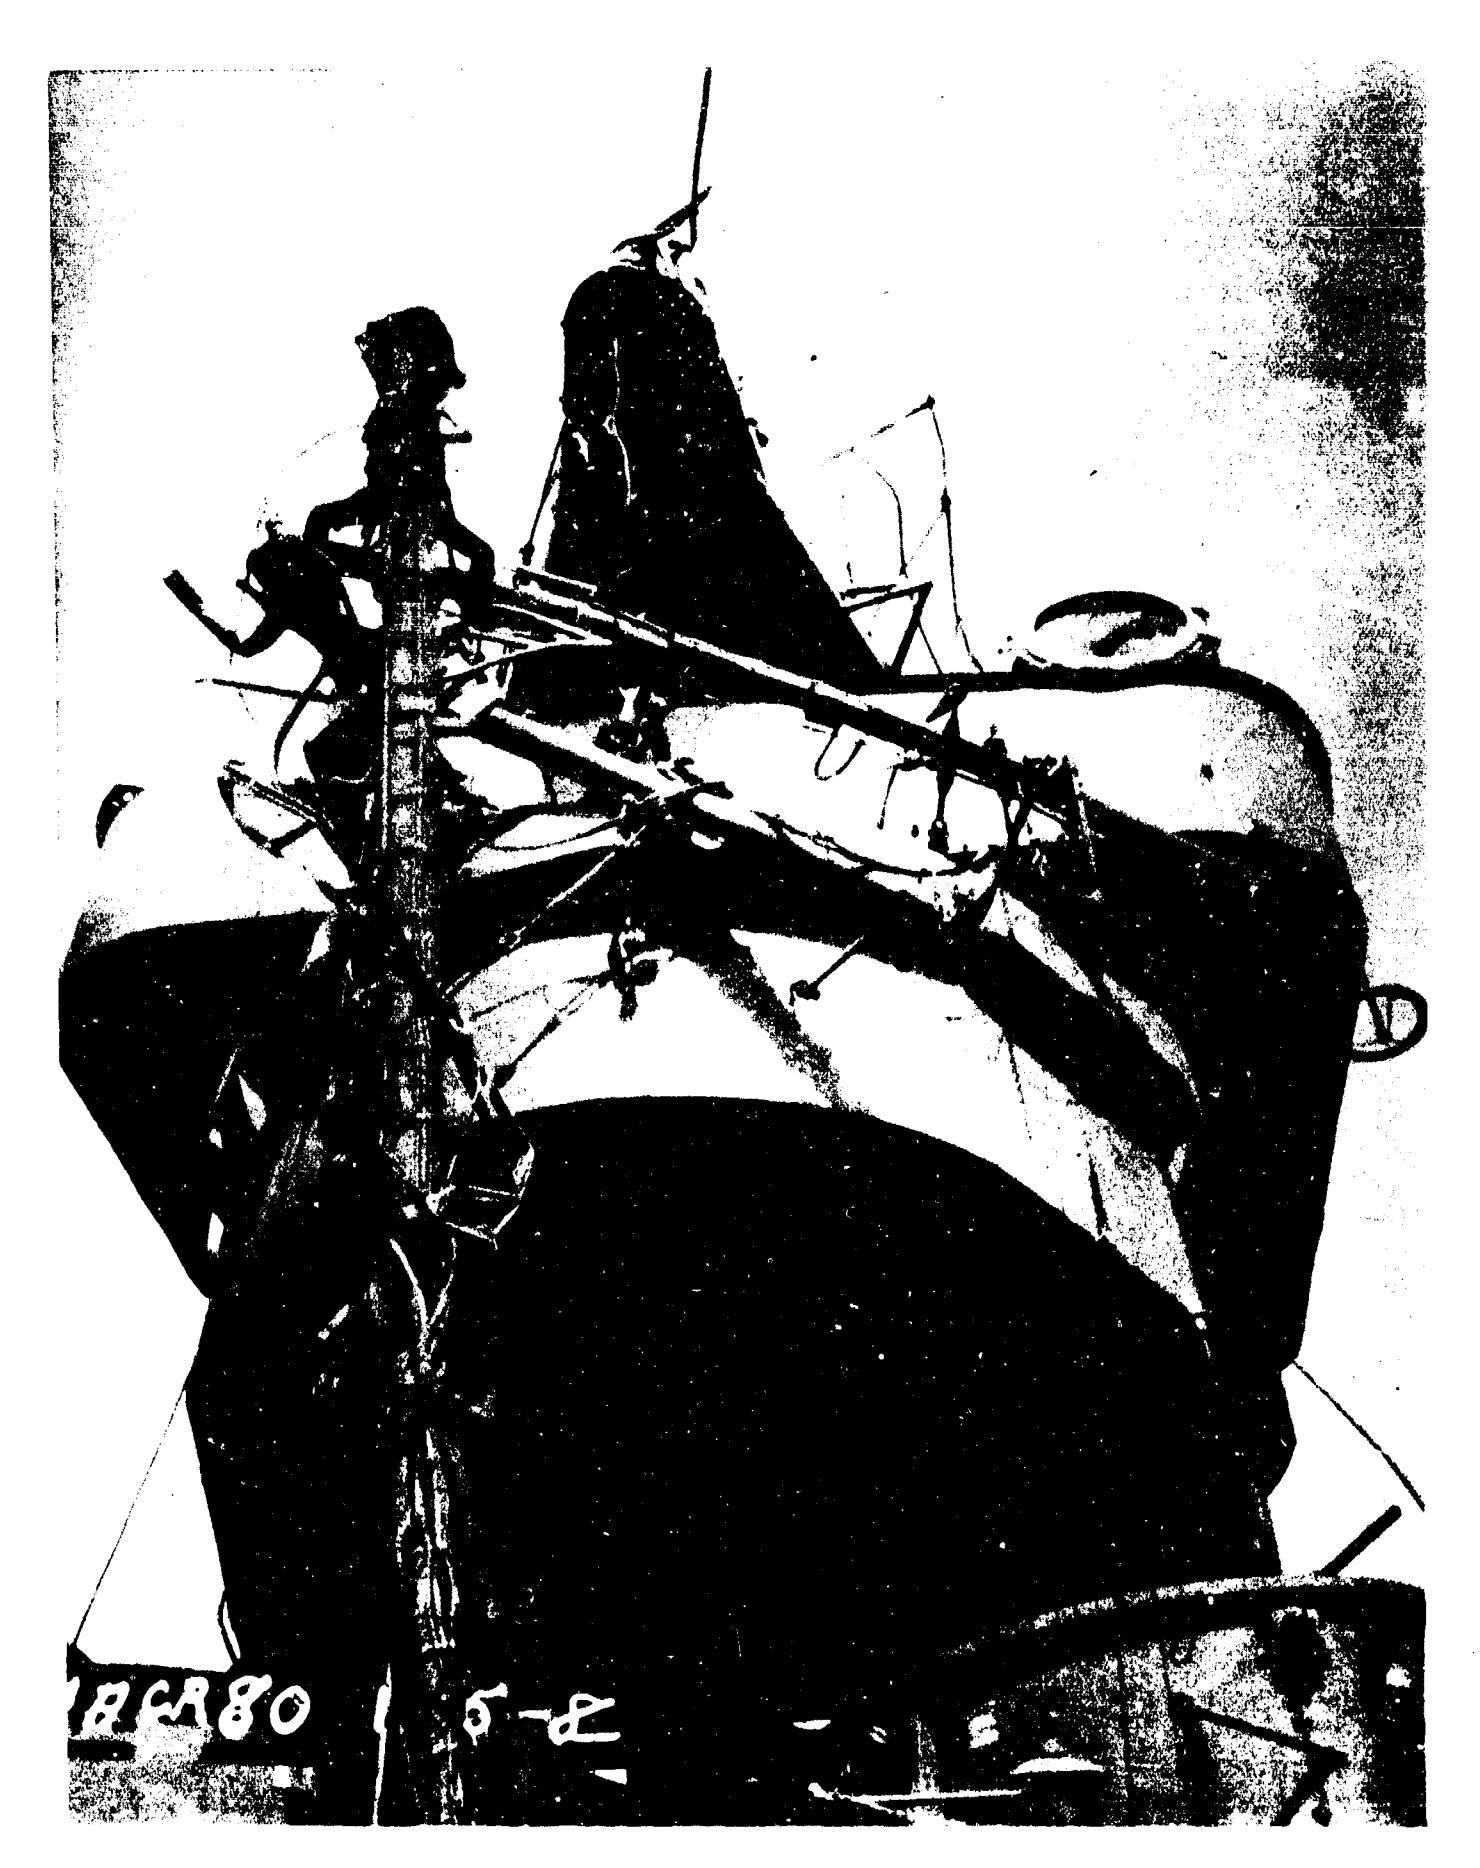
AA-CR-80-1895-8. USS ARKANSAS (BB33). Detail of lower end of mainmast and yardarm.
