BUREAU OF SHIPS GROUP

TECHNICAL INSPECTION REPORT

FAILURES OF MASTS, YARDARMS, BOOMS, AND RIGGING

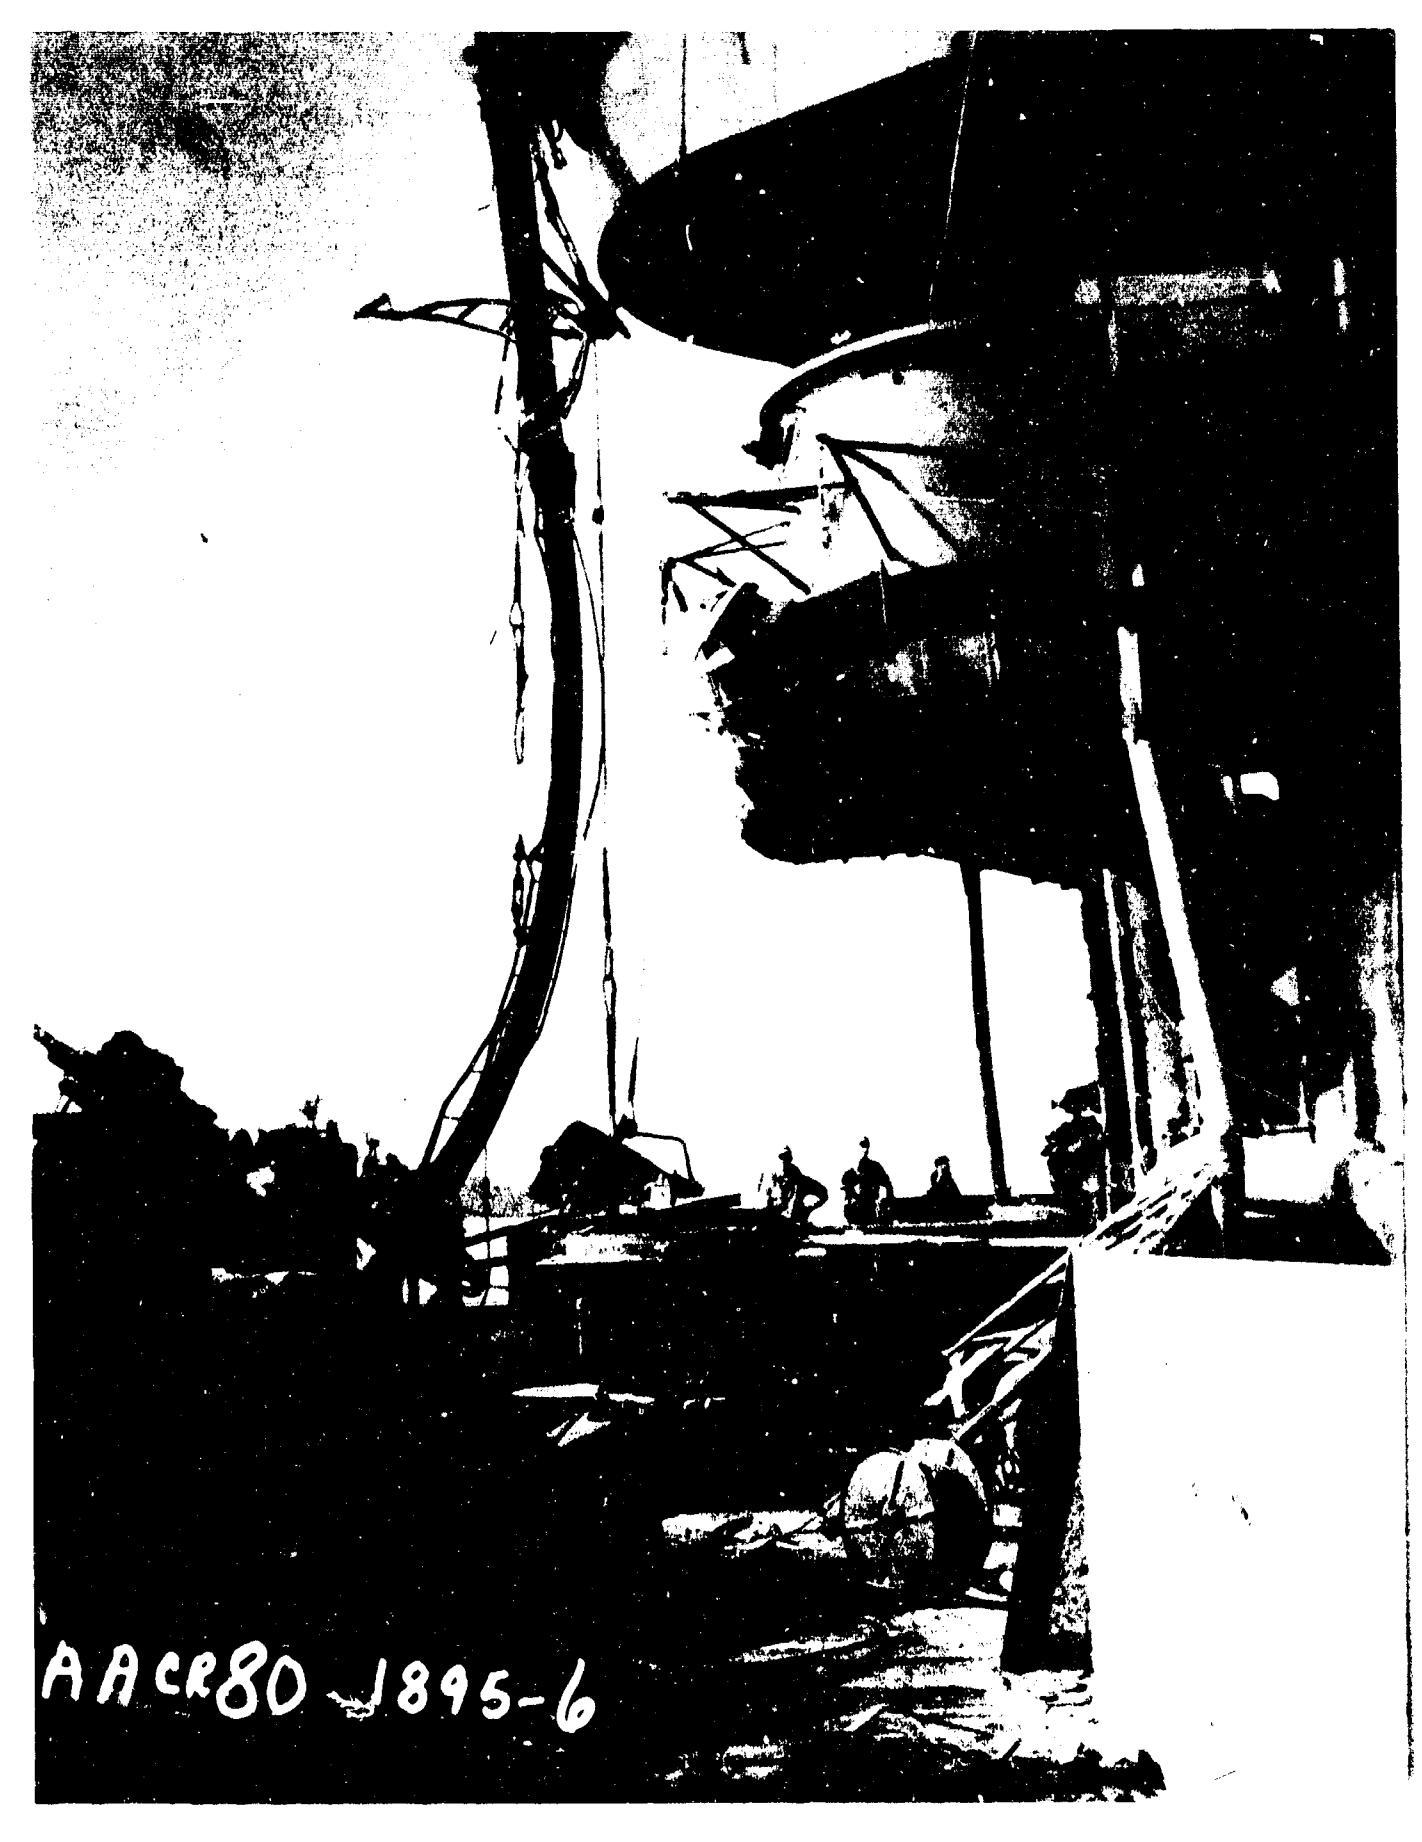
AA-CR-80-1895-6. USS ARKANSAS (BB33). General view of main deck and portion of main mast. Note that top of mast is in debris on deck.

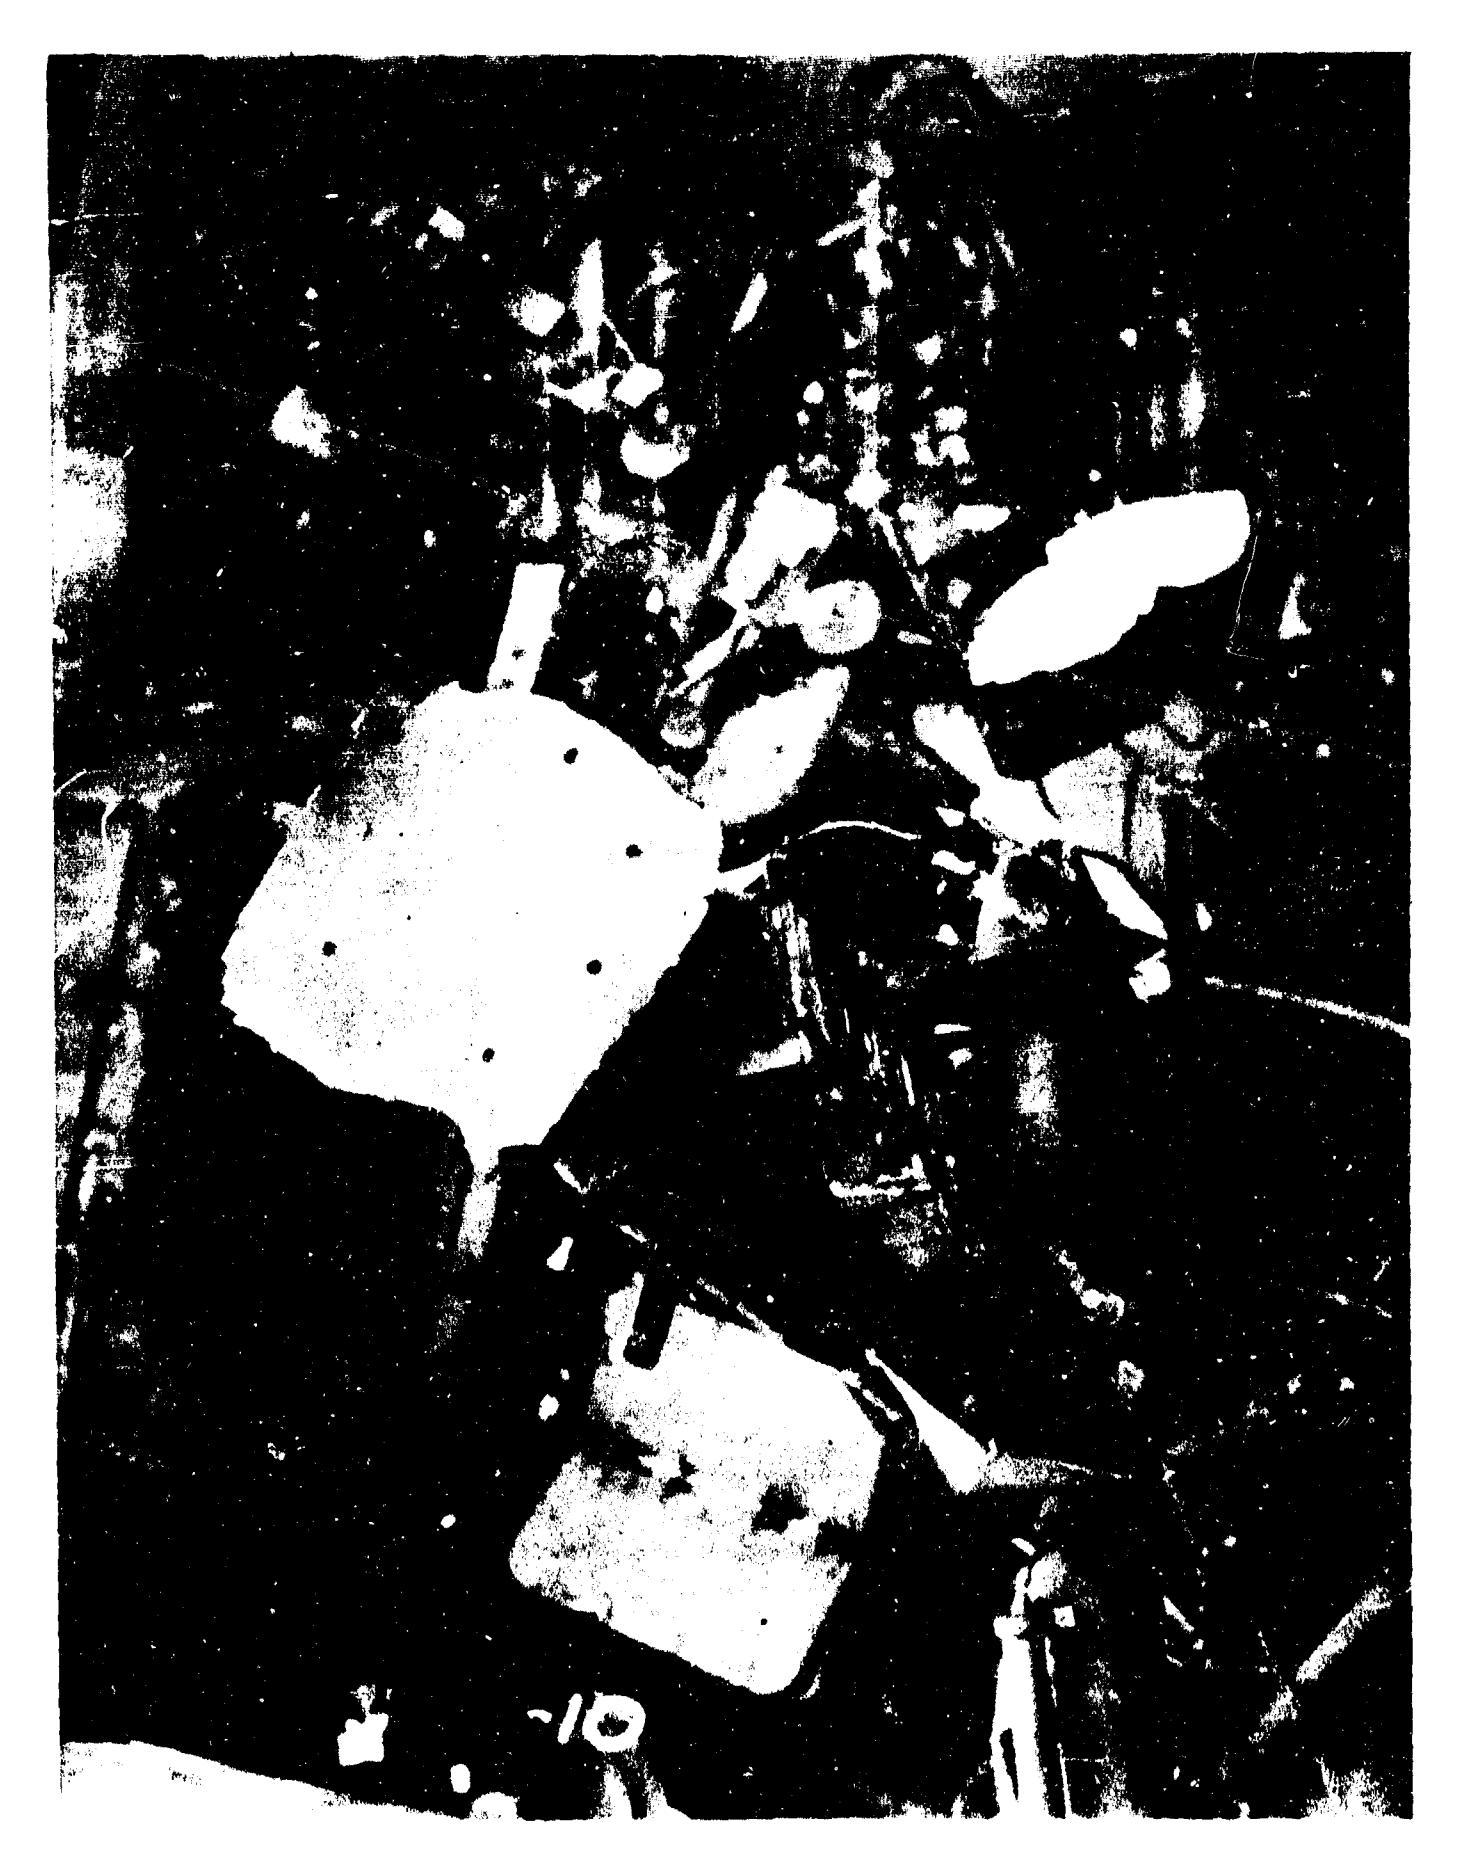
AA -CR-80-1895-10. USS ARKANSAS (BB33). Detail of base plate and yardarm brackets - mainmast.

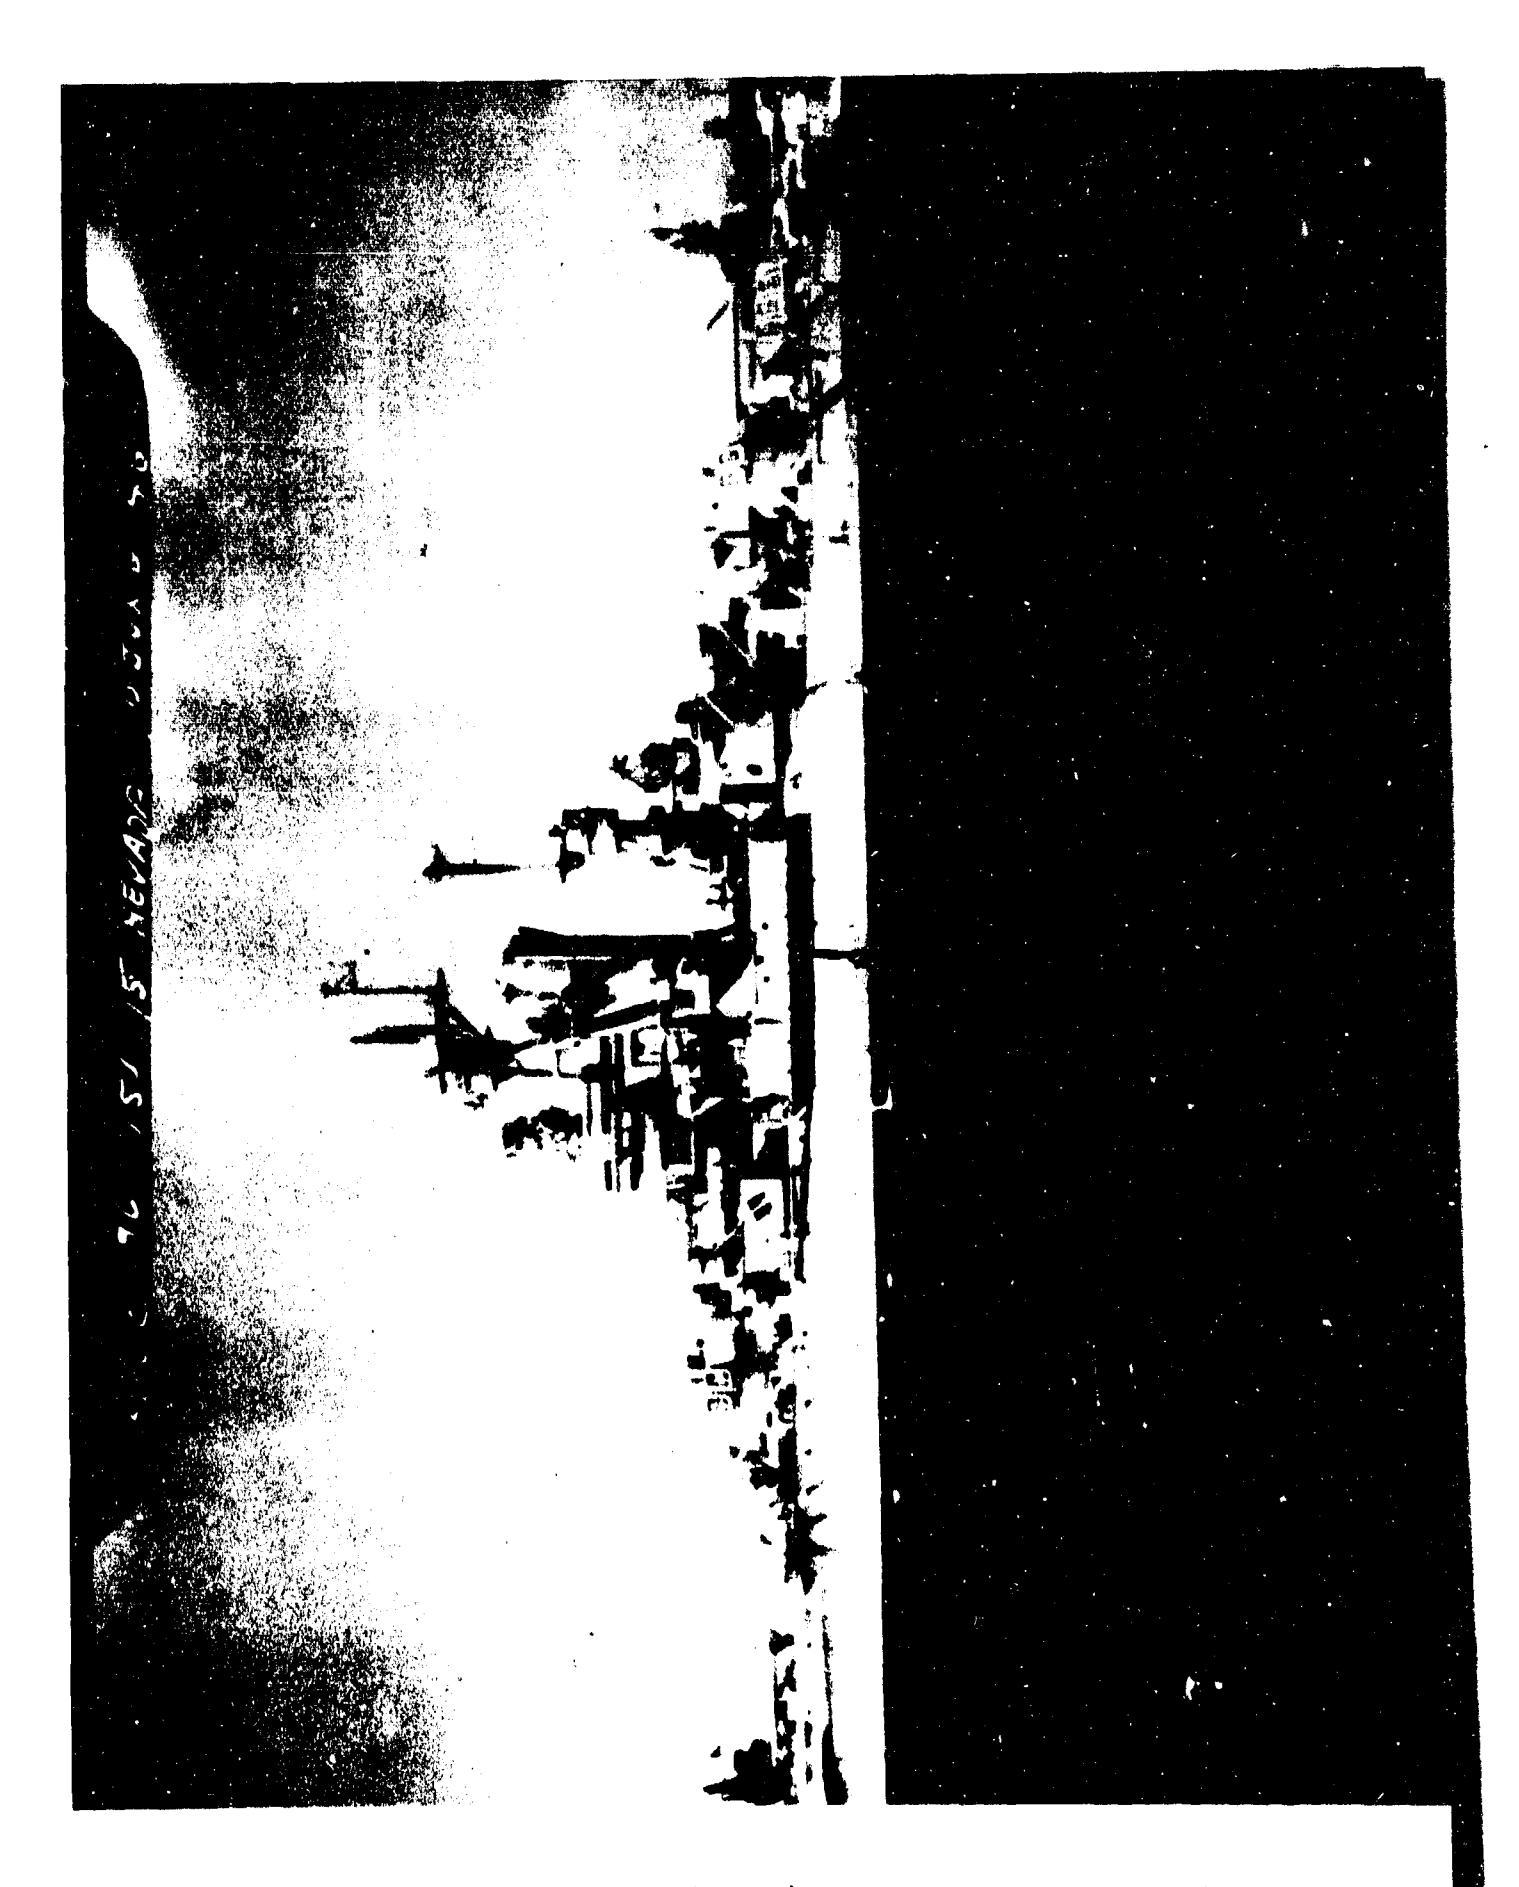
BA-CR-196-151-15. USS NEVADA (BB36). View of port beam before Test A.

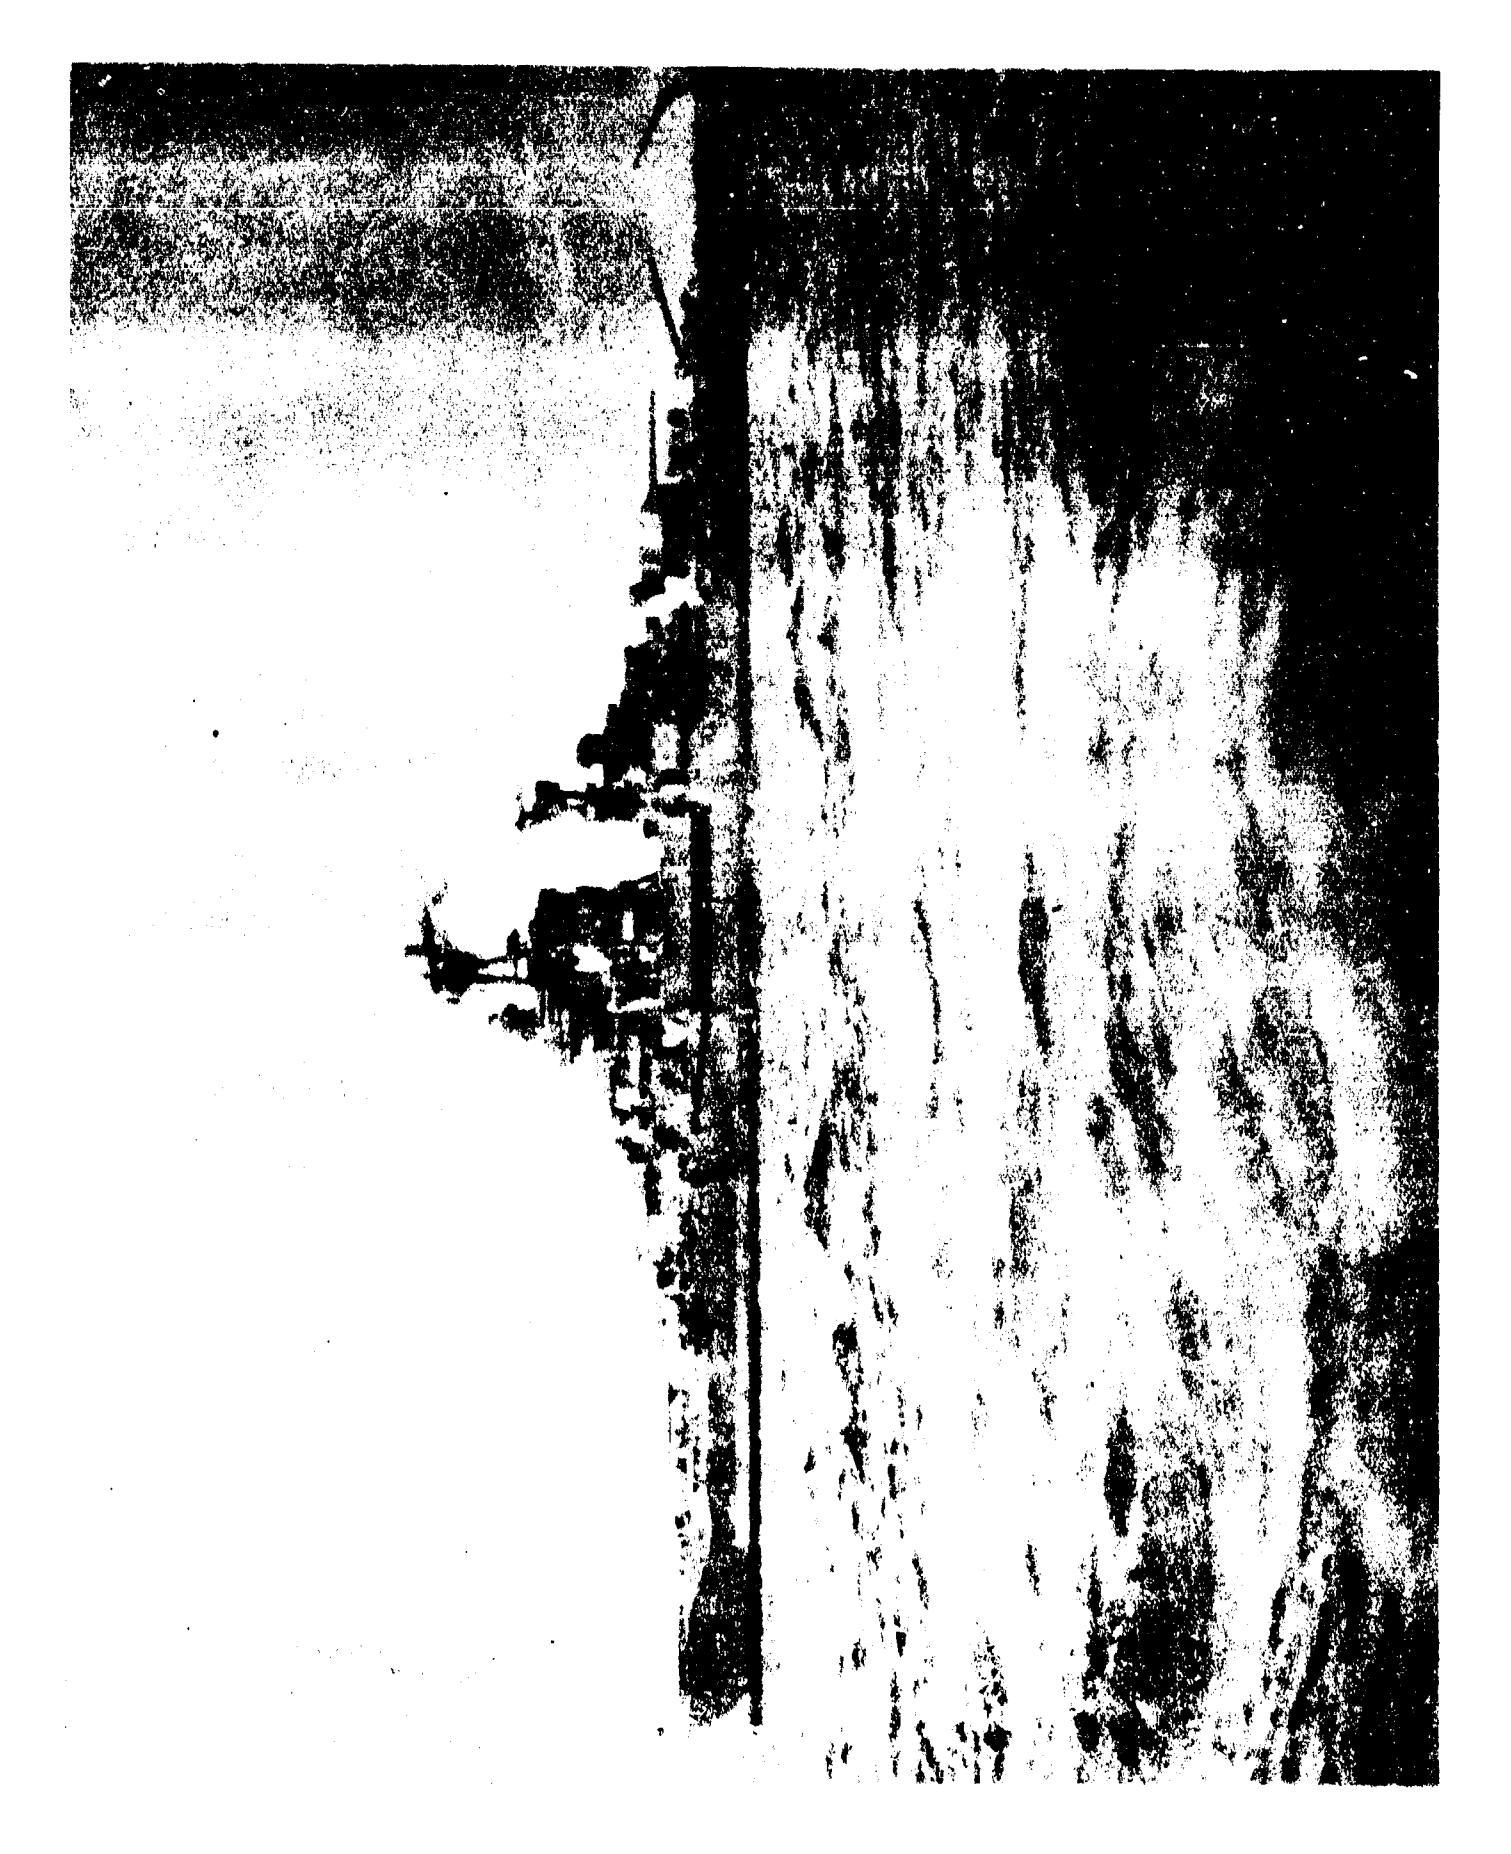
AA-CR-227-91-74. USS NEVADA (BB36). View of port beam after Test A

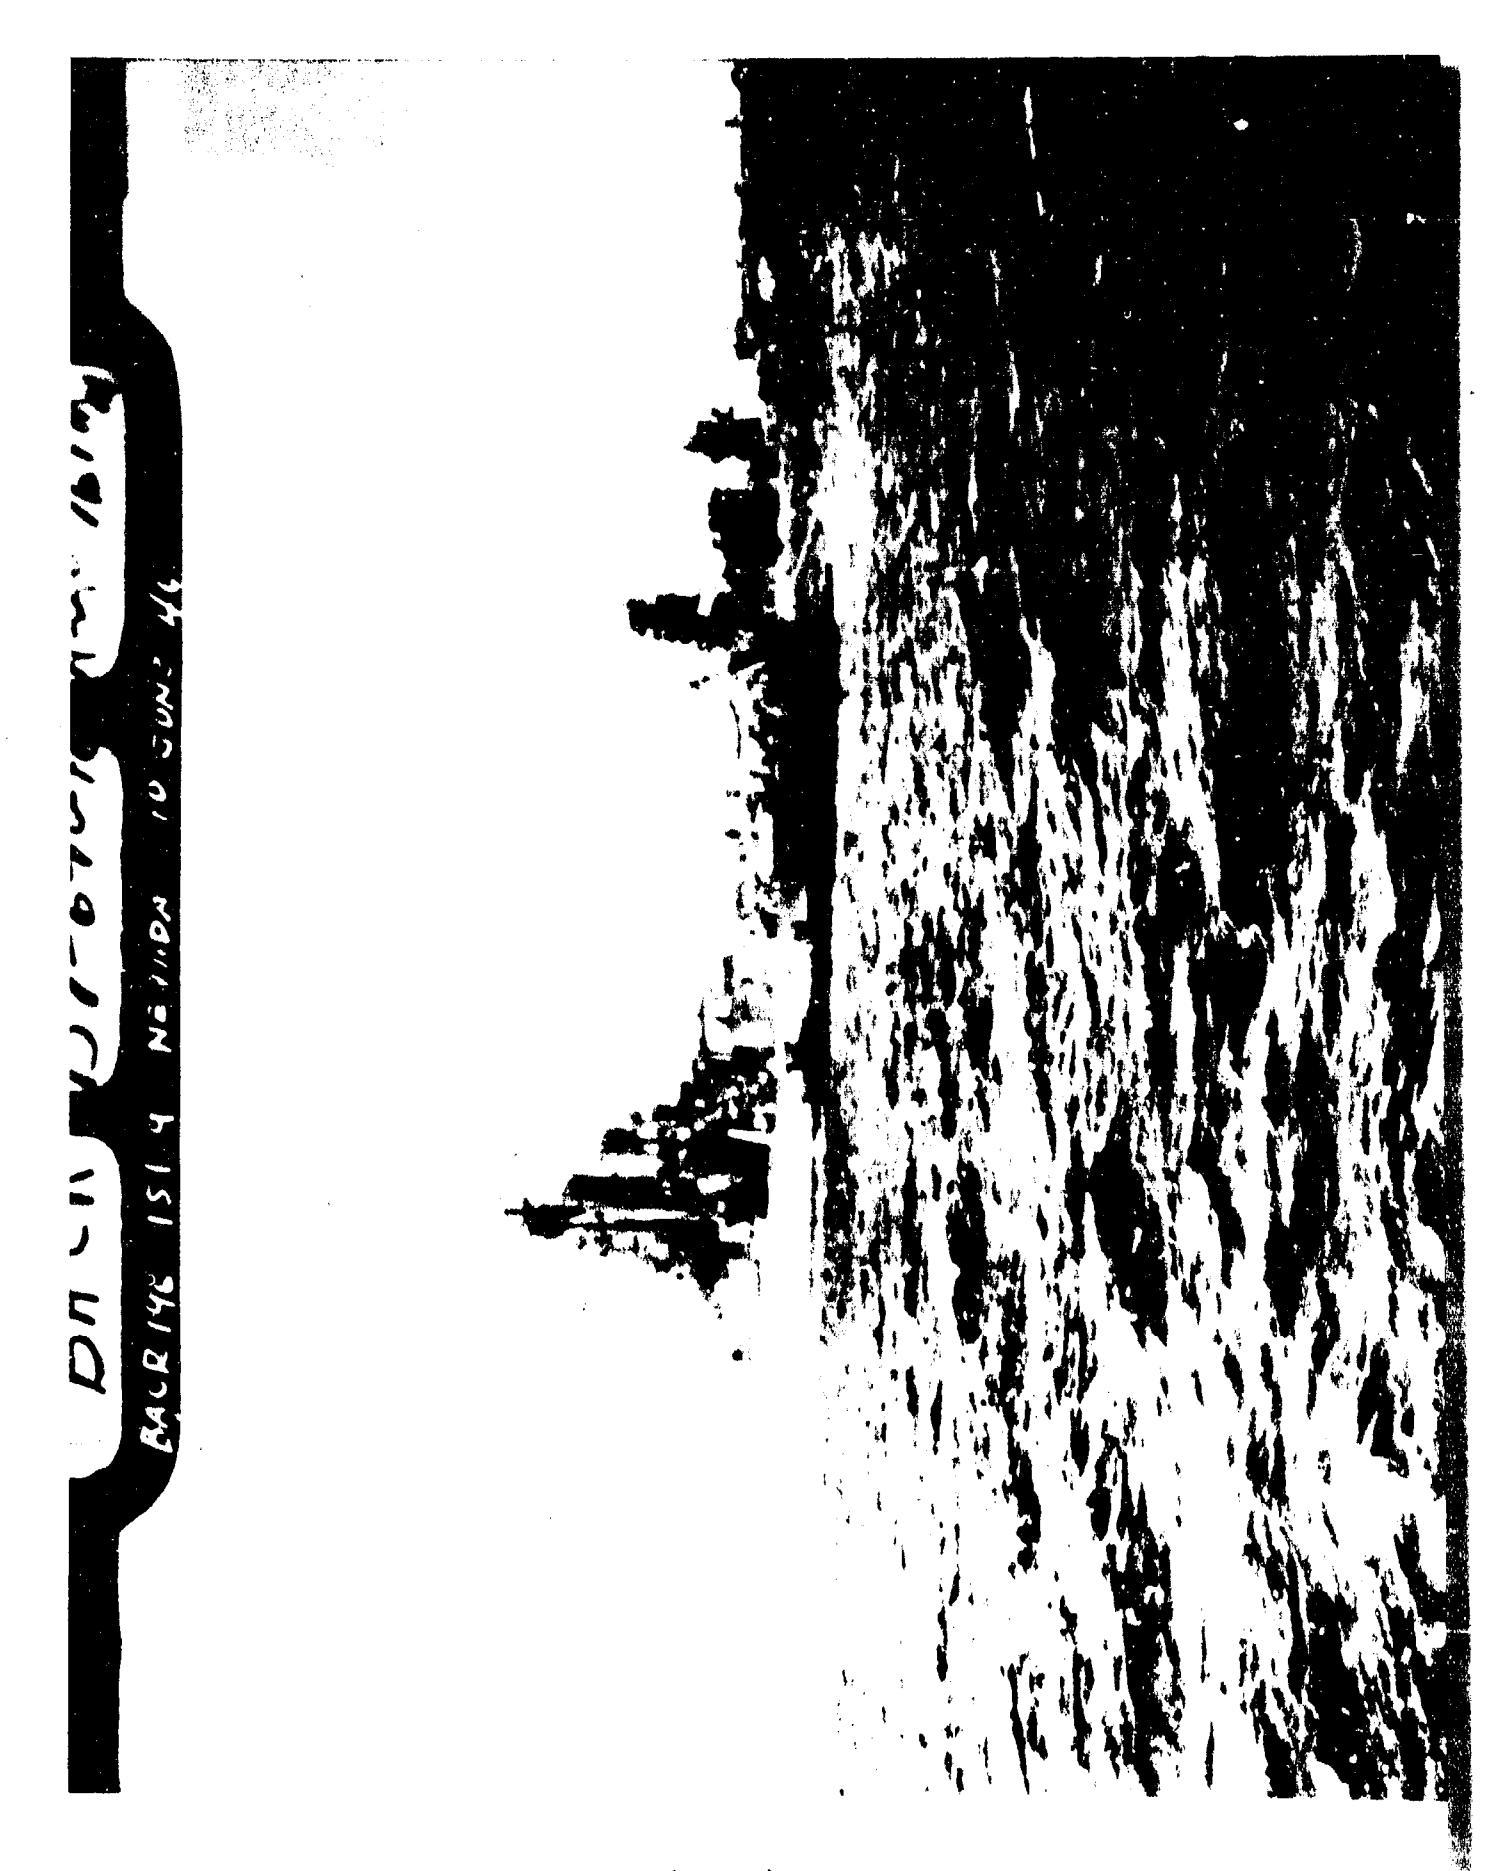
BA-CR-196-151-9. USS NEVADA (BB36). Port quarter before Test A.

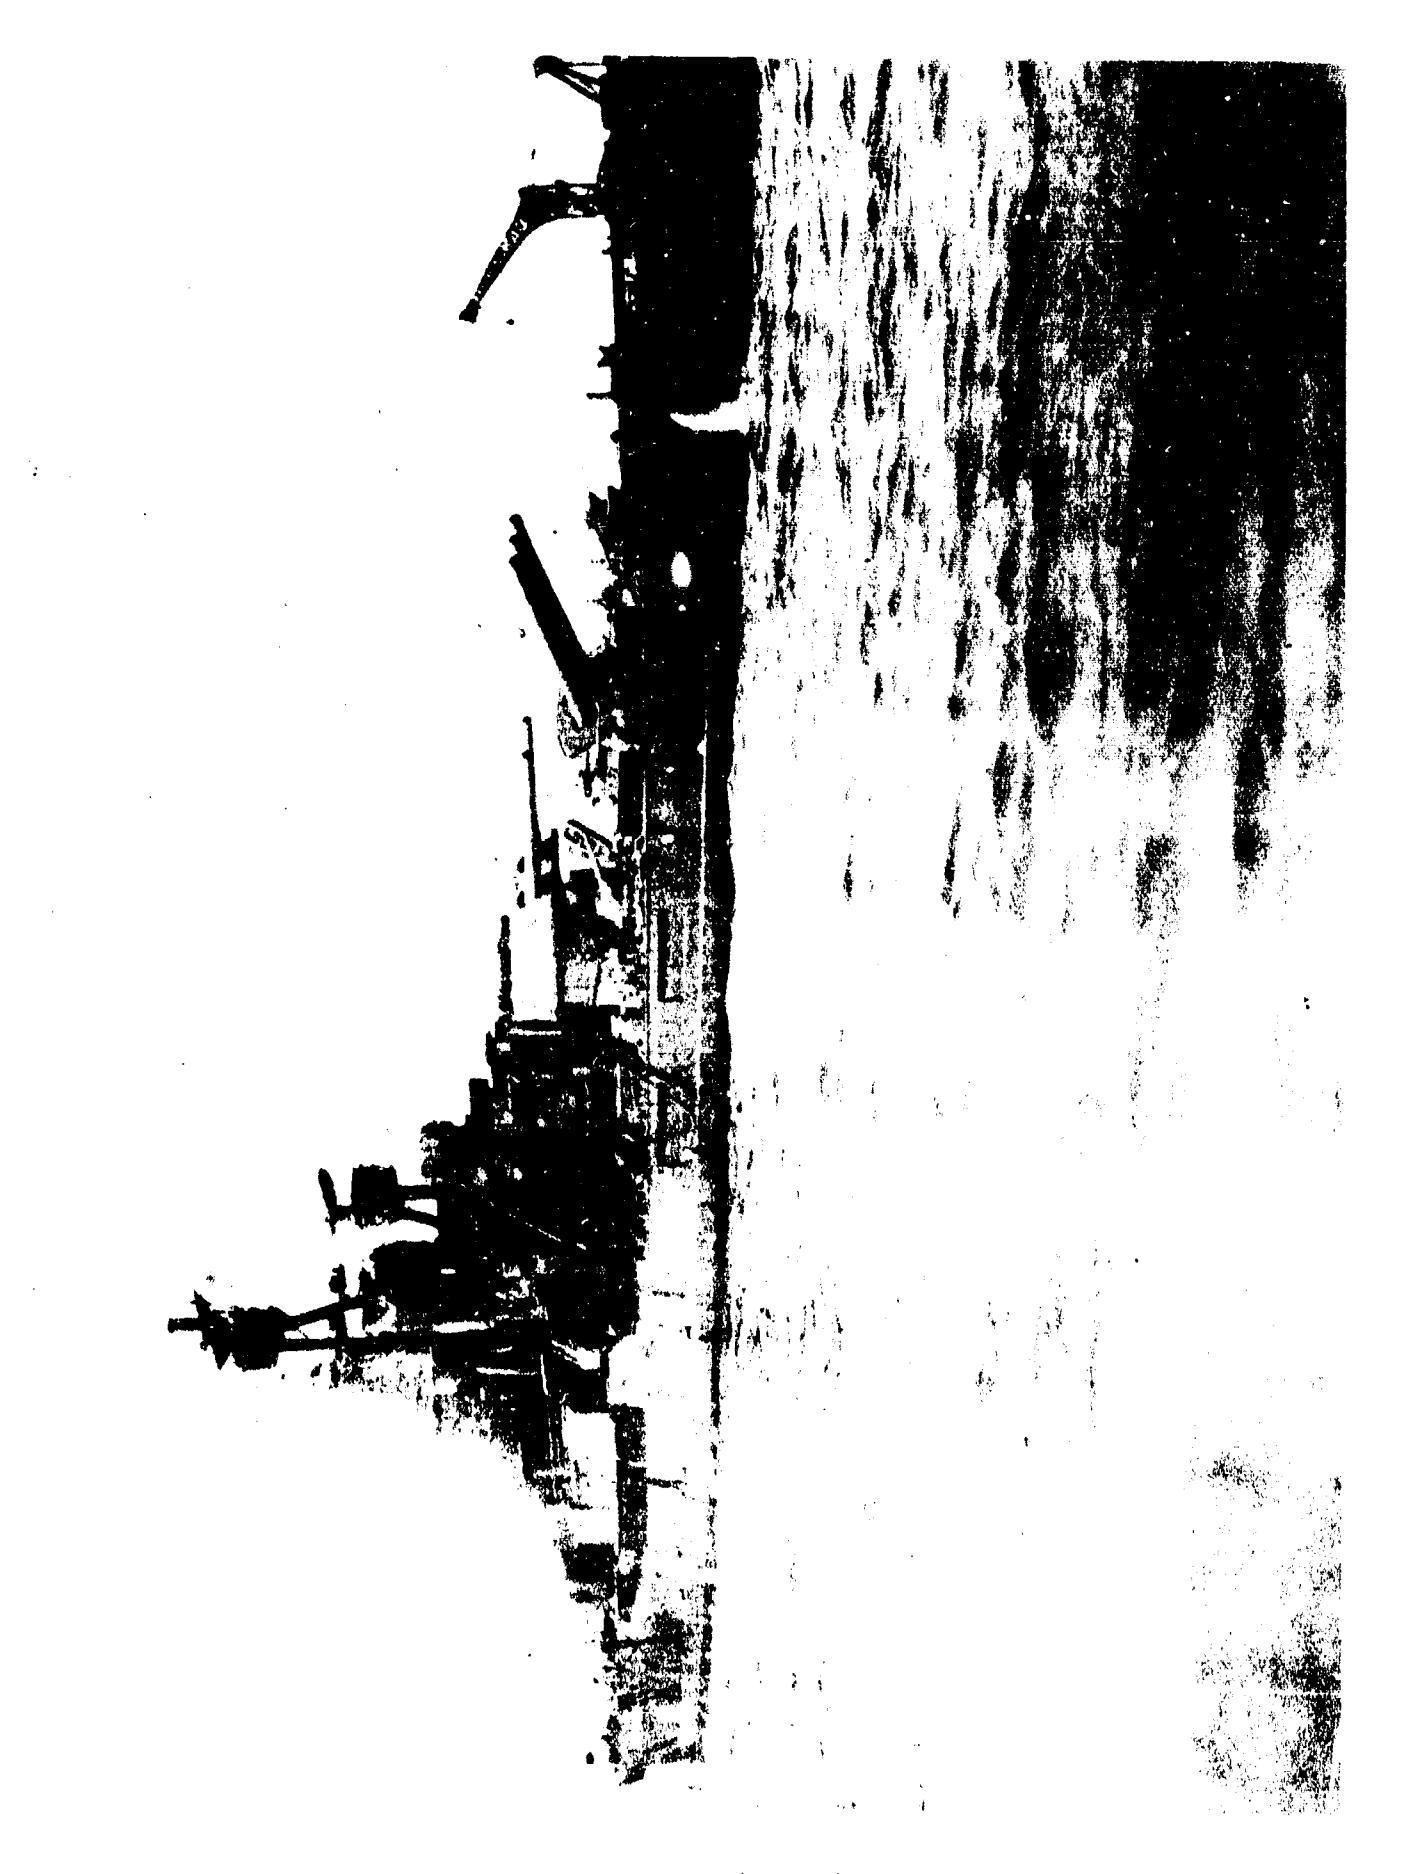
AA-CR-227-91-73. USS NEVADA (BB36). Port quarter after Test A.

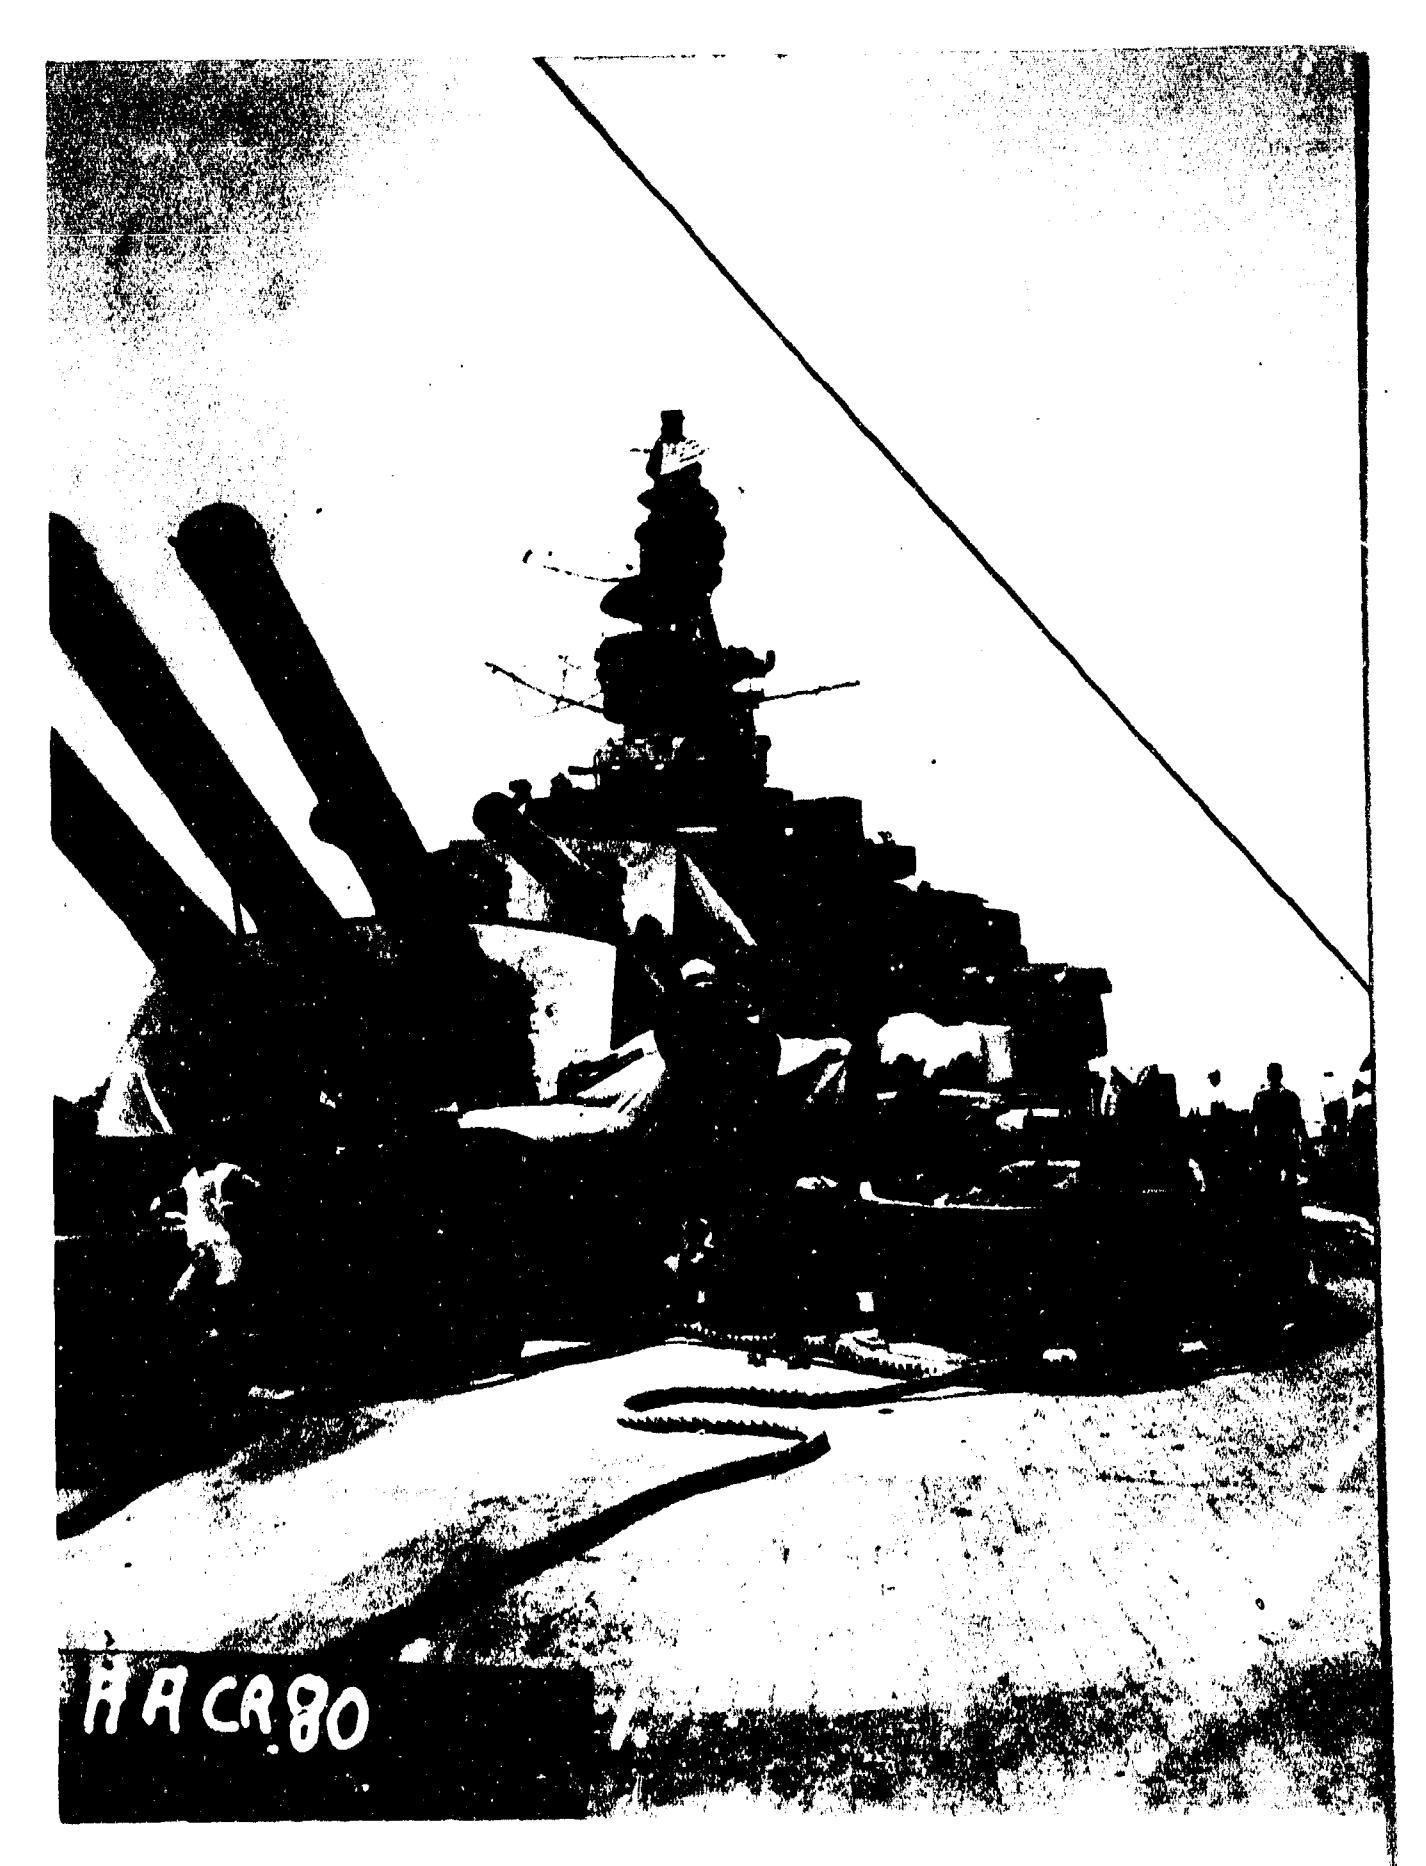
AA-CR-80-1909-1. USS NEVADA (BB36). Looking forward, showing after and forward tripod yardarms, and remains of forward starboard yardarms.

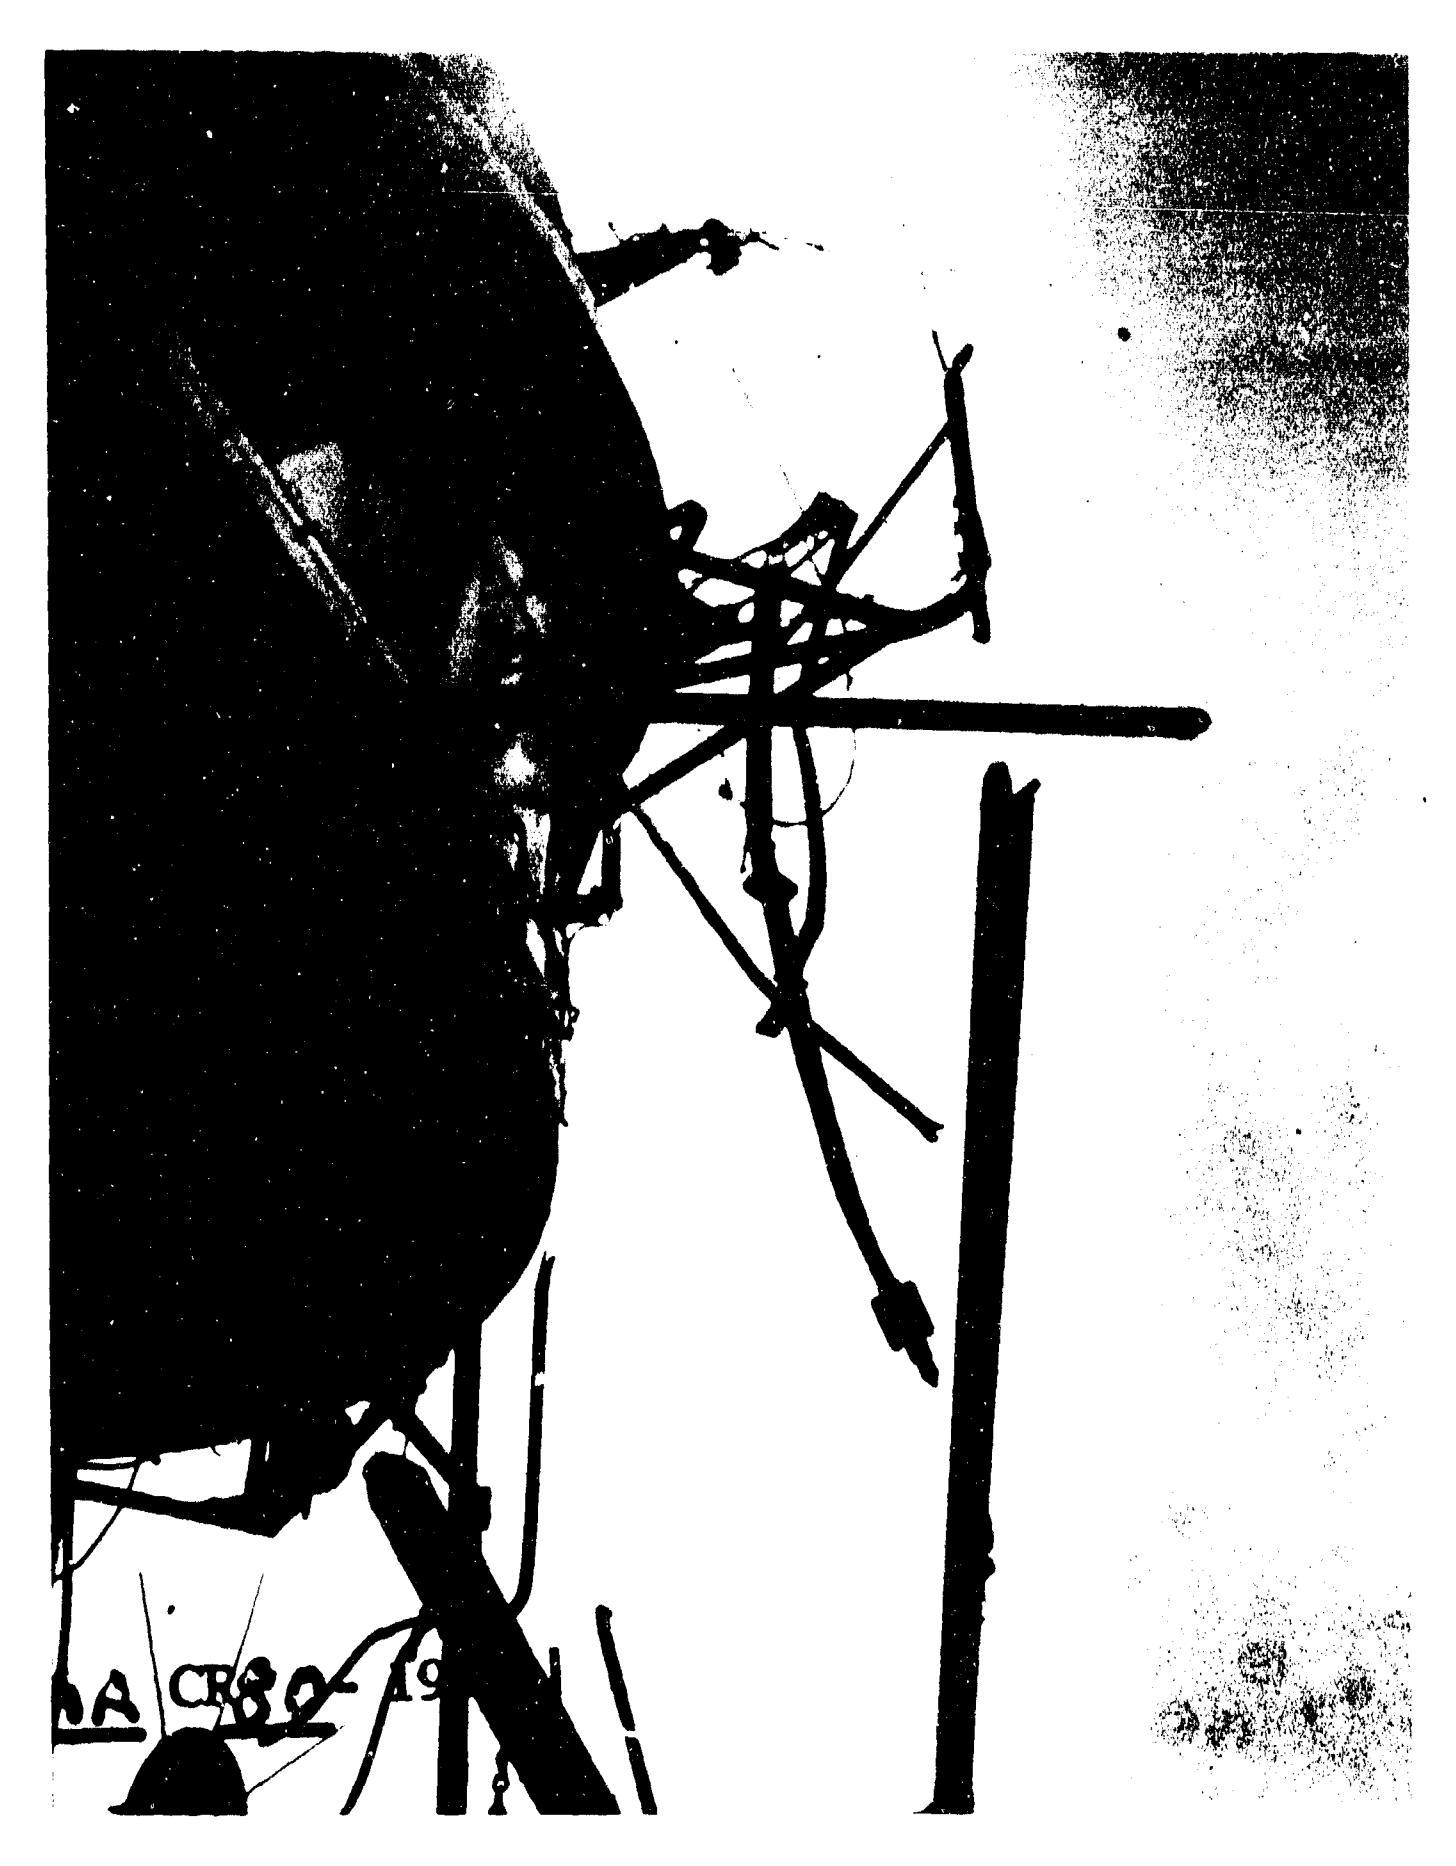
AA-CR-80-1900-3. USS NEVADA (BB36). Forward tripod, remains of starboard yardarm.
