BUREAU OF SHIPS GROUP

TECHNICAL INSPECTION REPORT

FAILURES OF MASTS, YARDARMS, BOOMS, AND RIGGING

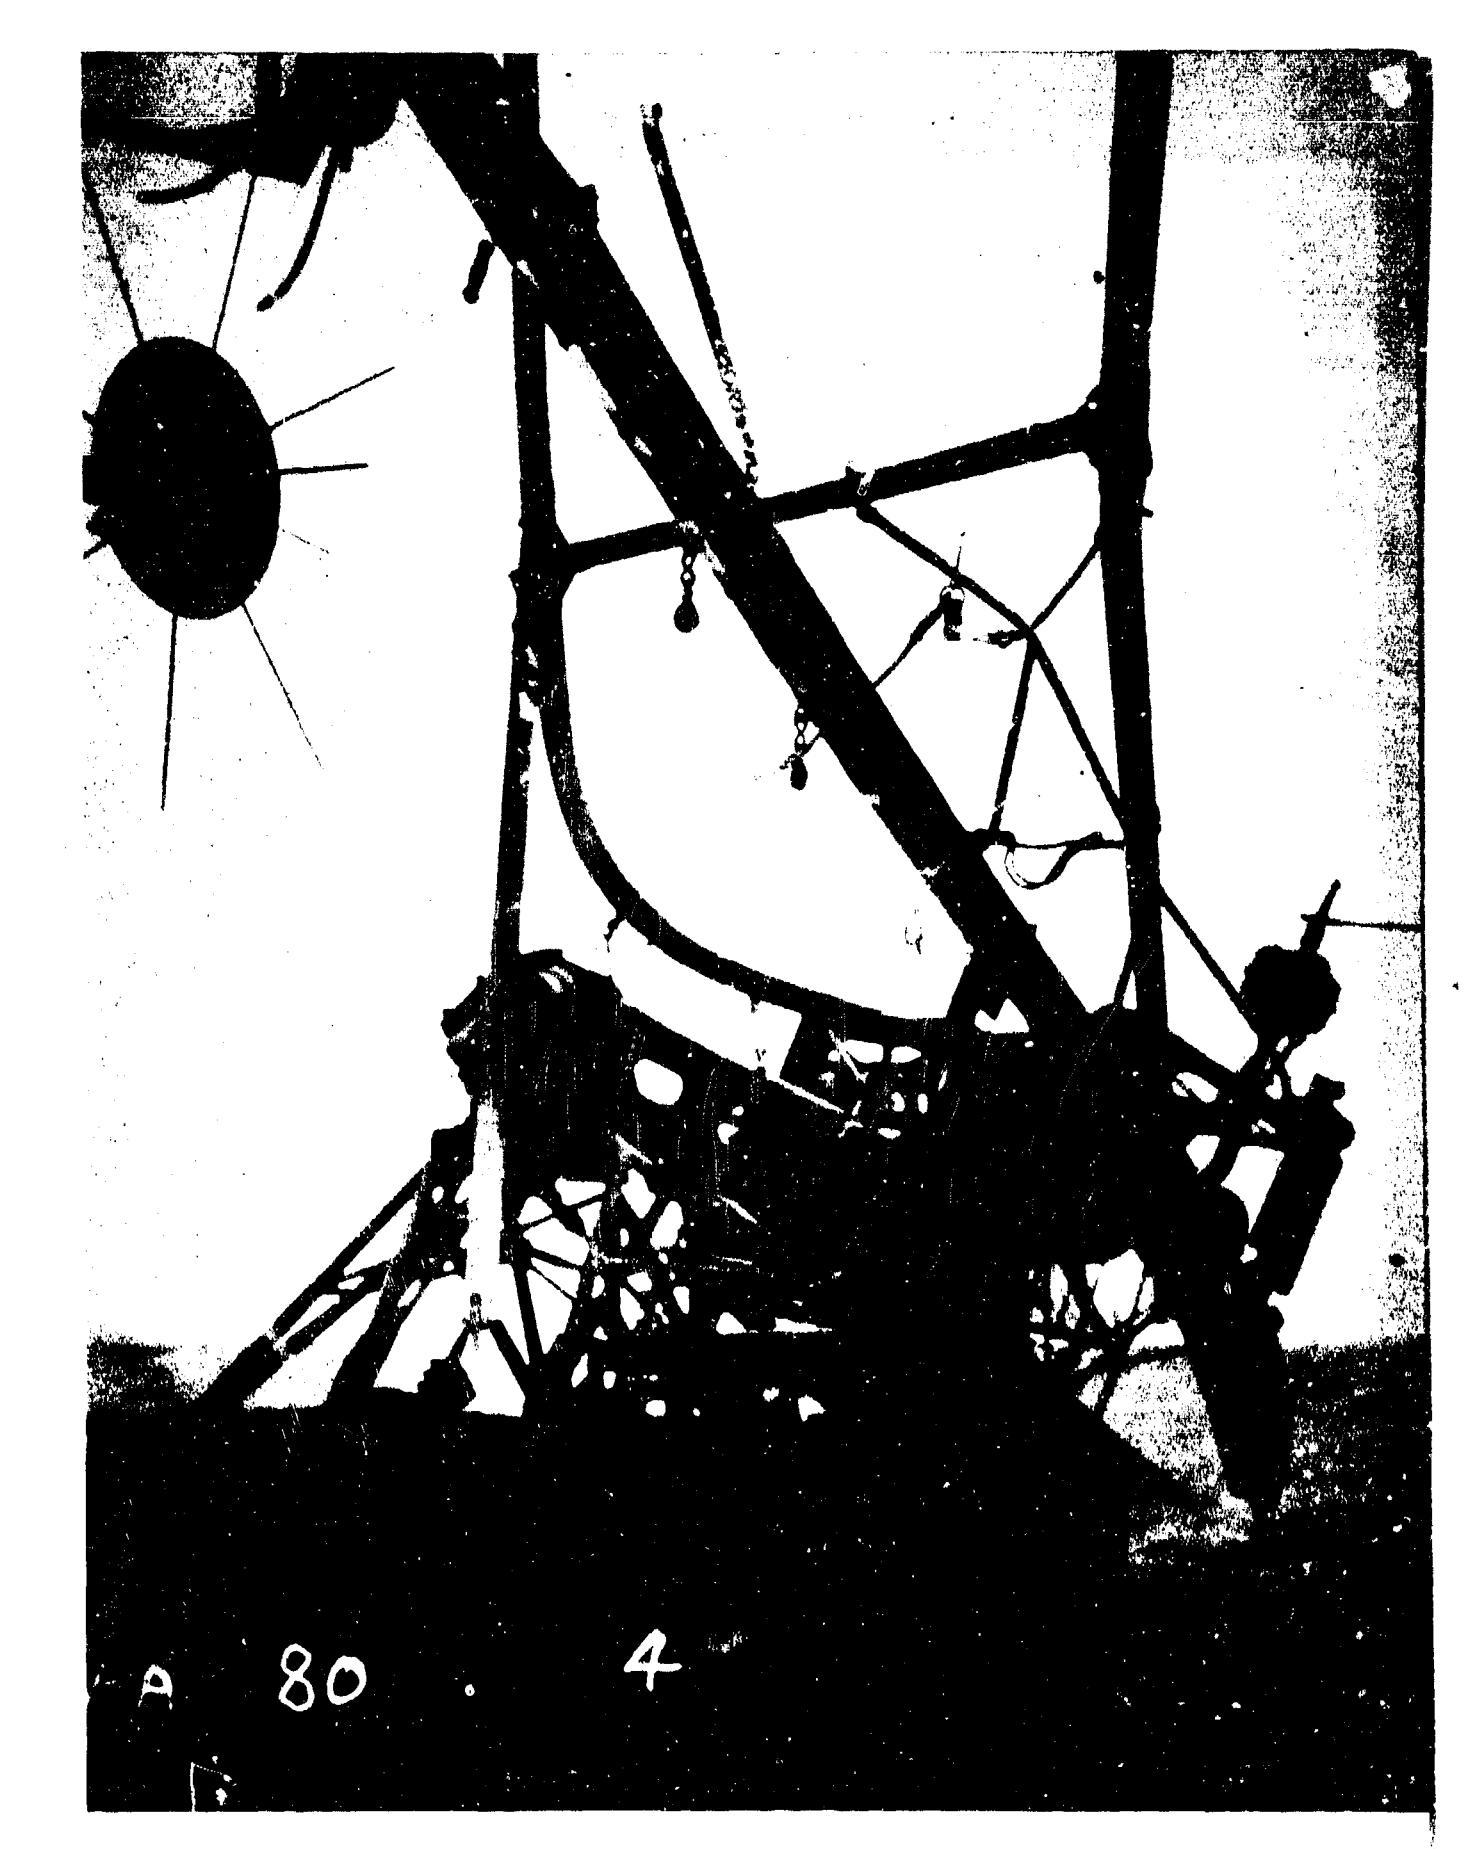
AA-CR-80-1900-4. USS NEVADA (BB36). Forward tripod, view looking forward at wreckage of starboard yardarm. Main member, truss and forward strut.

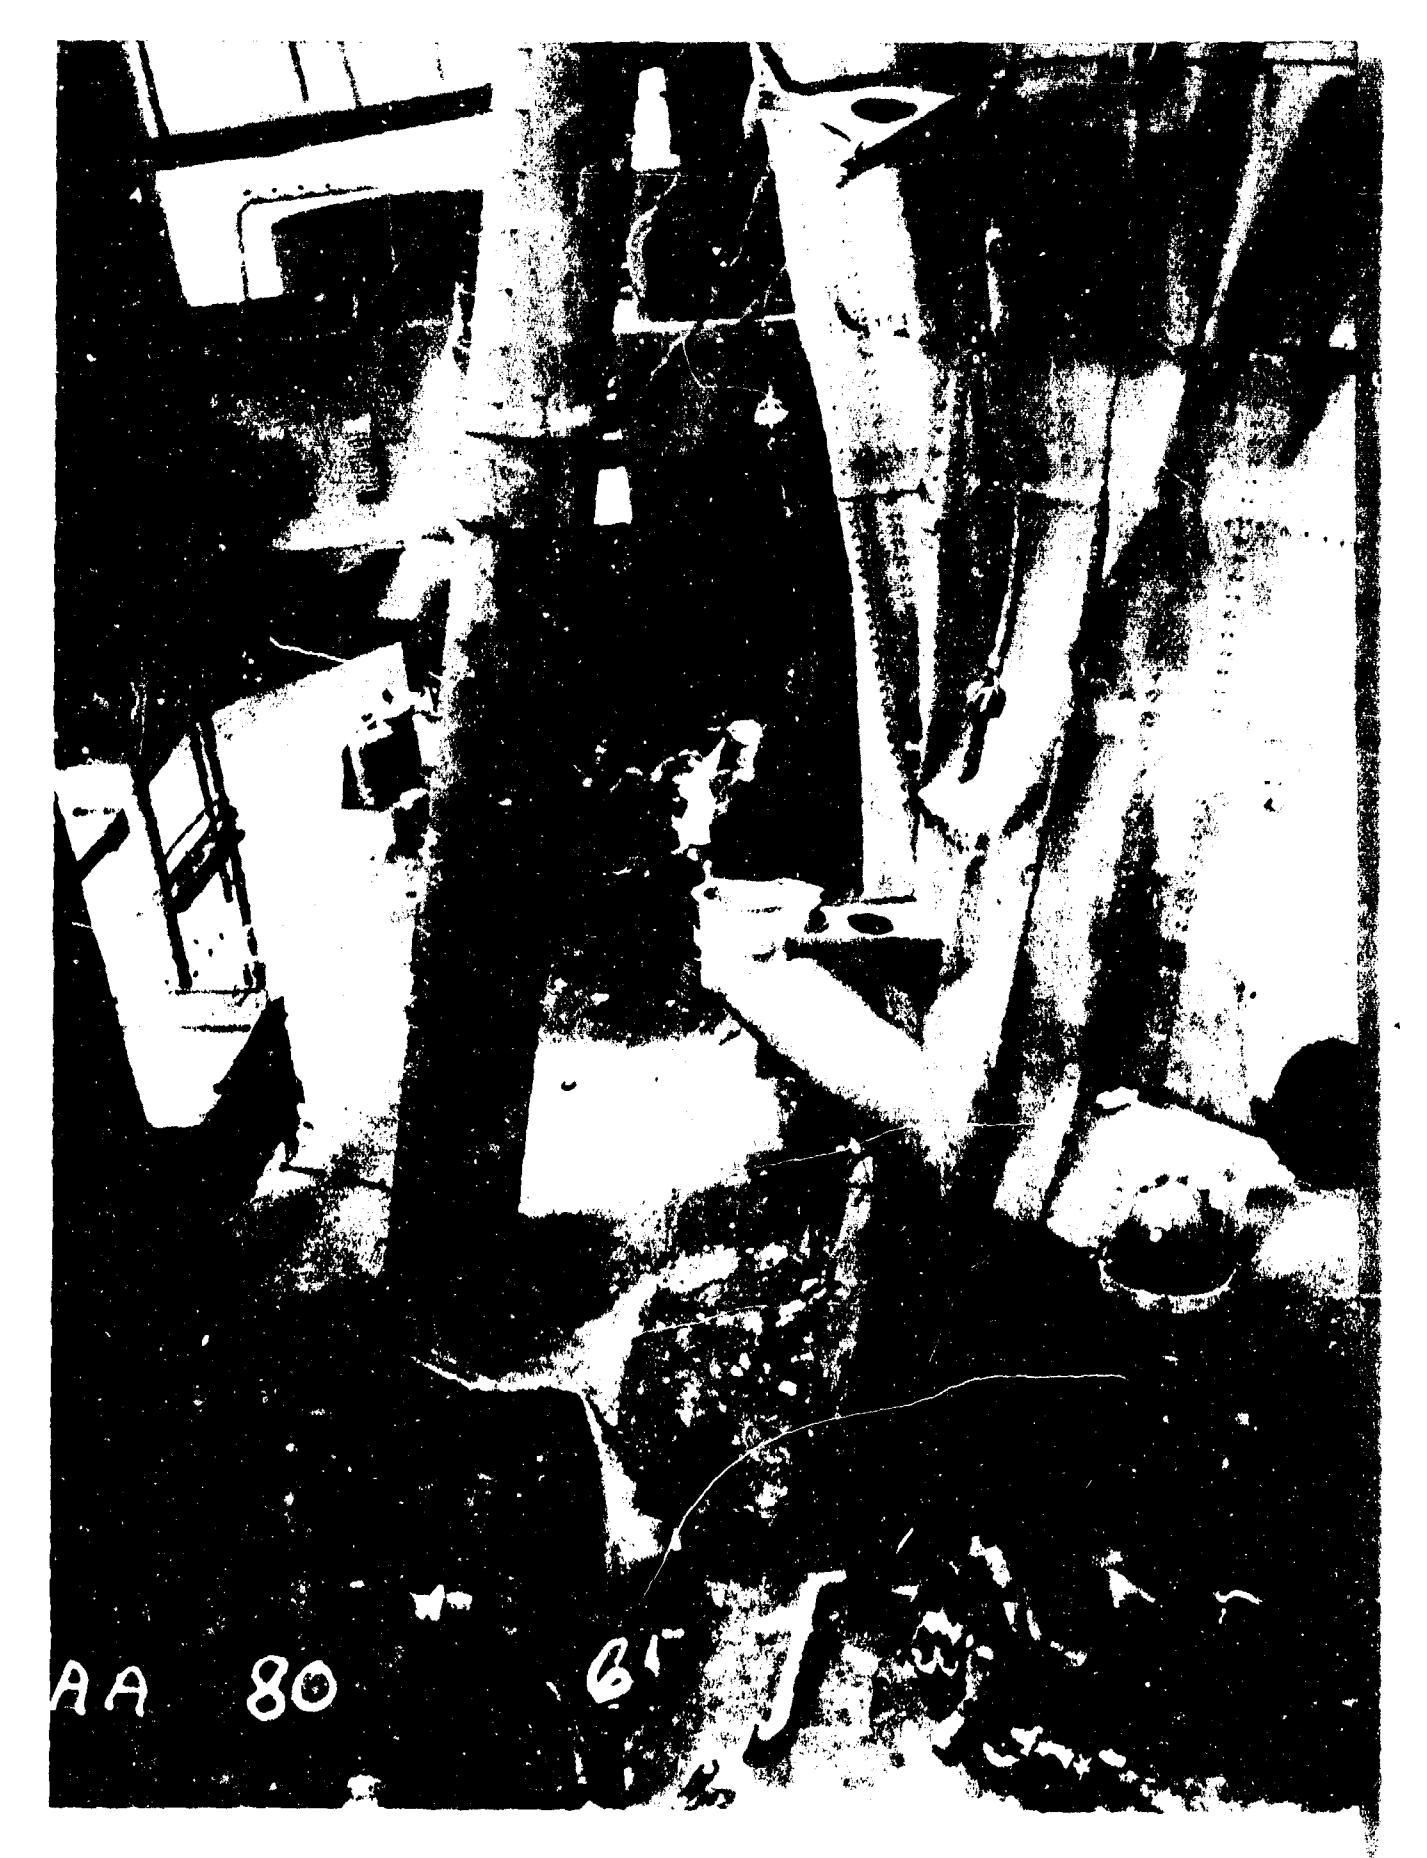
AA-CR-80-1900-6. USS NEVADA (BB36). Forward tripod. Port leg. Looking forward.

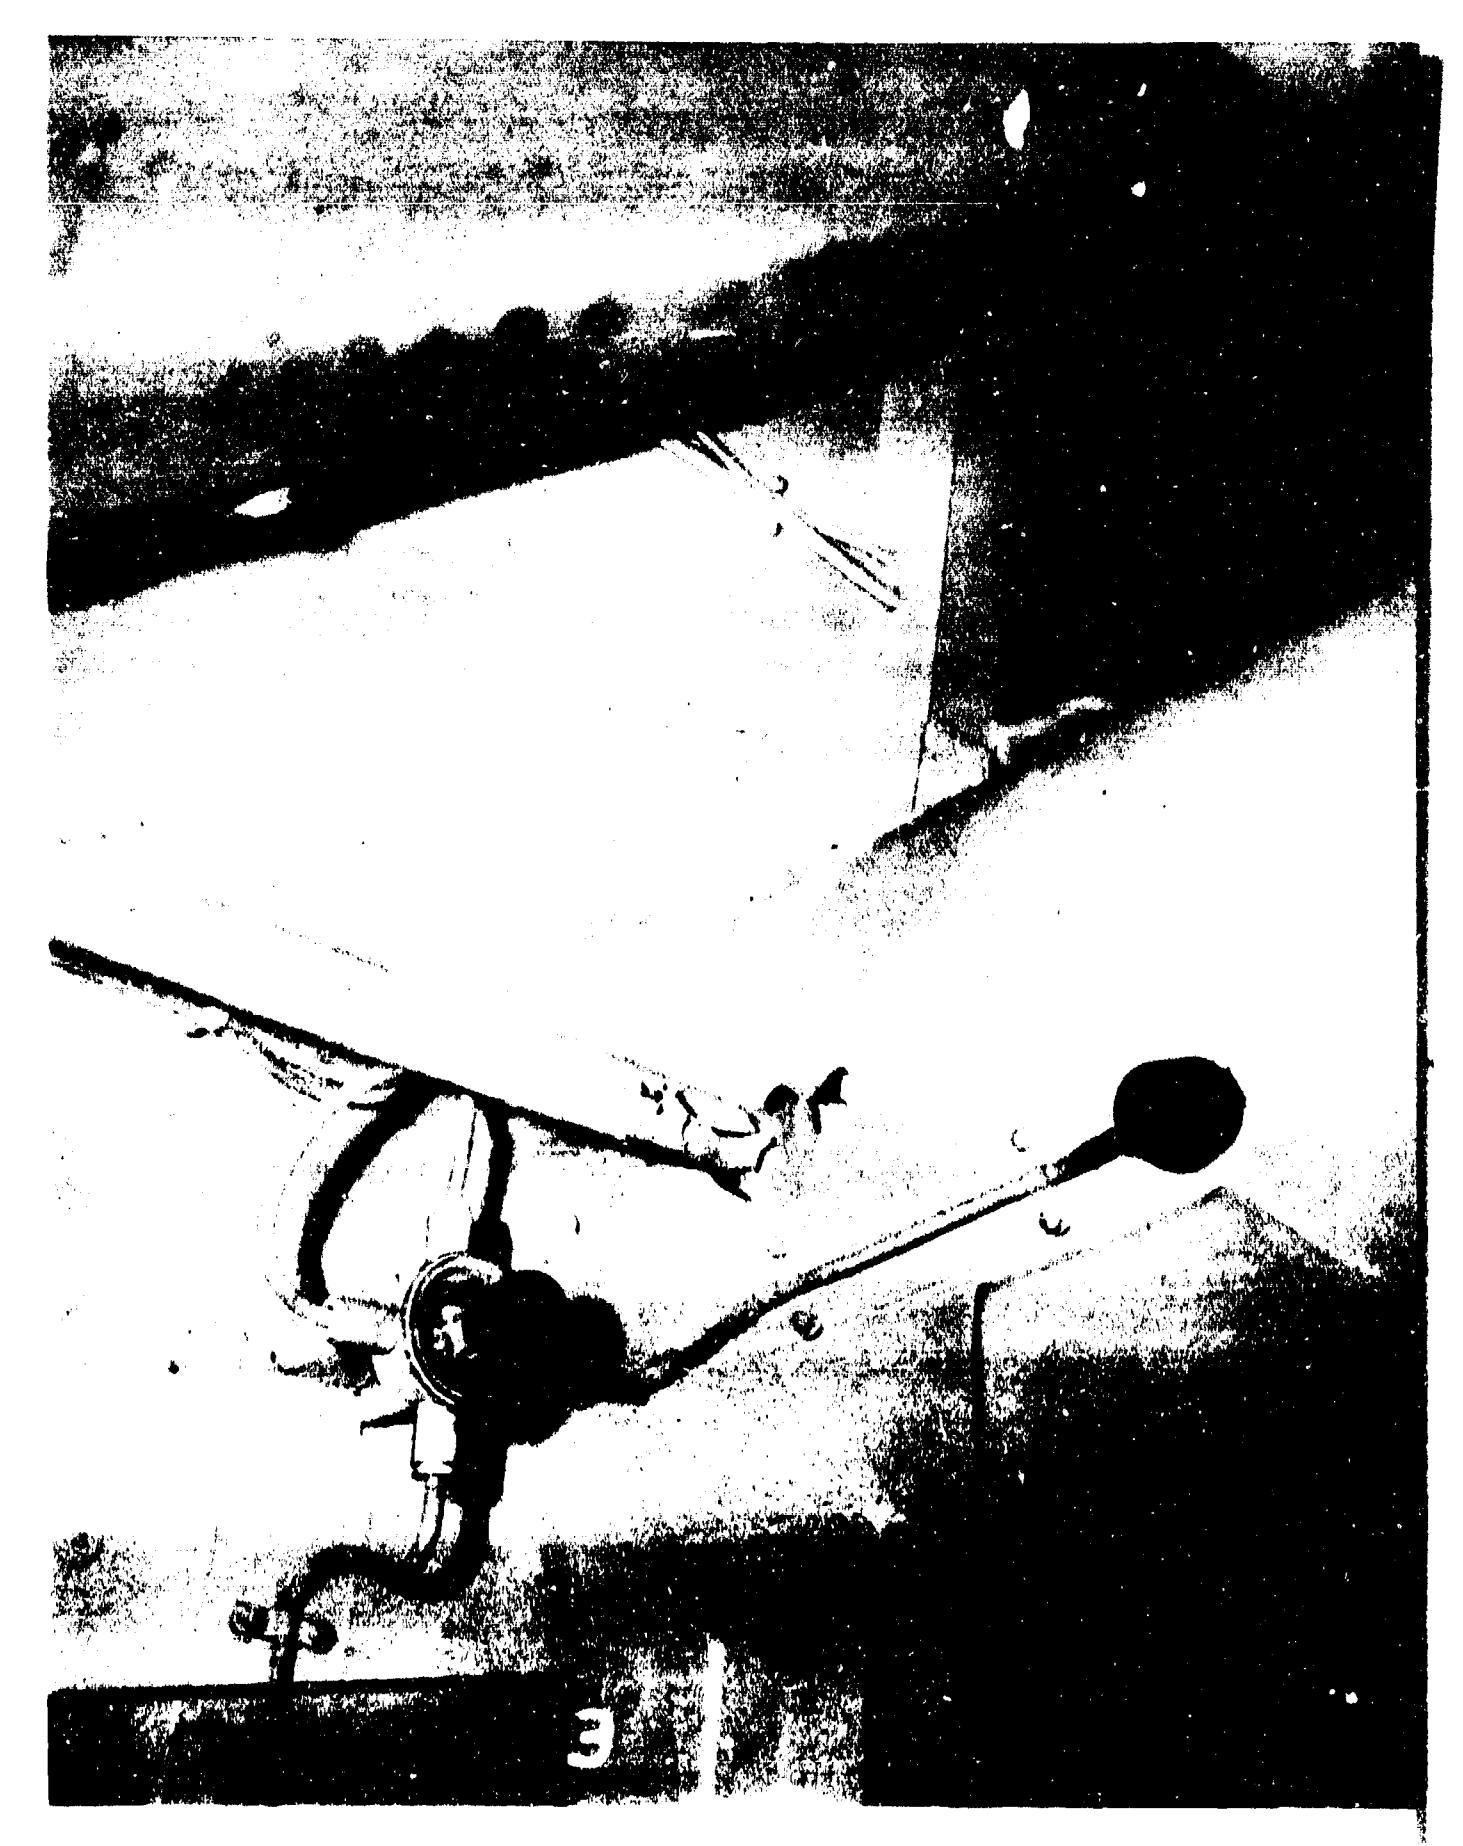
AA-CR-175-2154-3. USS NEVADA (BB36). Port leg of forward tripod looking aft and slightly outboard showing crumple in lower flange of longitudinal and slight dish in leg at this point.

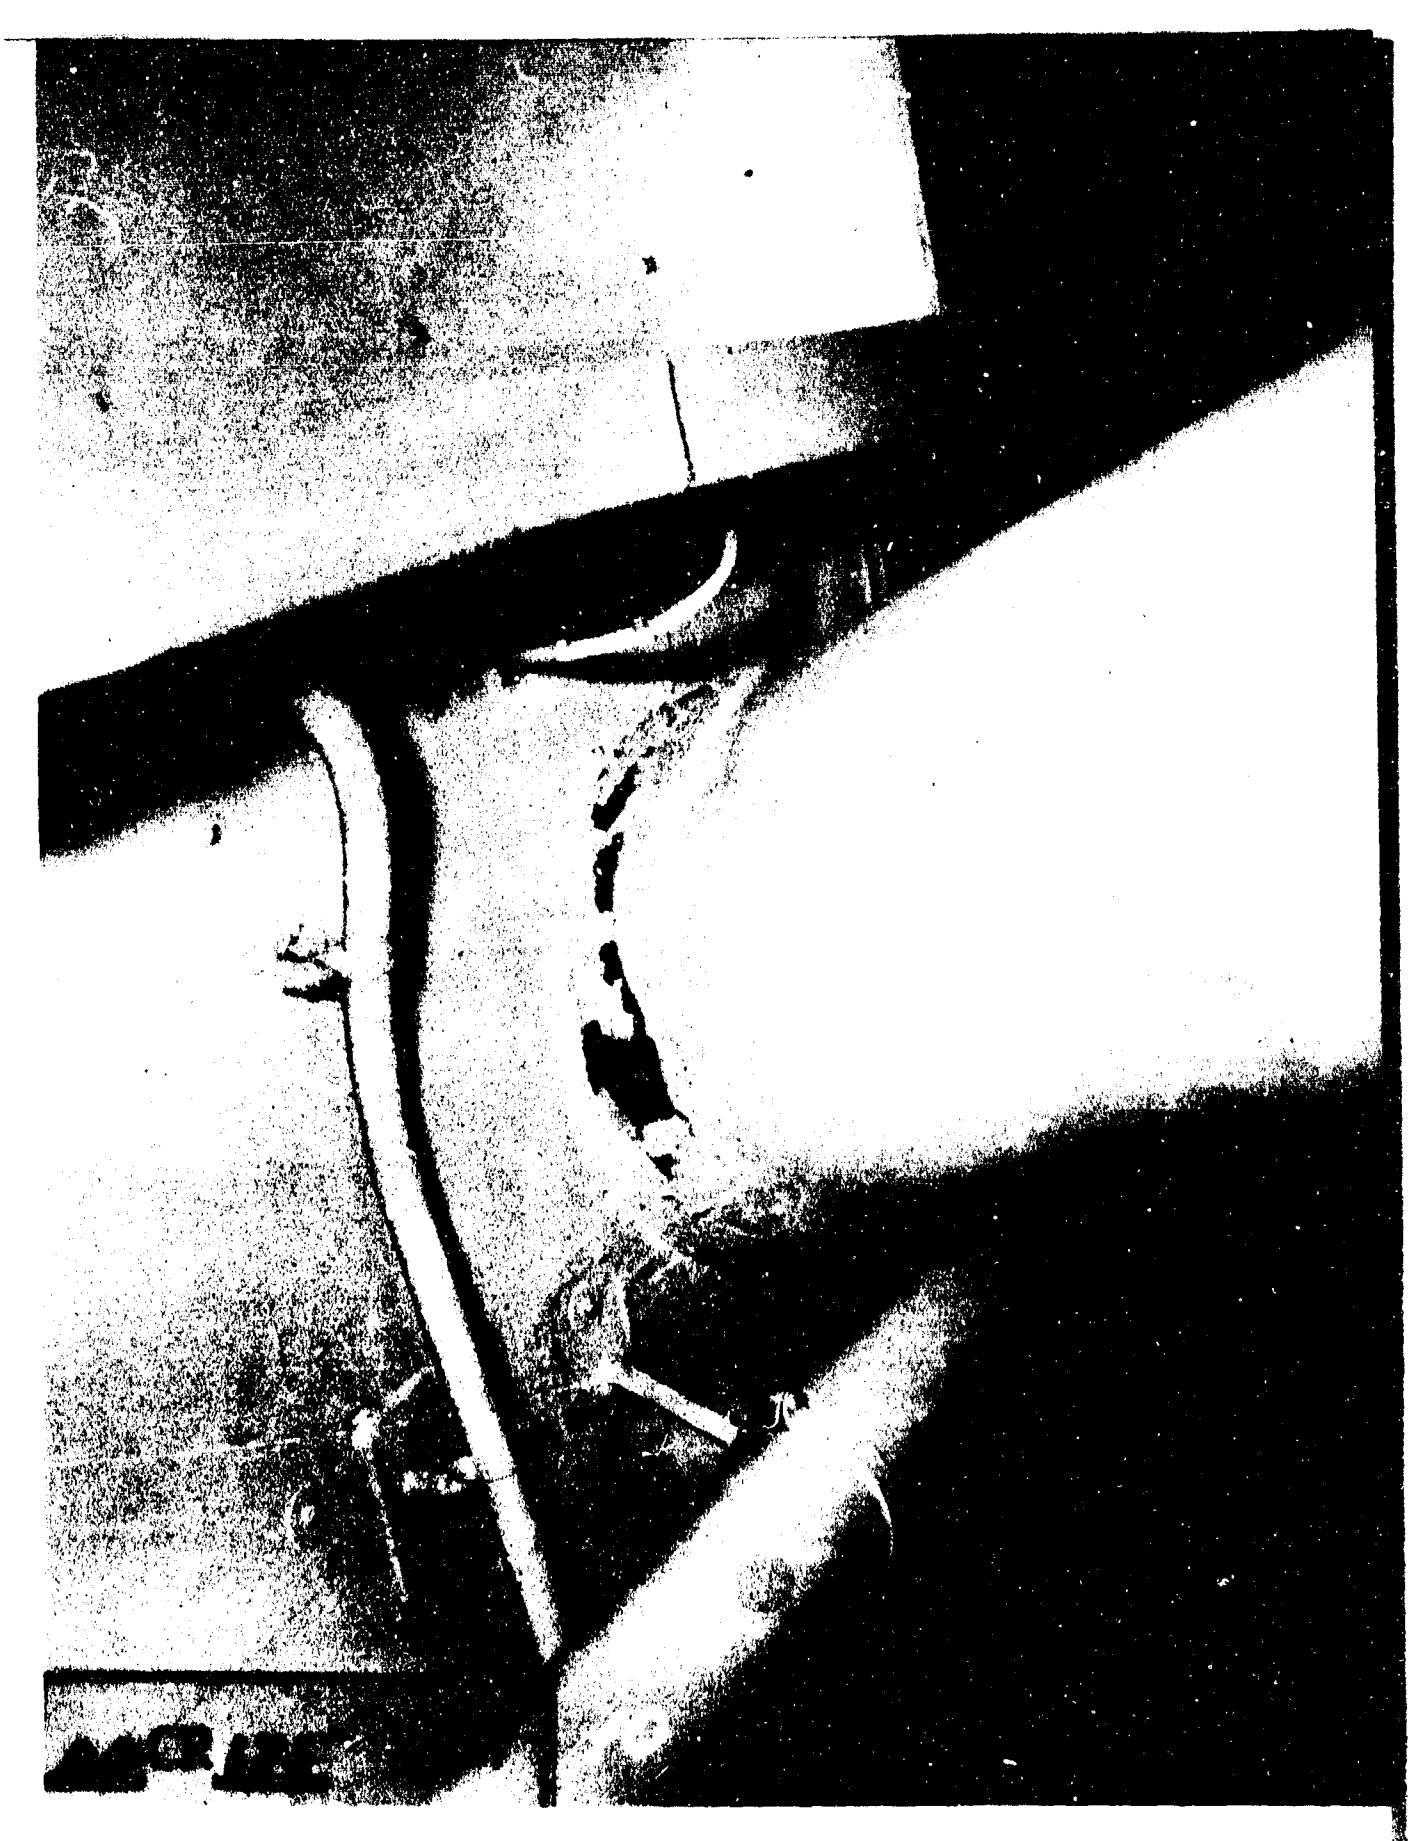
AA-CR-175-2137-10. USS NEVADA (BB36). Forward leg of starboard director tub, frame 68-69, looking inboard and slightly aft. Showing compression evidence at top of leg under 02 level and twist in beam at frame 68.

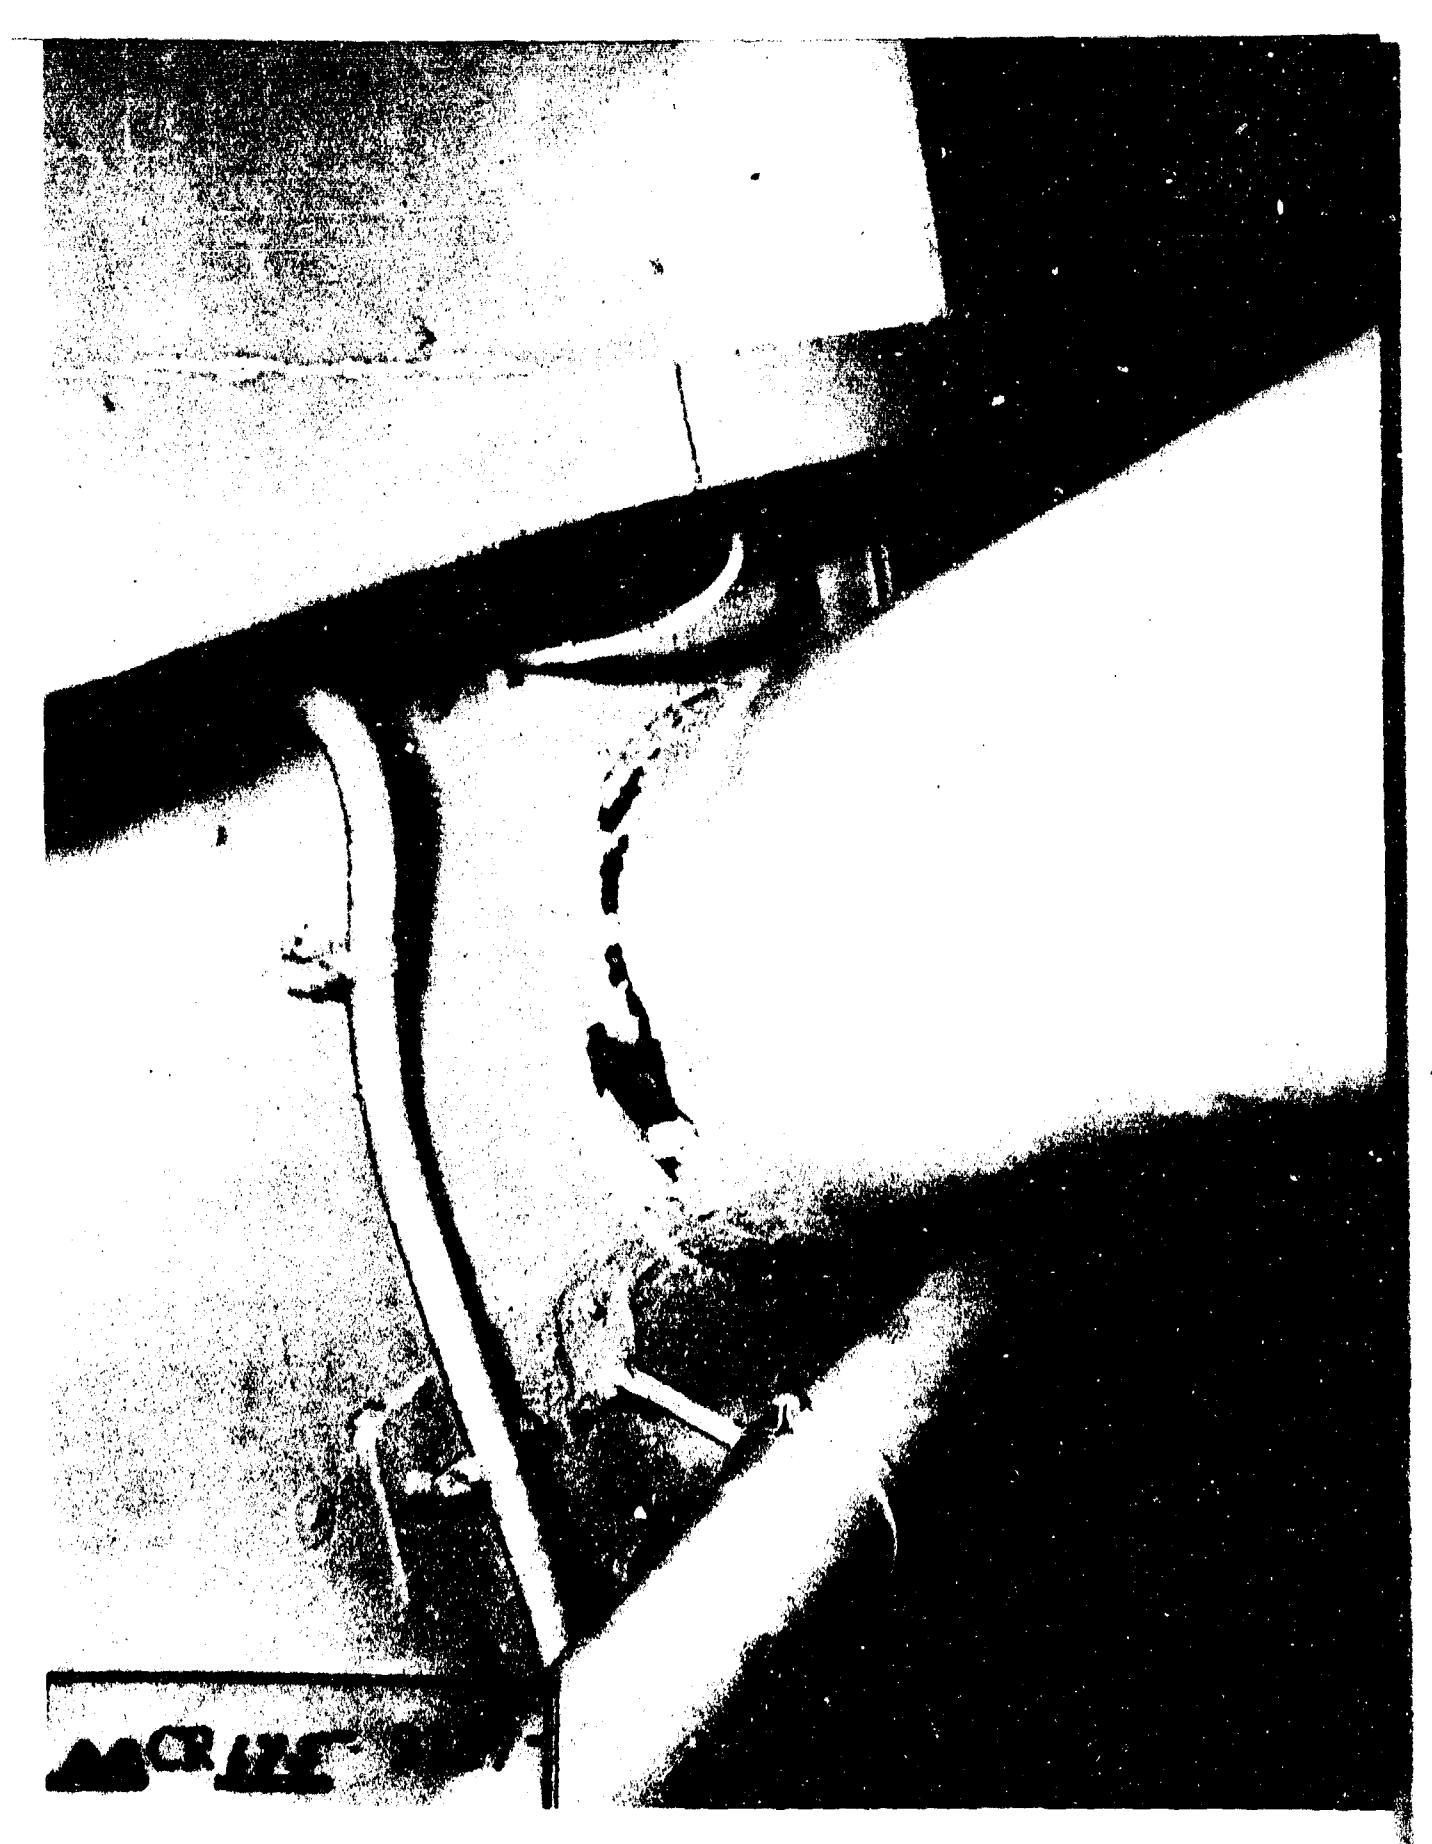
AA-CR-175-2137-10. USS NEVADA (BB36). Forward leg of starboard director tub, frame 68-69, looking inboard and slightly aft. Showing compression evidence at top of leg under 02 level and twist in beam at frame 68.

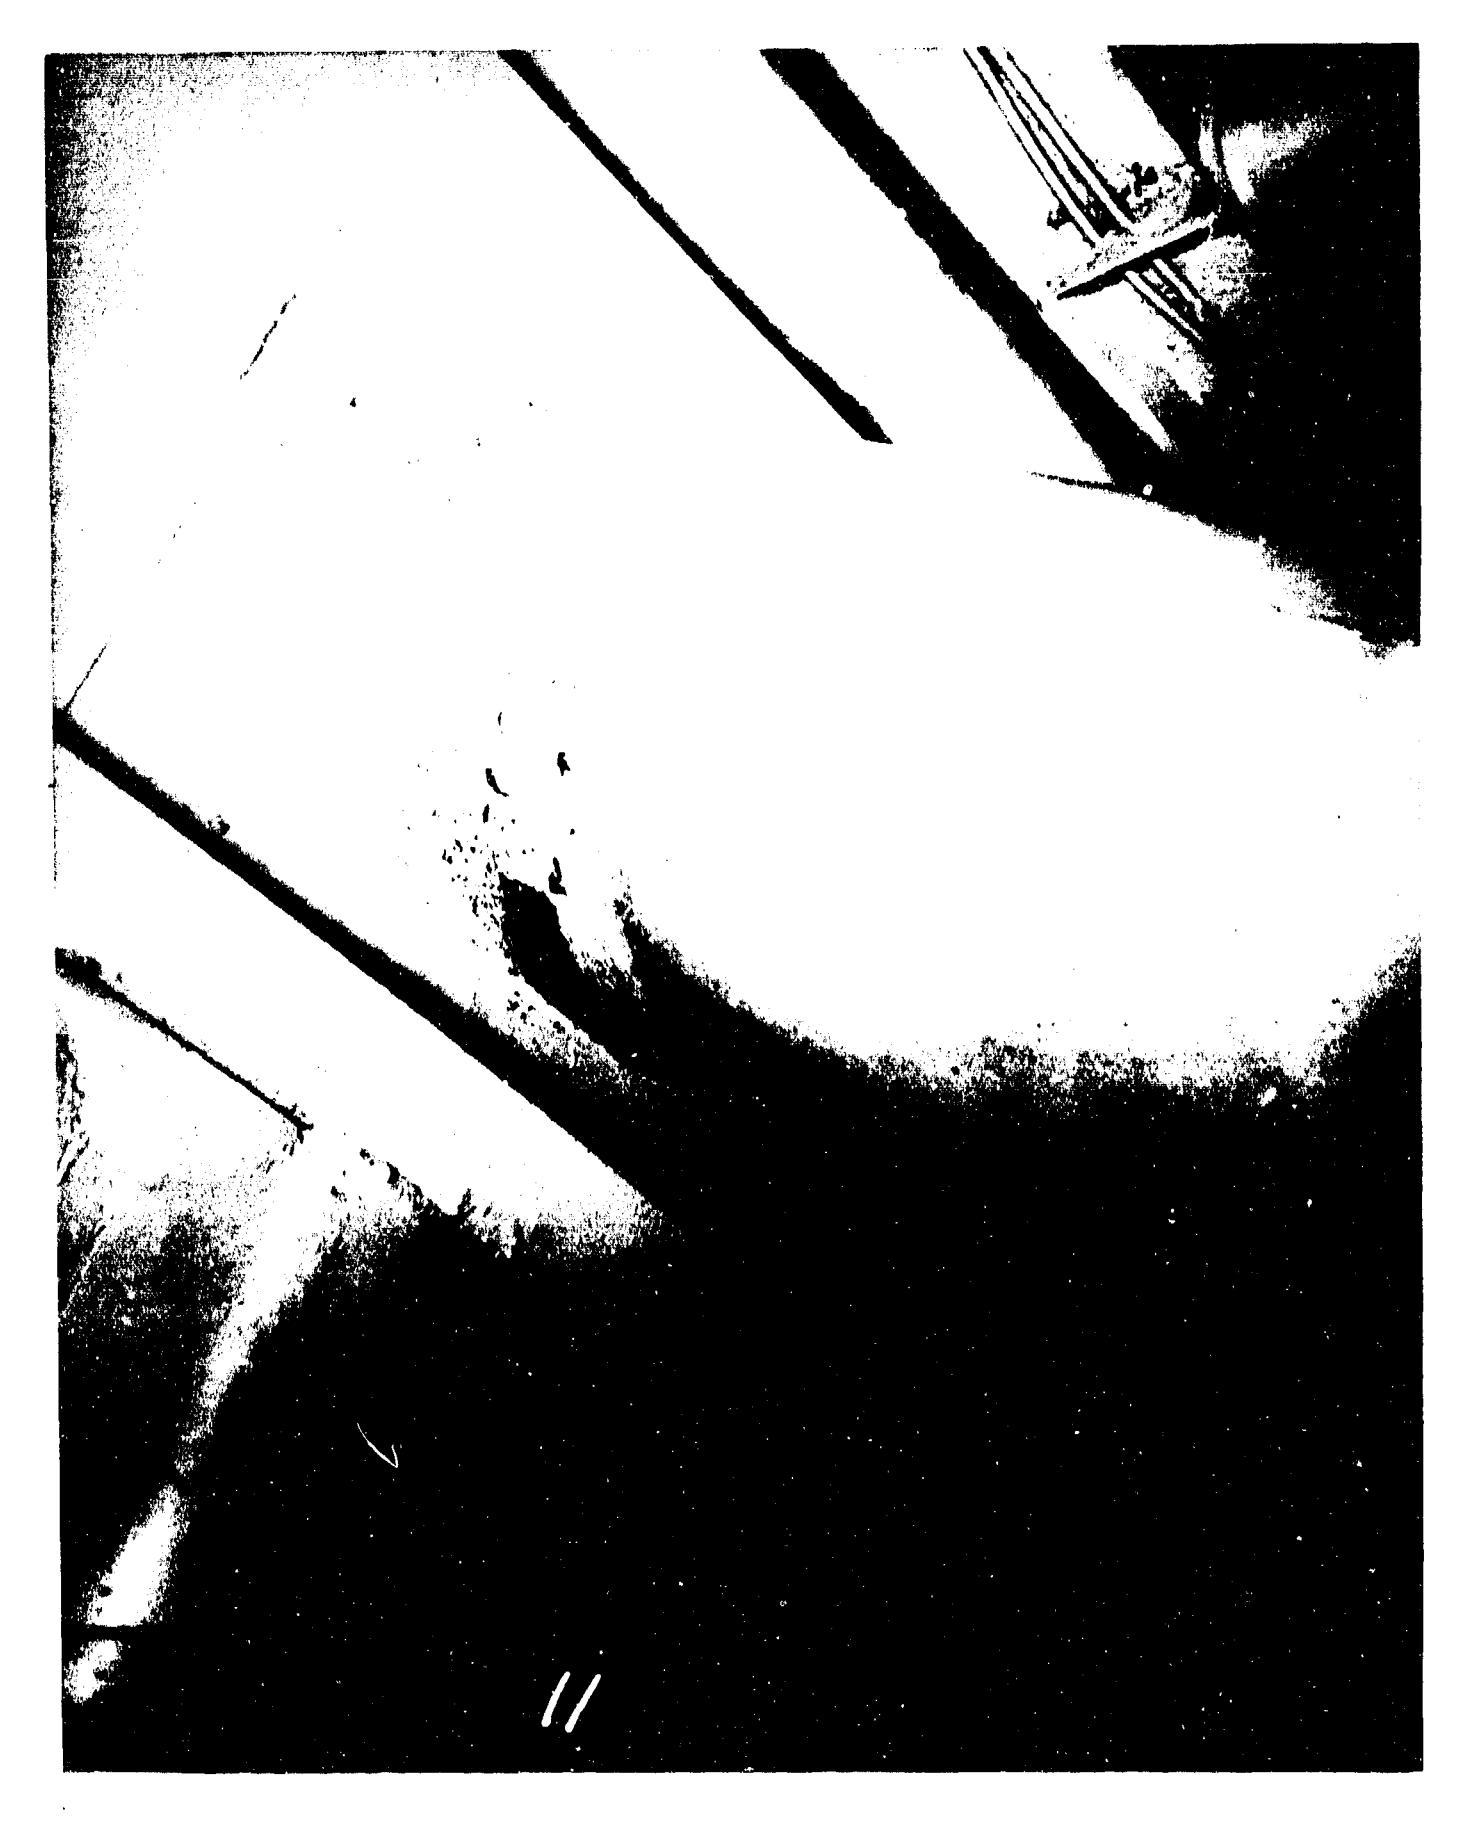
AA-CR-175-2137-11. USS NEVADA (BB36). Forward leg of starboard director tub, frame 68-69, looking aft and outboard. Showing compression evidence at top of leg under 02 level.

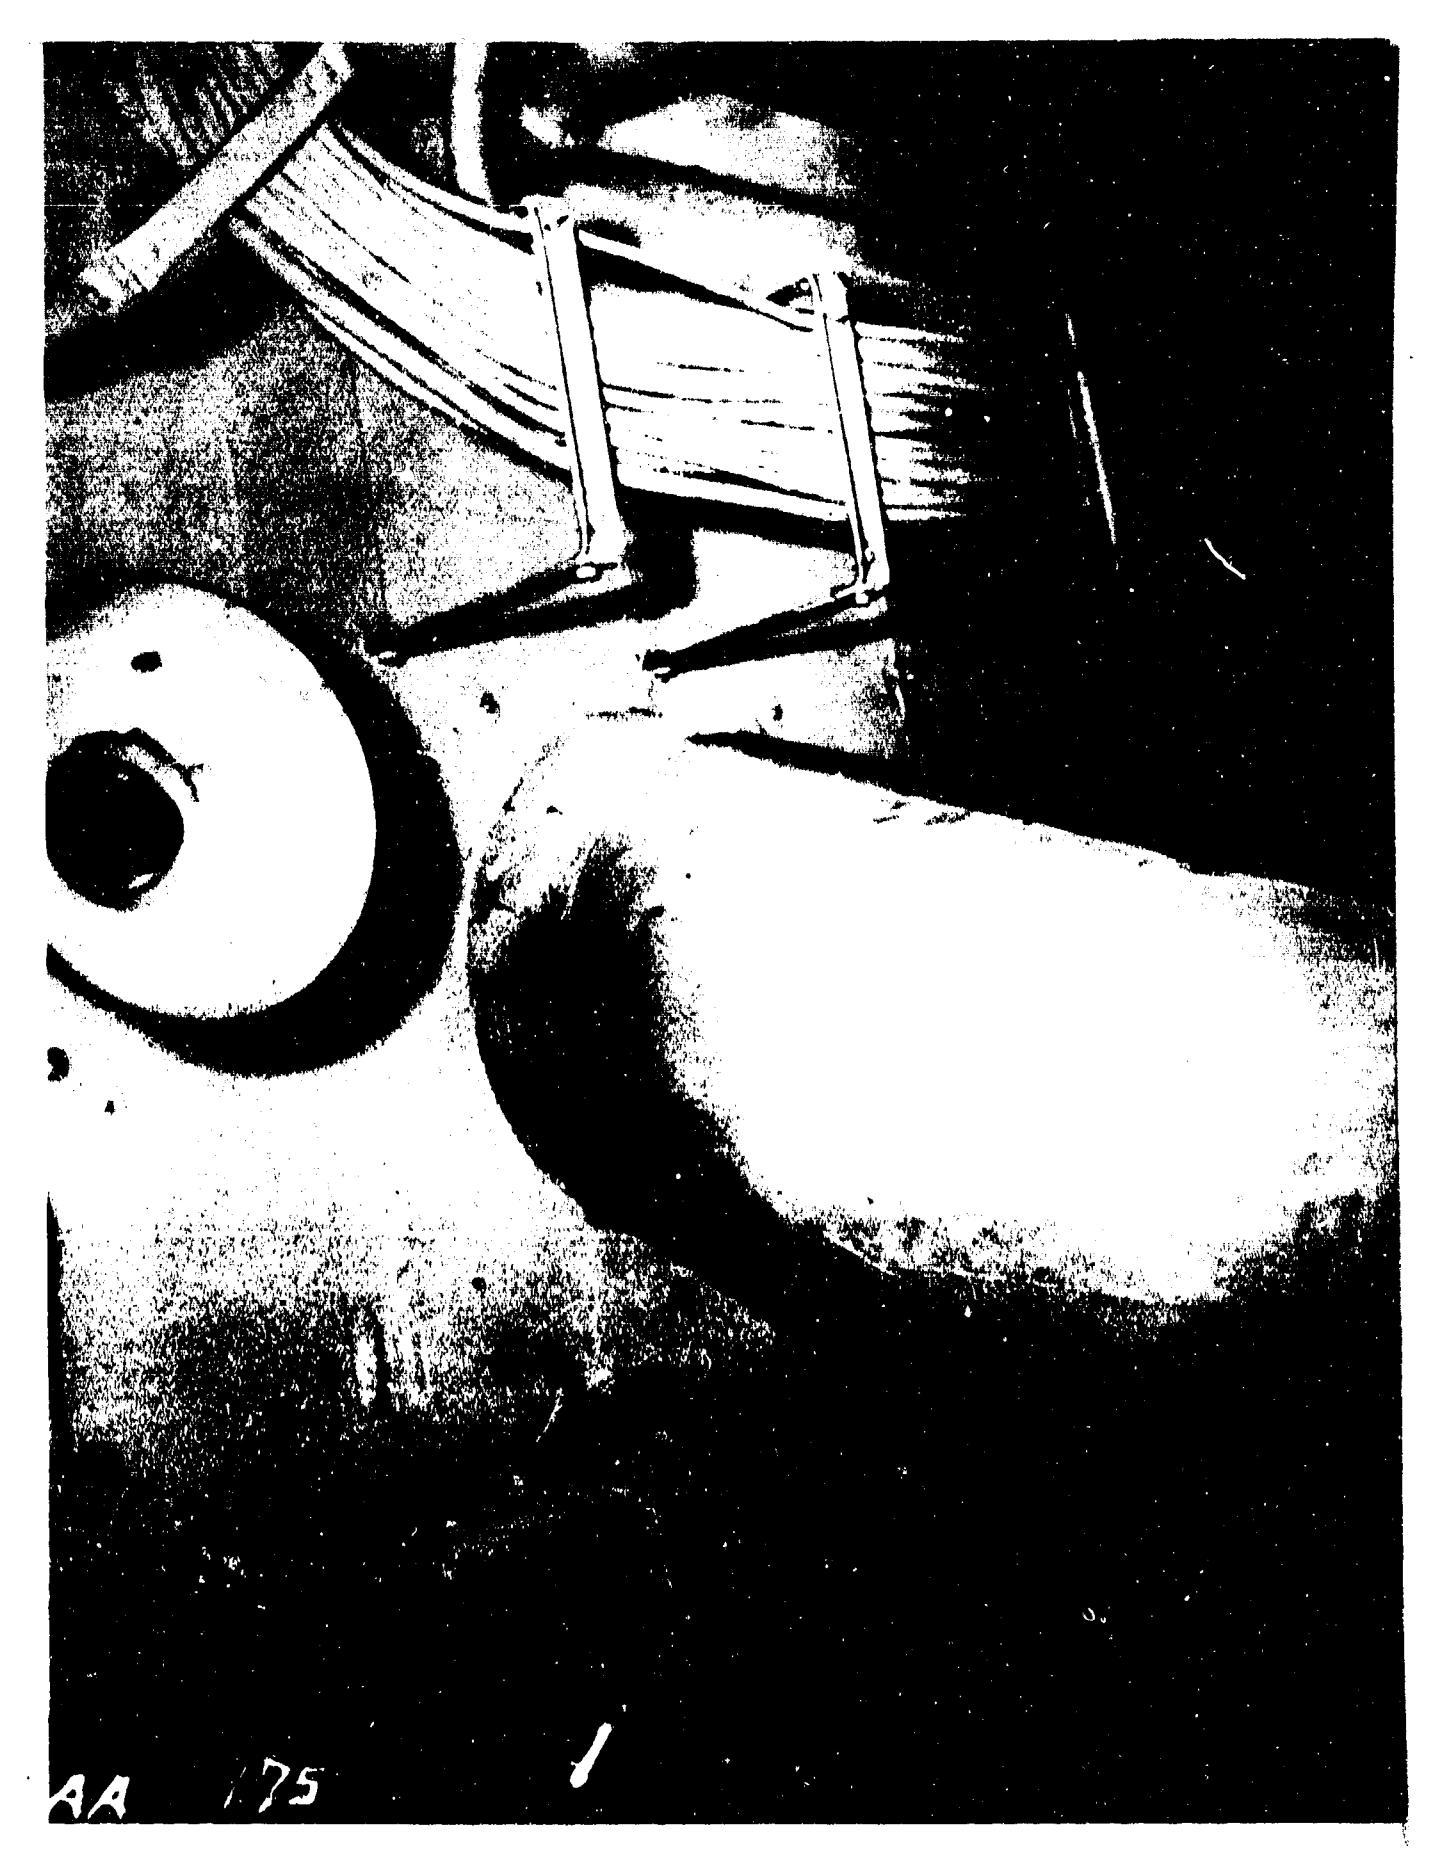
AA-CR-175-2154-1. USS NEVADA (BB36). Forward leg of port director tub, frame 68-69, looking inboard, showing compression evidence at top of leg under 02 level.

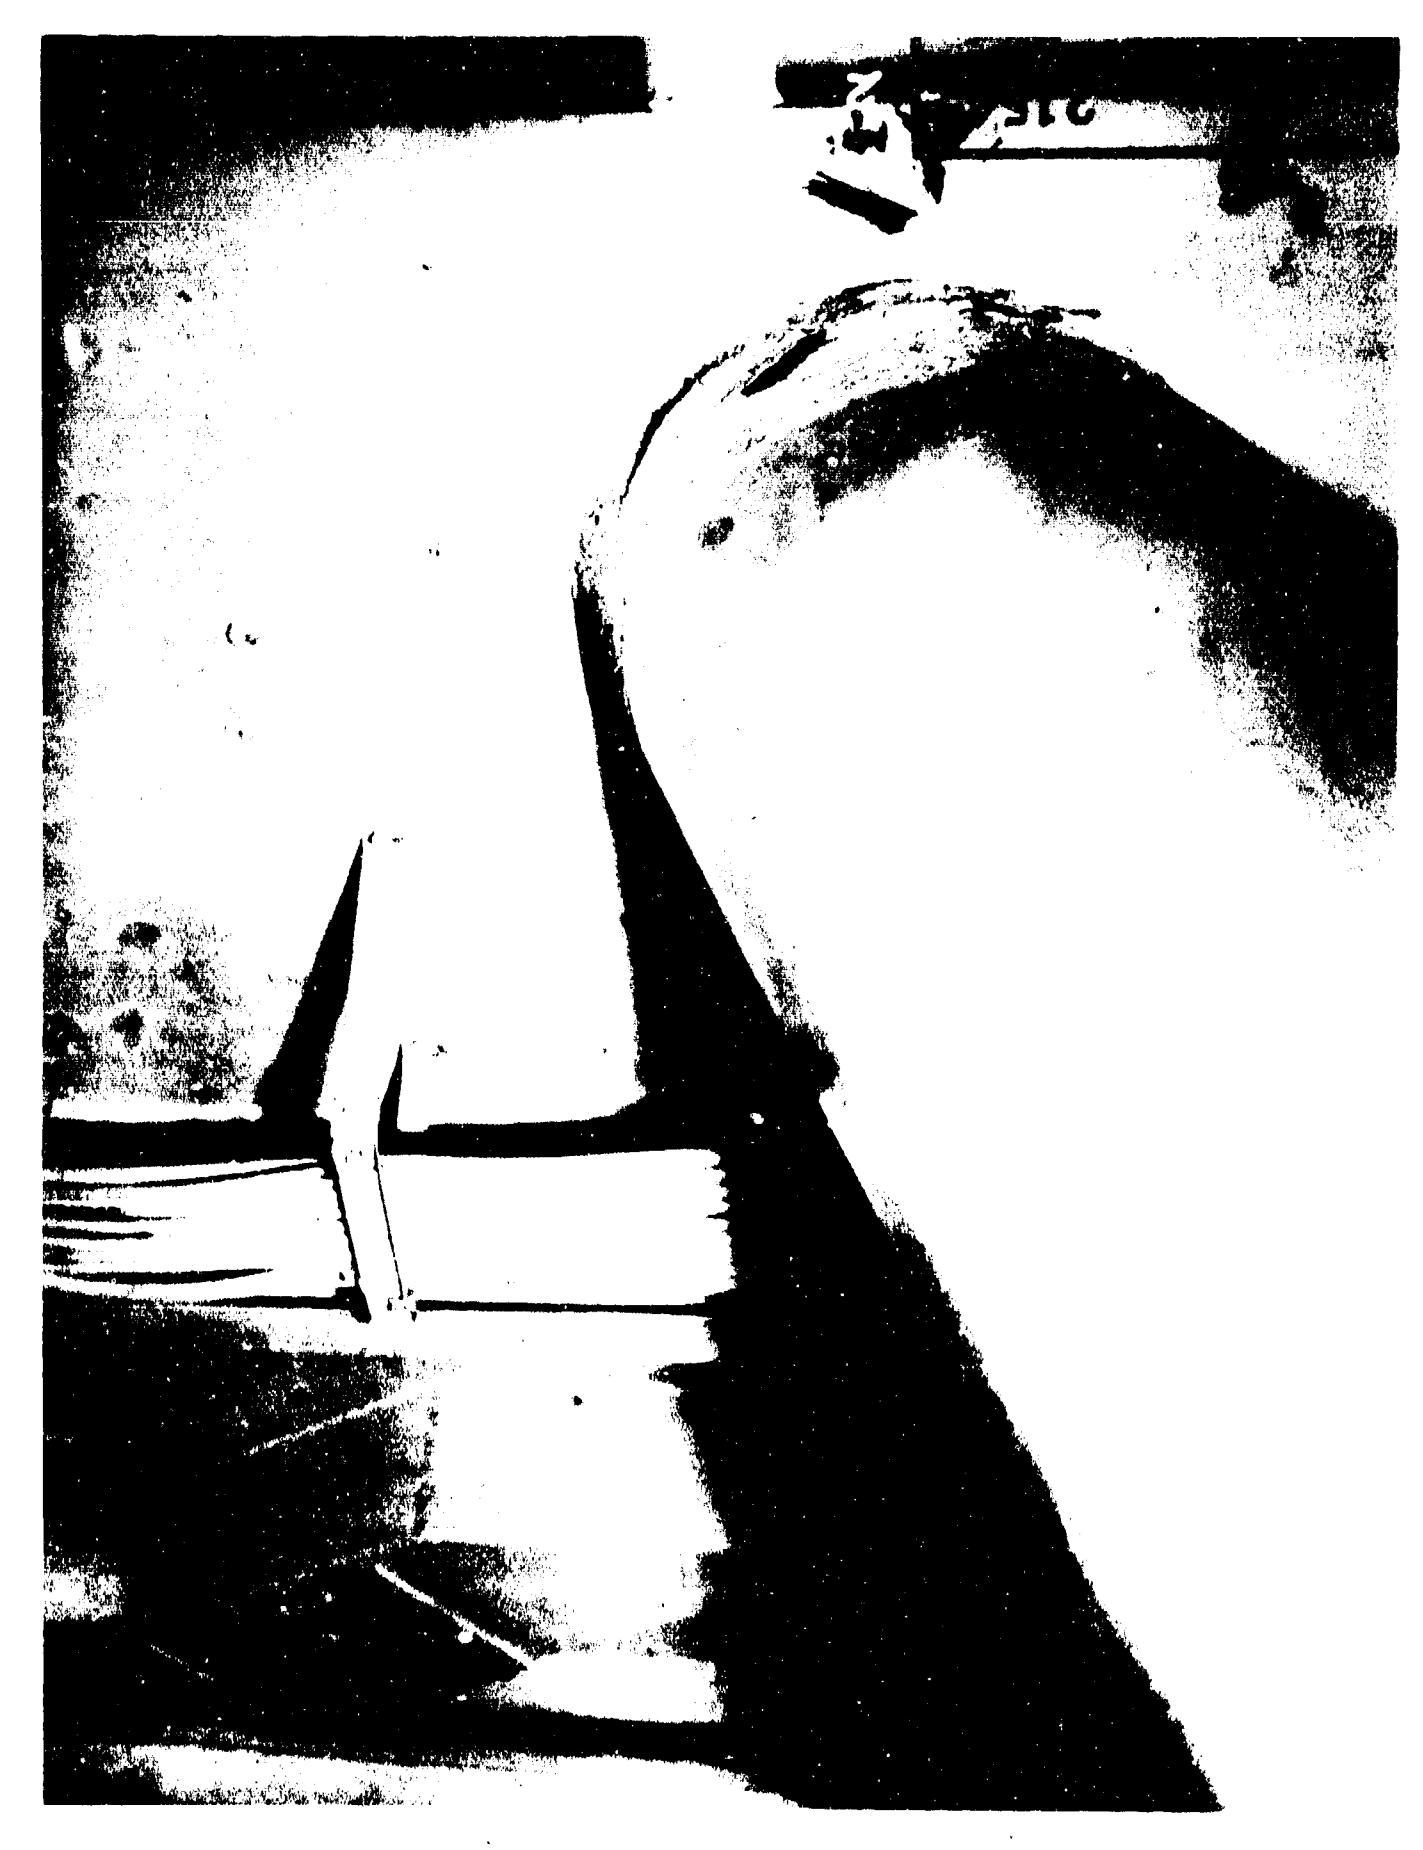
AA-CR-175-2154-2. USS NEVADA (BB36). Forward leg of port director tub, frame 68-69, looking up and slightly outboard.
