BUREAU OF SHIPS GROUP

TECHNICAL INSPECTION REPORT

FAILURES OF MASTS, YARDARMS, BOOMS, AND RIGGING

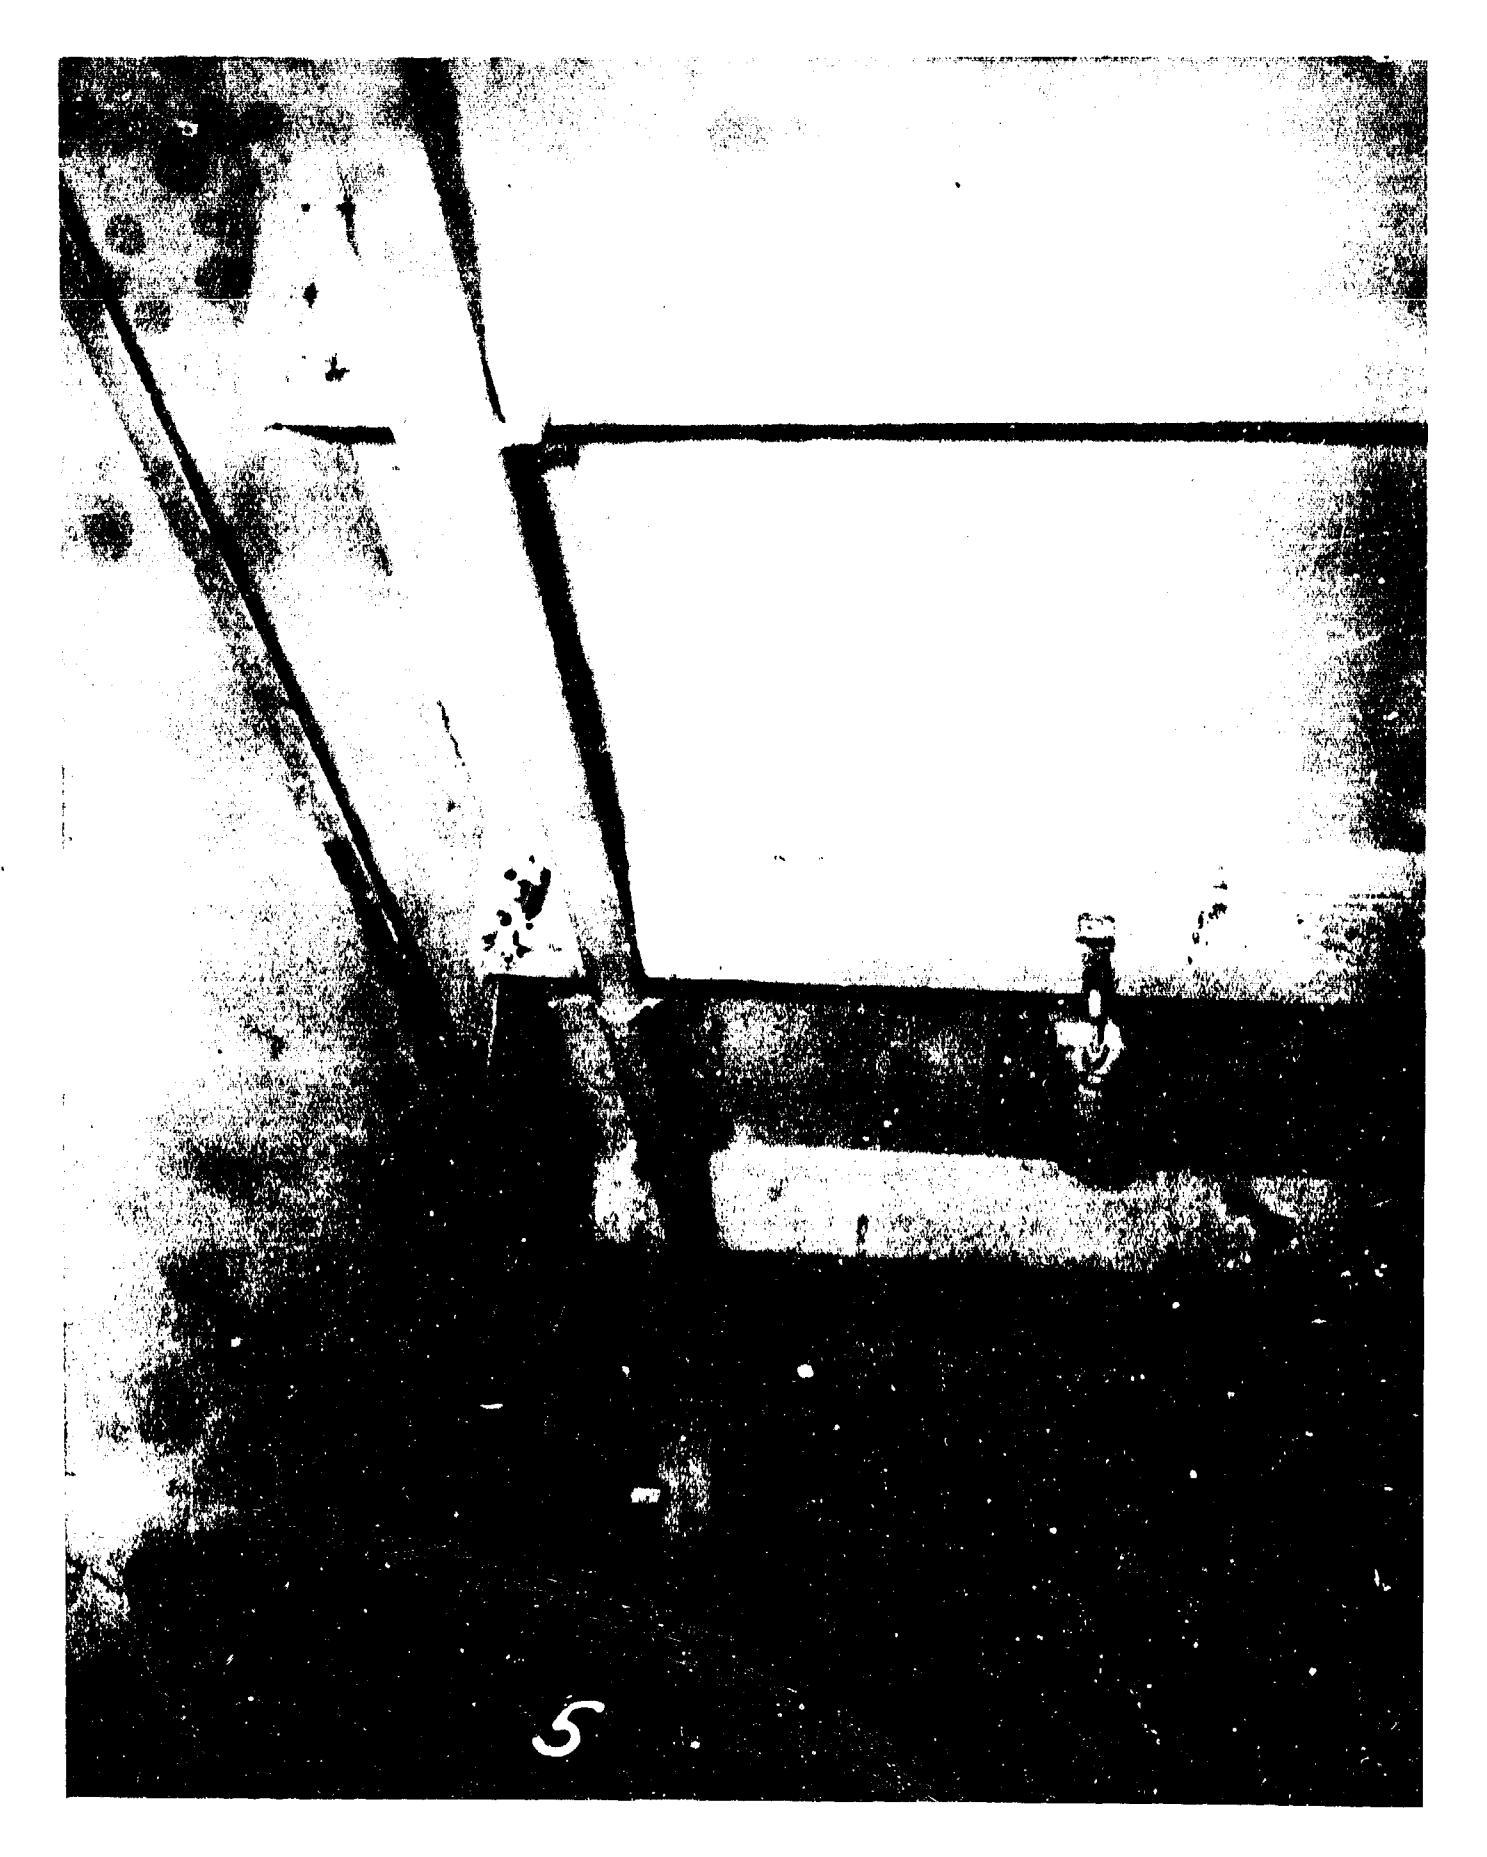
AA-CR-175-2154-5. USS NEVADA (BB36). Deck beams under 02 level frame 66-67 and 68, at longitudinal bulkhead 8 feet off centerline to starboard, looking aft.

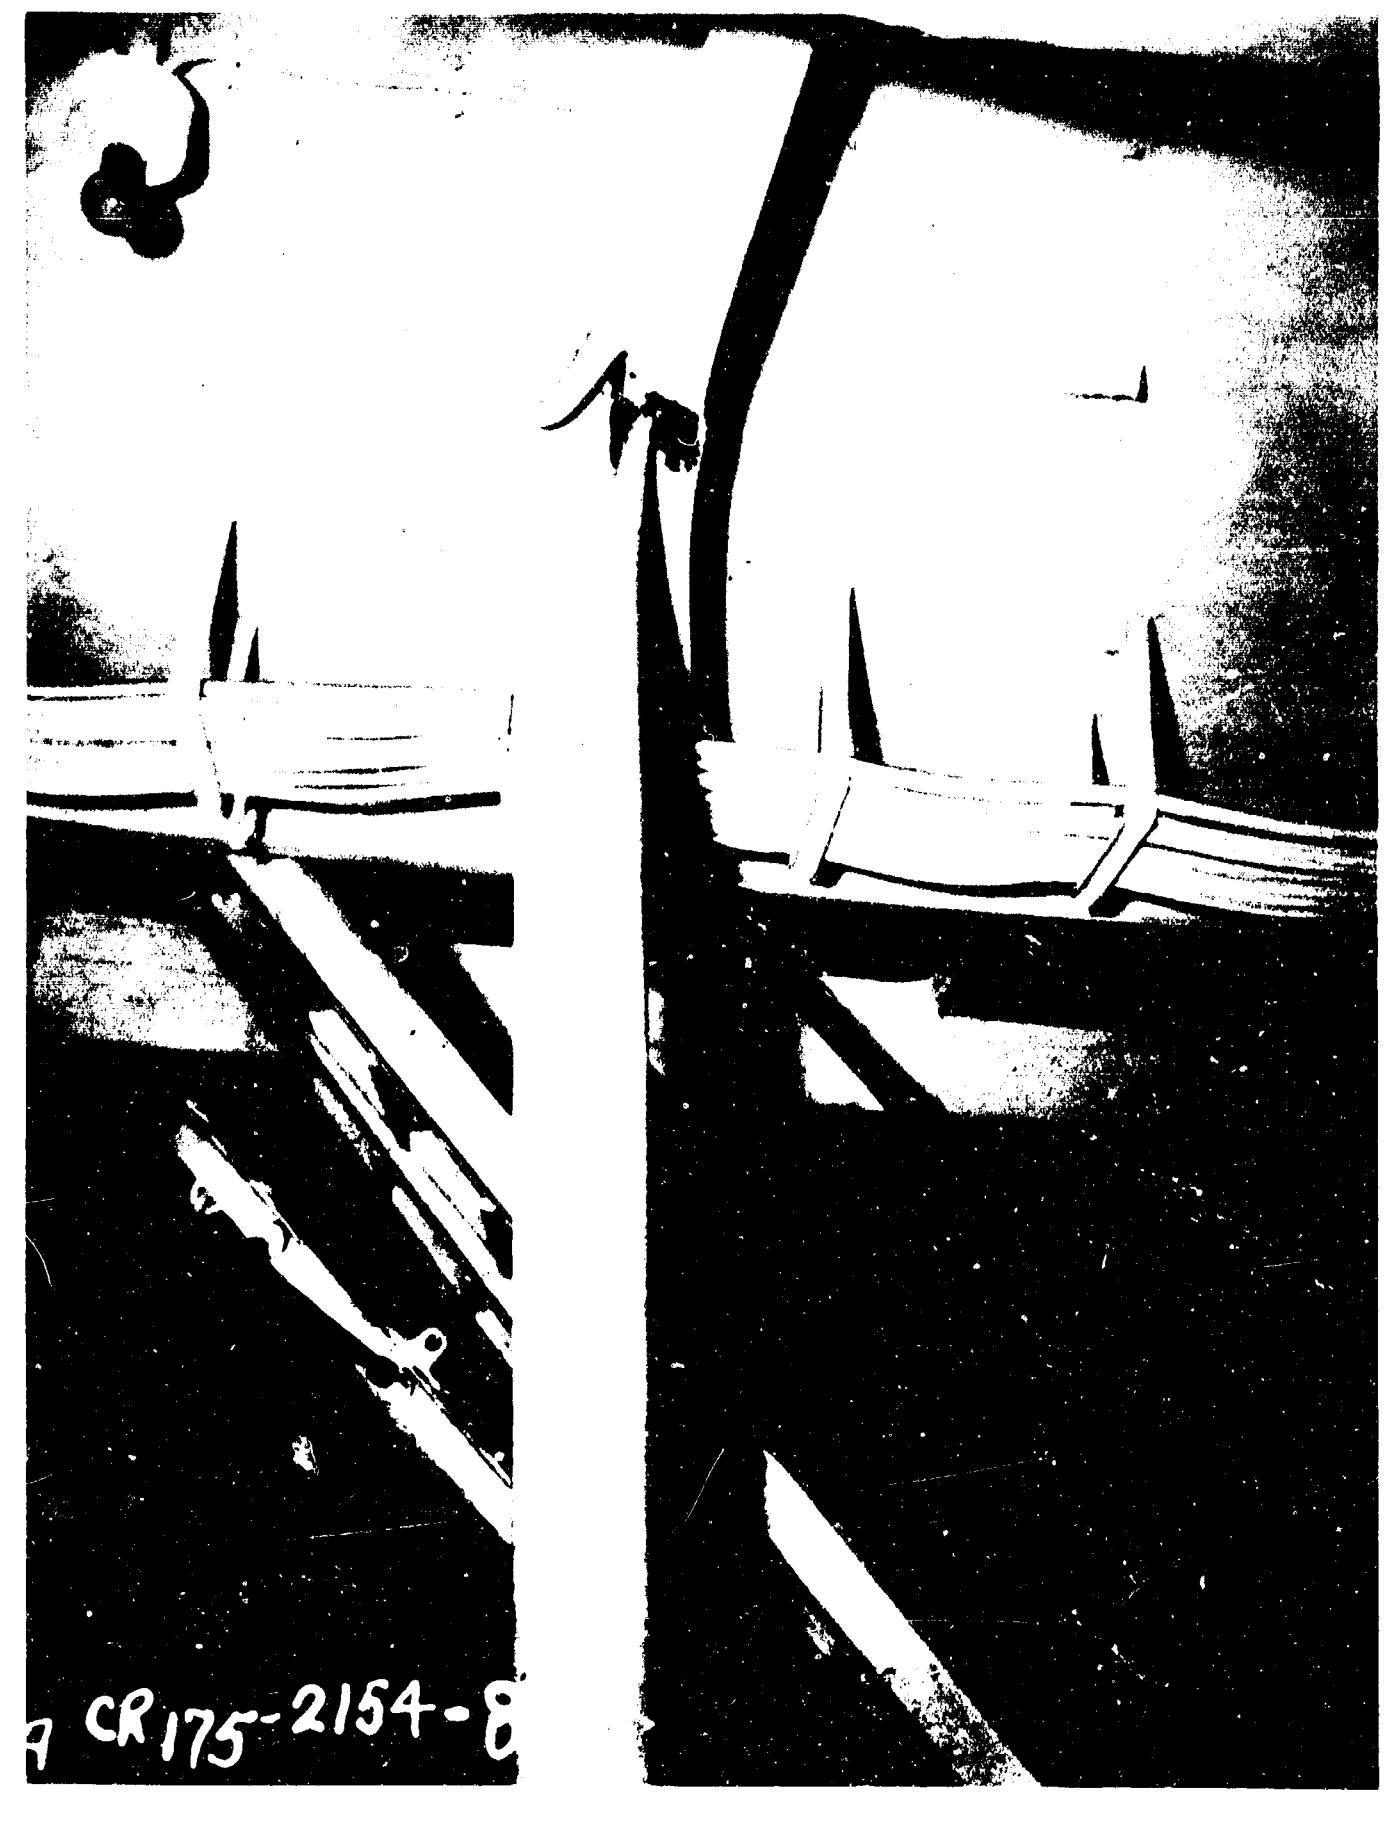
AA-CR-175-2154-8. USS NEVADA (BB36). Stanchion (16 feet off centerline) at frame 66 under 02 level, port side, showing distortion of beam and splitting of stanchion.

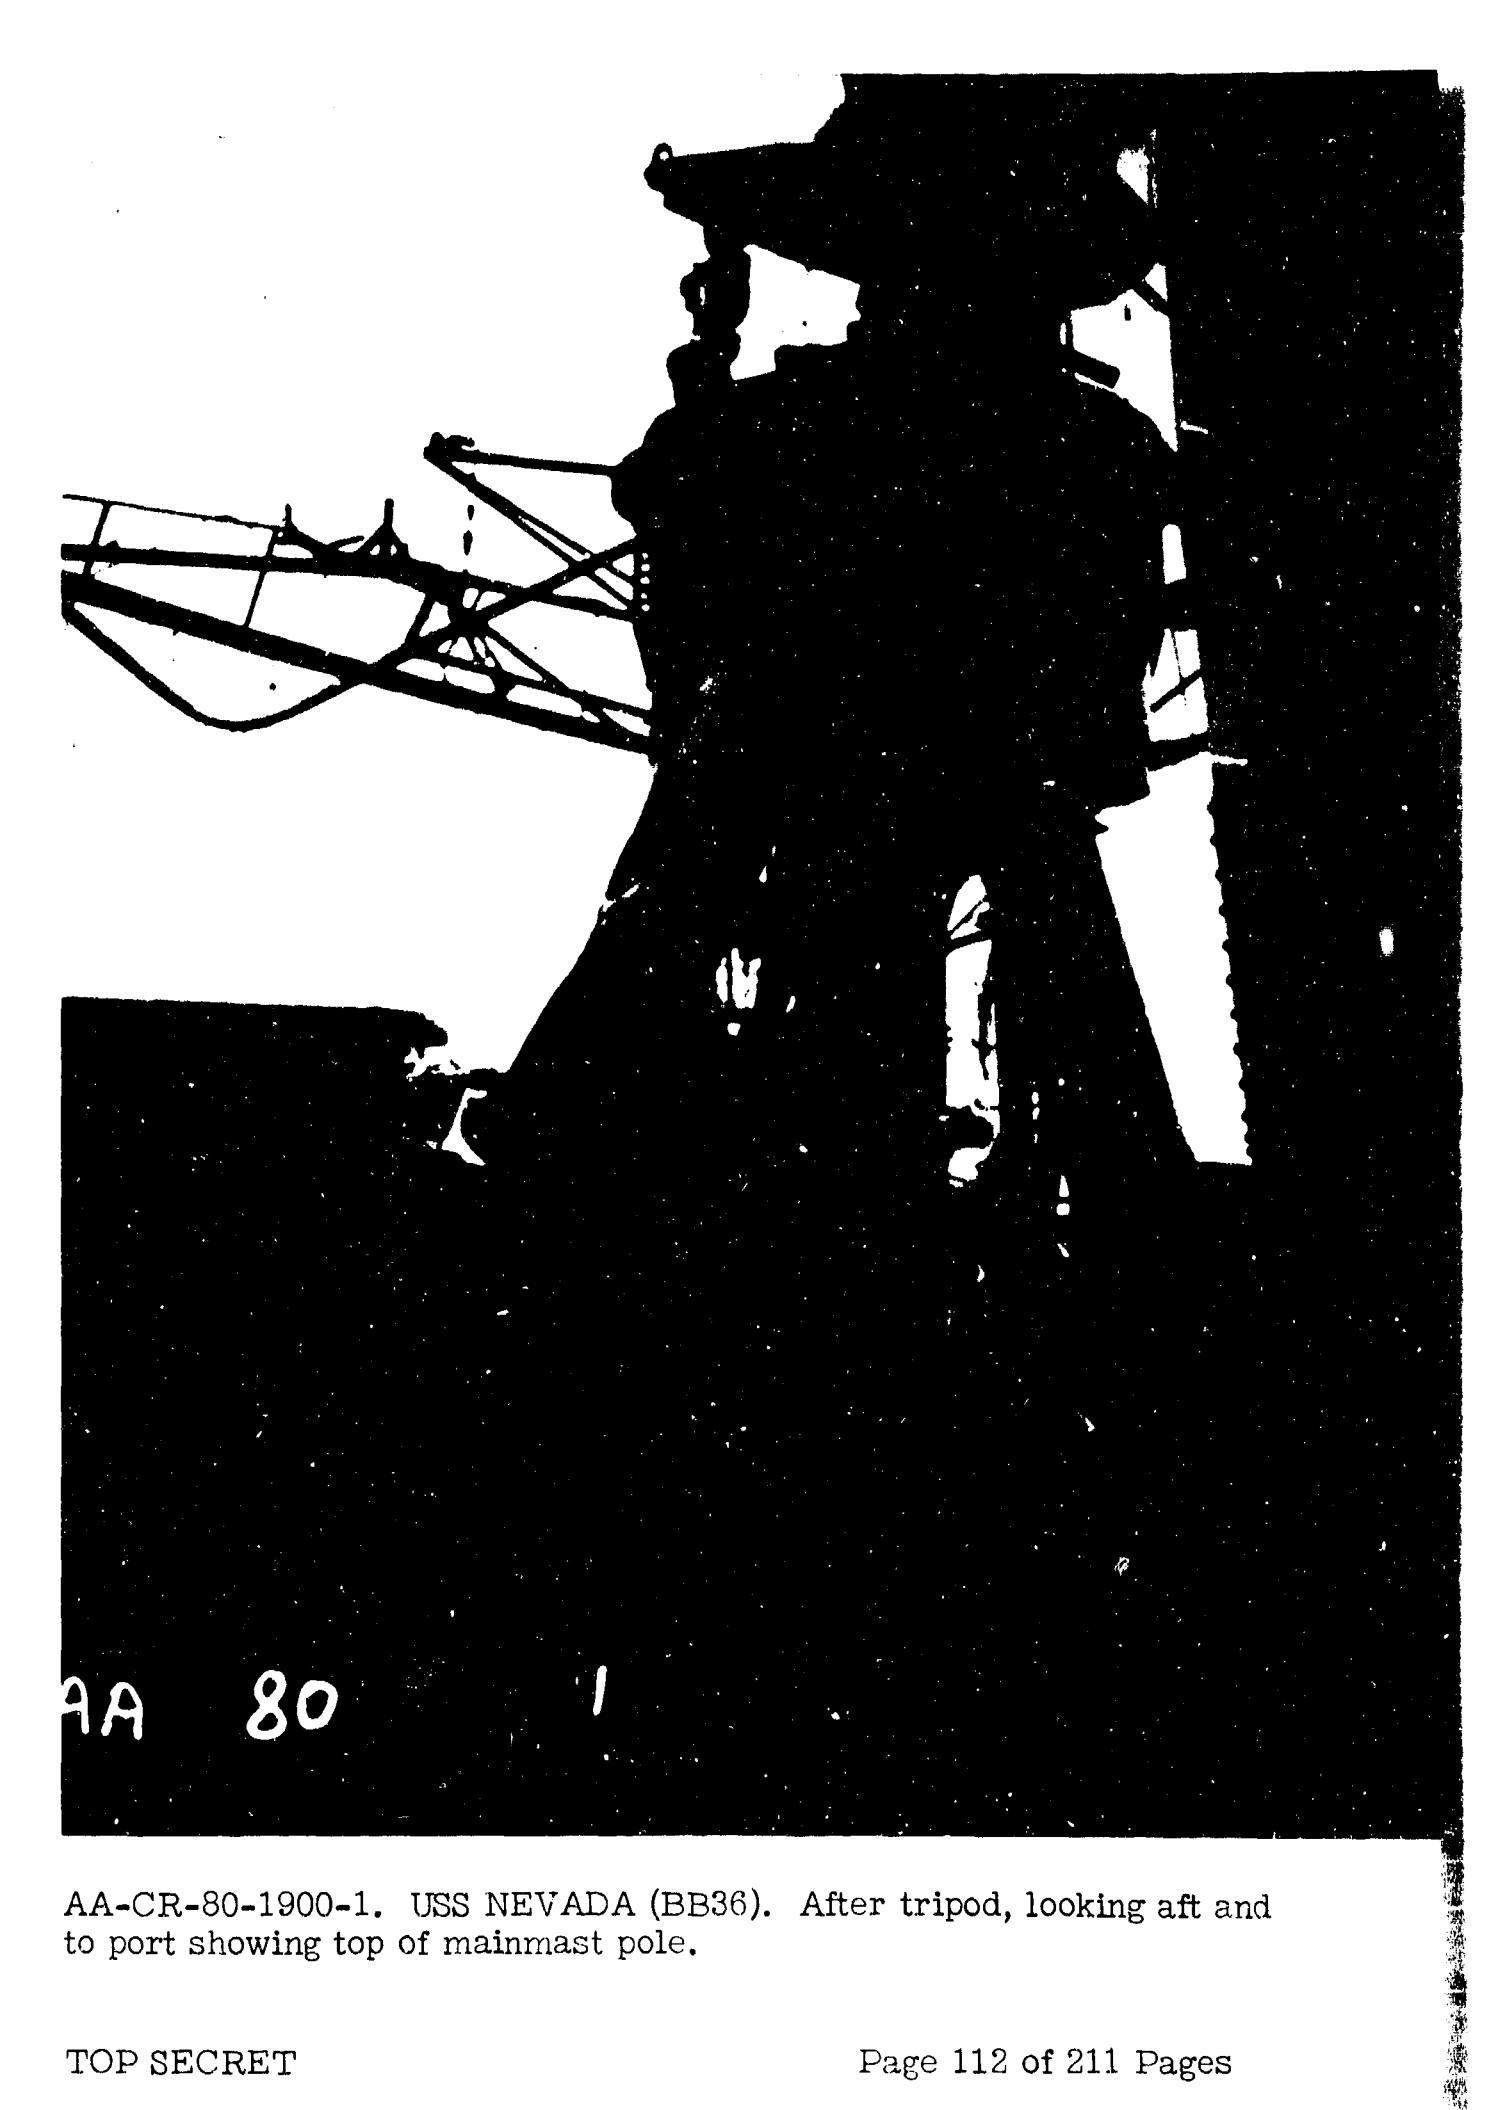
AA-CR-80-1900-1. USS NEVADA (BB36). After tripod, looking aft and to port showing top of mainmast pole.

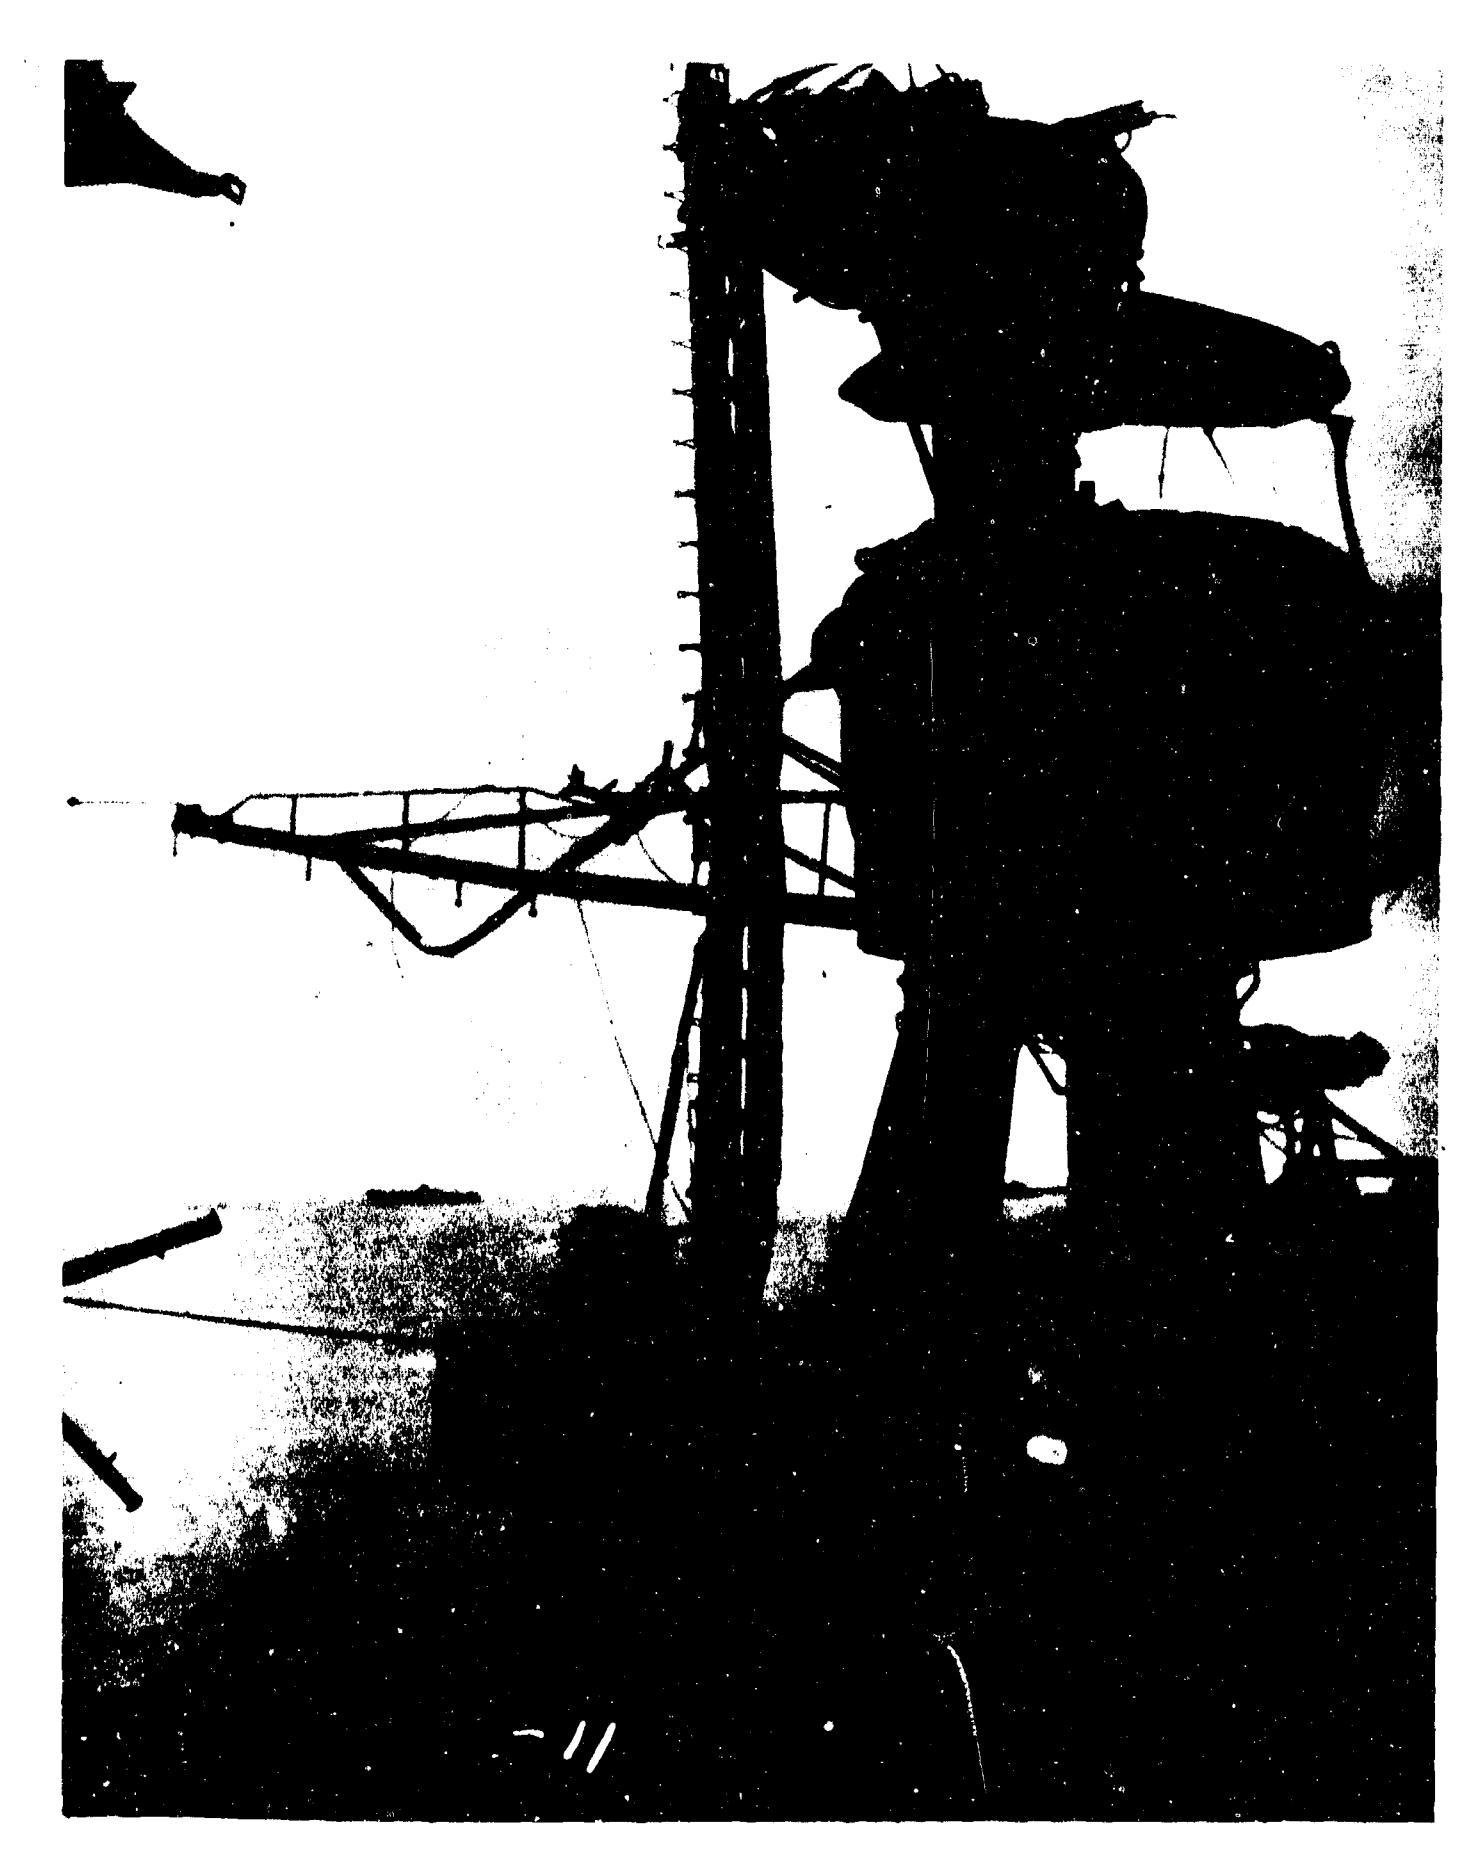
AA-CR-80-1897-11. USS NEVADA (BBUG). After tripod, looking aft and to starboard.

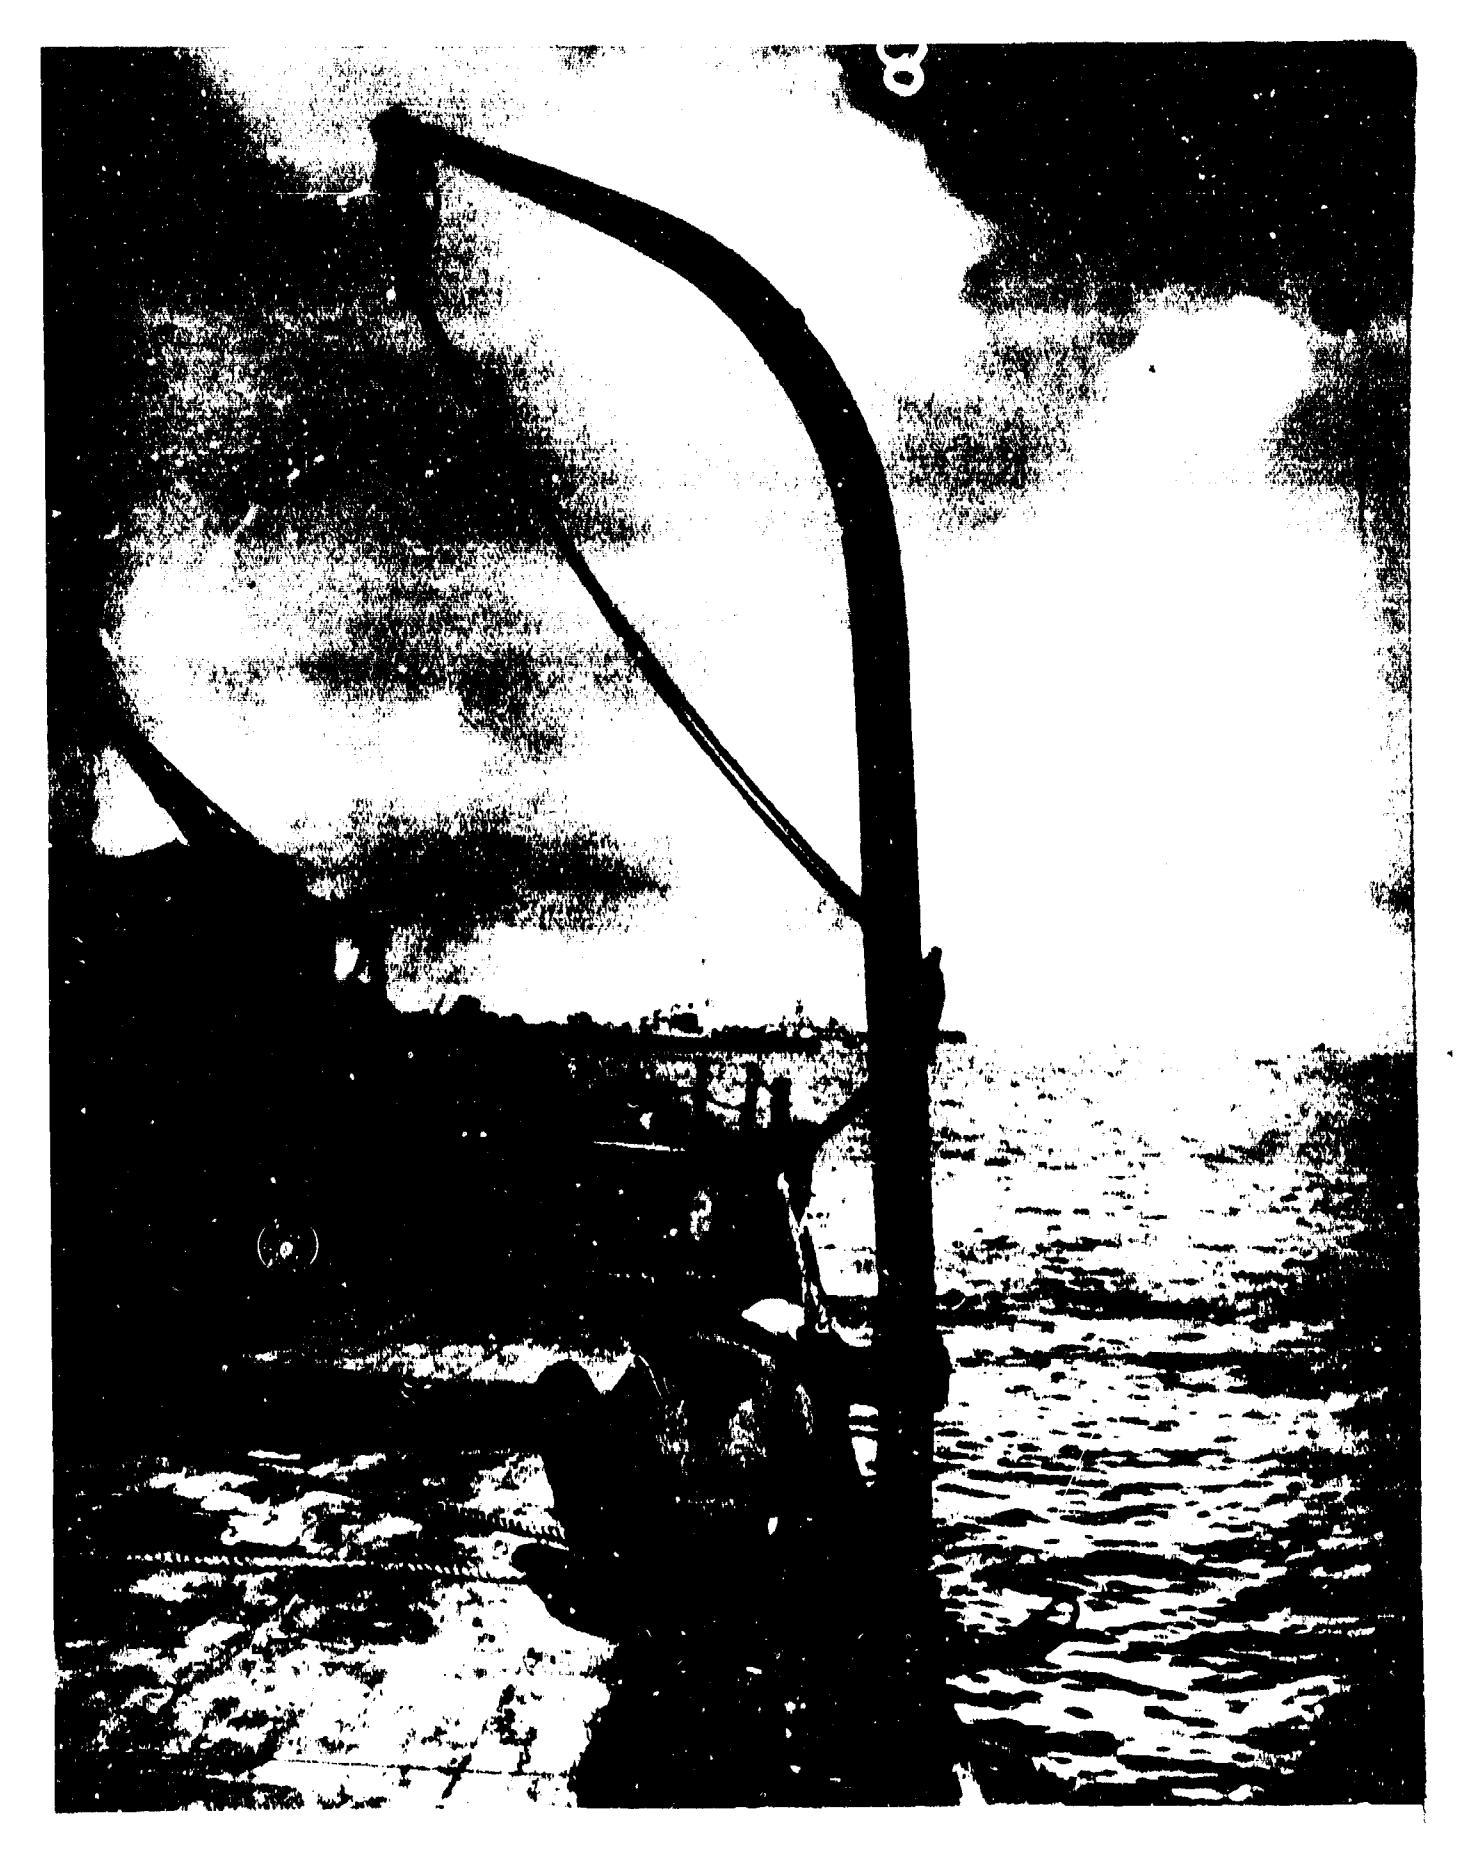
AA-CR-100-1889-8. USS NEVADA (BB36). Side ladder davit, frame 105, showing bend above deck edge fitting.

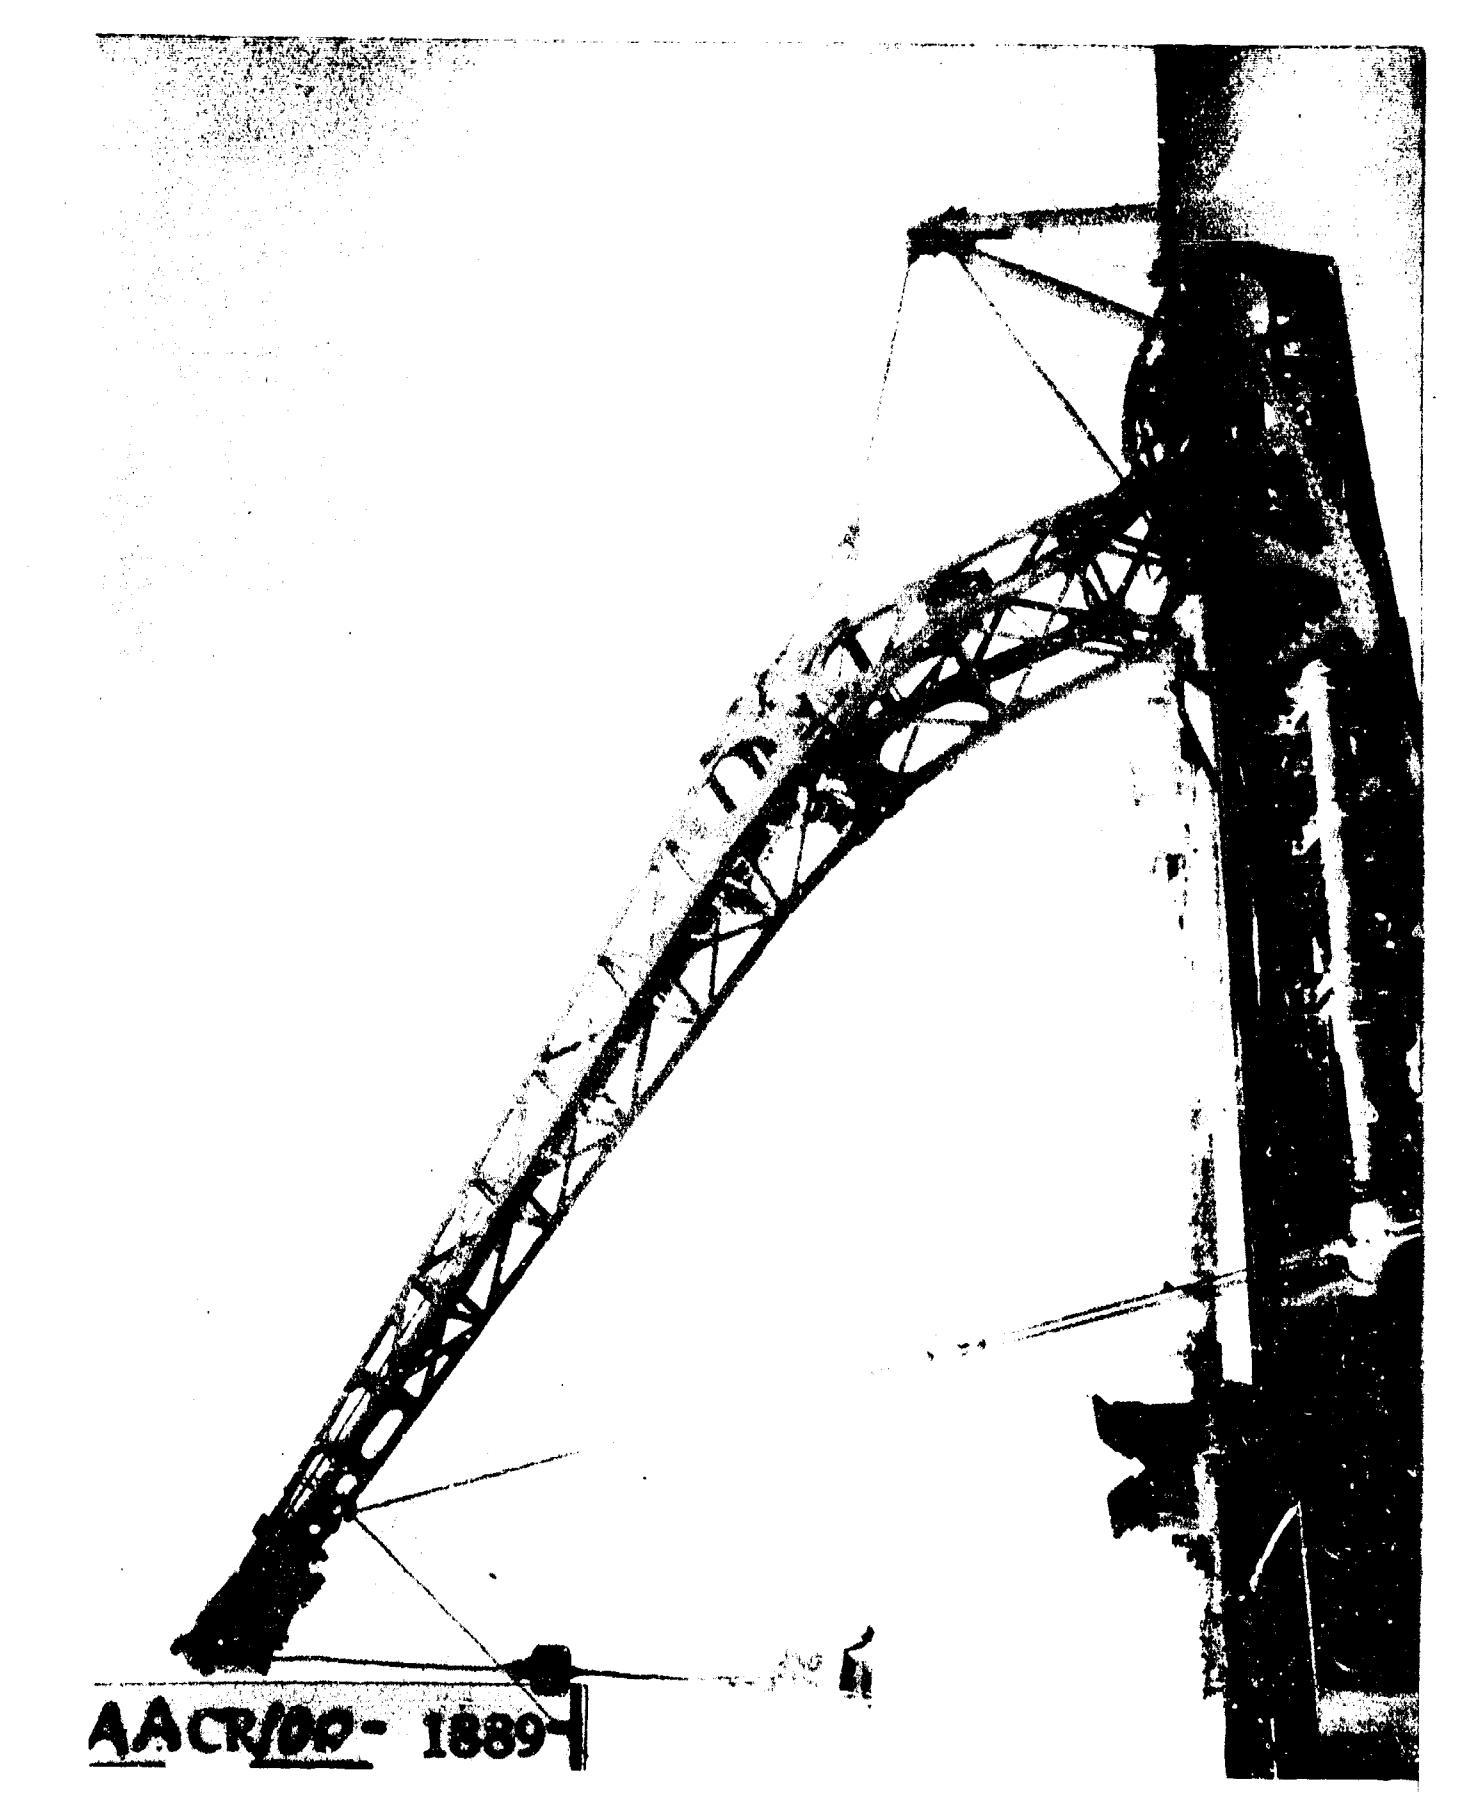
AA-CR-100-1889-9. USS NEVADA (BB36). Stern crane, showing lower section knuckled and resting on catapult. Looking aft and to starboard.

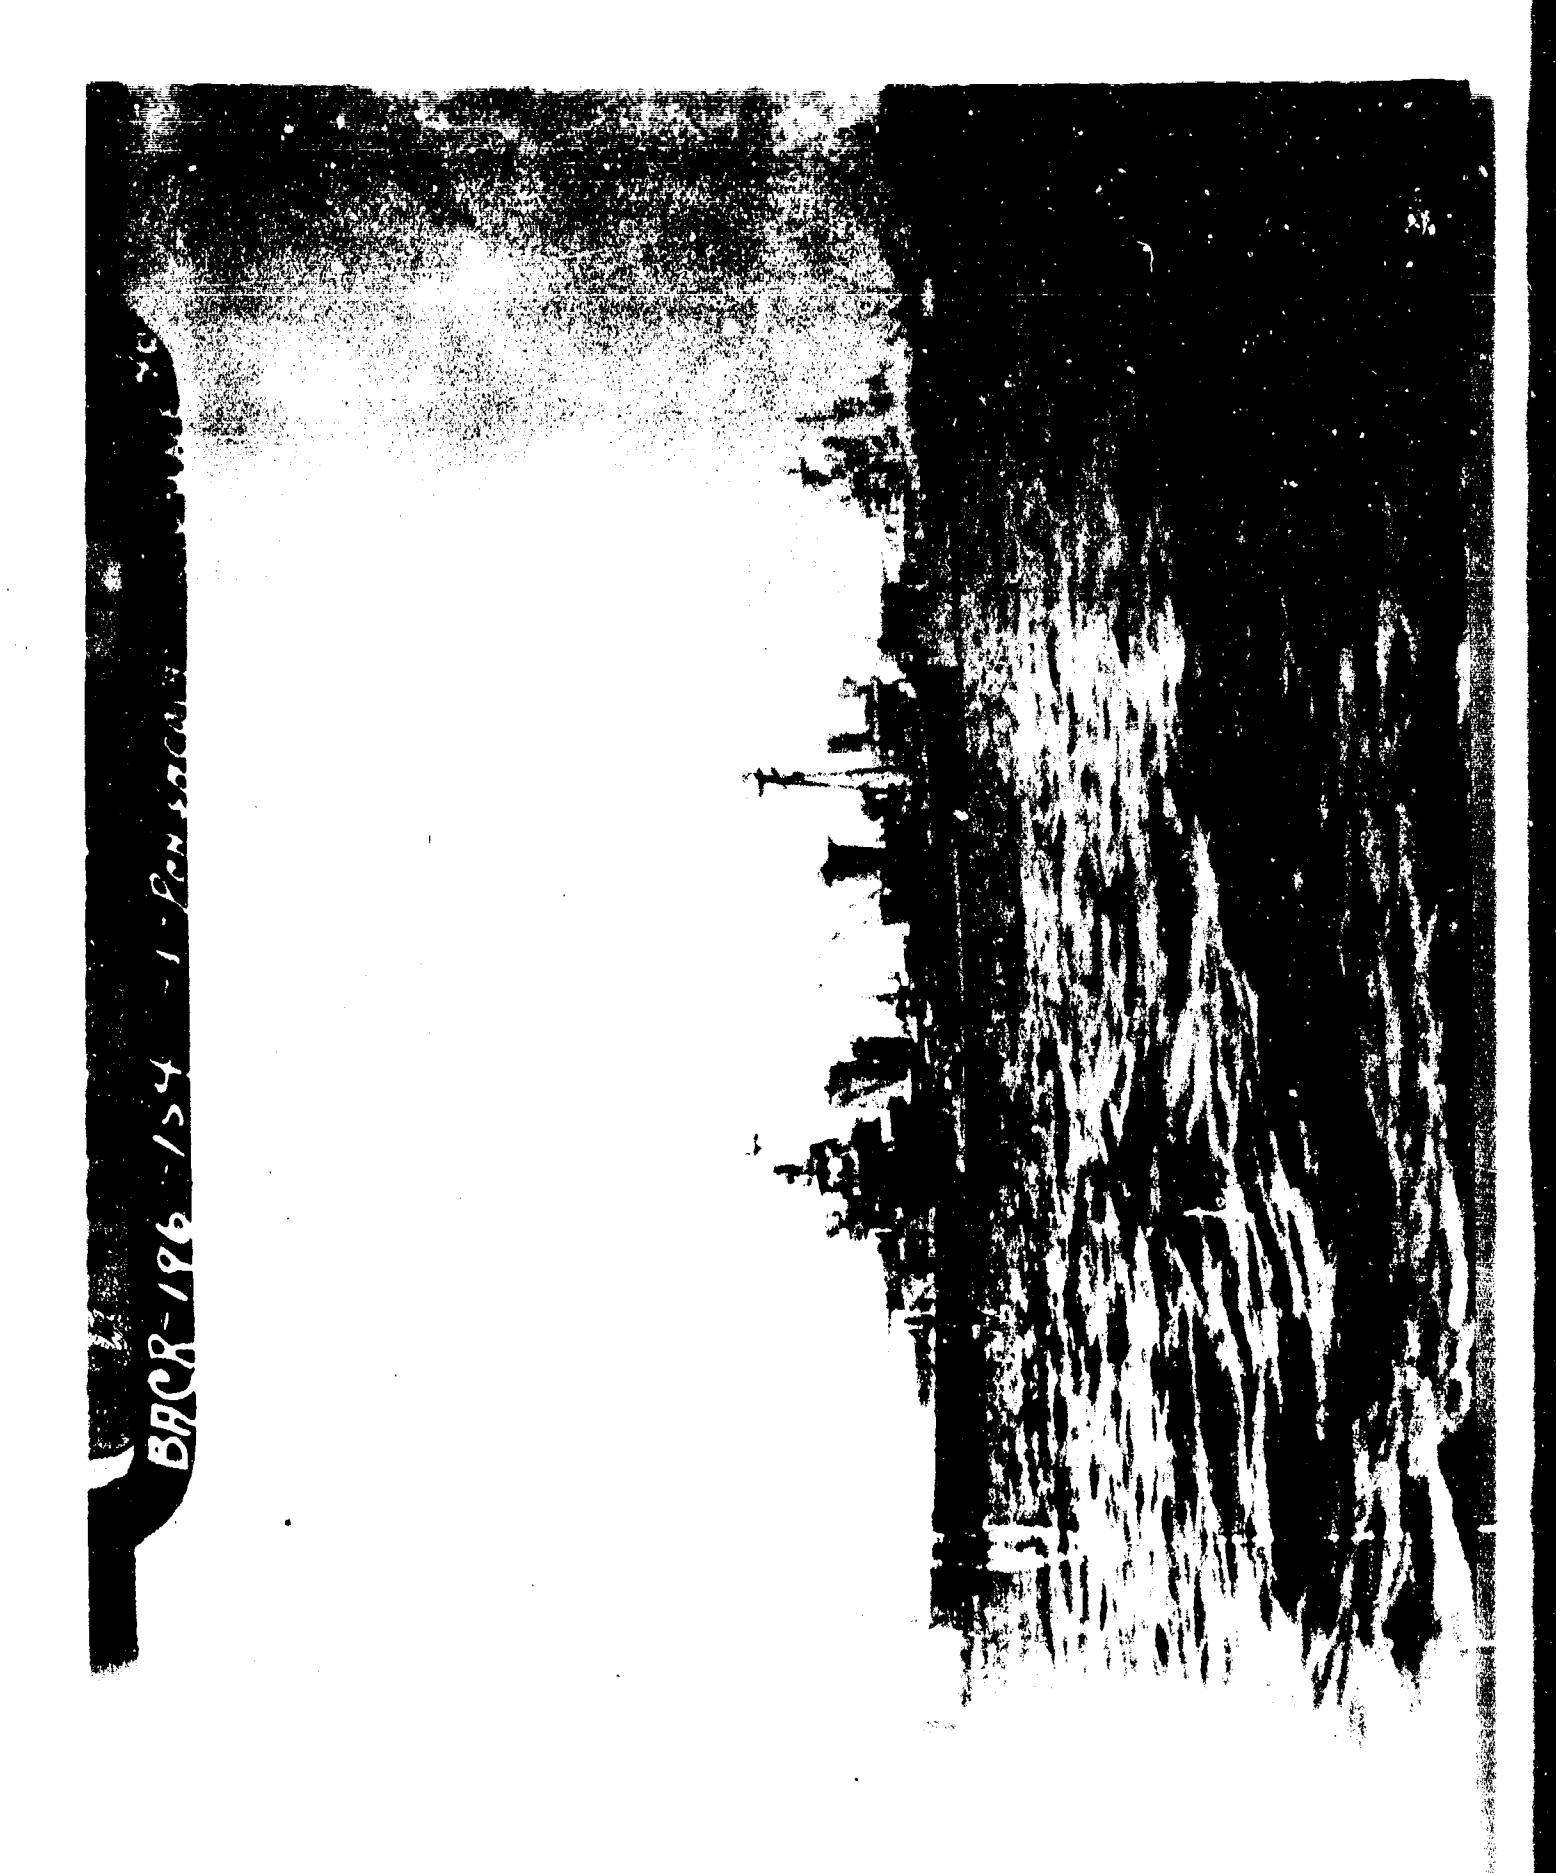
BA-CR-196-154-1. U.S.S. PENSACOLA (CA24). View looking at port beam. Before Test A.

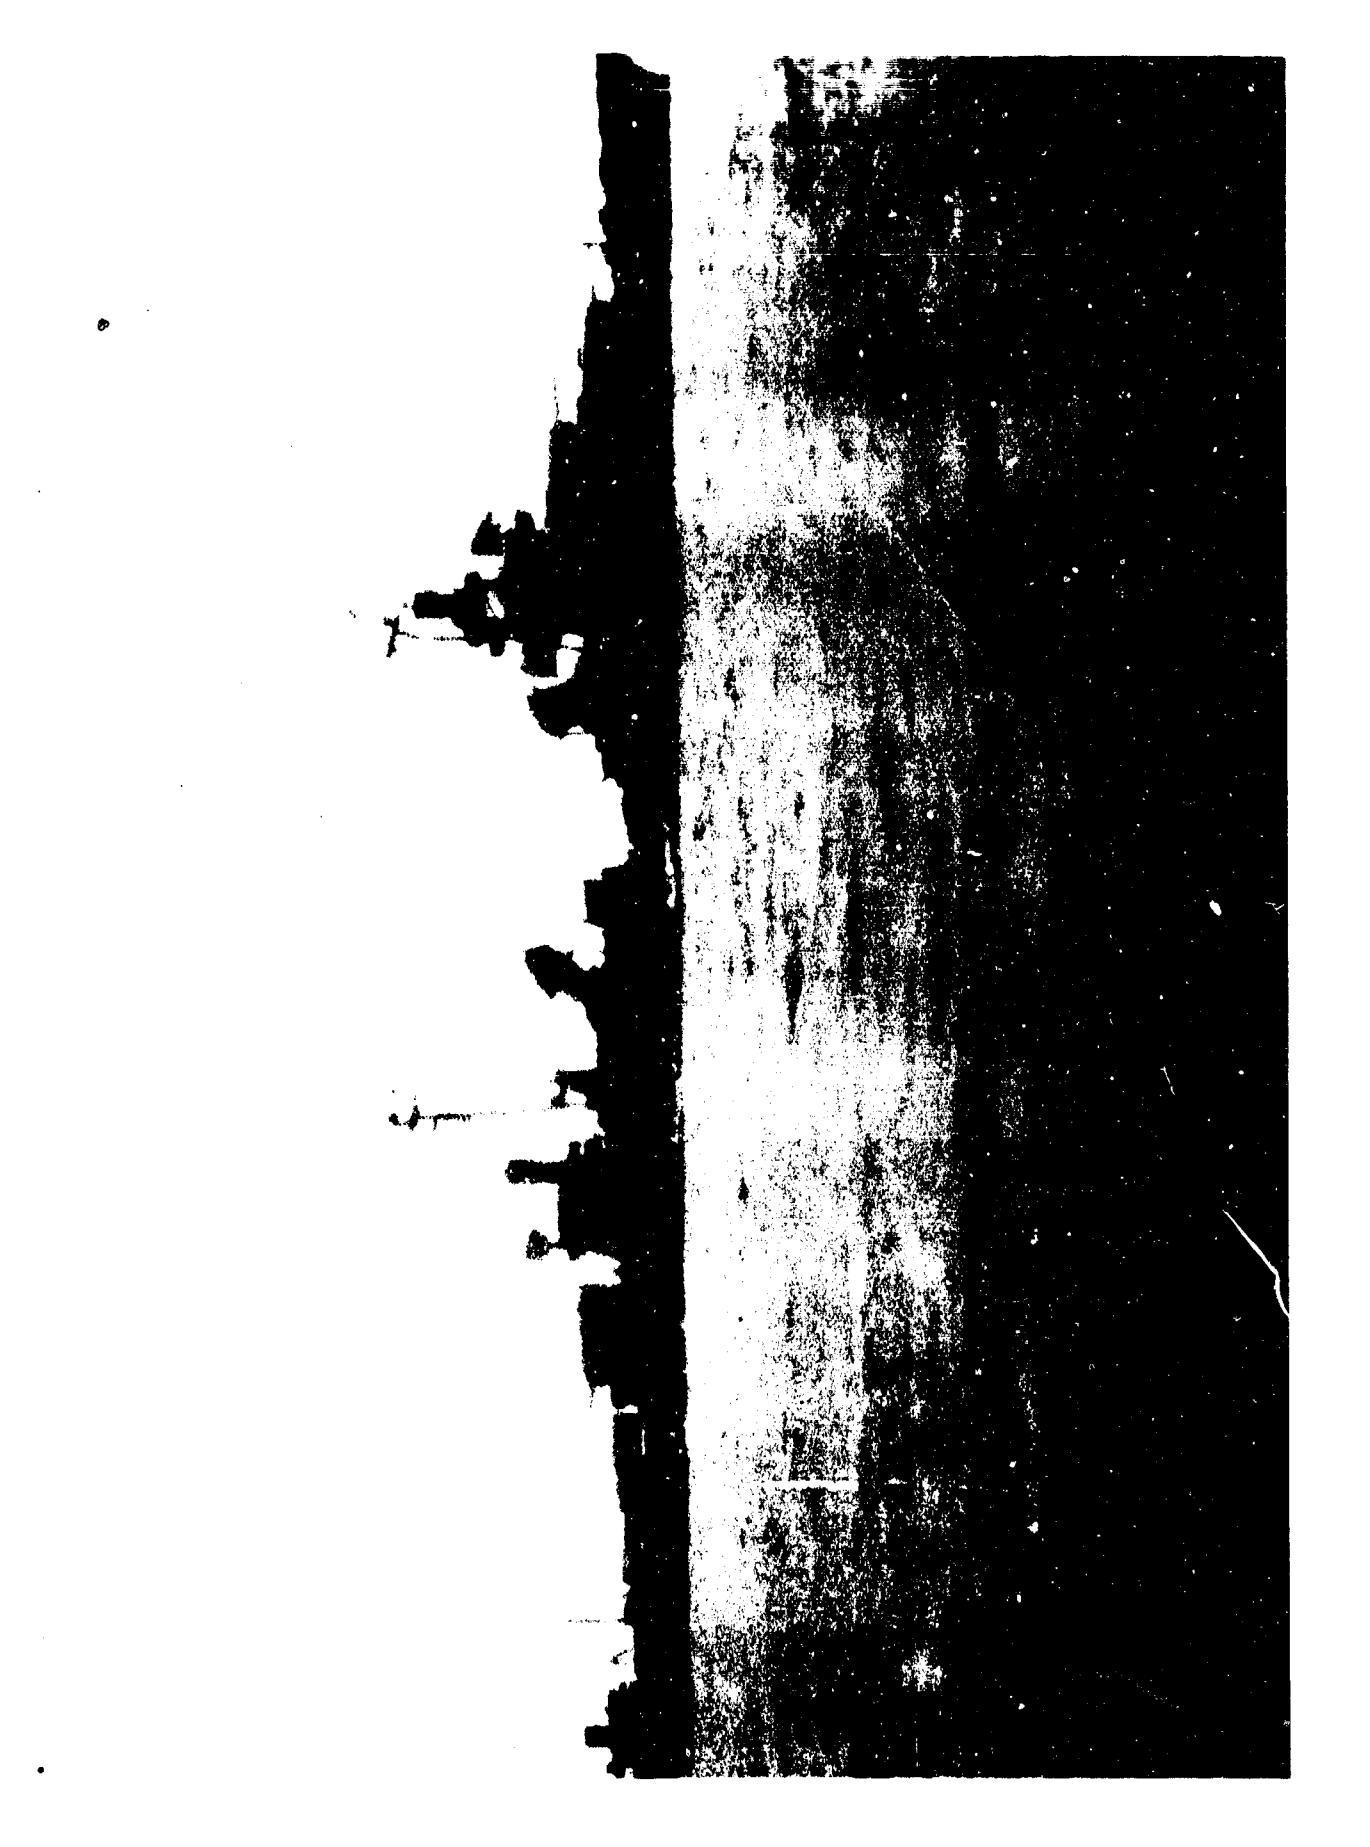
AA-CR-227-93-45. U.S.S. PENSACOLA (CA24). View looking at starboard beam. After Test A.
