BUREAU OF SHIPS GROUP

TECHNICAL INSPECTION REPORT

FAILURES OF MASTS, YARDARMS, BOOMS, AND RIGGING

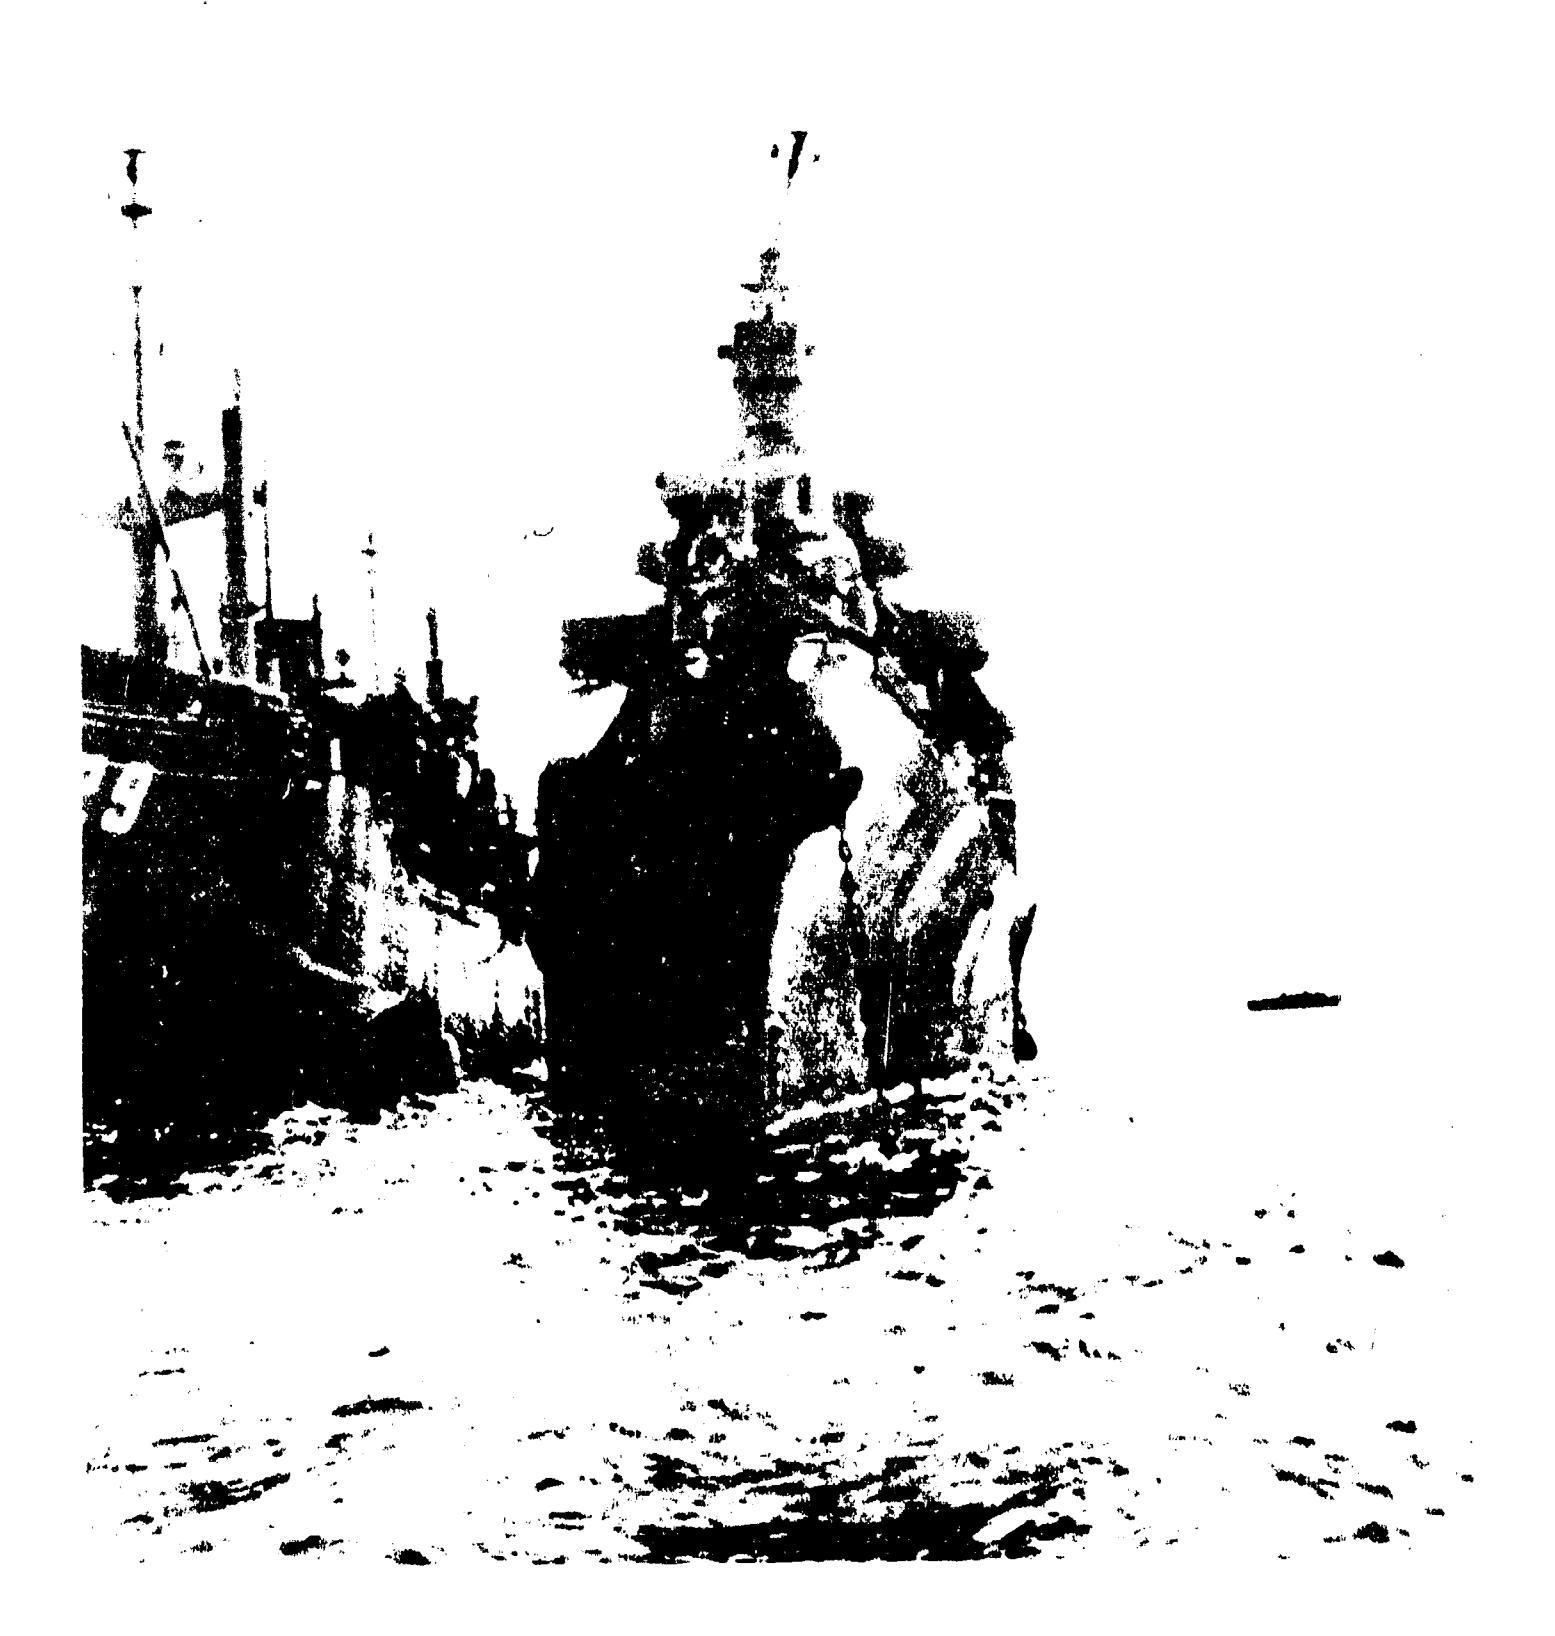
AA-CR-227-50-127. U.S.S. PENSACOLA (CA24). View looking at bow after Test A.

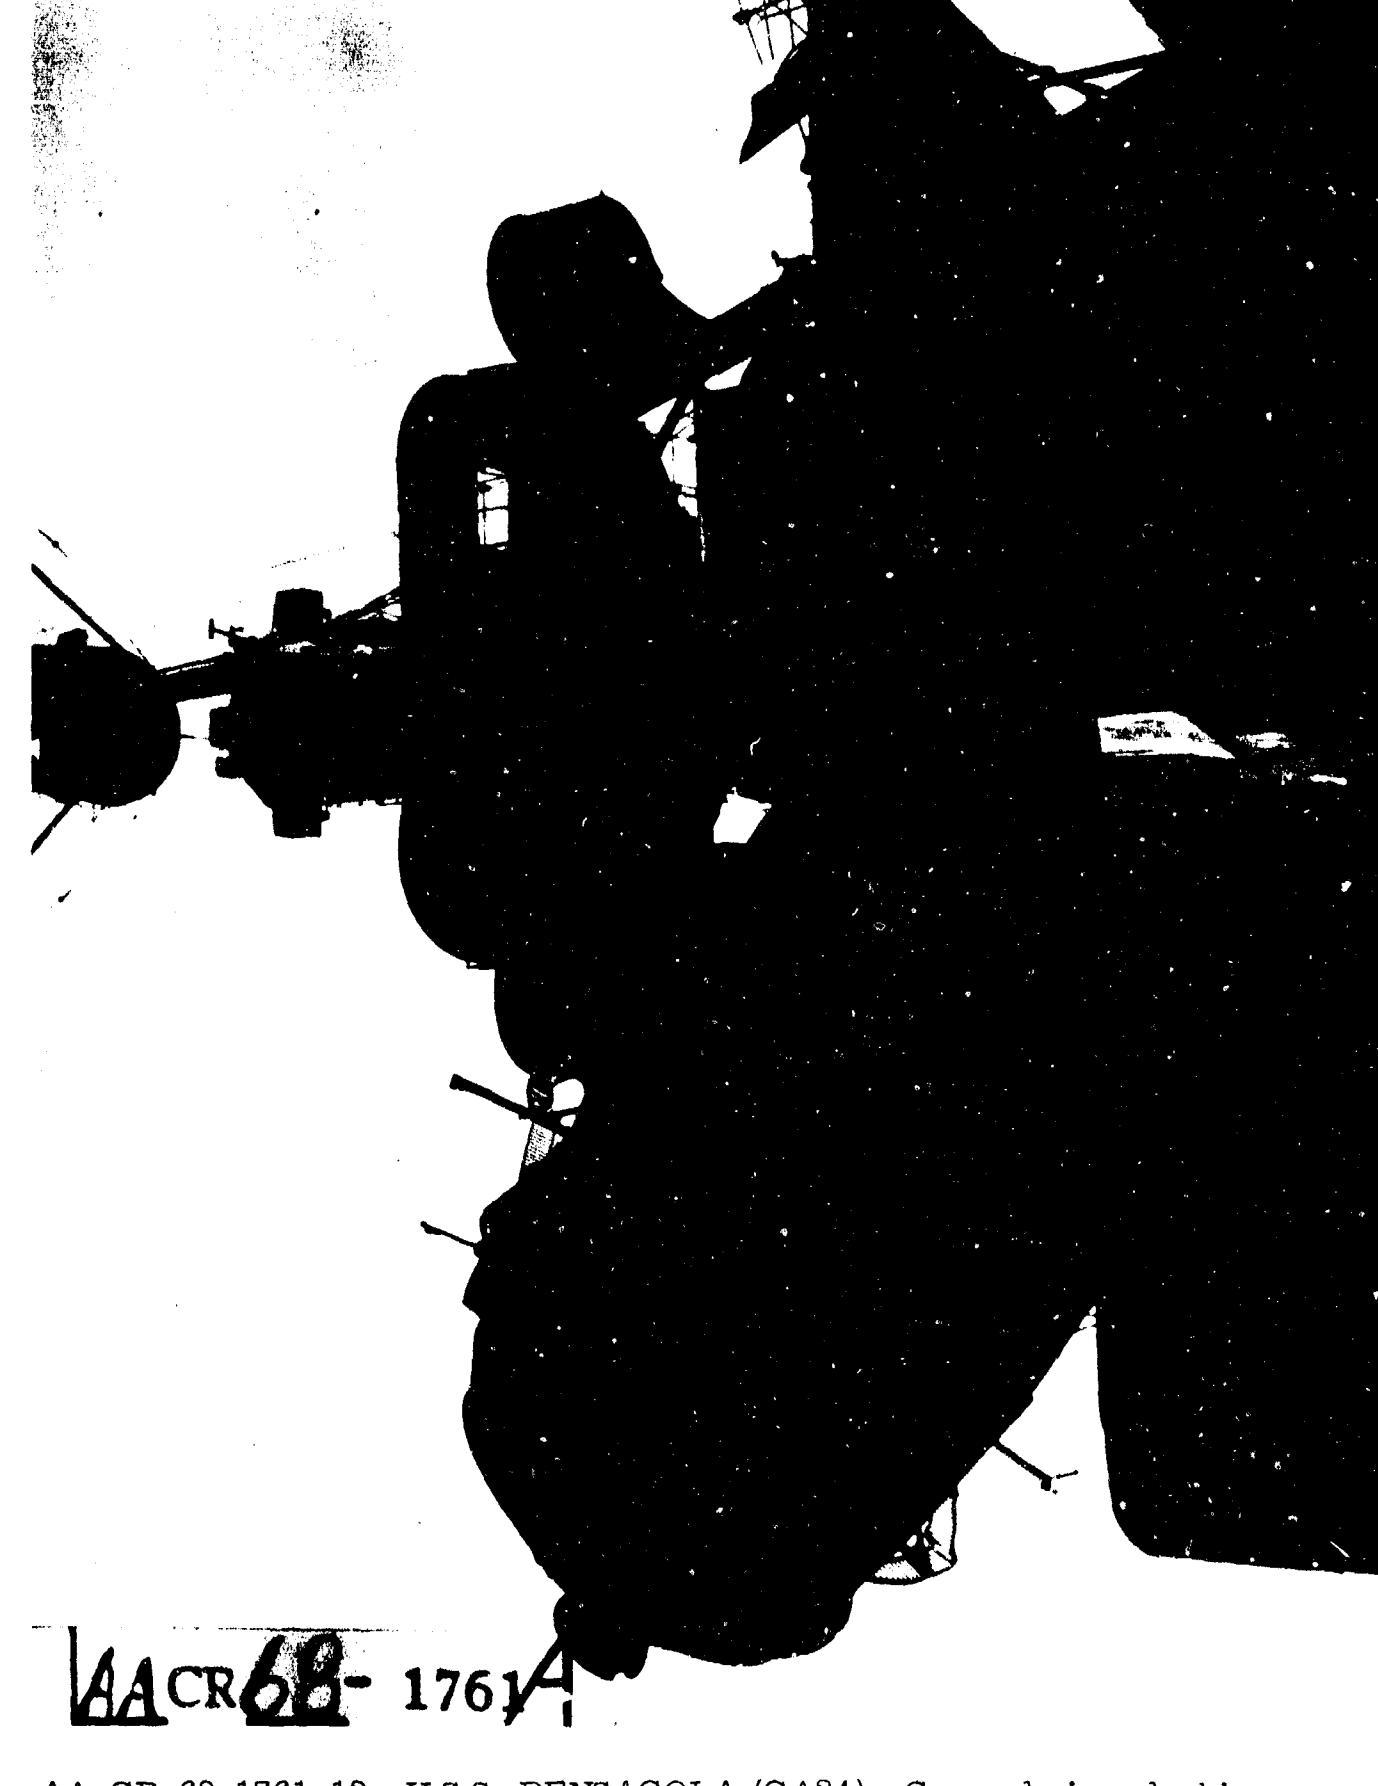
AA-CR-68-1761-12. U.S.S. PENSACOLA (CA24). General view, looking at forward superstructure and radar polemast.

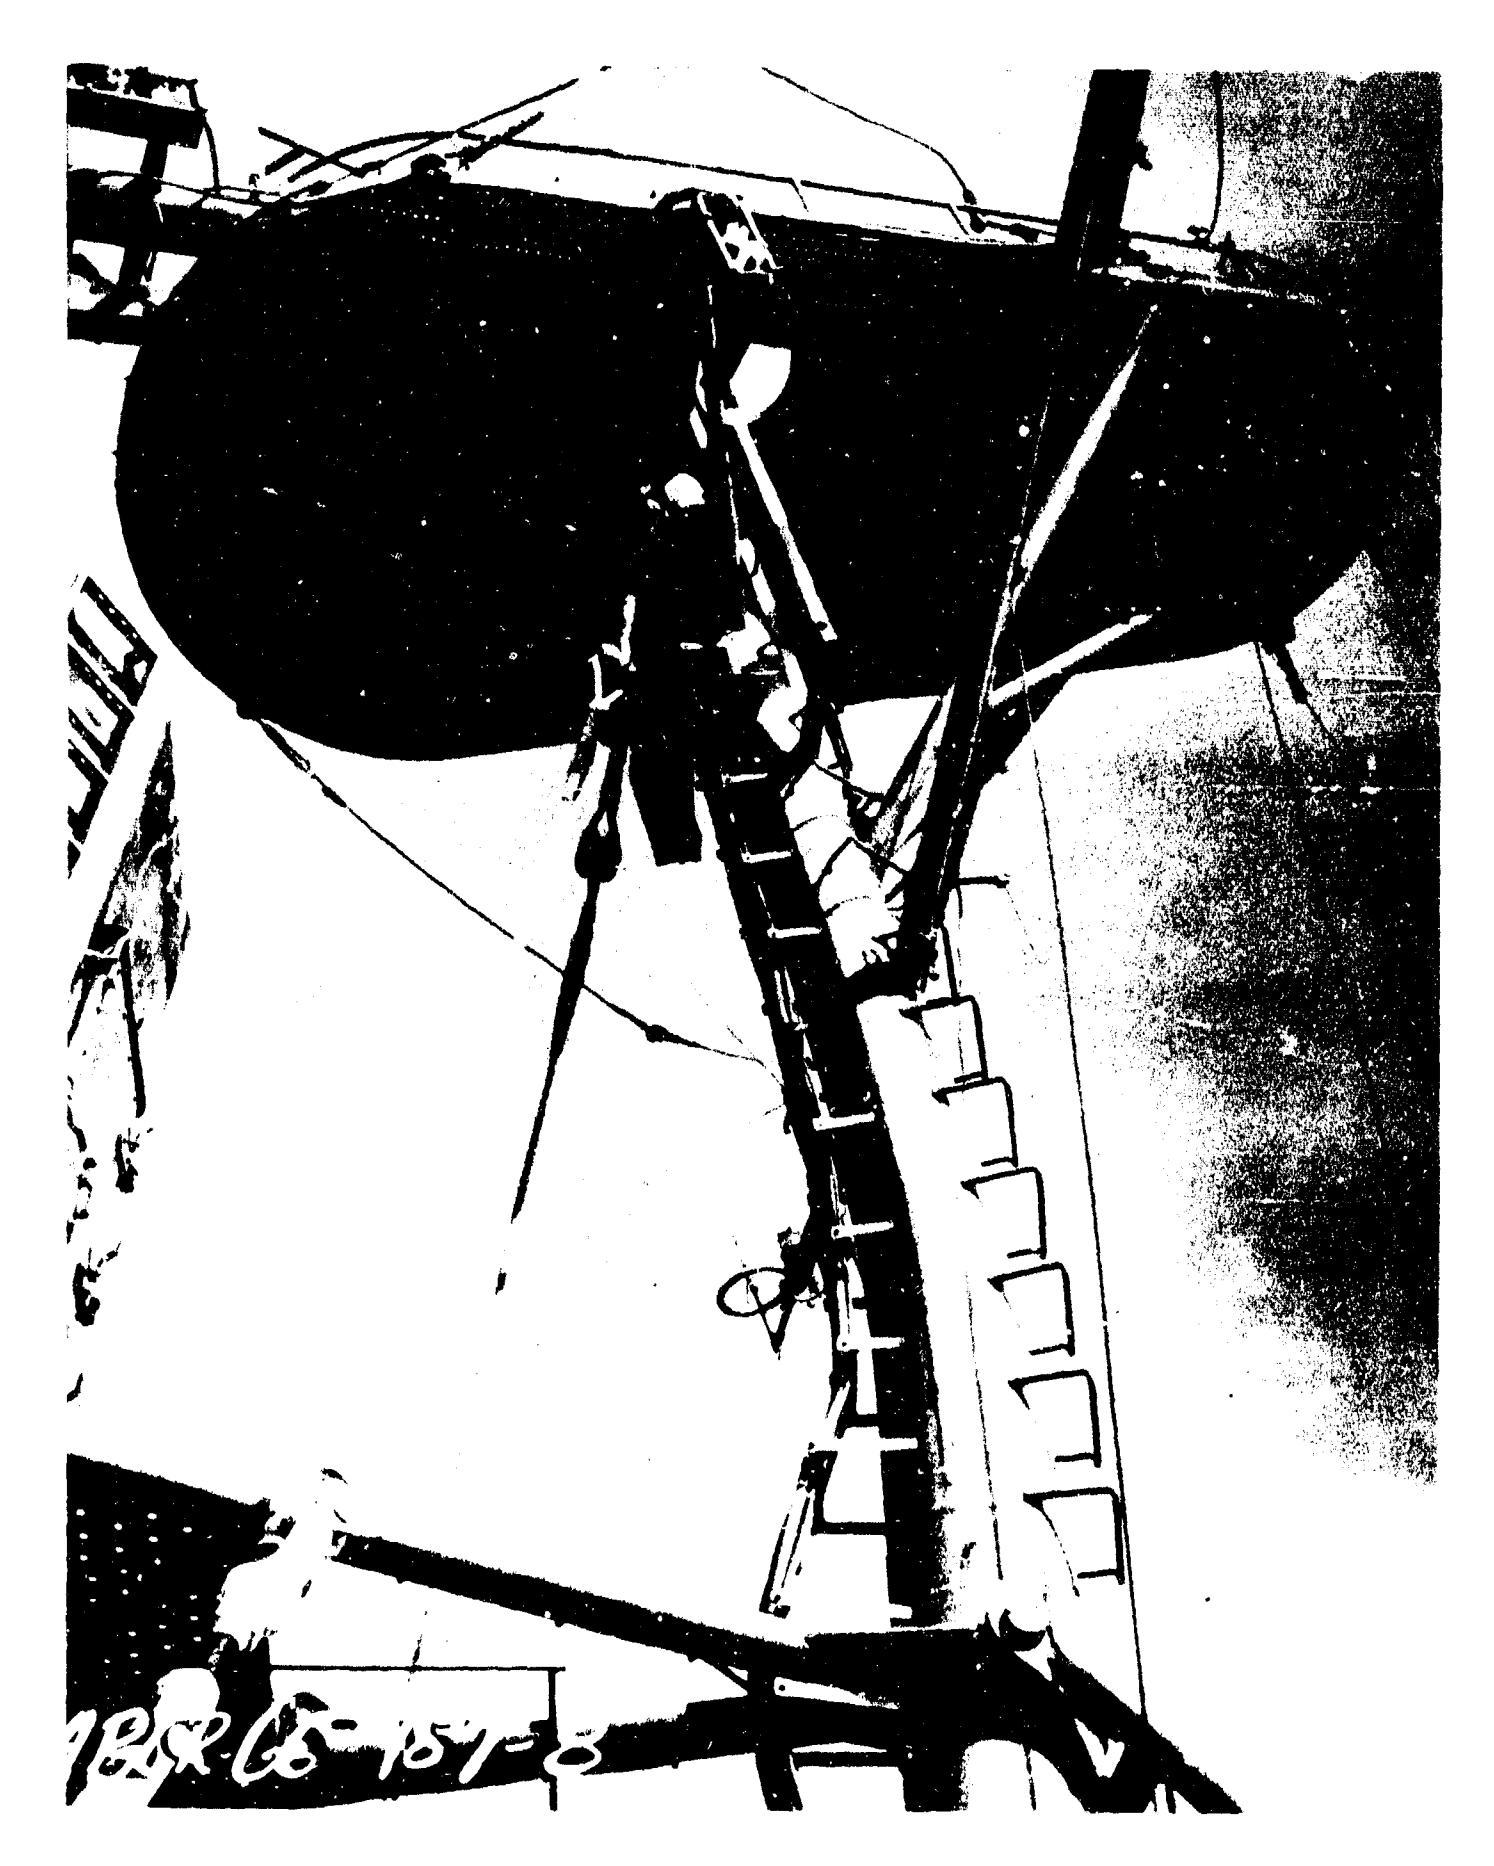
AB-CR-66-157-8. U.S.S. PENSACOLA (CA24). Forward radar polemast after test Baker showing platform and riggings.

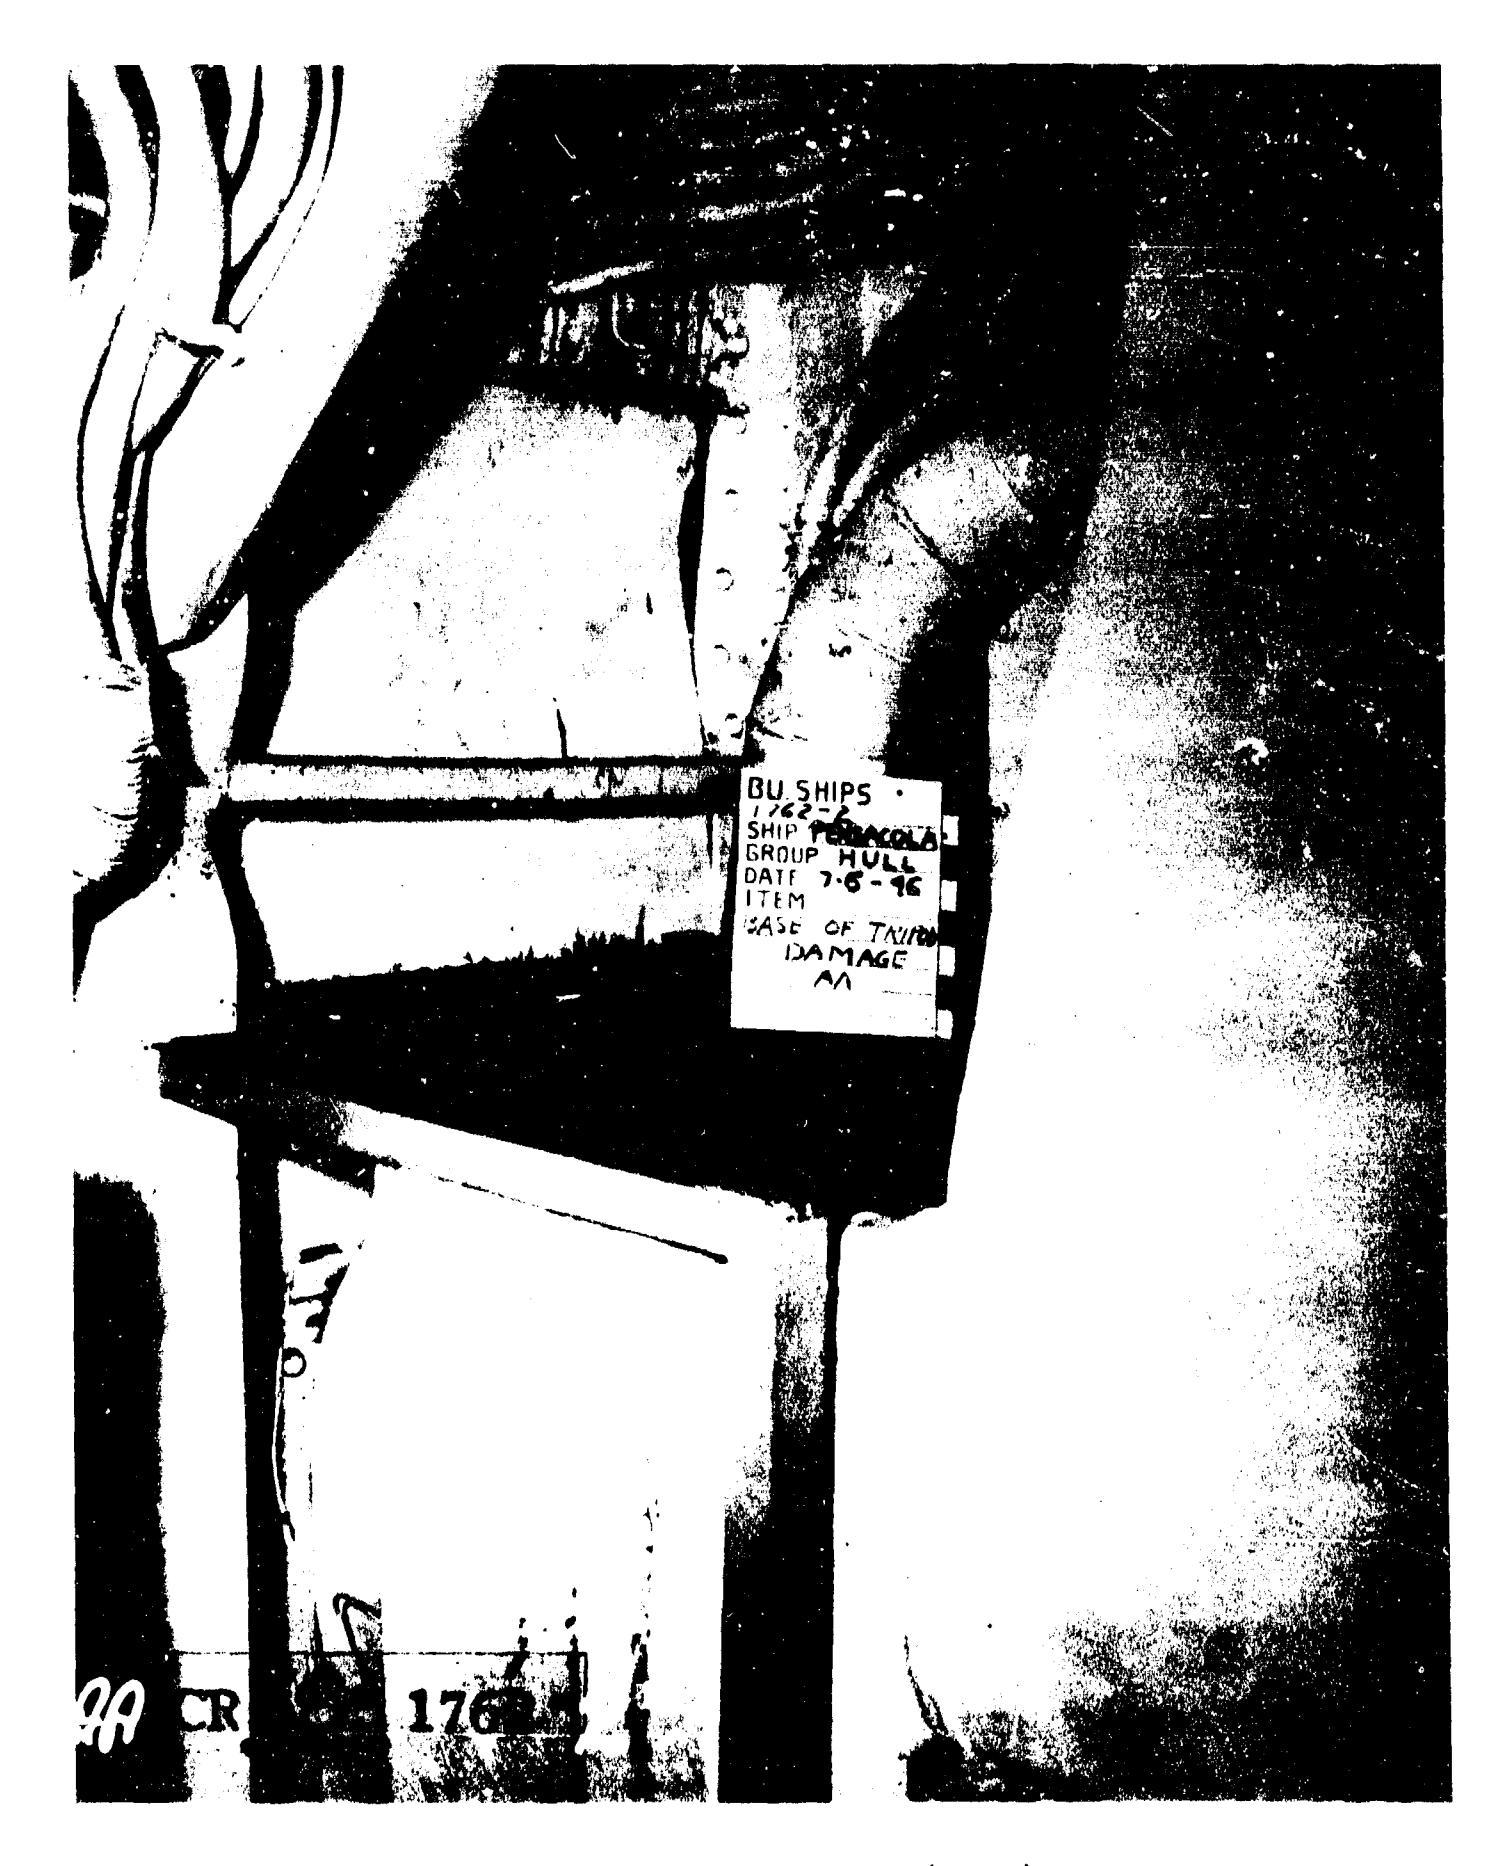
AA-CR-68-1762-2. U.S.S. PENSACOLA (CA24). bulkhead No. 42, showing crushing at centerline under forward leg of forward tripod. Looking aft from starboard side.

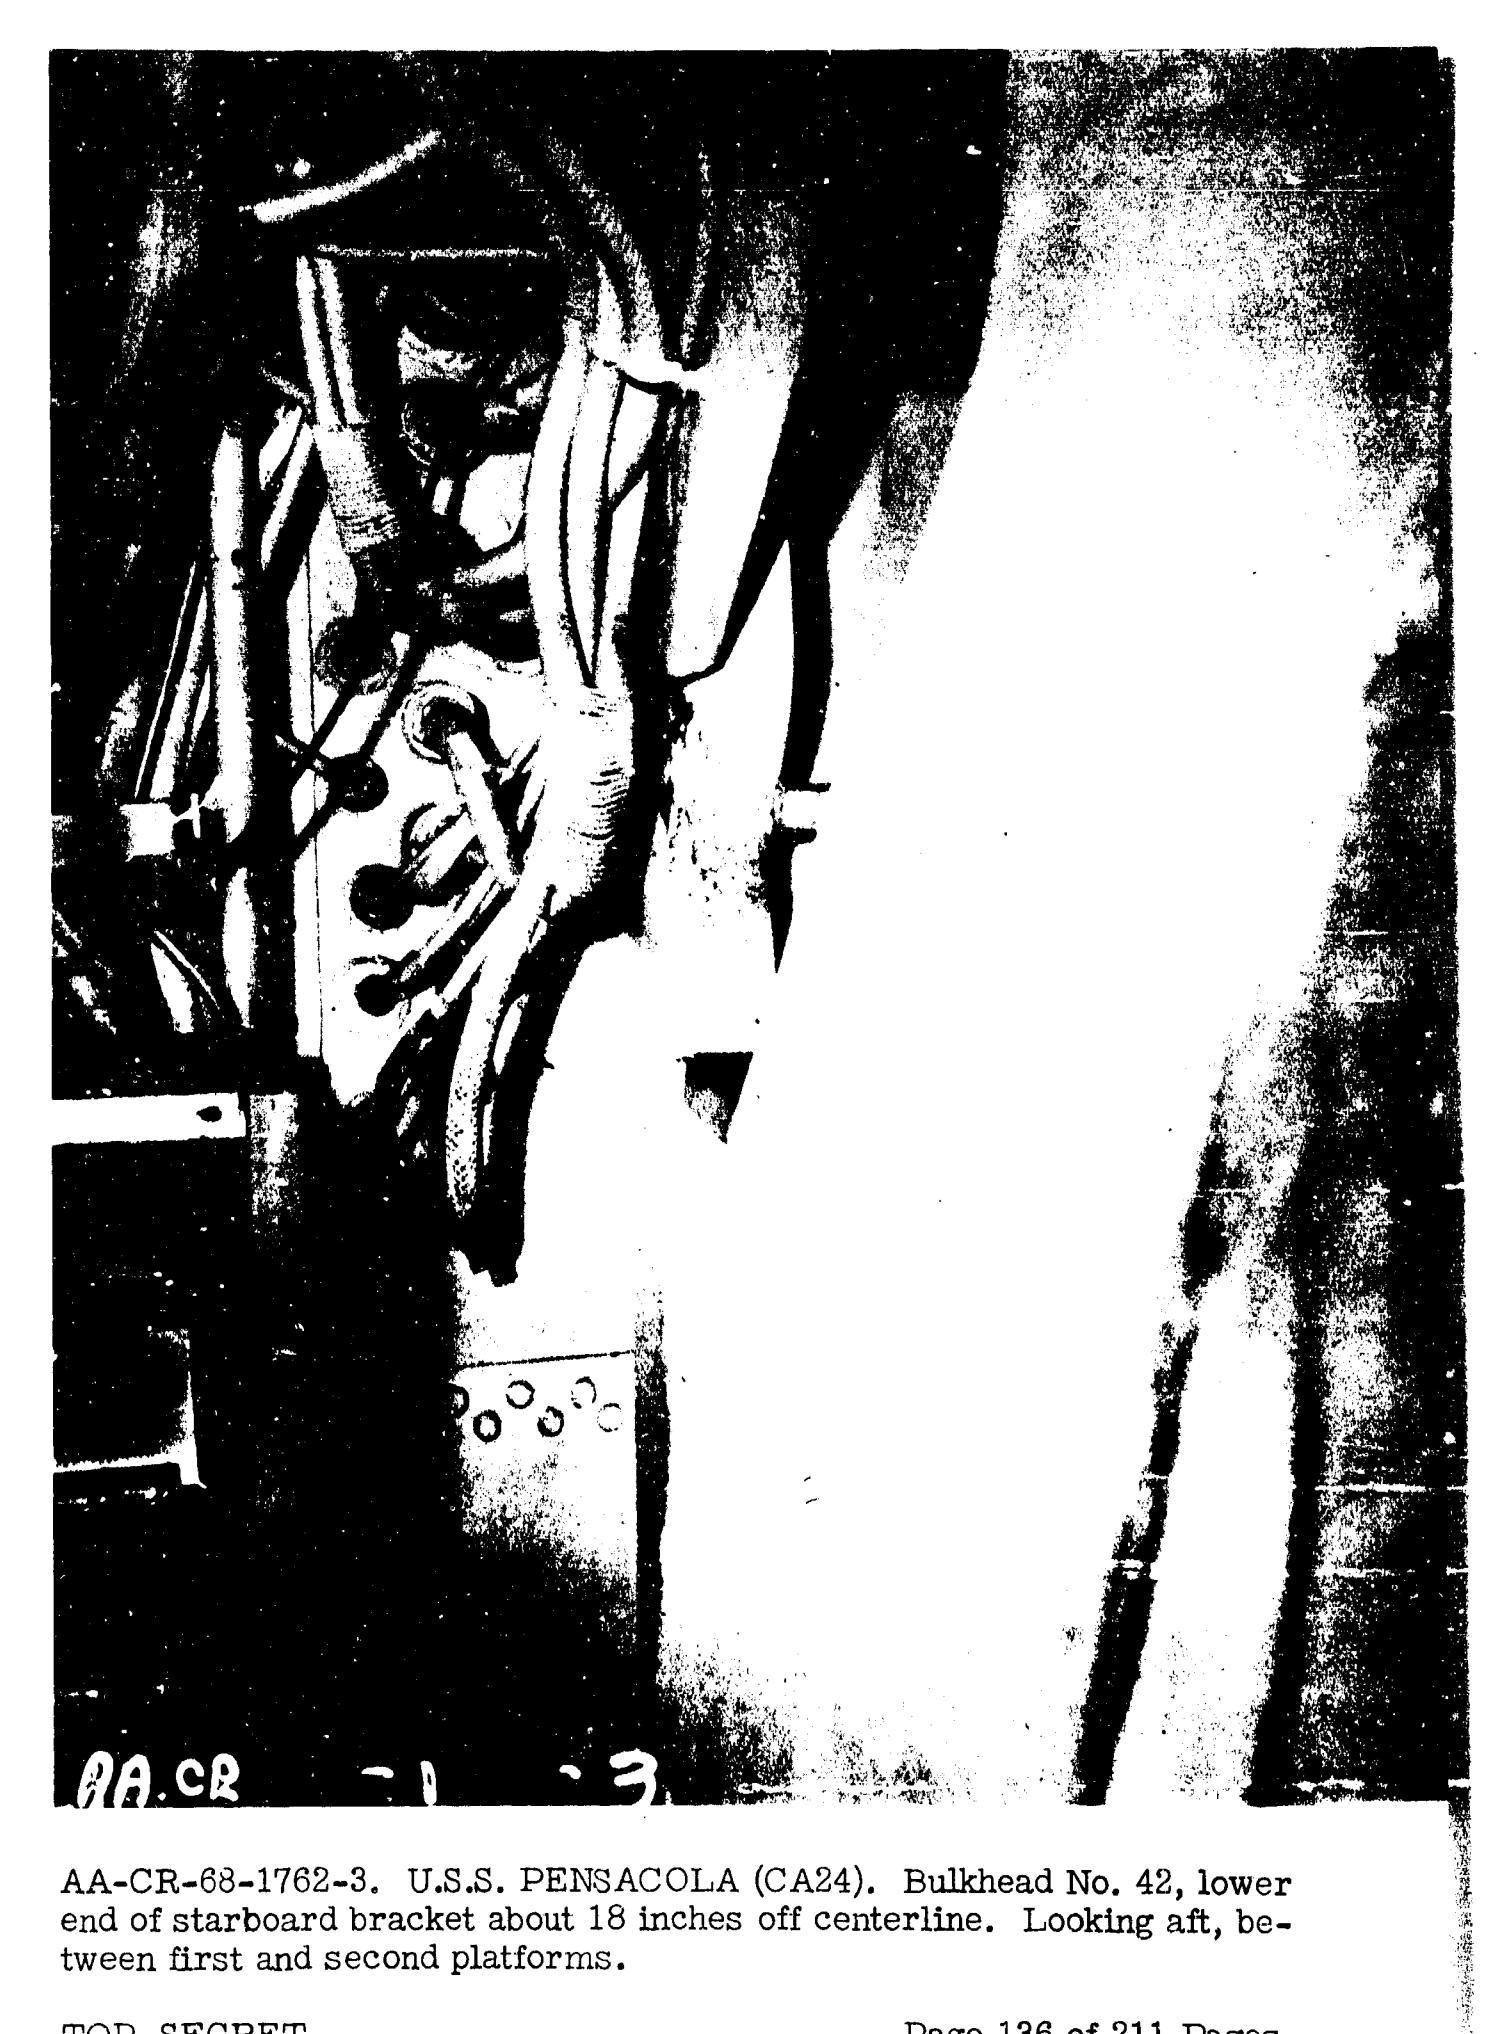
AA-CR-68-1762-3. U.S.S. PENSACOLA (CA24). Bulkhead No. 42, lower end of starboard bracket about 18 inches off centerline. Looking aft, between first and second platforms.

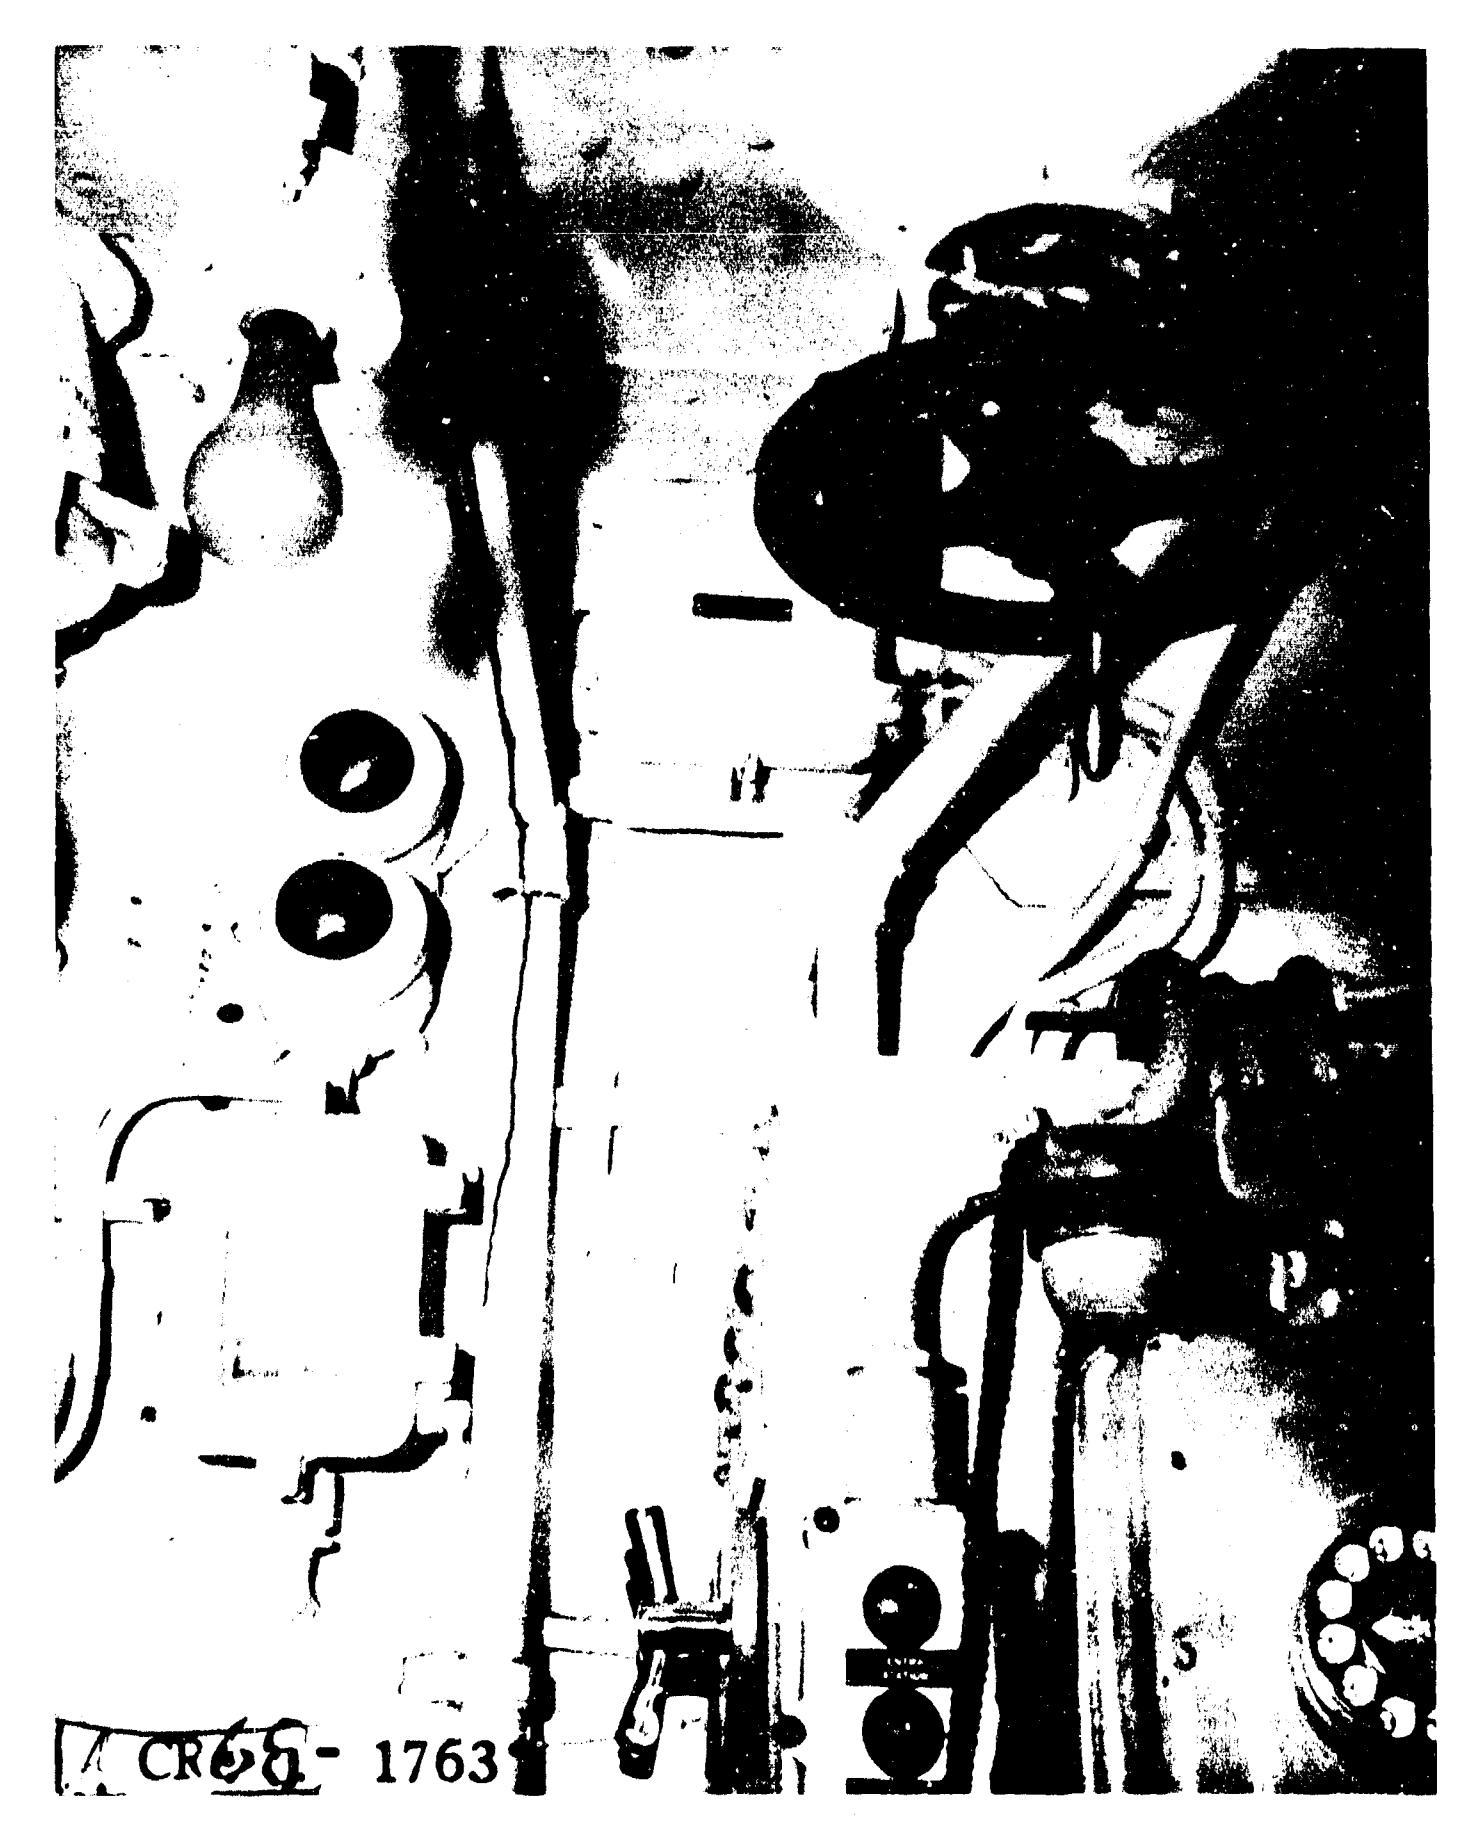
AA-CR-68-1763-5. U.S.S. PENSACOLA (CA24). Bulkhead No. 42, looking forward at centerline of slips between first and second platforms.

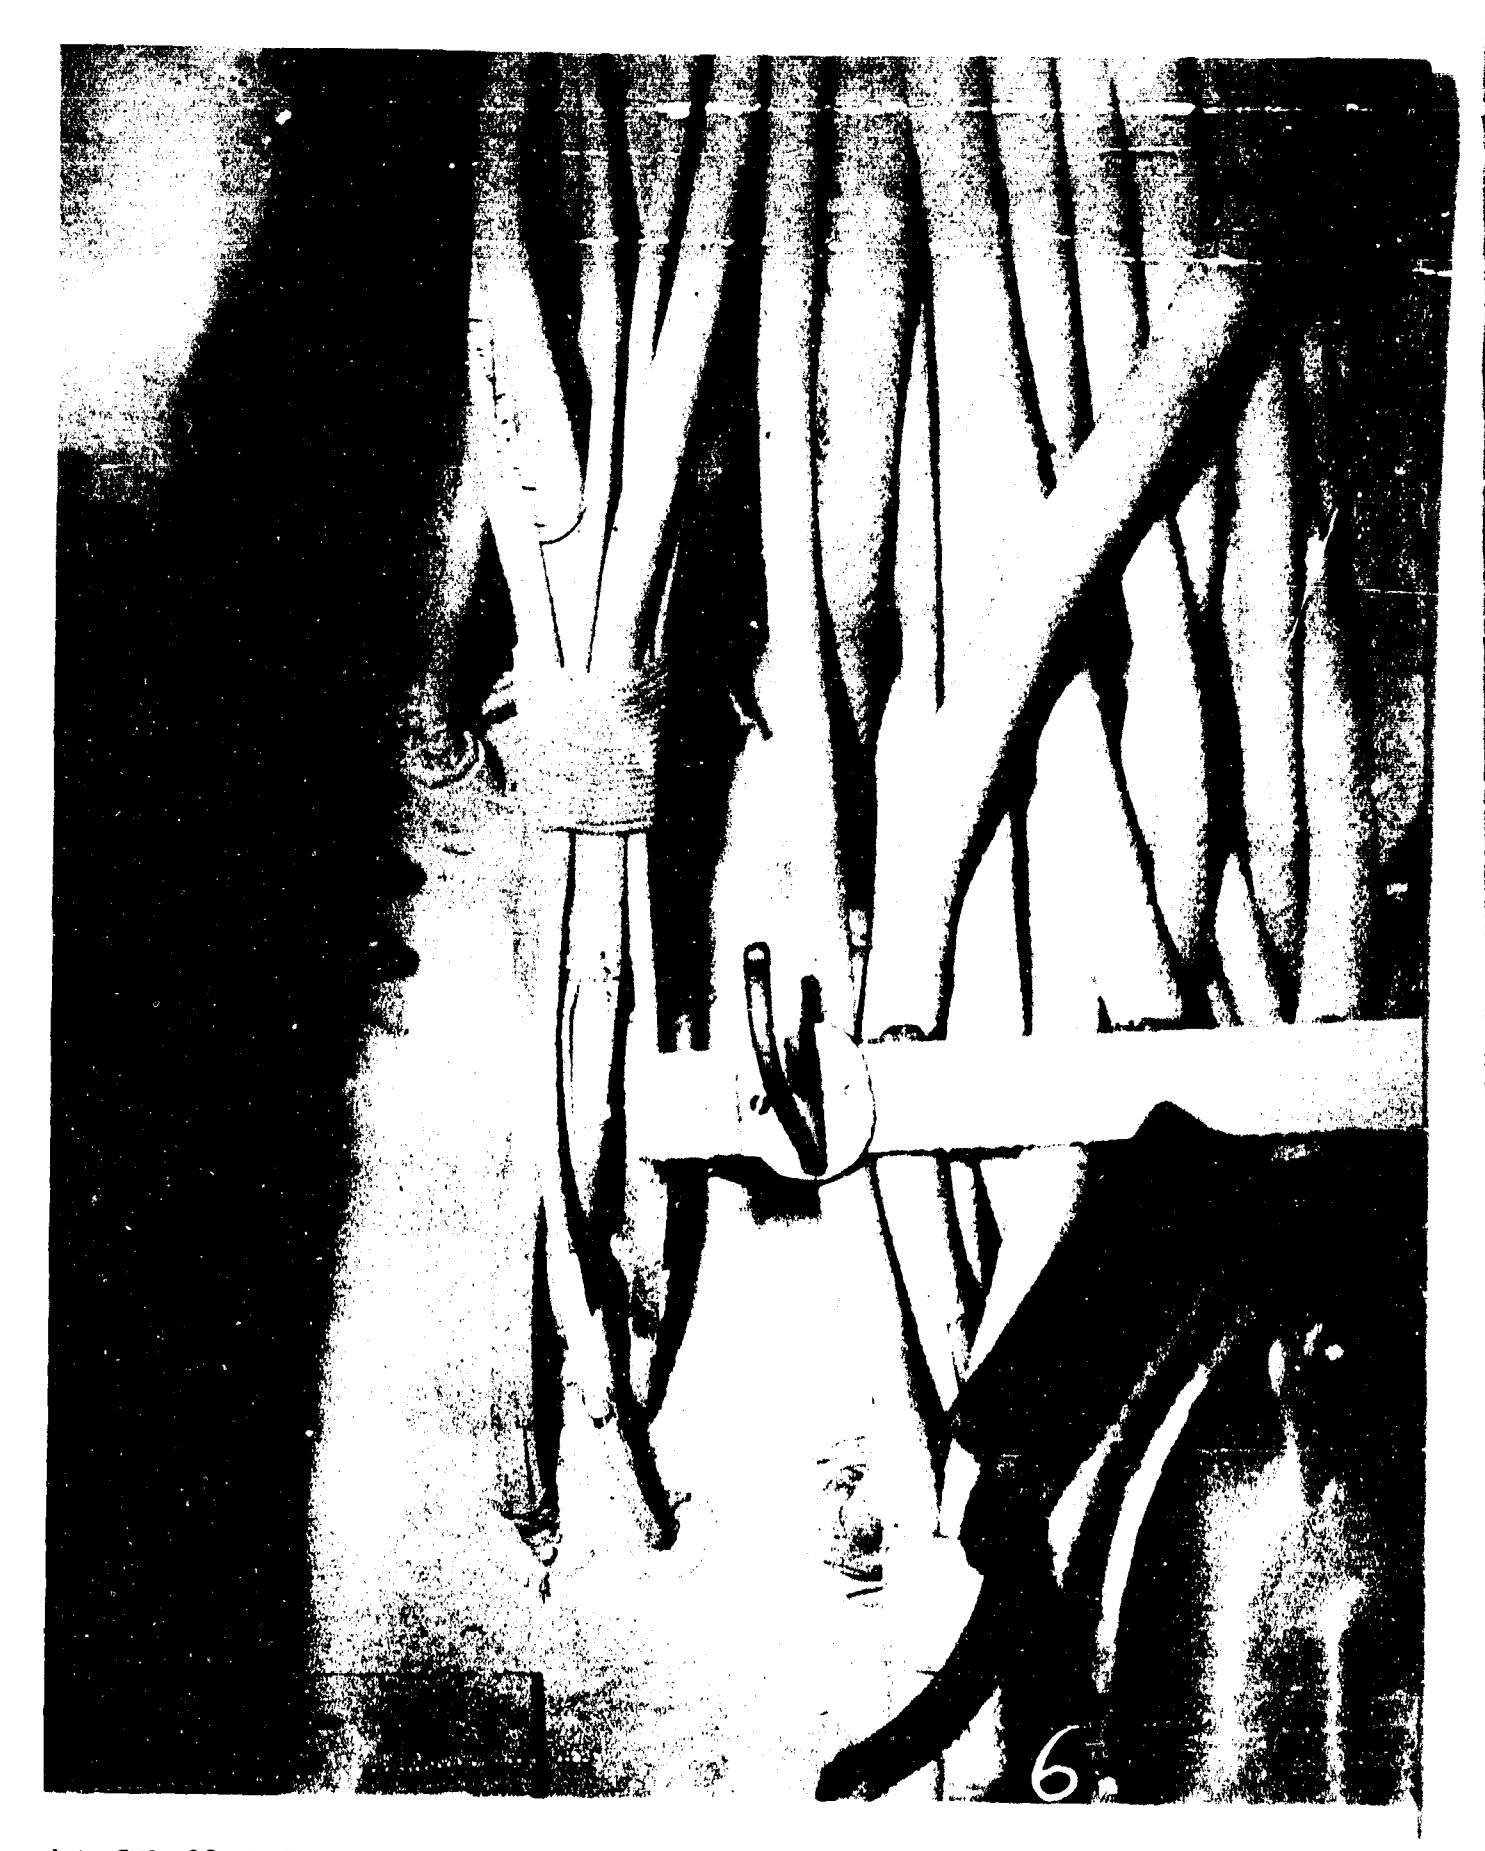
AA-CR-68-1763-6. U.S.S. PENSACOLA (CA24). Bulkhead No. 42, looking forward at centerline of ship between first and second plat-form.

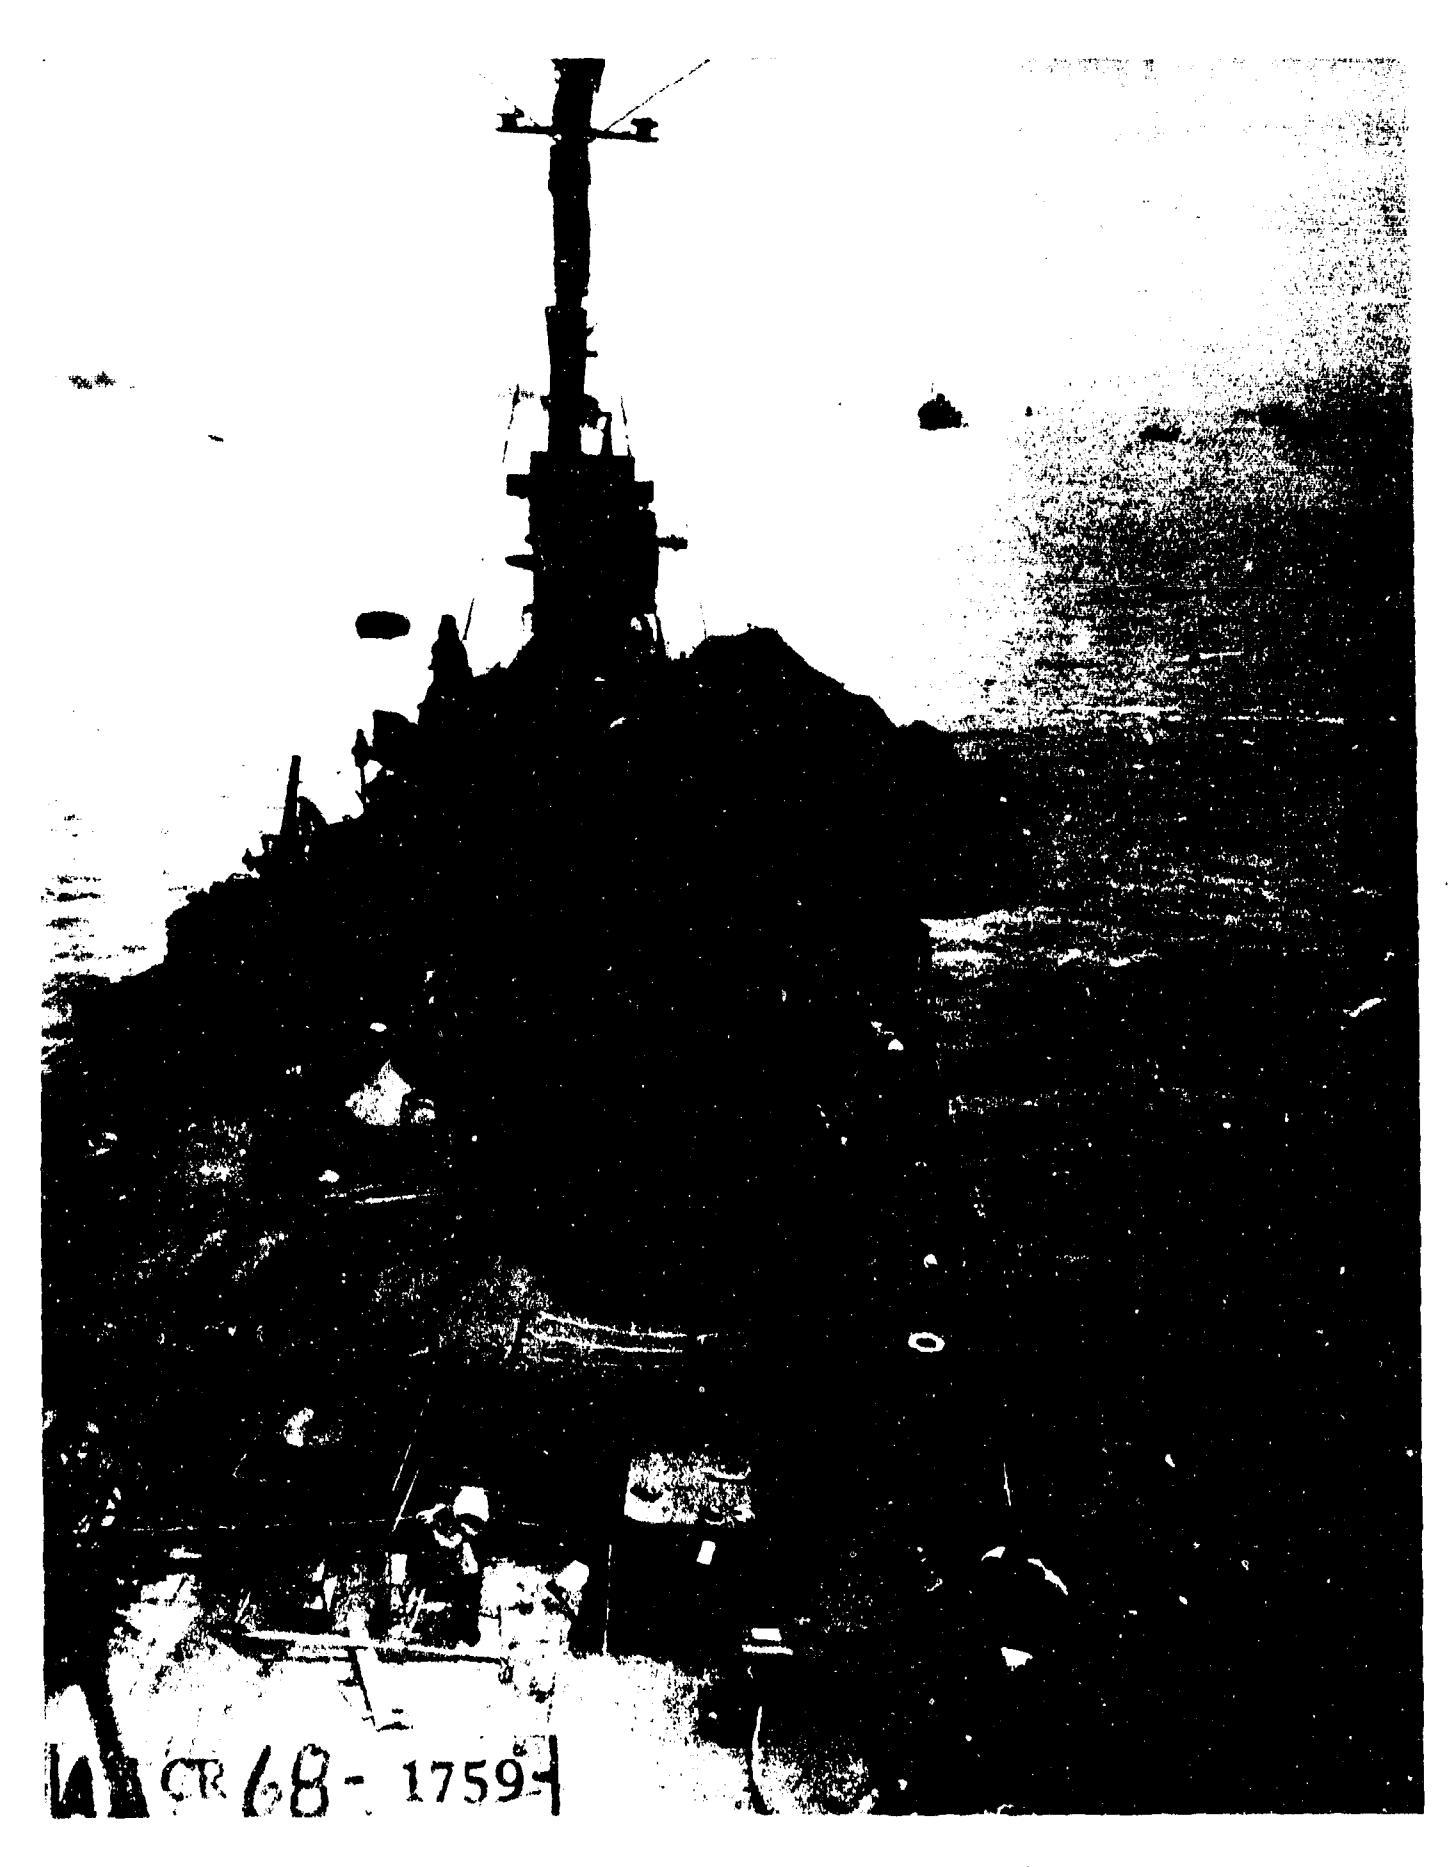
AA-CR-68-1759-4. U.S.S. PENSACOLA (CA24). Looking aft at mainmant showing yardarm and stays.
