BUREAU OF SHIPS GROUP

TECHNICAL INSPECTION REPORT

FAILURES OF MASTS, YARDARMS, BOOMS, AND RIGGING

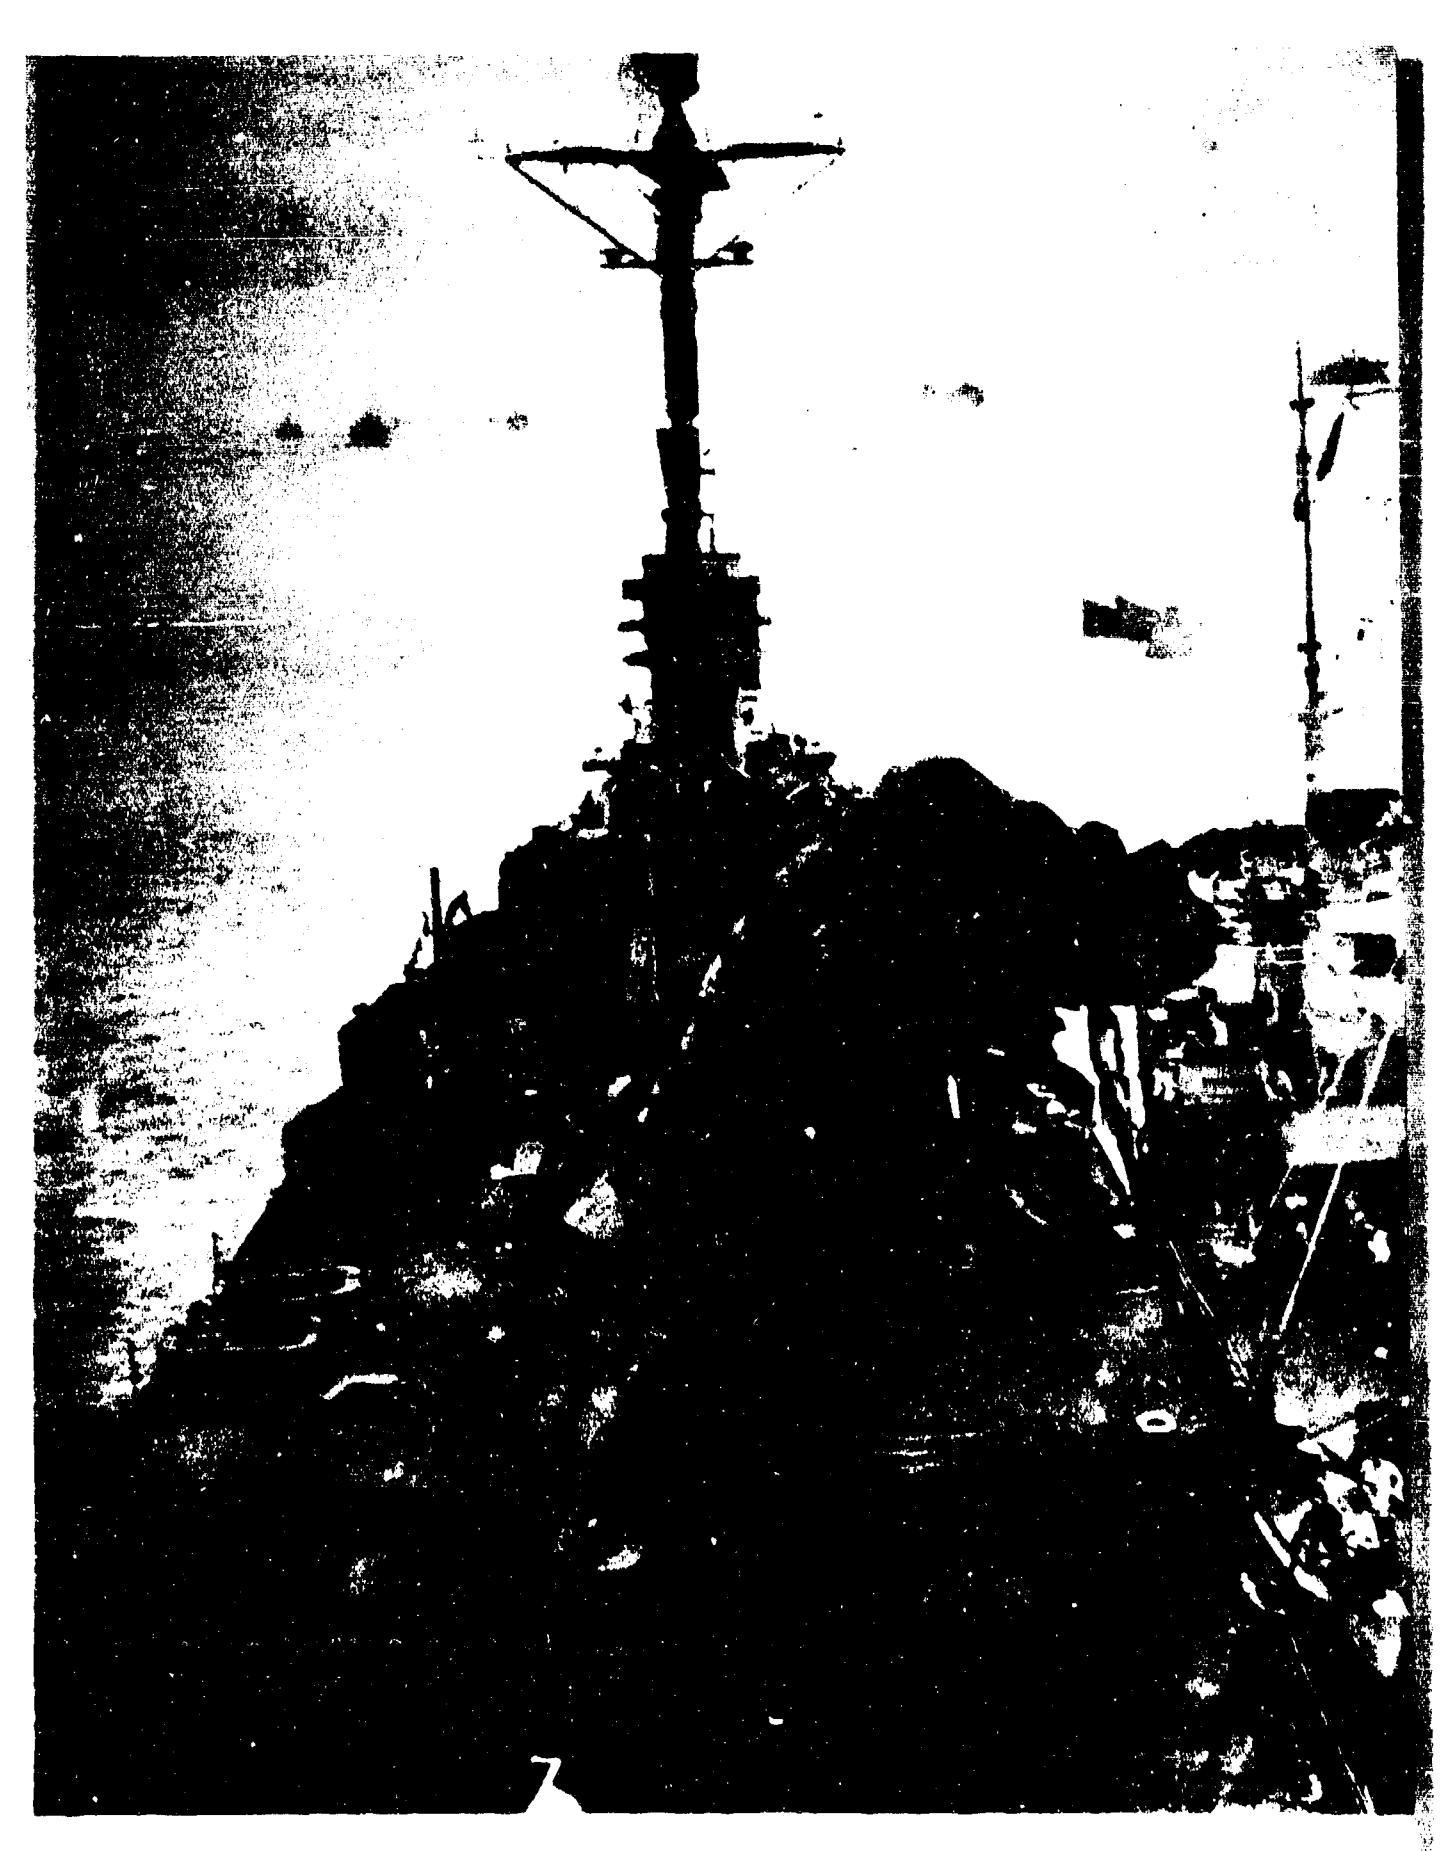
AA-CR-98-1968-7. U.S.S. 'PENSACOLA (CA24). General view looking aft.

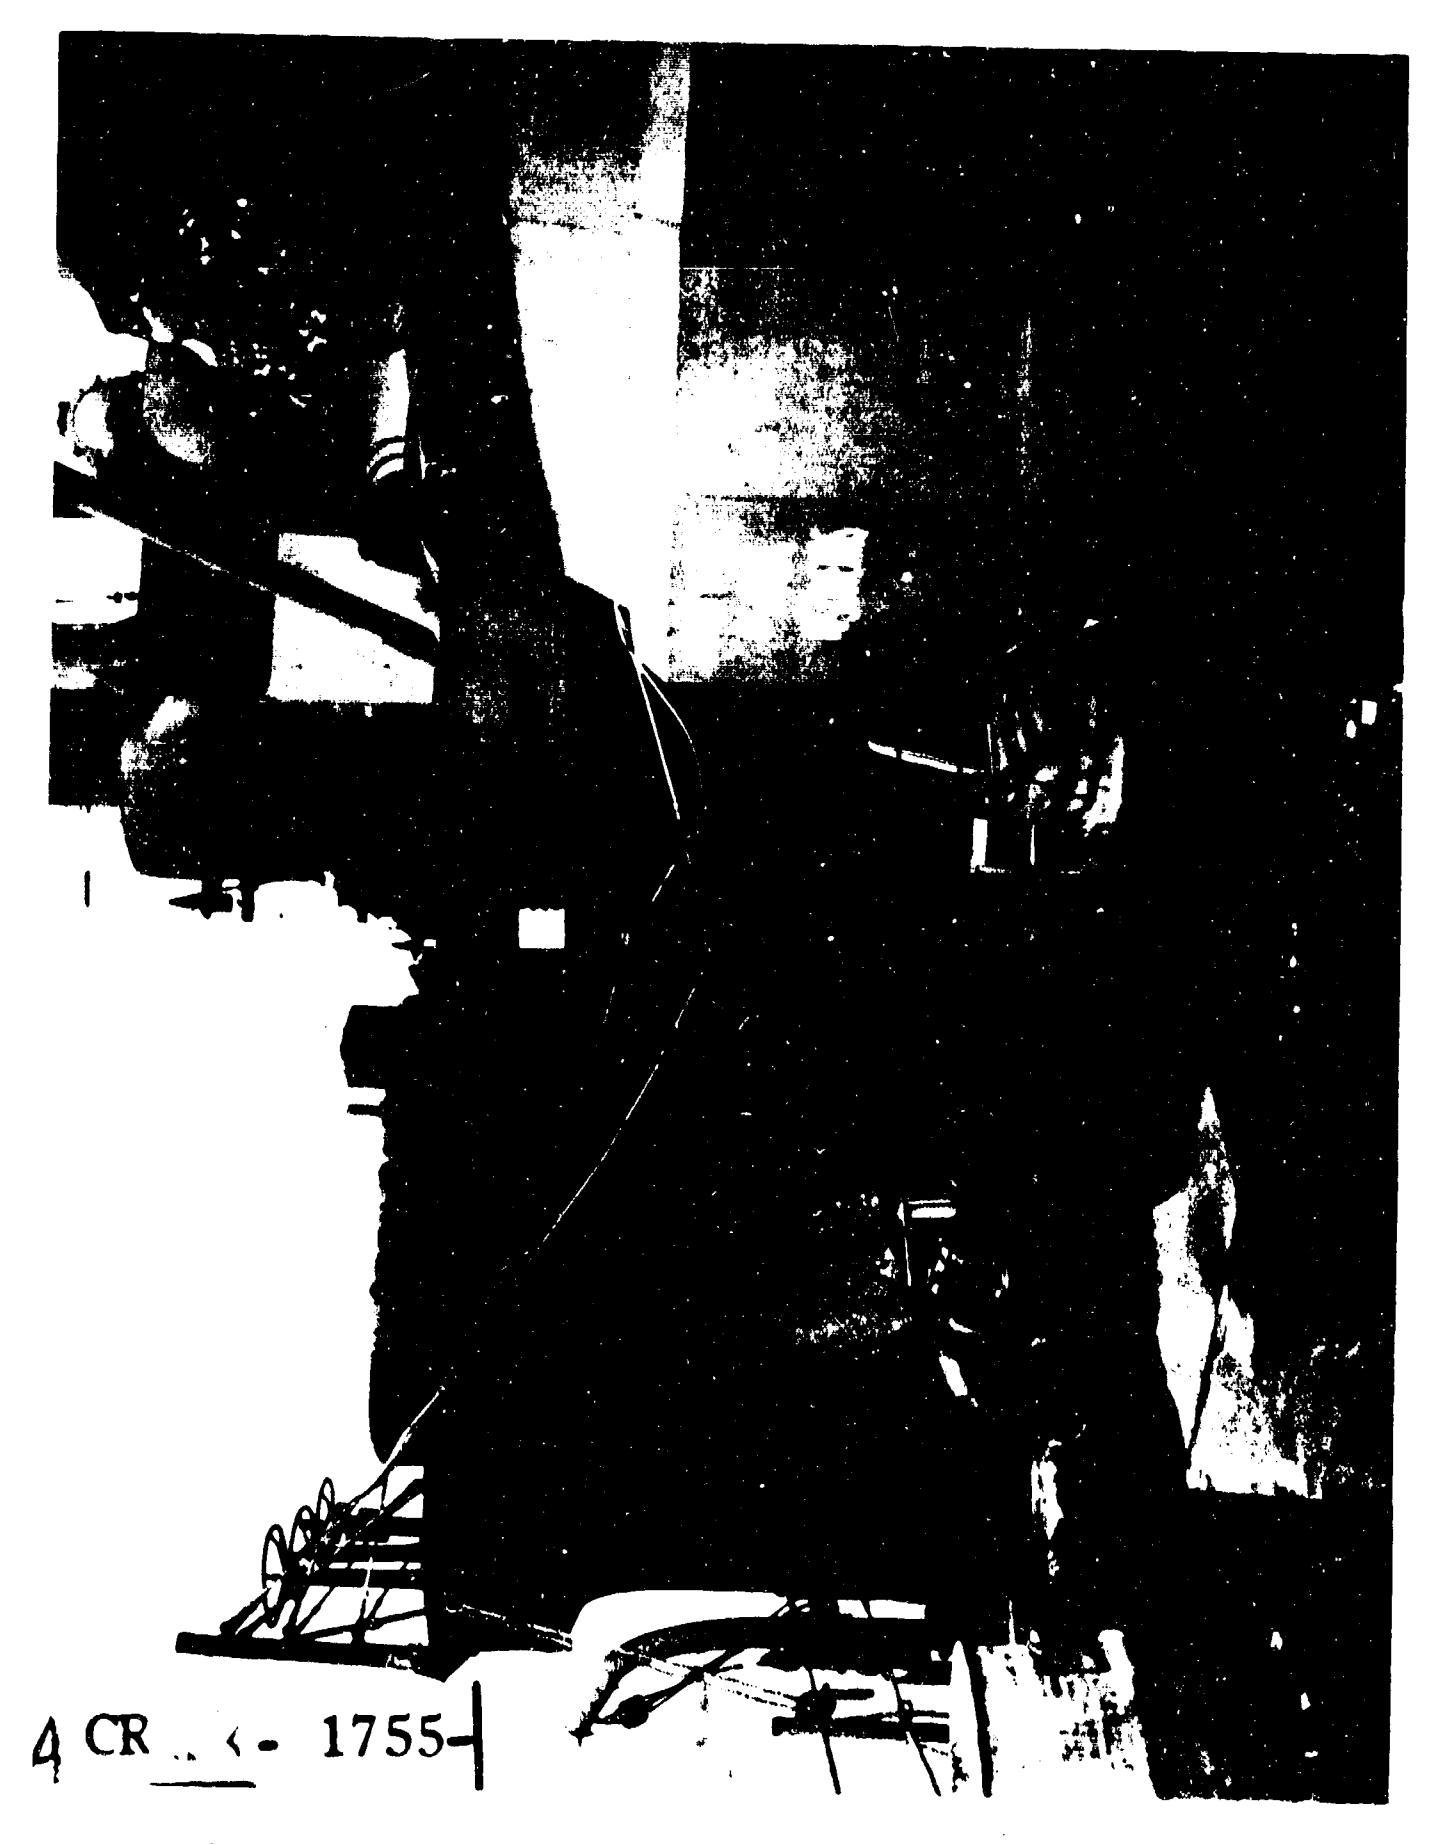
AA-CR-68-1755-10. U.S.S. PENSACOLA (CA24). Main mast strut and stay. Note life lines.

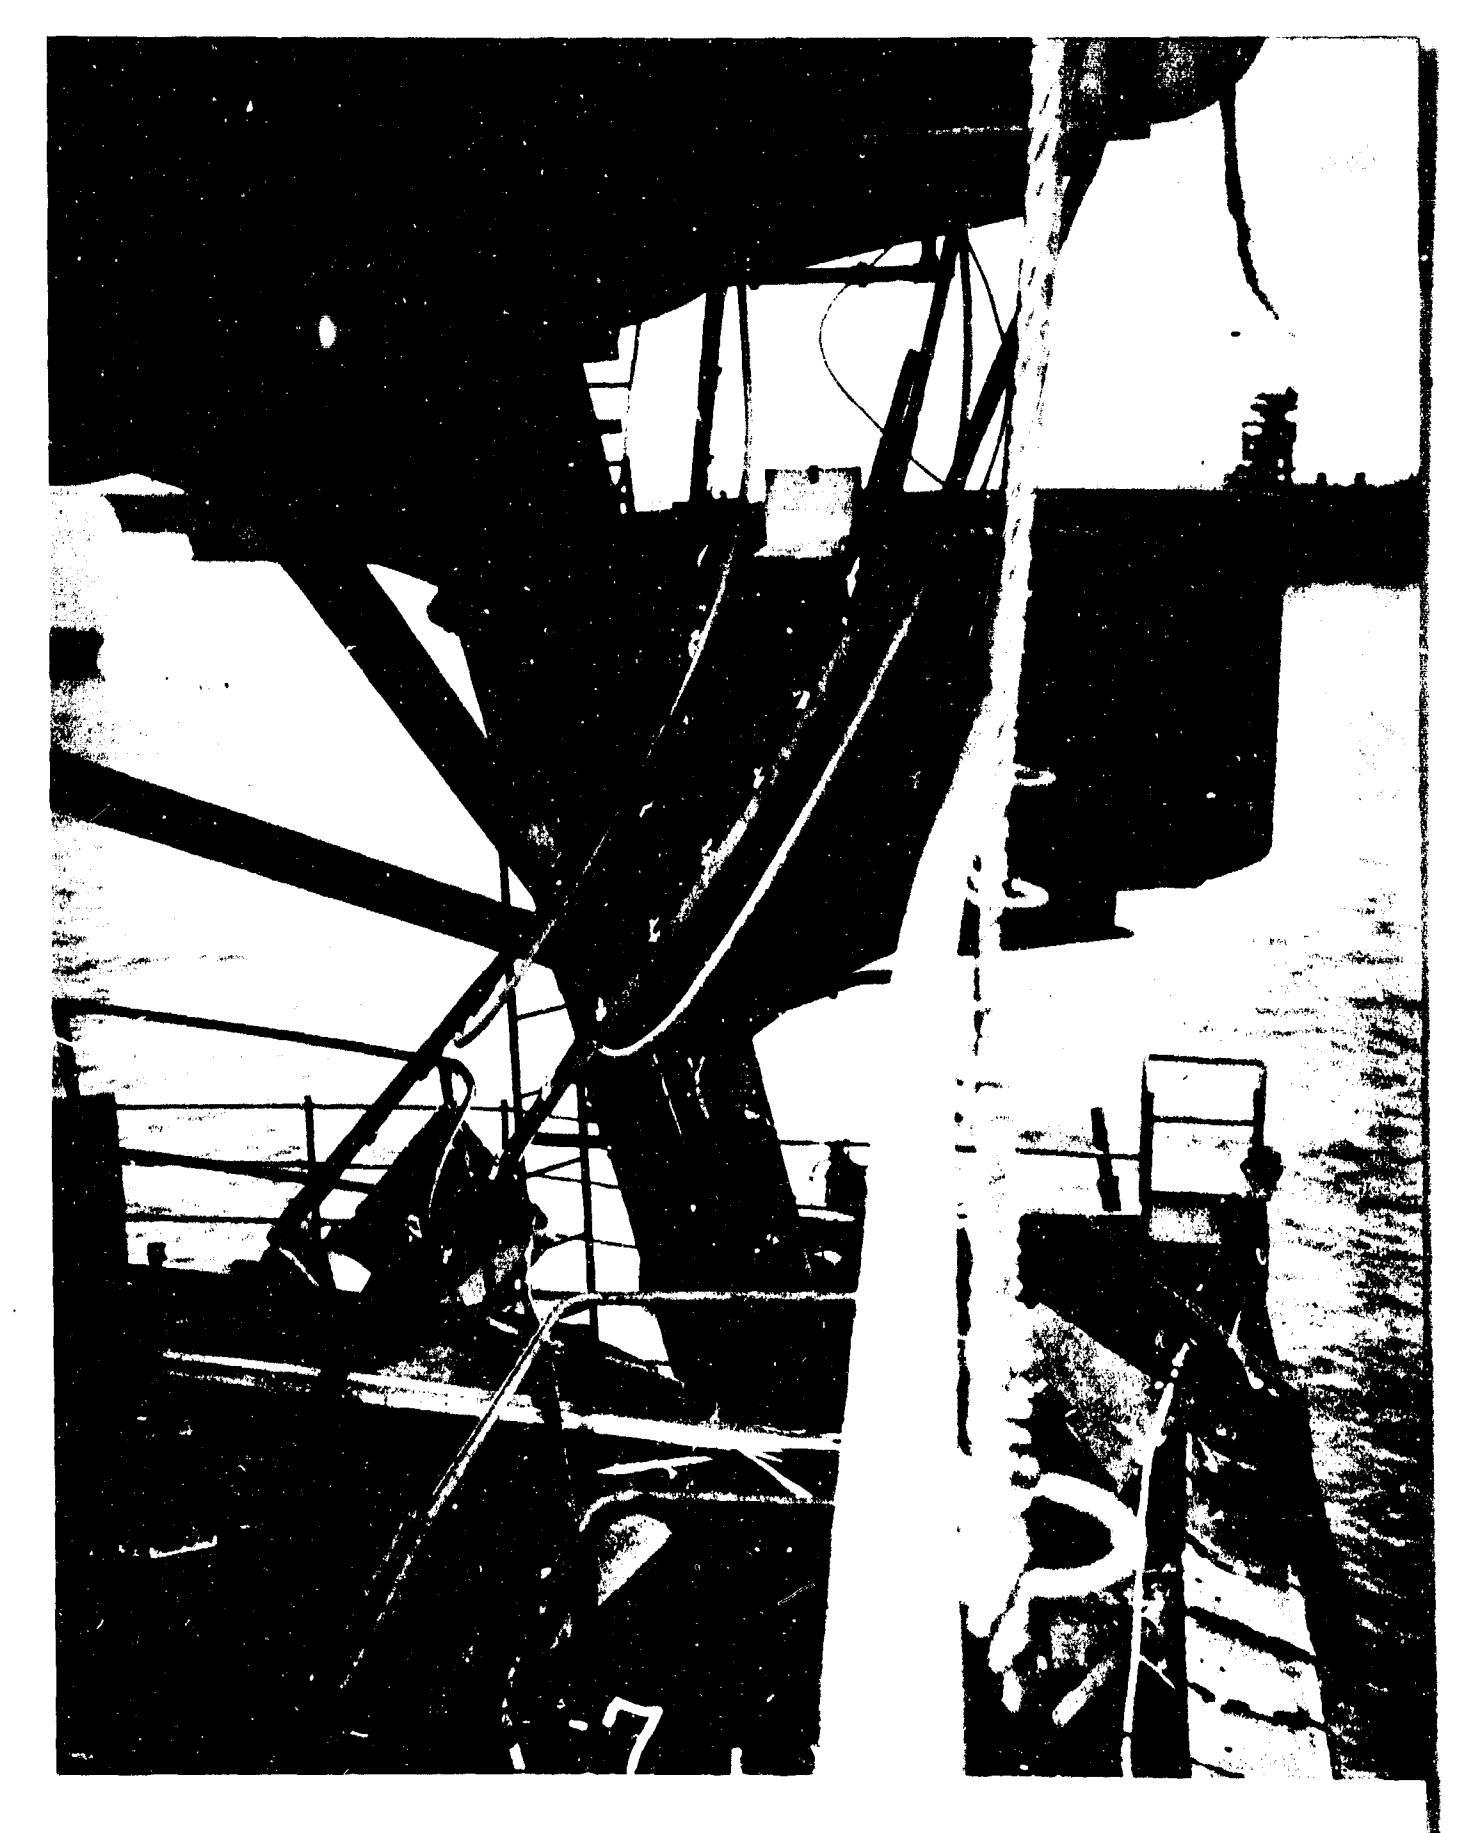
AA-CR-68-1759-7. U.S.S. PENSACOLA (CA24). View looking to starboard from tub in port leg. Note handrail.

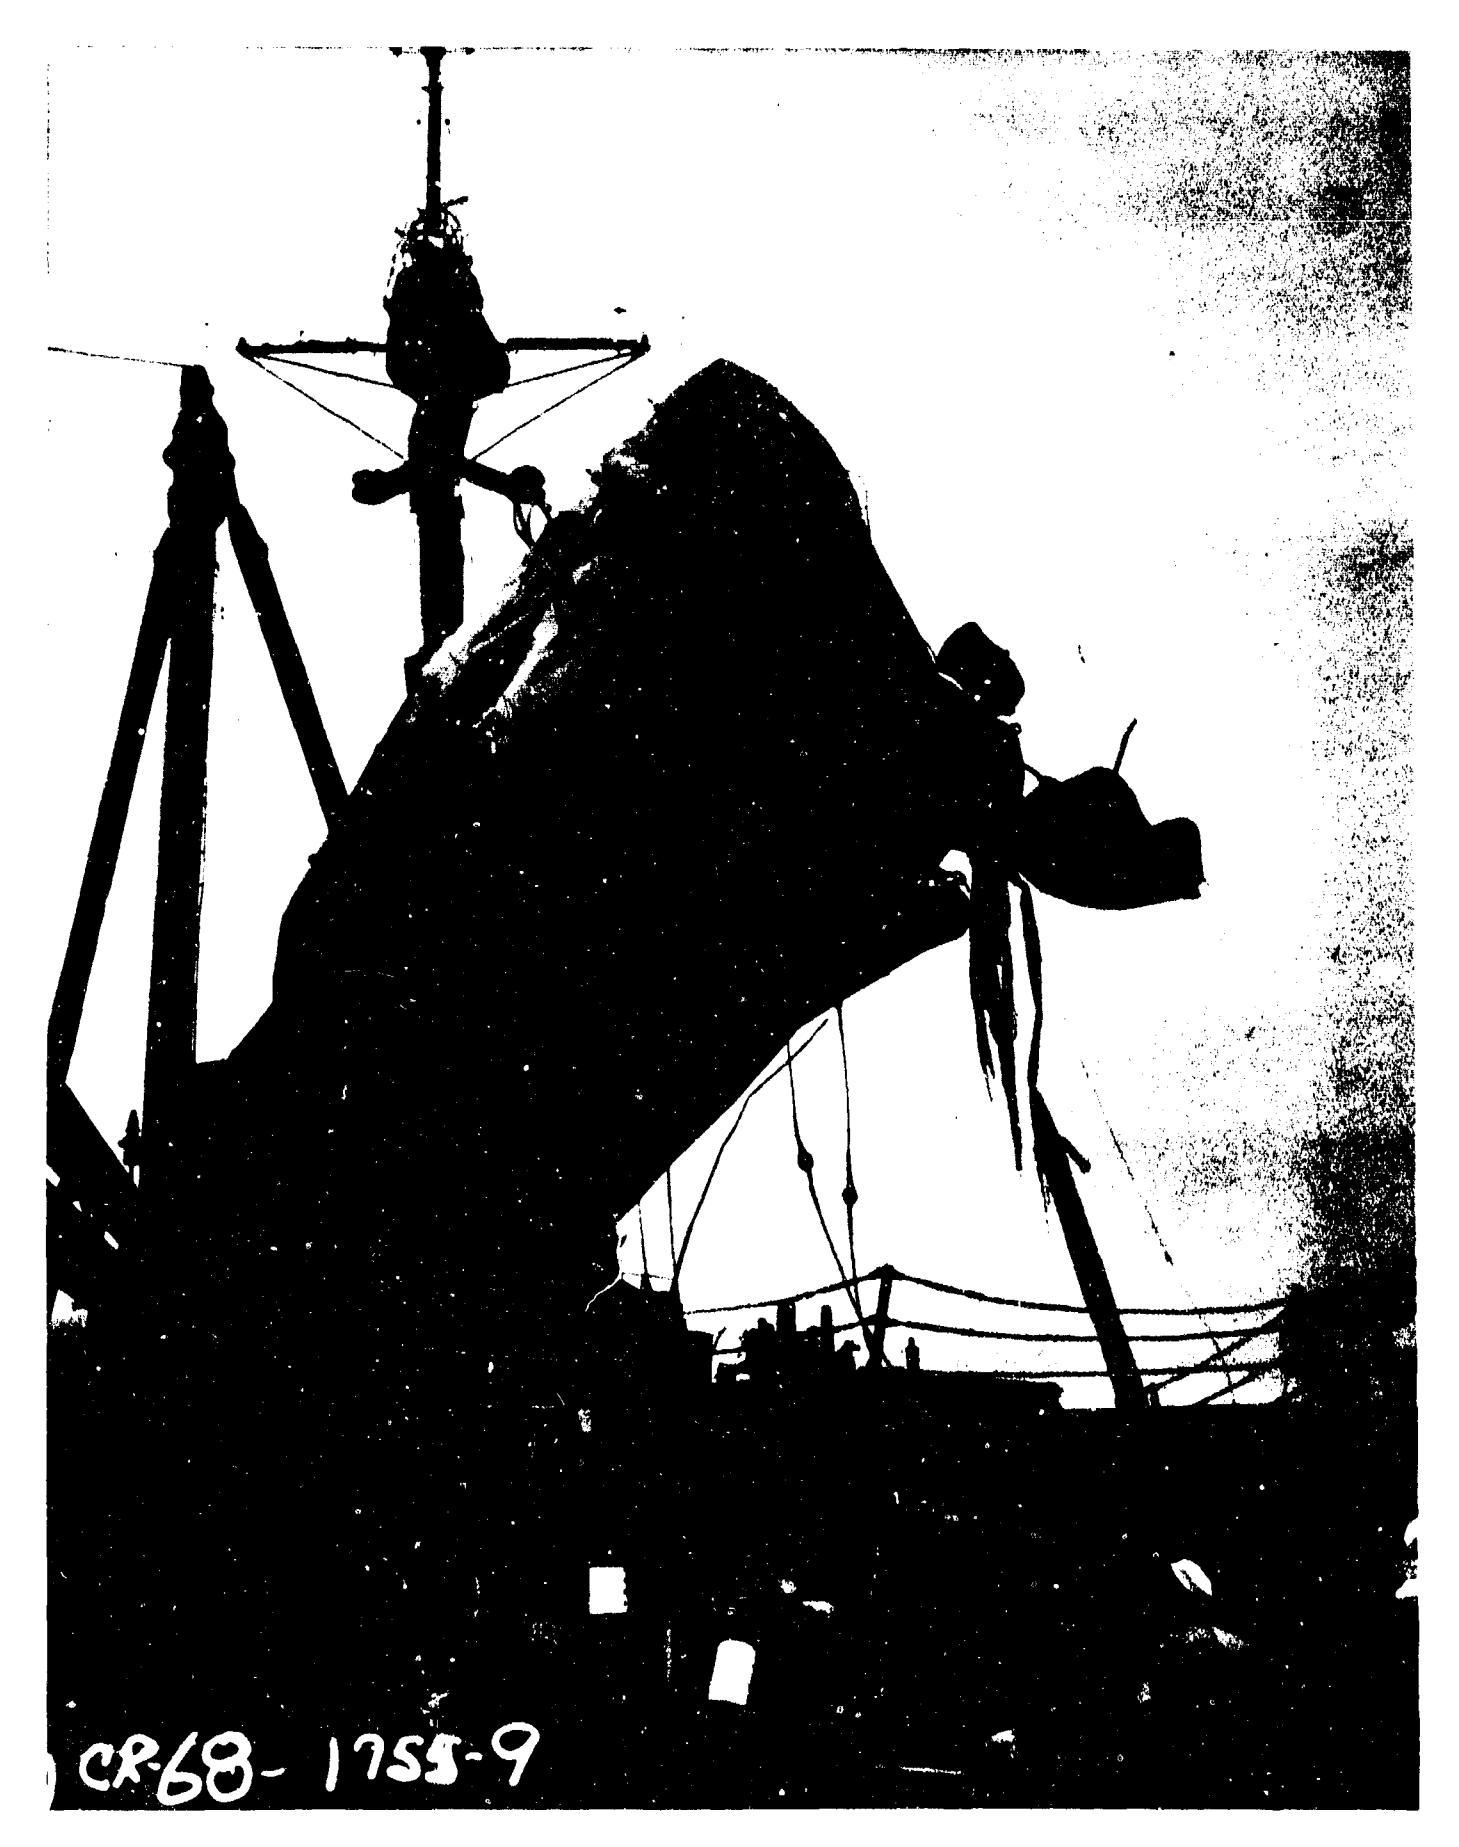
AA-CR-68-1755-9. U.S.S. PENSACOLA (CA24). View looking aft at mainmast and airplane boom tripod.

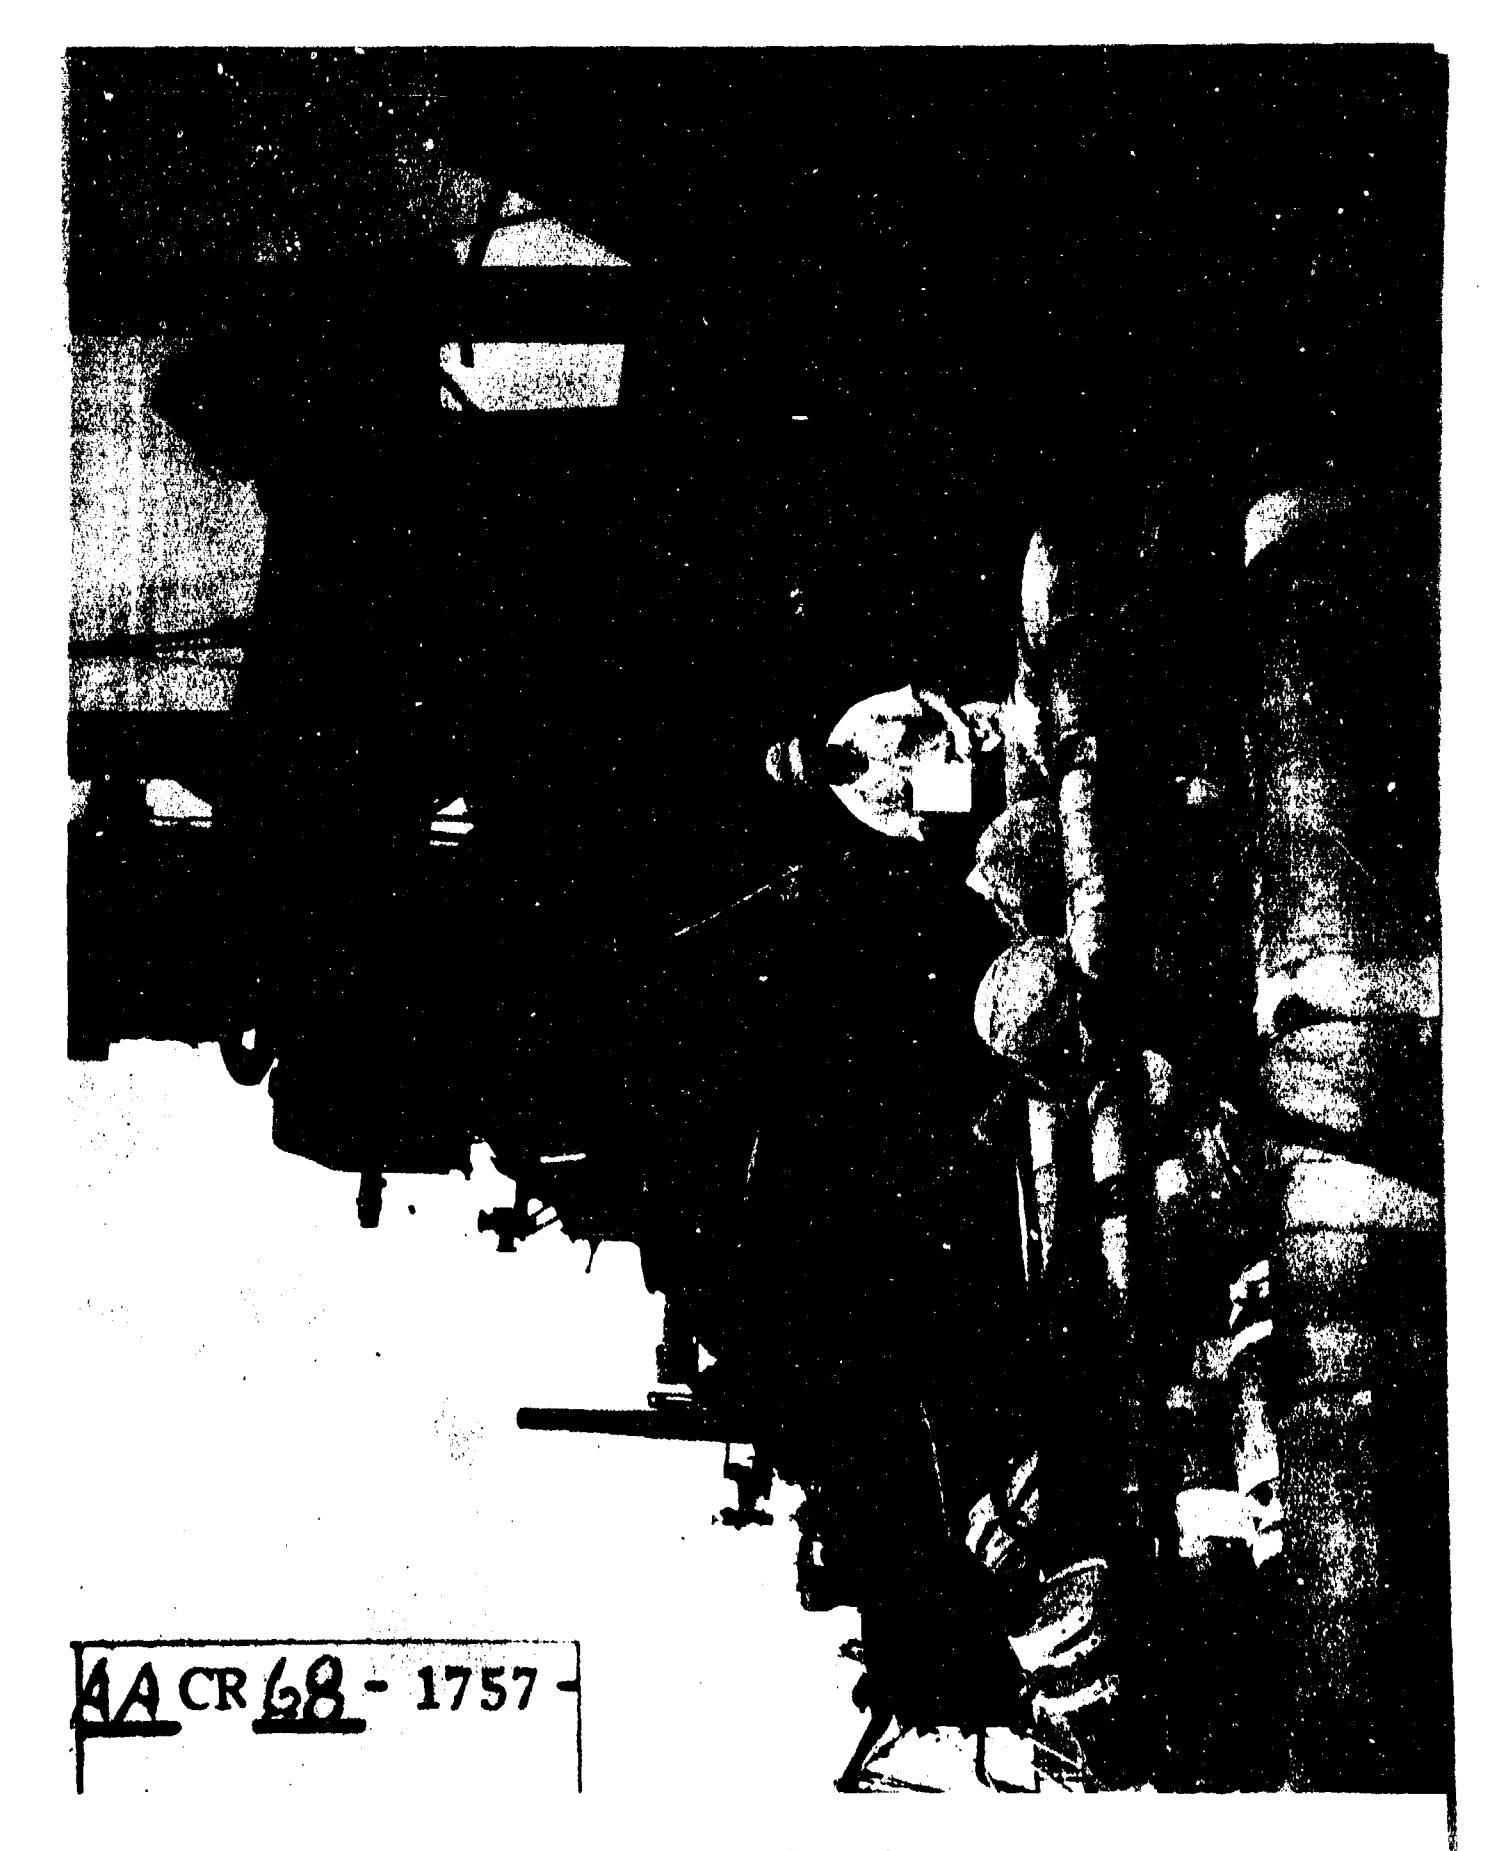
AA-CR-68-1757.11. U.S.S. PENSACOLA (CA24). Mainmast, strut and stays.

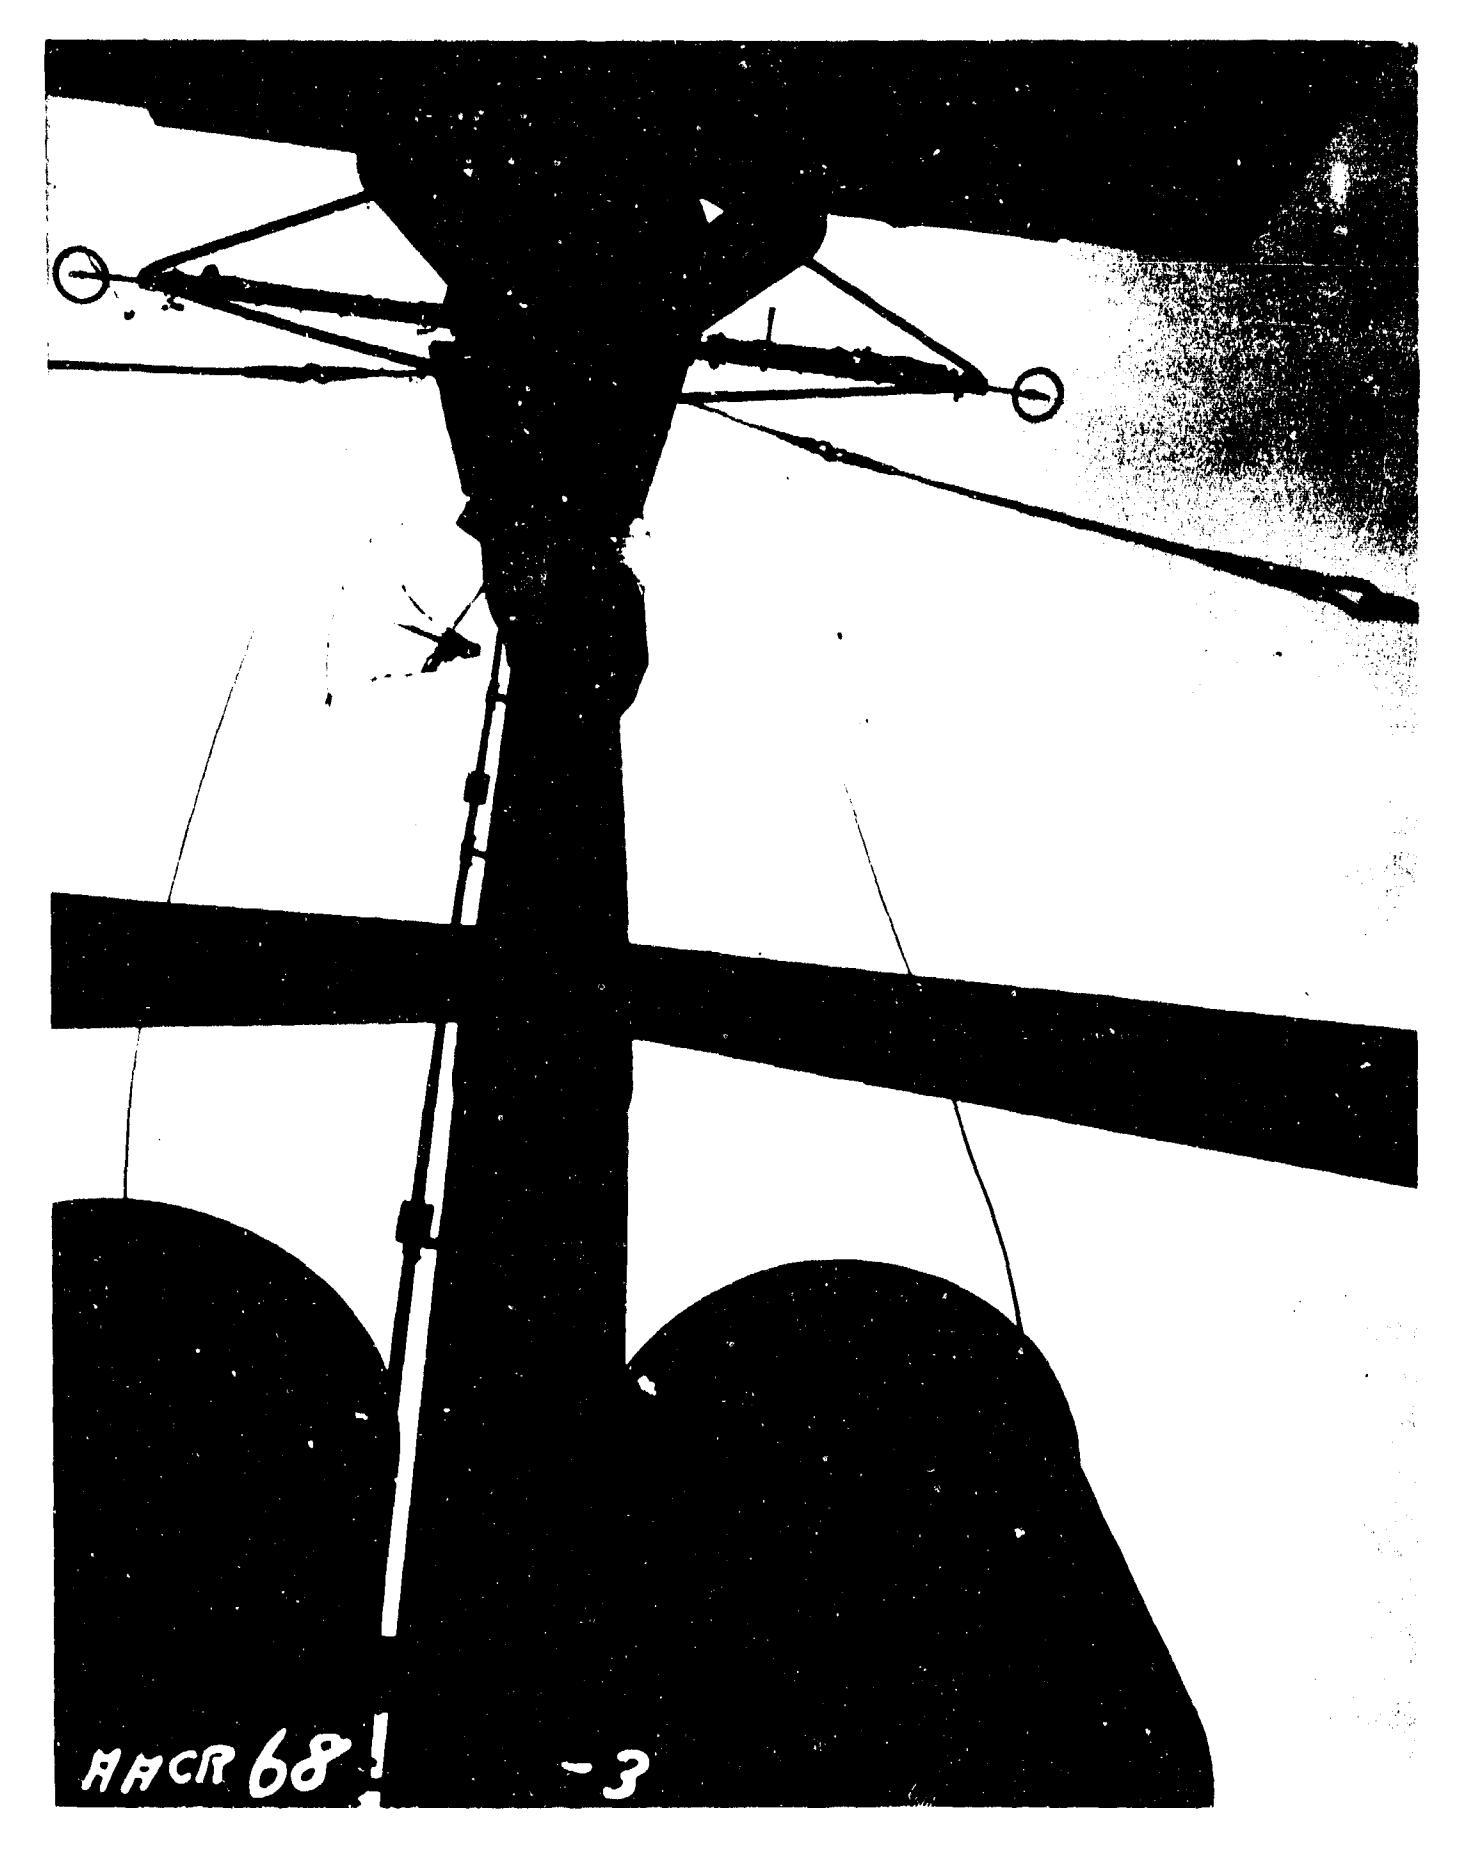
AA-CR-68-1761-3. U.S.S. PENSACOLA (CA24). Mainmast, looking forward and up at junction of struts.

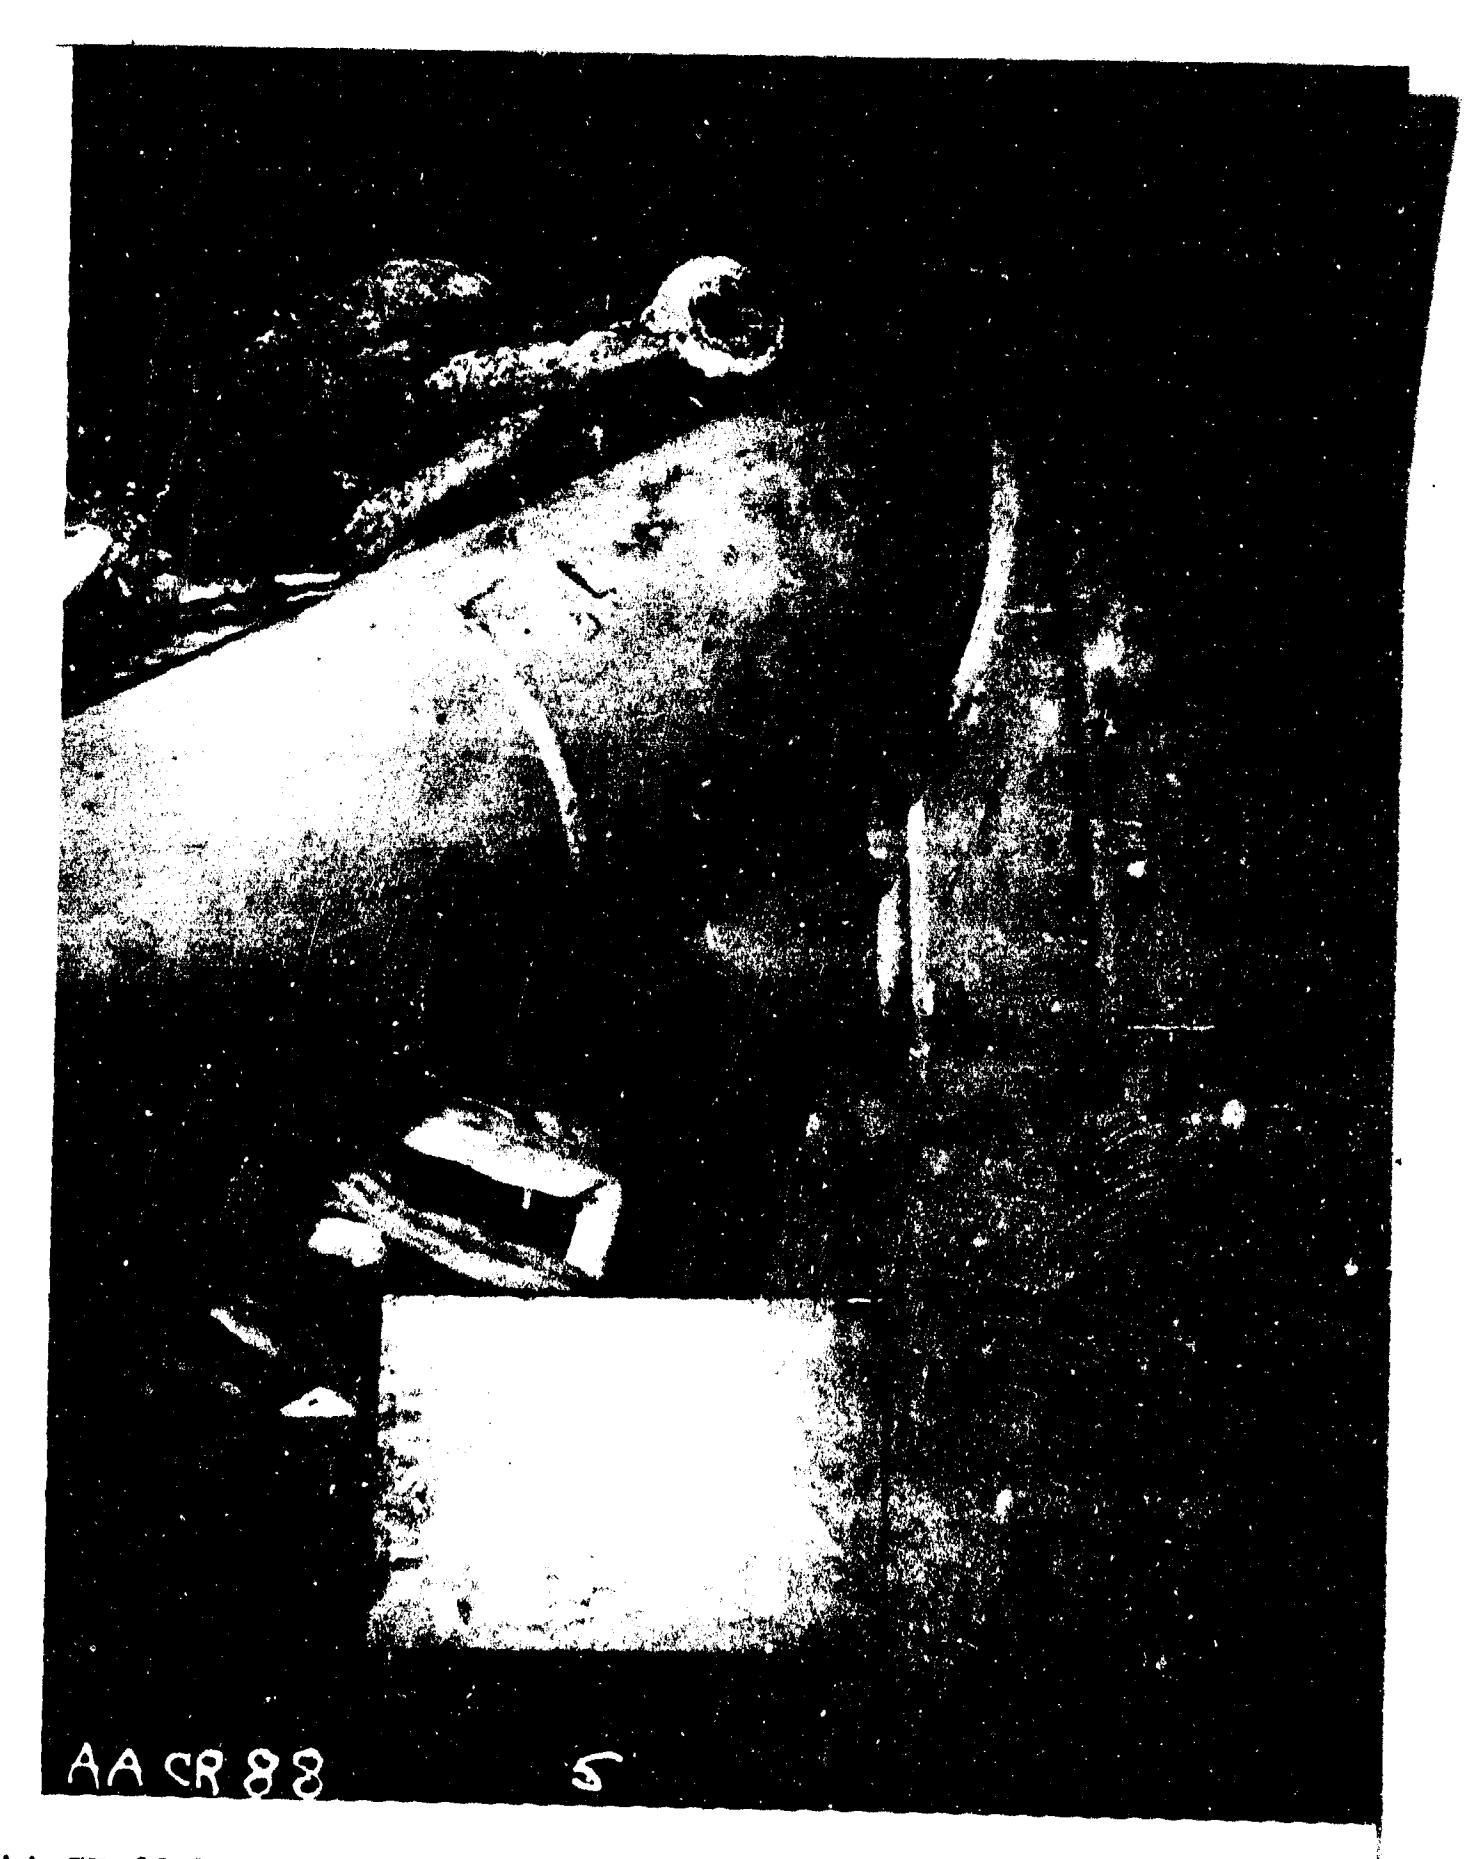
AA-CR-88-2161-5. U.S.S. PENSACOLA (CA24). Foot of port strut to mainmast after test able.

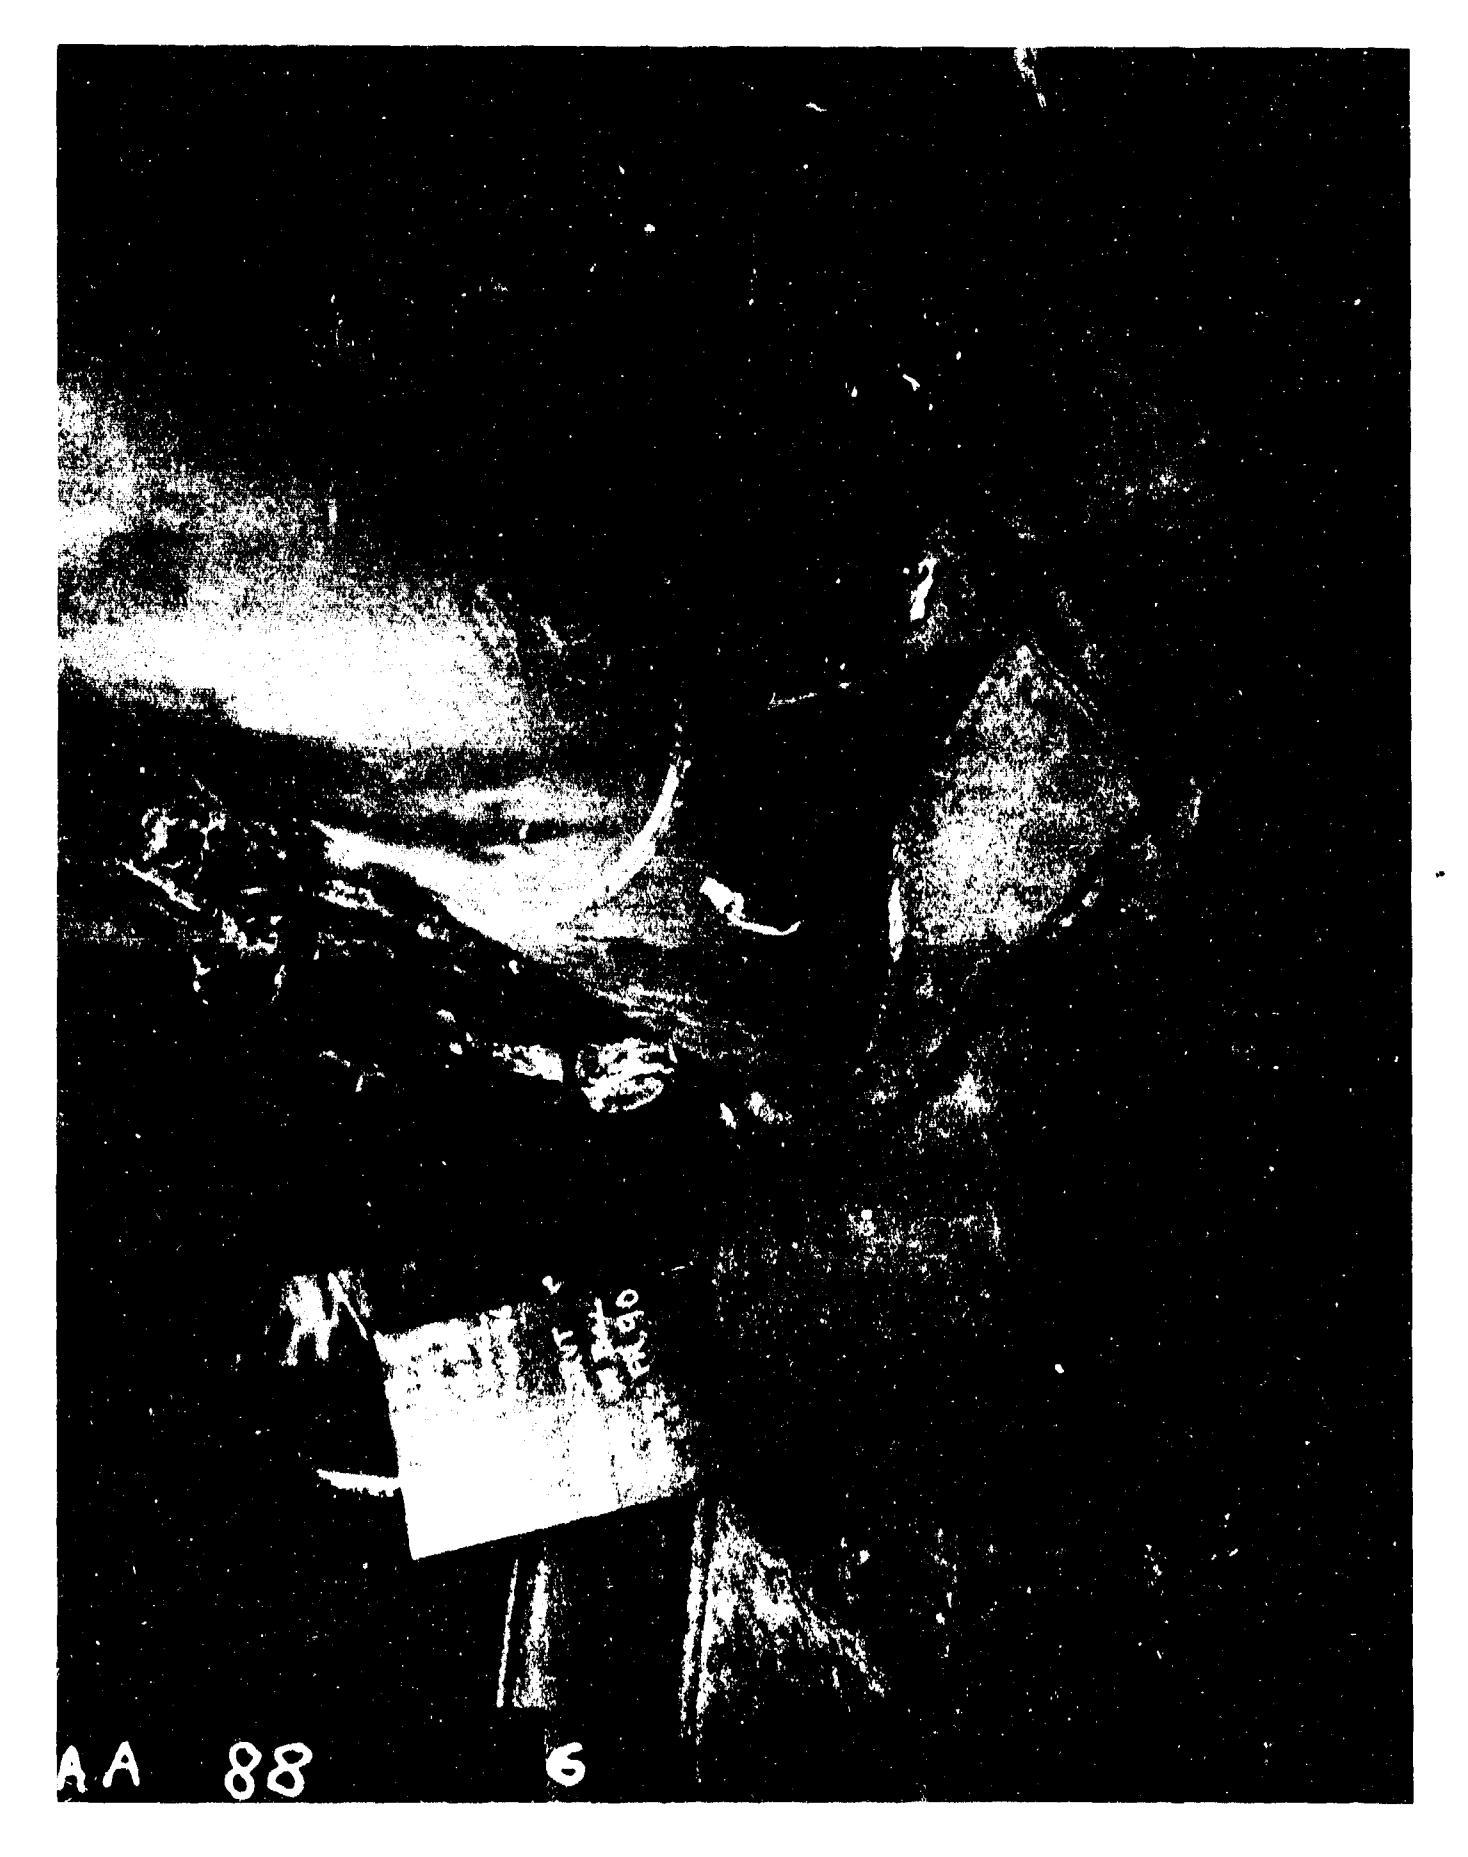
AA-CR-88-2161-6. U.S.S. PENSACOLA (CA24). Foot of starboard strut to mainmast after Test Able.
