BUREAU OF SHIPS GROUP

TECHNICAL INSPECTION REPORT

FAILURES OF MASTS, YARDARMS, BOOMS, AND RIGGING

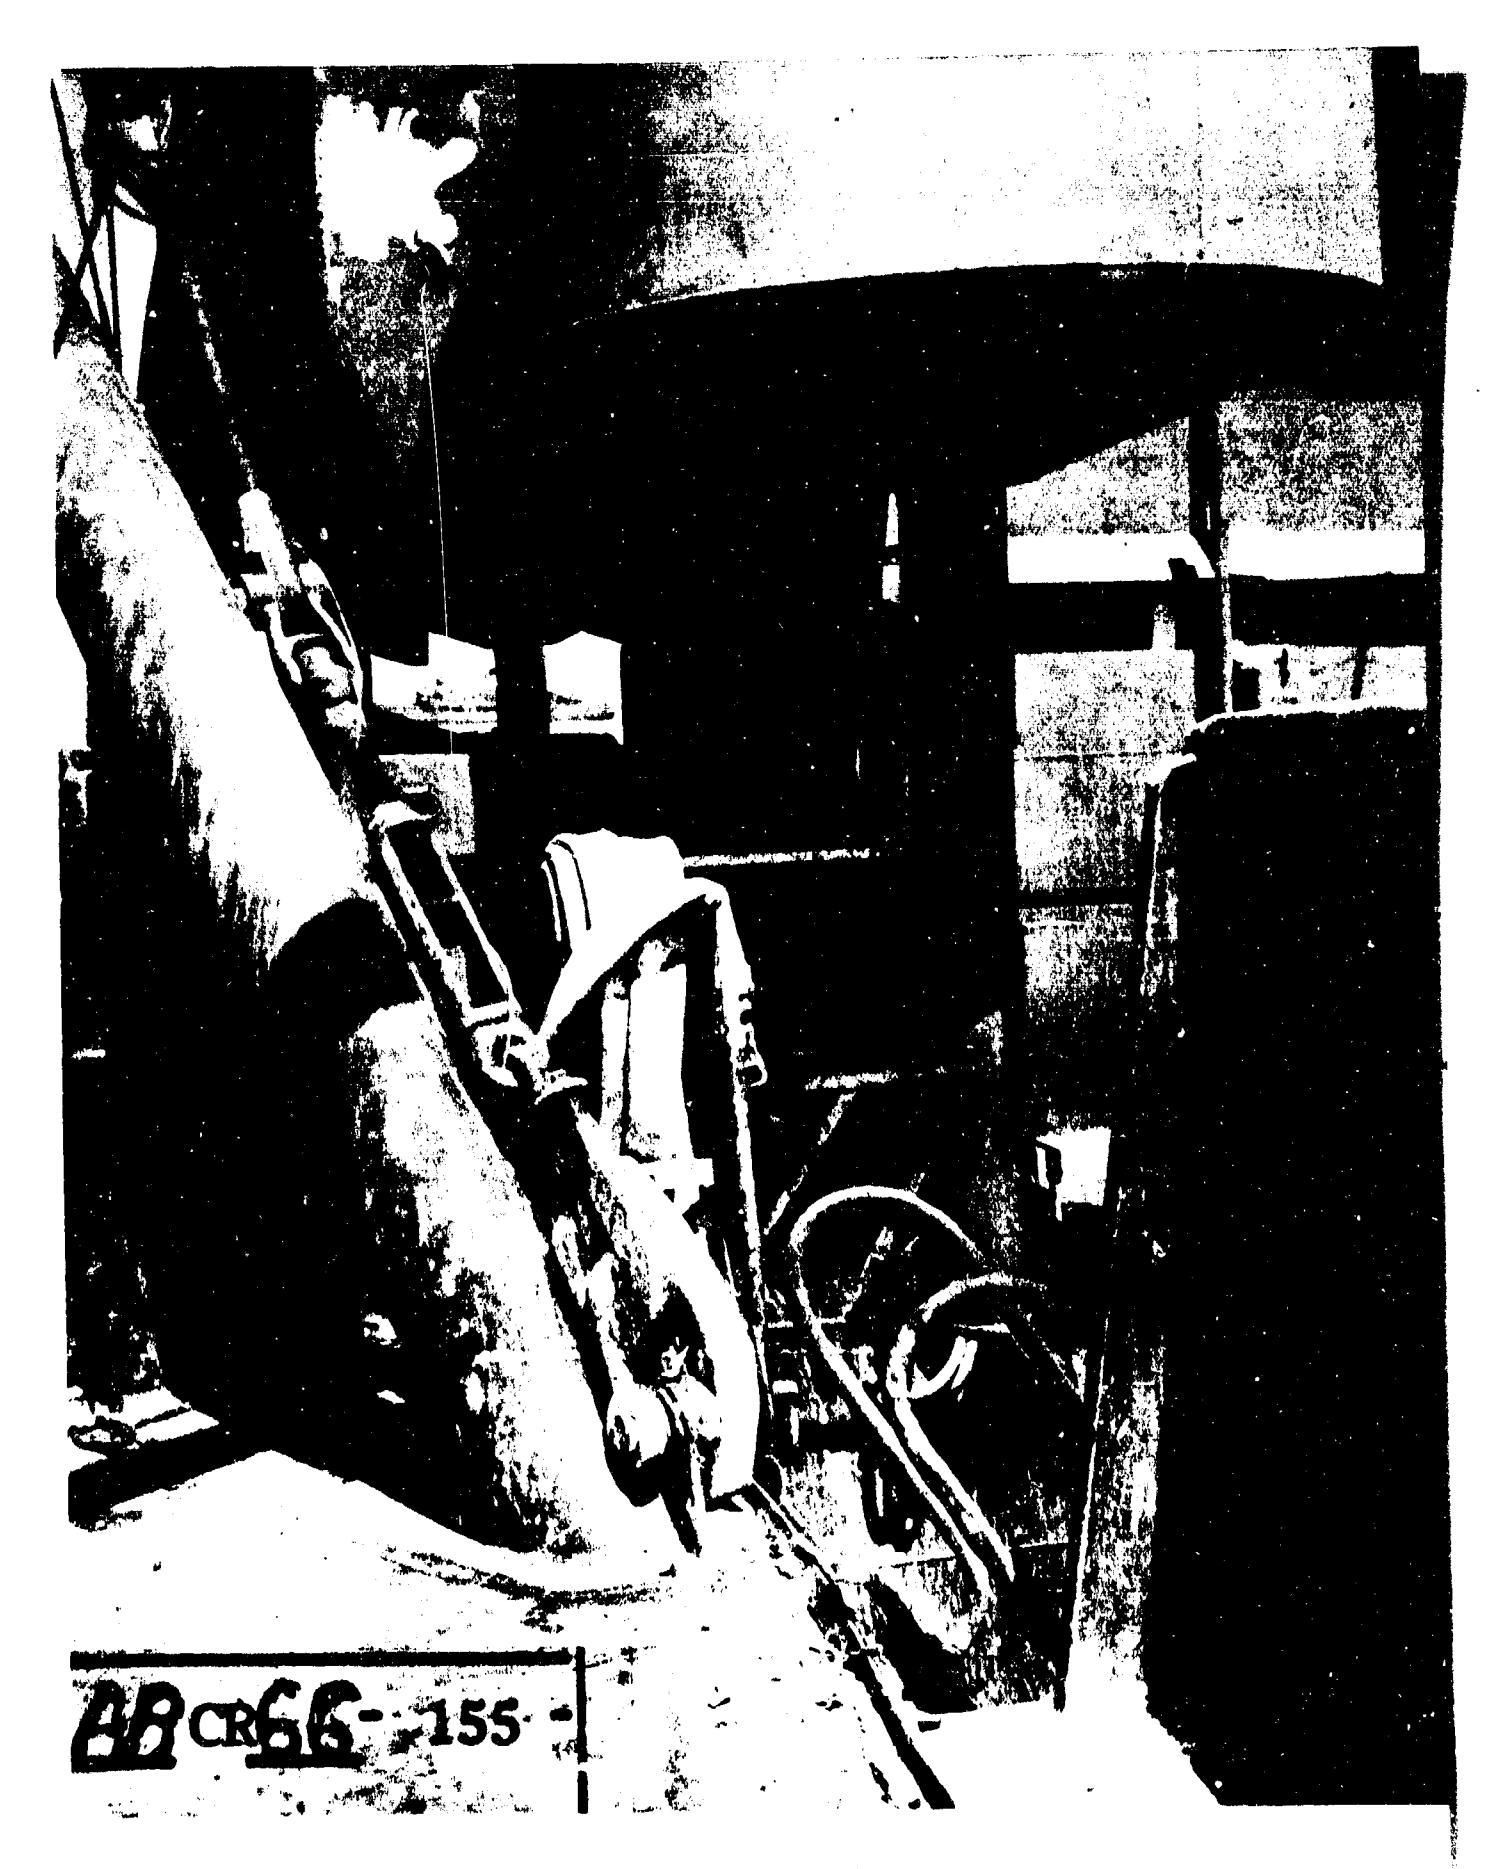
AB-CR-66-155-5. U.S.S. PENSACOLA (CA24). Foot of port strut to mainmast after Test Able.

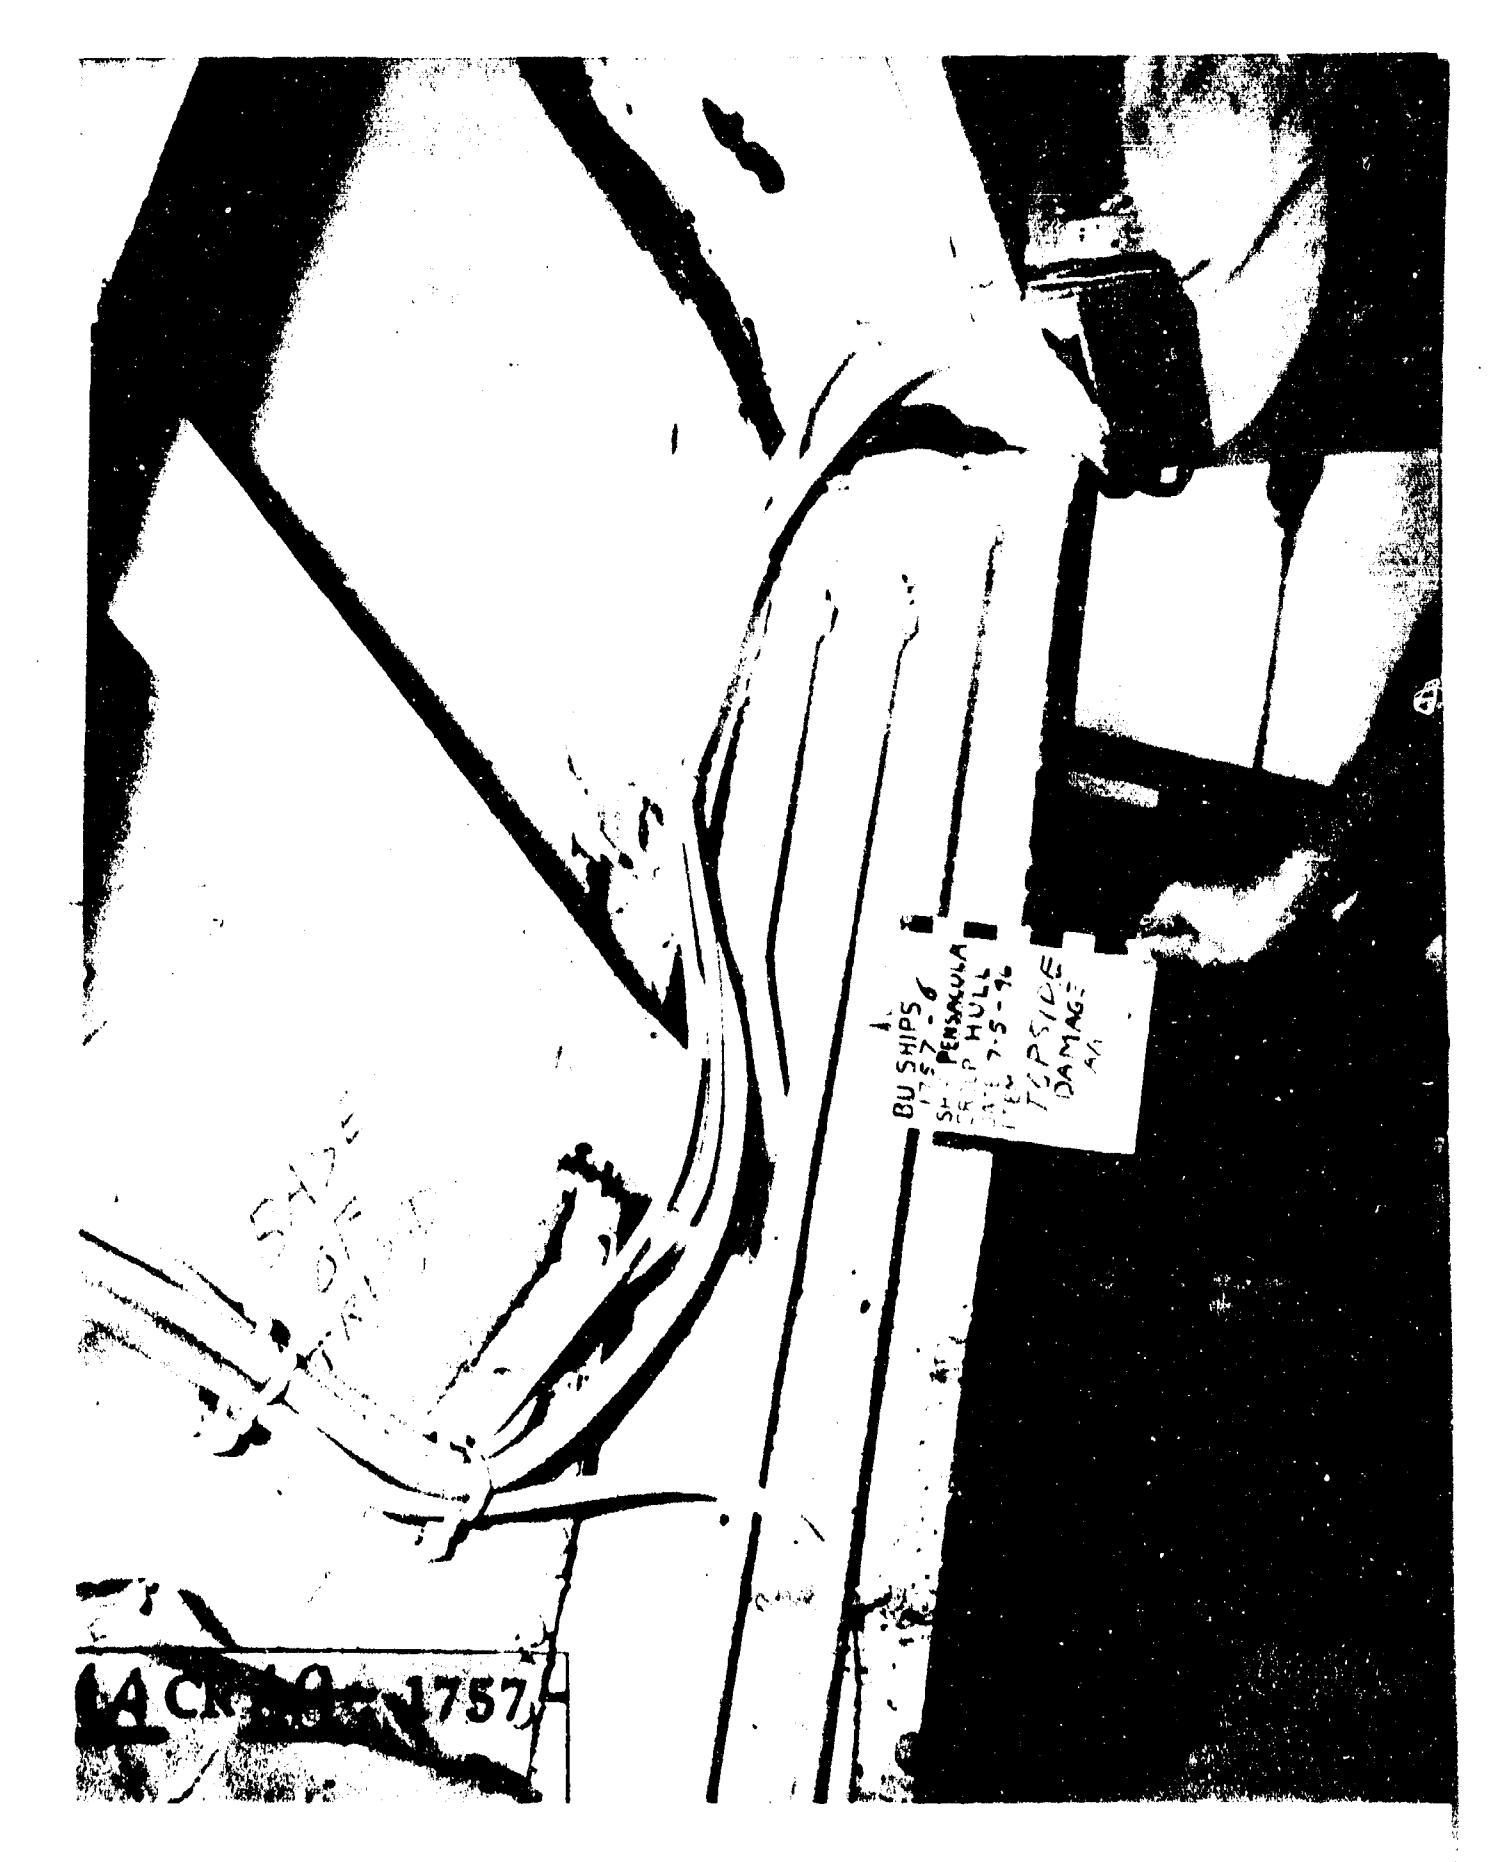
AA-CR-68-1757-6. U.S.S. PENSACOLA (CA24). Looking up at under side of 01 deck showing base of port after leg of mainmast strut - trame 92.

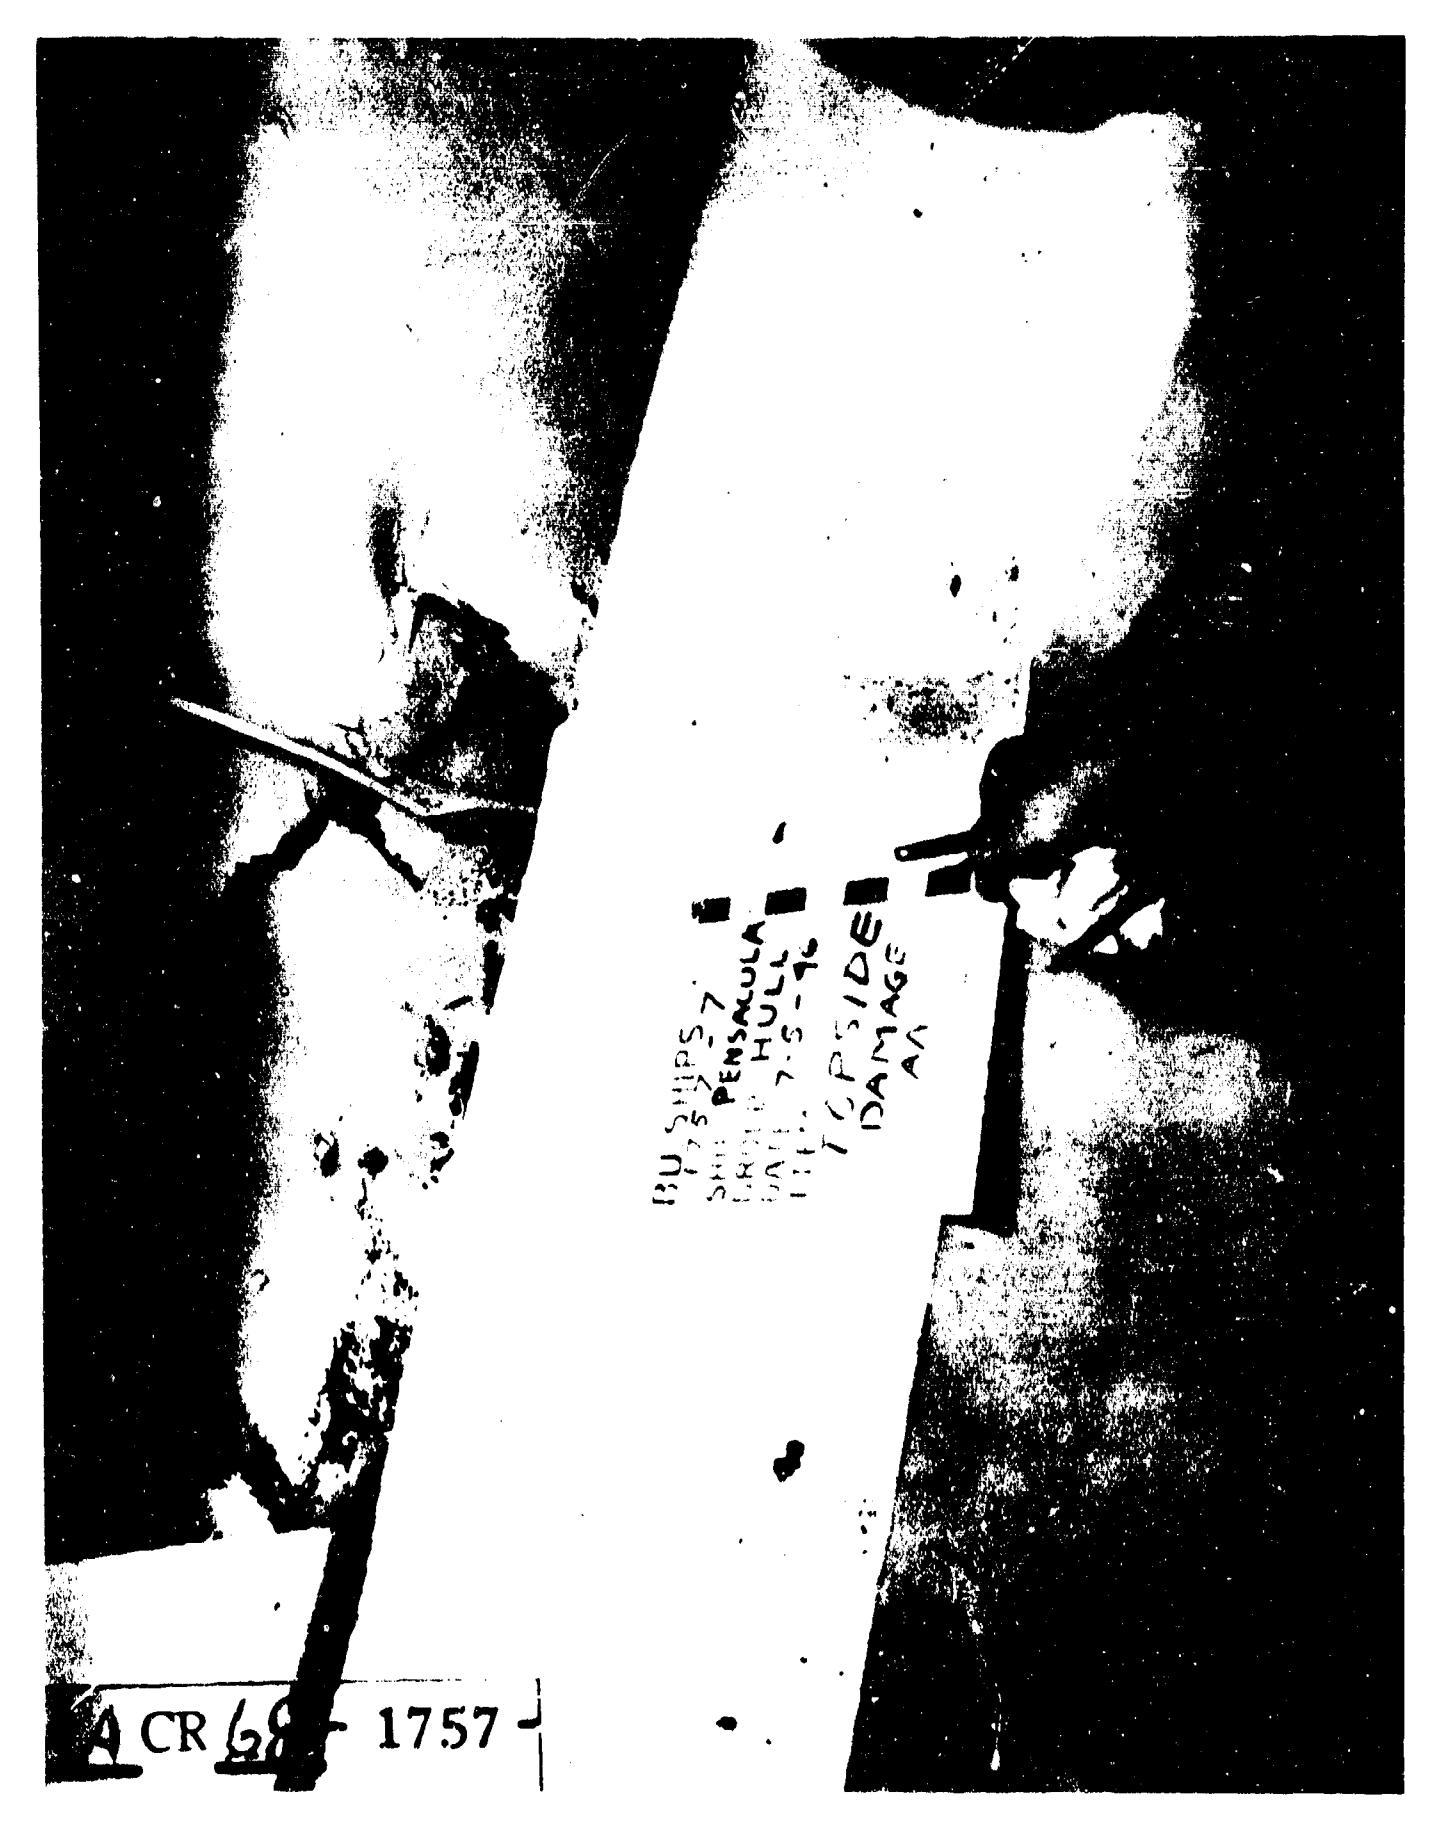
AA-CR-08-1757-7. U.S.S. PENSACOLA (CA24). Looking up at underside of 01 deck showing base of starboard after leg of mainmast strutframe 92.

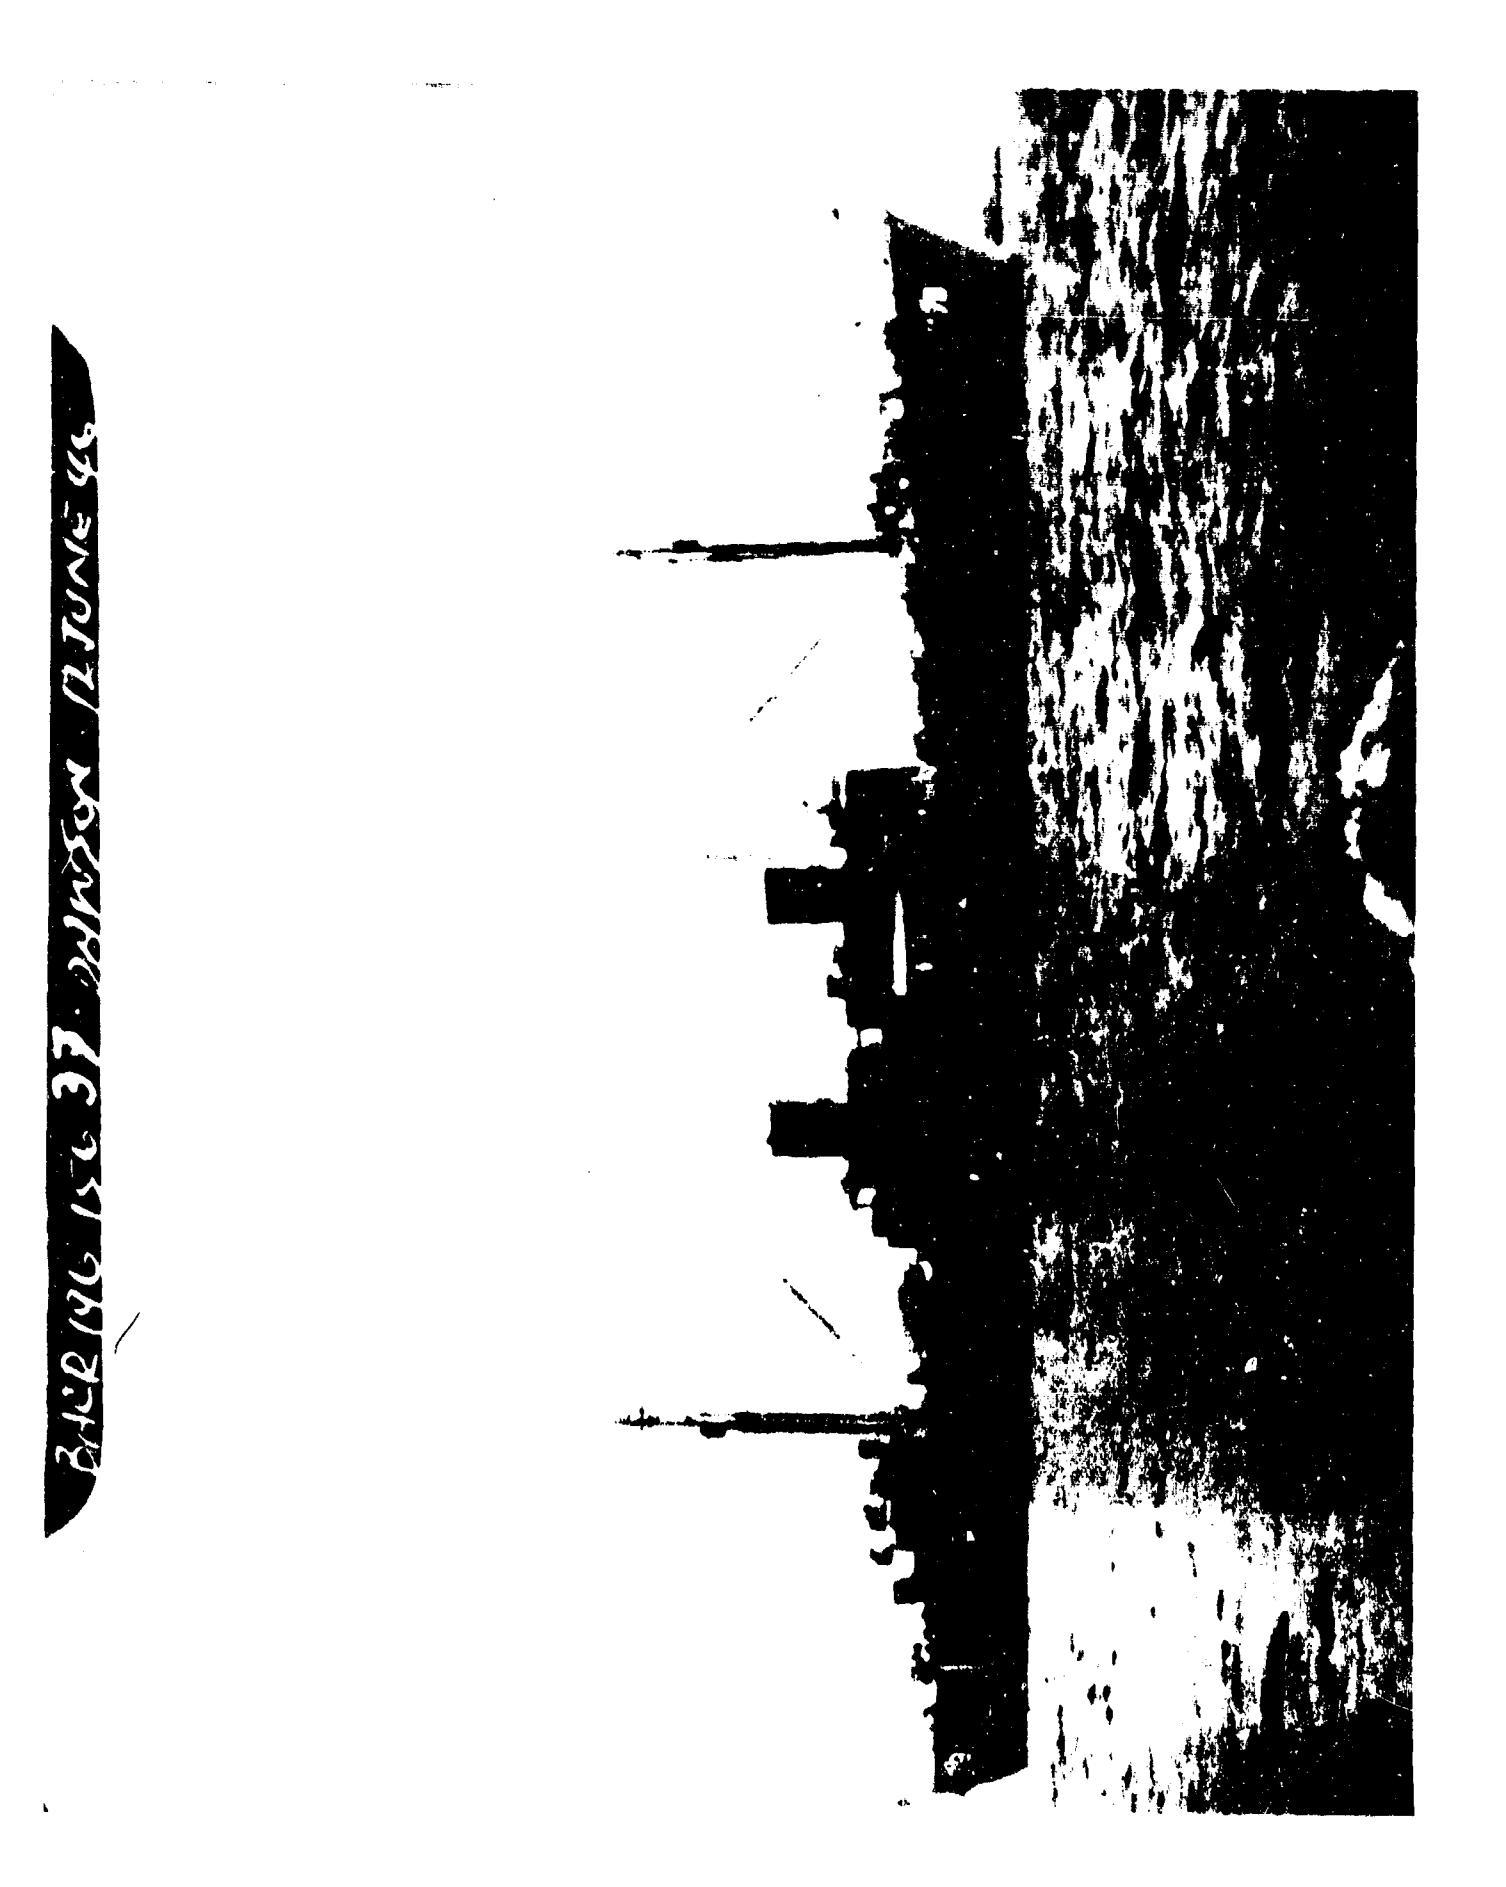
BA-CR-196-156-37. U.S.S. DAWSON (APA'79). View looking at starboard beam before Test A.

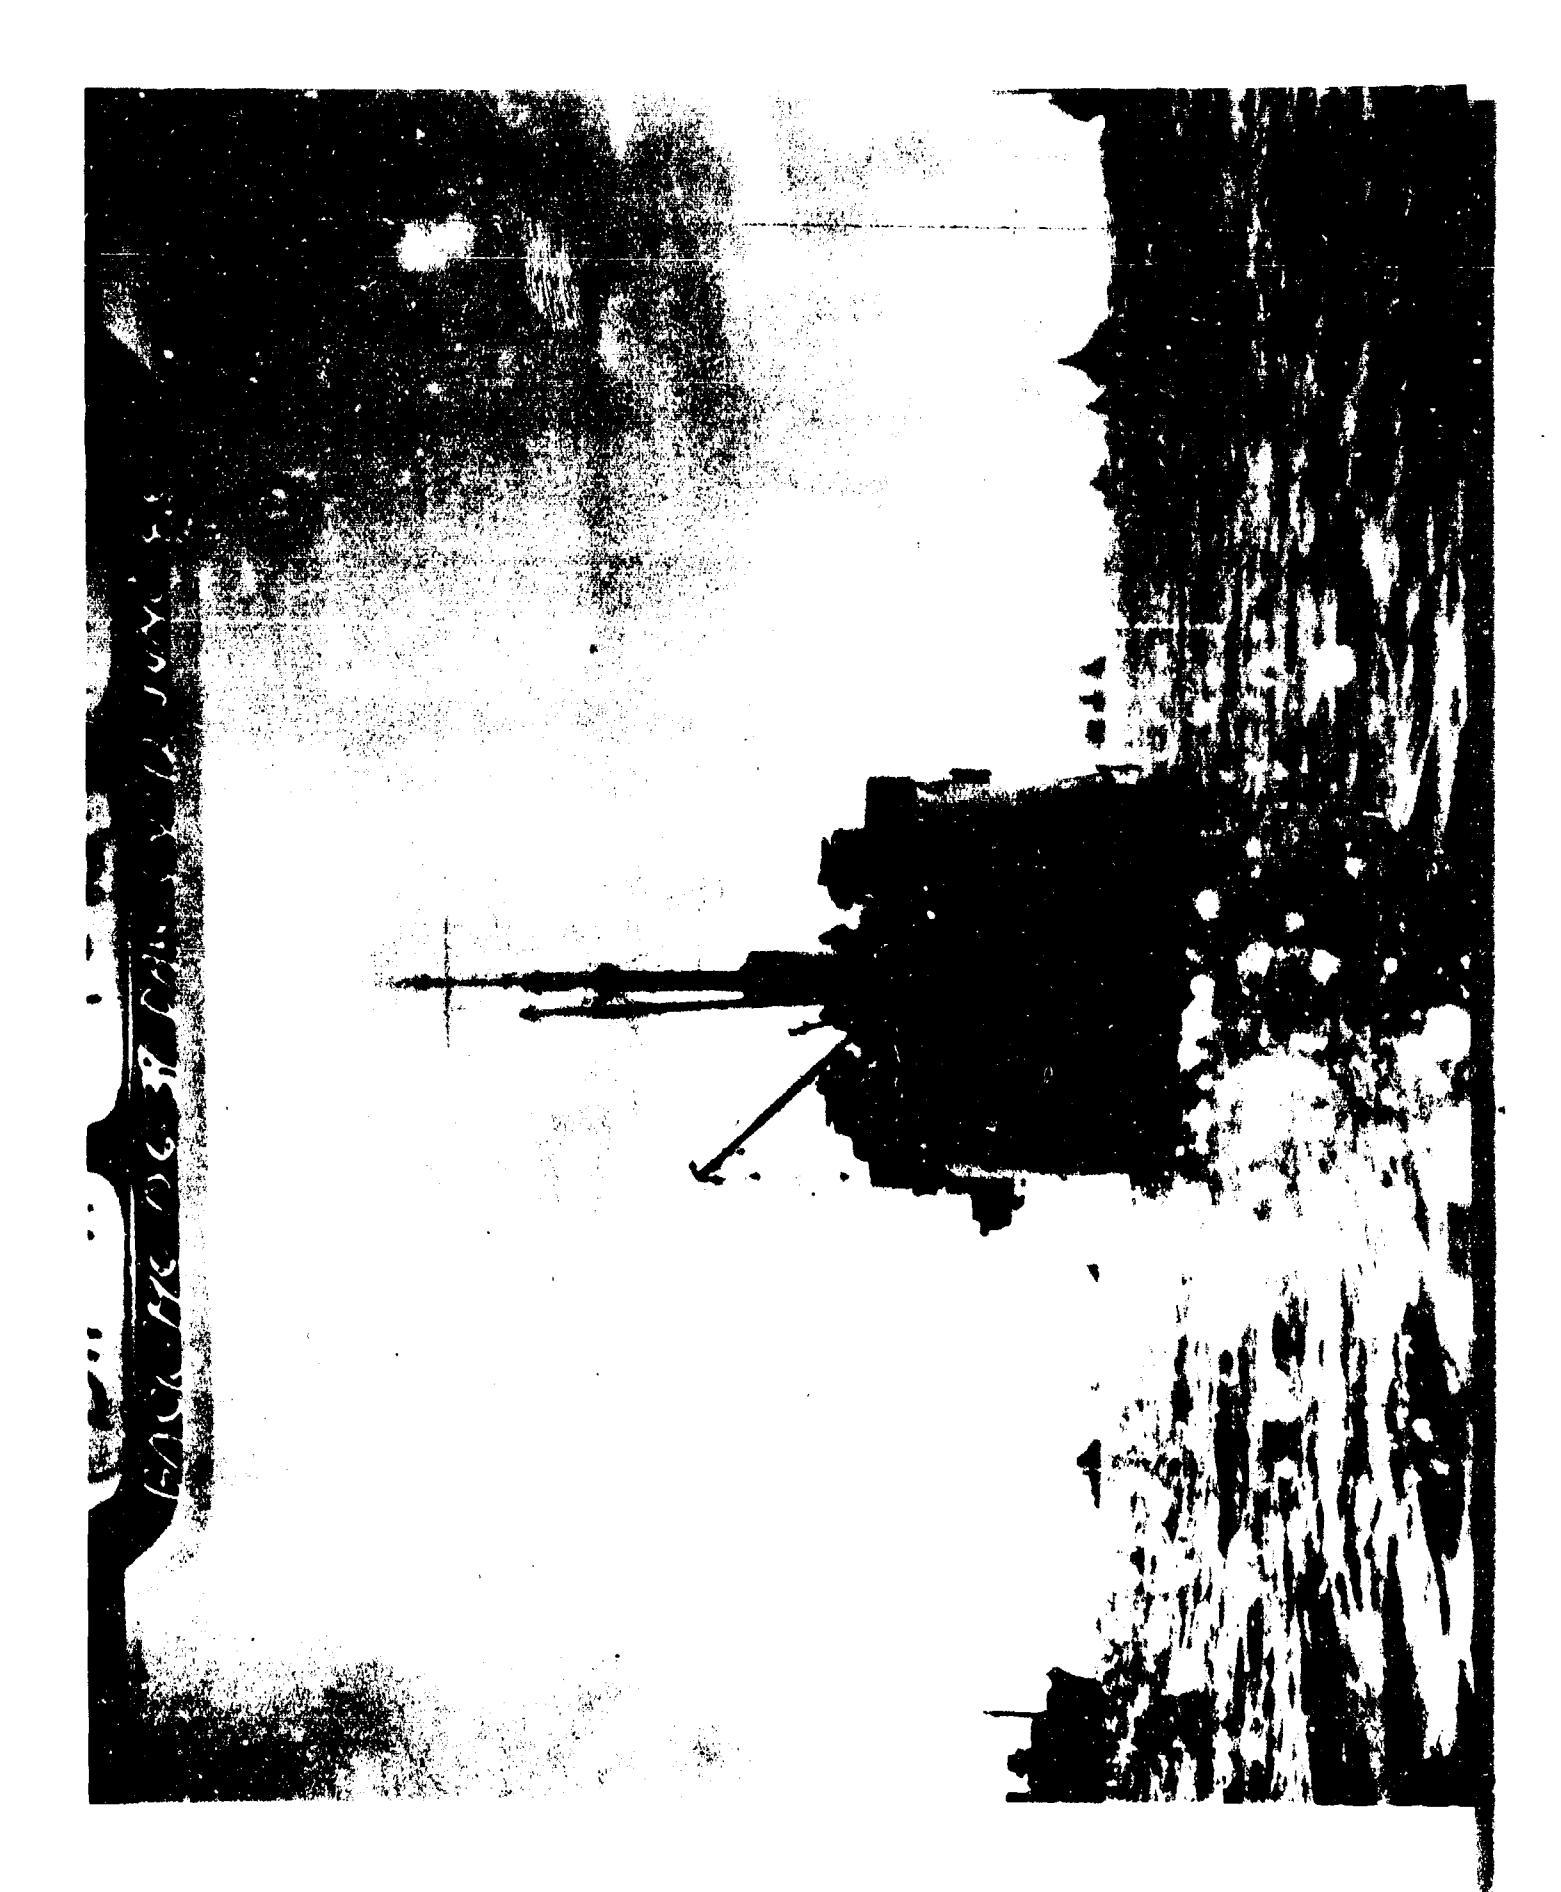
BA-CR-196-156-39. U.S.S. DAWSON (APA79). View looking at stern, before Test A.

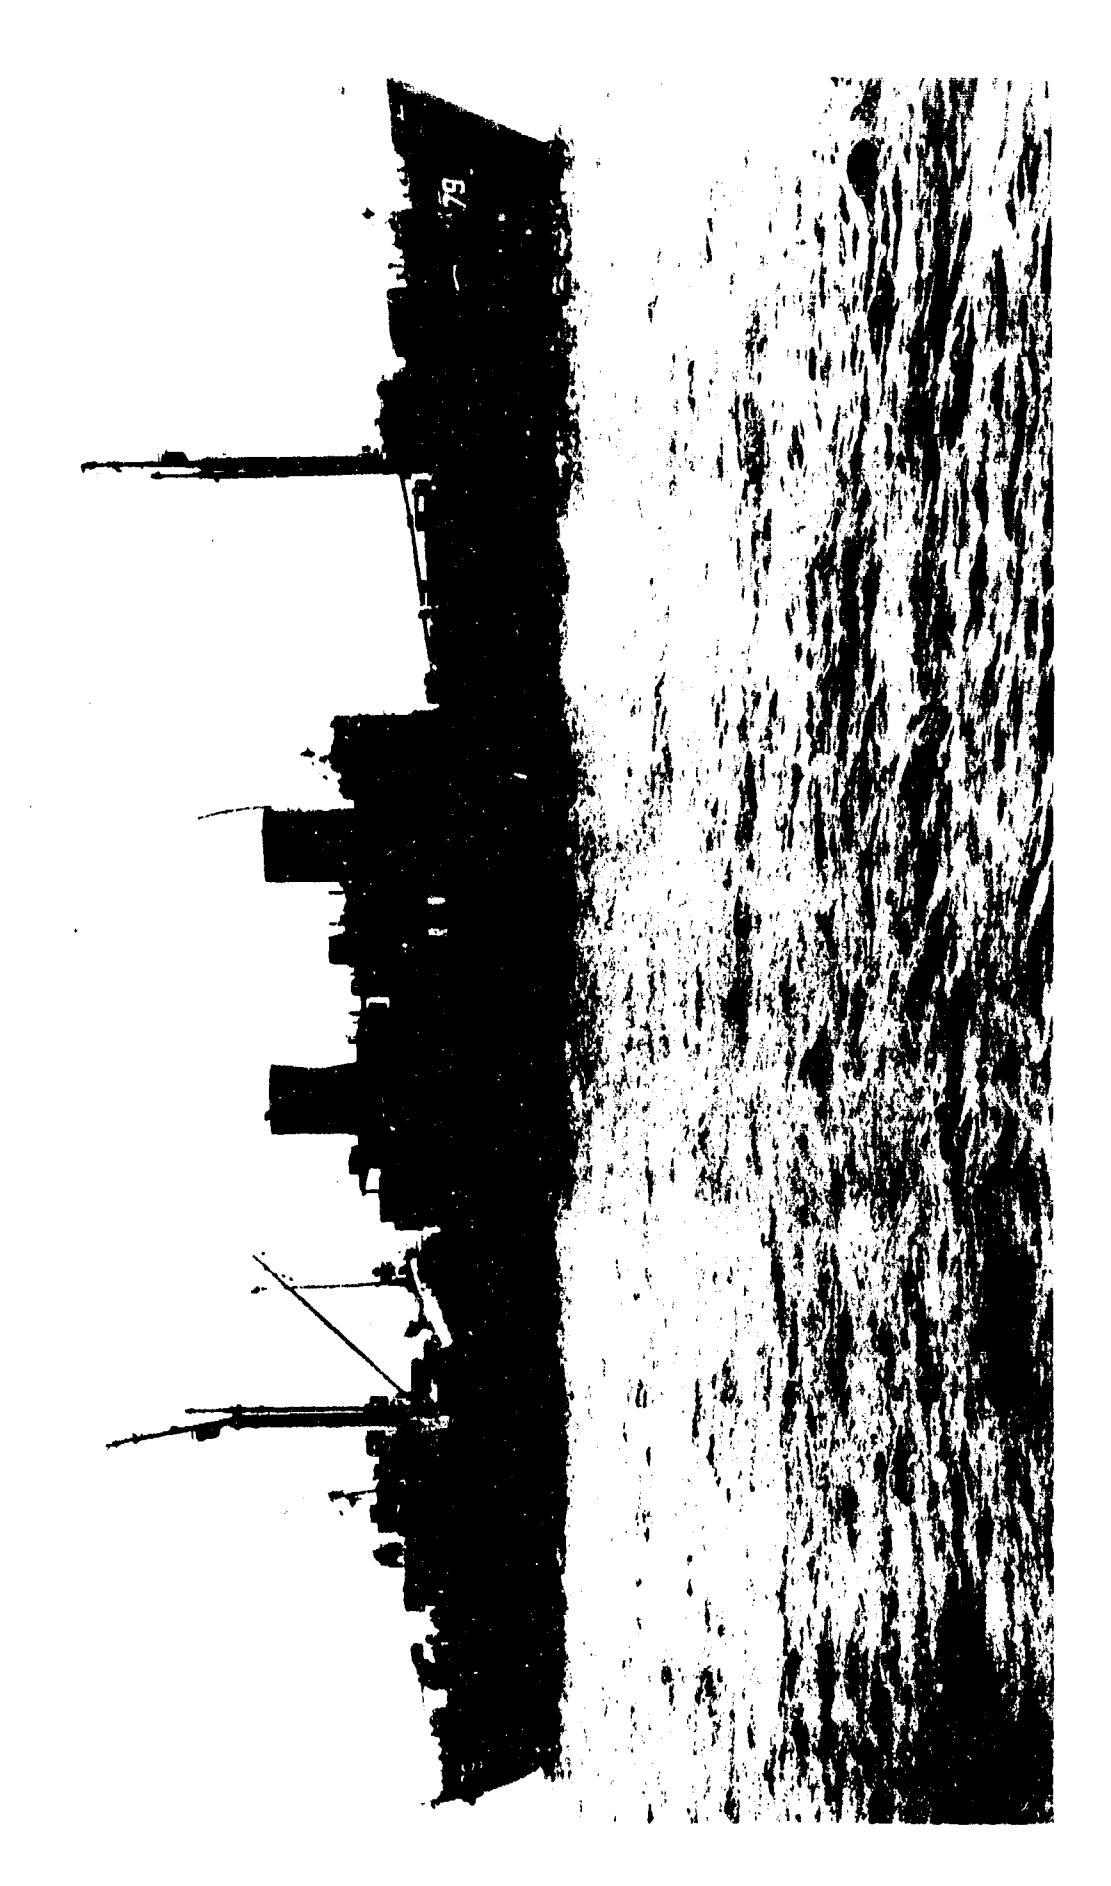
AA-CR-227-87-64. U.S.S. DAWSON (APA 79). View looking at starboard beam after Test A.

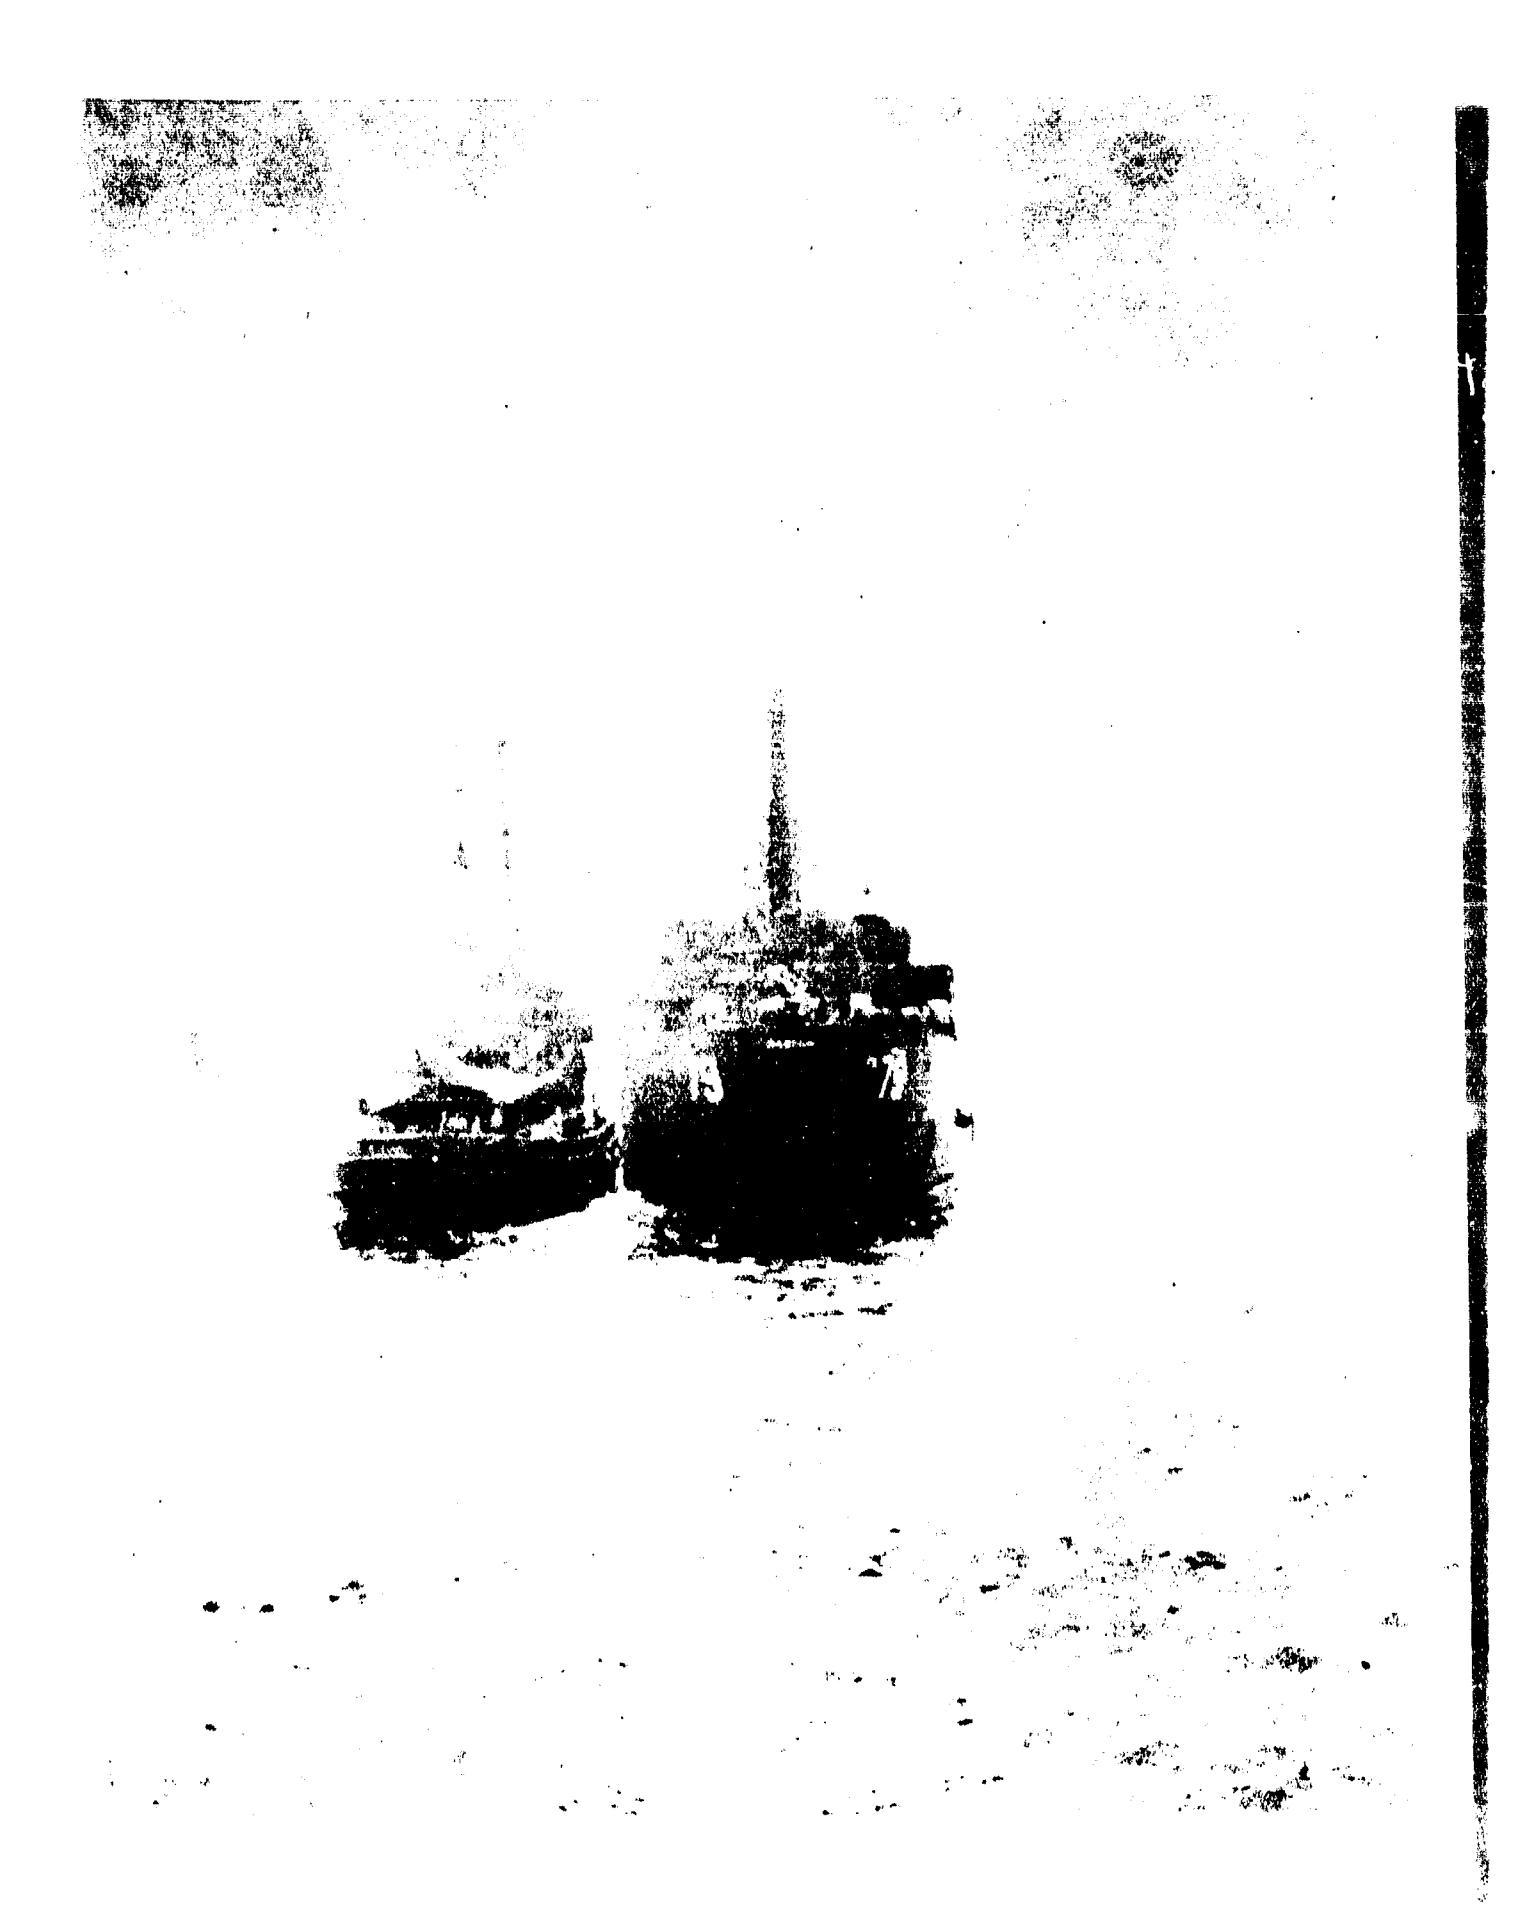
AA-CR-227-87-66. U.S.S. DAWSON (APA79). View looking at stern after Test A.

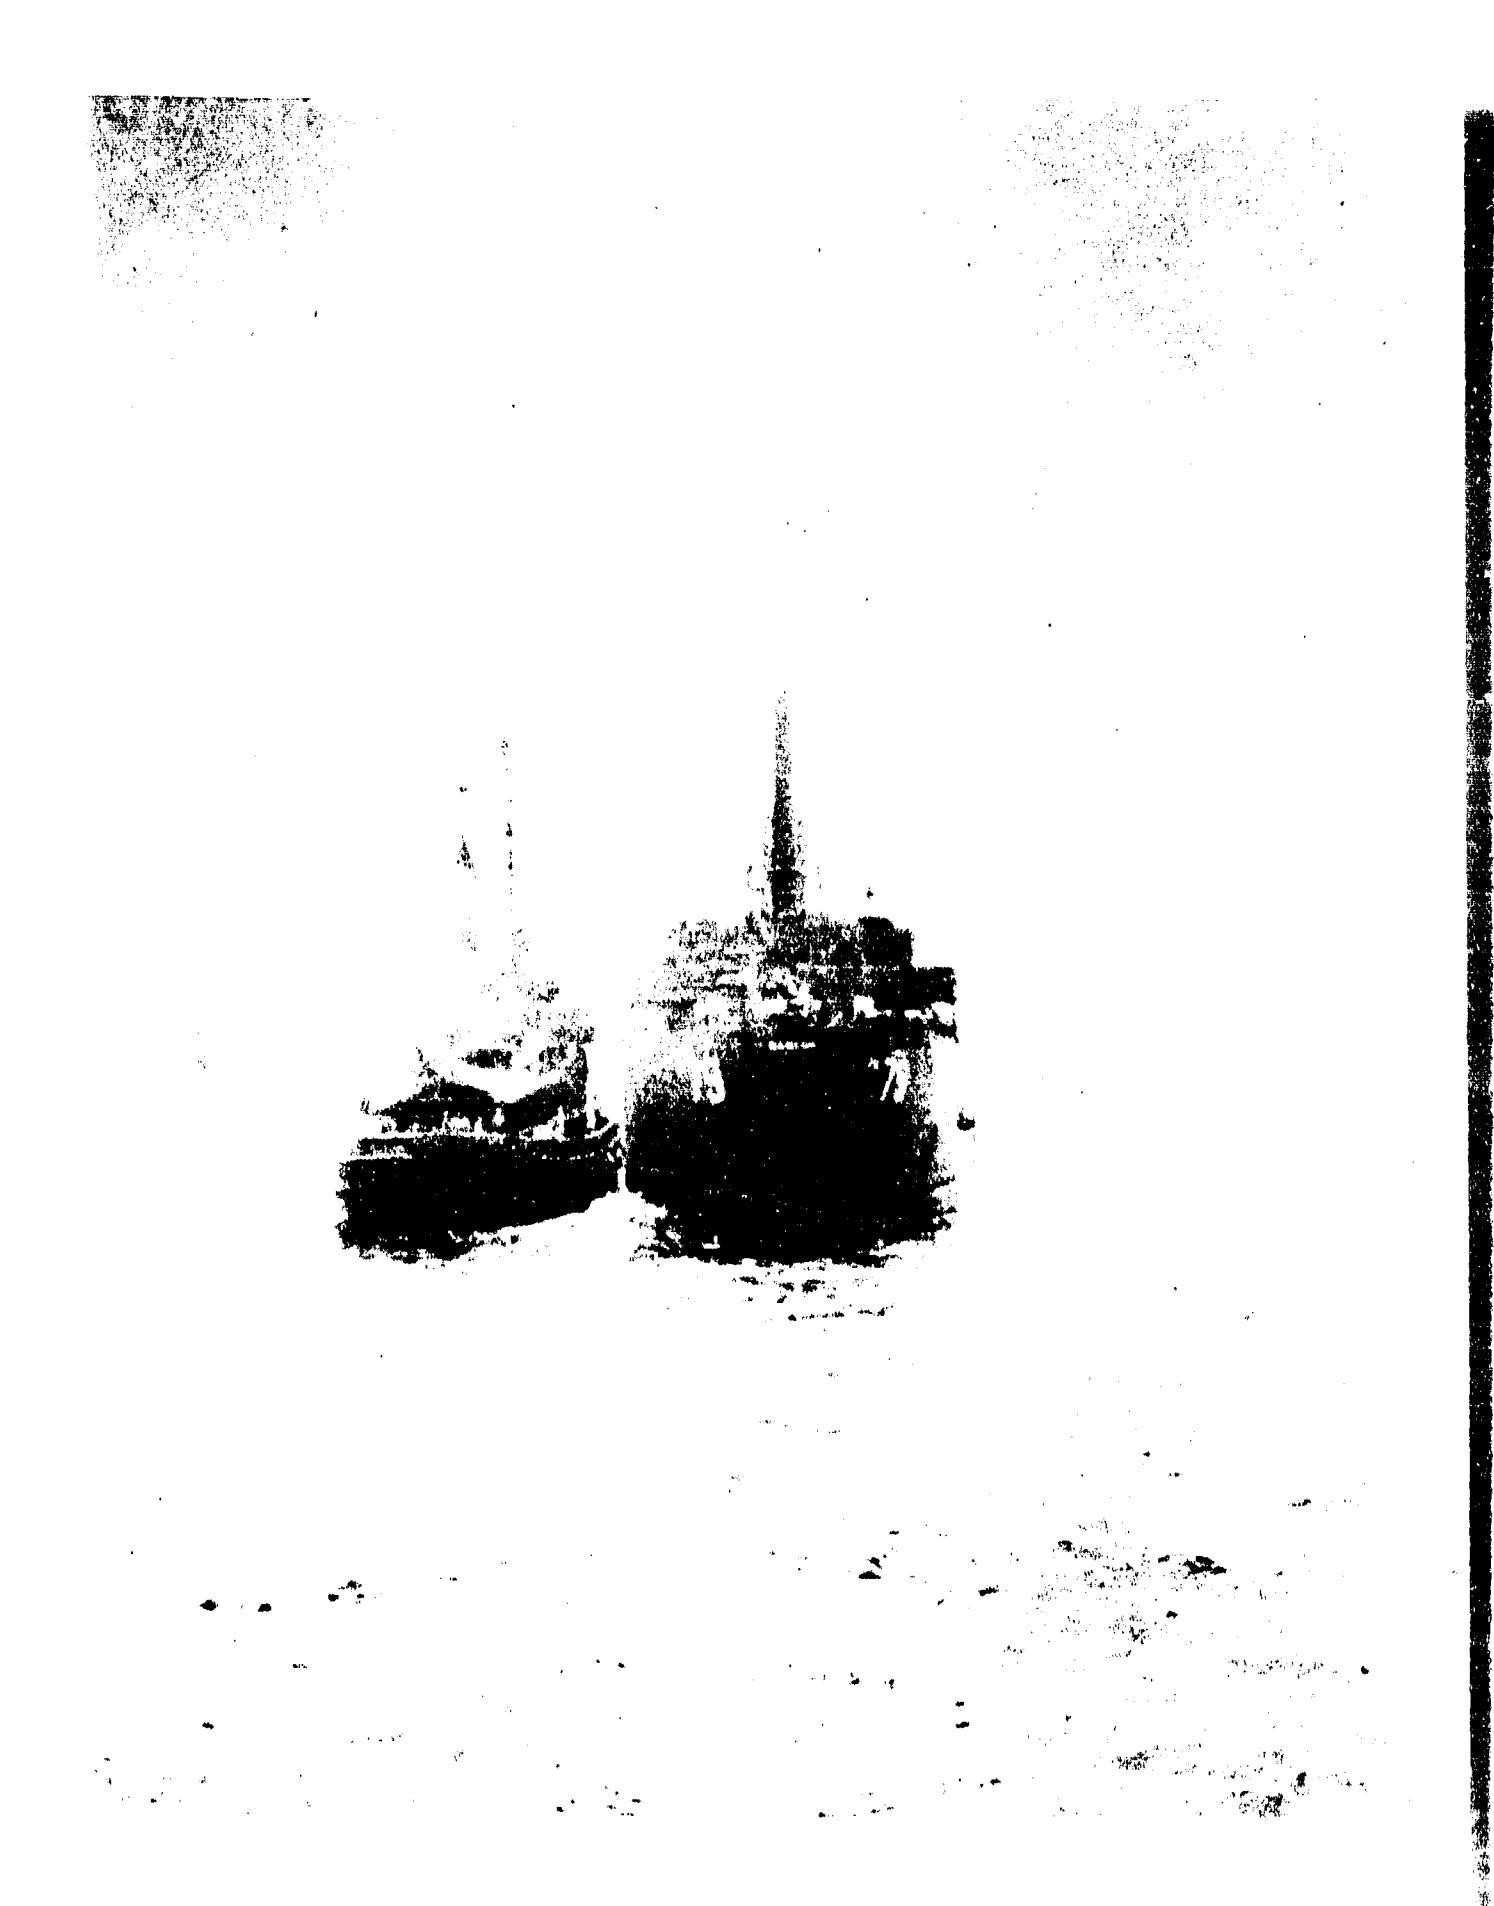
AA-CR-227-87-66. U.S.S. DAWSON (APA79). View looking at stern after Test A.
