BUREAU OF SHIPS GROUP

TECHNICAL INSPECTION REPORT

FAILURES OF MASTS, YARDARMS, BOOMS, AND RIGGING

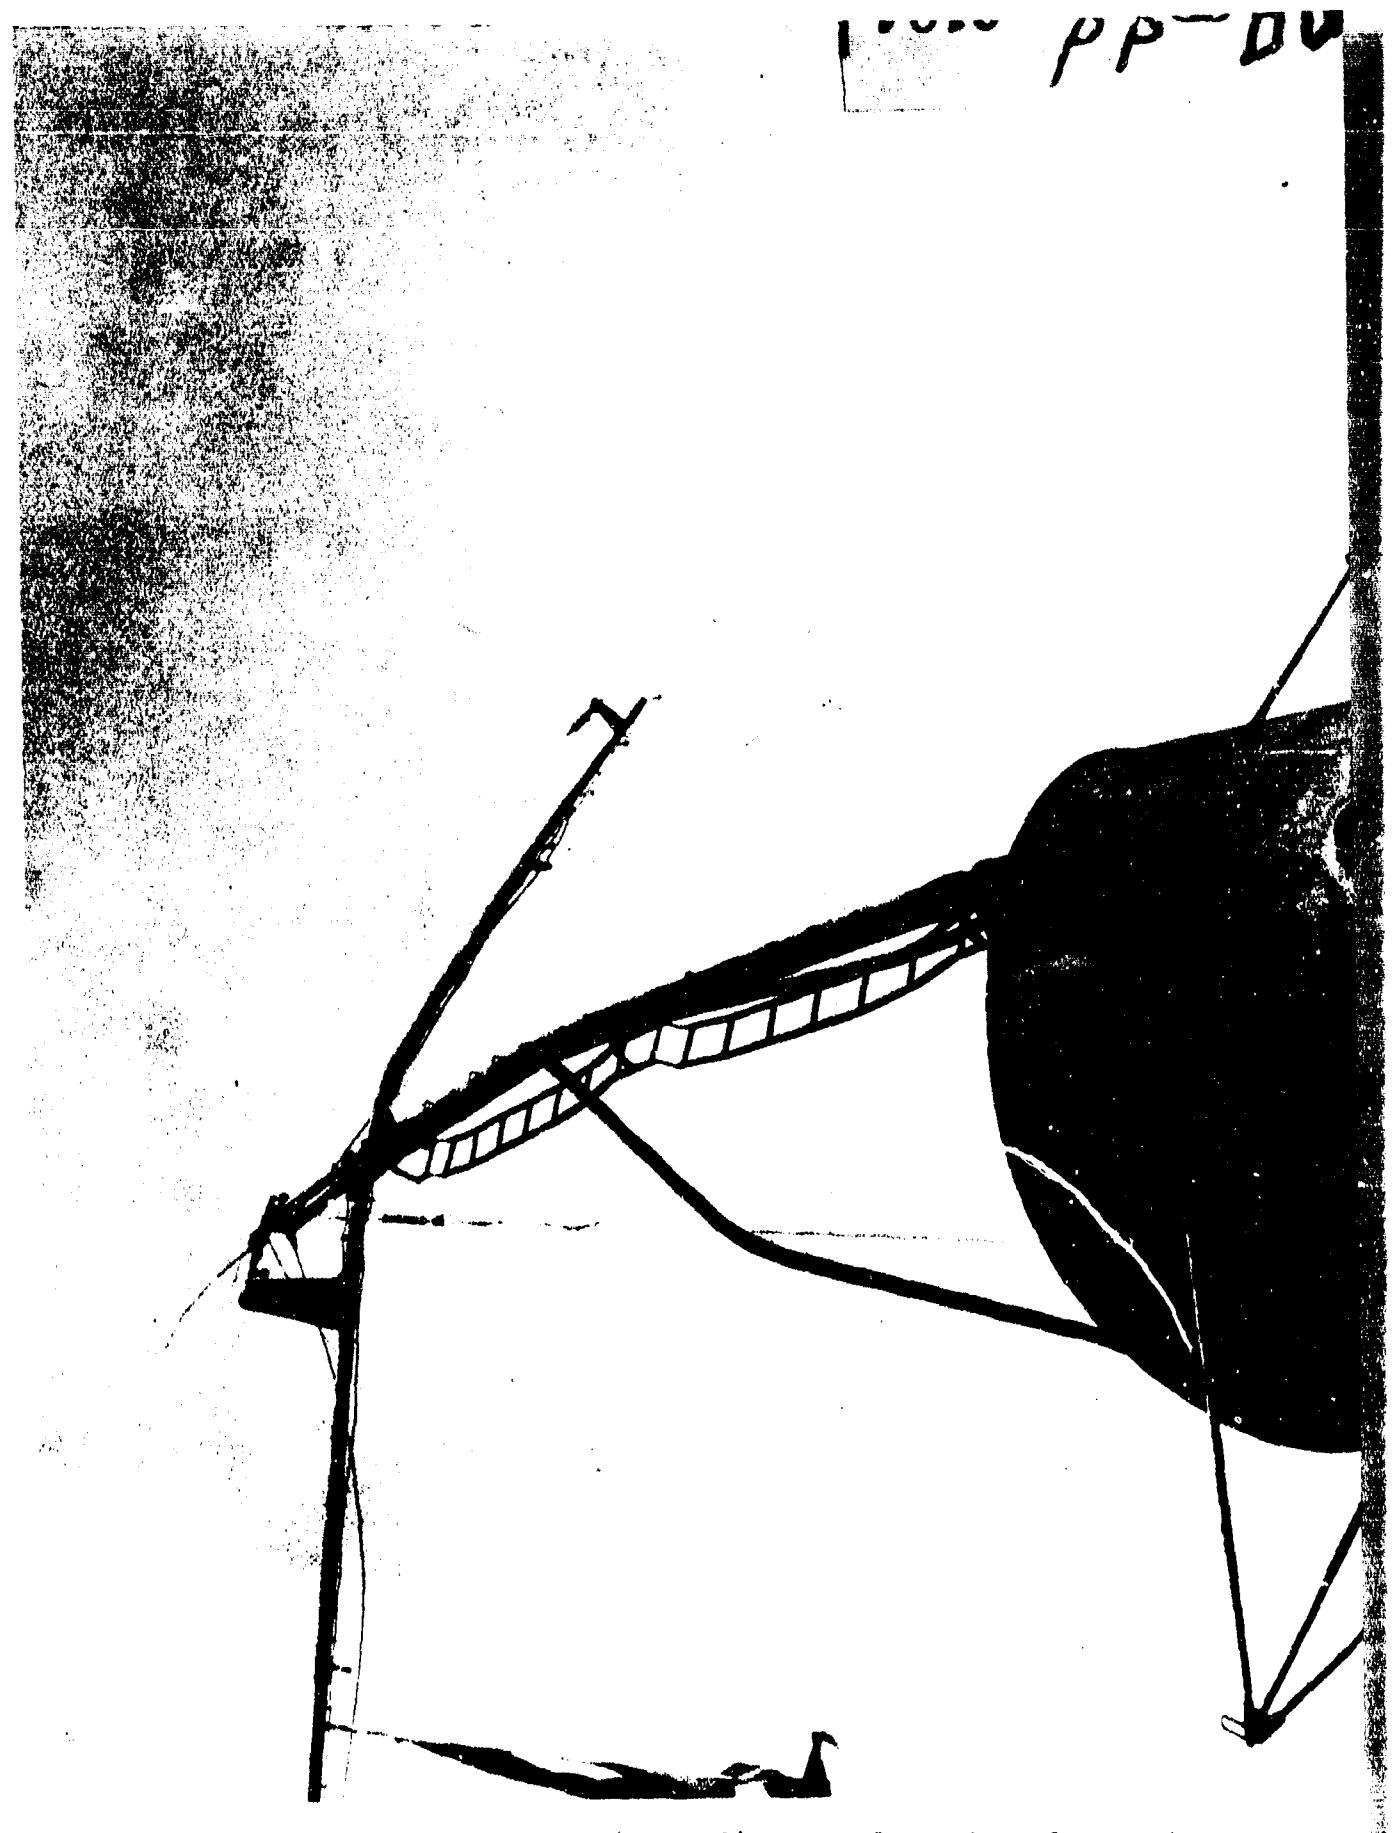
AA-CR-88-2104-10. U.S.S. DAWSON (APA79). Signal mast on forward stack.

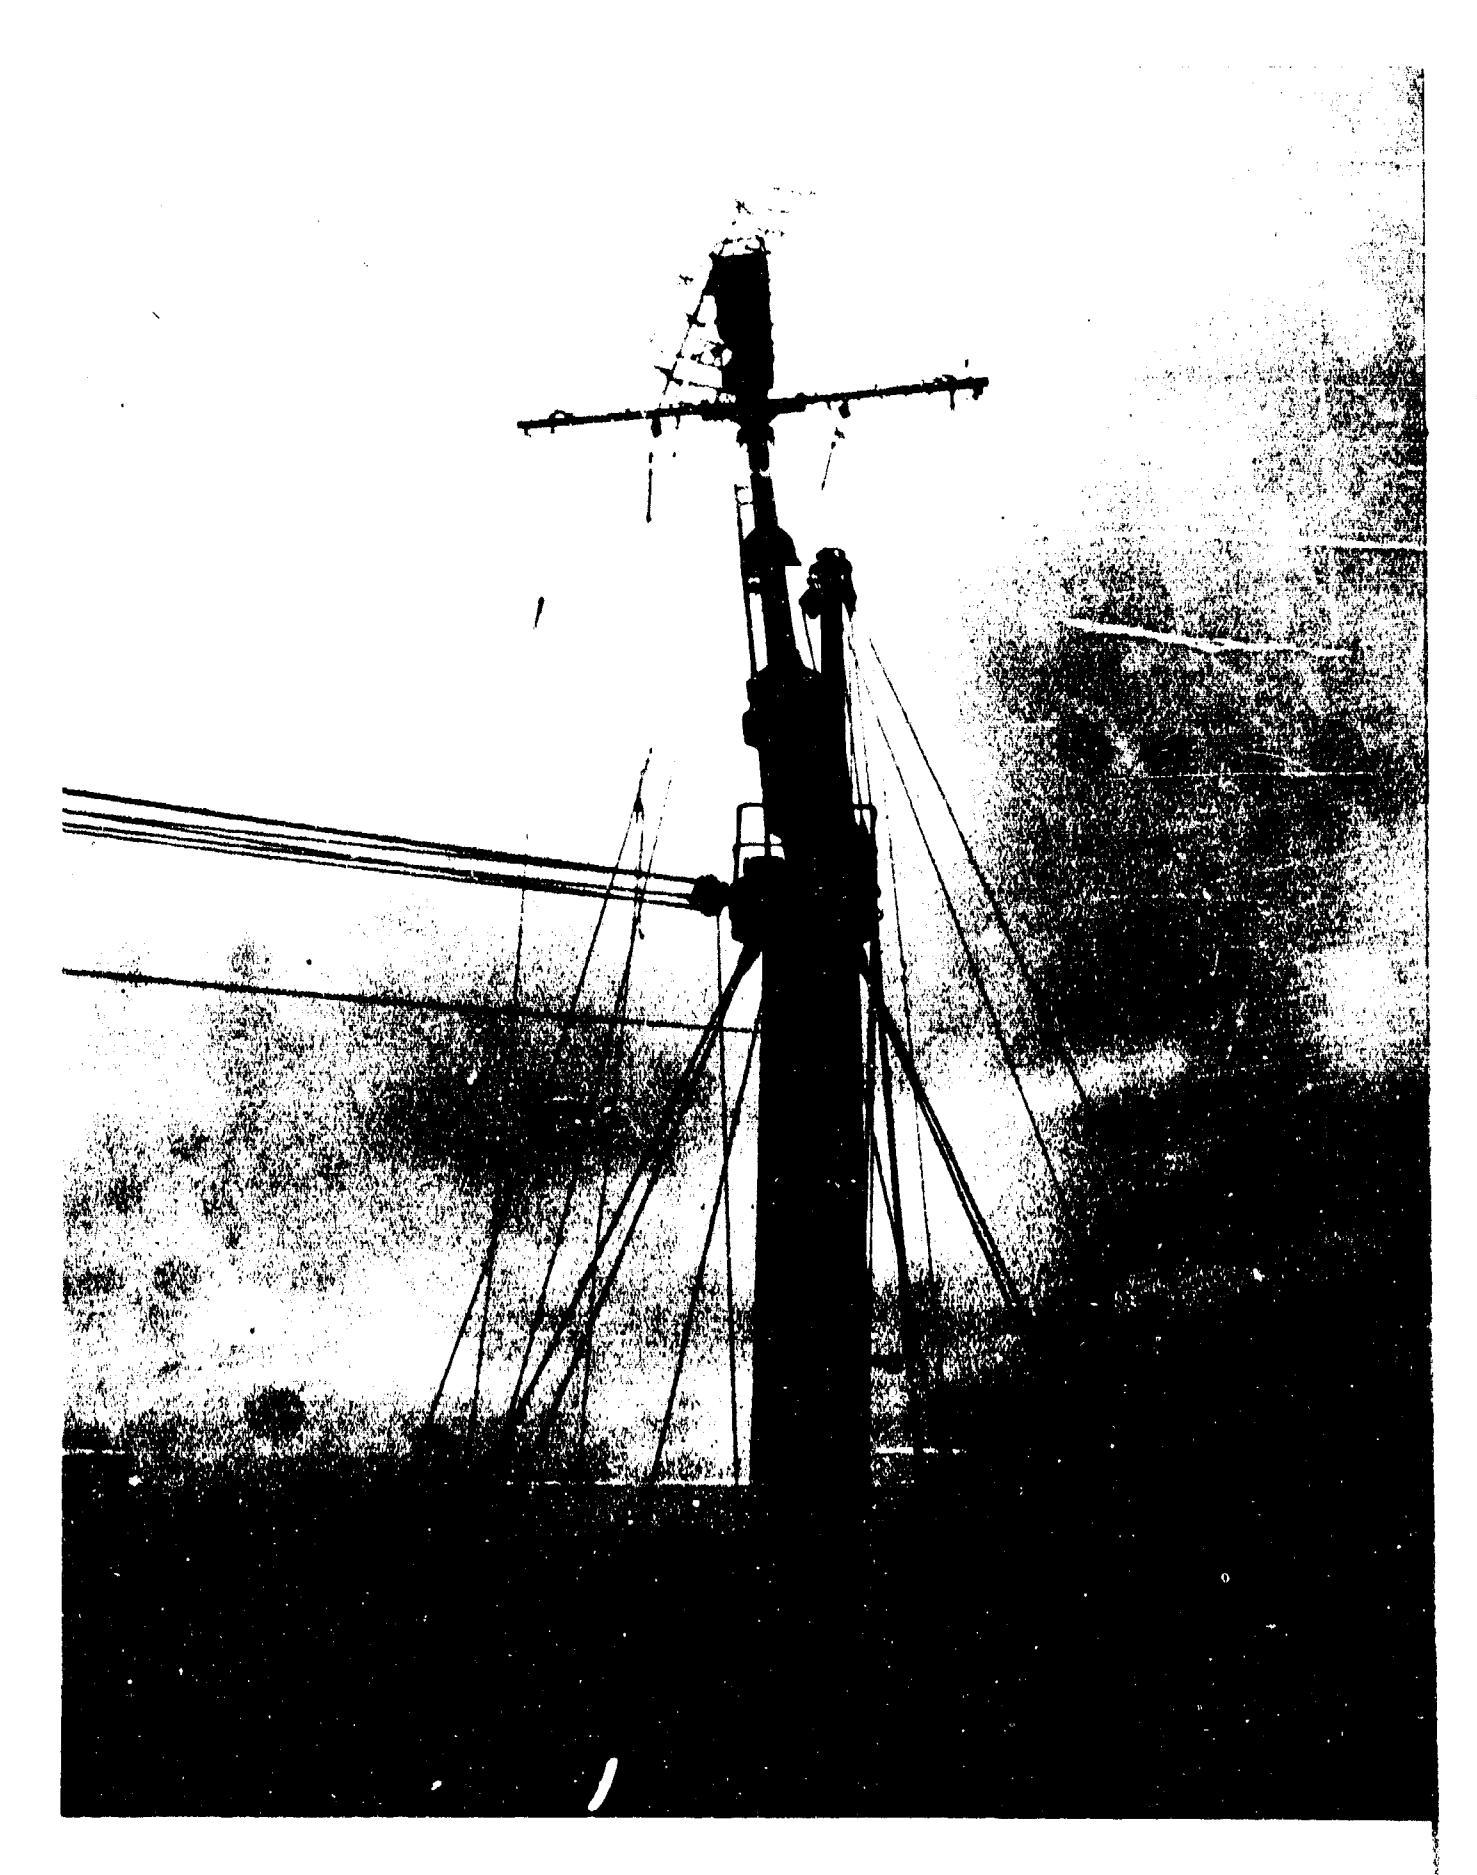
AA-CR-88-2103-1. U.S.S. DAWSON (APA79). Bend in main topmast showing displacement to starboard. Looking aft.

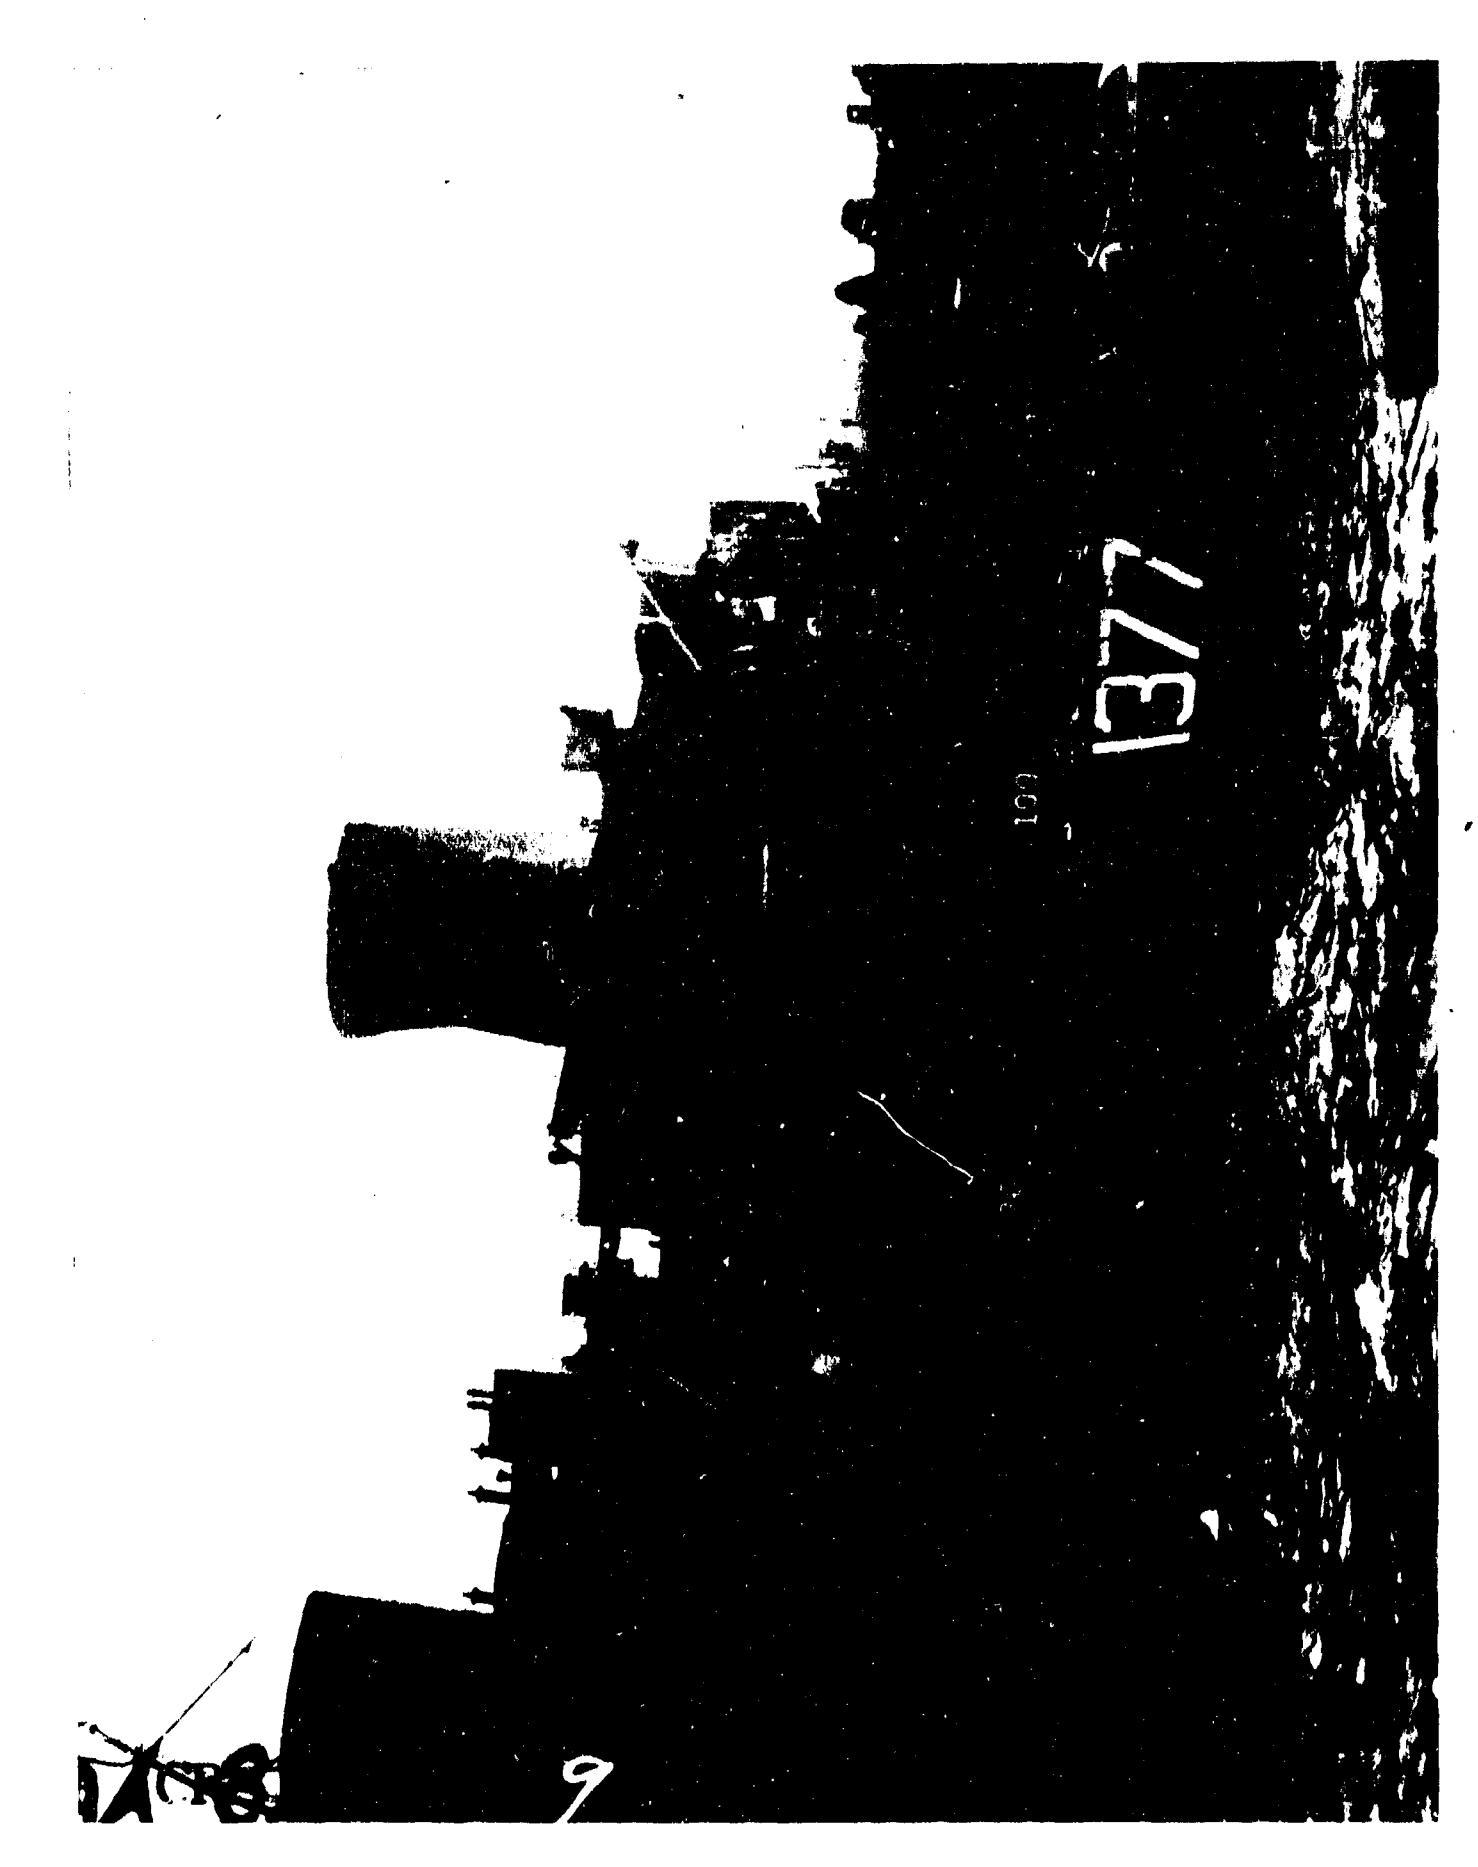
AA-CR-82-1922-9. U.S.S. DAWSON (APA79). View of No. 4 davit.

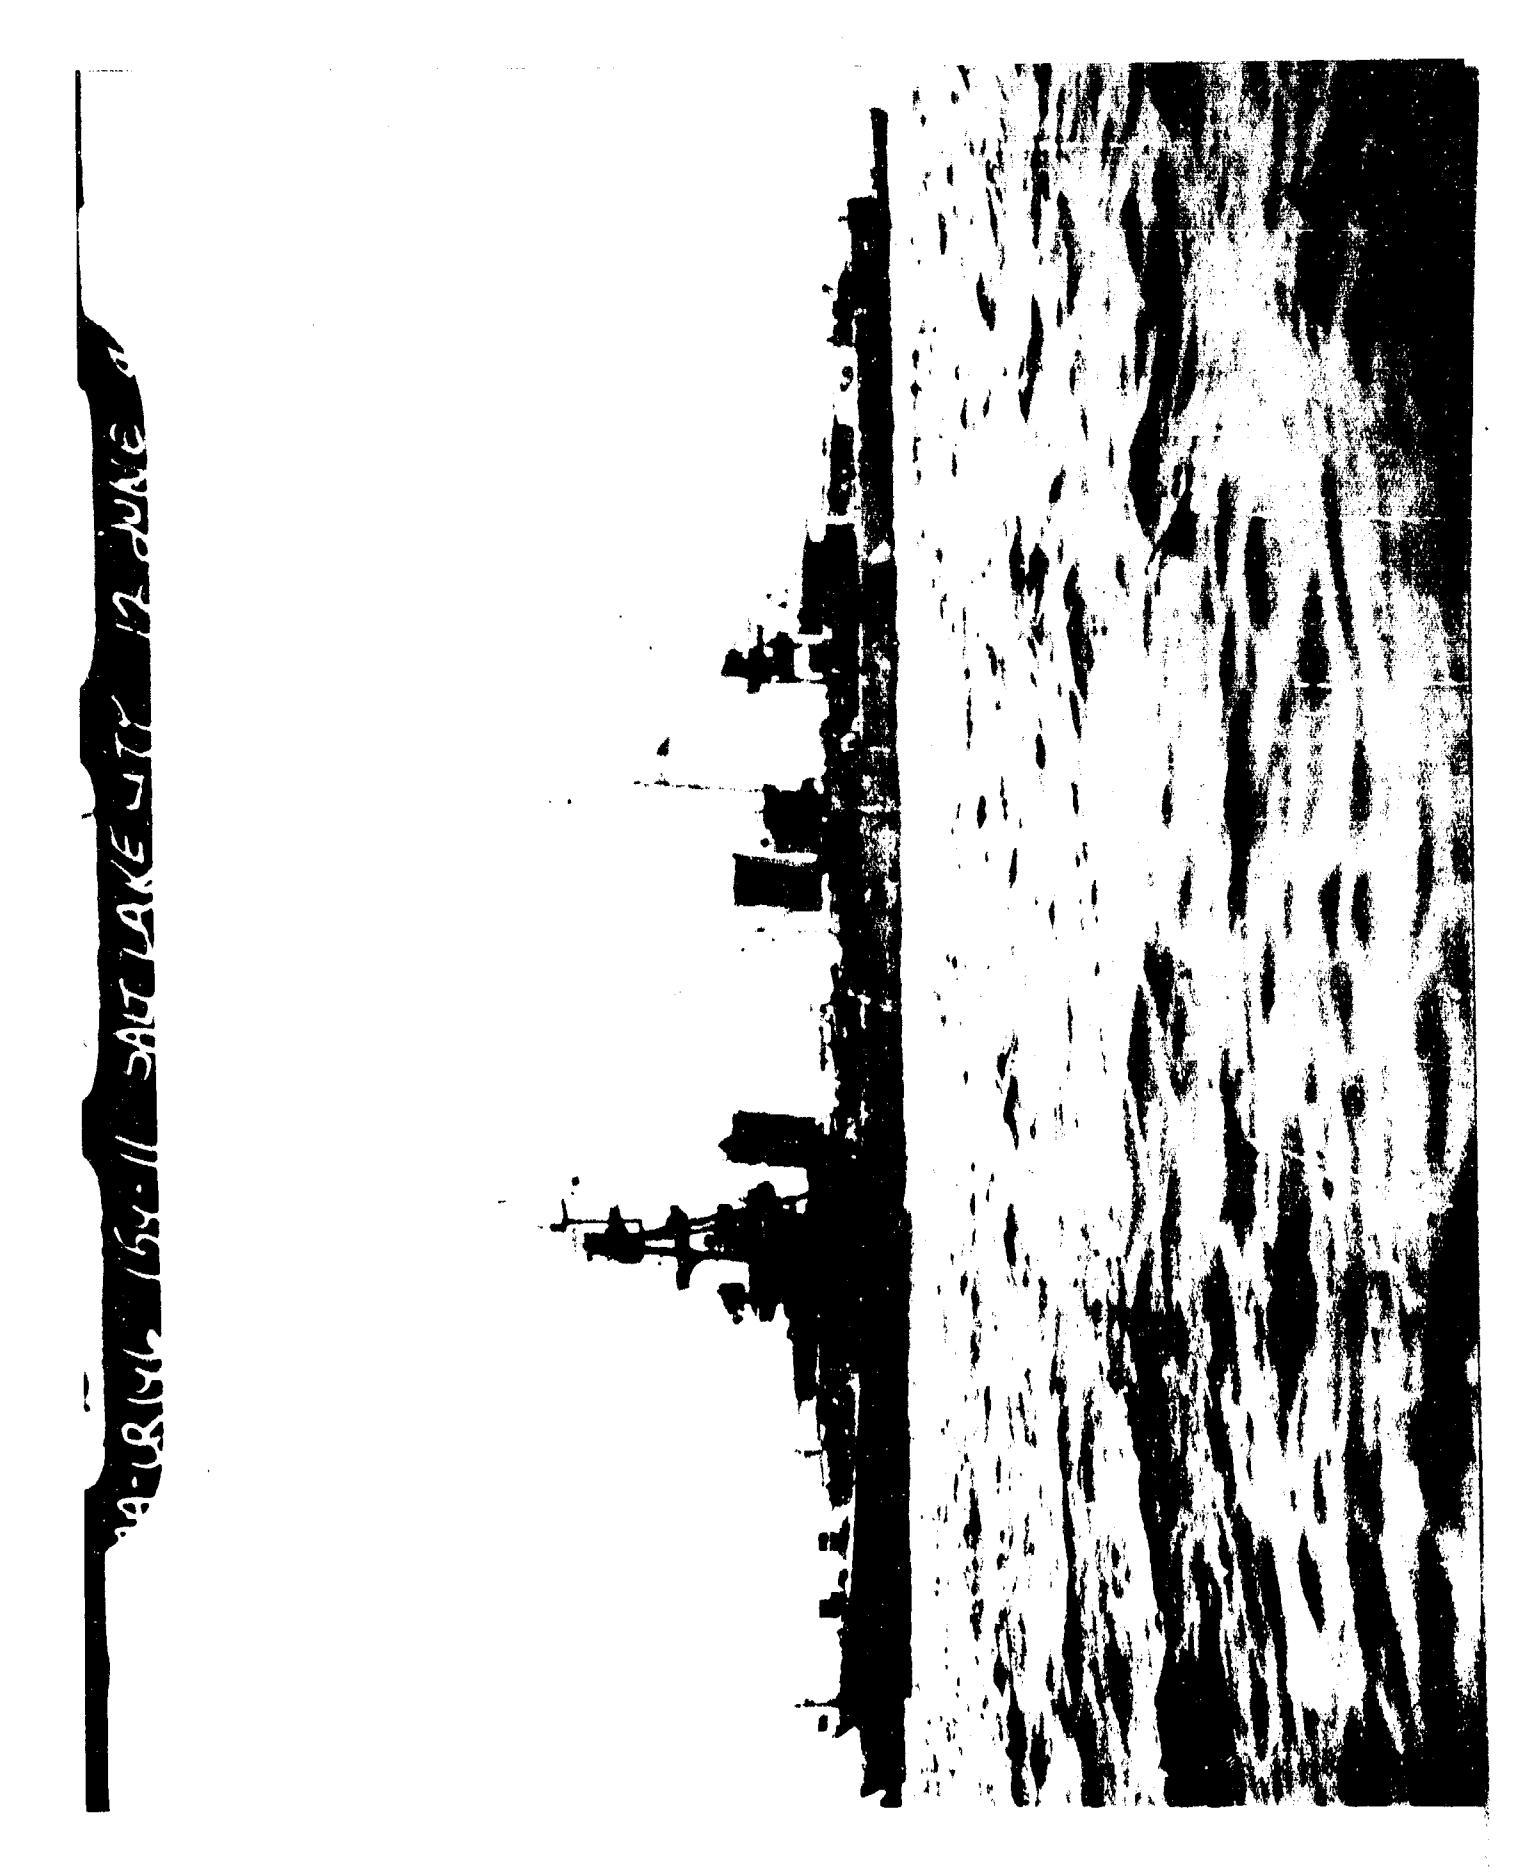
BA-CR-196-159-11. U.S.S. SALT LAKE CITY (CA25). View looking at port beam before Test A.

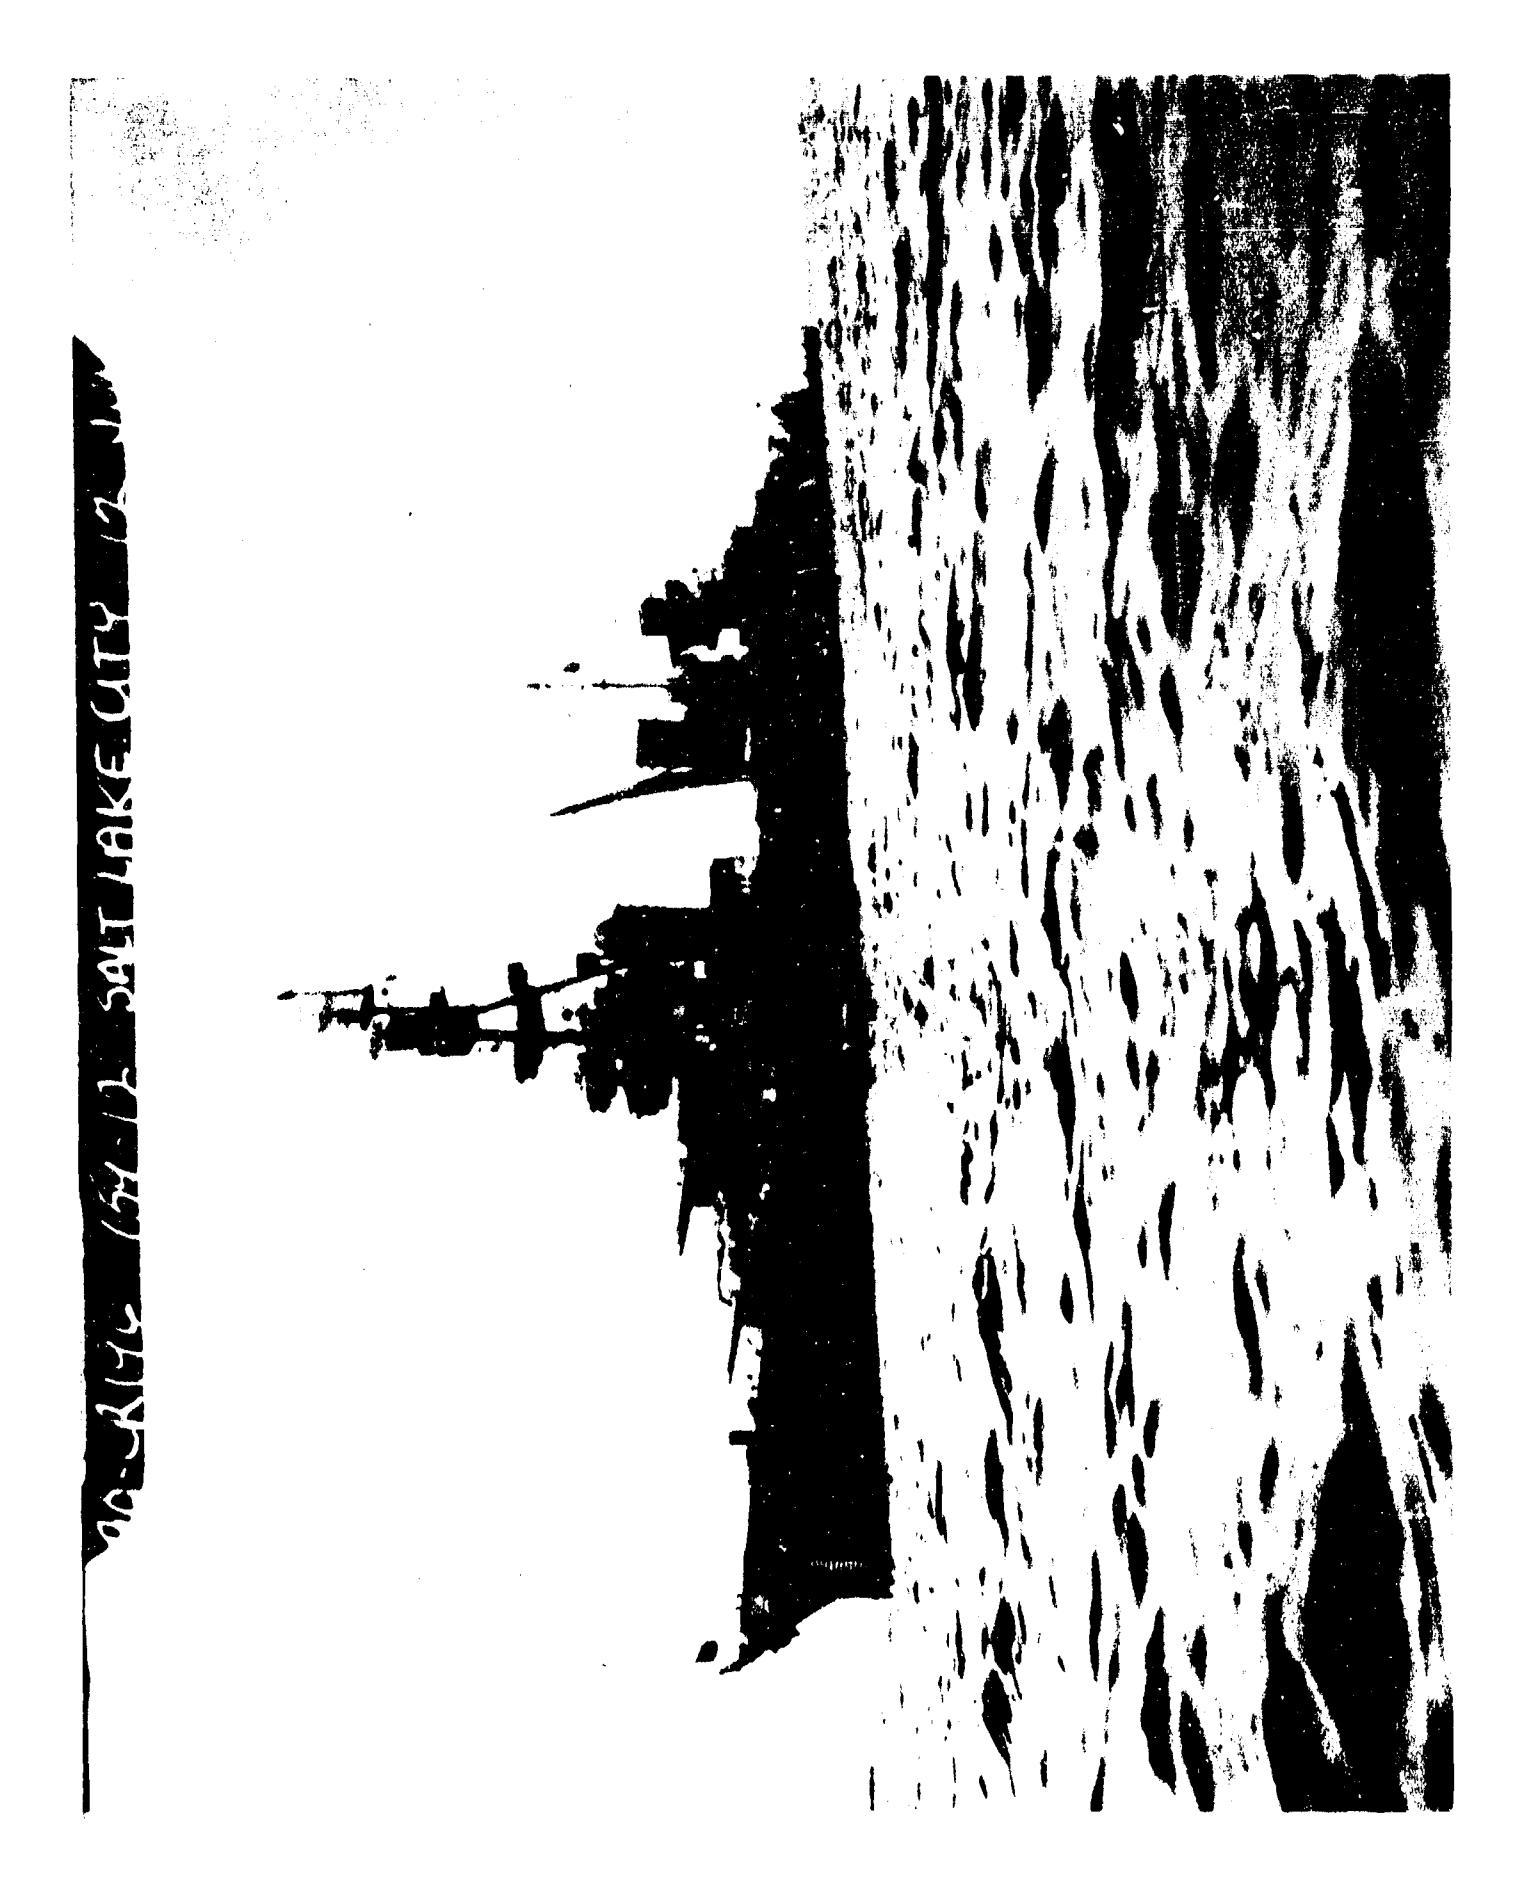
BA-CR-196-159-12. U.S.S. SALT LAKE CITY (CA25). View looking at port bow before Test A.

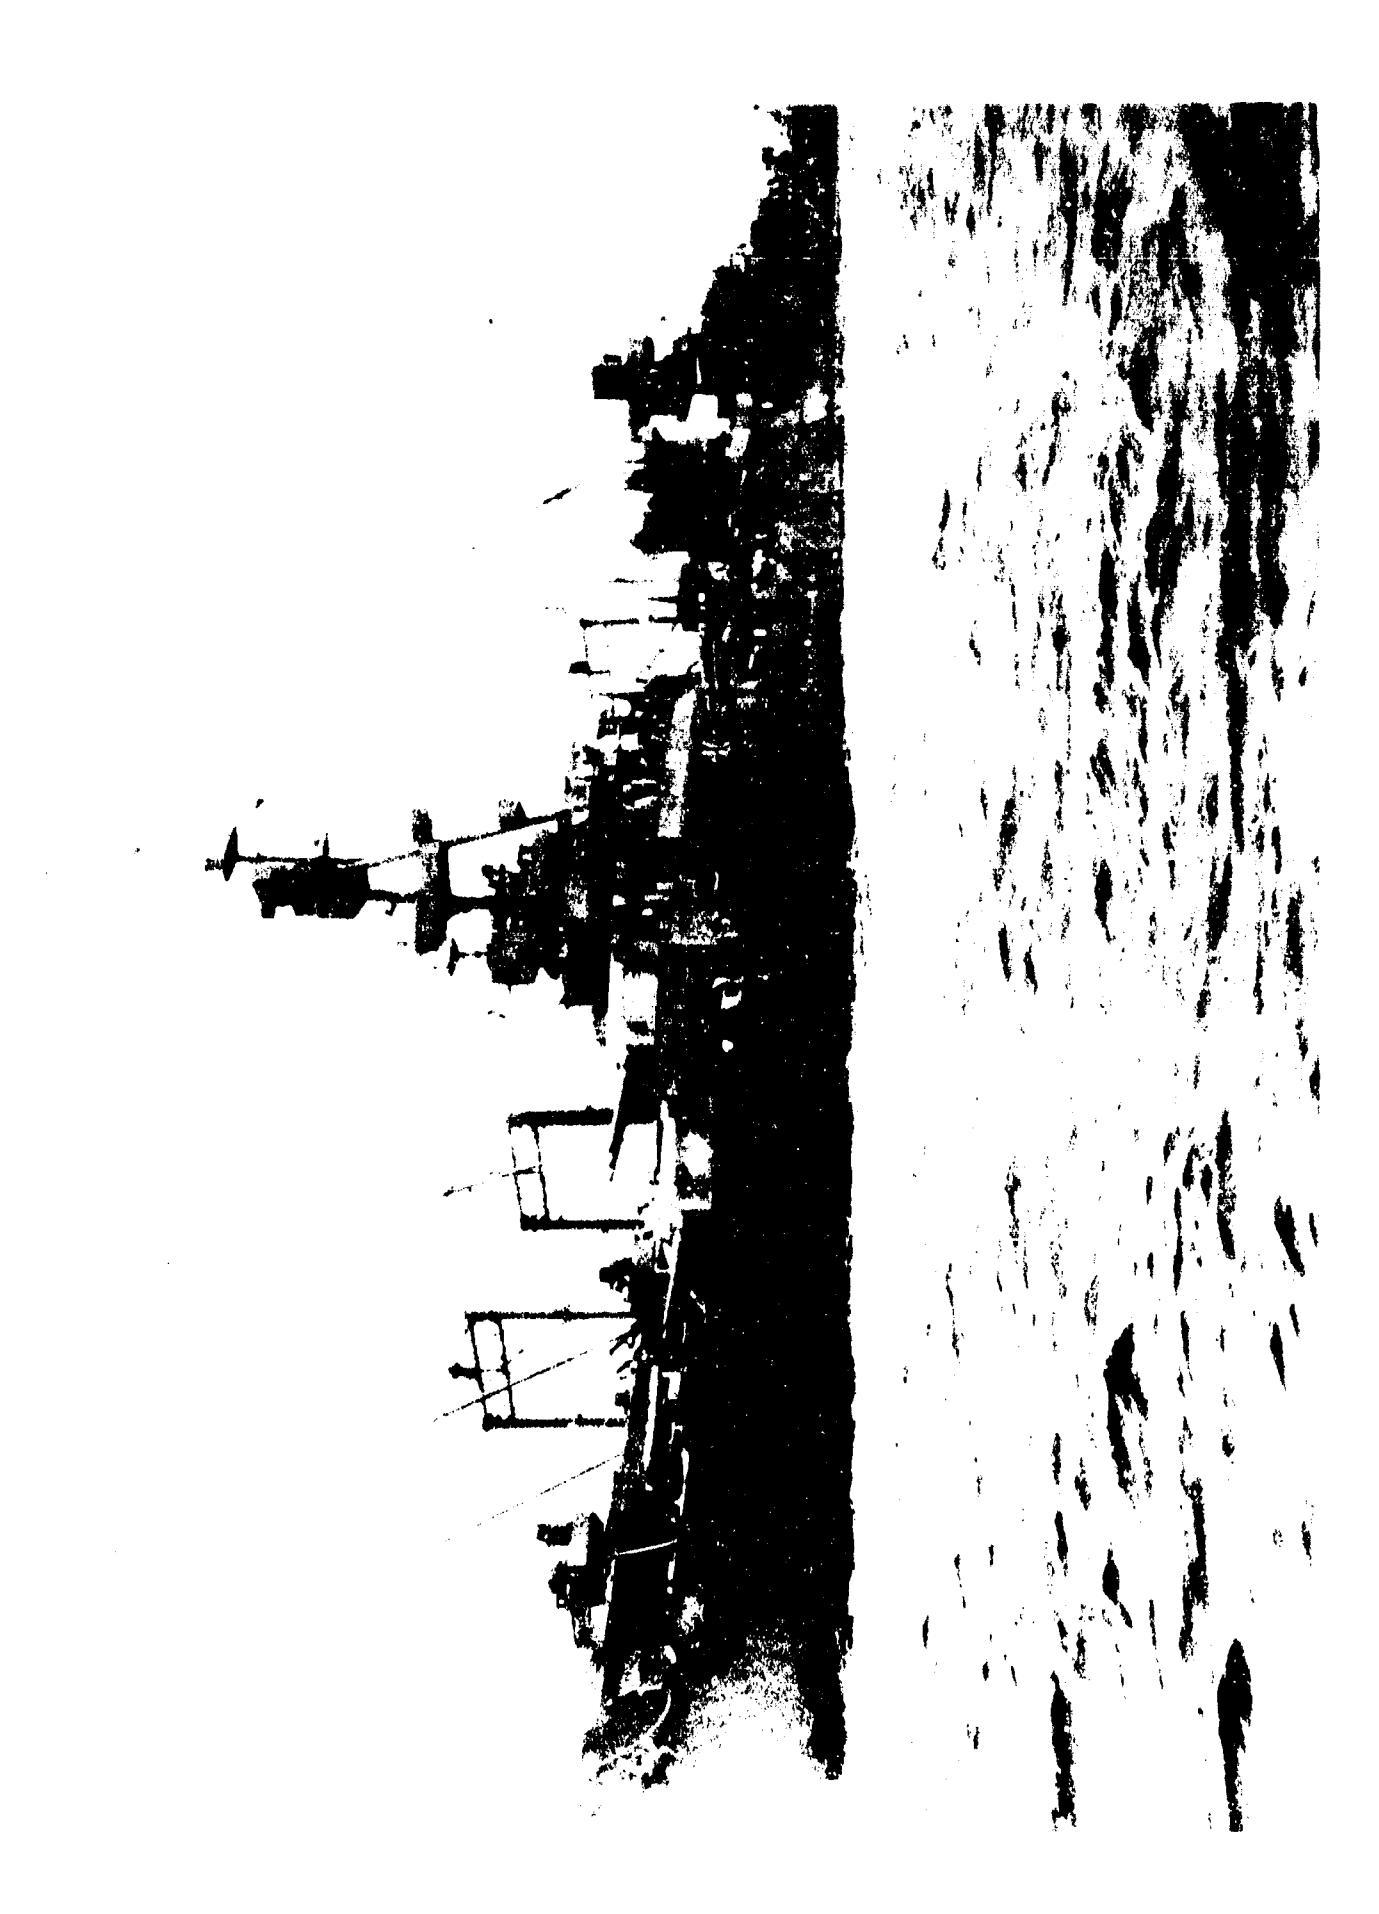
AA-CR-227-50-116. U.S.S. SALT LAKE CITY (CA25). View looking at port bow after Test A.

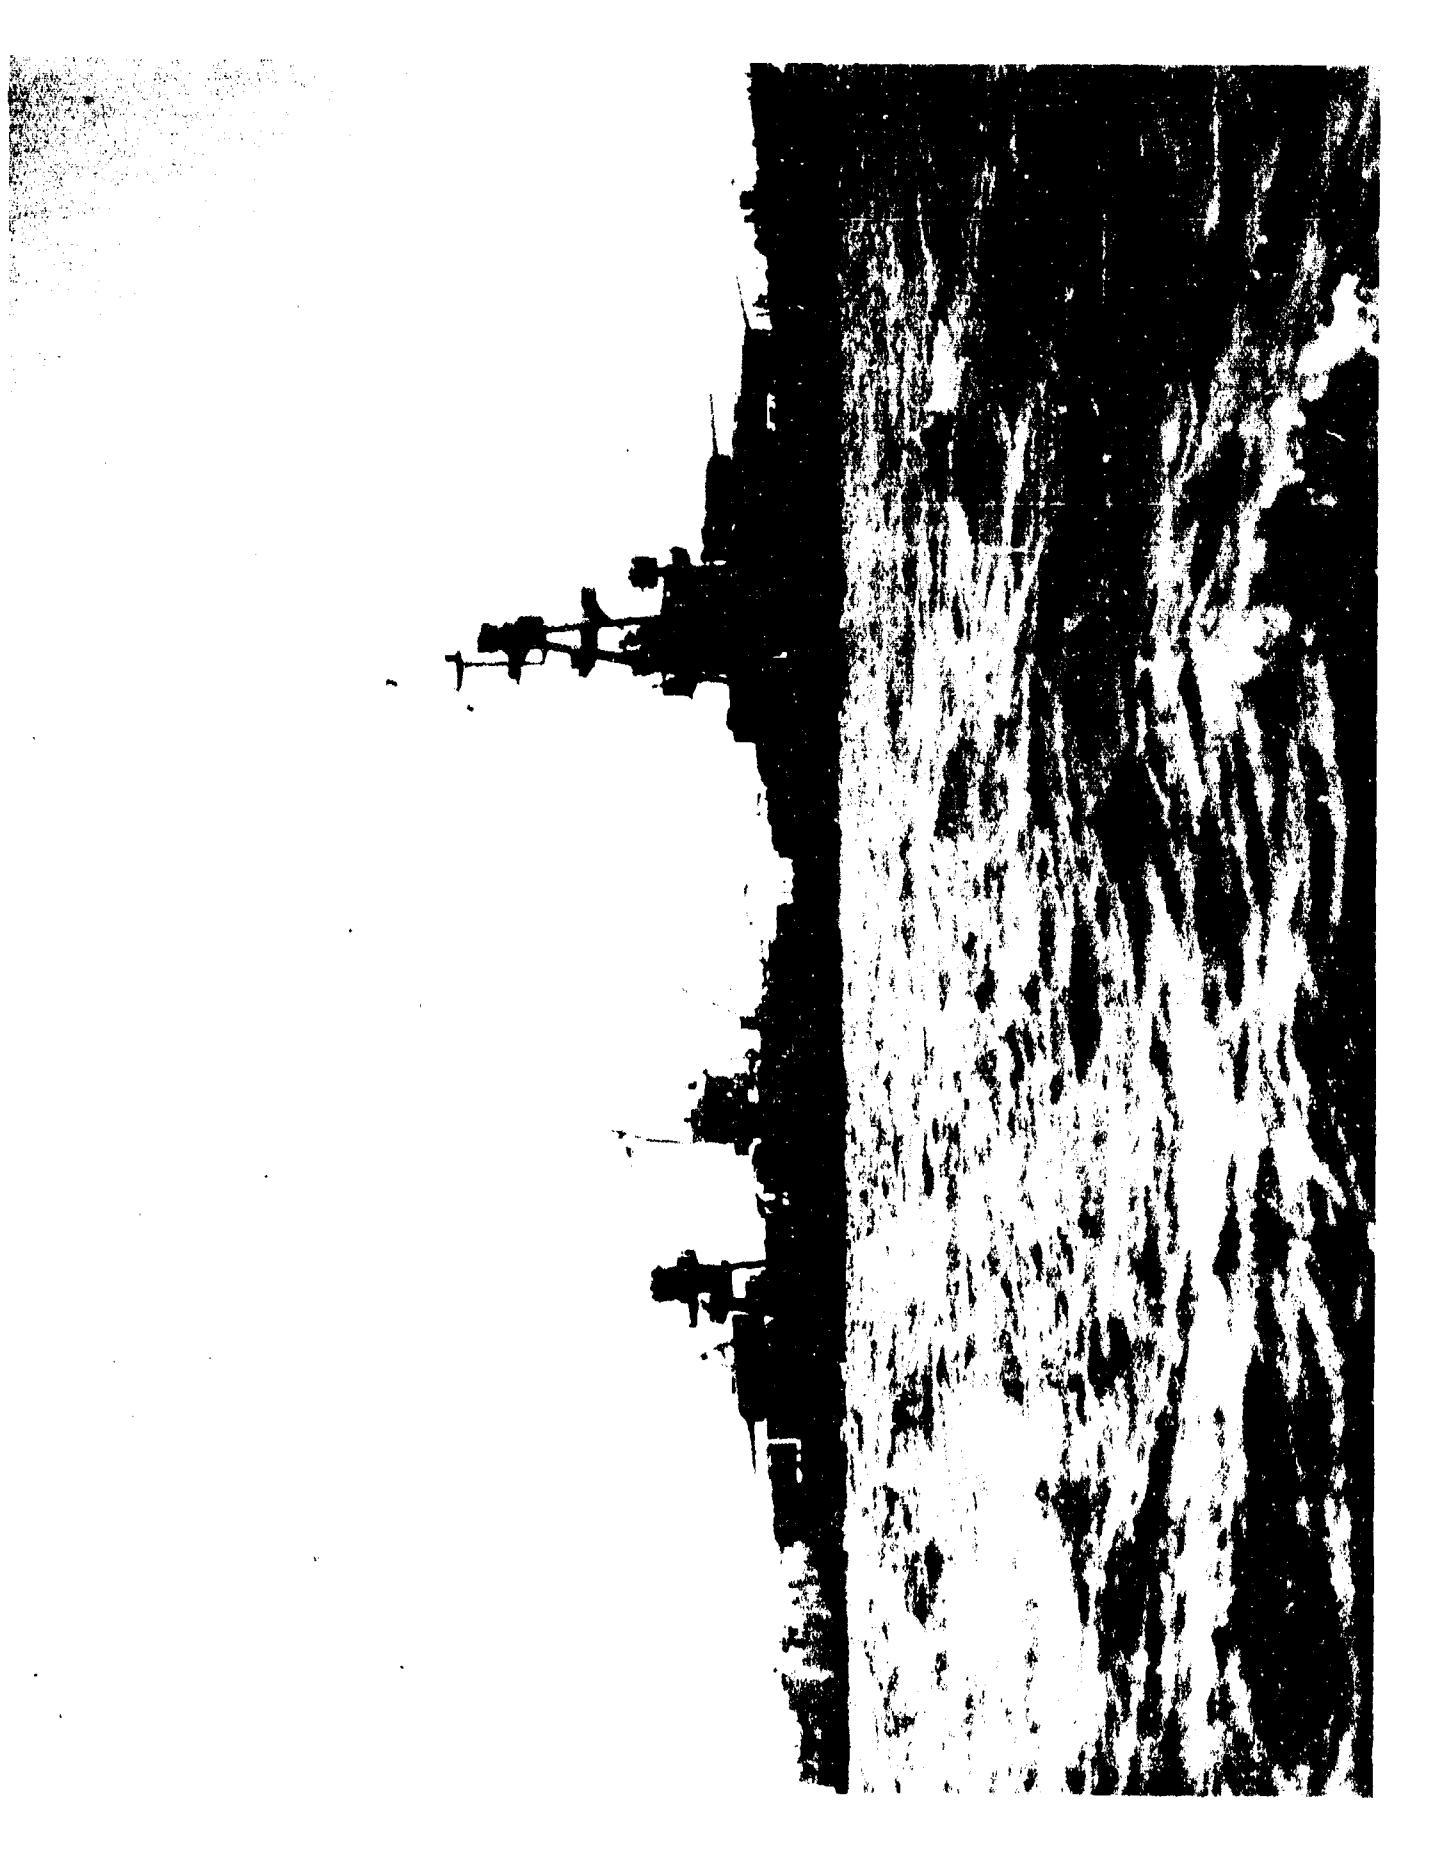
AA-CR-227-91-47. U.S.S. SALT LAKE CITY (CA25). View looking at starboard beam after Test A.

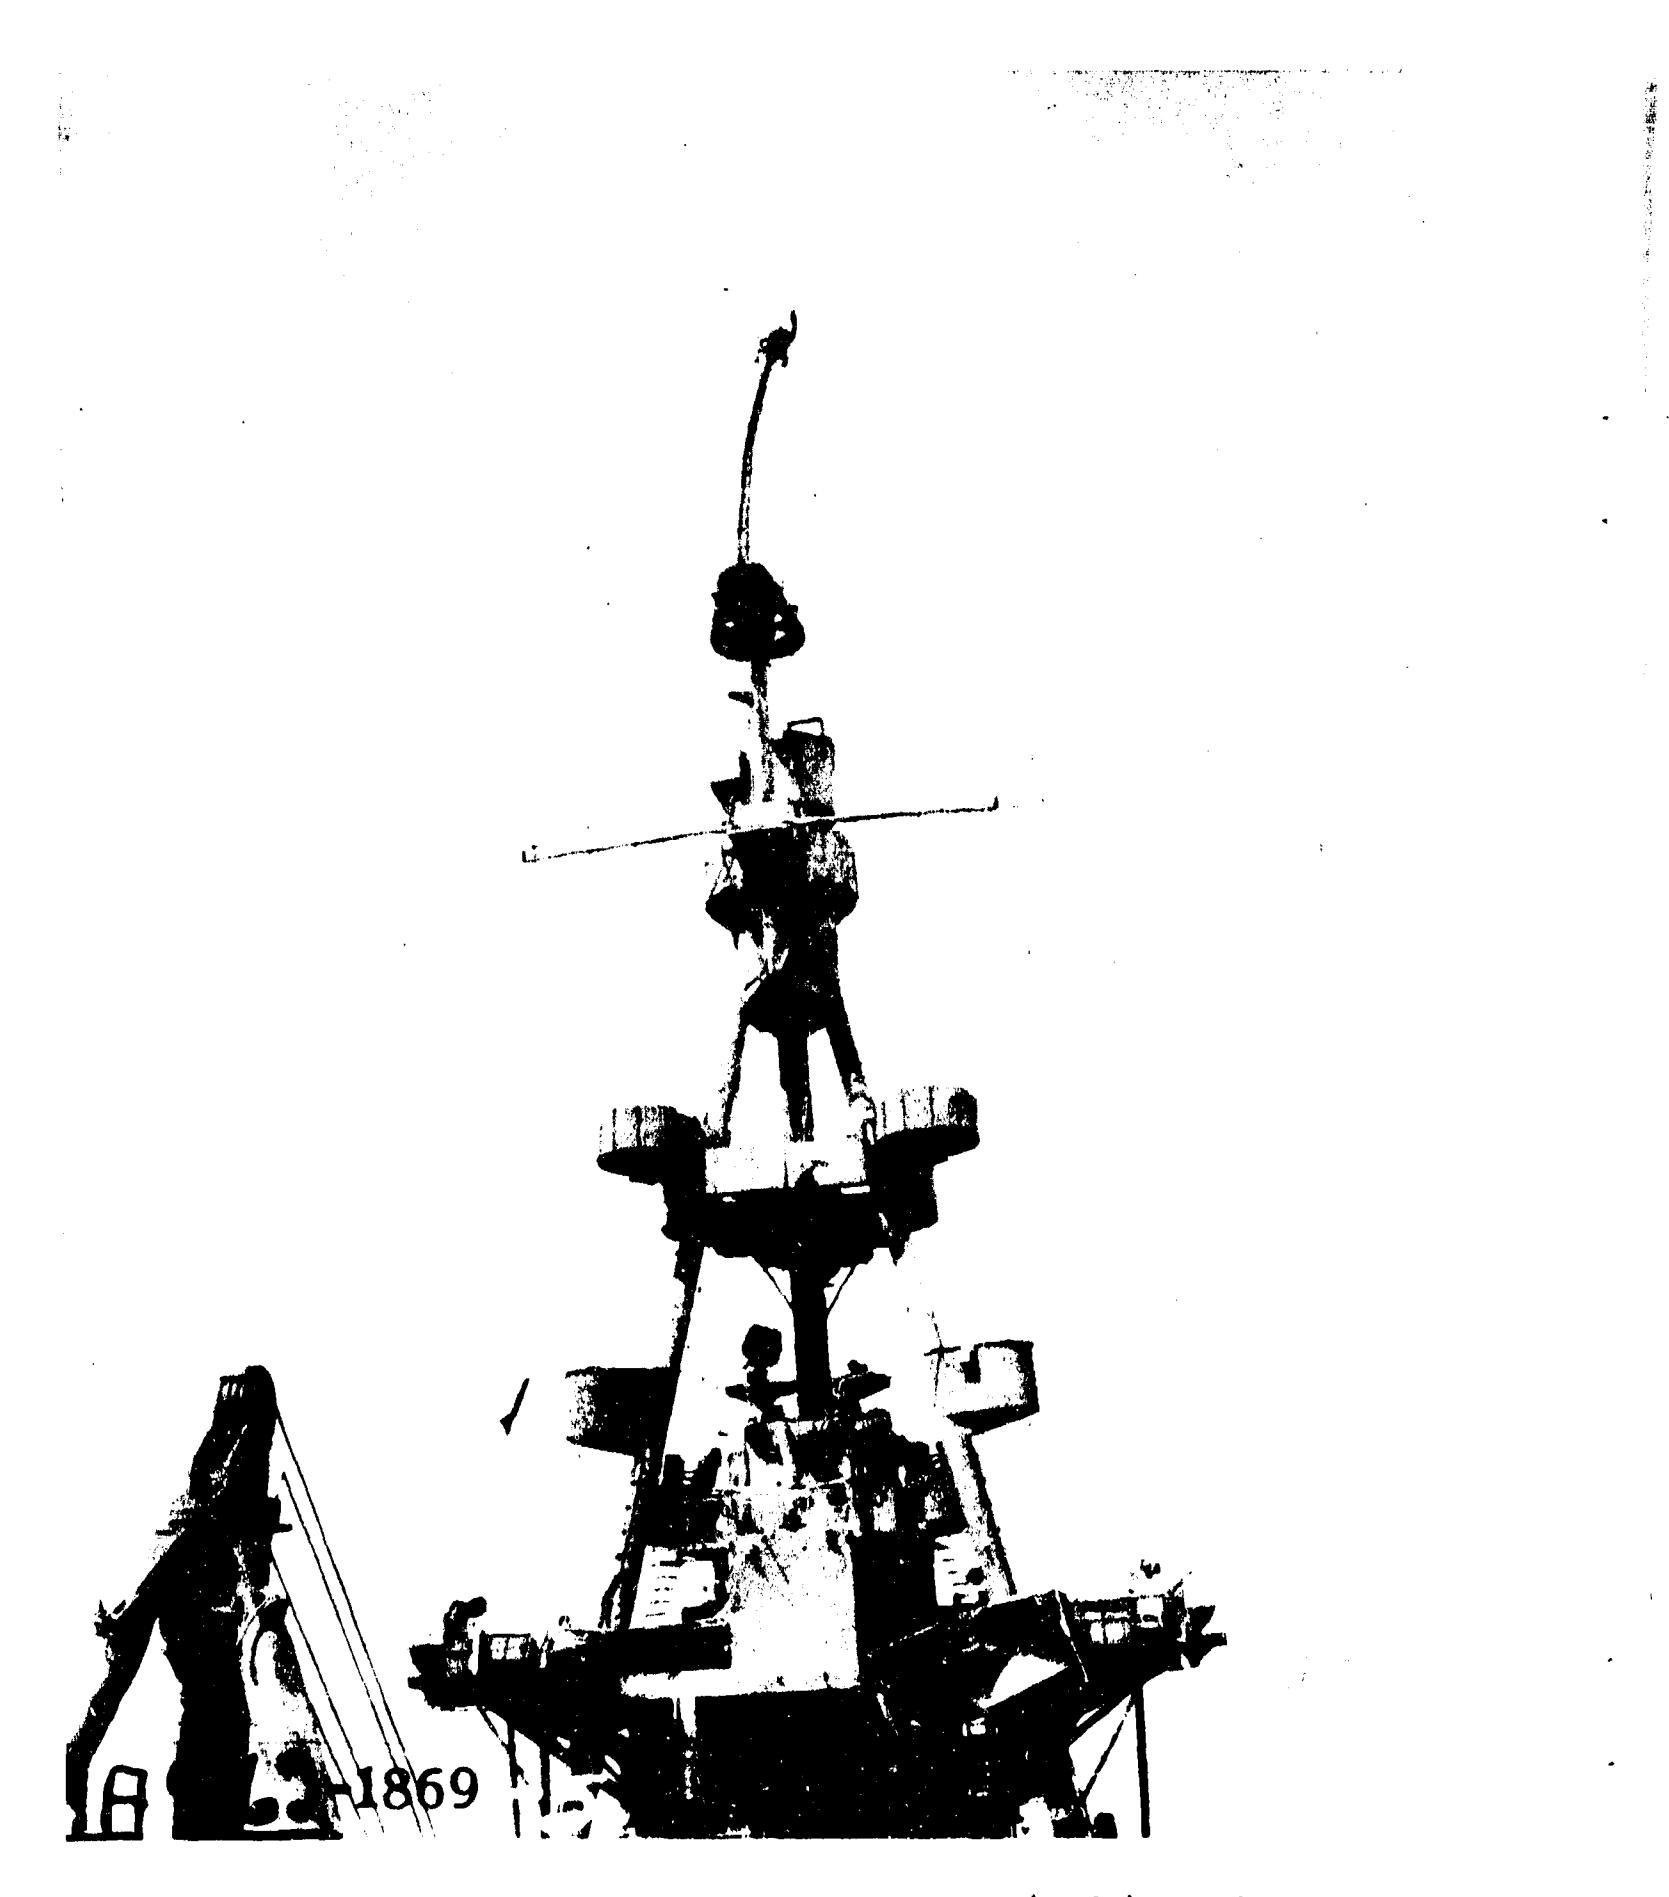
AA-CR-62-1869-5. U.S.S.SALT LAKE CITY (CA25). Looking forward at top of forward tripod and radar polemast from frame 74.
