BUREAU OF SHIPS GROUP

TECHNICAL INSPECTION REPORT

FAILURES OF MASTS, YARDARMS, BOOMS, AND RIGGING

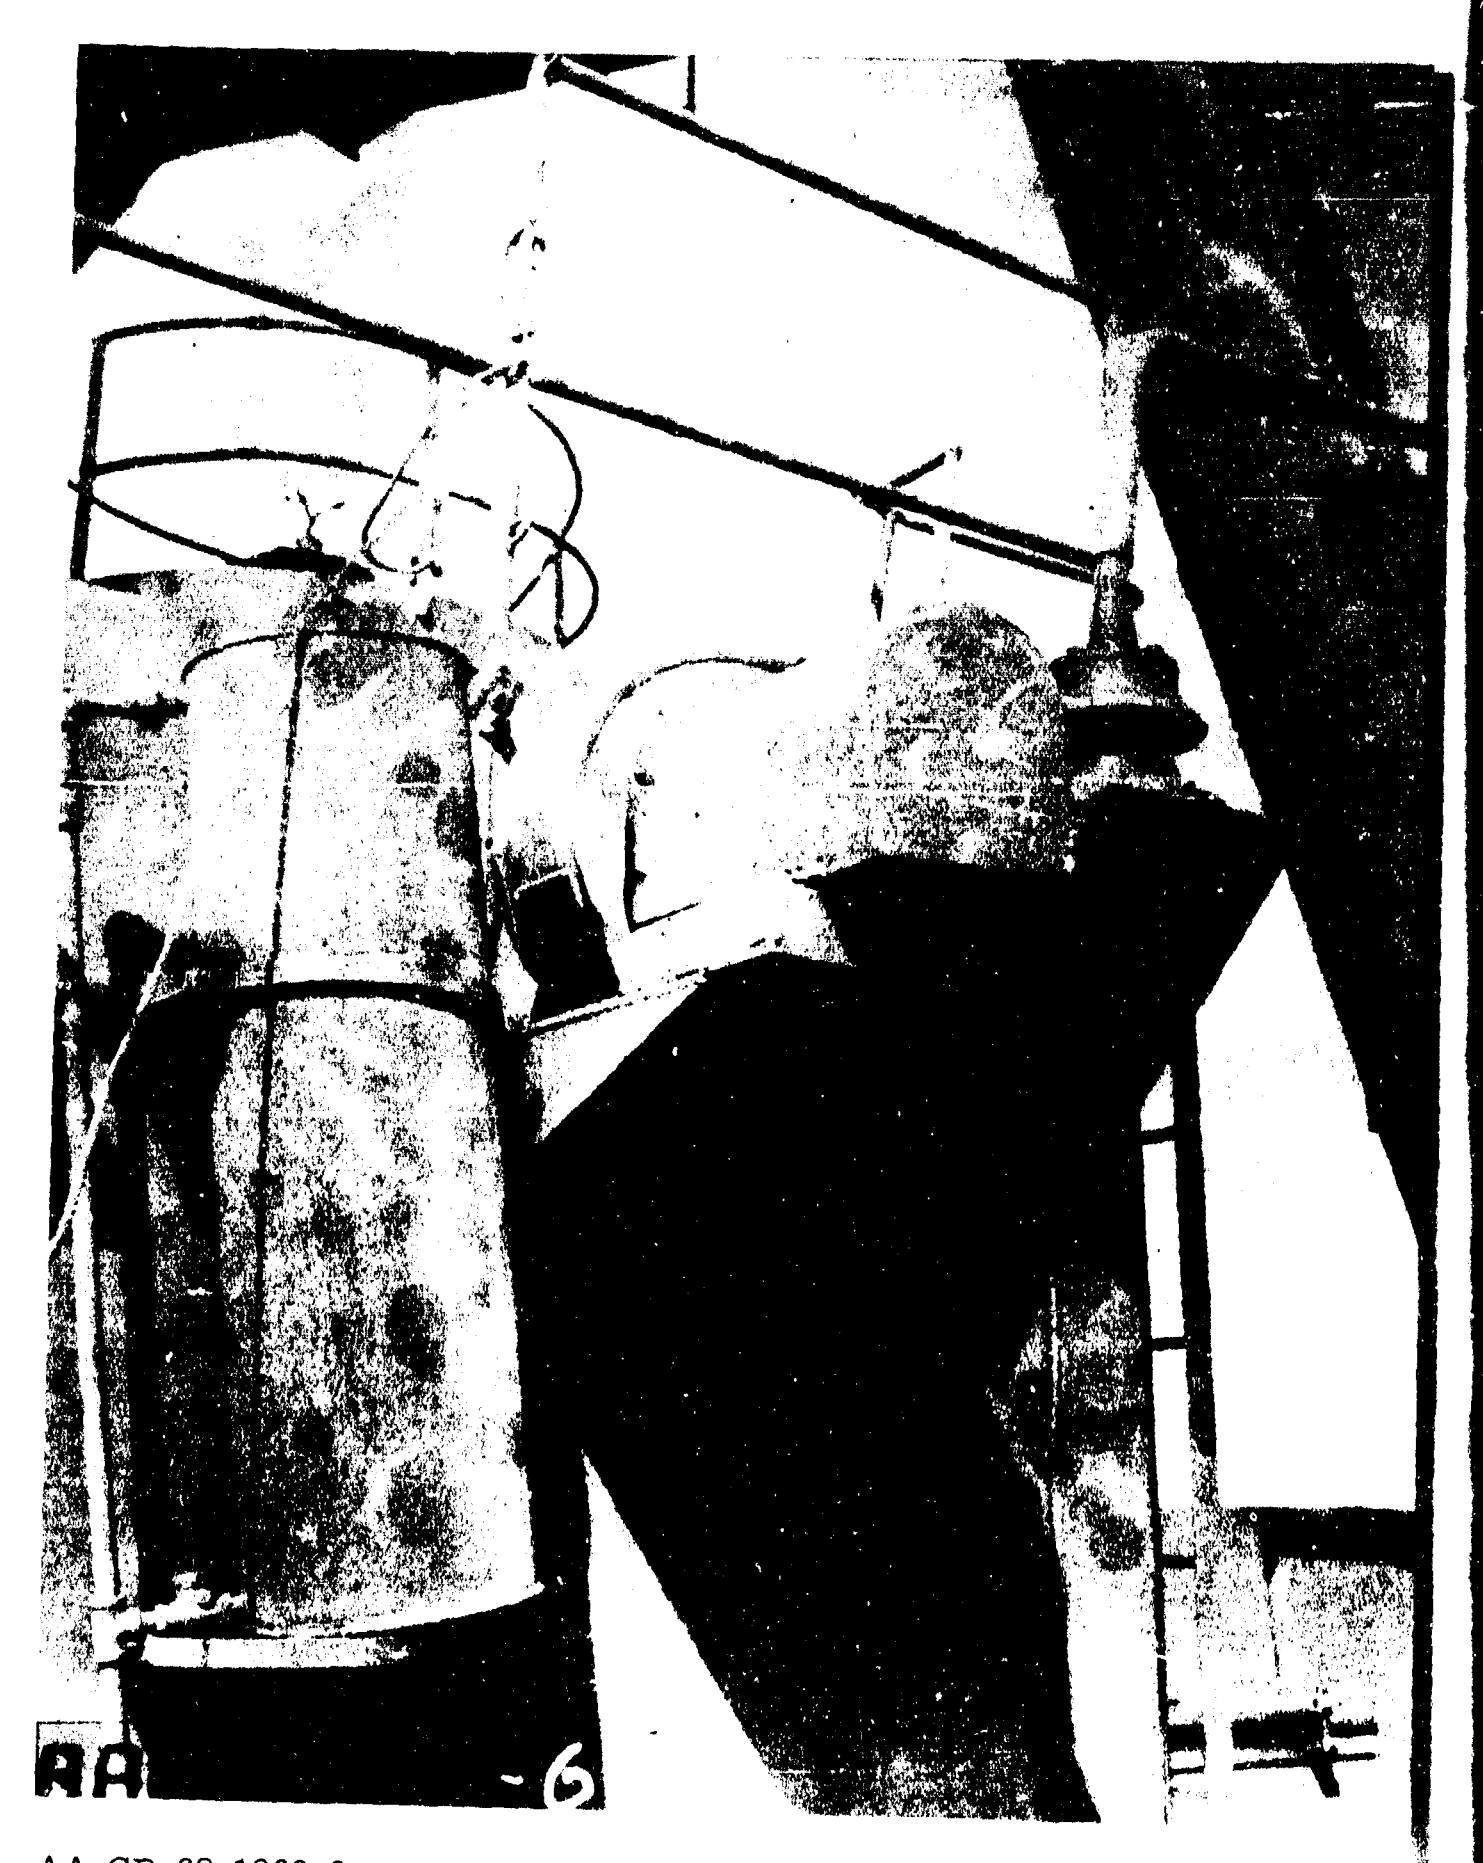
AA-CR-62-1869-6. U.S.S. SALT LAKE CITY (CA25). View showing effect of blast on TBM radio whip antennae.

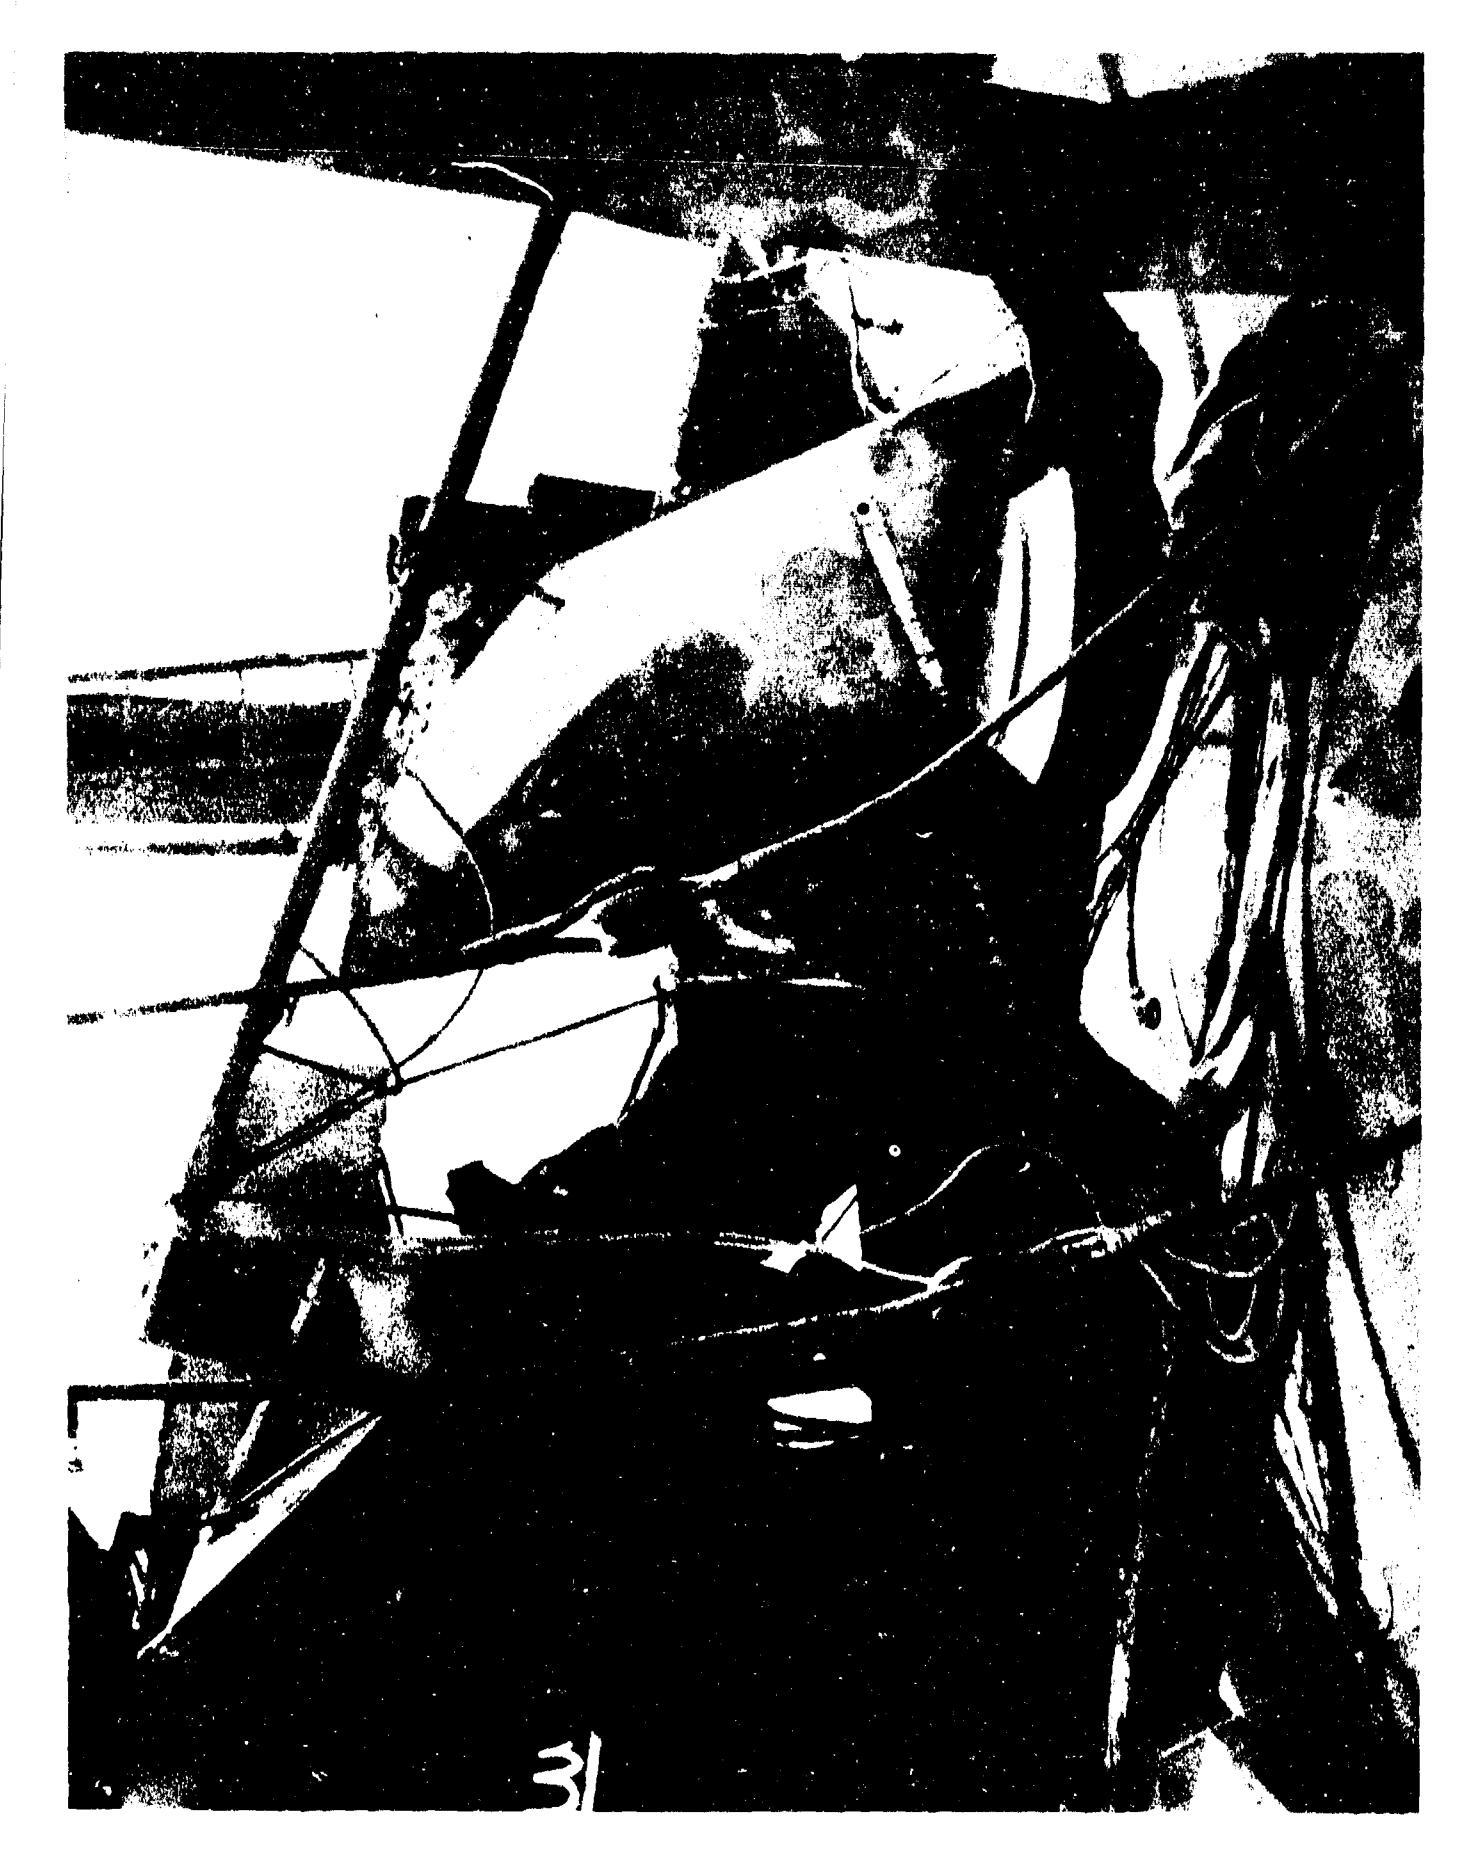
AA-CR-62-1869-3. U.S.S. SALT LAKE CITY (CA25). View of port side navigating bridge level.

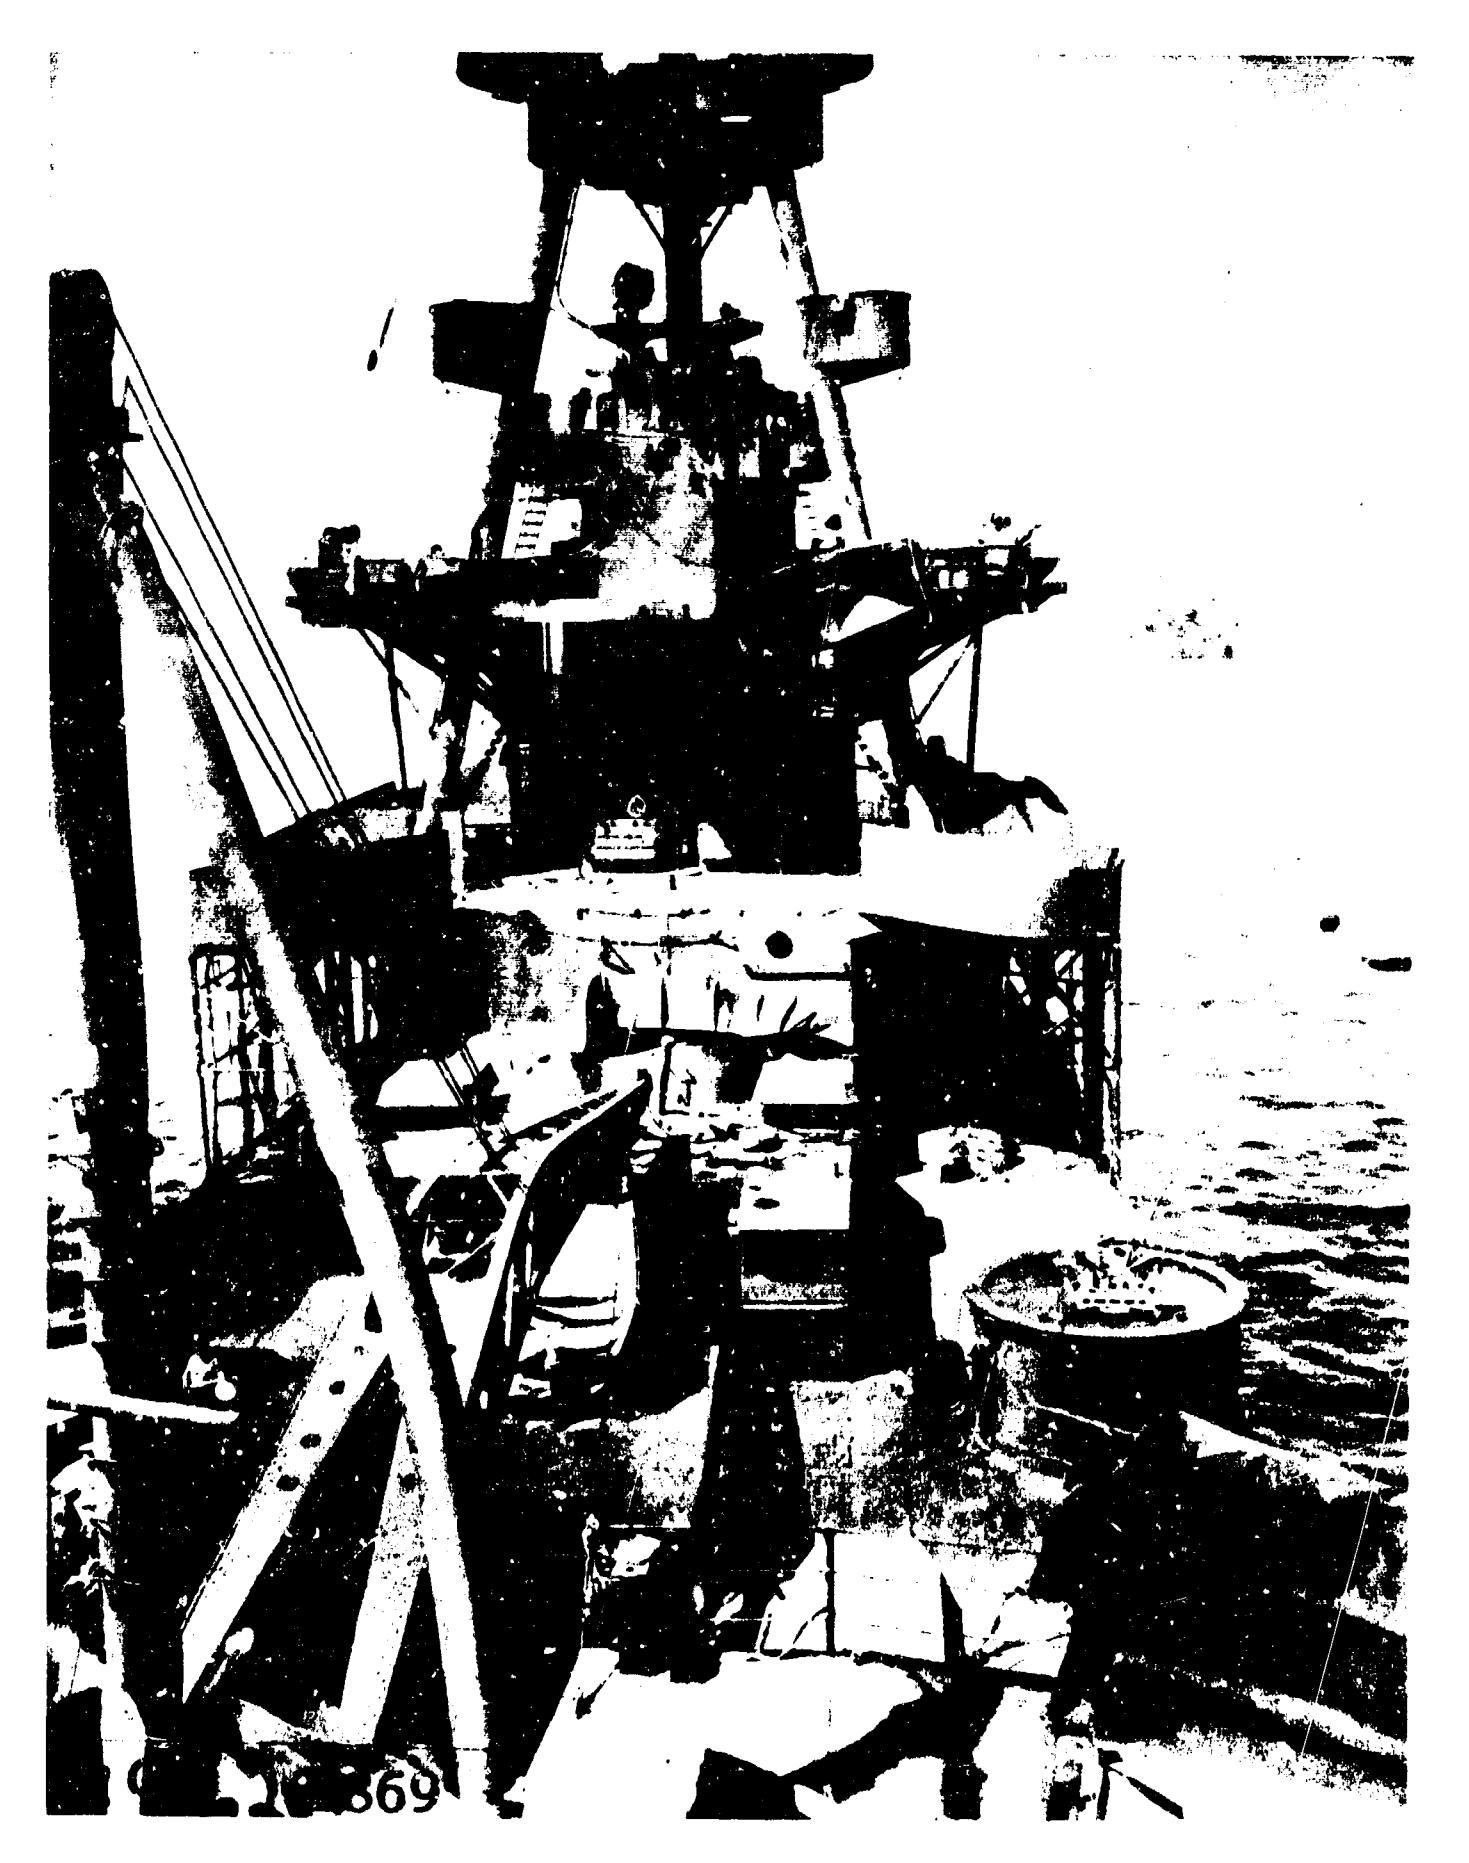
AA-CR-62-1869-4. U.S.S. SALT LAKE CITY (CA25). Looking at forward tripod from frame 74.

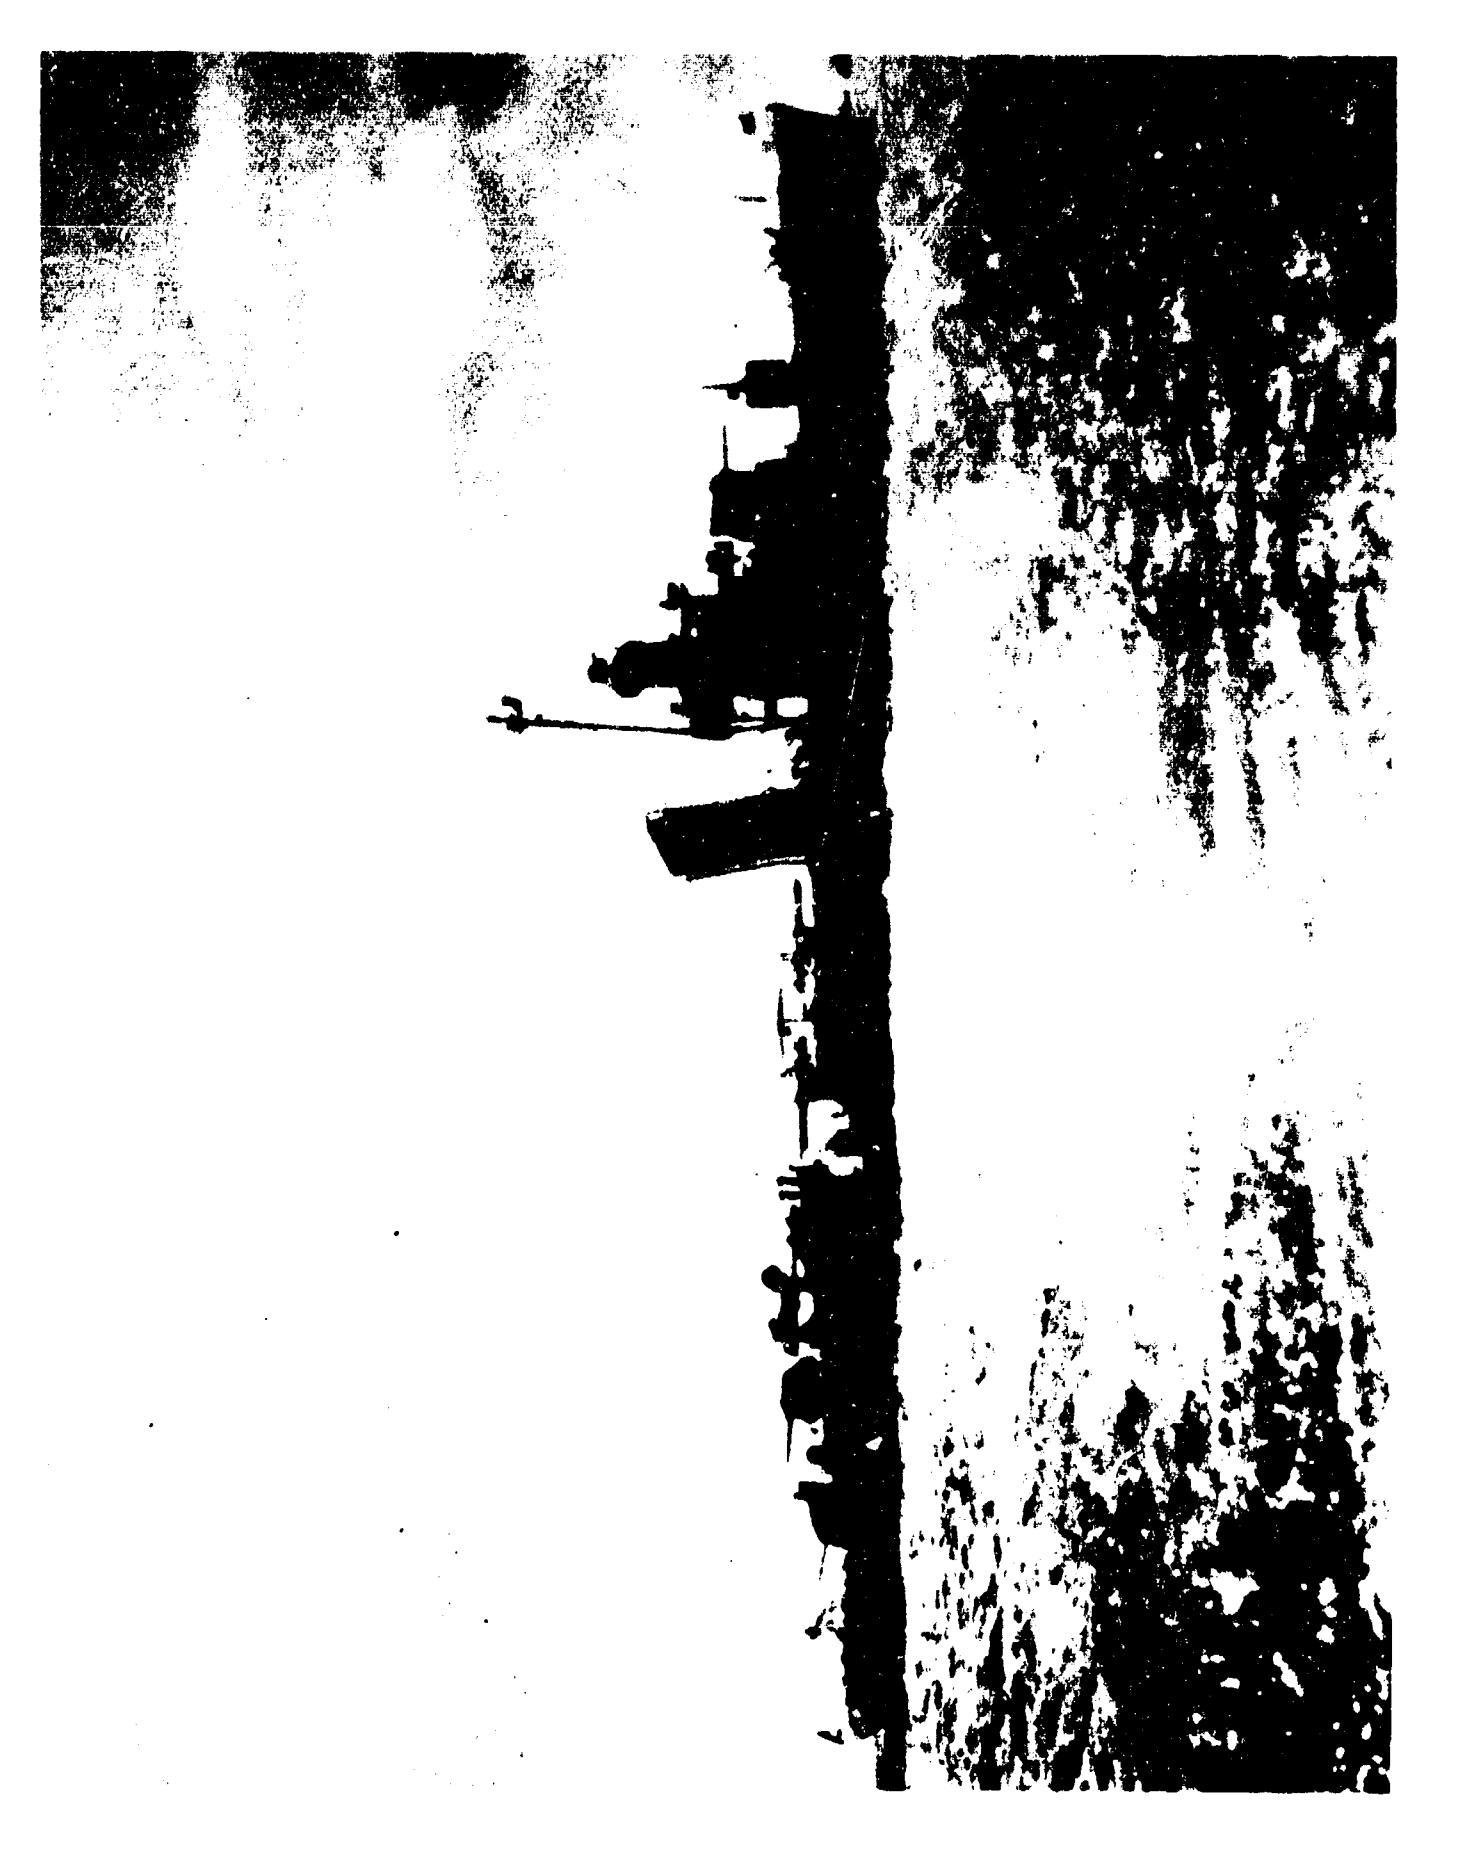
BB-CR-227-513-11. U.S.S. HUGHES (DD410). View looking at starboard beam after Test Able.

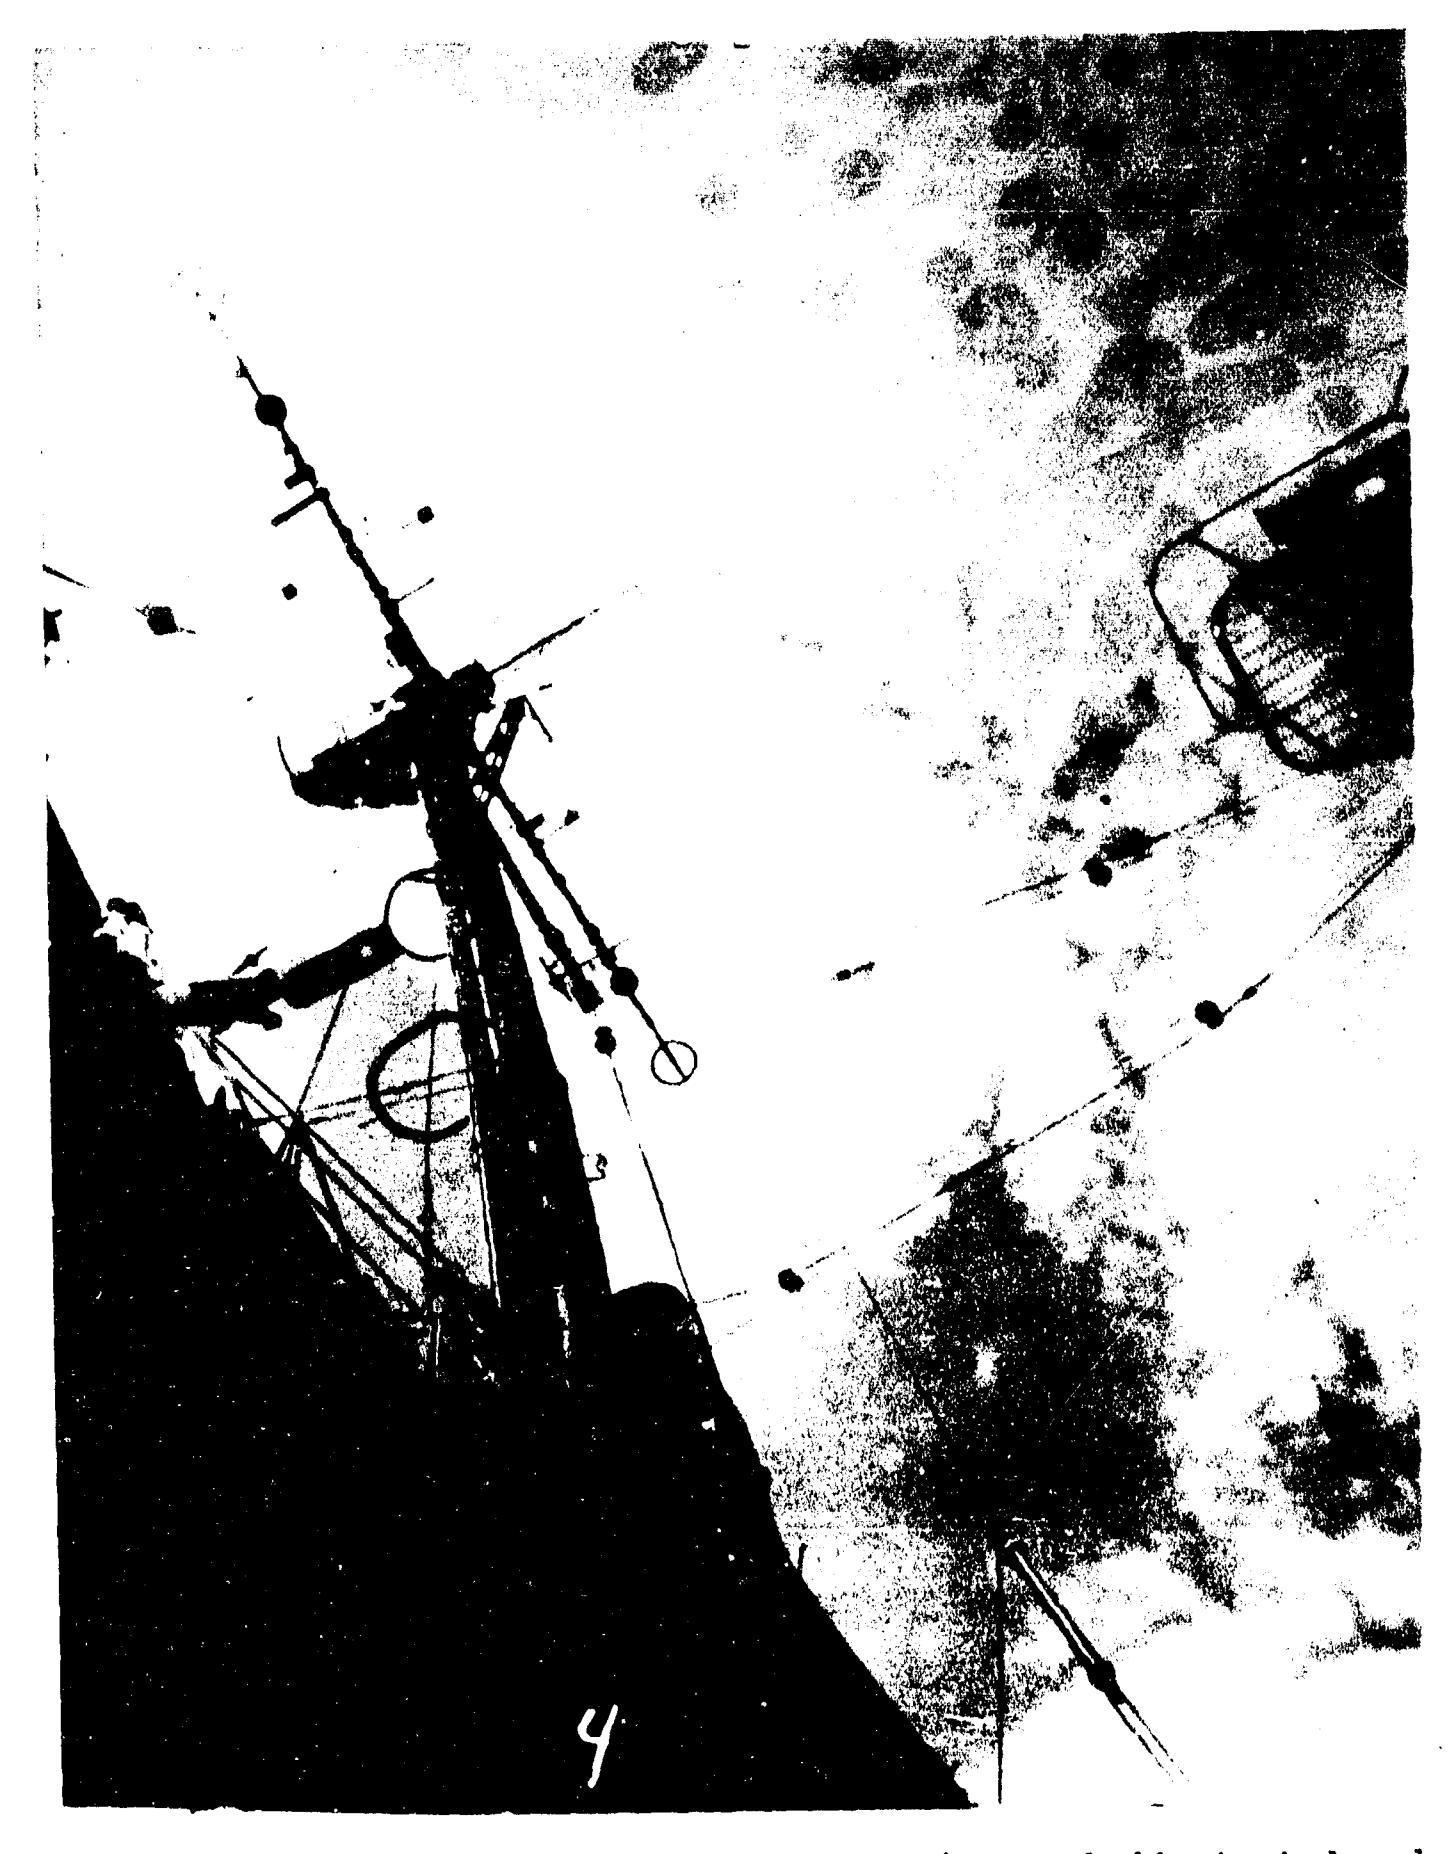
AA-CR-100-2198-4. U.S.S. HUGHES (DD410). View looking to starboard and up at foremast.

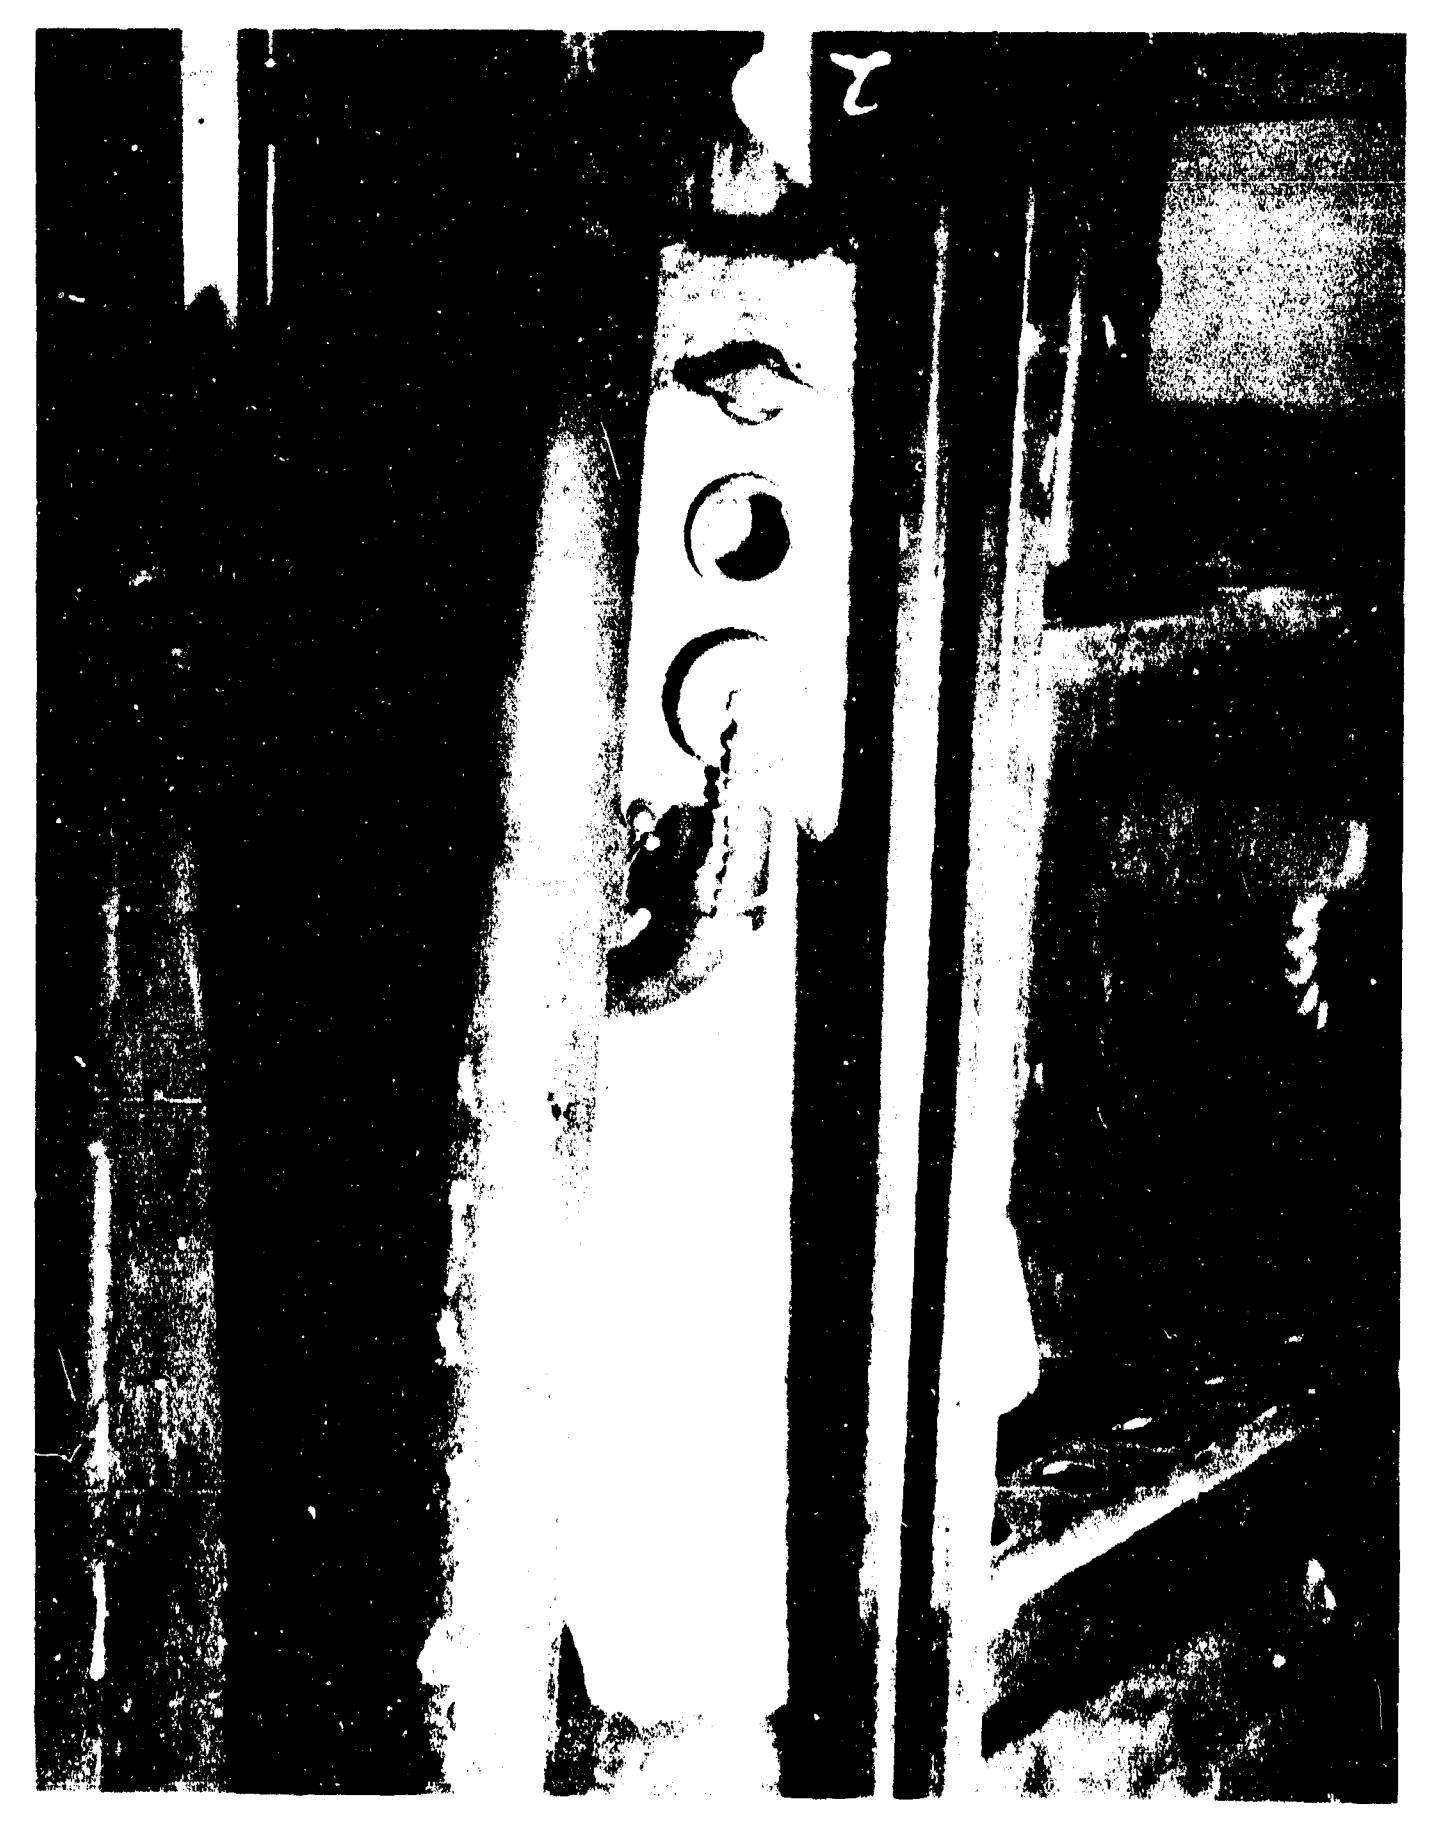
AA-CR-100-2198-2. U.S.S. HUGHES (DD410). Detail - forward side of foremast.

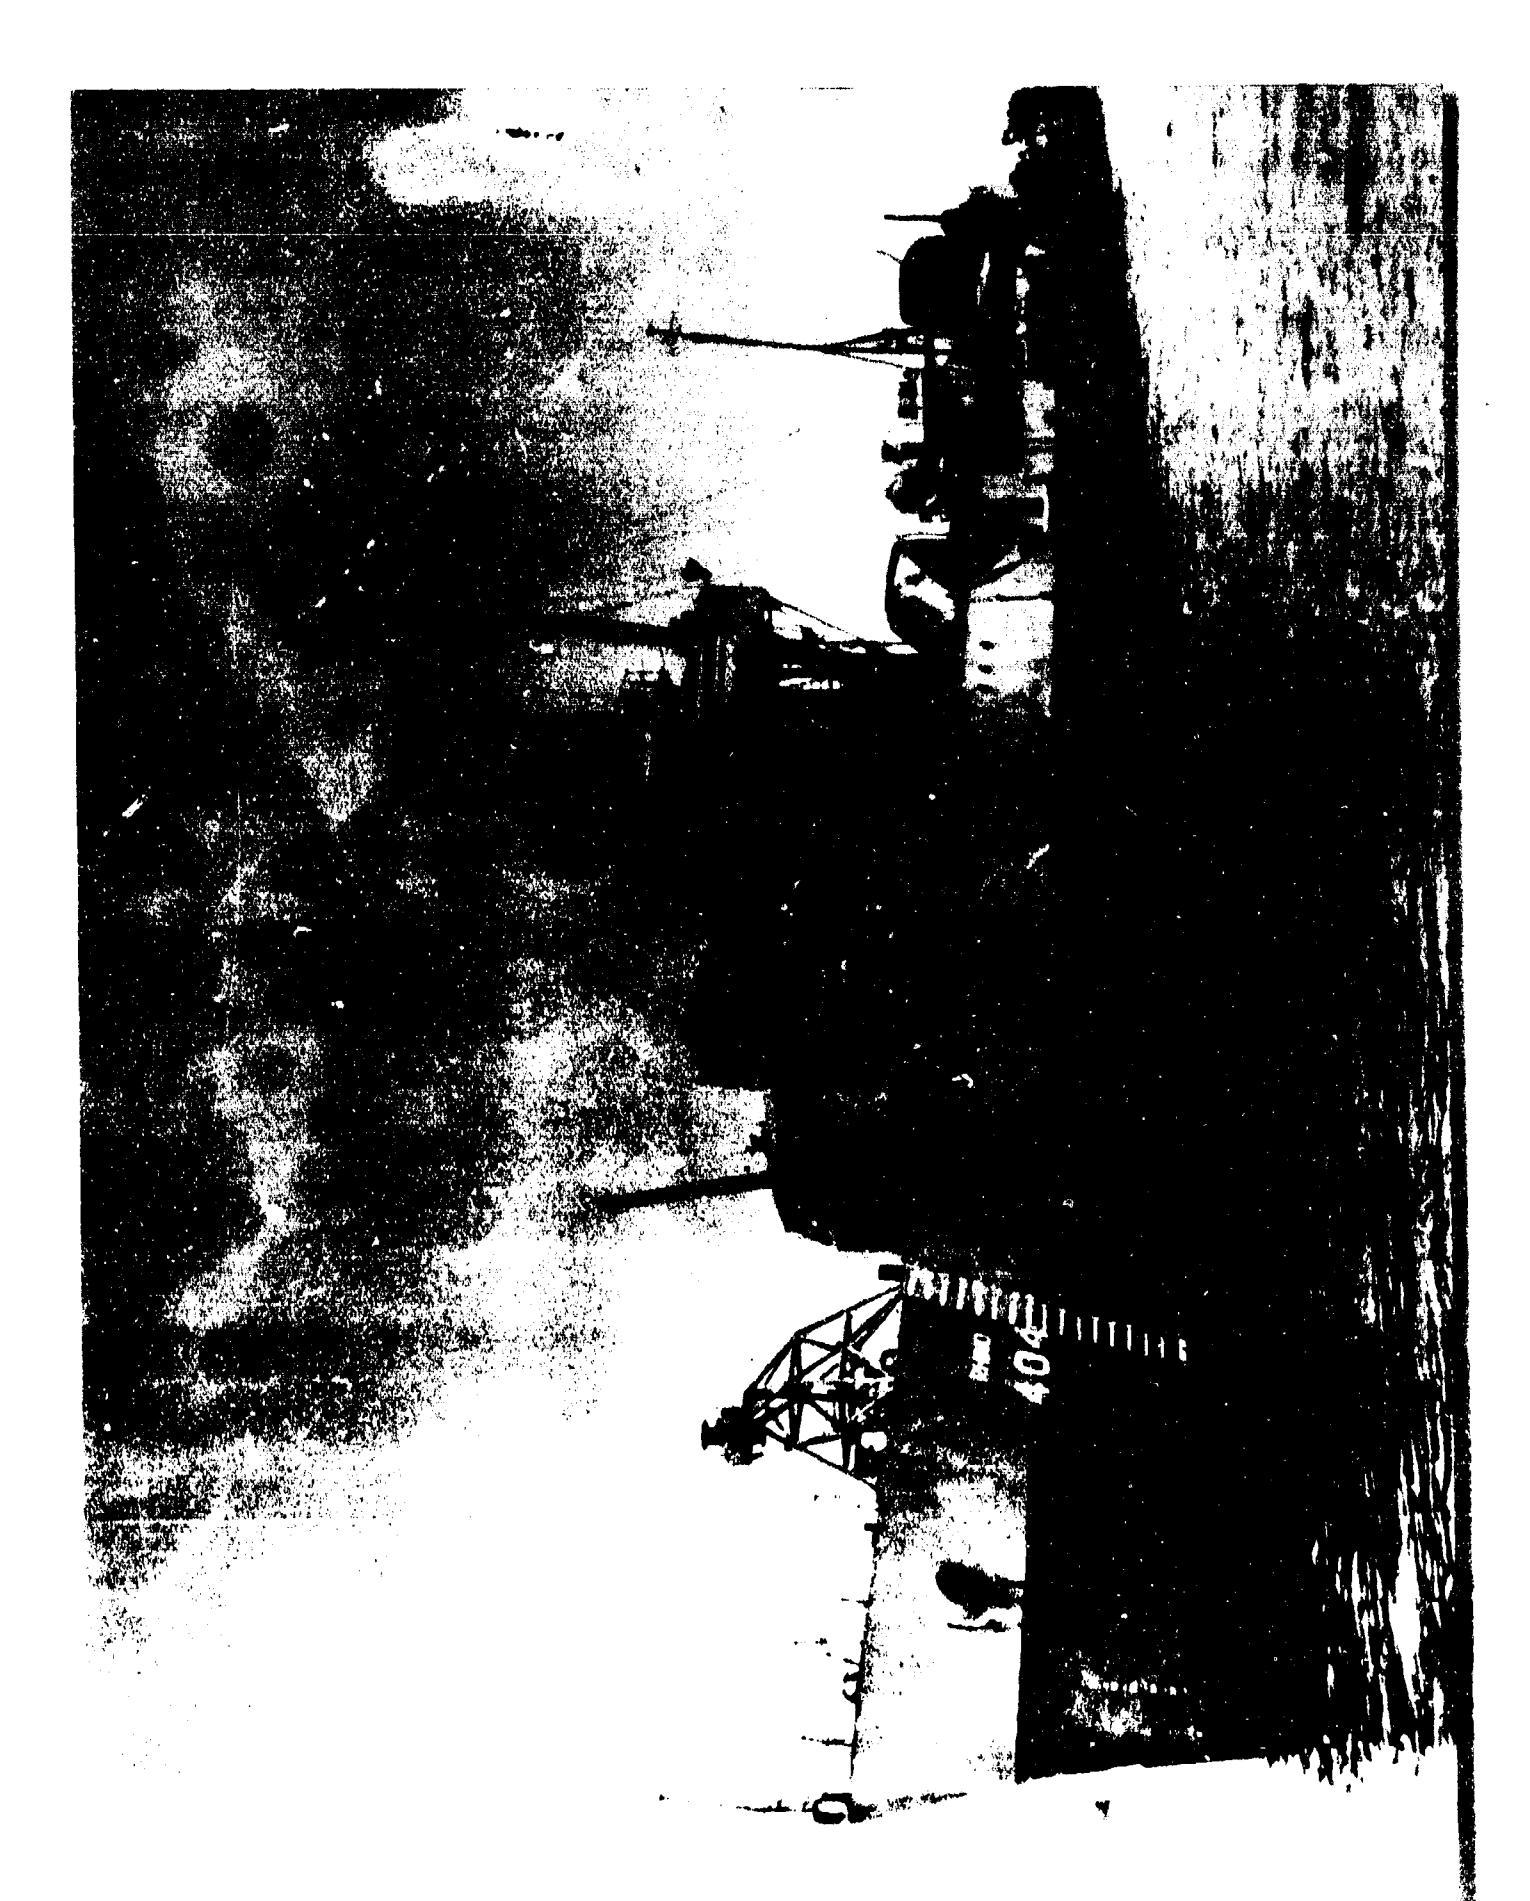
2. Photos 196-156-1, 227-49-137, 227-283-58 and 227-520-42; pages, 184, 185, 186, and 187 are comparative views before and after Test A. In photos 227-283-58 and 227-520-42, pages 186 and 187, it appears that while the foremast and mainmast have been bent in the direction of the blast, the head of the foremast has been bent into the blast. Investigation showed that the foremast is cracked just below the yard. The position of the yardarm is relatively unchanged with respect to the upper portion of the mast which is askew to the main body of the mast. Radar on the starboard yardarm are gone but the upper stays are intact. All strand antennae are down and whip antennae are bent or broken. The main body of the foremast is about 10 degrees out of its normal position. The foremast is about 10 degrees out of its normal position. The foremast wave guide is twisted around the breakdown lights. There are bends, kinks nearly, in the foremast just above the padeyes to which the lower mast guys were secured about 12 feet above the brackets connecting the mast to the main deck. There are similar bends just at the tops of the brackets. The two 3/4 inch wire lower forward guys parted about 20 feet from the lower end. The remaining guys on this mast have approximately 14 inches slack. Photo 2200-9, page 188 shows the rigging and antennae still remaining and indicate that most of it is slack. Photo 2200-2, page 189 shows breaks in the cable guards at the navigating bridge level. Photo 2200-1, page 190 shows the frayed end in the lower portion of the starboard lower guy.

AB-CR-227-283-58. U.S.S. RHIND (DD404). View looking at port bow after Test Baker.

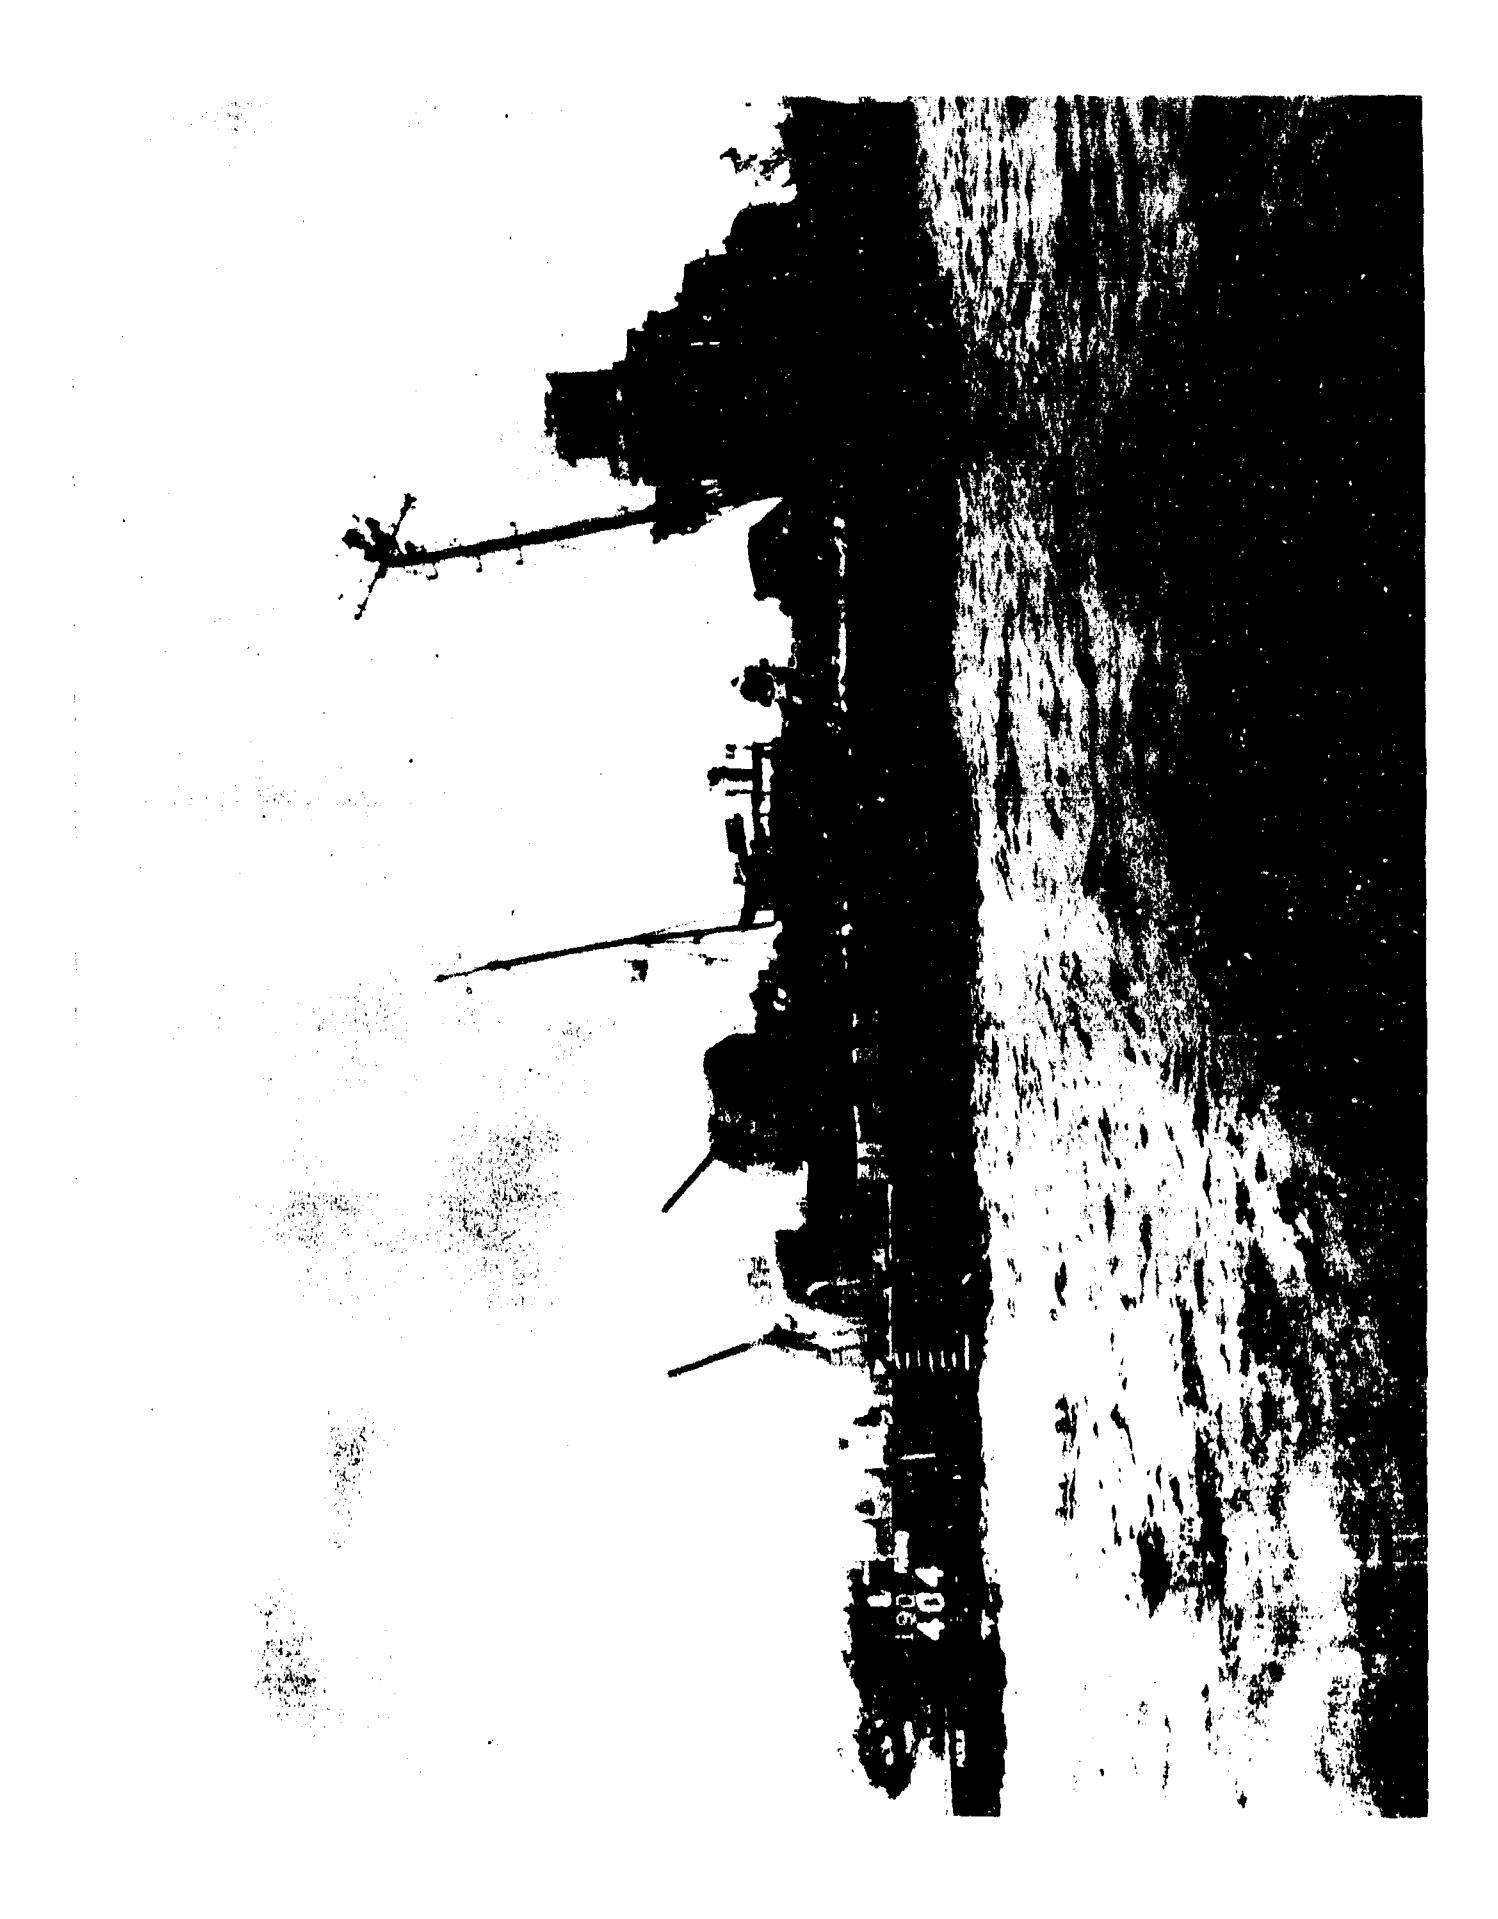
BB-CR-227-520-42. U.S.S. RHIND (DD404). View looking at starboard quarter, after Test A.
