BUREAU OF SHIPS GROUP

TECHNICAL INSPECTION REPORT

FAILURES OF MASTS, YARDARMS, BOOMS, AND RIGGING

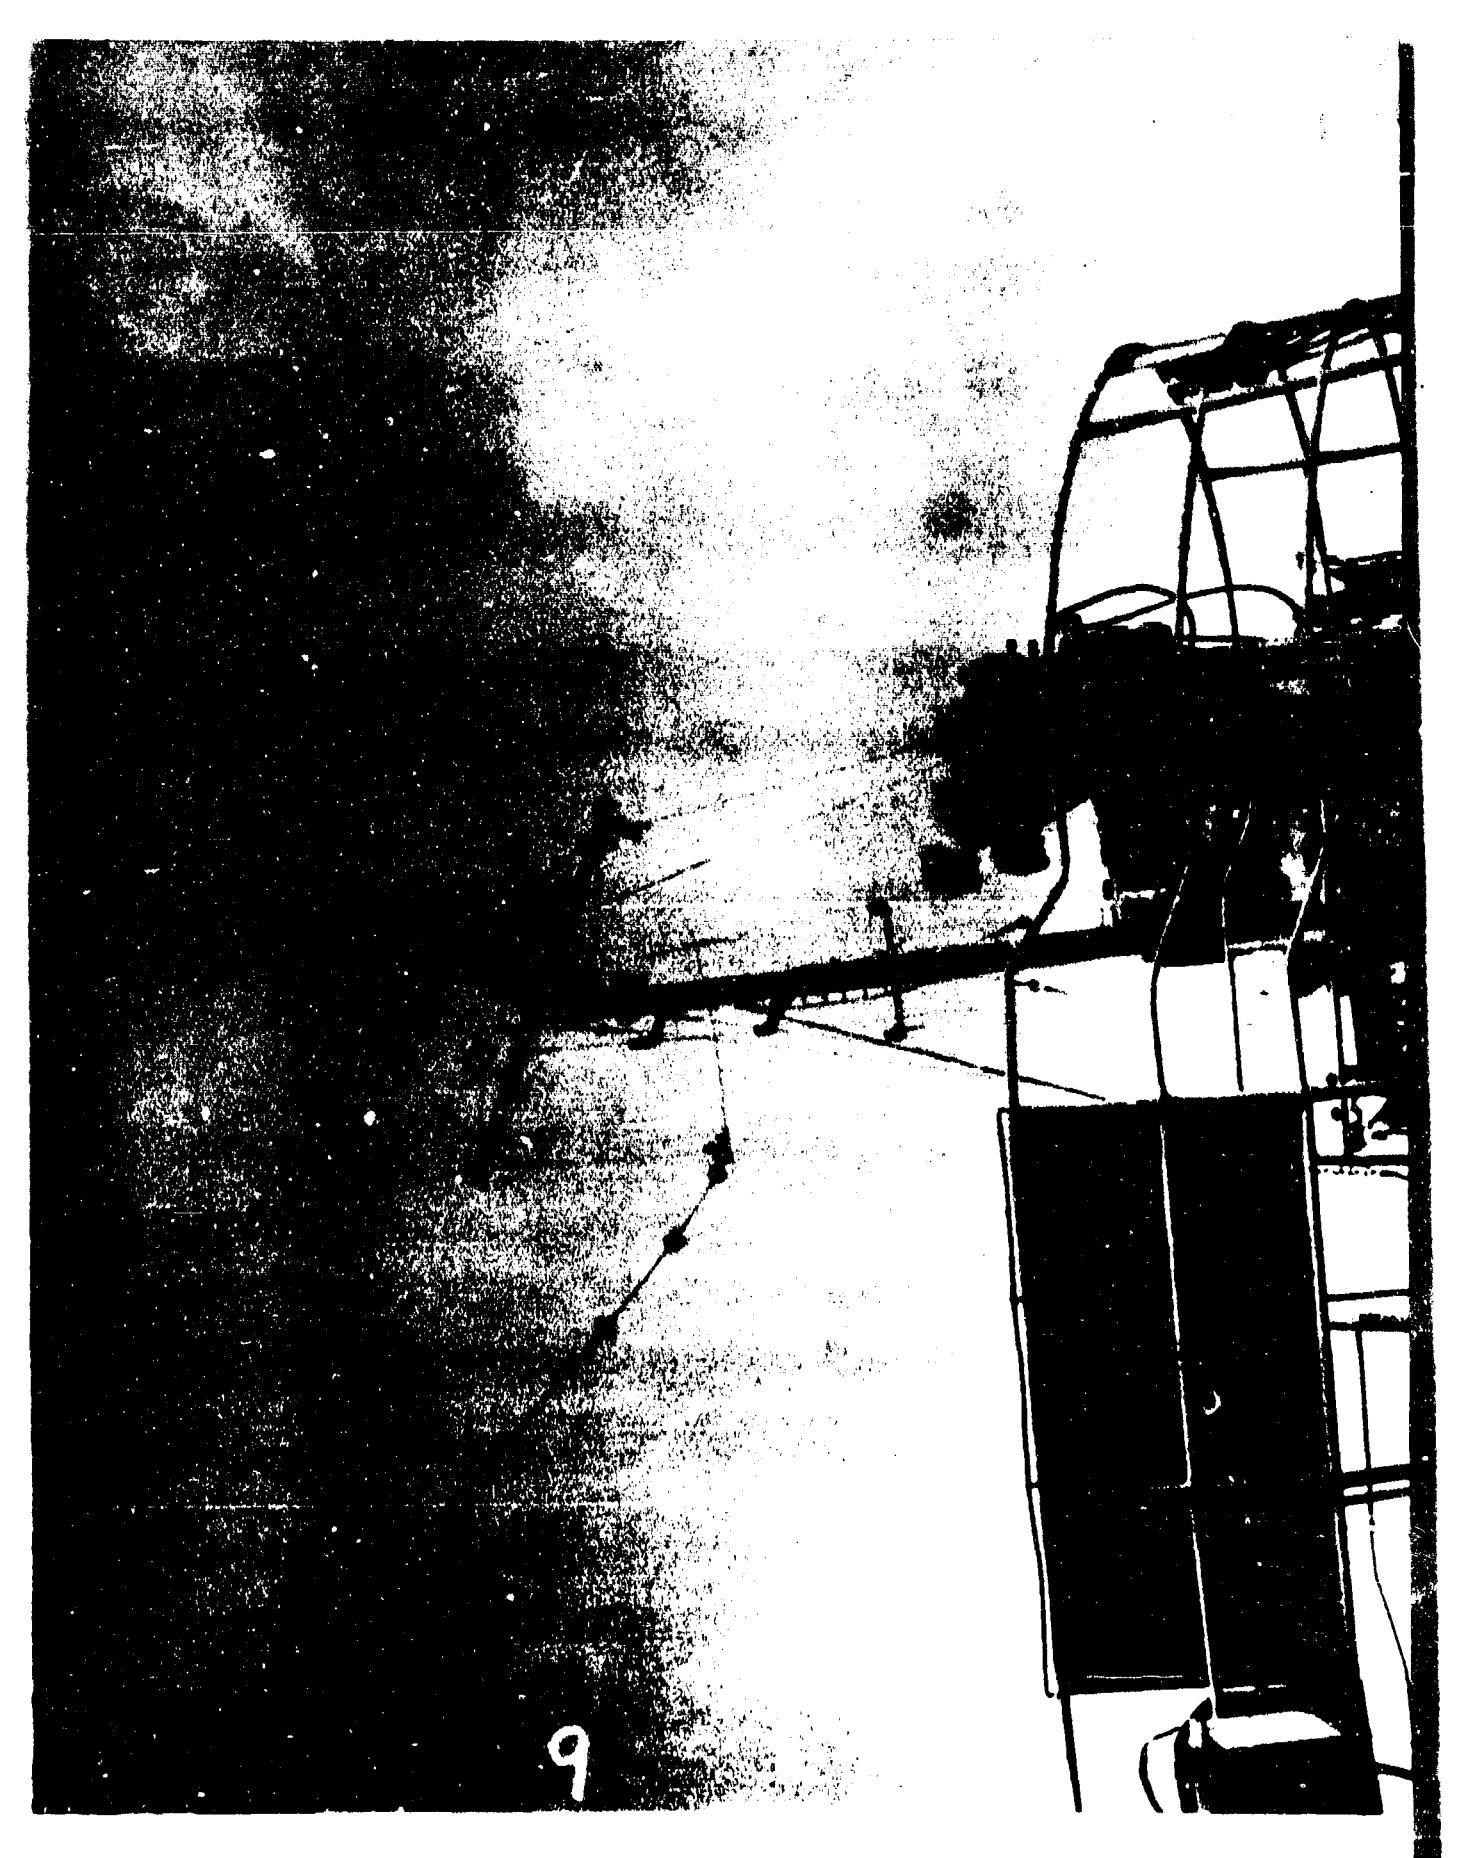
AA-CR-100-2200-9. U.S.S. RHIND (DD404). Foremast from frame 133.

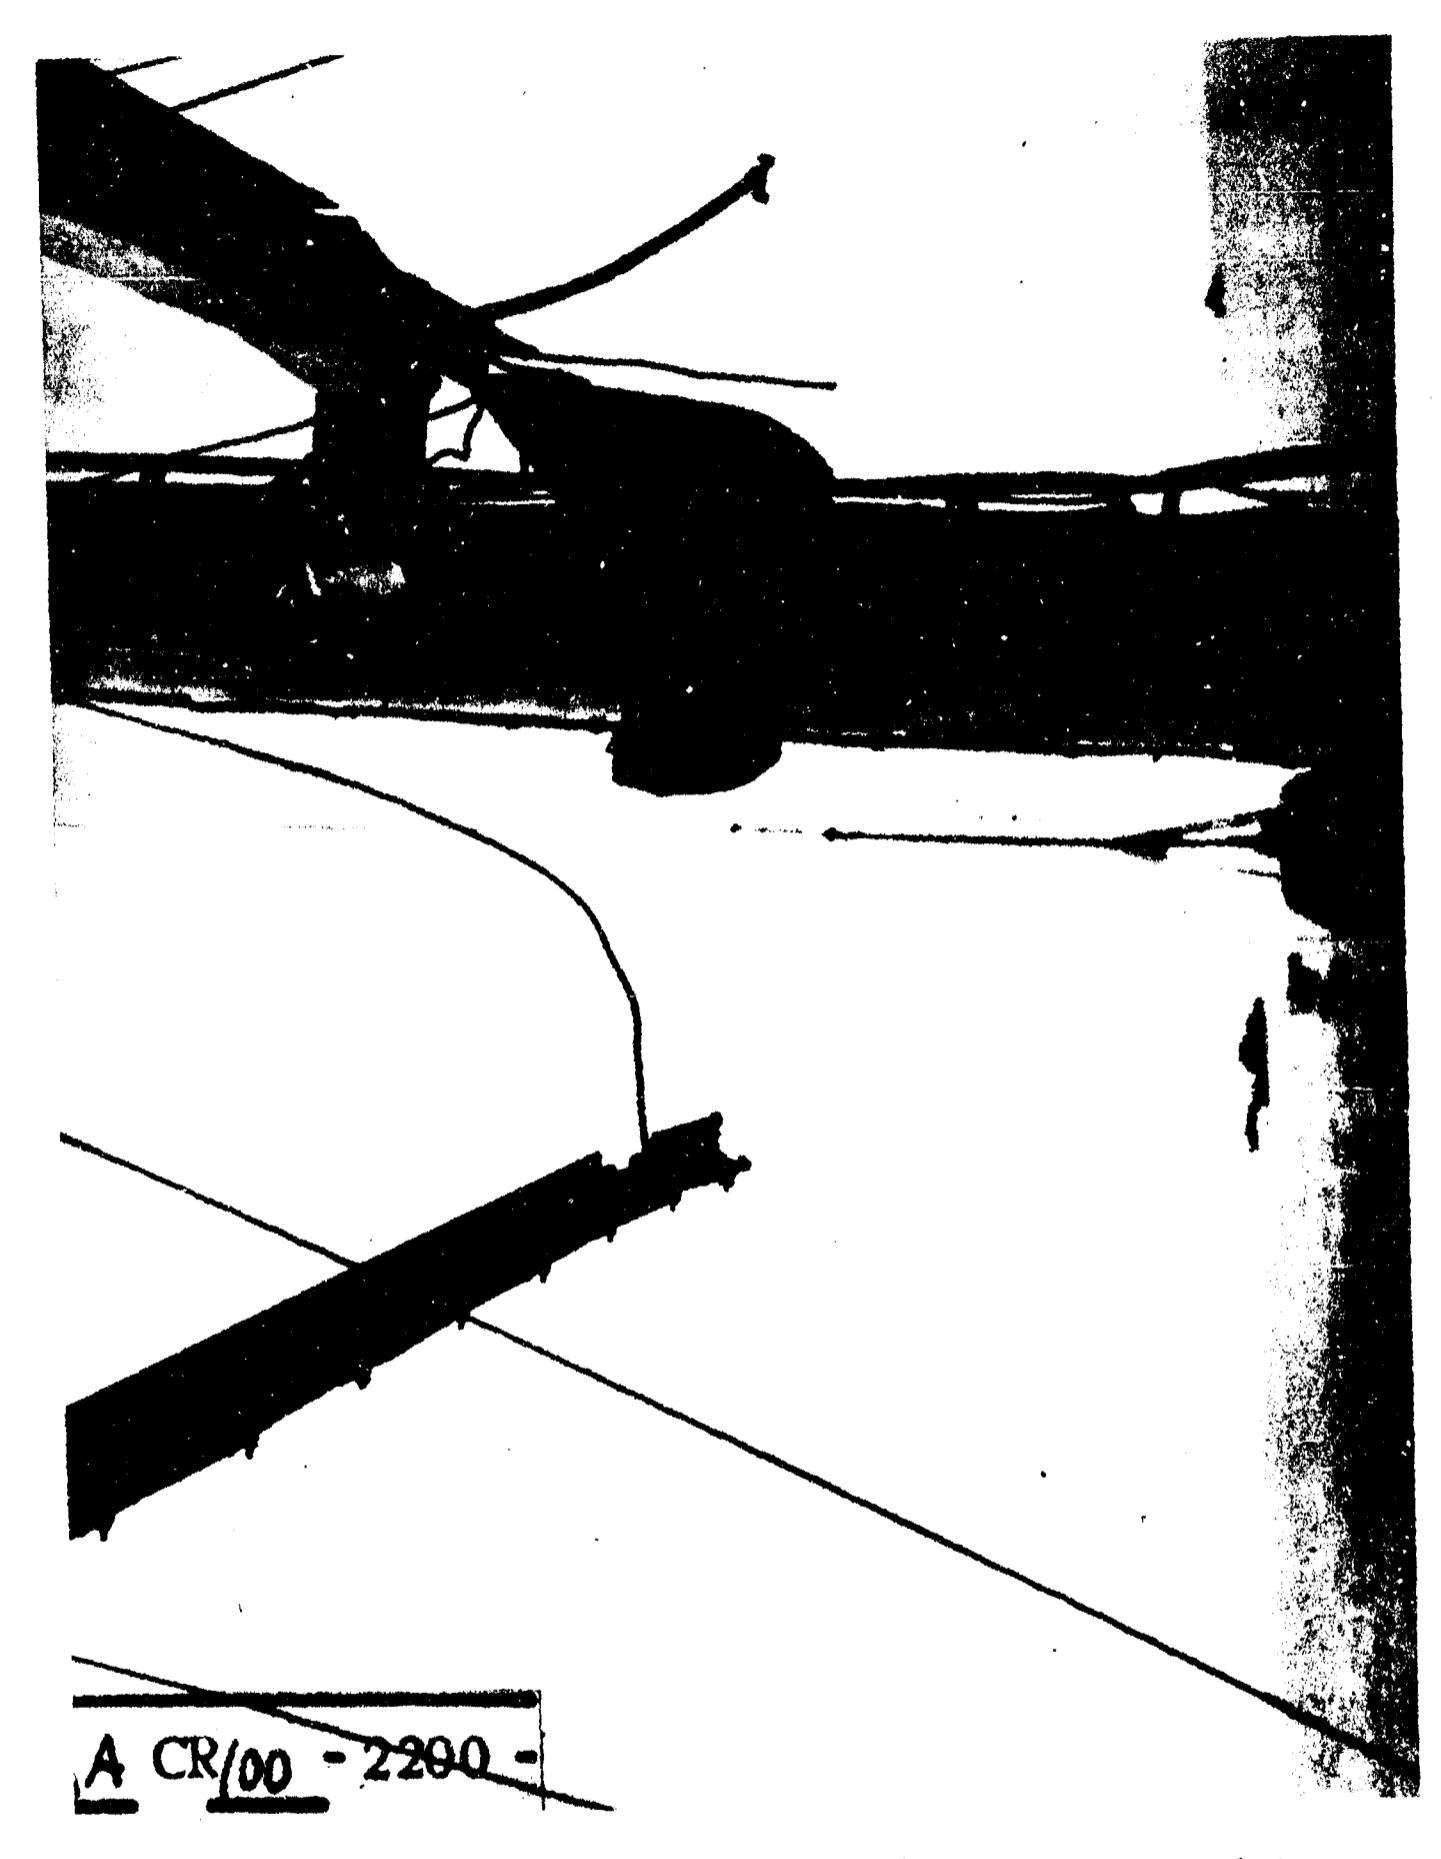
AA-CR-100-2200-2. U.S.S. RHIND (DD404). Break in port and starboard cable shields on foremast.

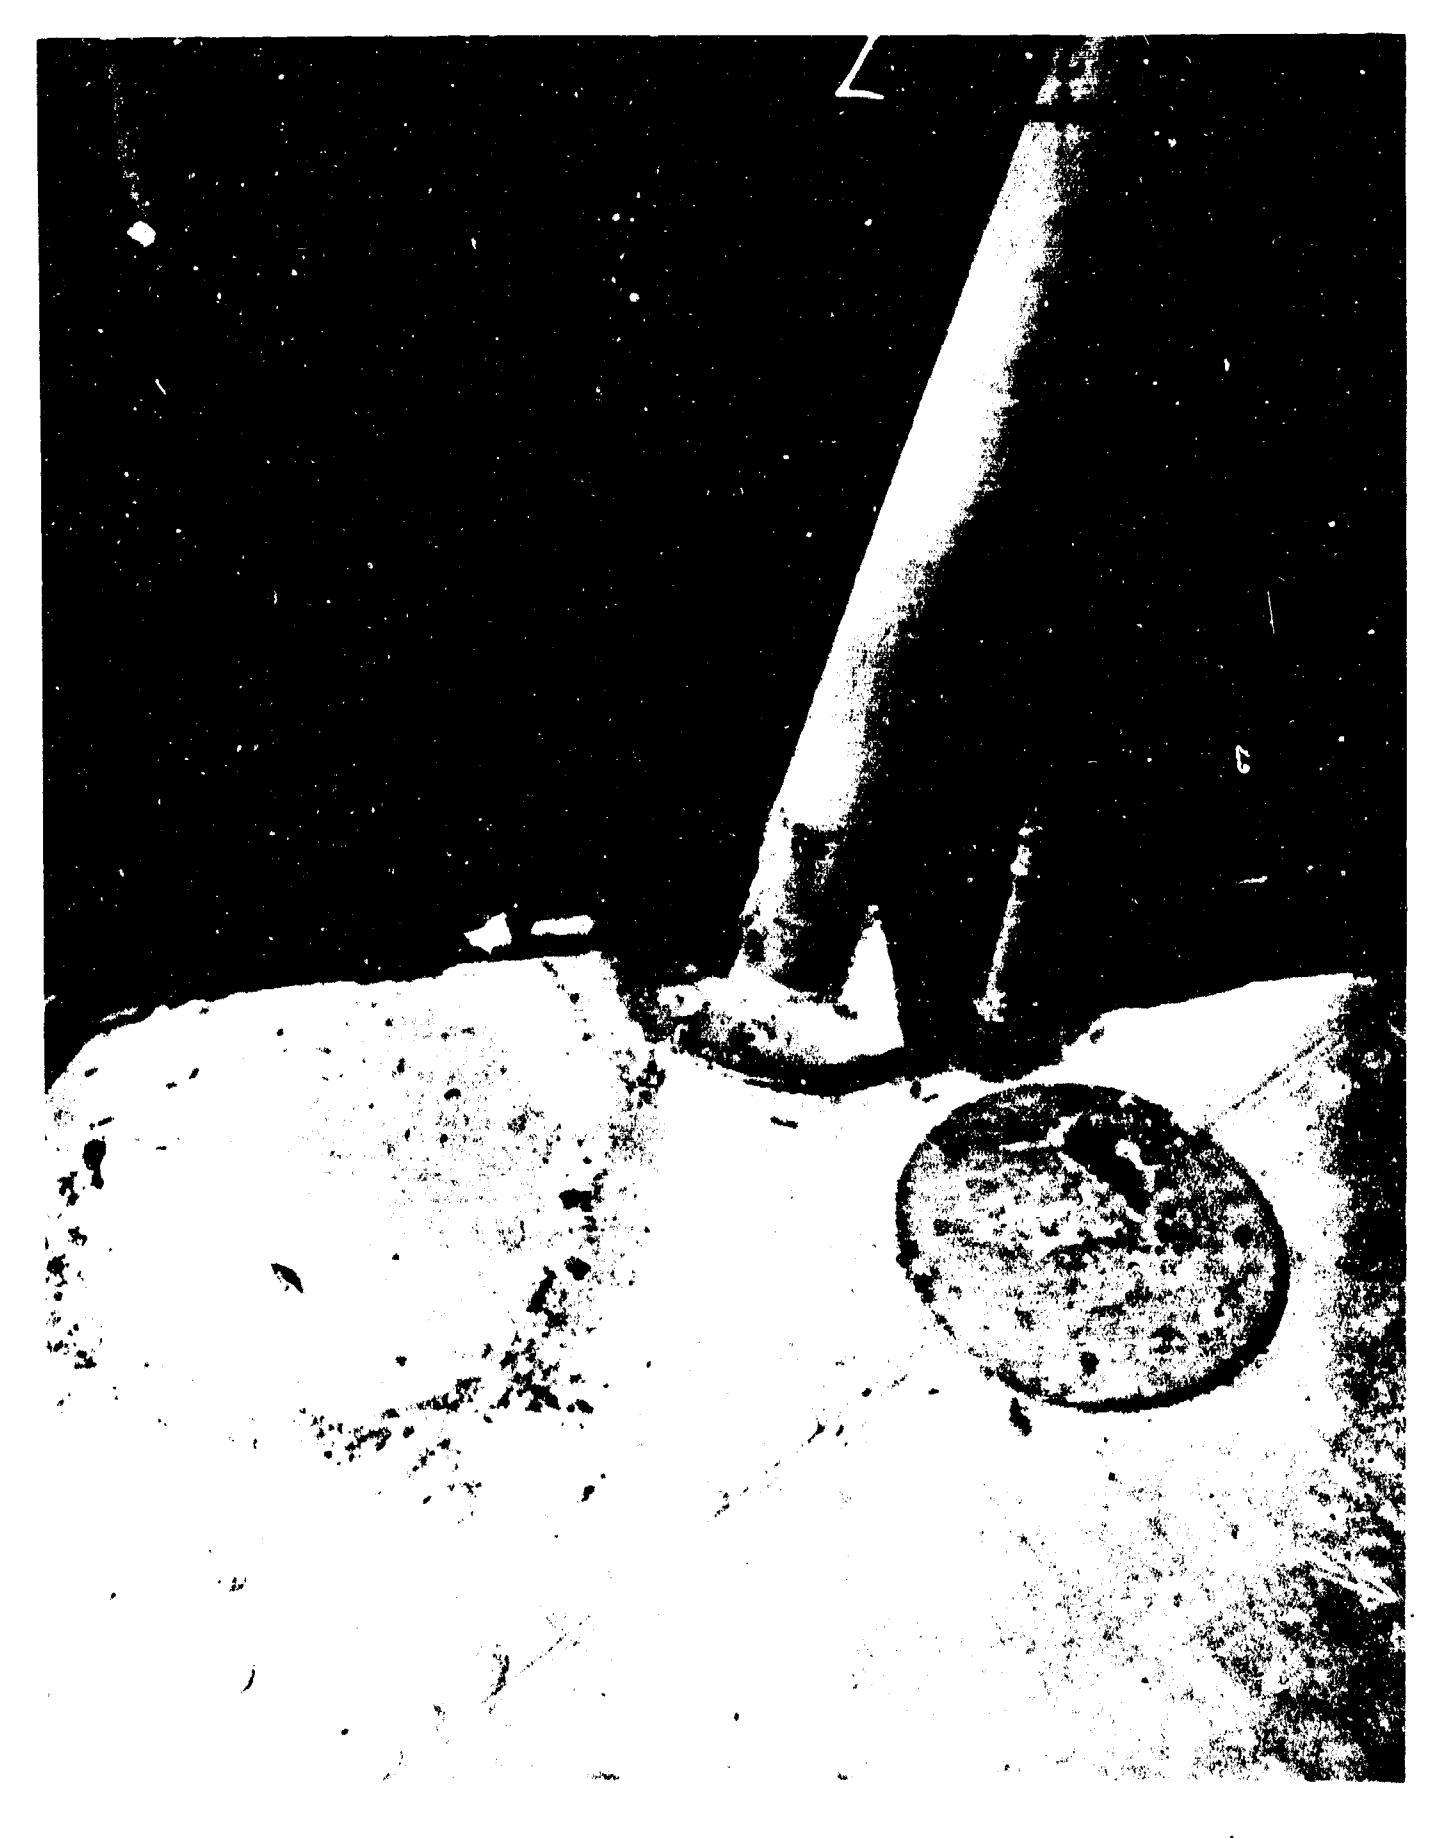
AA-CR-100-2200-7. U.S.S. RHIND (DD404). Base of after strut to after tripod.

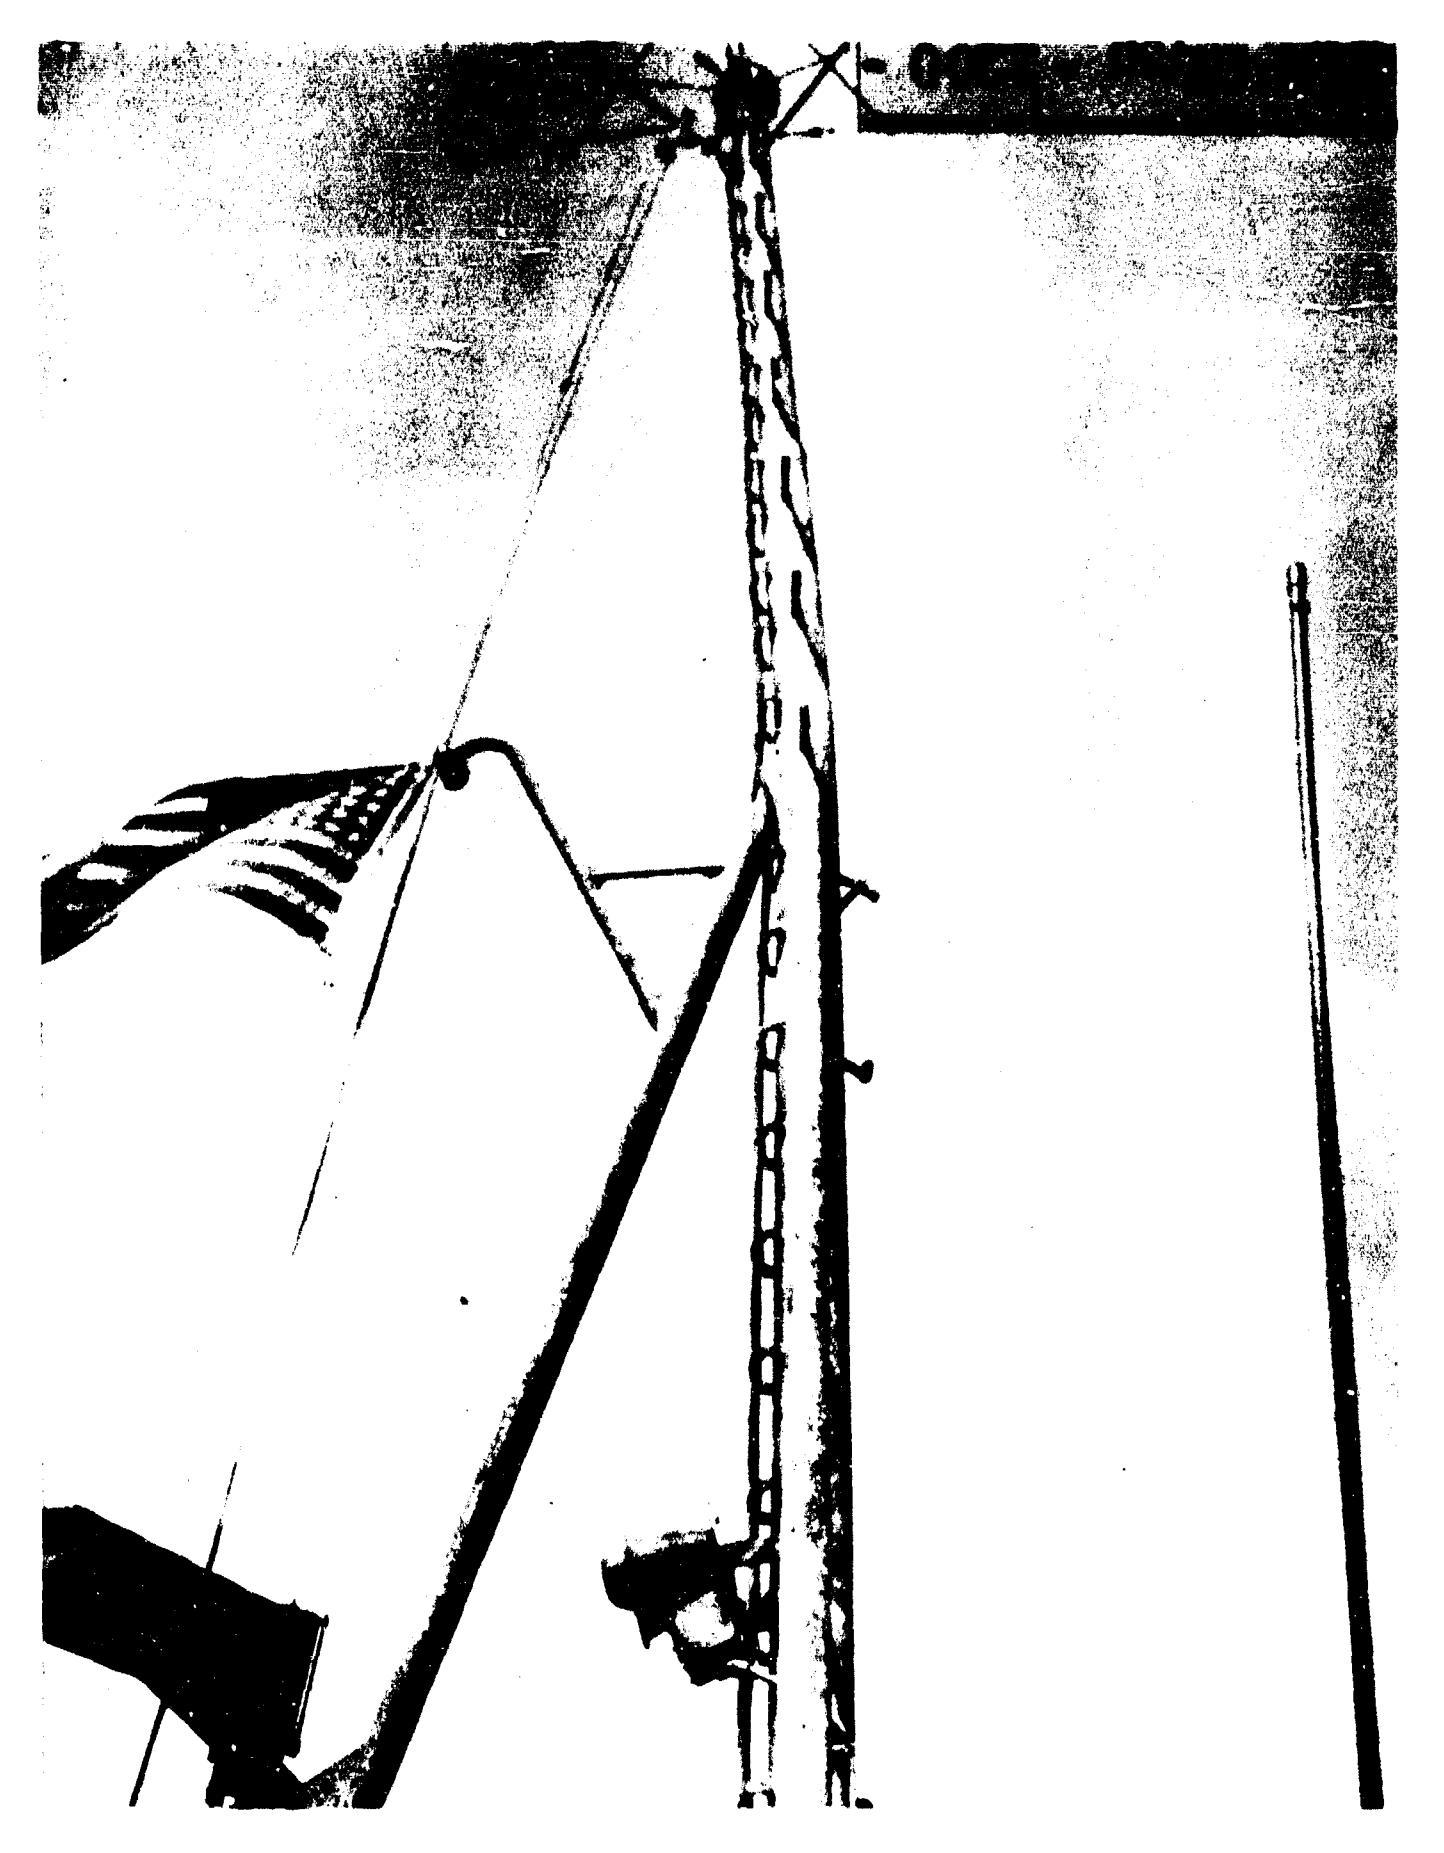
AA-CR-100-2200-10. U.S.S. RHIND (DD404). View of mainmast looking to port.

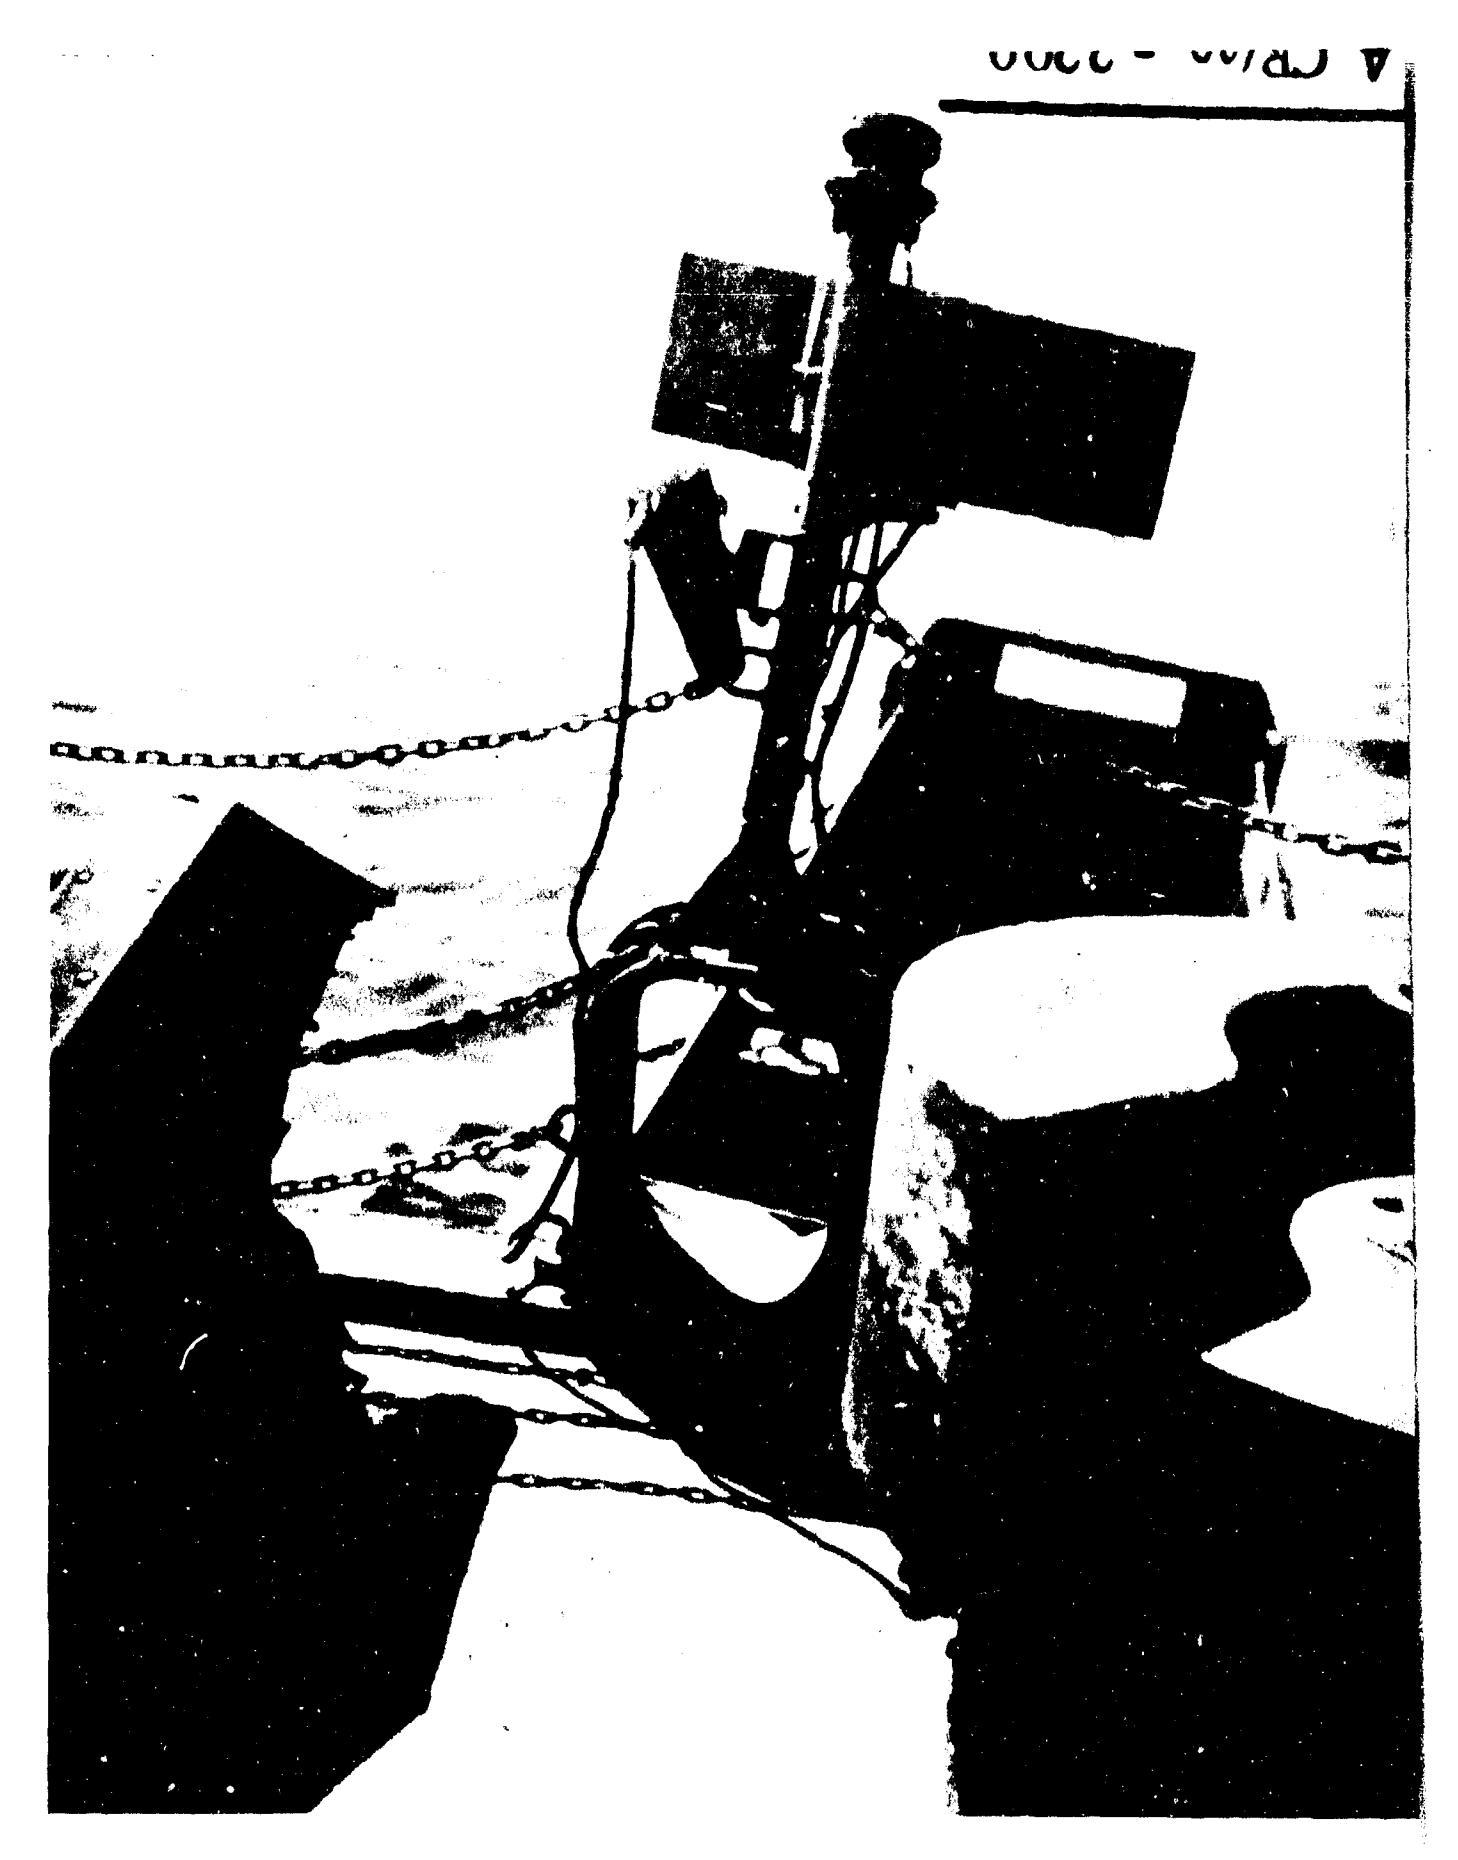
AA-CR-100-2200-11. U.S.S. RHIND (DD404). Sternlight pole.

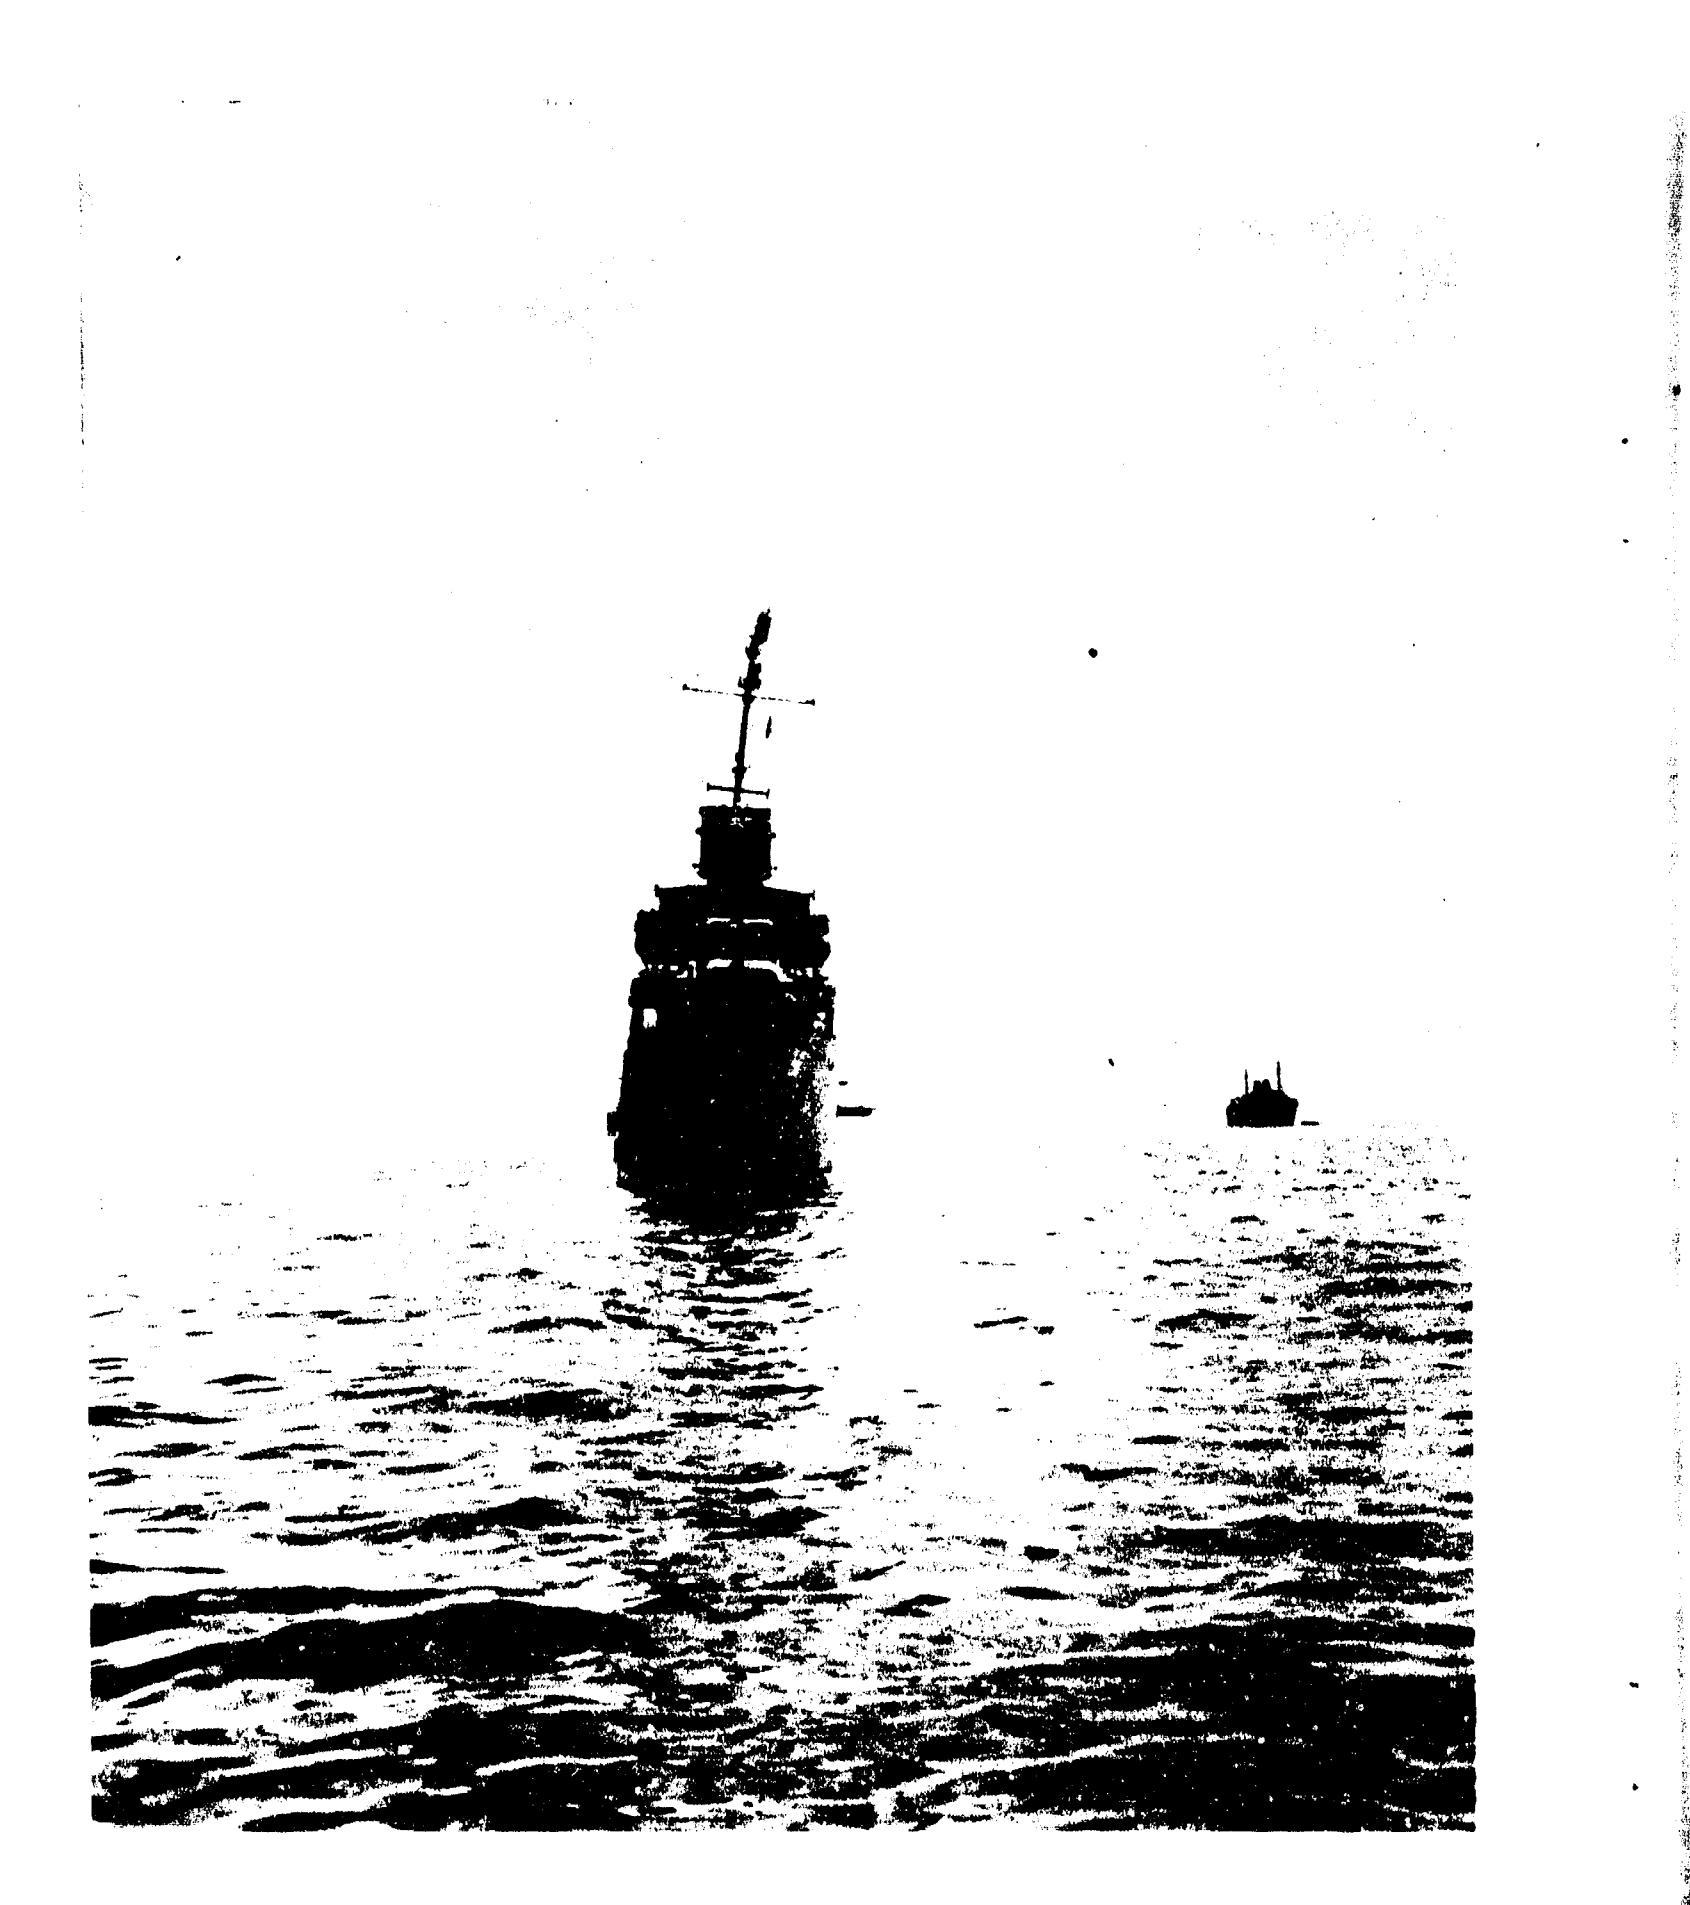
AB-CR-227-243-22. U.S.S. RALPH TALBOT (DD390). Bow - after Test Baker.

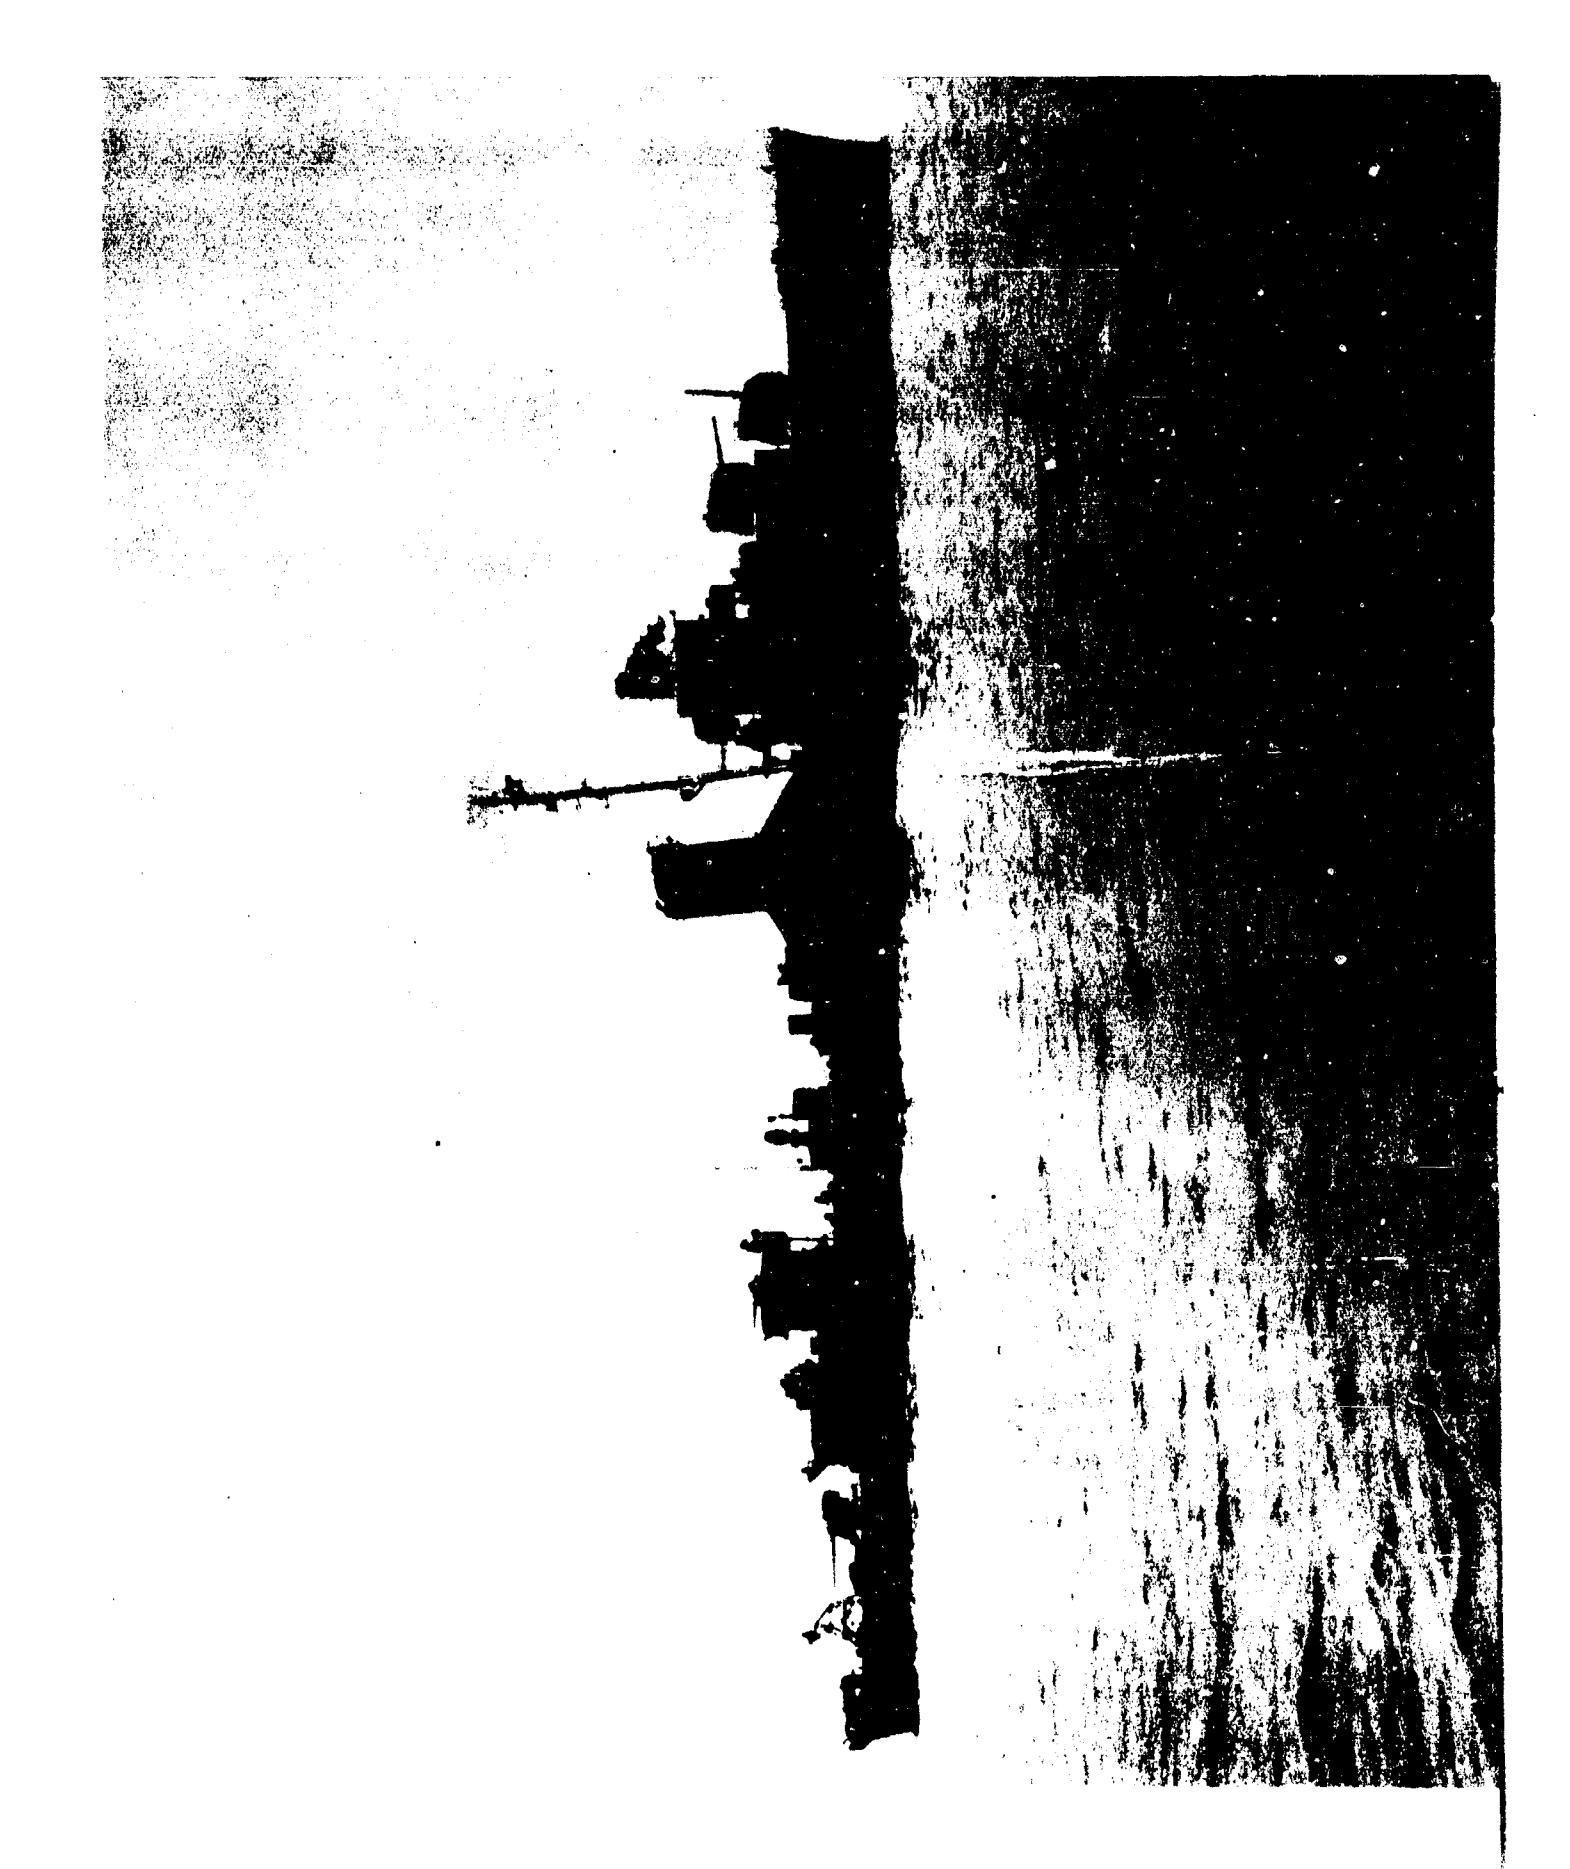
AB-CR-227-243-24. U.S.S. RALPH TALBOT (DD390). Starboard beam after Test Baker.

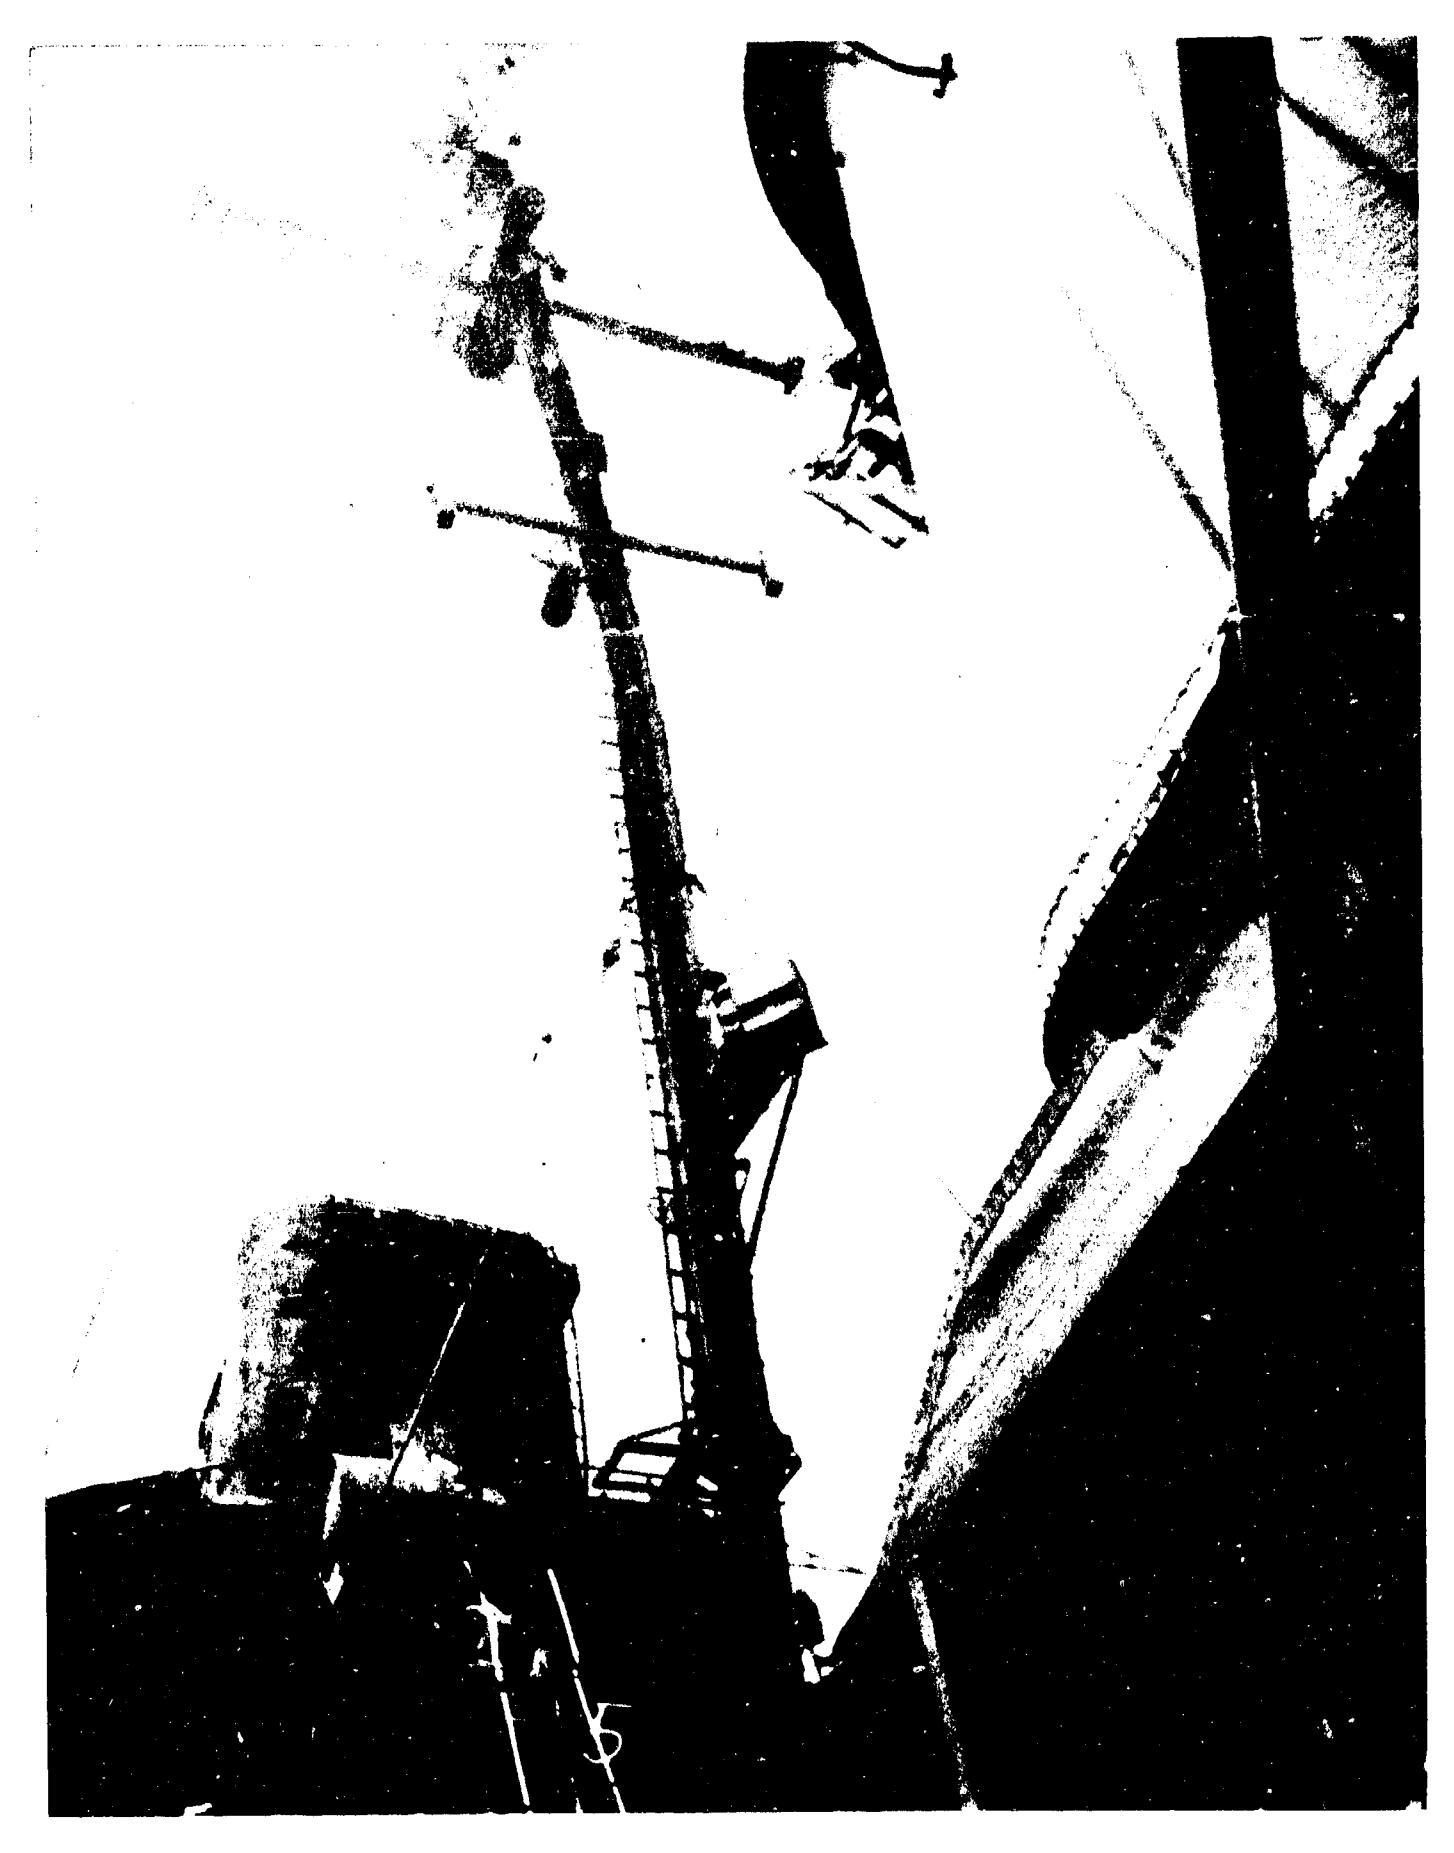
AA-CR-100-2198-5. U.S.S. RALPH TALBOT (DD390). View looking forward and up at foremast from port side.
