BUREAU OF SHIPS GROUP

TECHNICAL INSPECTION REPORT

FAILURES OF MASTS, YARDARMS, BOOMS, AND RIGGING

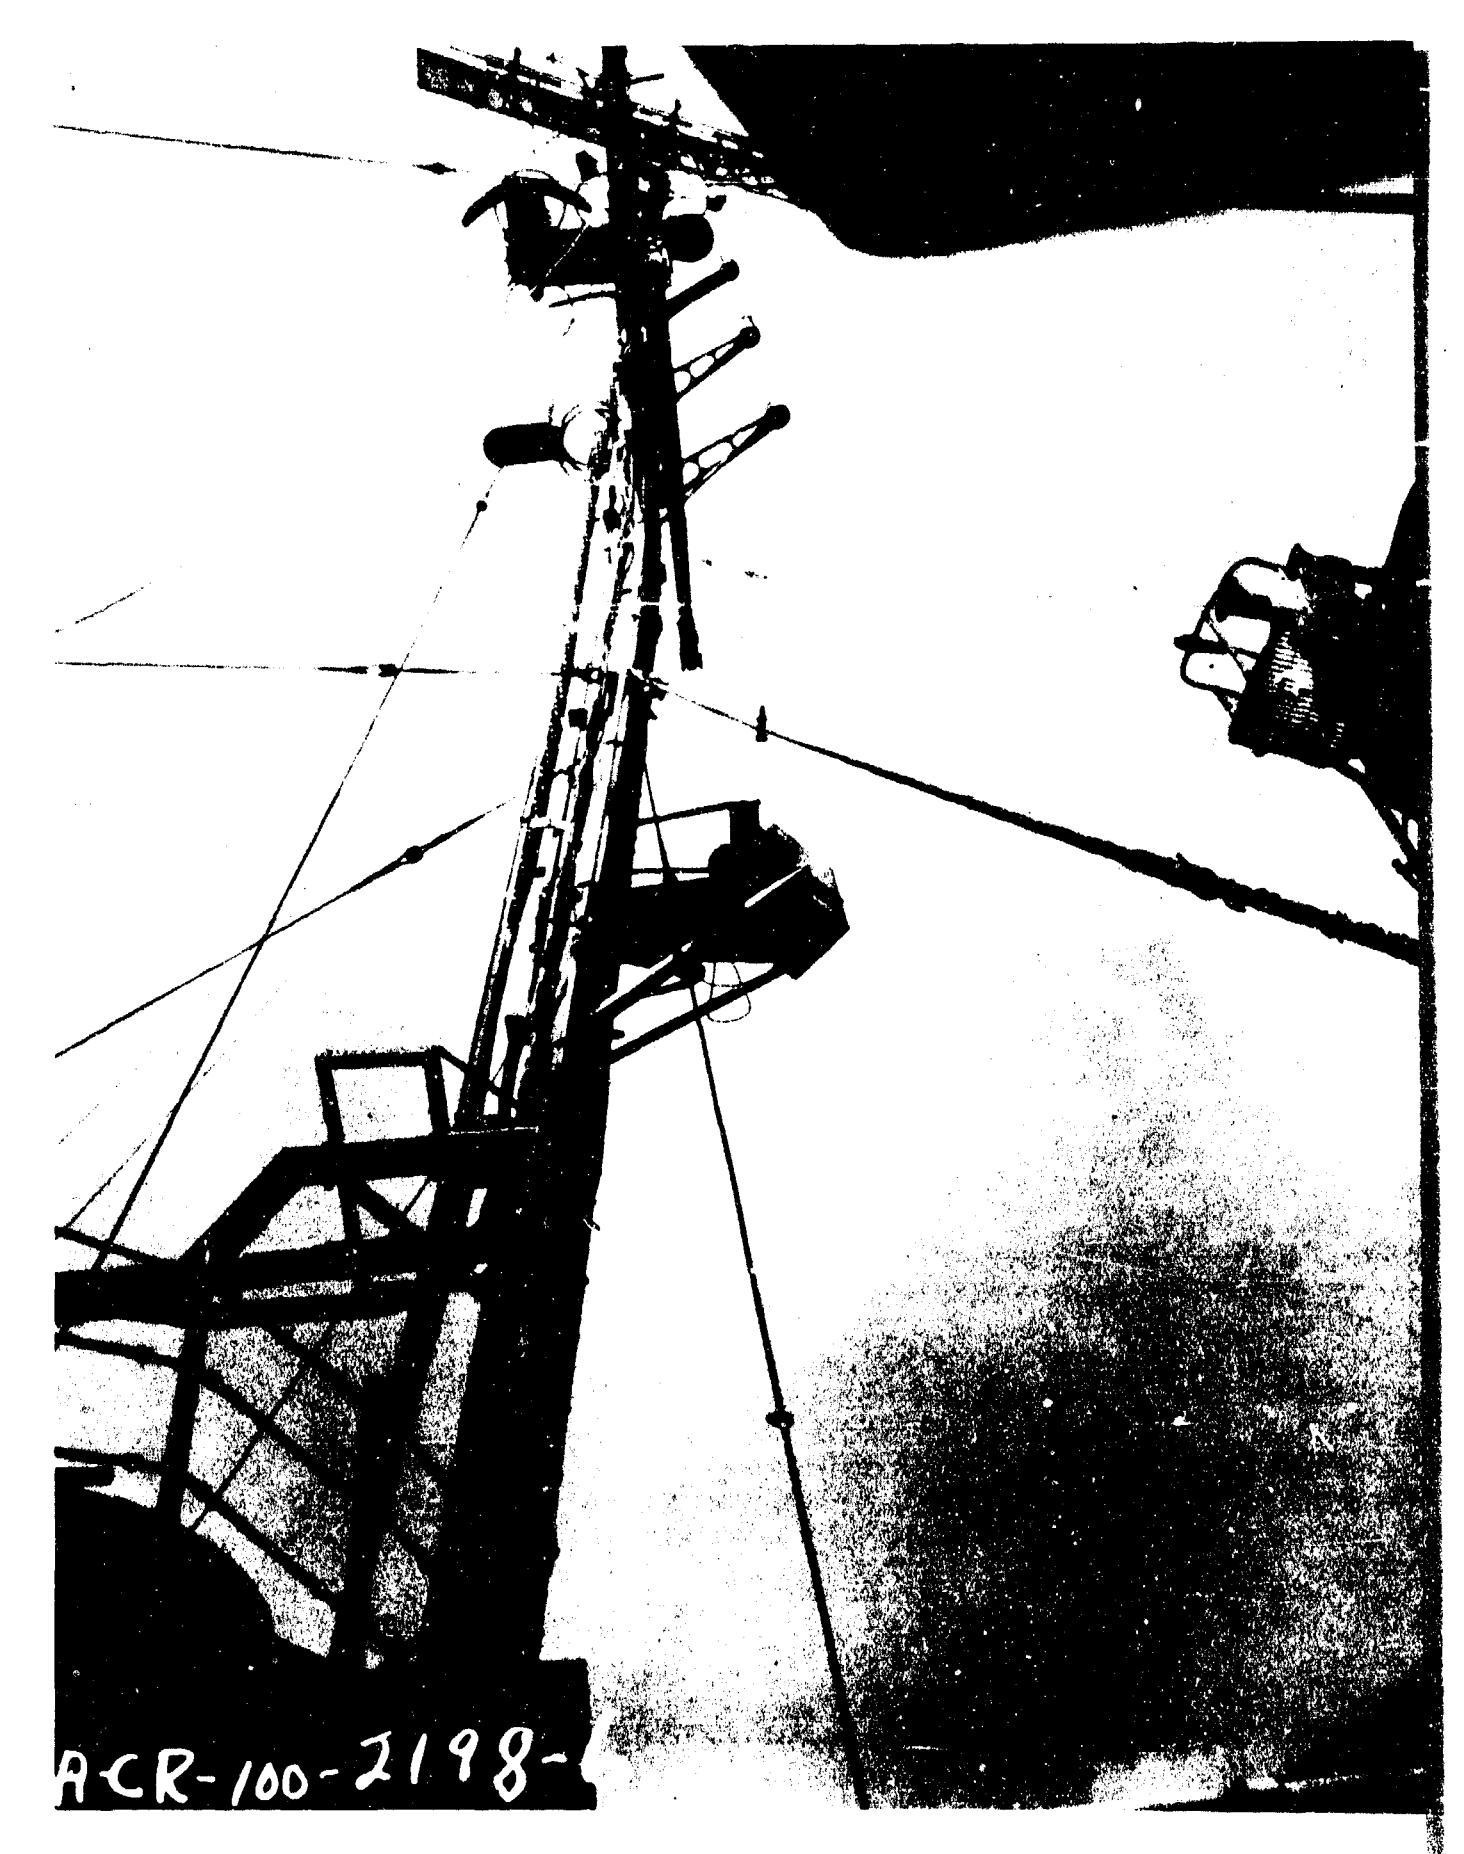
AA-CR-100-2198-6. U.S.S. RALPH TALBOT (DD390). View looking up foremast from port side.

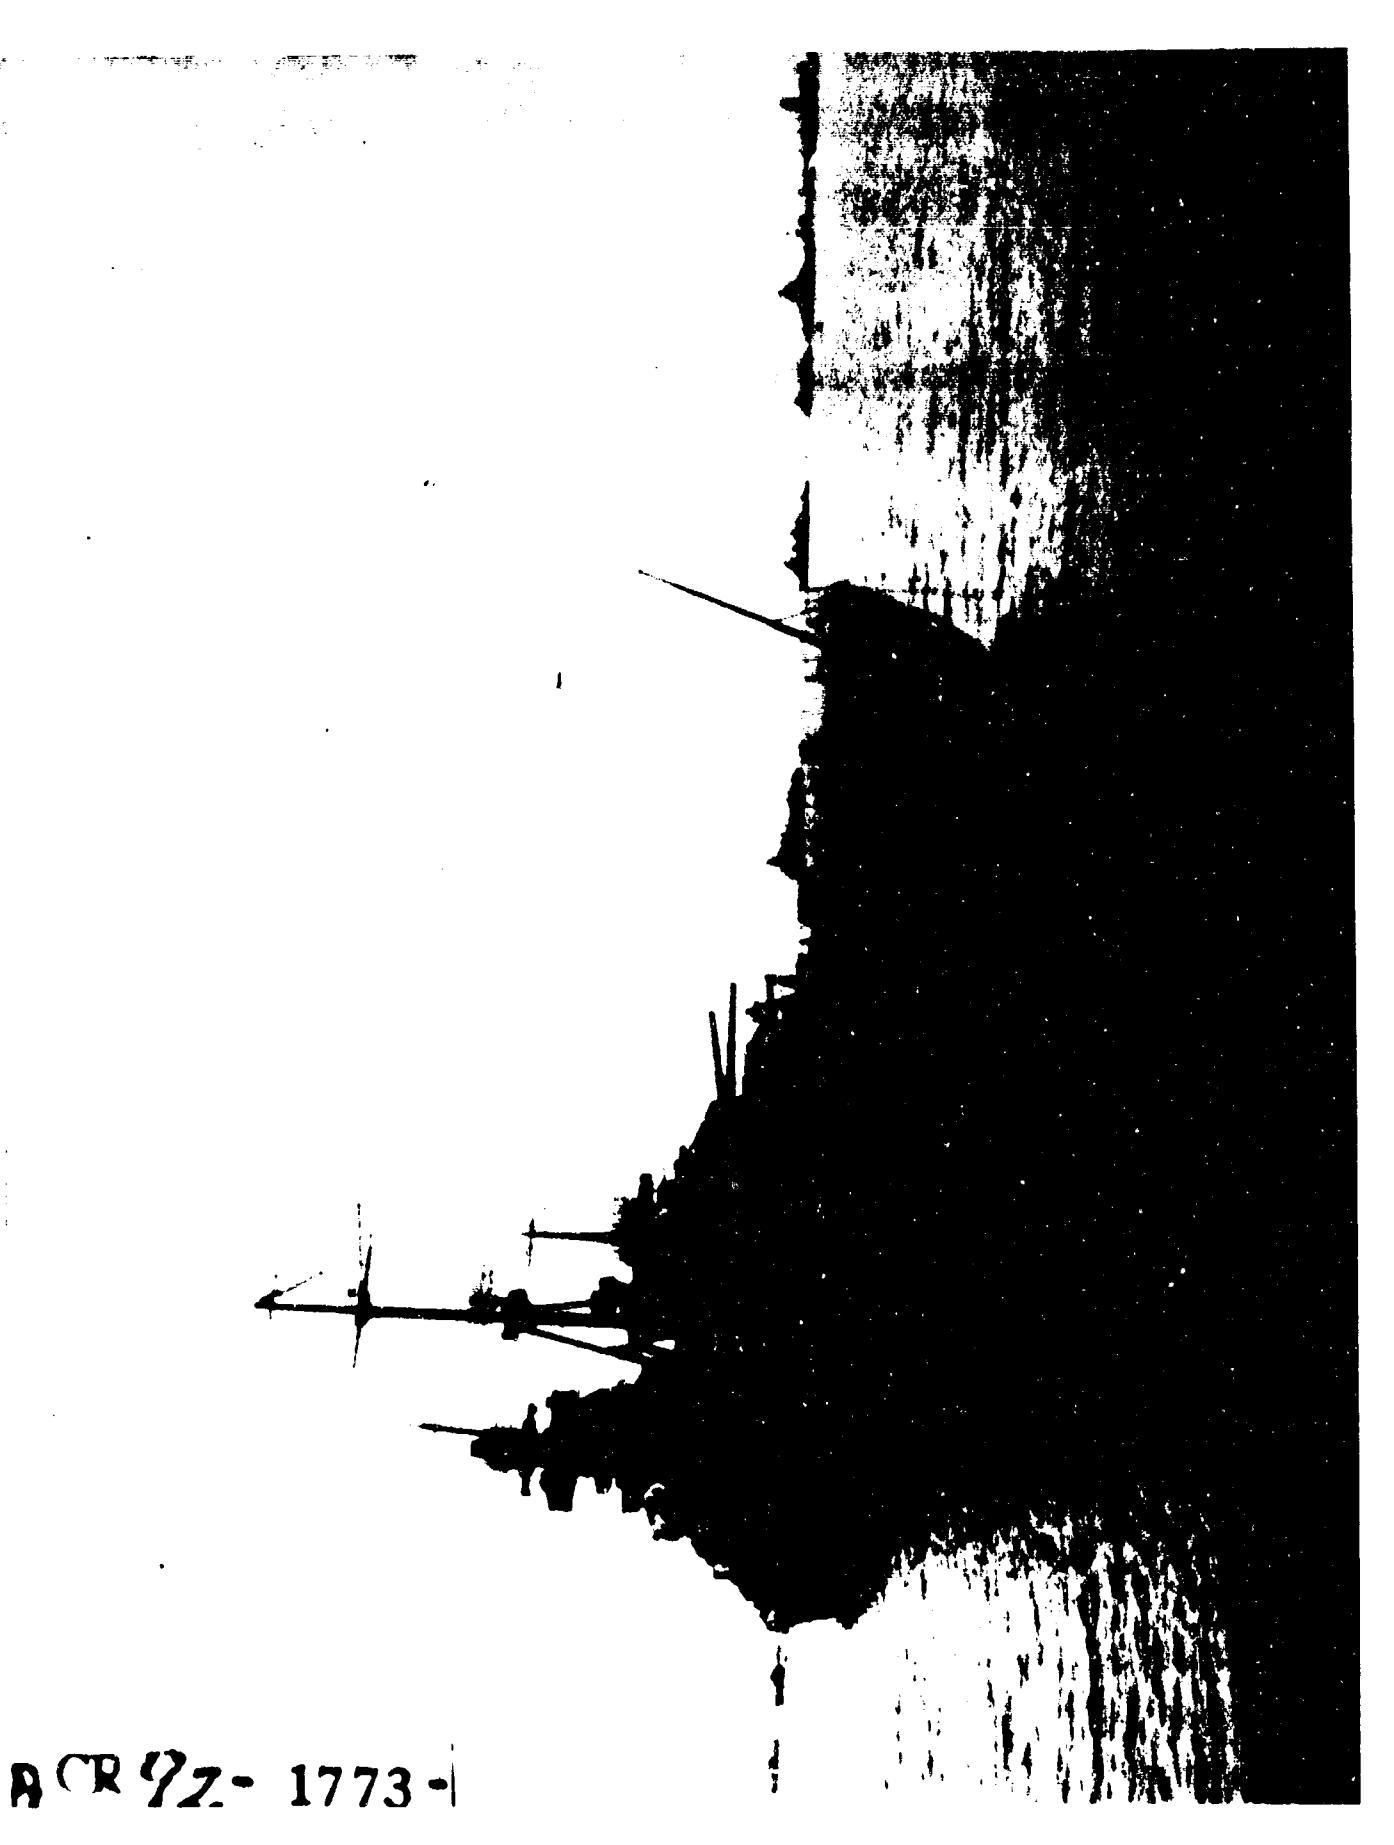
1. The blast, attacking this ship practically head on, caused little damage except to fore and main top masts. Photos 196-157-38 and 227-92-101, pages 203 and 204 are comparative views before and after Test A. Photos 2199-2, 3; 2200-12, 2199-1, 1773-8 and 1774-5; pages 205, 206, 207, 208, 210 and 211 show details of damage to the fore topmast. Photo 1773-7, page 209 shows the broken main topmast. The main top mast was removed immediately after reboarding as a safety measure. Both of the masts are wood.

AA-CR-92-1773-7. PRINZ EUGEN (IX300). View looking at port after quarter showing main topmast hanging after Able.
