# U.S.S. PENSACOLA (CA24)

TEST ABLE

VOLUME 2 OF 2

OPERATION CROSSROADS DDC

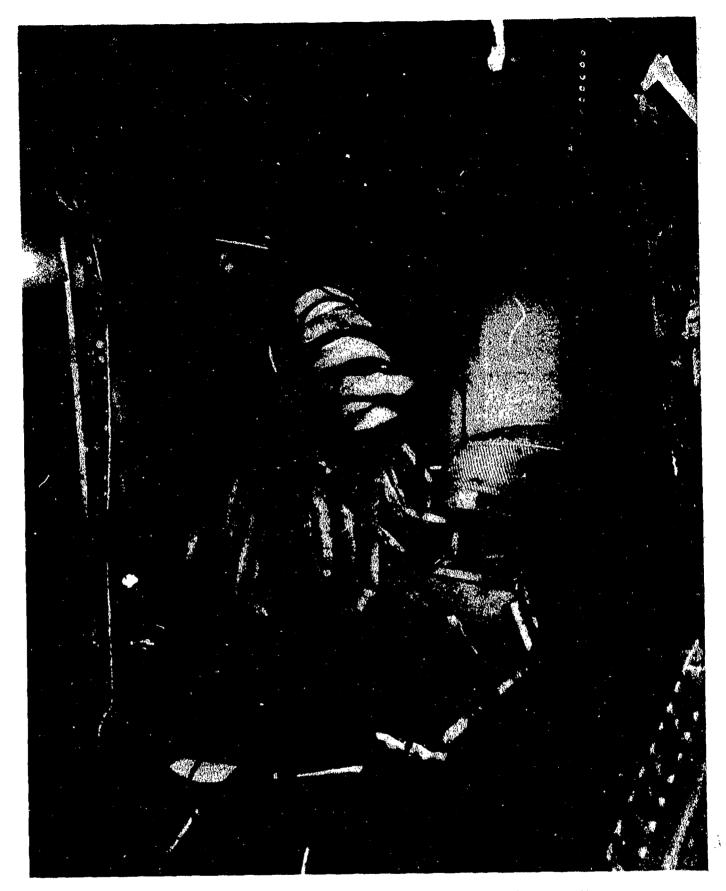
AA-CR-98-1968-1. Emergency cabin on port after side of navigating bridge level, looking forward and to starboard. Cabin bulkhead is aluminum. Note piece of port flagbag at lower right.

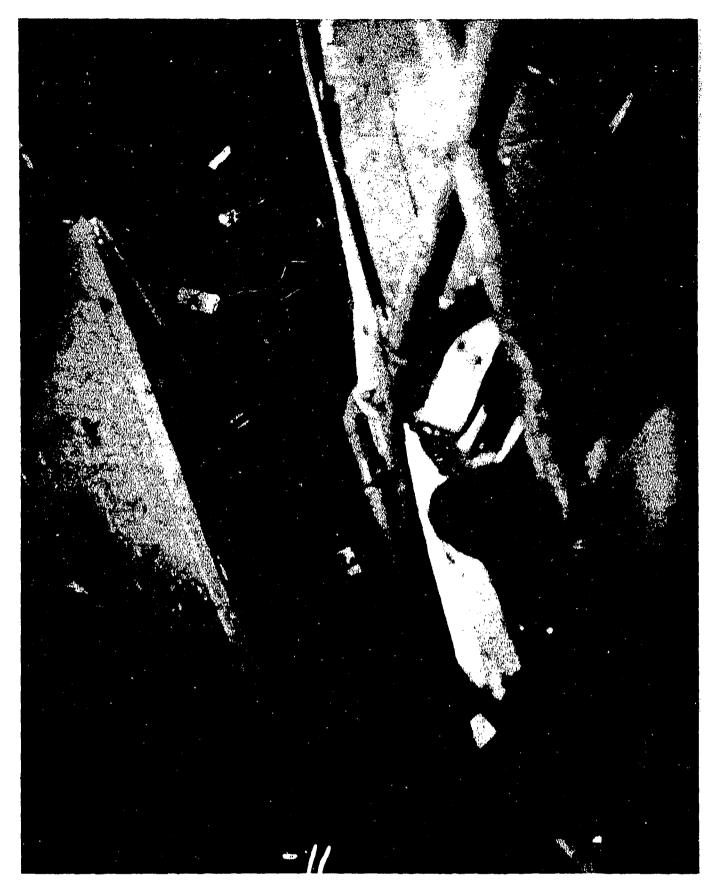
AA-CR-68-1760-11. Remains of flag bag on port side of after edge of navigation bridge, frame 50.

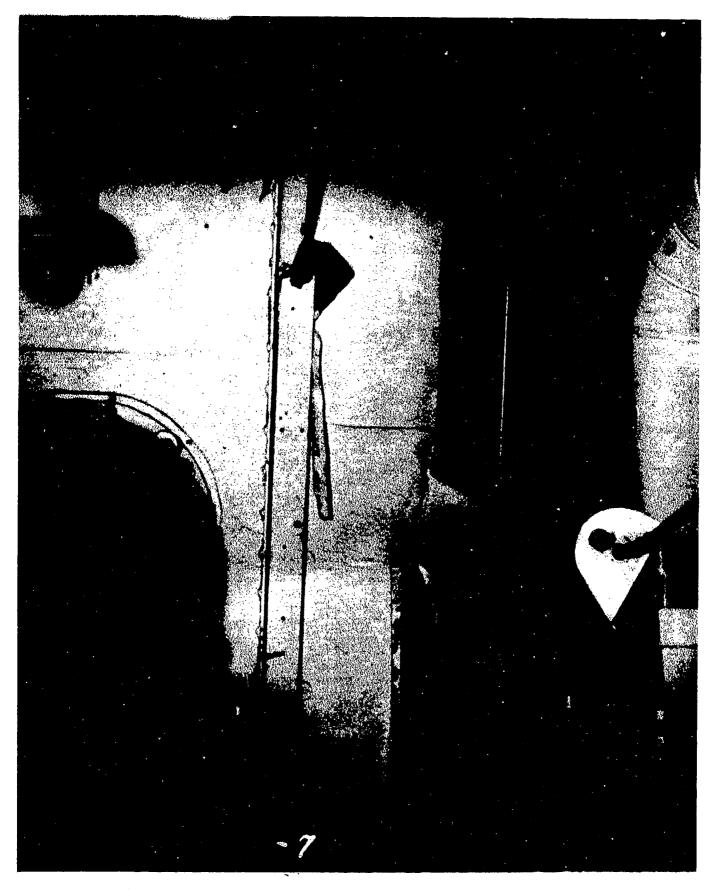
AA-CR-68-1760-7. Break in aluminum bulkhead seam, port side of deckhouse on navigating bridge.

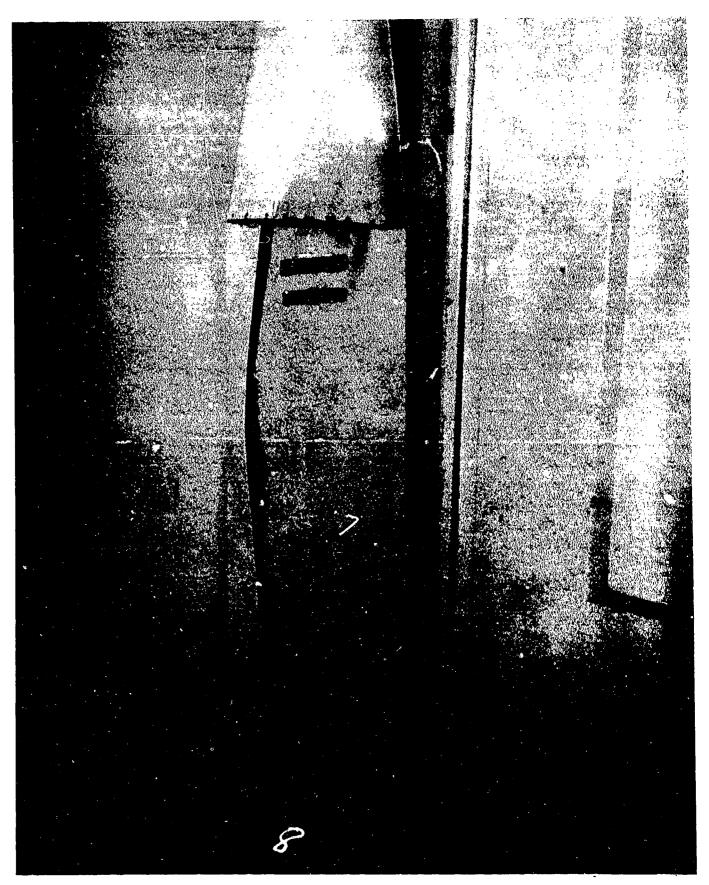
AA-CR-68-1761-8. Damaged vent duct in passage on superstructure deck, frame 50. This duct exhausts battery room below.

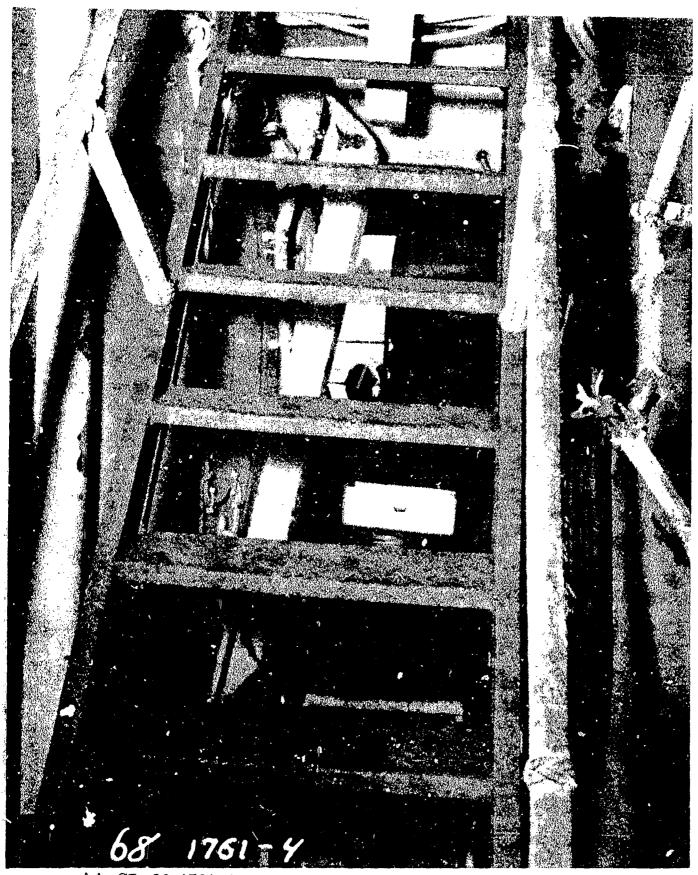
AA-CK-68-1761-4. Interior view of trunk at main deck level, frames 46-47, looking to port. Note inward deflection of trunk bulkhead 47.

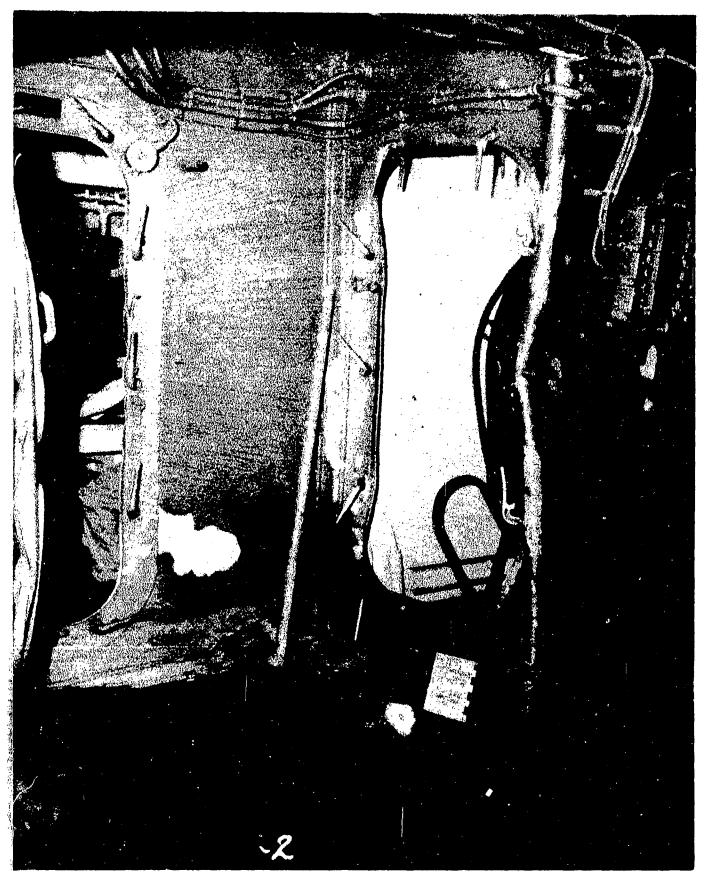
AA-CR-68-1754-2. View on main deck, port side, looking forward and to starboard, showing damage to bulkheads 46 and trunk bulkhead 47.

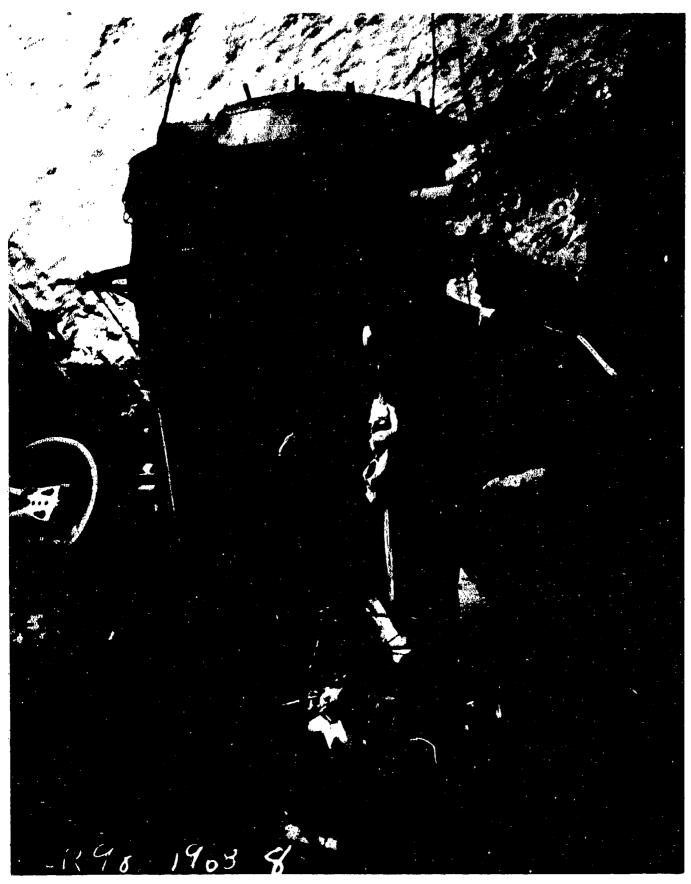
AA-CR-98-1968-8. Looking down and aft from fire control platform show-ind damage to starboard side of forward stack.

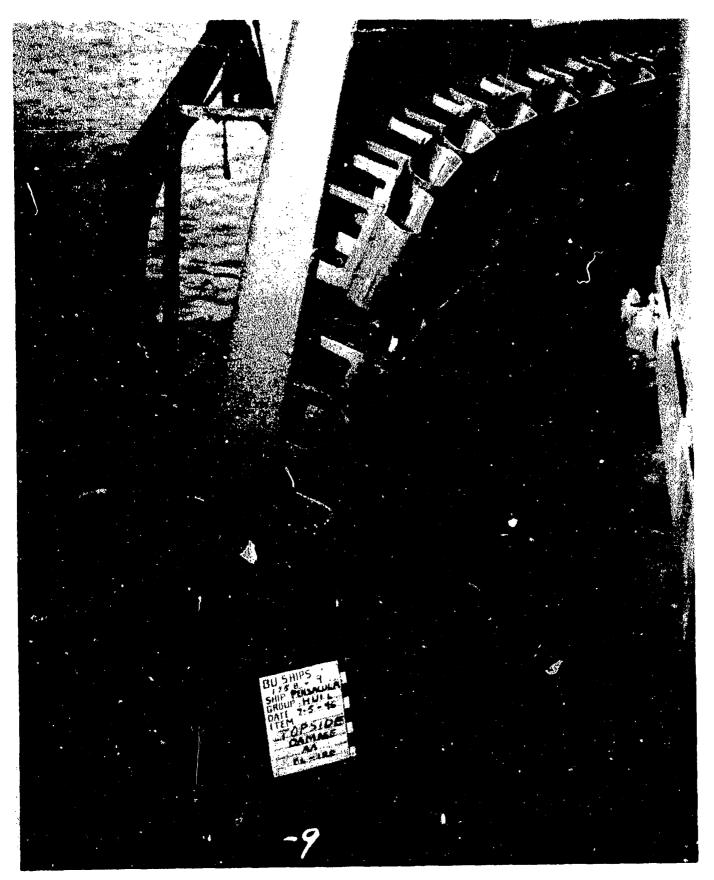
AA-CR-68-1758-9. Looking to port on superstructure deck at frame 97. Note tear in deck in way of 40 mm gun shield.

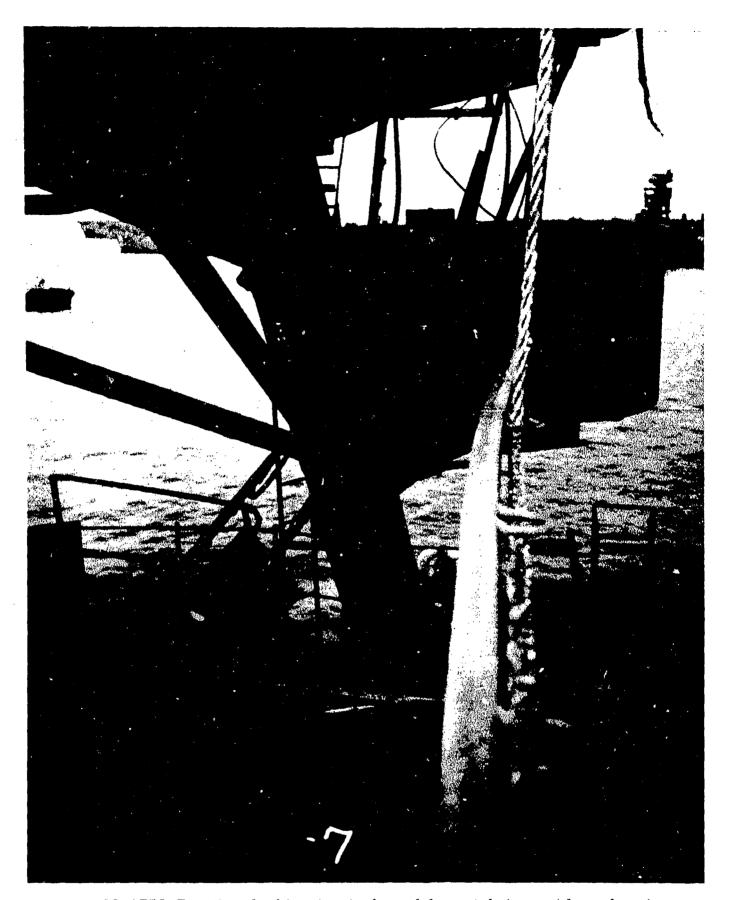
AA-CR-68-1759-7. View looking to starboard from tub in port leg of main mast.

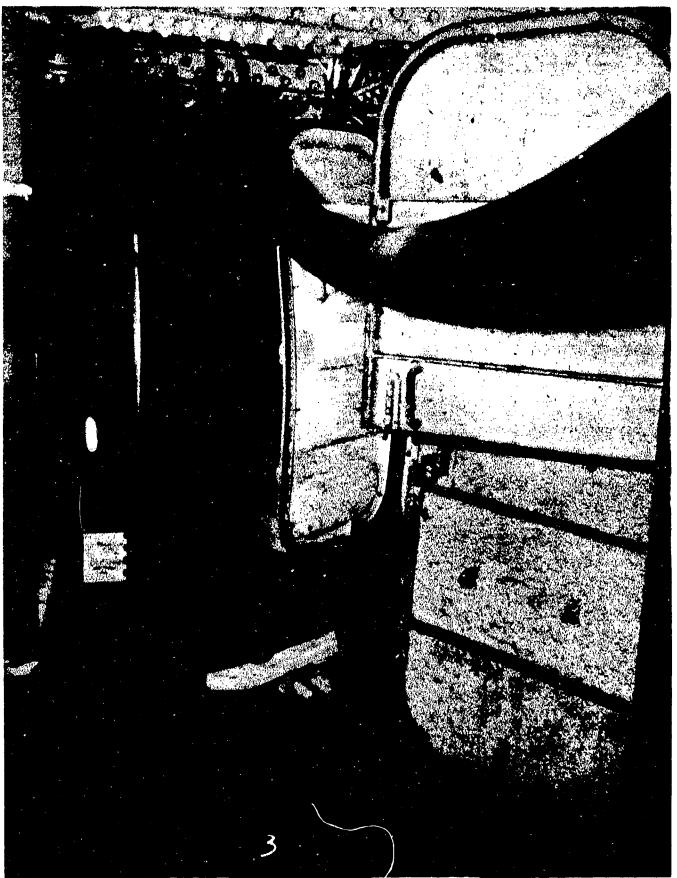
AA-CR-68-1756-3. Starboard main deck passageway, looking forward from frame 89.

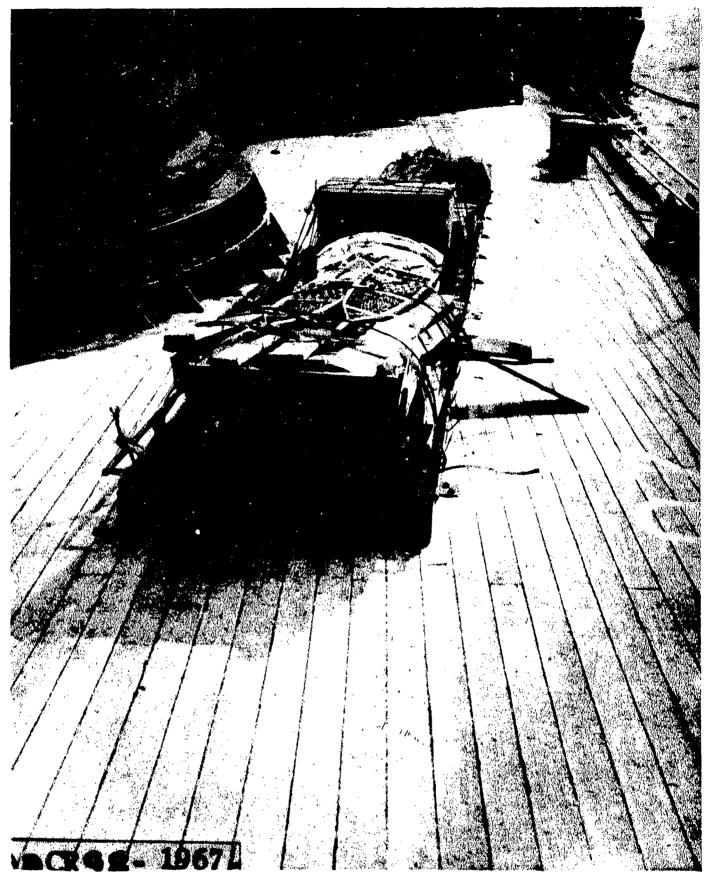
AA-CR-98-1967-4. Port side of main deck in way of frame 20, looking aft.

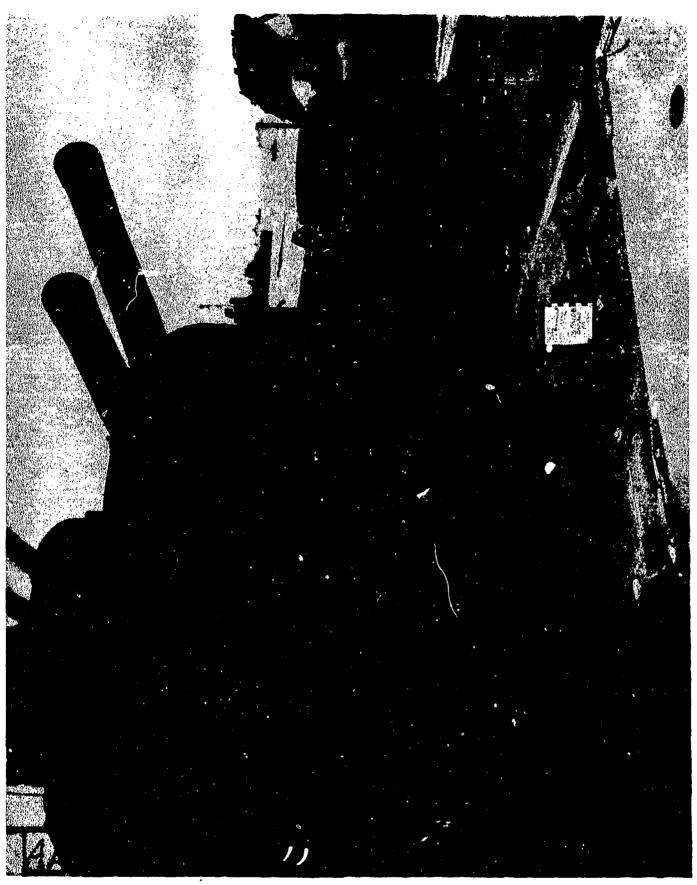
AA-CR-68-1756-11. Looking forward on weather deck from frame 130; the deflection of the deck is noticeable from edge of number 4 mount aft. Note pocket of water, also separation in deck just aft of turret foundation.

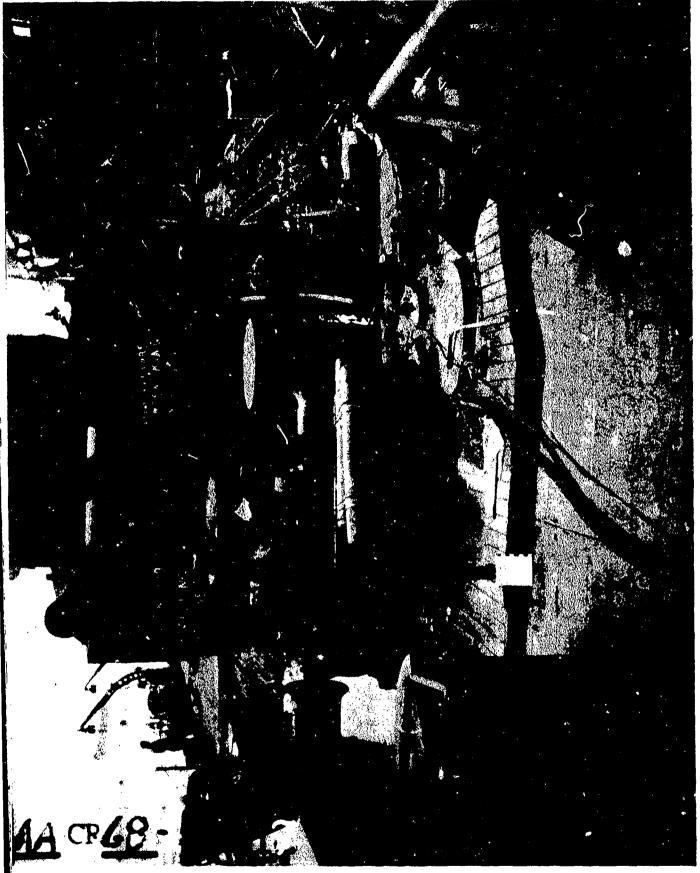
AA-CR-68-1764-7. Looking forward on main deck aft from frame 133, (APA 229 alongside).

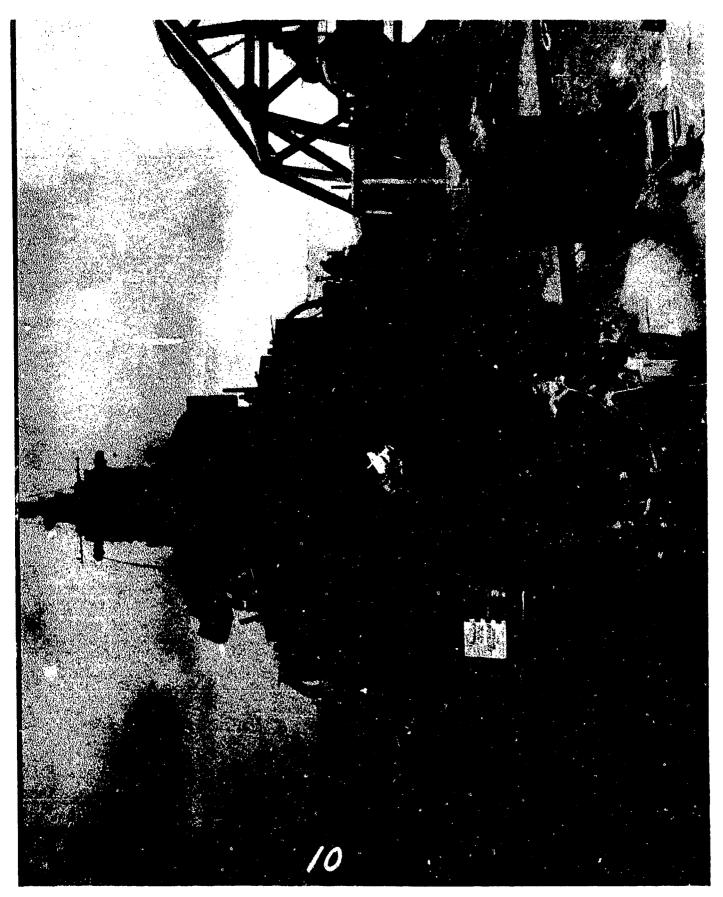
AA-CR-68-1756-10. Looking forward on weather deck from frame 138. Note maximum deflection of deck occurs in way of the two companion hatches in the background, frames 125-126.

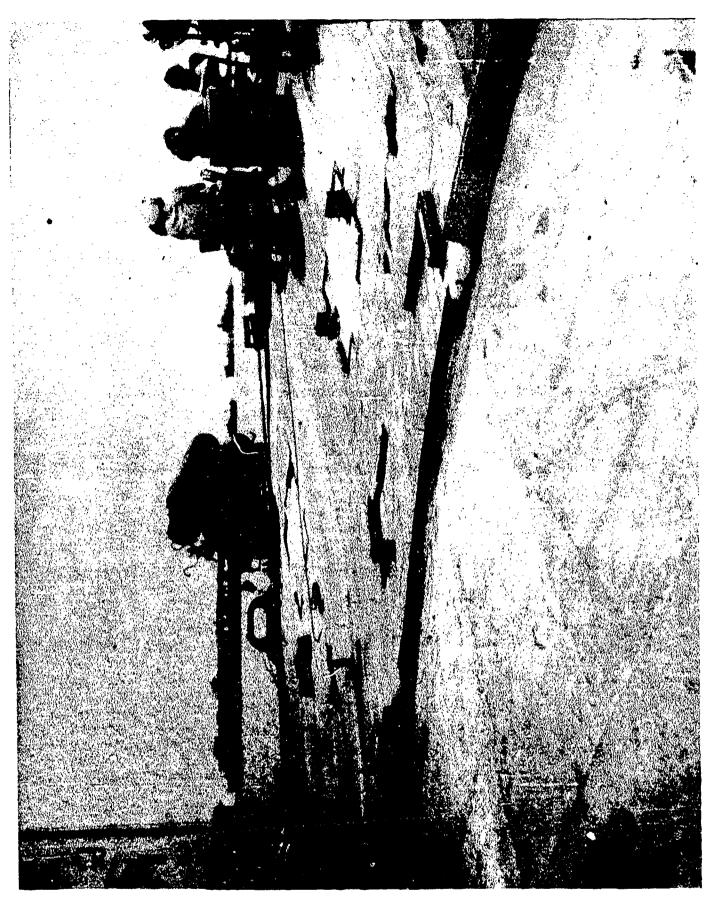
AA-CR-175-2158-11. Looking aft and to starboard from frame 134 after debris had been removed.

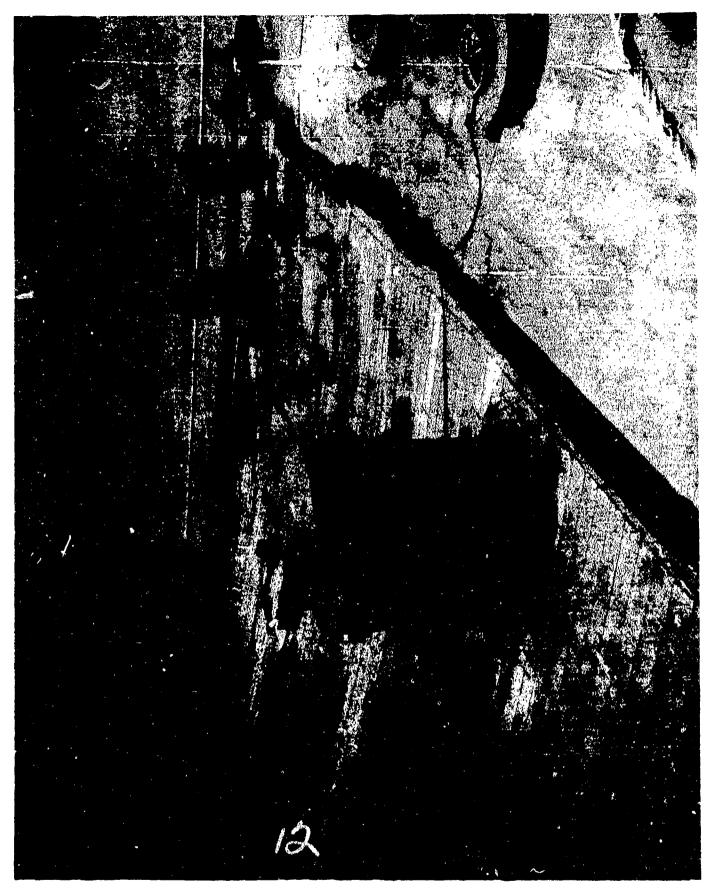
AA-CR-175-2158-12. Looking to port on weather deck from frame 134 after debris had been removed.

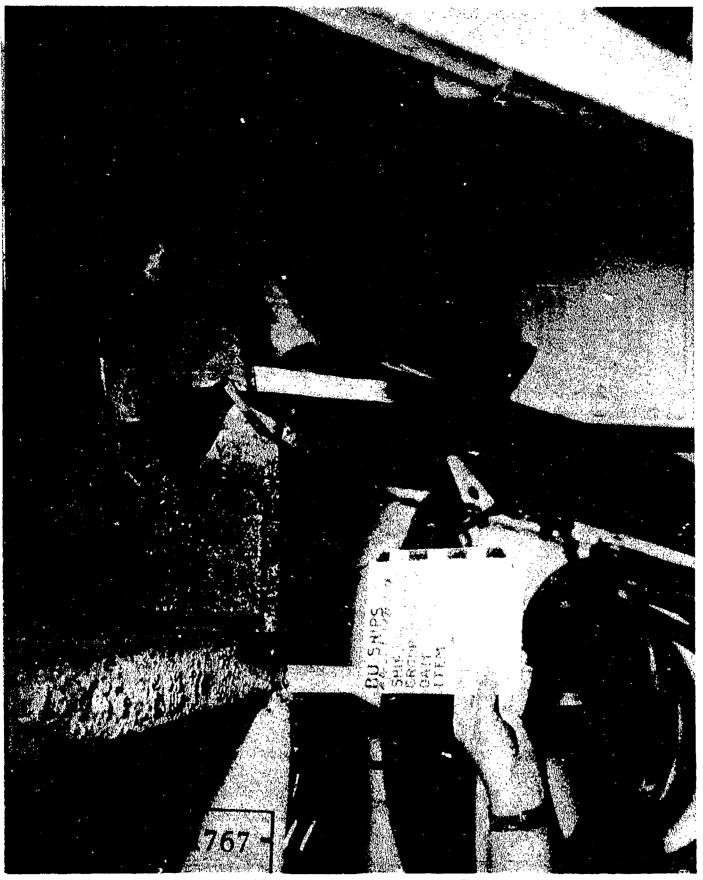
AA-CR-68-1767-11. C-201L. Looking to port on 2nd deck from centerline in crew's space showing failure of main deck longitudinal at frame 62 1/2.

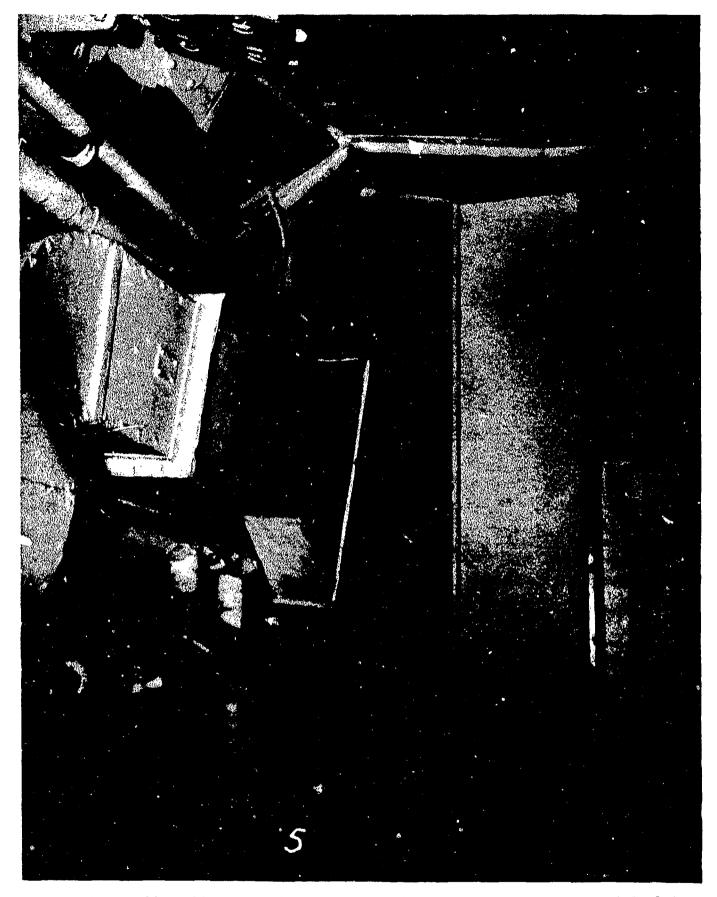
AA-CR-68-1768-5. C-201L. Looking forward and to port on 2nd deck in crew's wash room showing buckling of bulkhead 70.

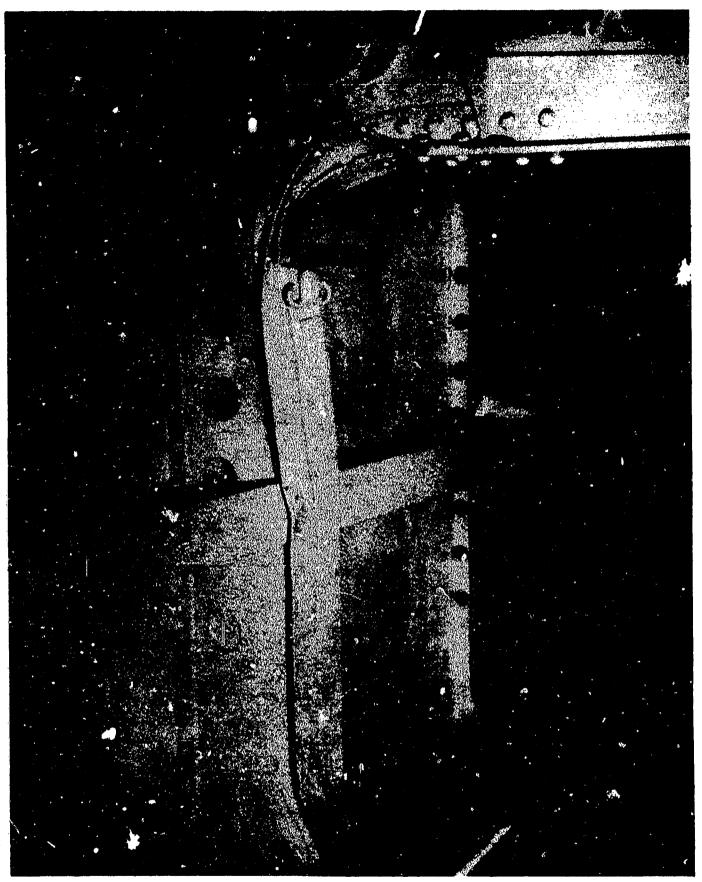
AA-CR-175-2178-1. Looking aft and to starboard shell on 2nd deck showing damage to web frame 125.

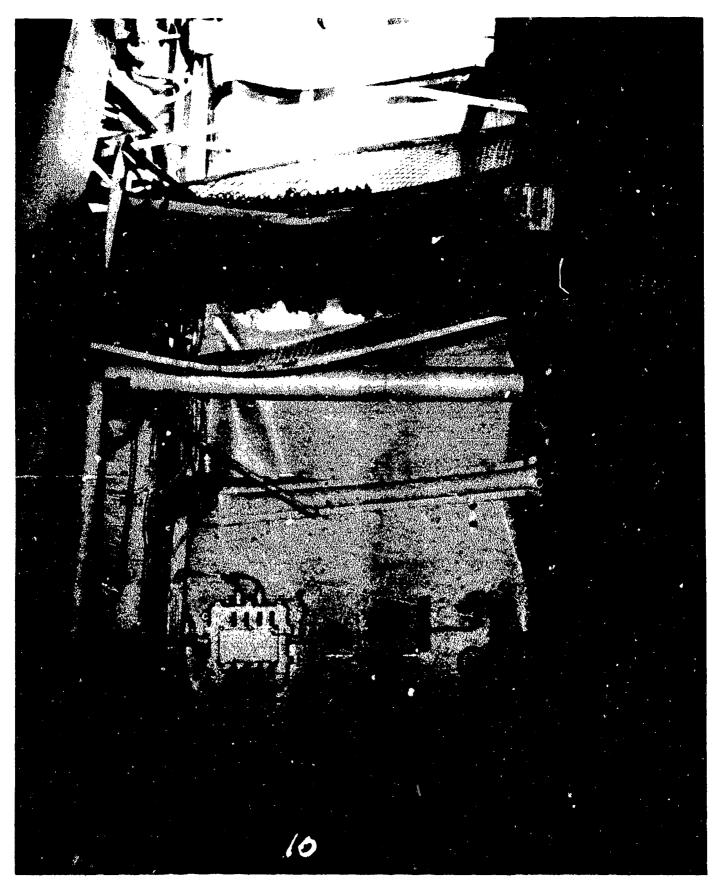
AA-CR-68-1765-10. Compartment D-203-L, crew's space, 2nd deck, forward face of bulkhead 128, just inboard of starboard access.

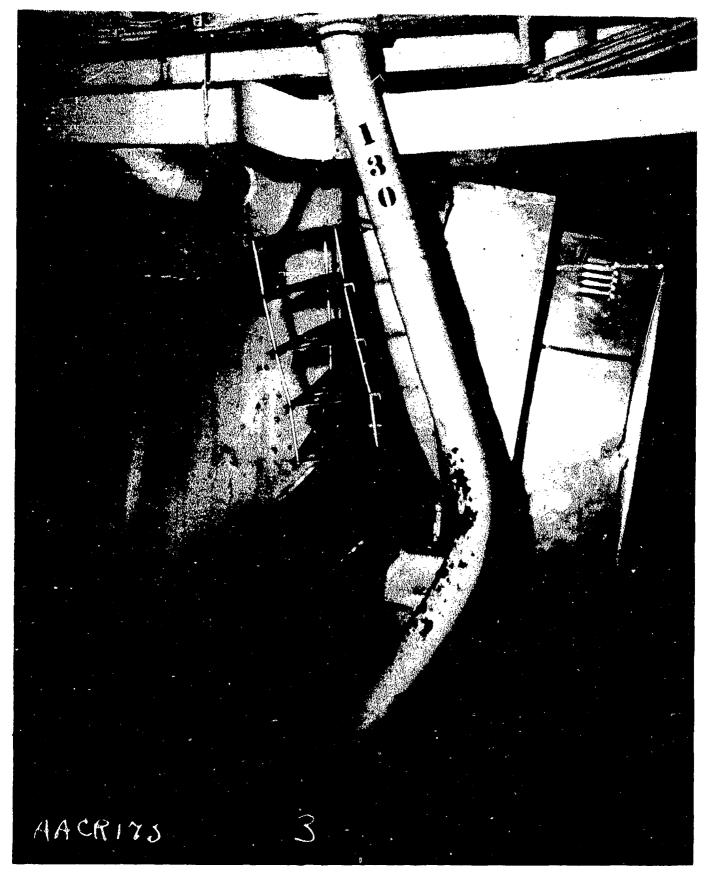
AA-CR-175-2179-3. D-203-2L. Looking aft on 2nd deck in C.P.O. mess showing damage to stanchion at frame 130, starboard.

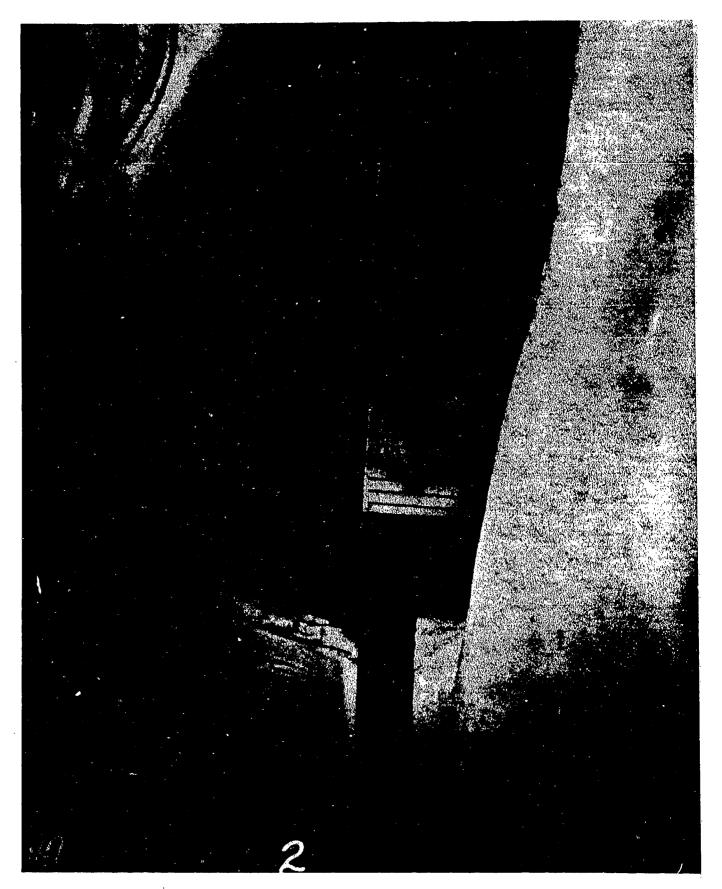
AA-CR-68-1762-2. Bulkhead No. 43, showing crushing at centerline under forward leg of forward tripod. Looking aft from starboard side.

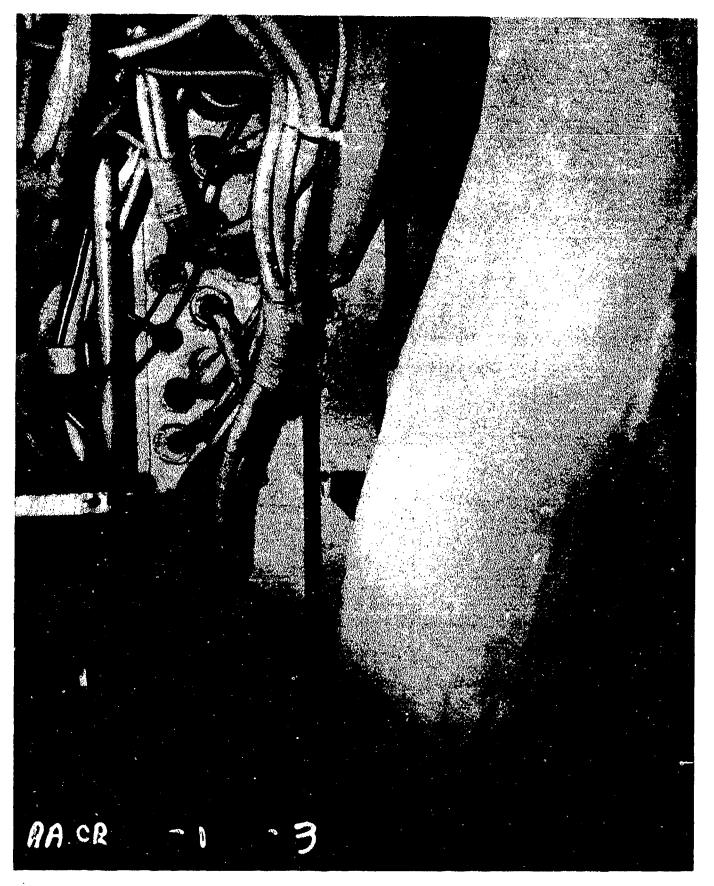
AA-CR-68-1762-3. Bulkhead No. 43, lower end of starboard bracket about 18 inches off centerline. Looking aft, between first and second platform.

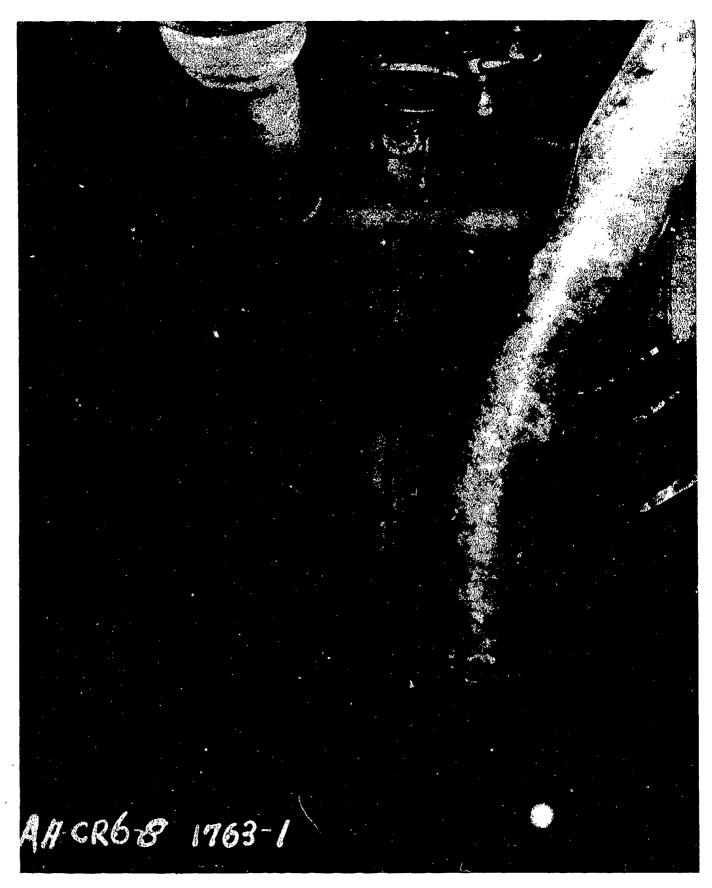
AA-CR-68-1763-1. View in No. 2 fireroom, upper level, looking aft between boilers to centerline column. Note stress lines on column.

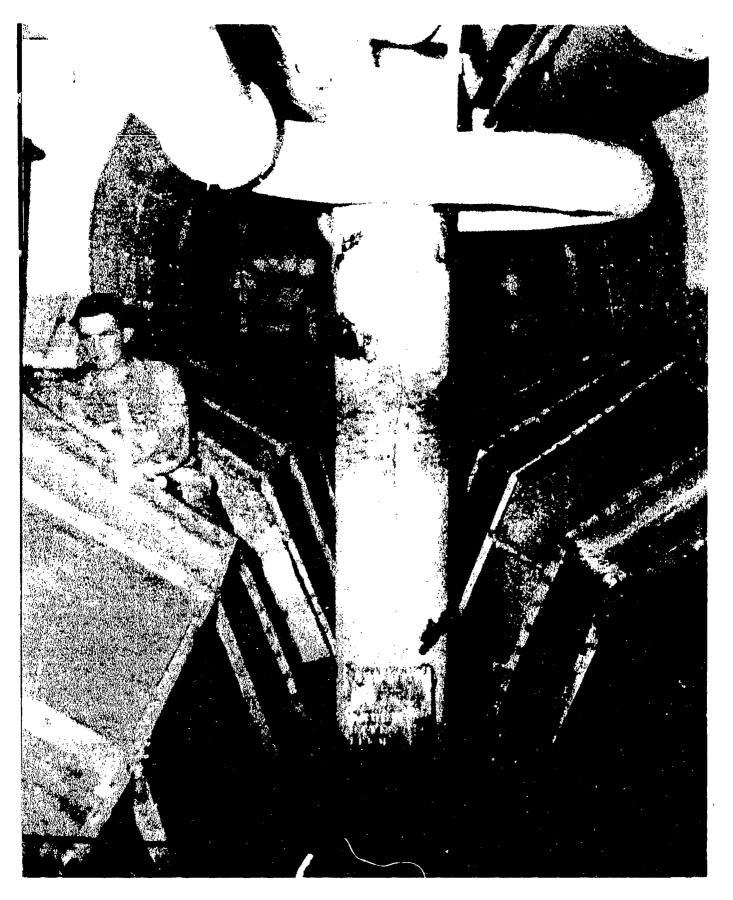
AA-CR-90-575-1. B-2. Looking aft in after fireroom showing centerline stanchion at frame 78 1/2.

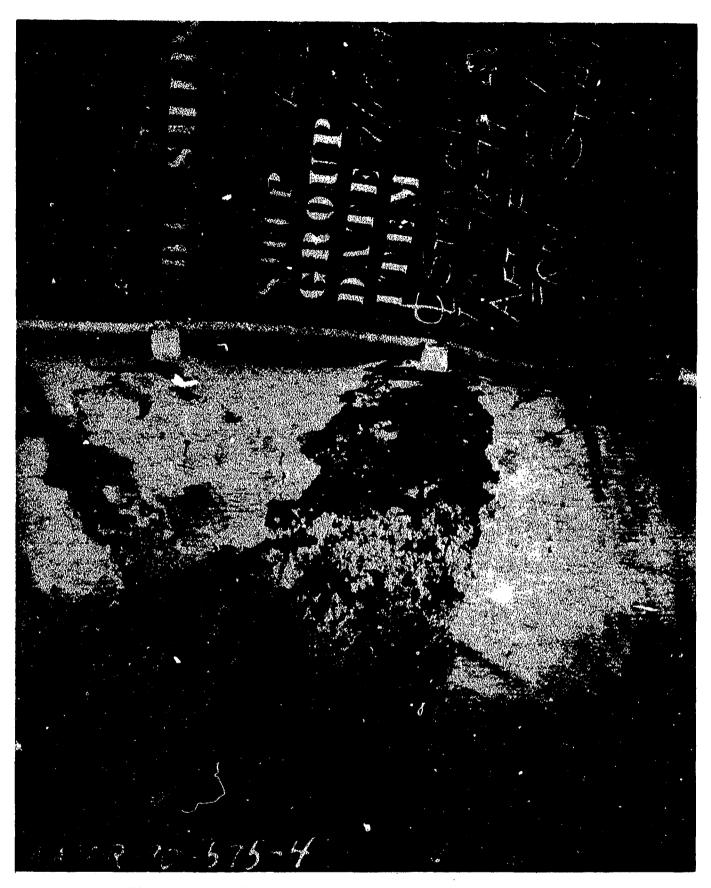
AA-CR-90-575-4. B-2. Close-up of stressed paint on centerline stanchion in after fireroom at frame 78 1/2.

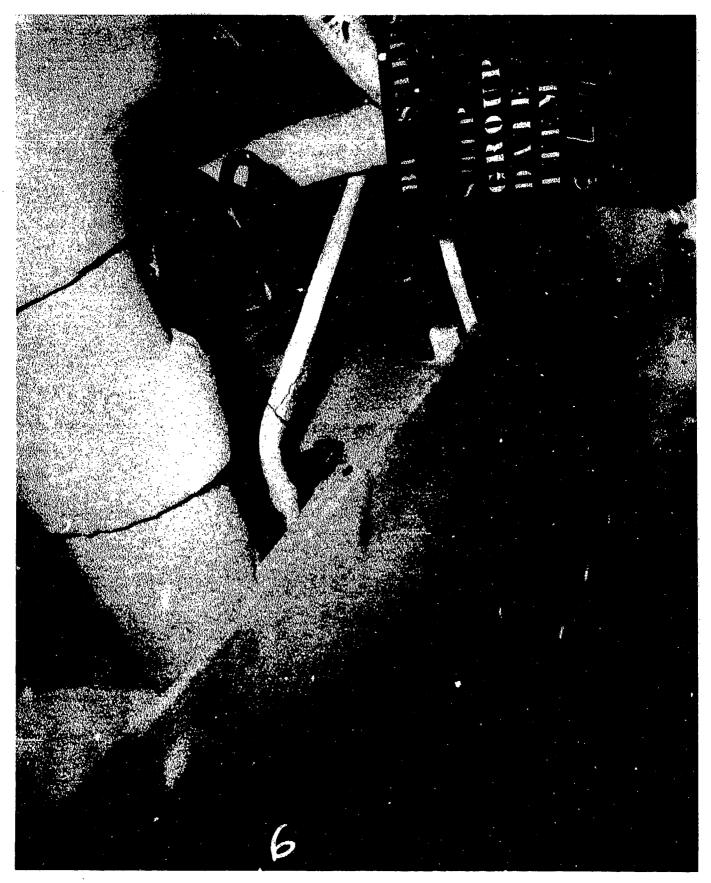
AA-CR-90-574-6. Looking aft in after engine room showing centerline girder, frames 95-96.

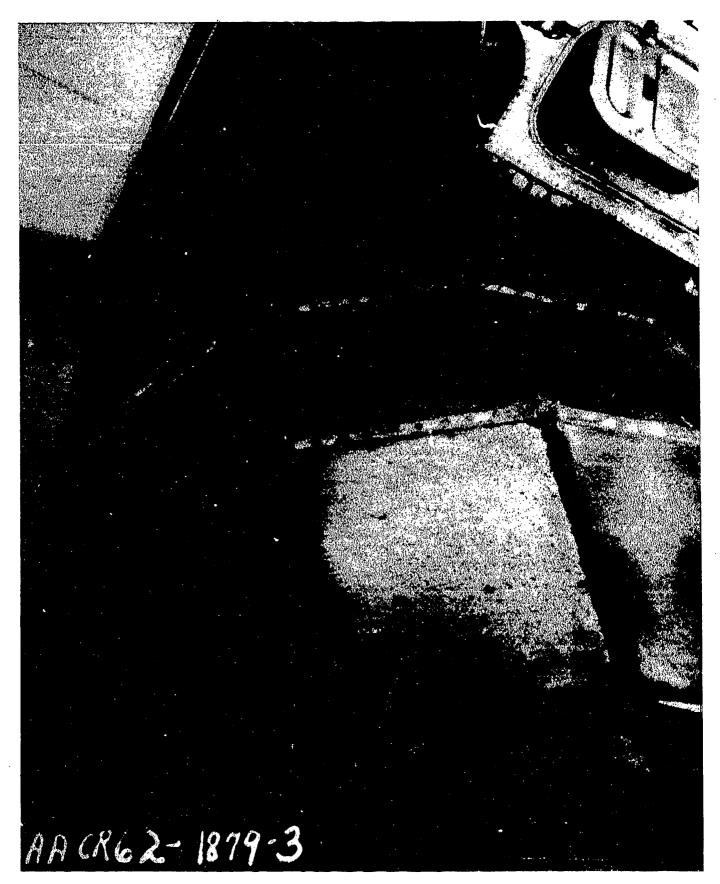
AA-CR-62-1879-3. #2 Boiler, upper port side casing.

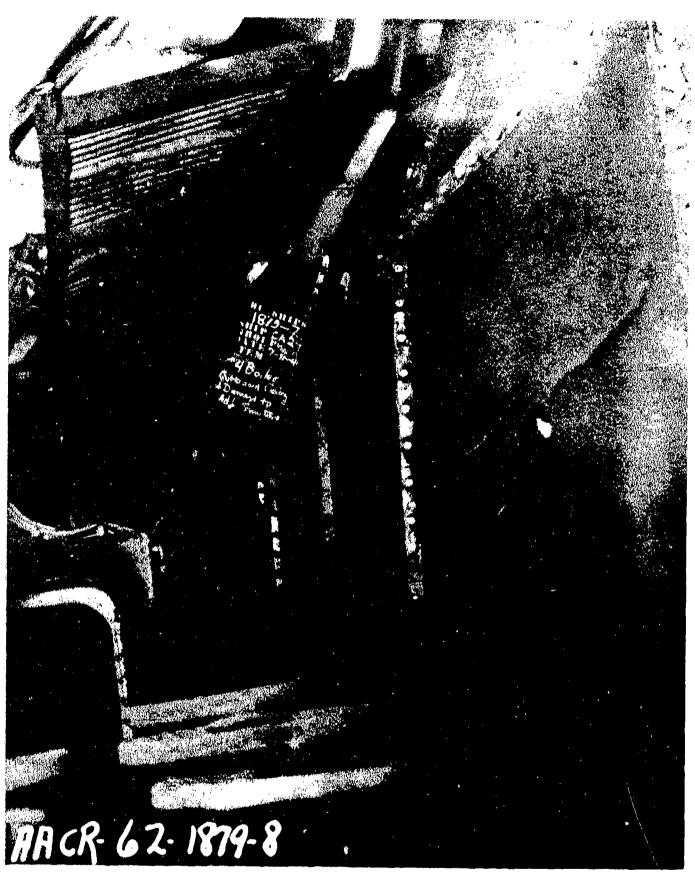
AA-CR-62-1879-8. #4 Boiler, outboard casing.

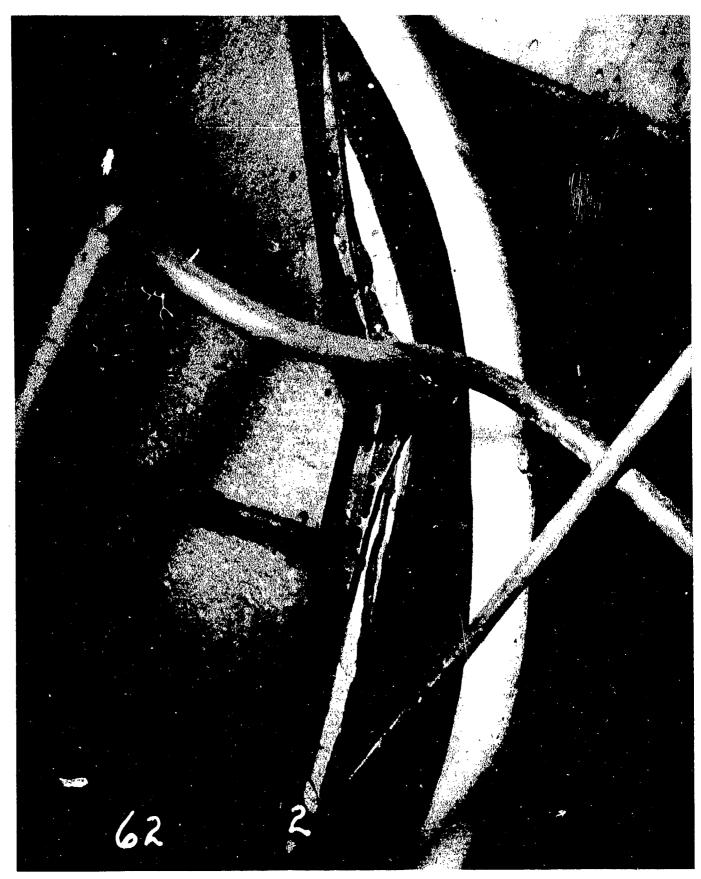
AA-CR-62-1879-2. #2 Boiler, upper front casing, outboard.

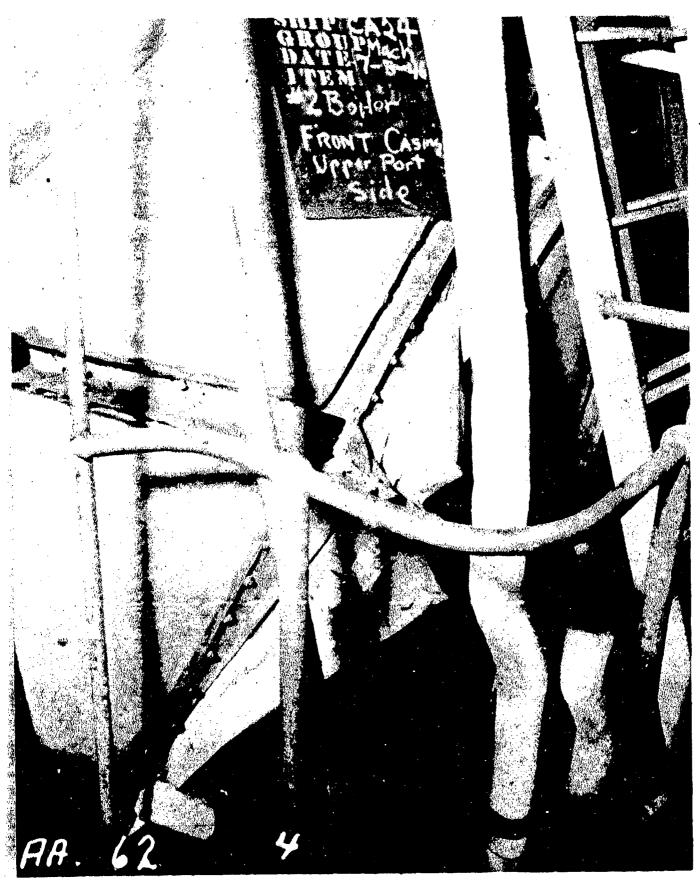
AA-CR-62-1879-4. #2 Boiler, upper front casing.

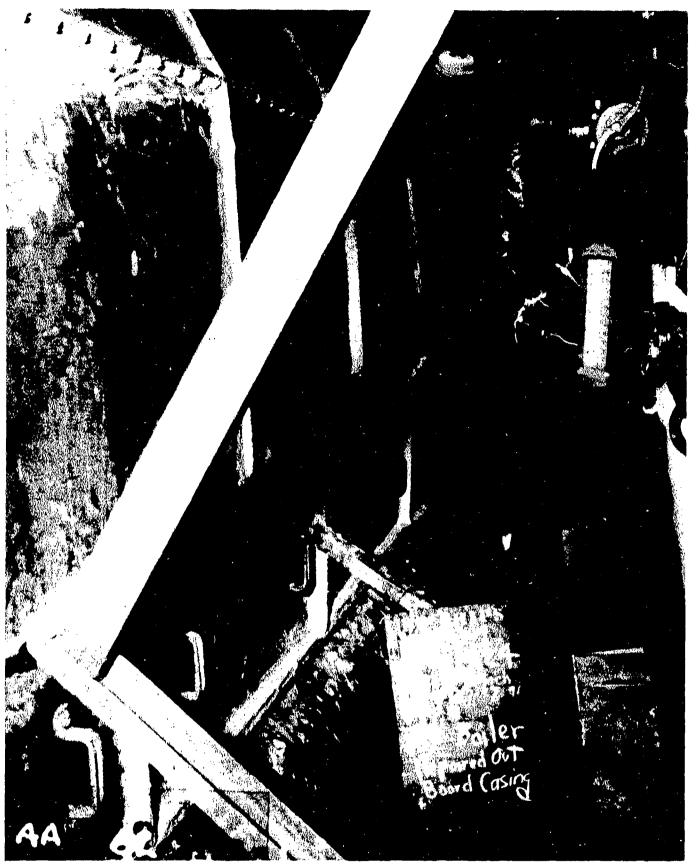
AA-CR-62-2173-1. #7 Boiler, repaired outboard casing.

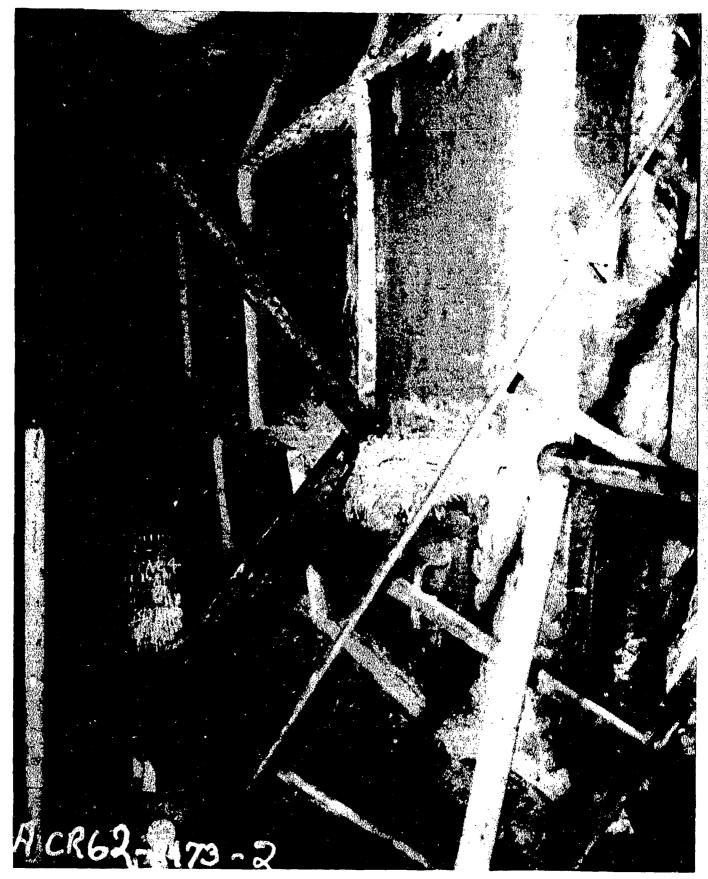
AA-CR-62-2173-2. #7 Boiler, repaired outboard casing.

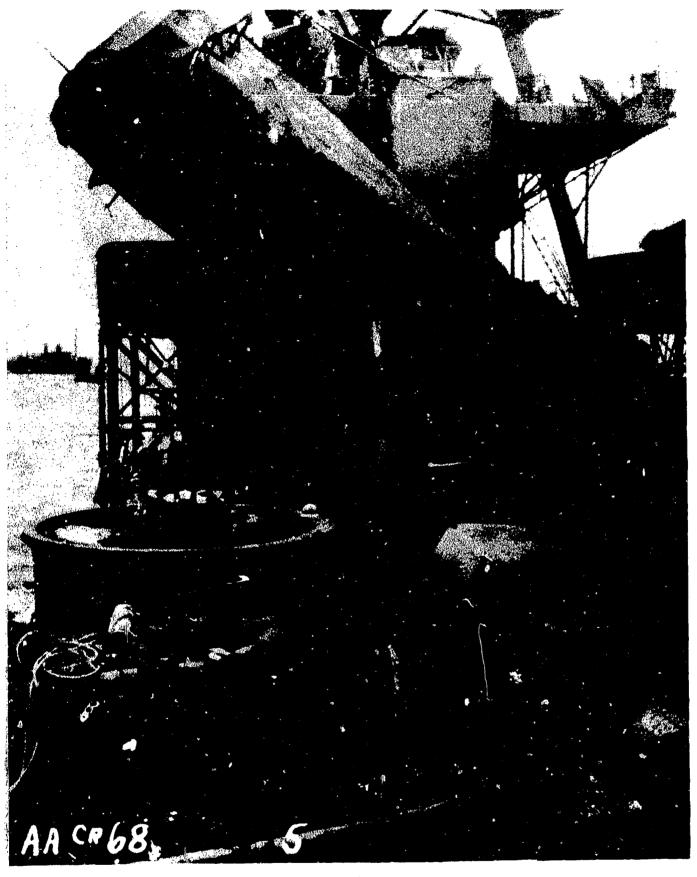
AA-CR-68-1758-5. Forward stack.

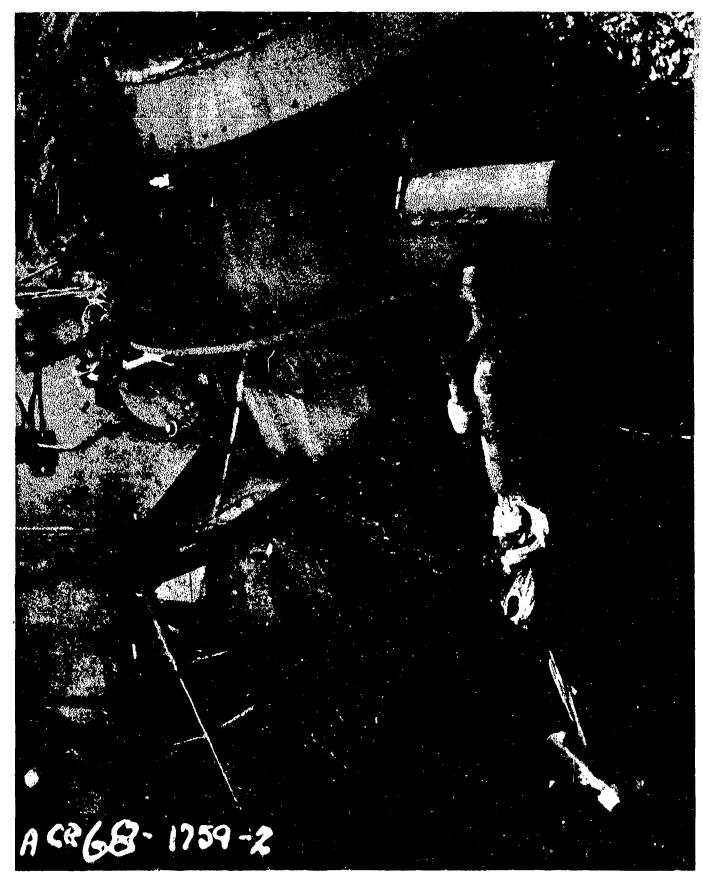
AA-CR-68-1759-2. Forward stack.
