# U.S.S. PENSACOLA (CA24)

TEST ABLE

VOLUME 2 OF 2

OPERATION CROSSROADS DDC

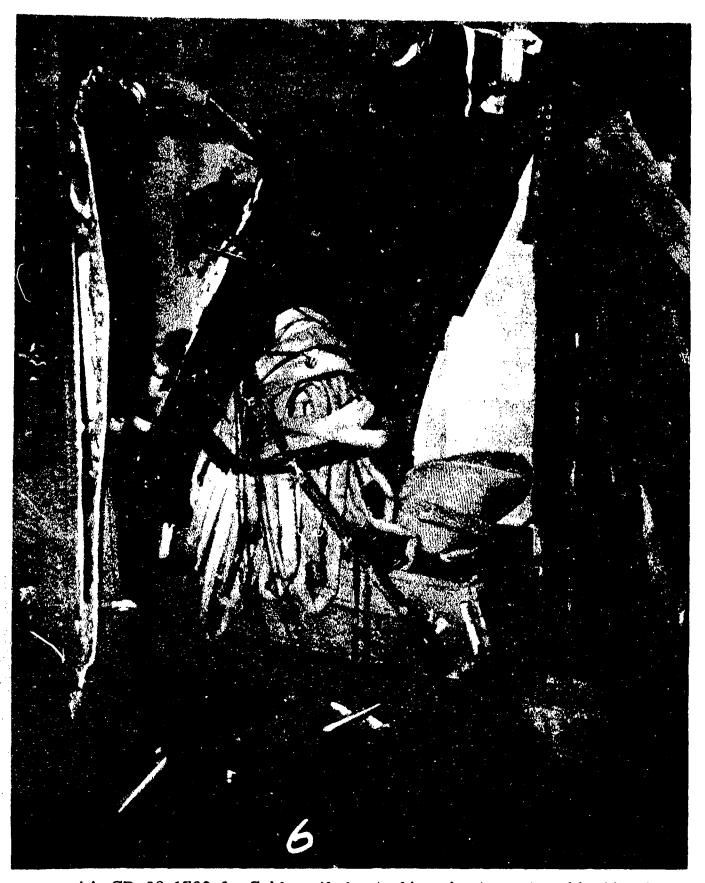
AA-CR-68-1760-6. Cable pulled out of box due to ruptured bulkhead.

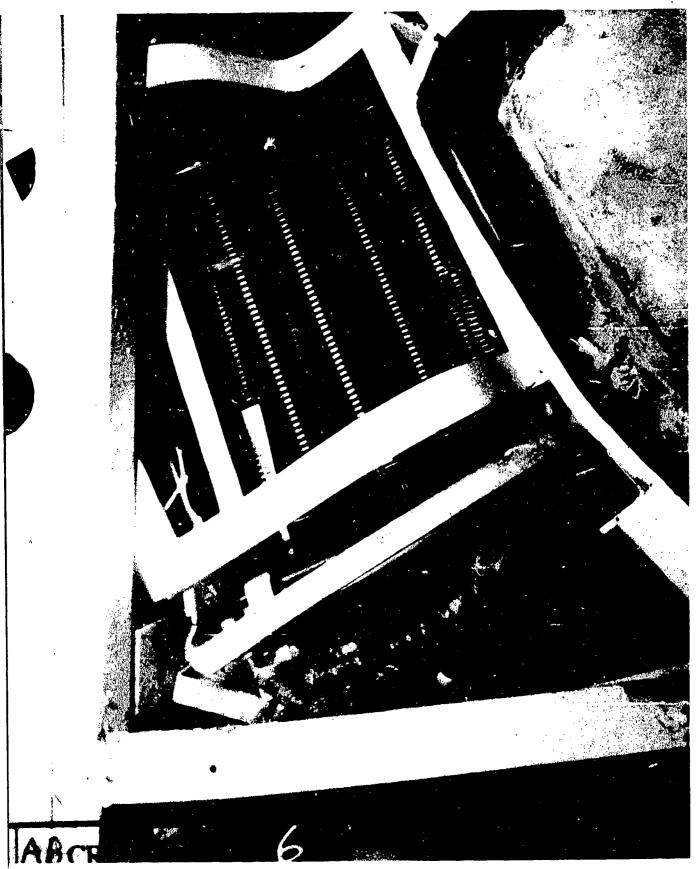
AB-CR-234-1692-6. Resistance unit for after warping winch, framework distorted to dishing of deck overhead.
