U.S.S. INDEPENDENCE (CVL22)

TEST ABLE

OPERATION CROSSROADS

BUREAU OF SHIPS GROUP
TECHNICAL INSPECTION REPORT

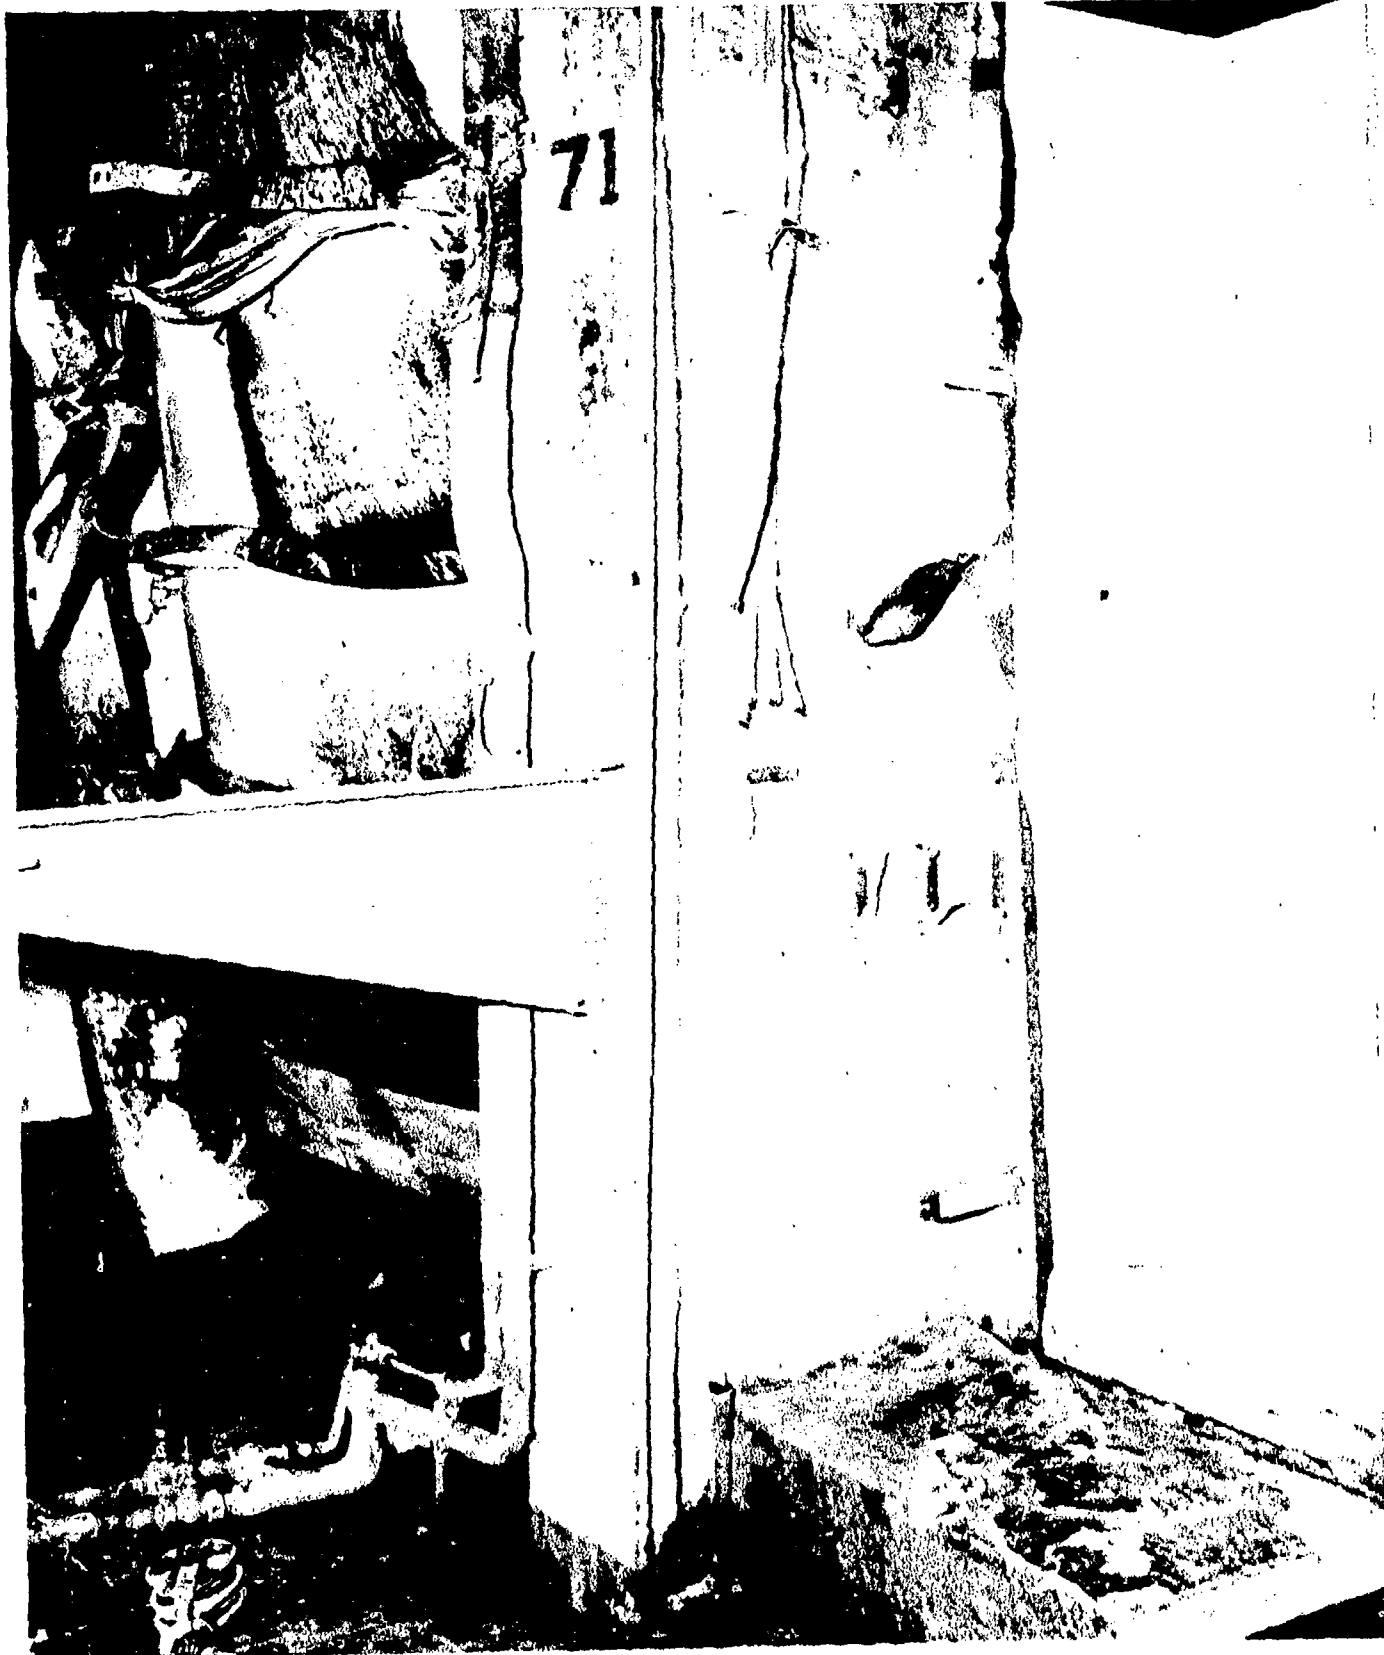
AB-CR-80-4186-4. After Baker - Flight deck Bent 71, port bottom, looking aft.

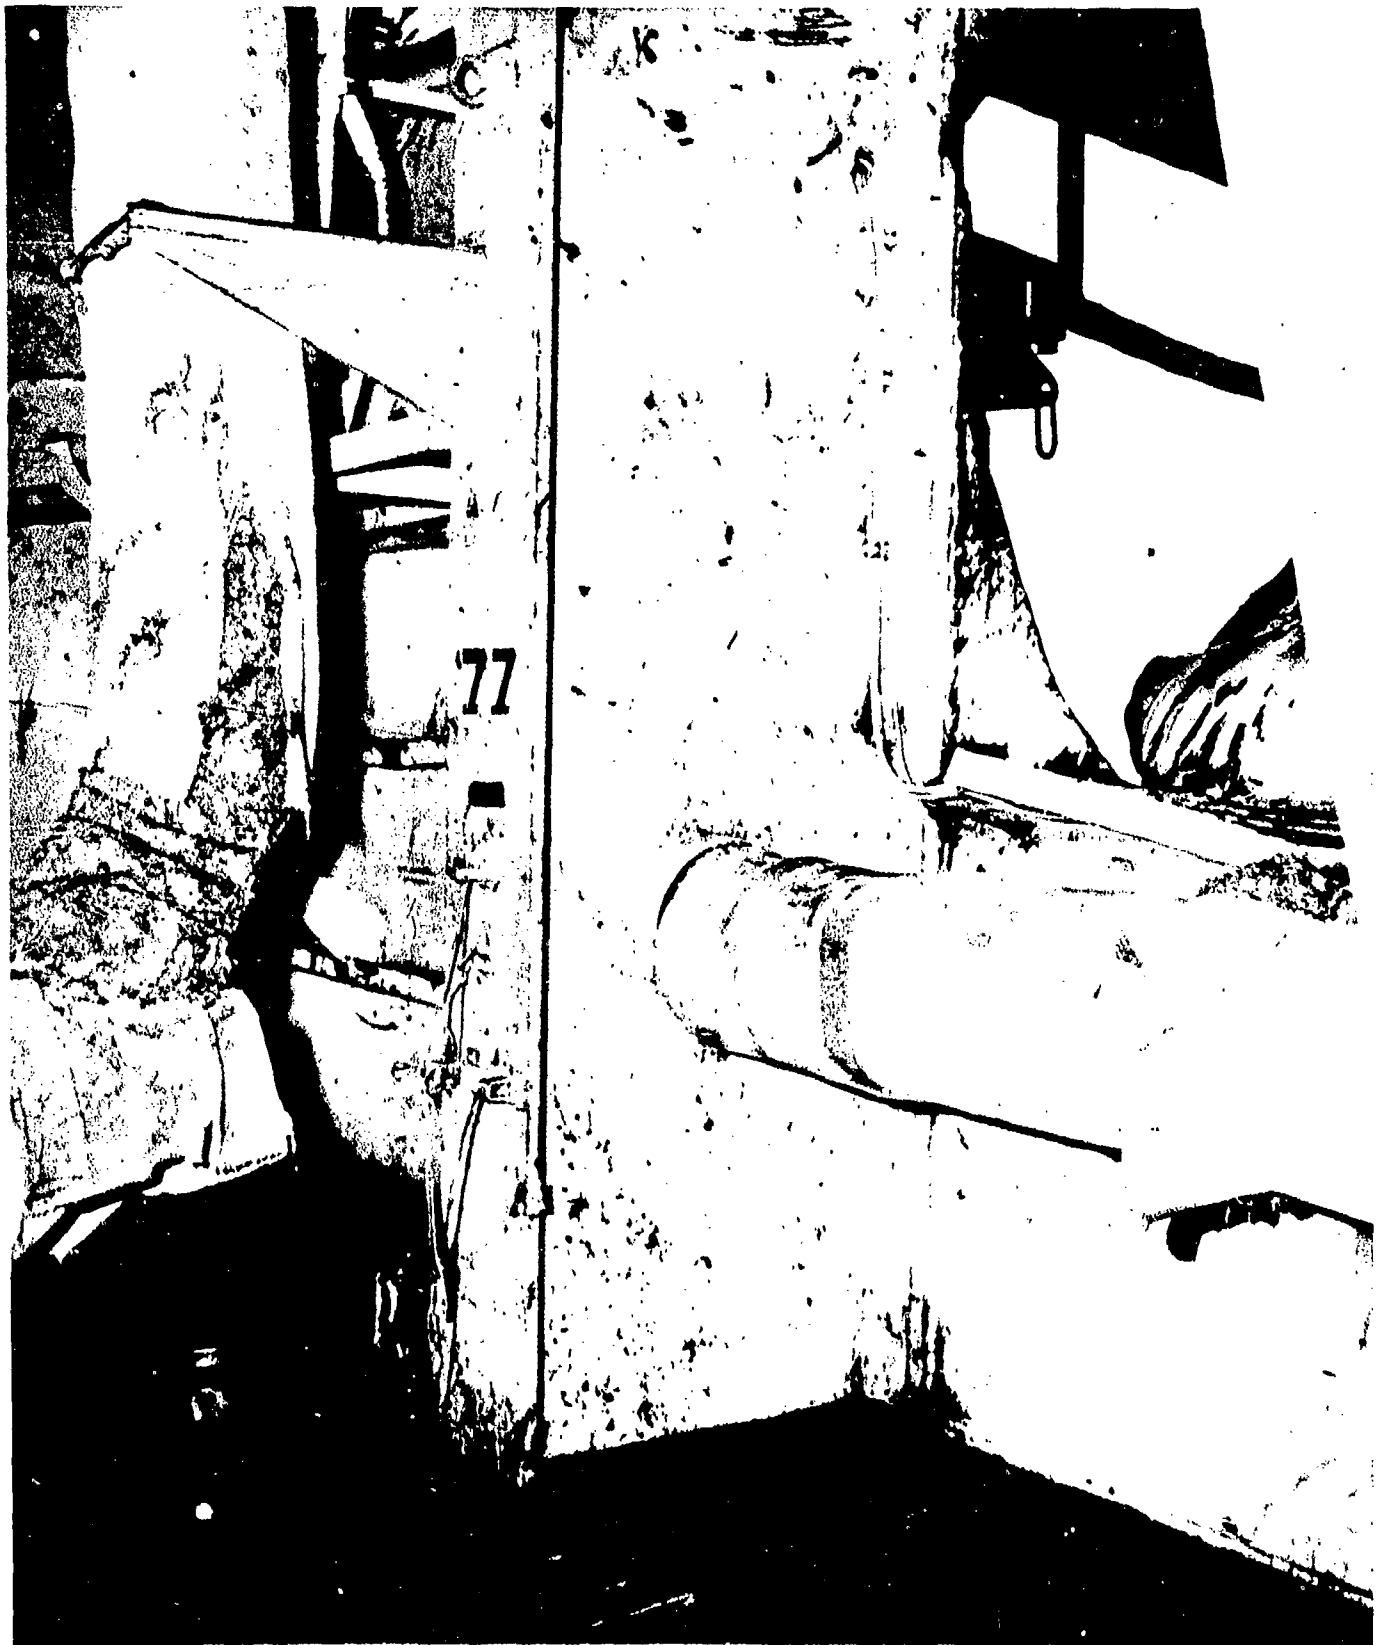
AA-CR-80-4186-9. After Baker - Flight deck Bent 77, Starboard bottom, looking forward.

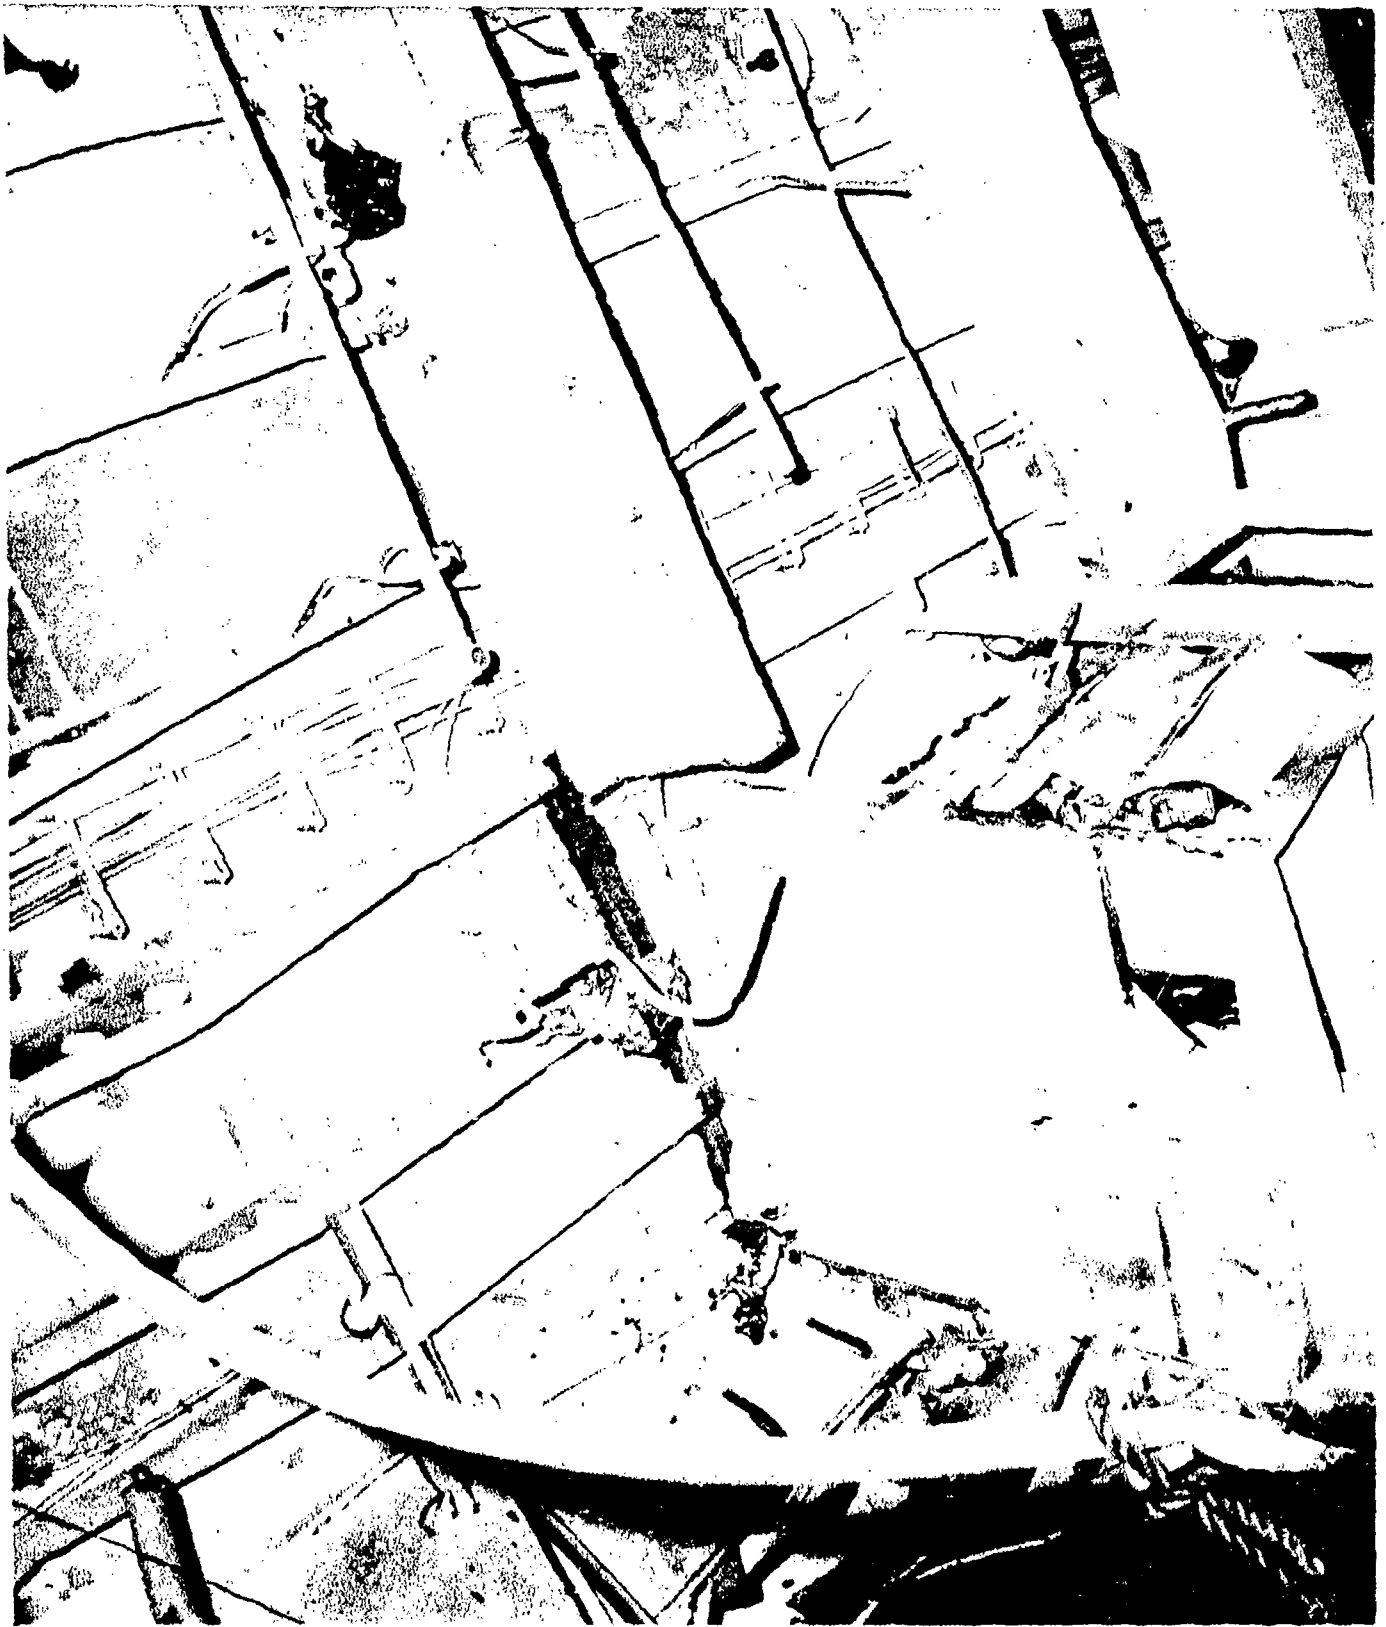
AA-CR-175-2131-4. Flight deck Bent 80, port side, looking forward from Bent 83.

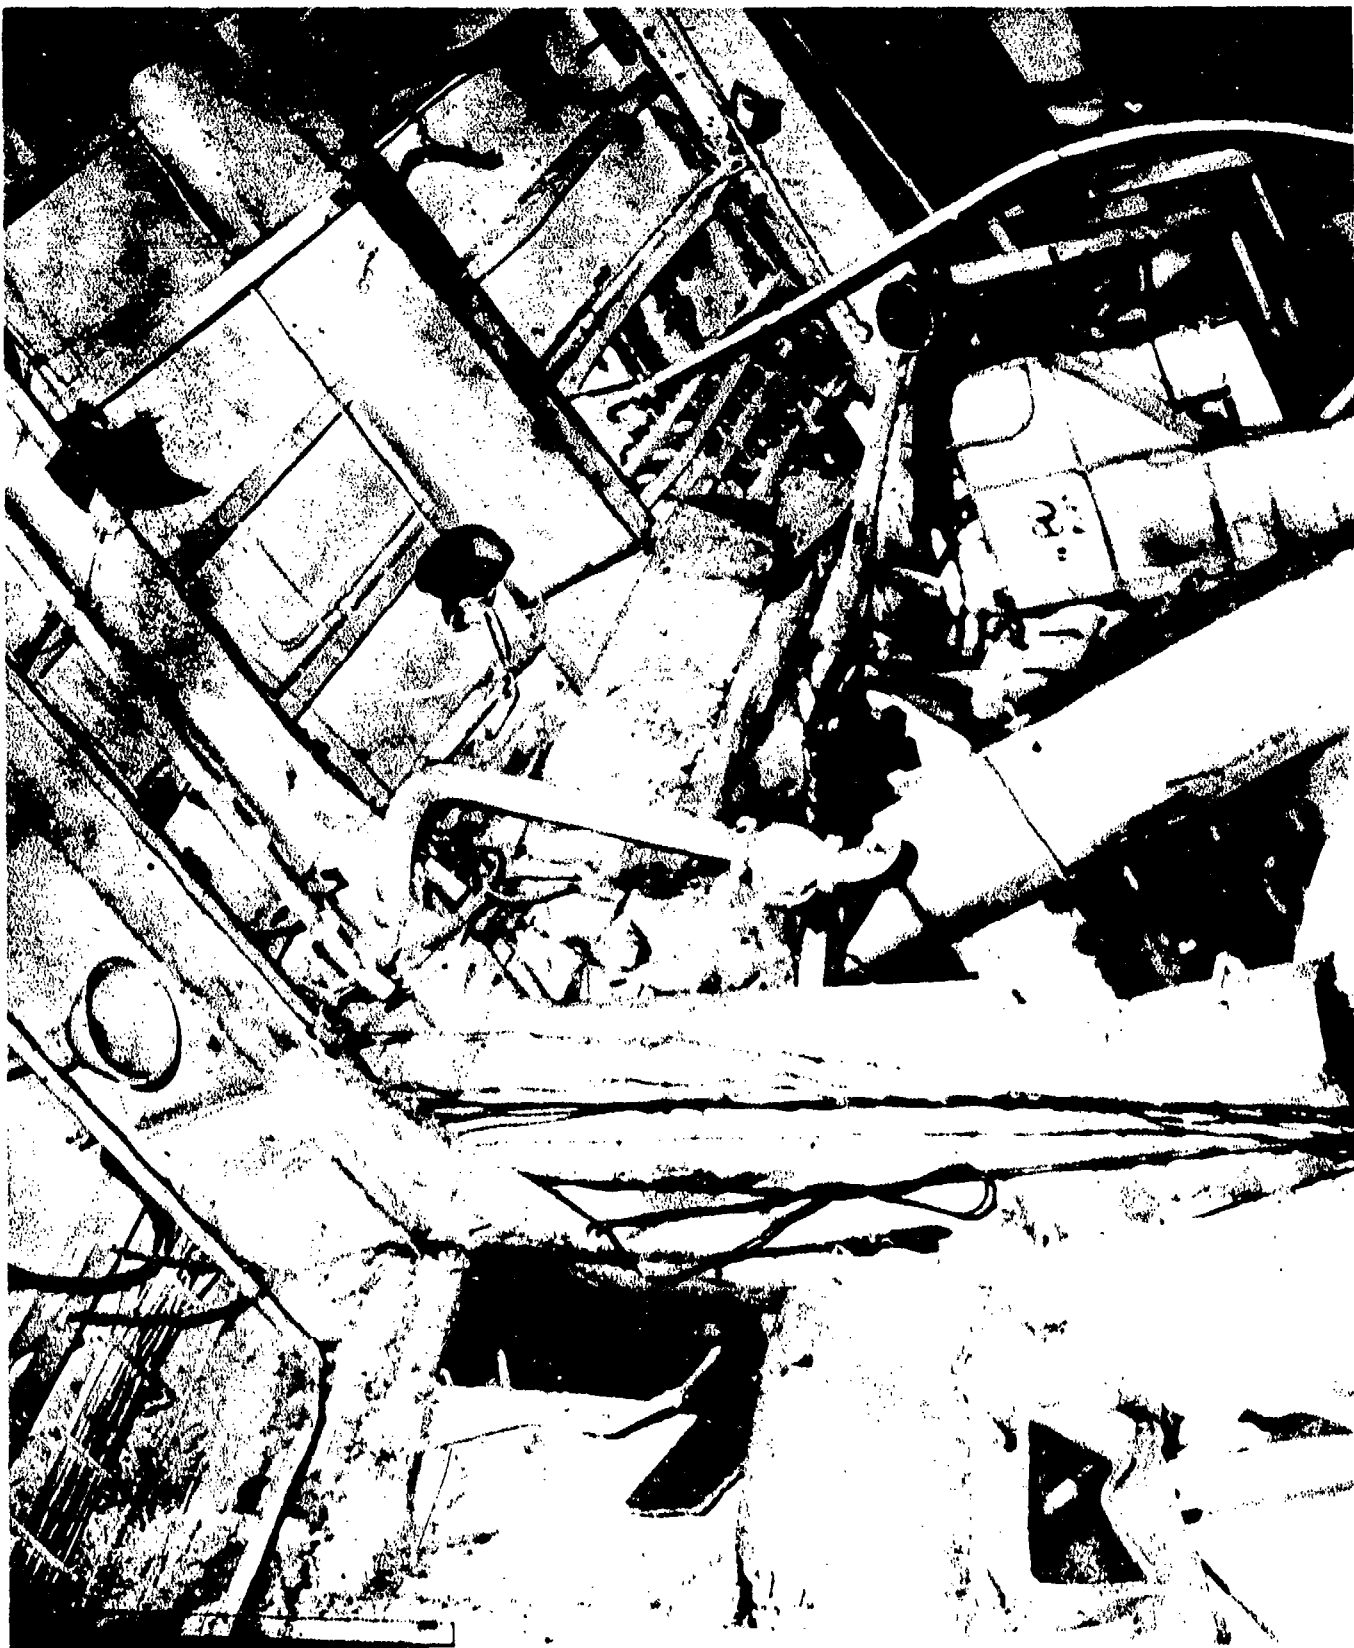
AB-CR-80-4187-2. After Baker. Flight deck Wobble Bents 86 and 83, port top, looking forward.

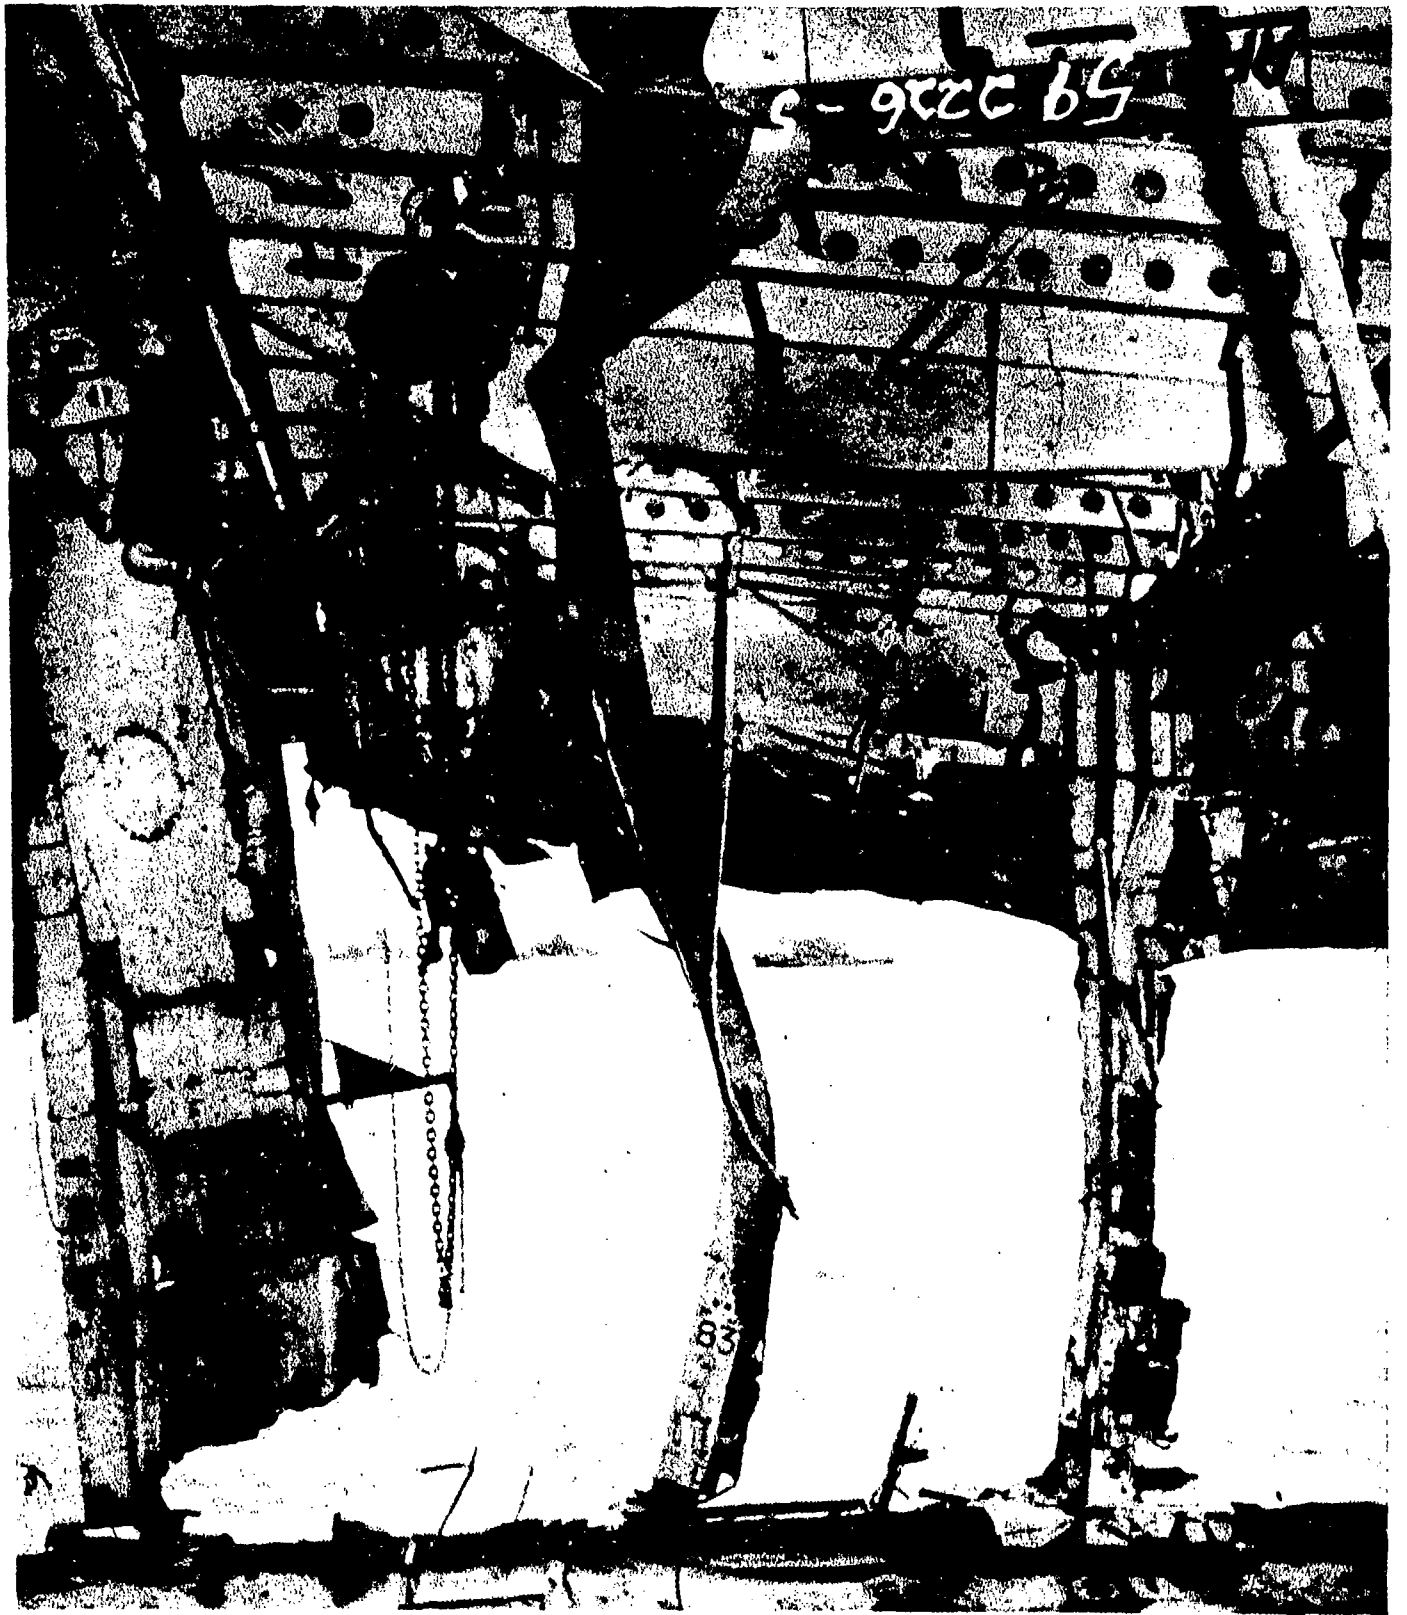
AA-CR-59-2226-5. Wobble Bents 83 and 86, port side.

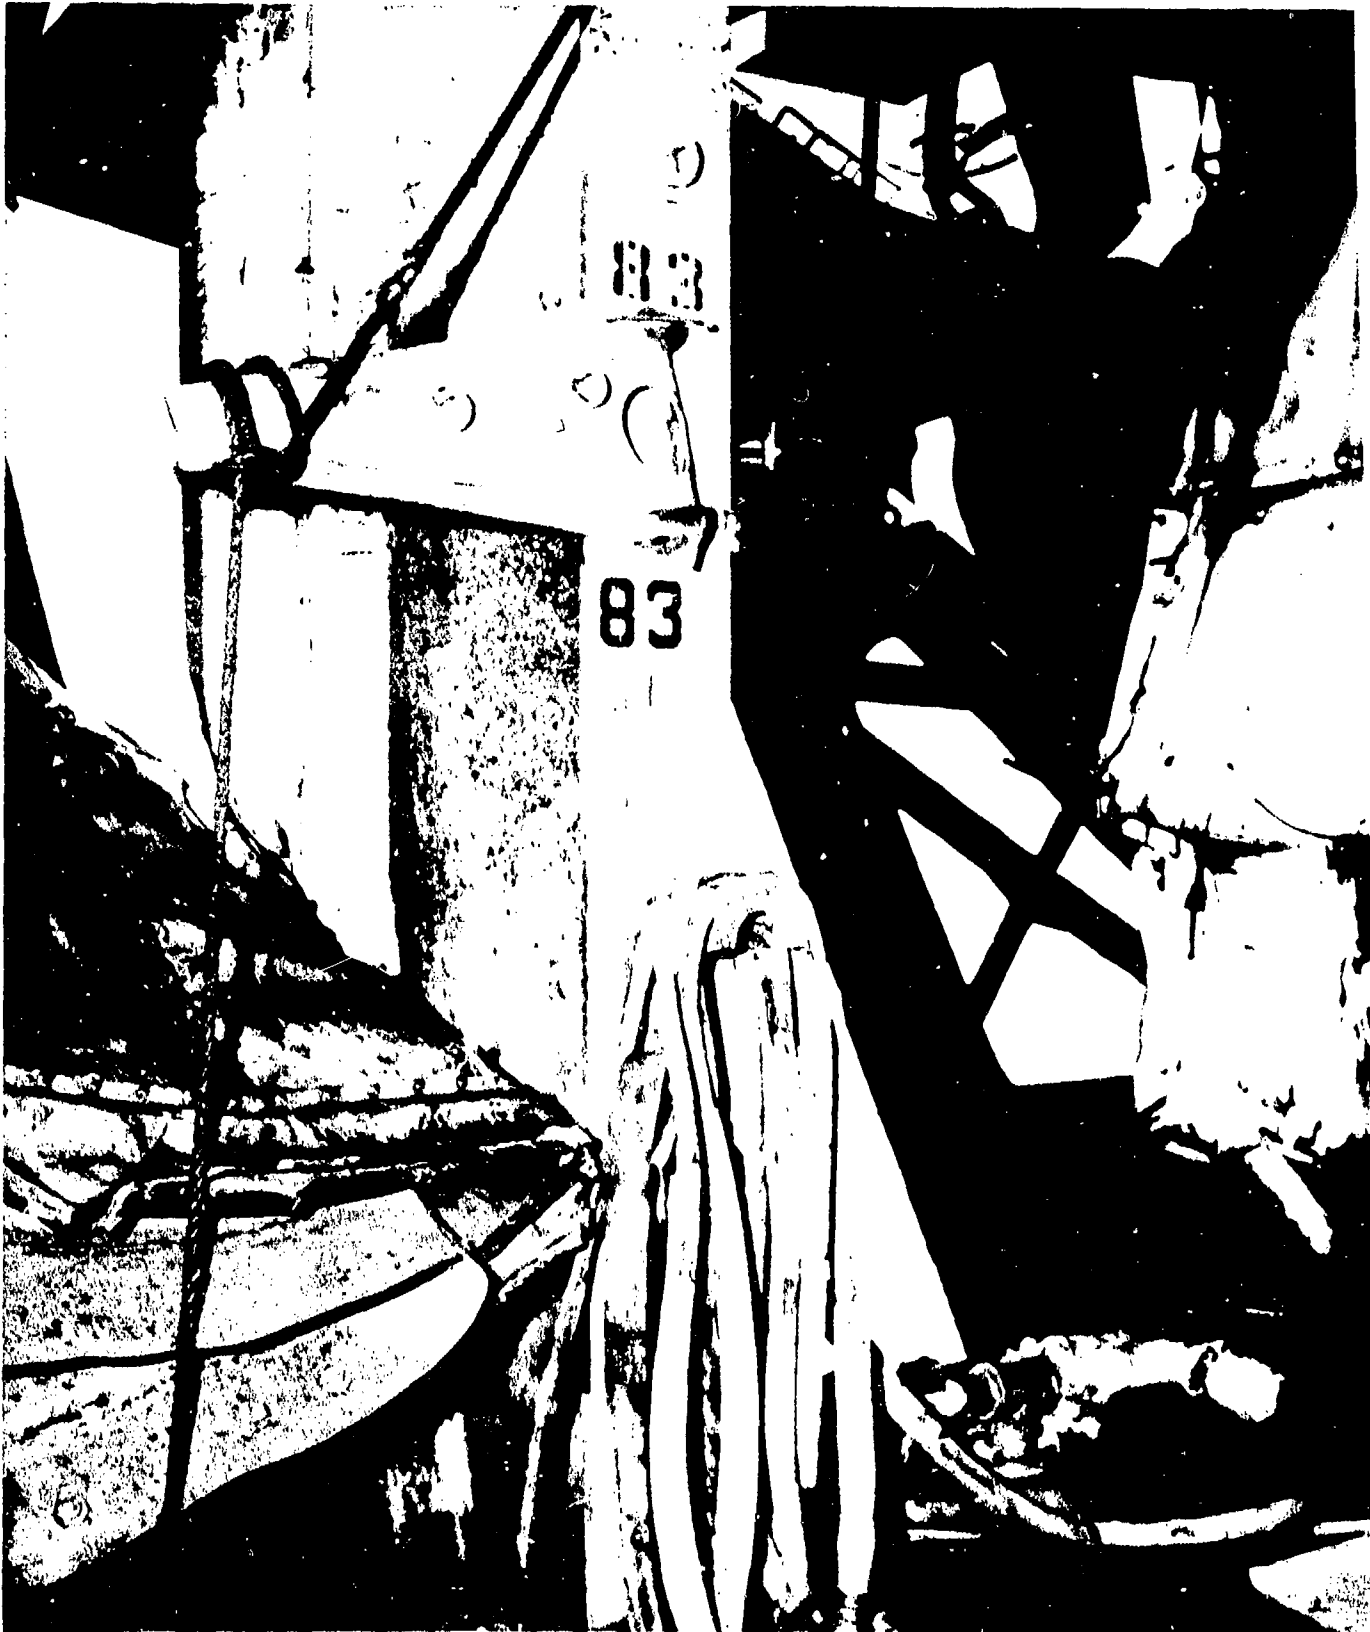
AA-CR-80-4187-1. After Baker. Flight deck Wobble Bent 83, starboard bottom, looking aft.

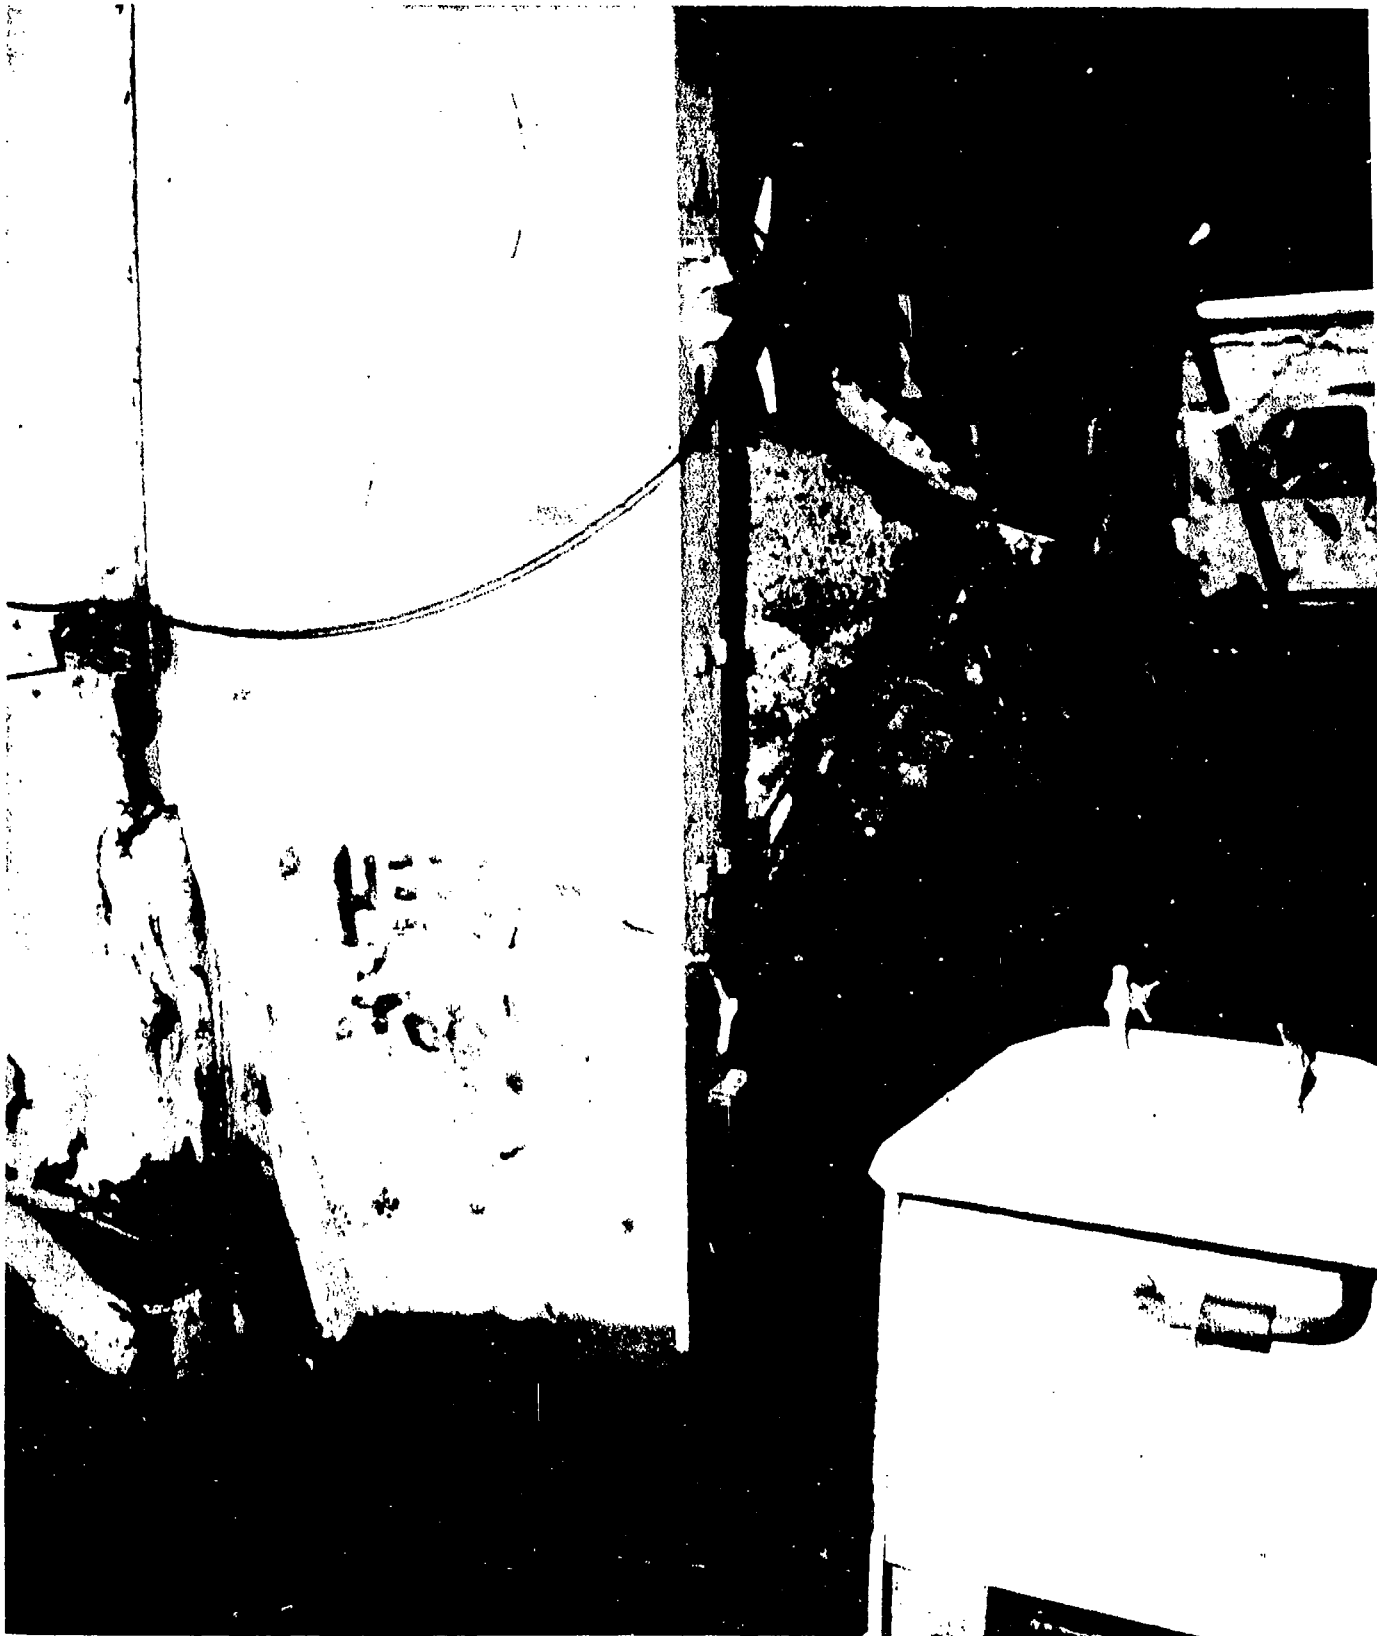
AB-CR-80-4187-5. After Baker. Flight deck Wobble Bent 86, starboard bottom, looking aft.

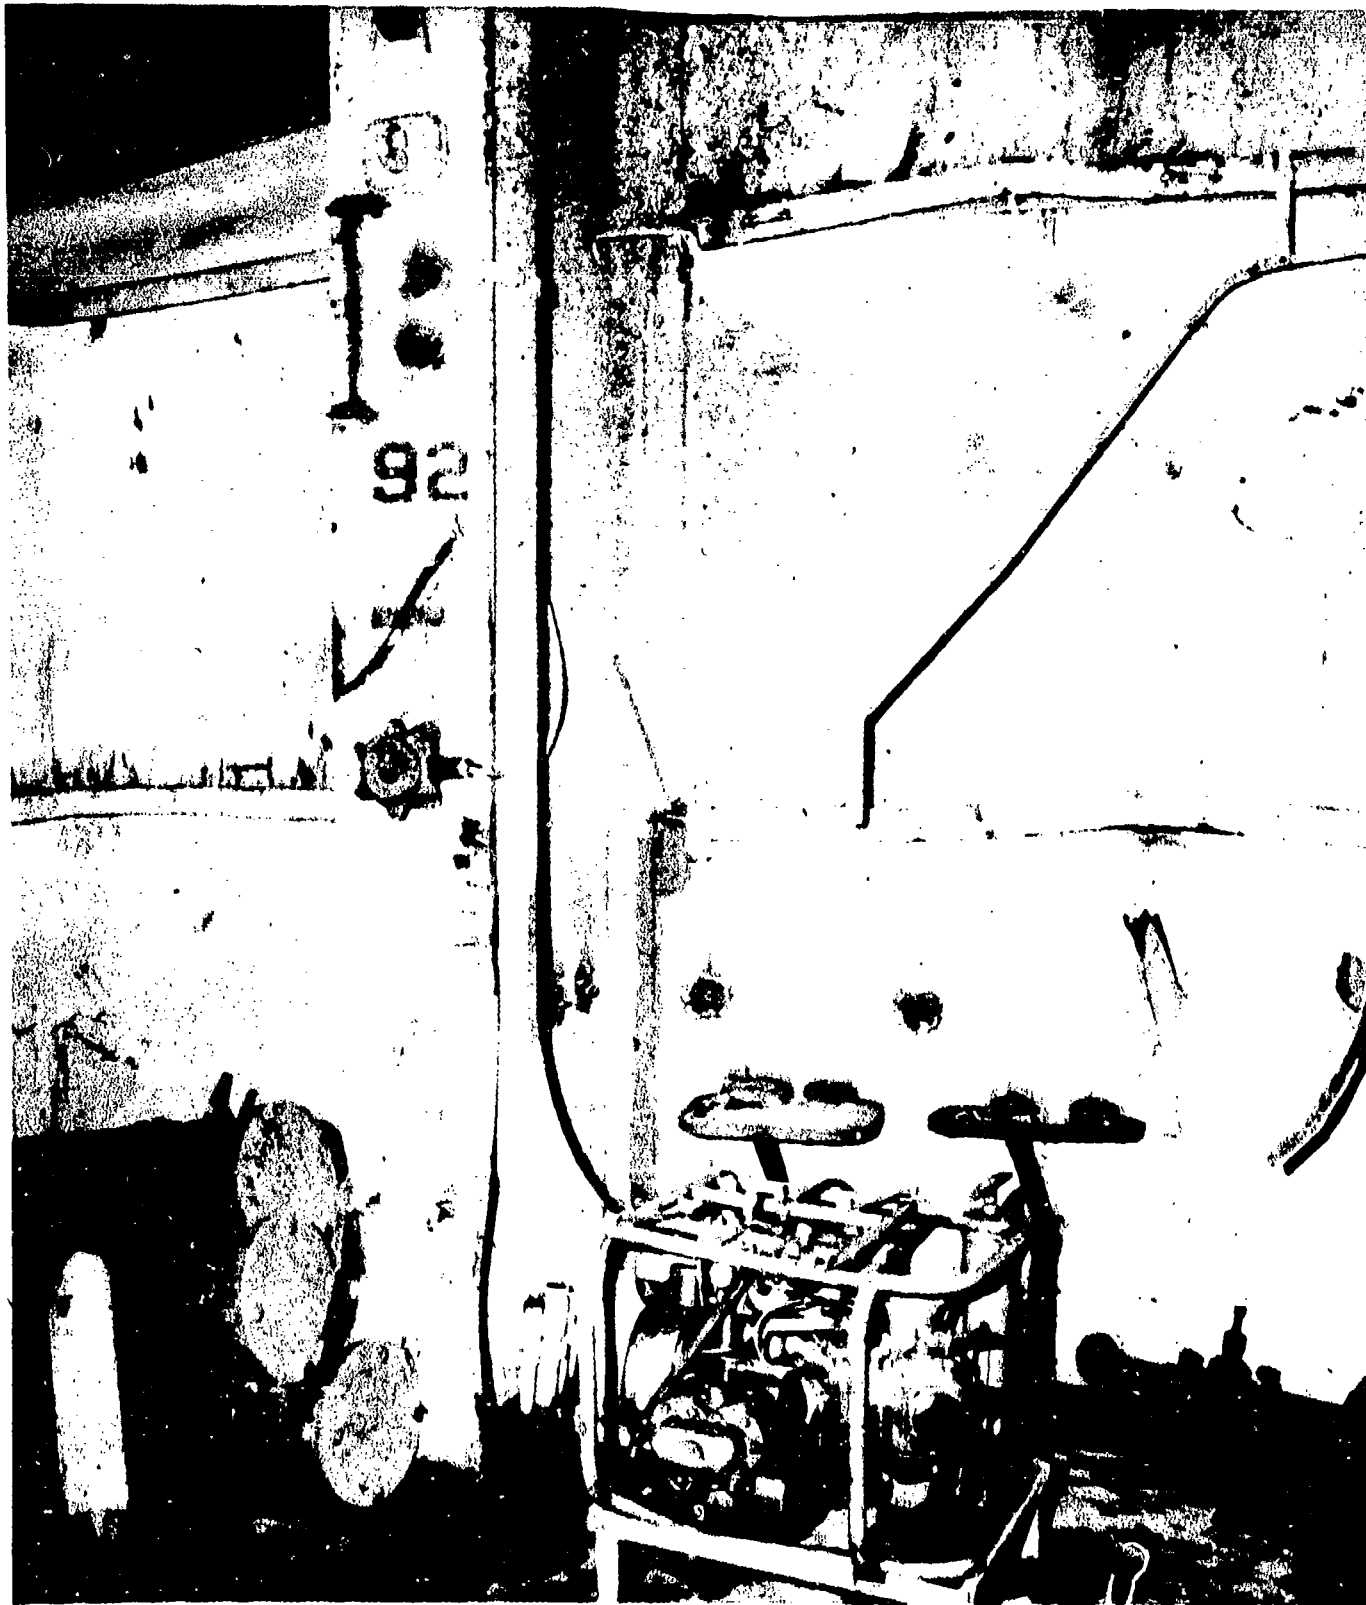
AA-CR-80-4187-8. After Baker - Flight deck Bent 92, starboard bottom, looking starboard and slightly forward.
