TECHNICAL INSPECTION REPORT

OPERATION CROSSROADS.
U.S.S. CRITTENDEN (APA 77)
U.S. NAVY
U.S. BUREAU OF SHIPS
U.S. NAVY REPORT DIRECTLY FROM THE FIELD
TEST ABLE.
U.S. NAVY Support Agency
Washington, D. C. 20301
VOLUME 2 [U].

OPERATION CROSSROADS

BUREAU OF SHIPS GROUP
TECHNICAL INSPECTION REPORT

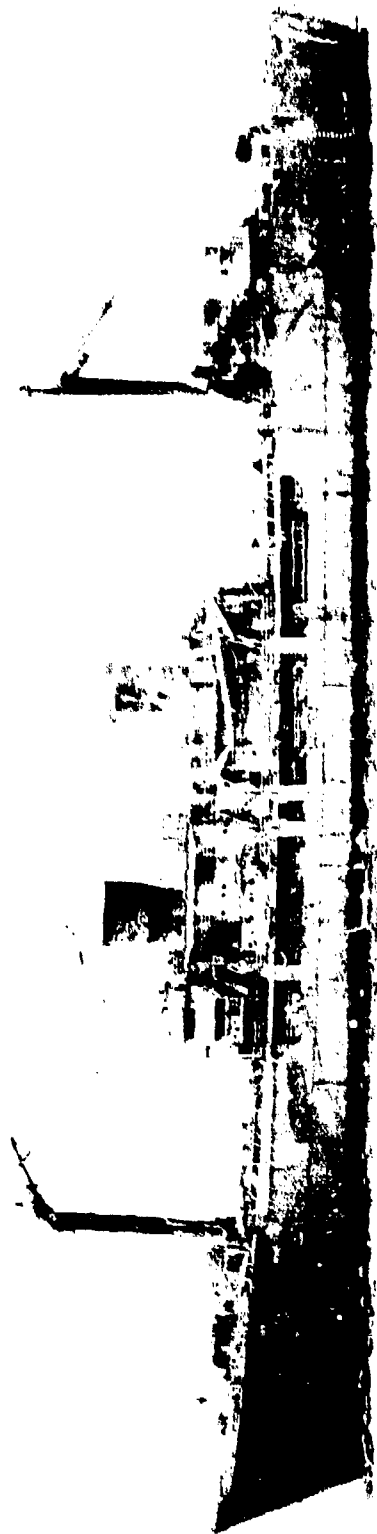
AA-CR-227-49-120. After test Port Beam view.

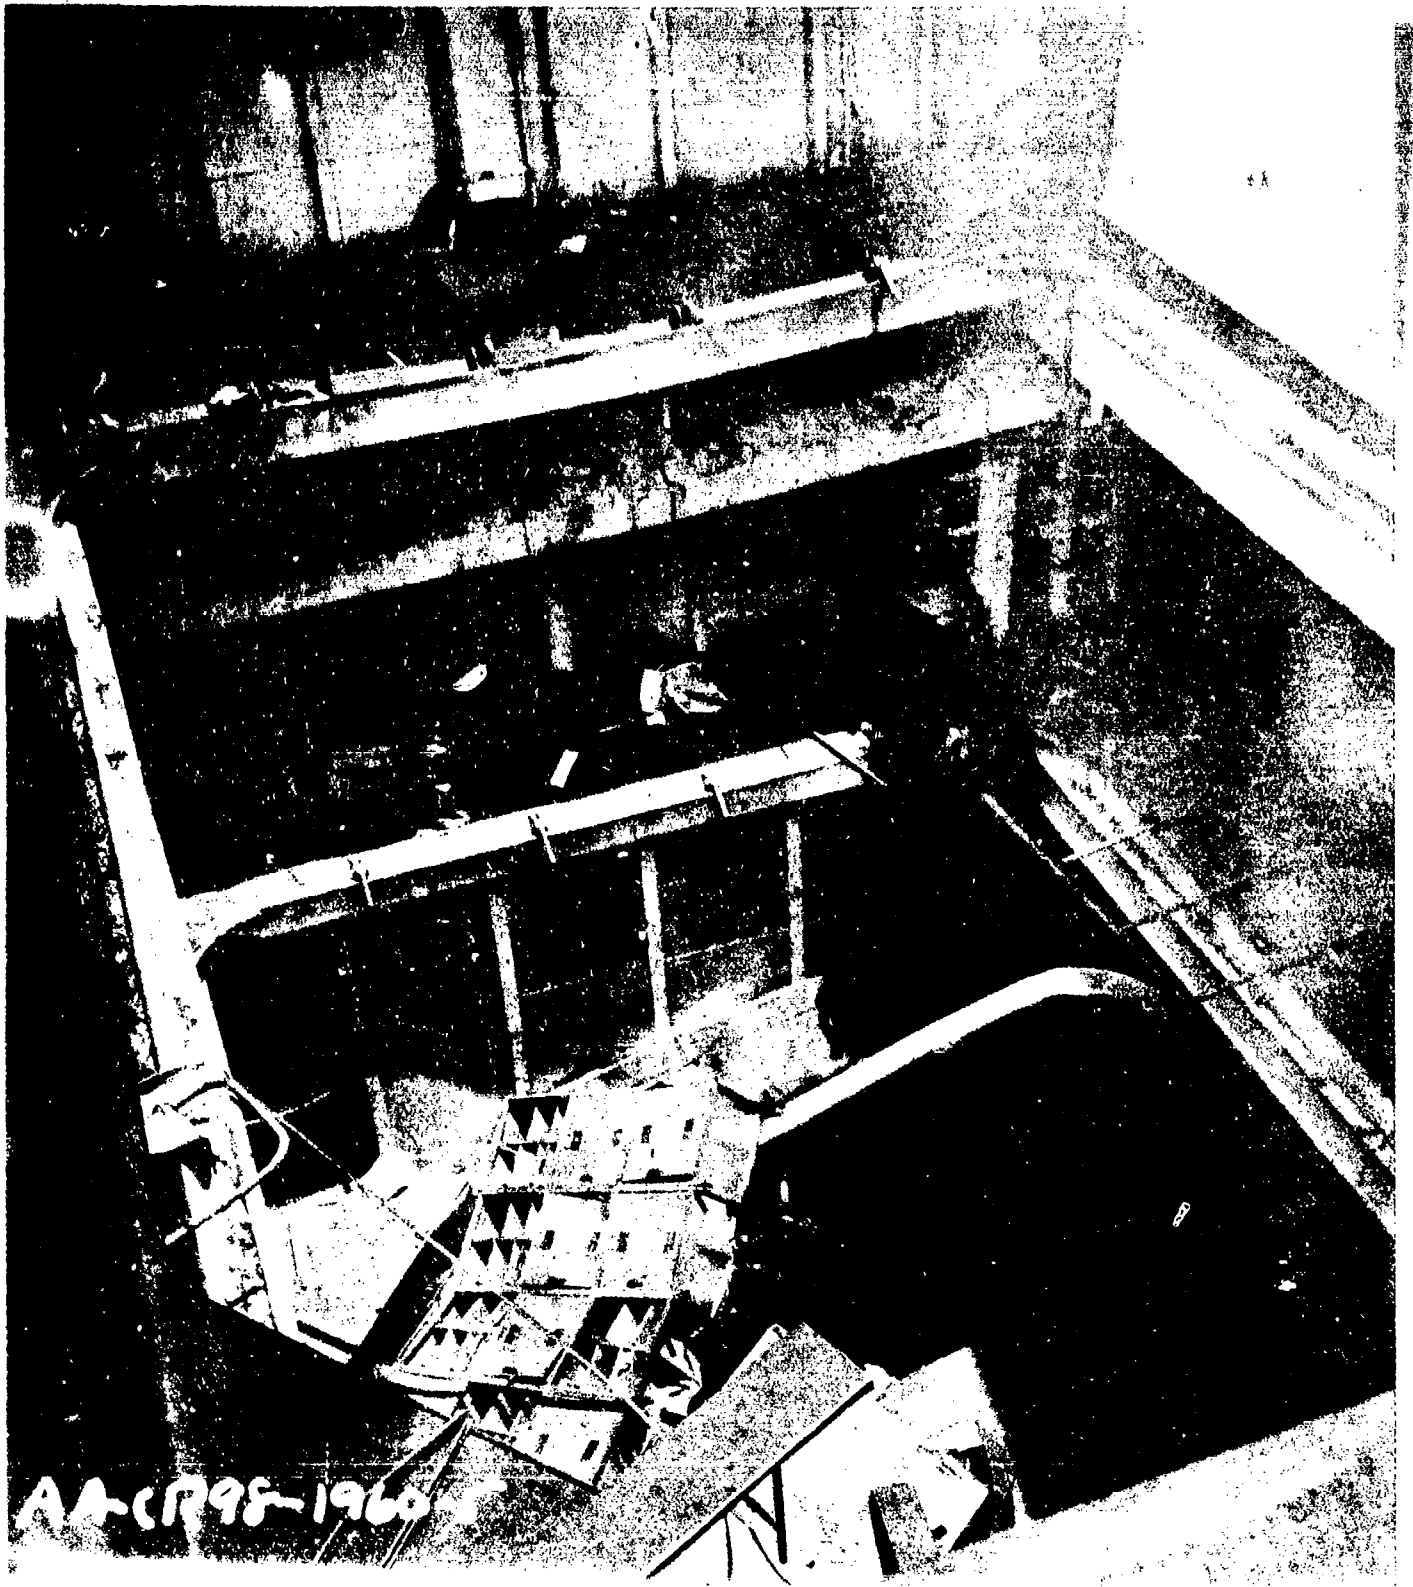
AA-CR-98-1960-5. Looking aft and down into forward cargo hold showing main deck level, first platform level and wreckage in hold.
