TECHNICAL INSPECTION REPORT

(6) OPERATION CROSSROADS,  
U.S.S. NEW YORK (BB34).

TEST BAKER *[initials]*

OPERATION CROSSROADS

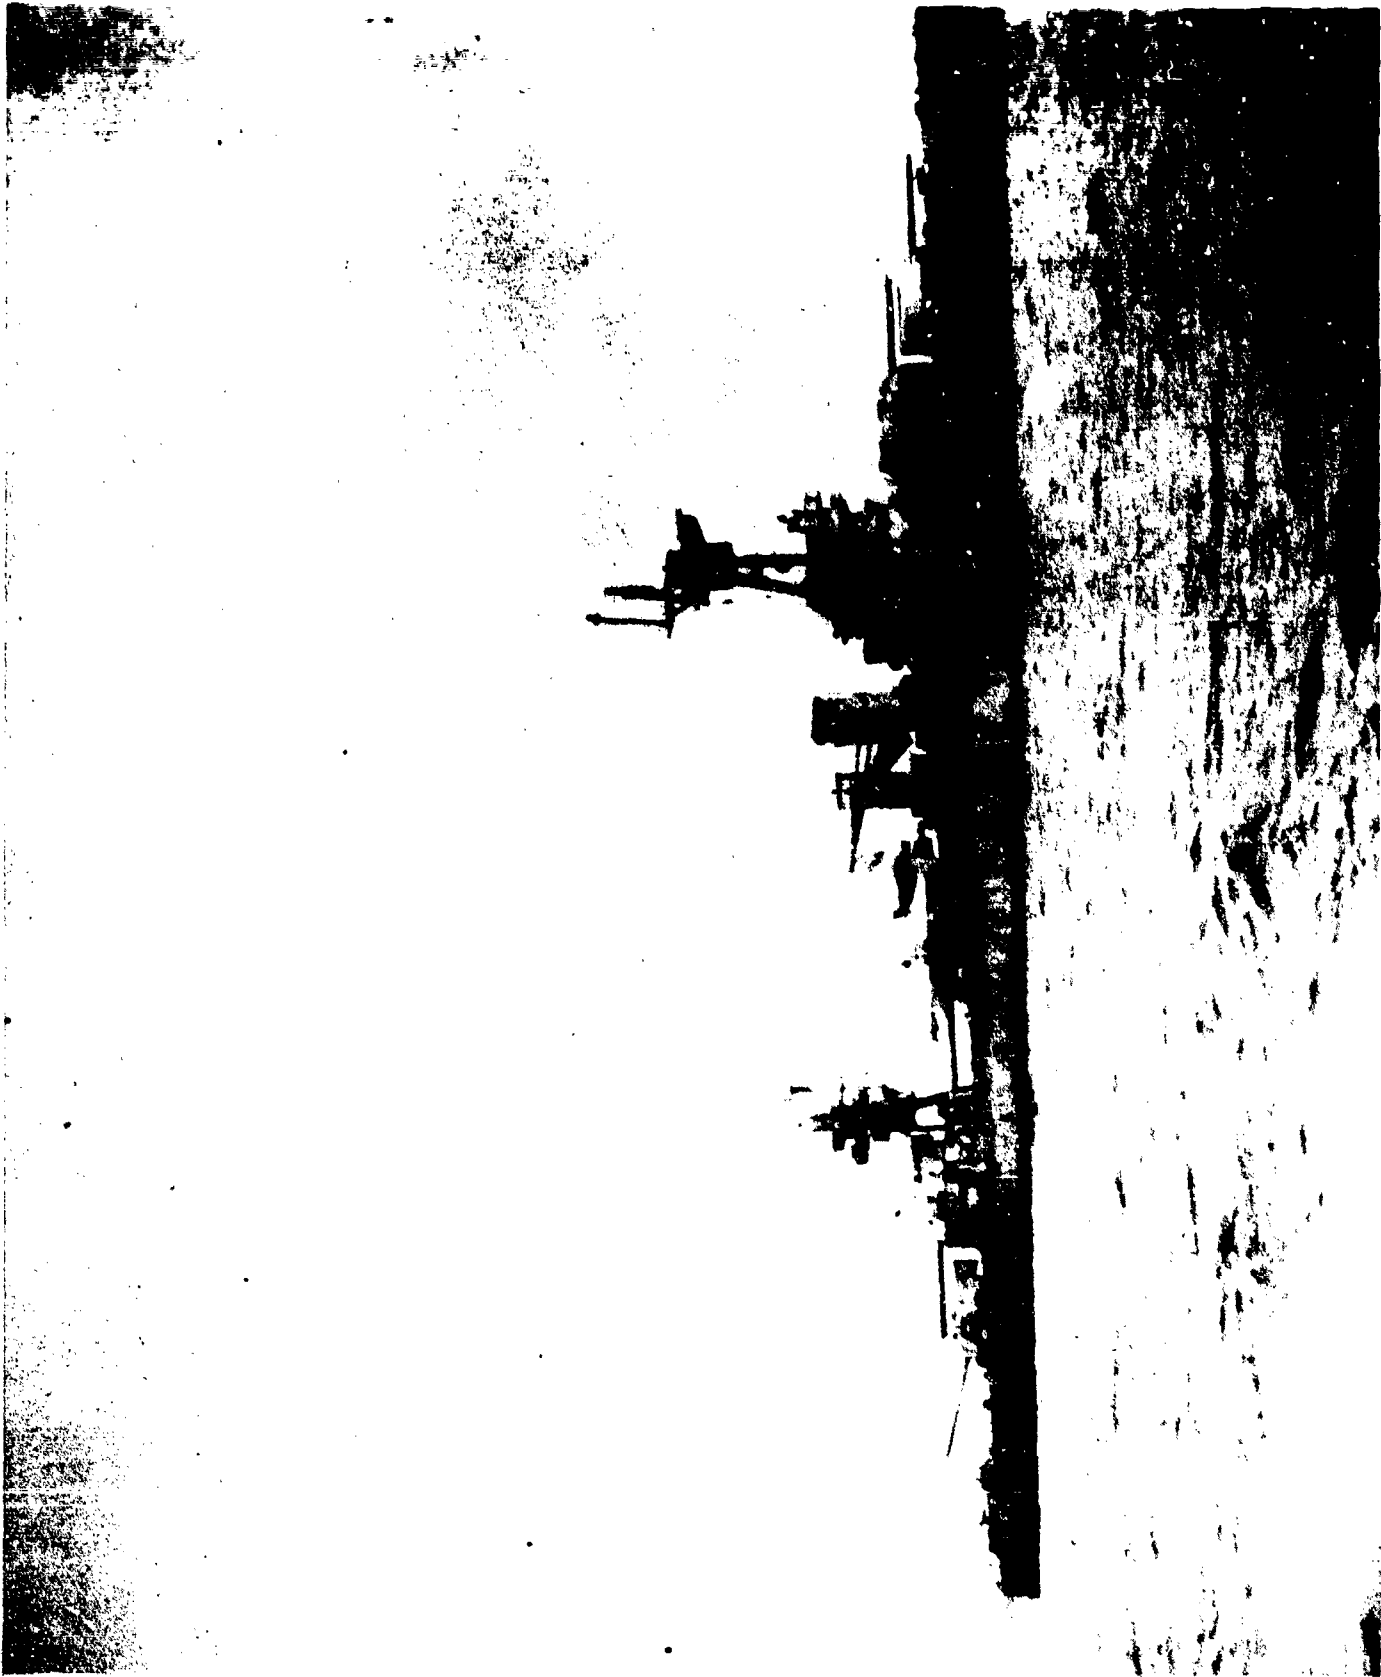
AB-CR-227-289-67. View from off starboard beam after Test B.

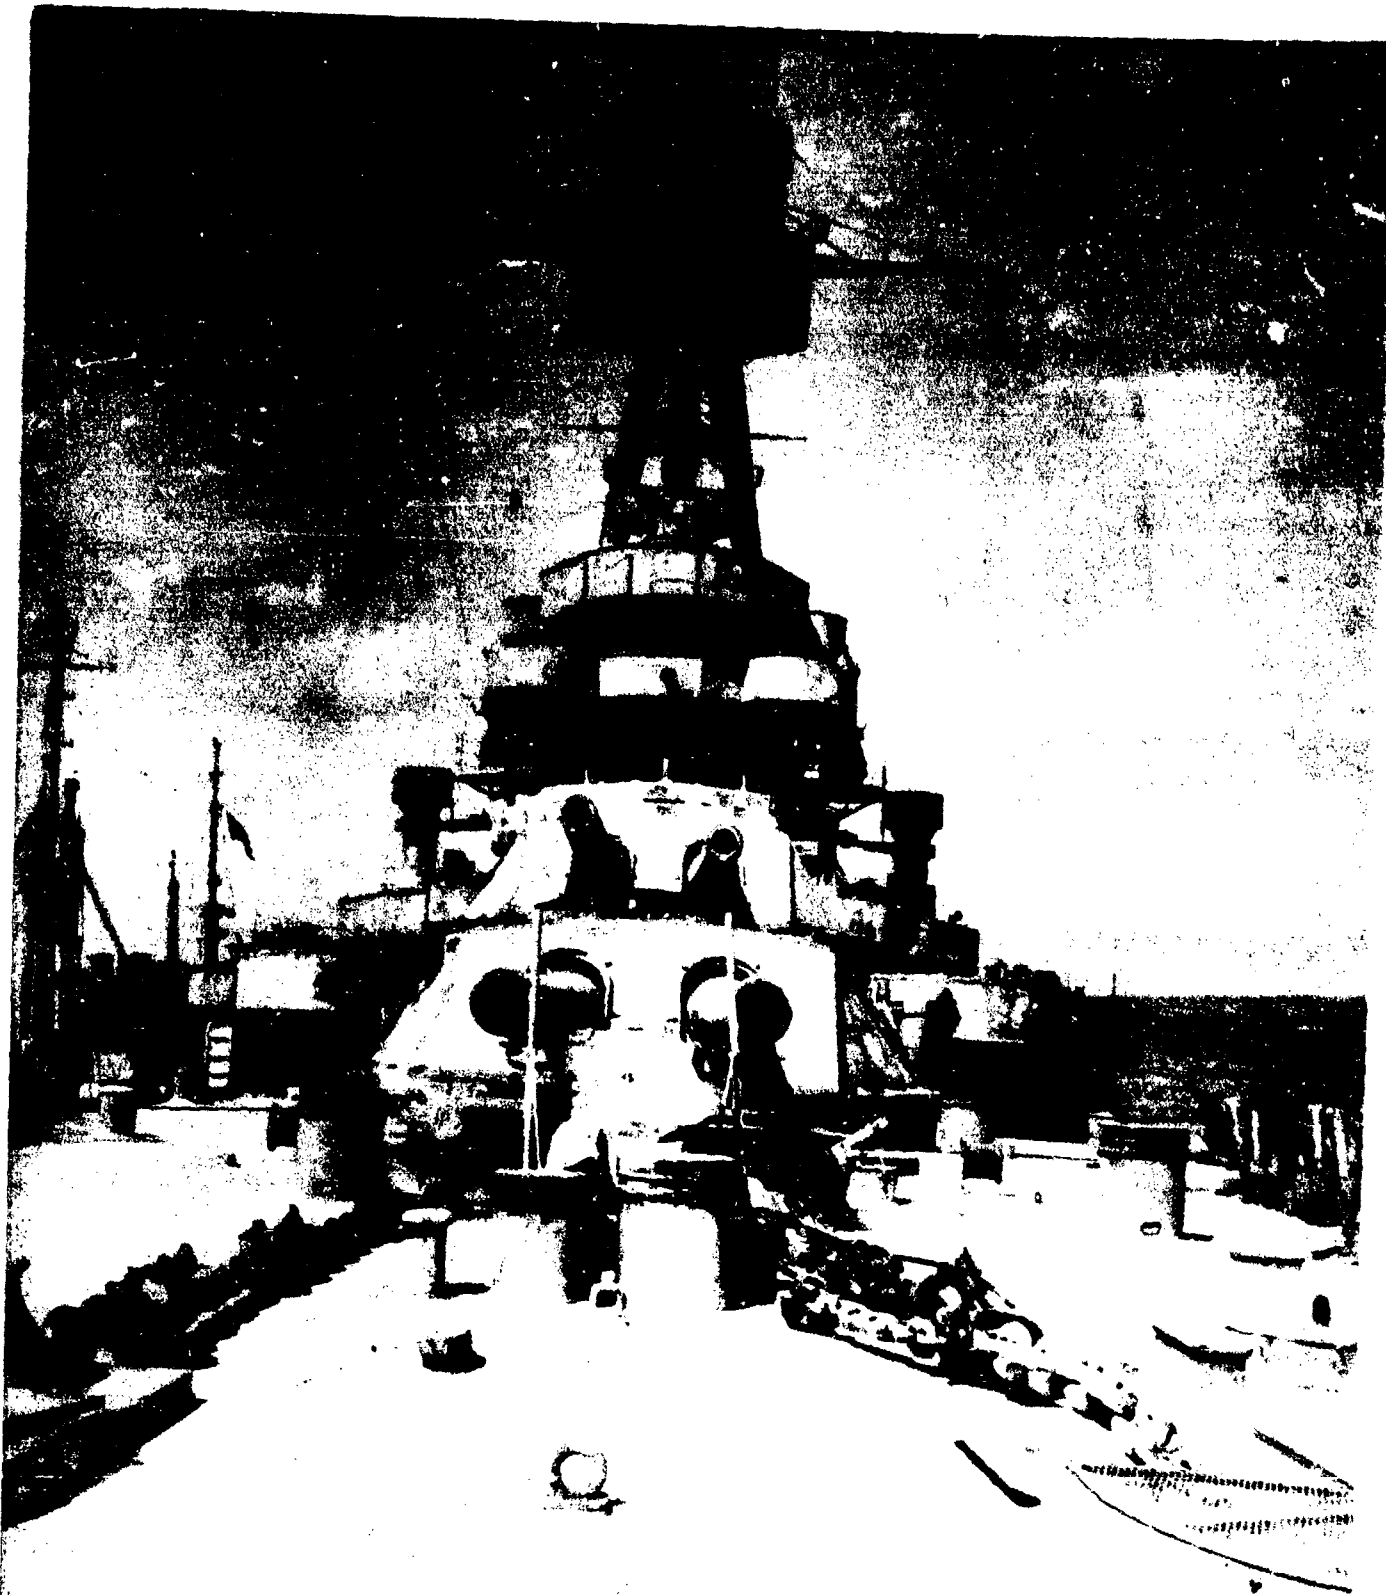
ABCR 68-2953 -1

AB-CR-68-2953-2. Weather deck and forward superstructure from bow of vessel.

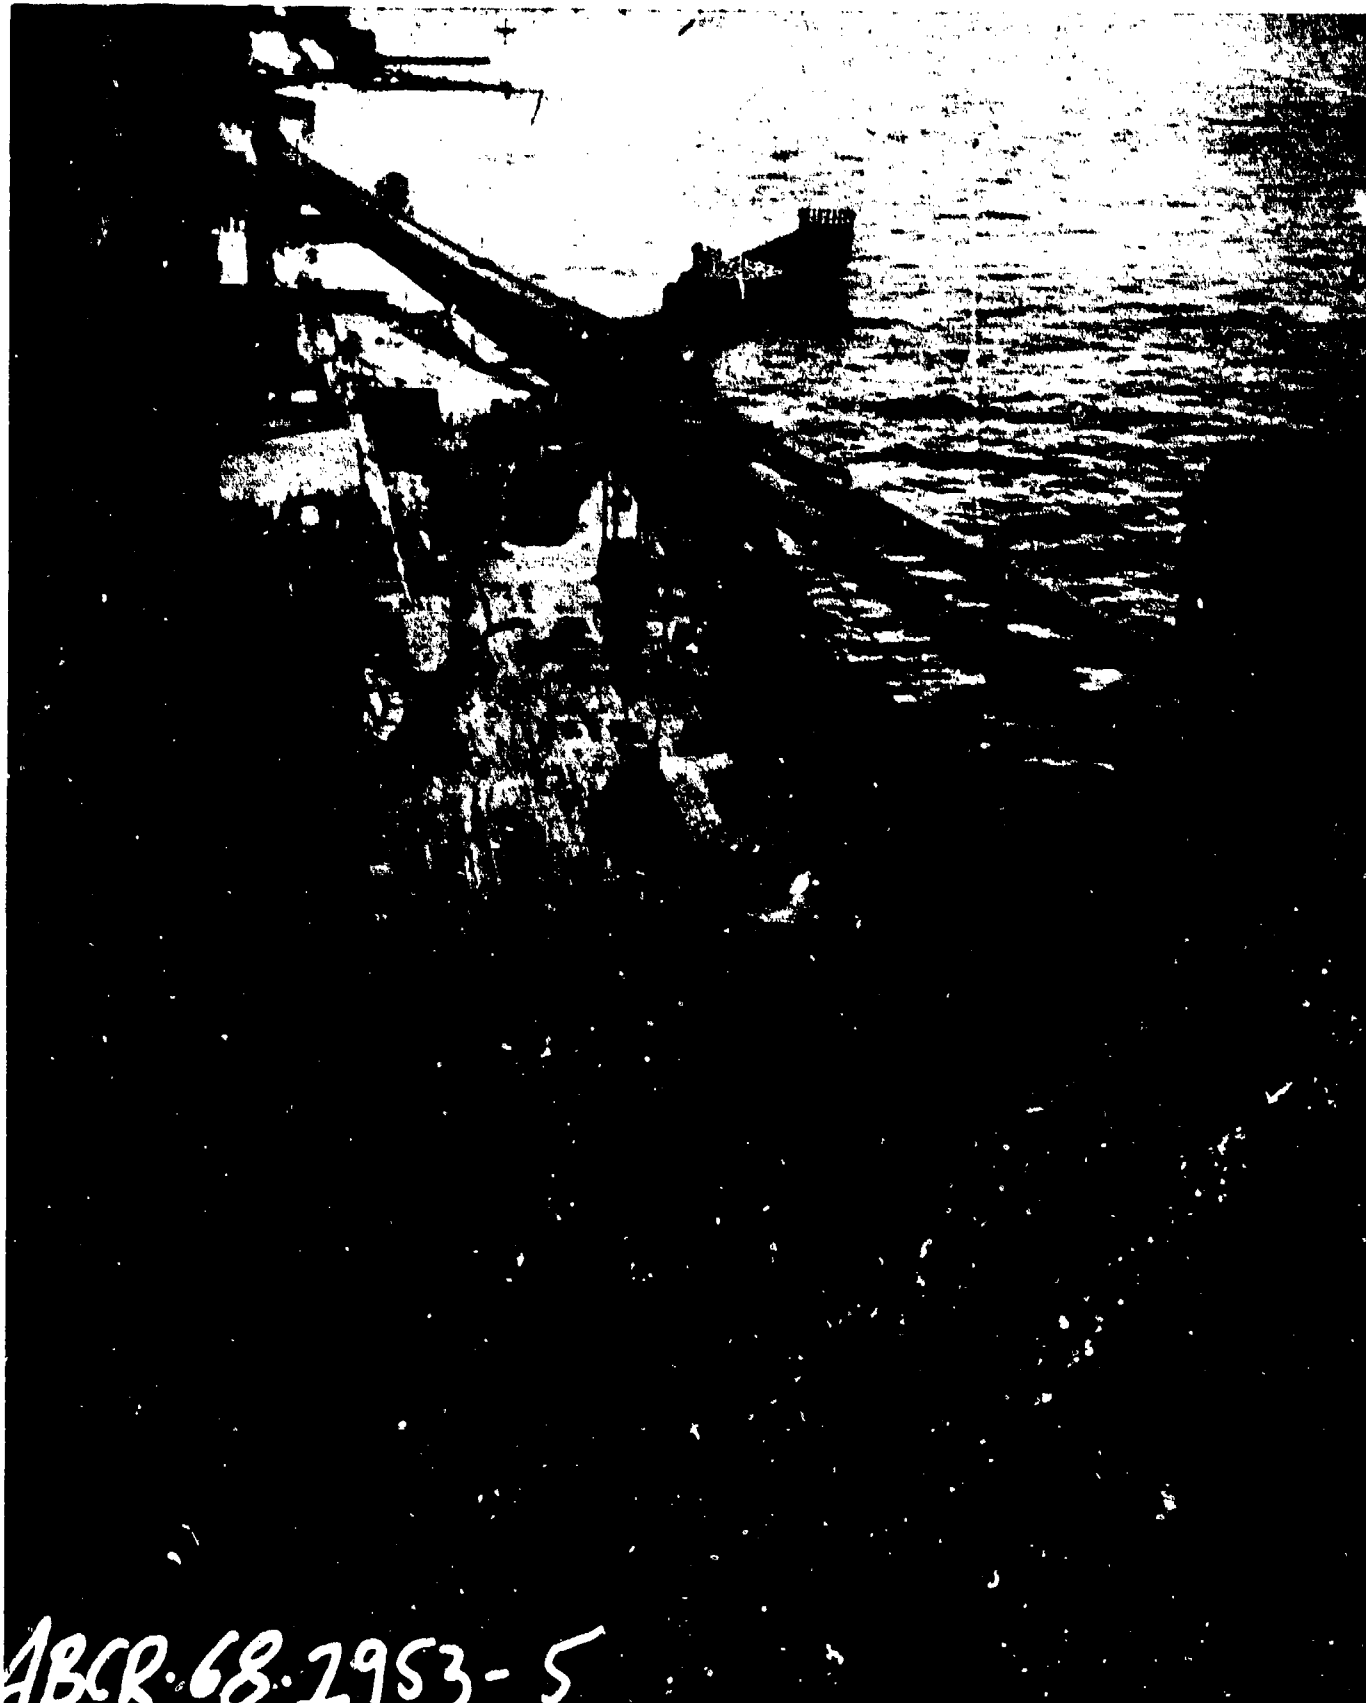
AB-CR-68-2953-5. Looking aft along port side from foremast structure.
